November 2, 2022

ENTECH
ENGINEERING, INC.

Re: Soil, Geology, and Geologic Hazard Study
Parcel No. 51100-01-009
High Forest Estates Subdivision, Filing No. 1
8855 Walker Road
El Paso County, Colorado
Entech Job No. 221954

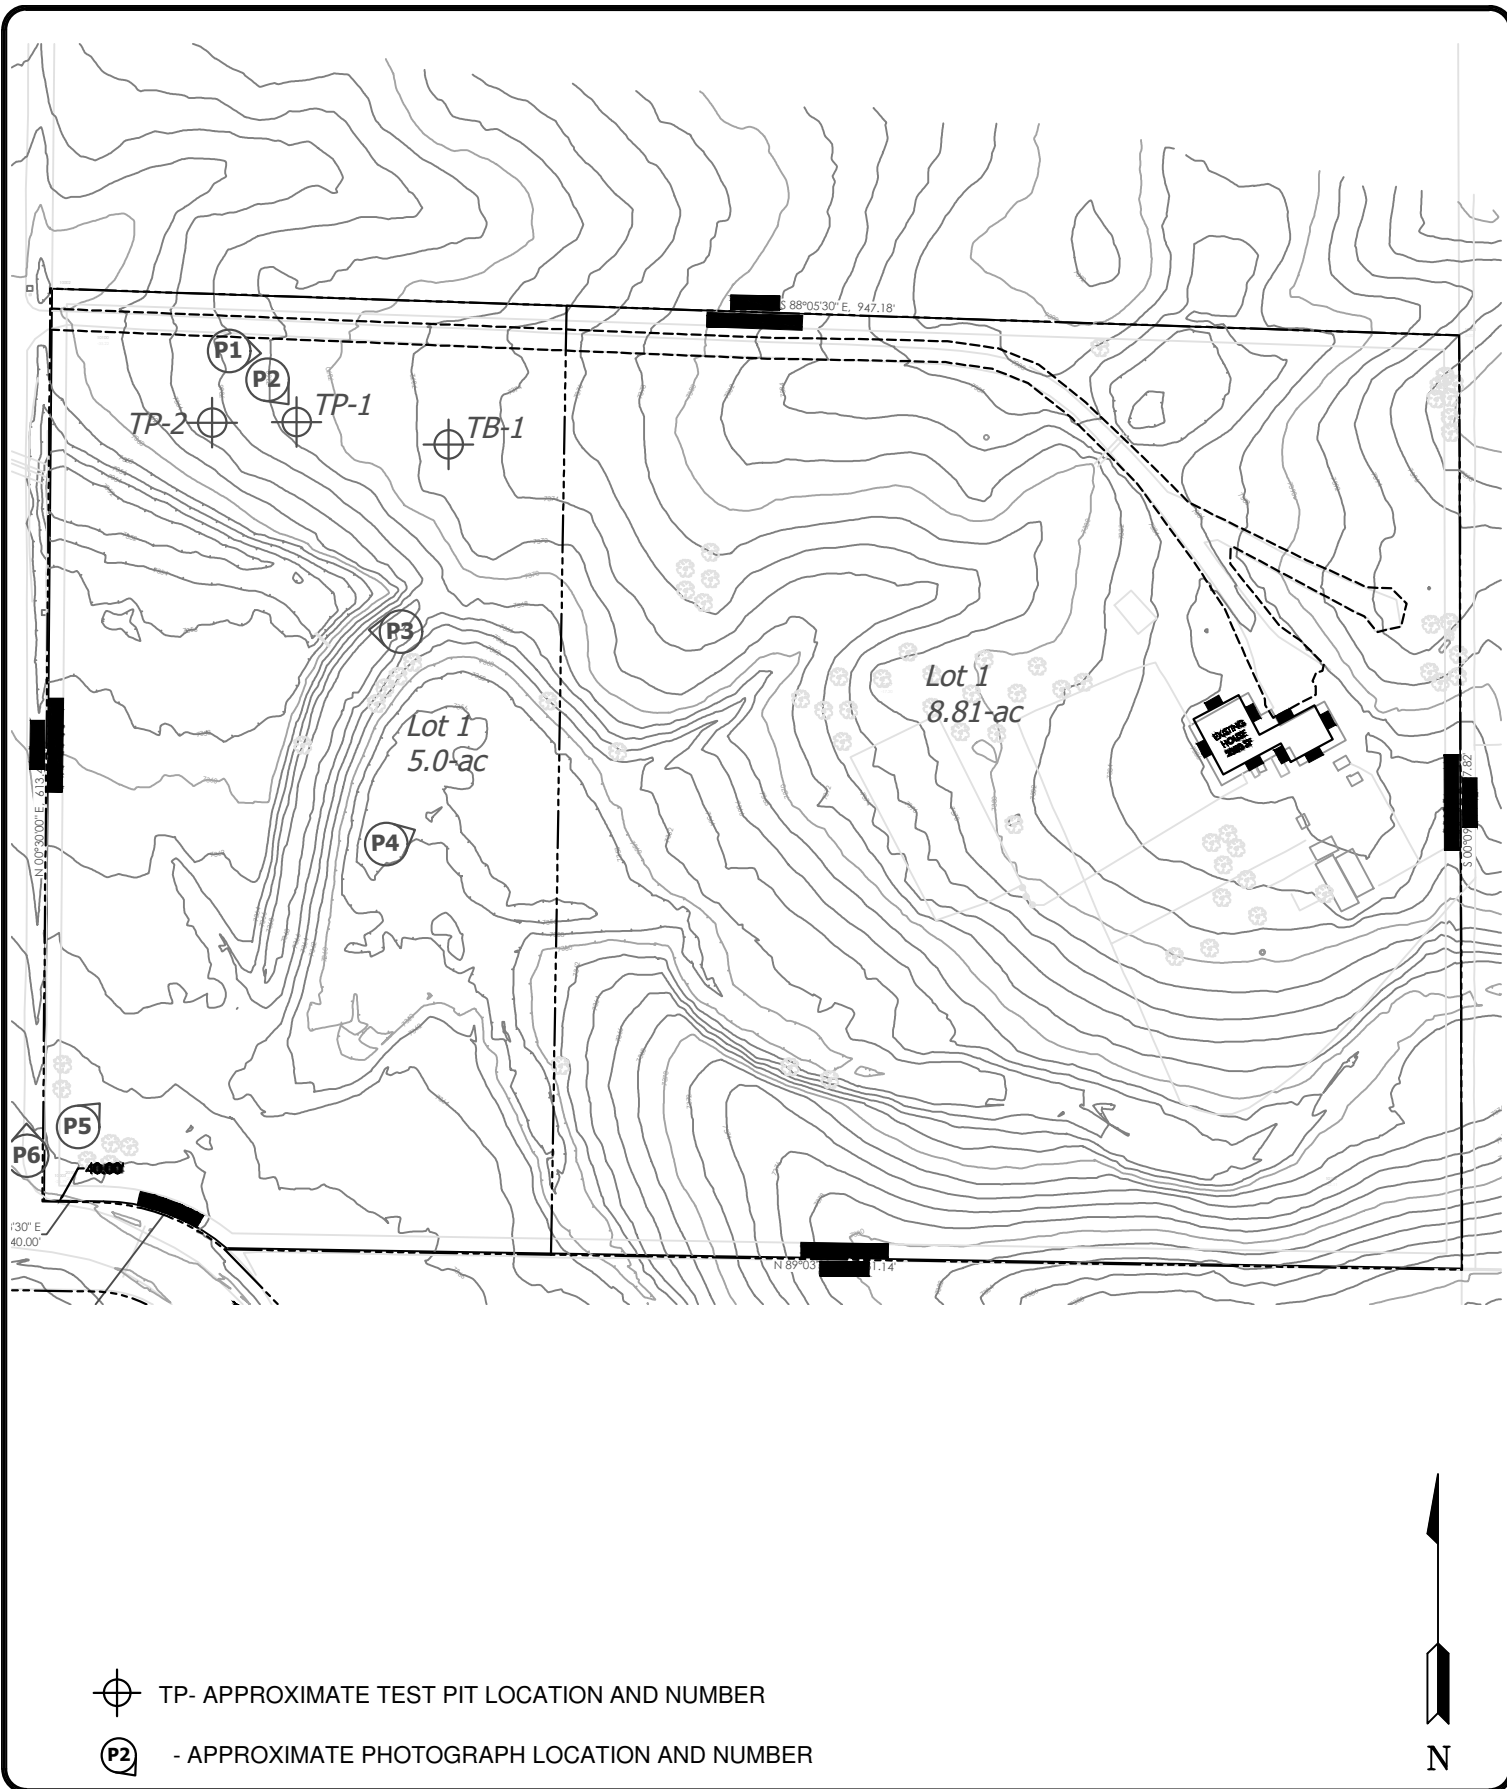
FIG NO.:
3

SITE PLAN/TESTING LOCATION MAP
HIGH FOREST ESTATES SUBDIVISION FIL. NO 1
8855 WALKER ROAD
EL PASO COUNTY, CO.
FOR: PAULA DONOHOO

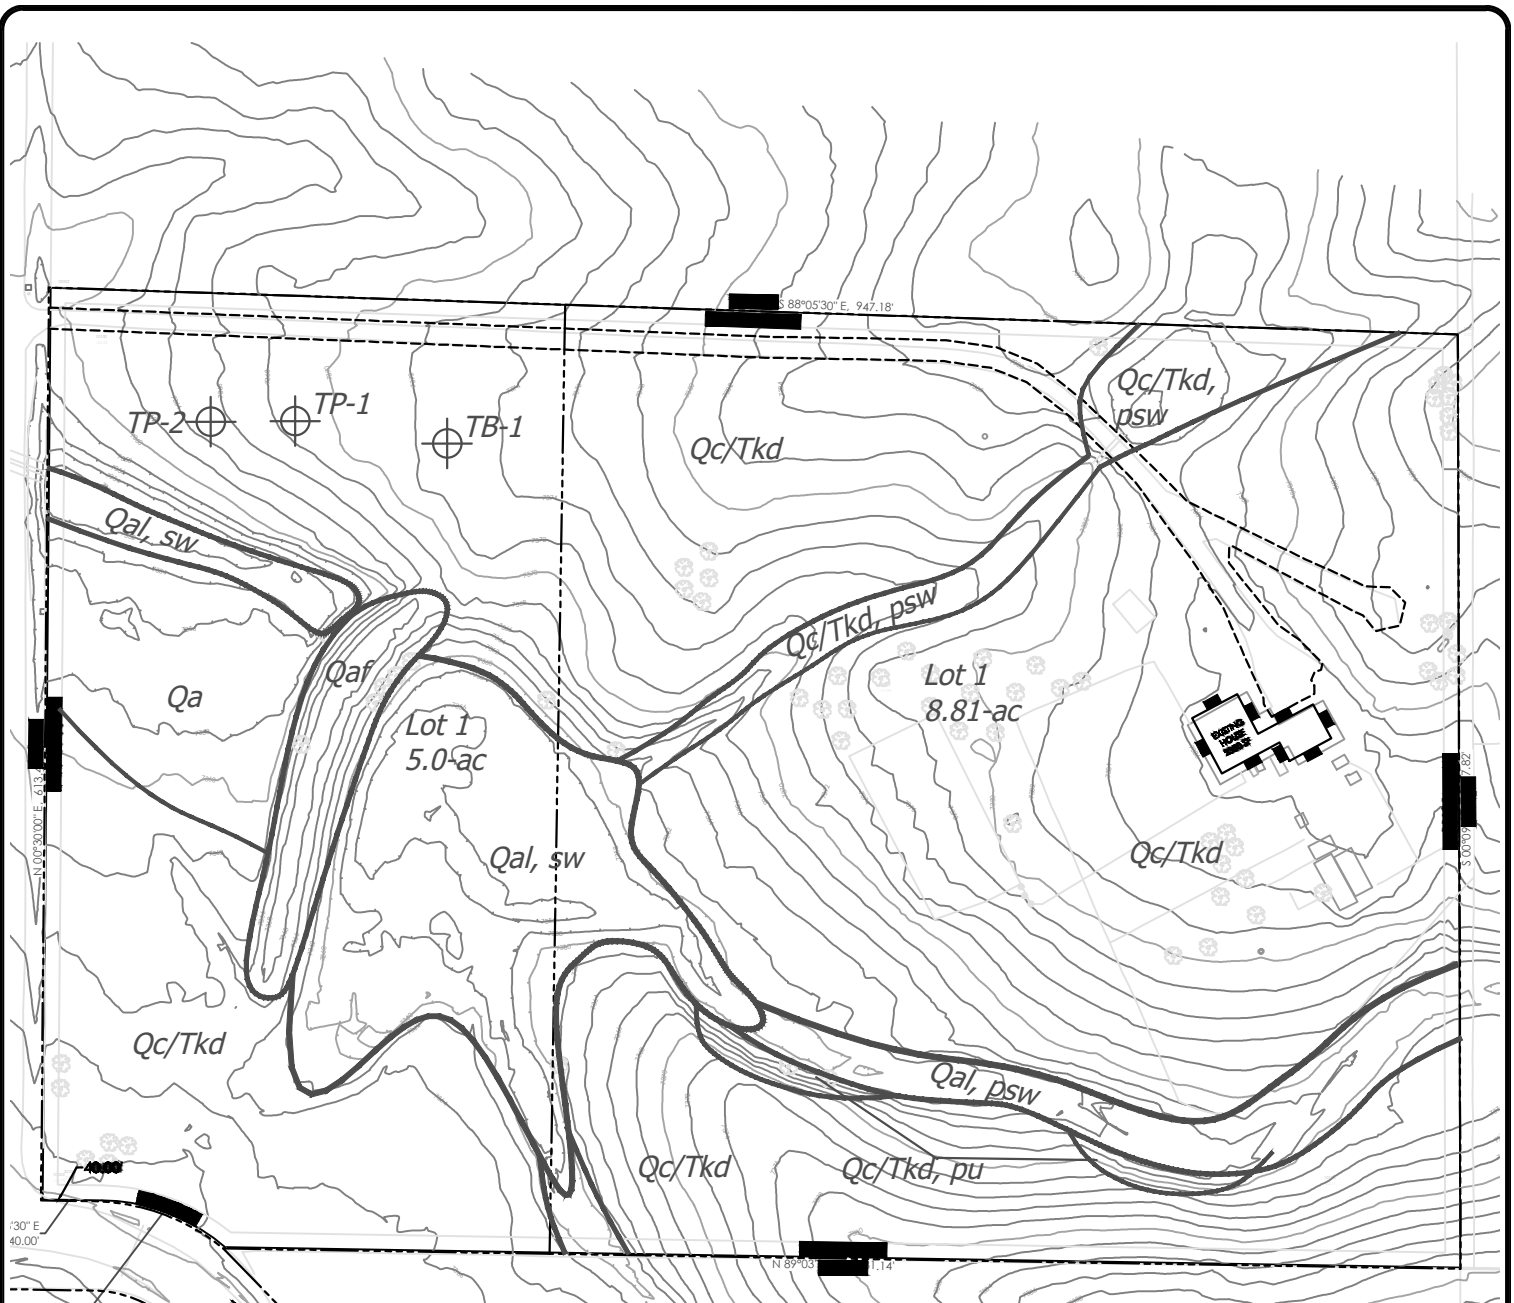
FIG NO.:
6

These are areas of man-made fill associated with an existing dam located in the western portion of the site. The dam is currently in good condition; the inlet and outlet are visible, free of debris, and appear to be functional and in good condition. Areas of fill other than those mapped may exist on the site. The dam will be avoided by the proposed site development on Lot 1.

The majority of the slopes in the building areas on site are gently to moderately sloping and do not exhibit any past or potential unstable slopes or landslides. However, the steeply sloping areas along the drainage on the site have been mapped as potentially unstable slopes. These areas are along the drainage and will be avoided by future site development. The recommendations for these areas are as follows:

Portions of the main drainage area and a minor drainage swale in the northeastern portion of the site in the northeastern portion of the site have been identified as a potentially seasonal shallow groundwater area. In these areas we would anticipate the potential for periodically high subsurface moisture conditions, frost heave potential and highly organic soils. These area lies within defined minor drainage or and will be avoided by the proposed development. Construction in any portions of these areas, if required, or immediately adjacent to these areas should follow these precautions.

These are areas where water is ponded behind earthen dam on-site. These areas will be avoided by development. Water was not observed in the drainage or pond at the time of this investigation, however, review of historical photographs indicate the pond typically has water. The same mitigation techniques for seasonally high groundwater areas are recommended for these seasonally ponded areas as well.

Mitigation: It is anticipated these areas would be avoided by development or regraded. Should any uncontrolled fill be encountered beneath foundations, removal and recompaction at a minimum of 95% of its maximum Modified Proctor Dry Density, ASTM D-1557 will be required.

Mitigation: These slopes lie in the southern of the property along the drainage. Construction is not proposed on these slopes and this hazards will be avoided. Any cuts into the hillside should be no steeper than 3:1 unless held by engineer designed retaining walls.

Mitigation: Foundations must have a minimum 30-inch depth for frost protection. In areas where high subsurface moisture conditions are anticipated periodically, subsurface perimeter drains are recommended to help prevent the intrusion of water into areas below grade. Typical drain details are presented in Figure 8. Any grading in these areas should be done to direct surface flow around construction to avoid areas of ponded water. All organic material would be completely removed prior to any fill placement. **Specific drainage studies are beyond the scope of this report.**

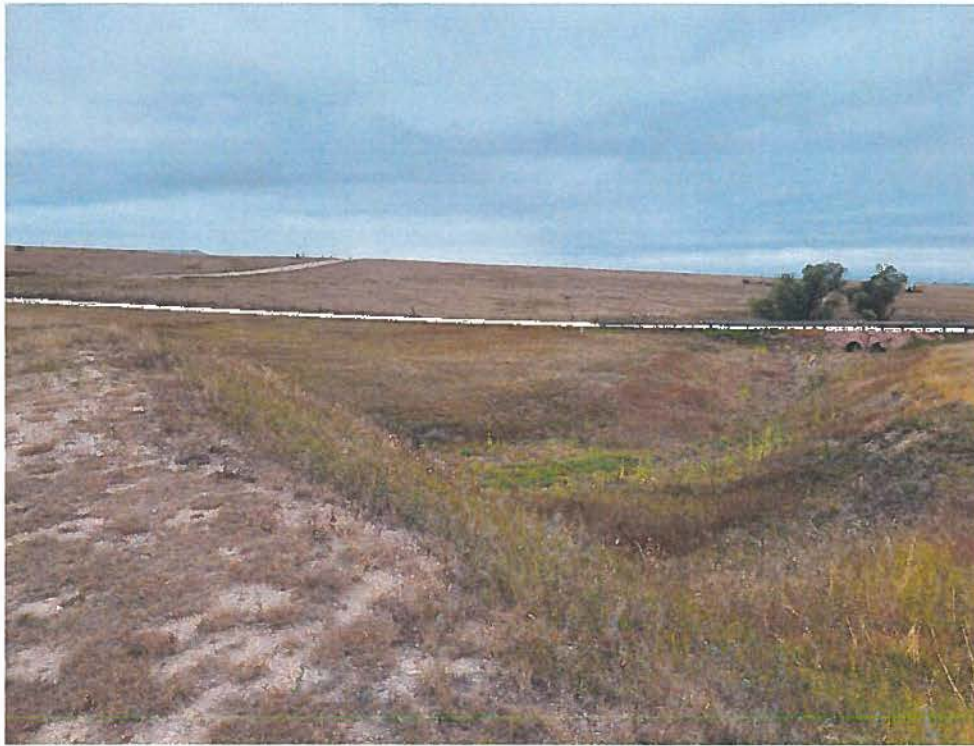
**Looking west from
earthen dam along
drainage towards
Walker Road.**

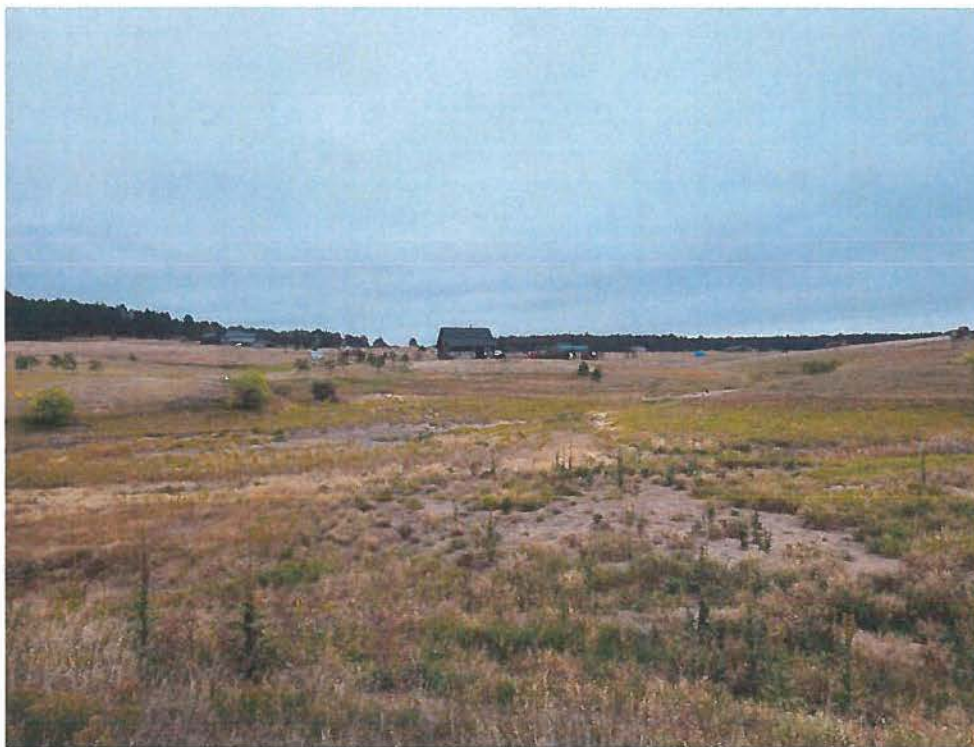
**Looking east from the
pond in the western
portion of the site.**
