ENTECH
ENGINEERING, INC.

September 22, 2021
Revised November 16, 2023

Re: Soil, Geology and Geologic Hazard Evaluation
Joyful View Subdivision
Joyful View & Peyton Highway
Schedule Nos. 33000-00-466 & 33000-00-467
El Paso County, Colorado

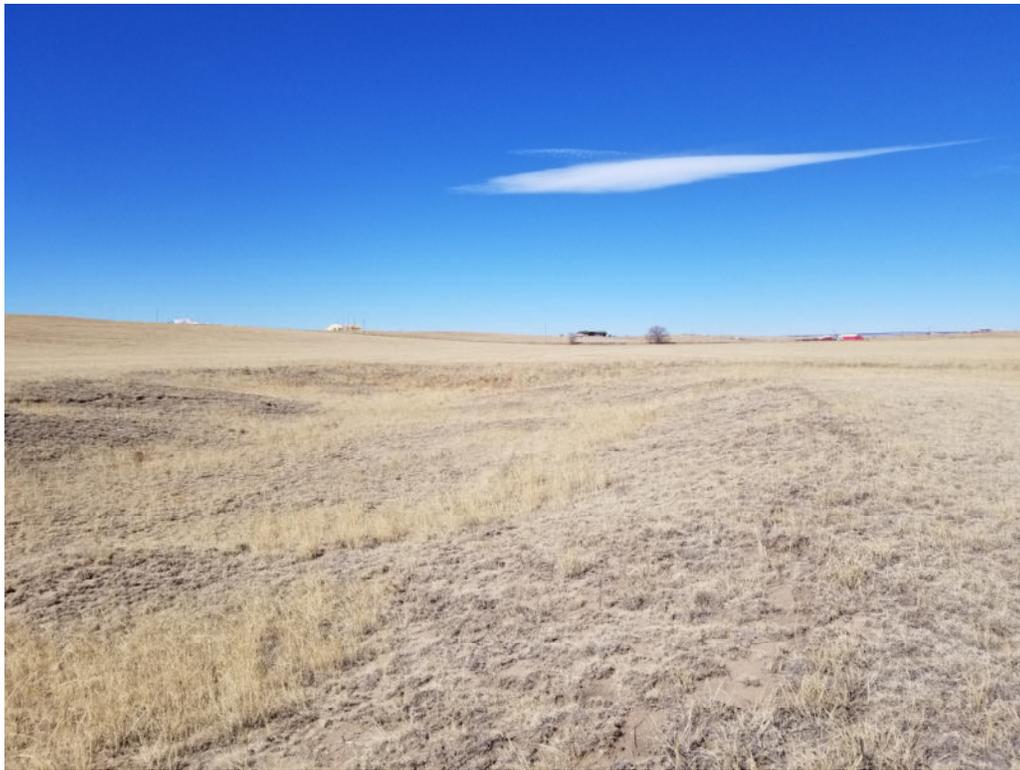
**Looking northwest
along drainage in the
southeastern portion
of the site.**

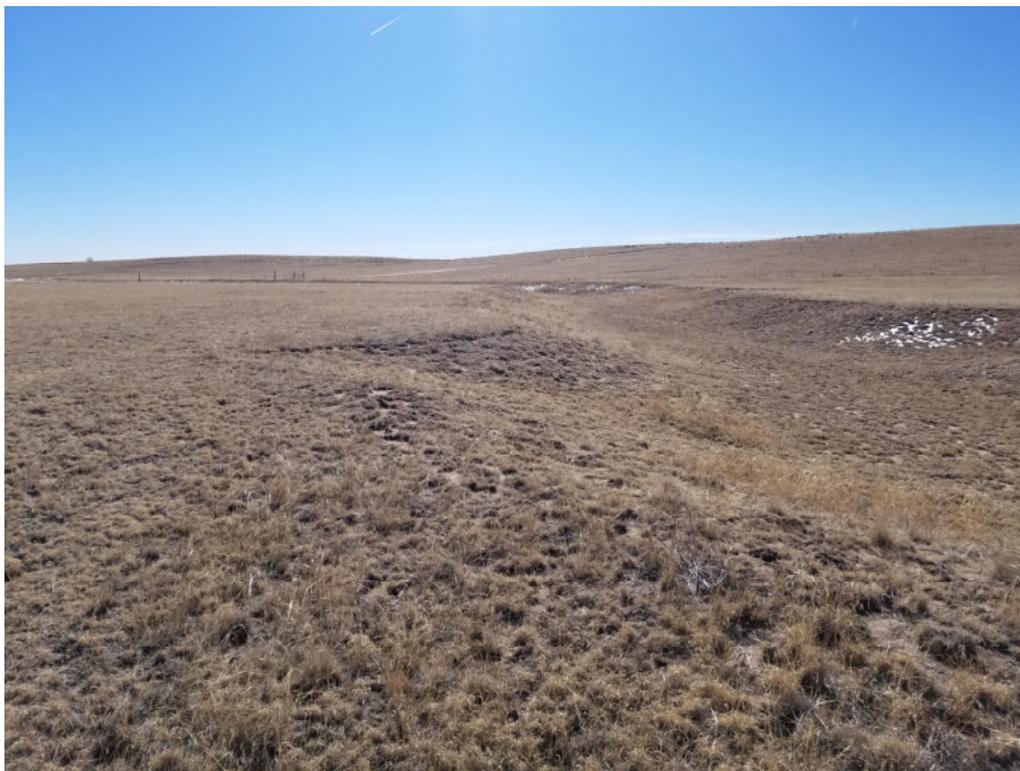
**Looking southeast
along drainage in the
southeastern portion
of the site.**

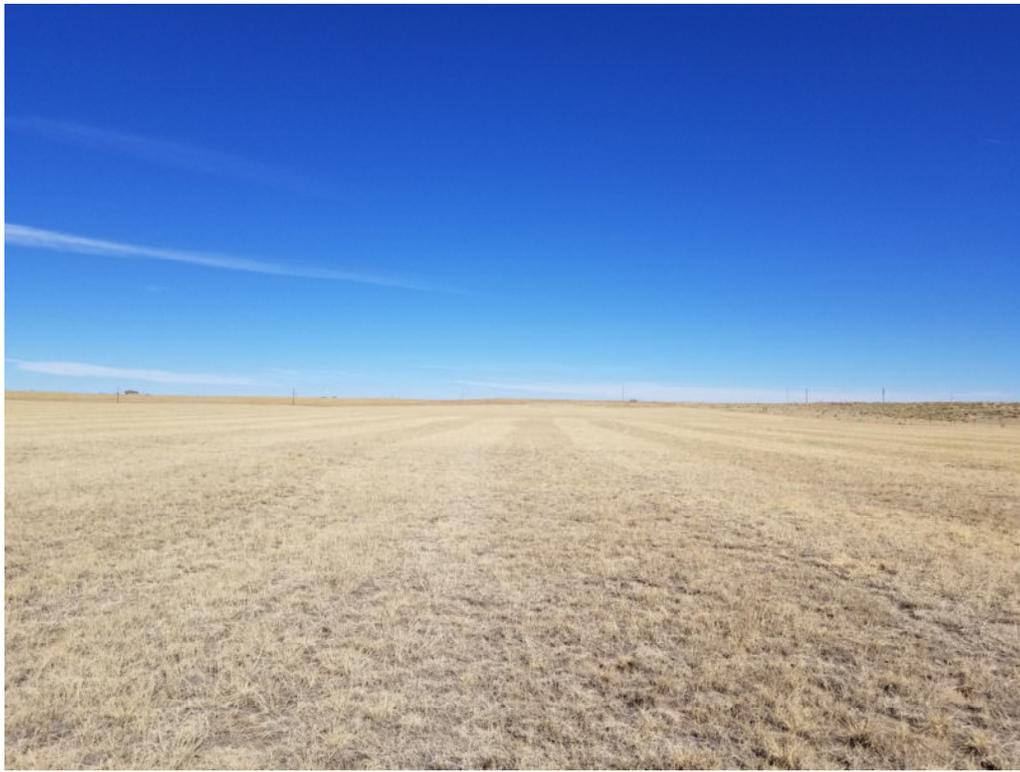
Looking north from the eastern side of the site.

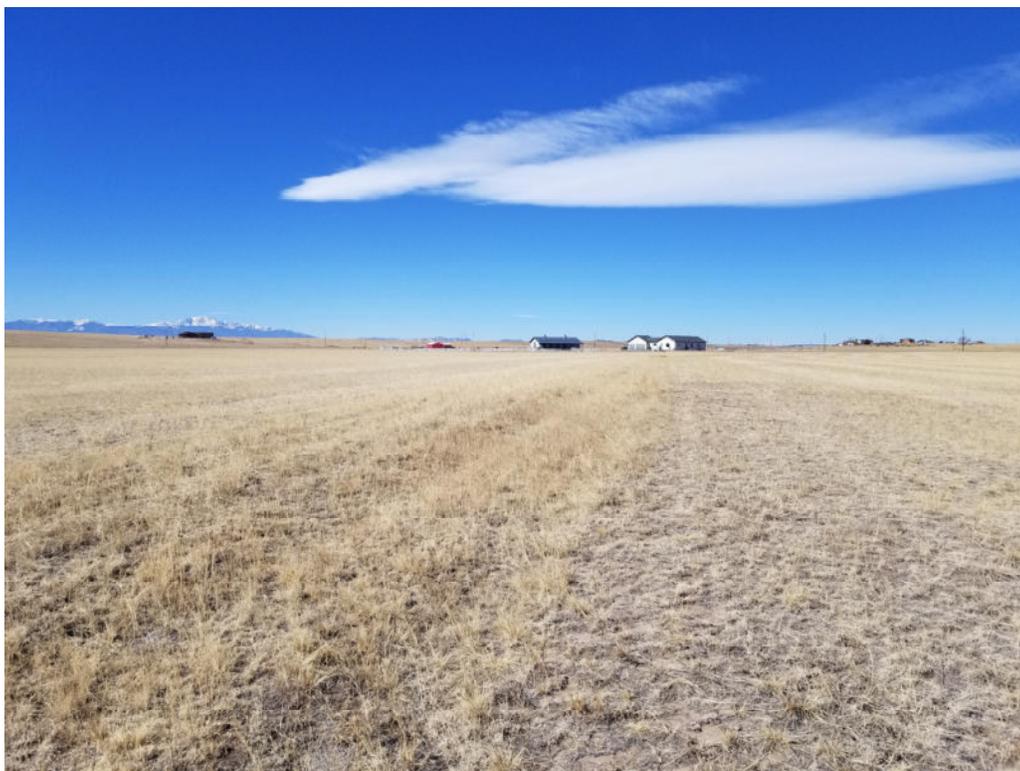
Looking west from the central portion of the site.

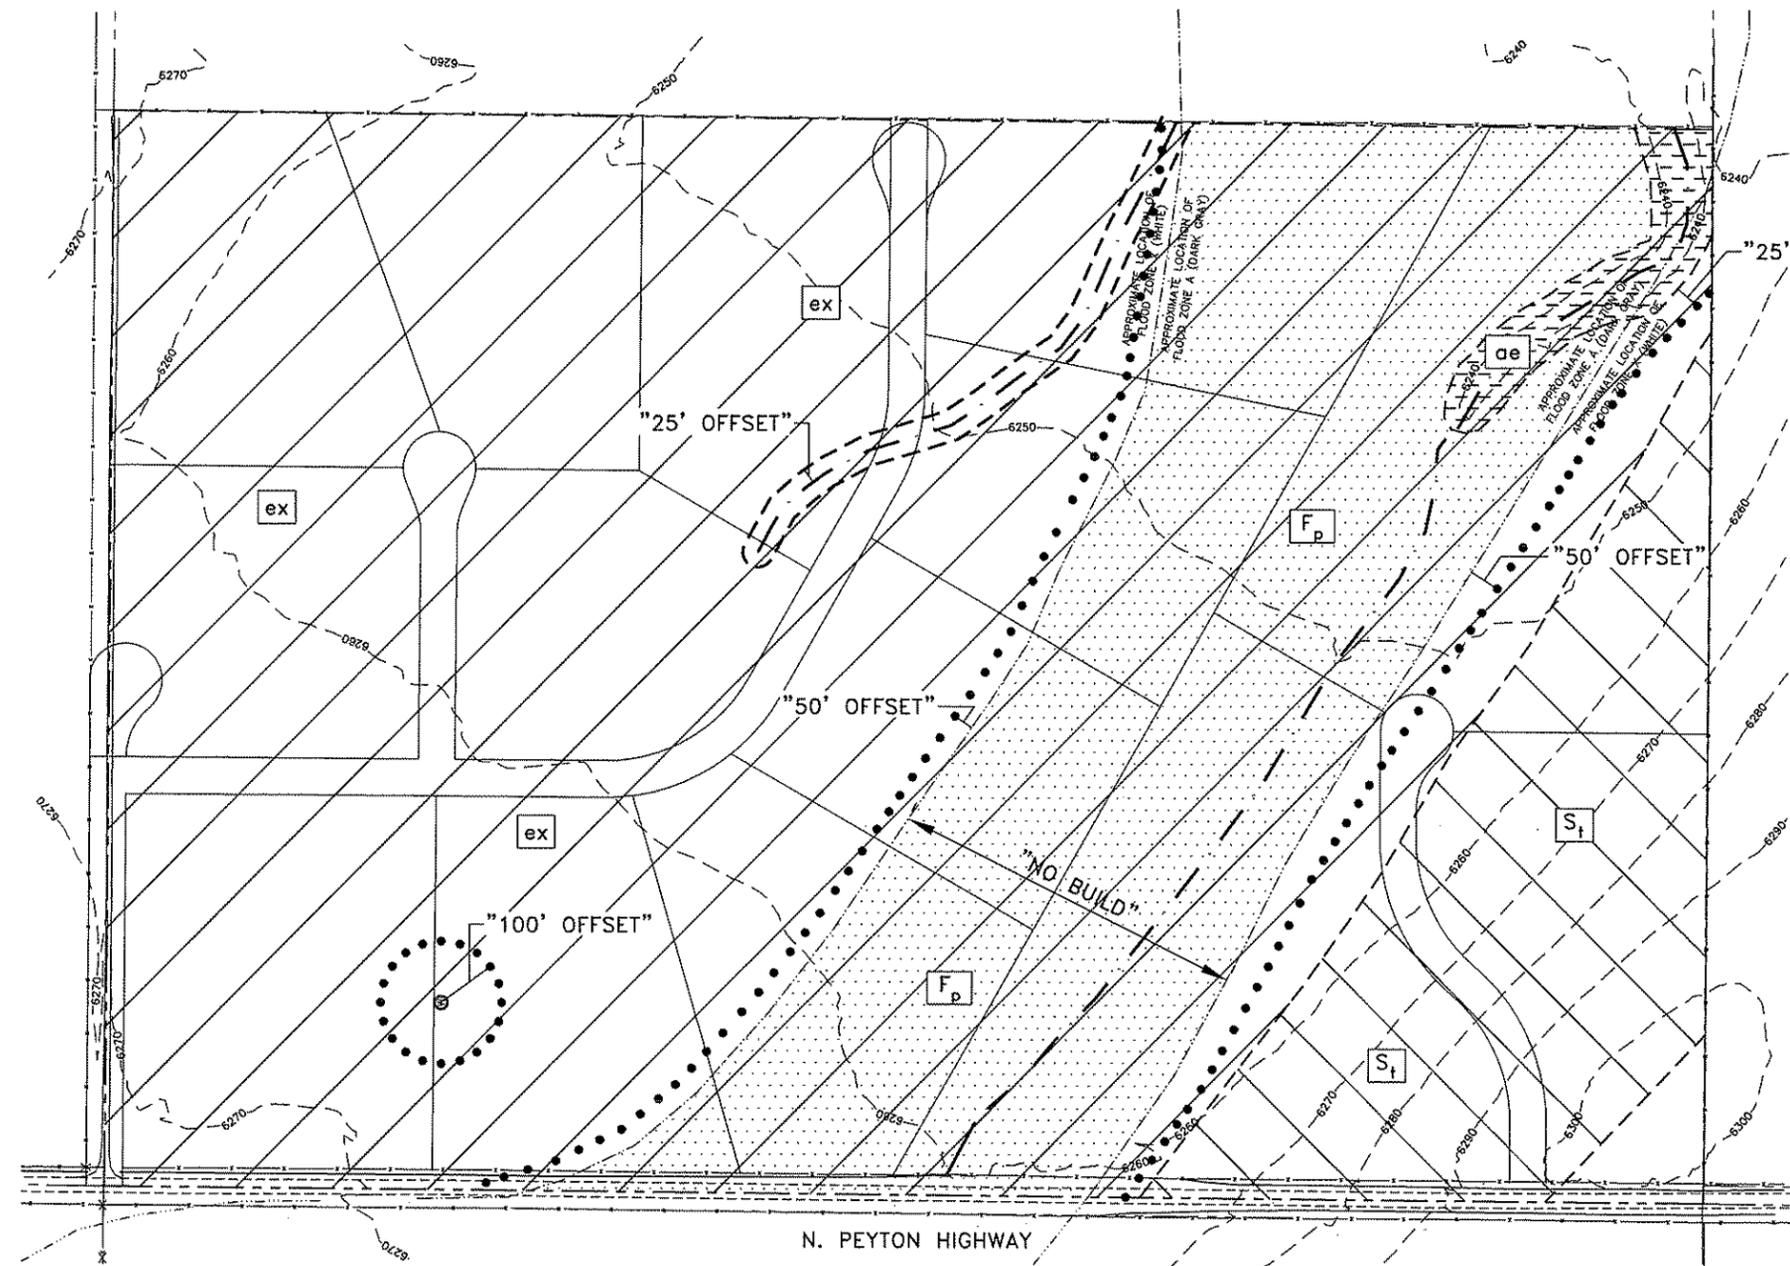
mapped as potentially seasonal shallow groundwater areas. These areas are indicated in the Geology/Engineering Geology Map (Figure 6) and are discussed below. Due to the size of the proposed lots these areas can be avoided or redirected around proposed structures or proposed soil treatment areas. The proposed building areas are not affected by these areas.

The southern portion of the site lies within a mapped floodplain zone according to the FEMA Map No. 08041CO805G dated December 7, 2018 (Figure 7, Reference 7). The floodplains area located in no-build area and will be avoided by future development on the lots. Finished floor levels must be a minimum of one foot above the floodplain level. Exact locations of floodplain and specific drainage studies are beyond the scope of this report.

100-YEAR FLOODPLAIN AND ARE PRONE TO EROSION OR SEDIMENTATION. SHOULD BE CONSIDERED A NO BUILD AREA UNLESS ADDITIONAL STUDY DETERMINES THIS AREA IS OUTSIDE OF THE 100-YEAR FLOODPLAIN OR METHODS TO MITIGATE FLOOD, EROSION AND SEDIMENTATION HAZARDS ARE PROVIDED. THE FLOODPLAIN IS CONSIDERED A WATER COURSE FOR PURPOSE OF ABSORPTION FIELDS.

Mitigation: Foundations must have a minimum 30-inch depth for frost protection. In areas where high subsurface moisture conditions are anticipated periodically, subsurface perimeter drains are recommended to help prevent the intrusion of water into areas below grade. Typical drain details are presented in Figure 8. Any grading in these areas should be done to direct surface flow around construction to avoid areas of ponded water. All organic material would be completely removed prior to any fill placement. **Specific drainage studies are beyond the scope of this report.**
