**SOIL, GEOLOGY, GEOLOGIC HAZARD,
AND WASTEWATER STUDY
ARVIDSON SUBDIVISION
2310 WAKONDA WAY
MONUMENT, COLORADO**

September 14, 2017

Entech Job No. 171248
AAprojects/2017/171248 countysoil/geo/ww

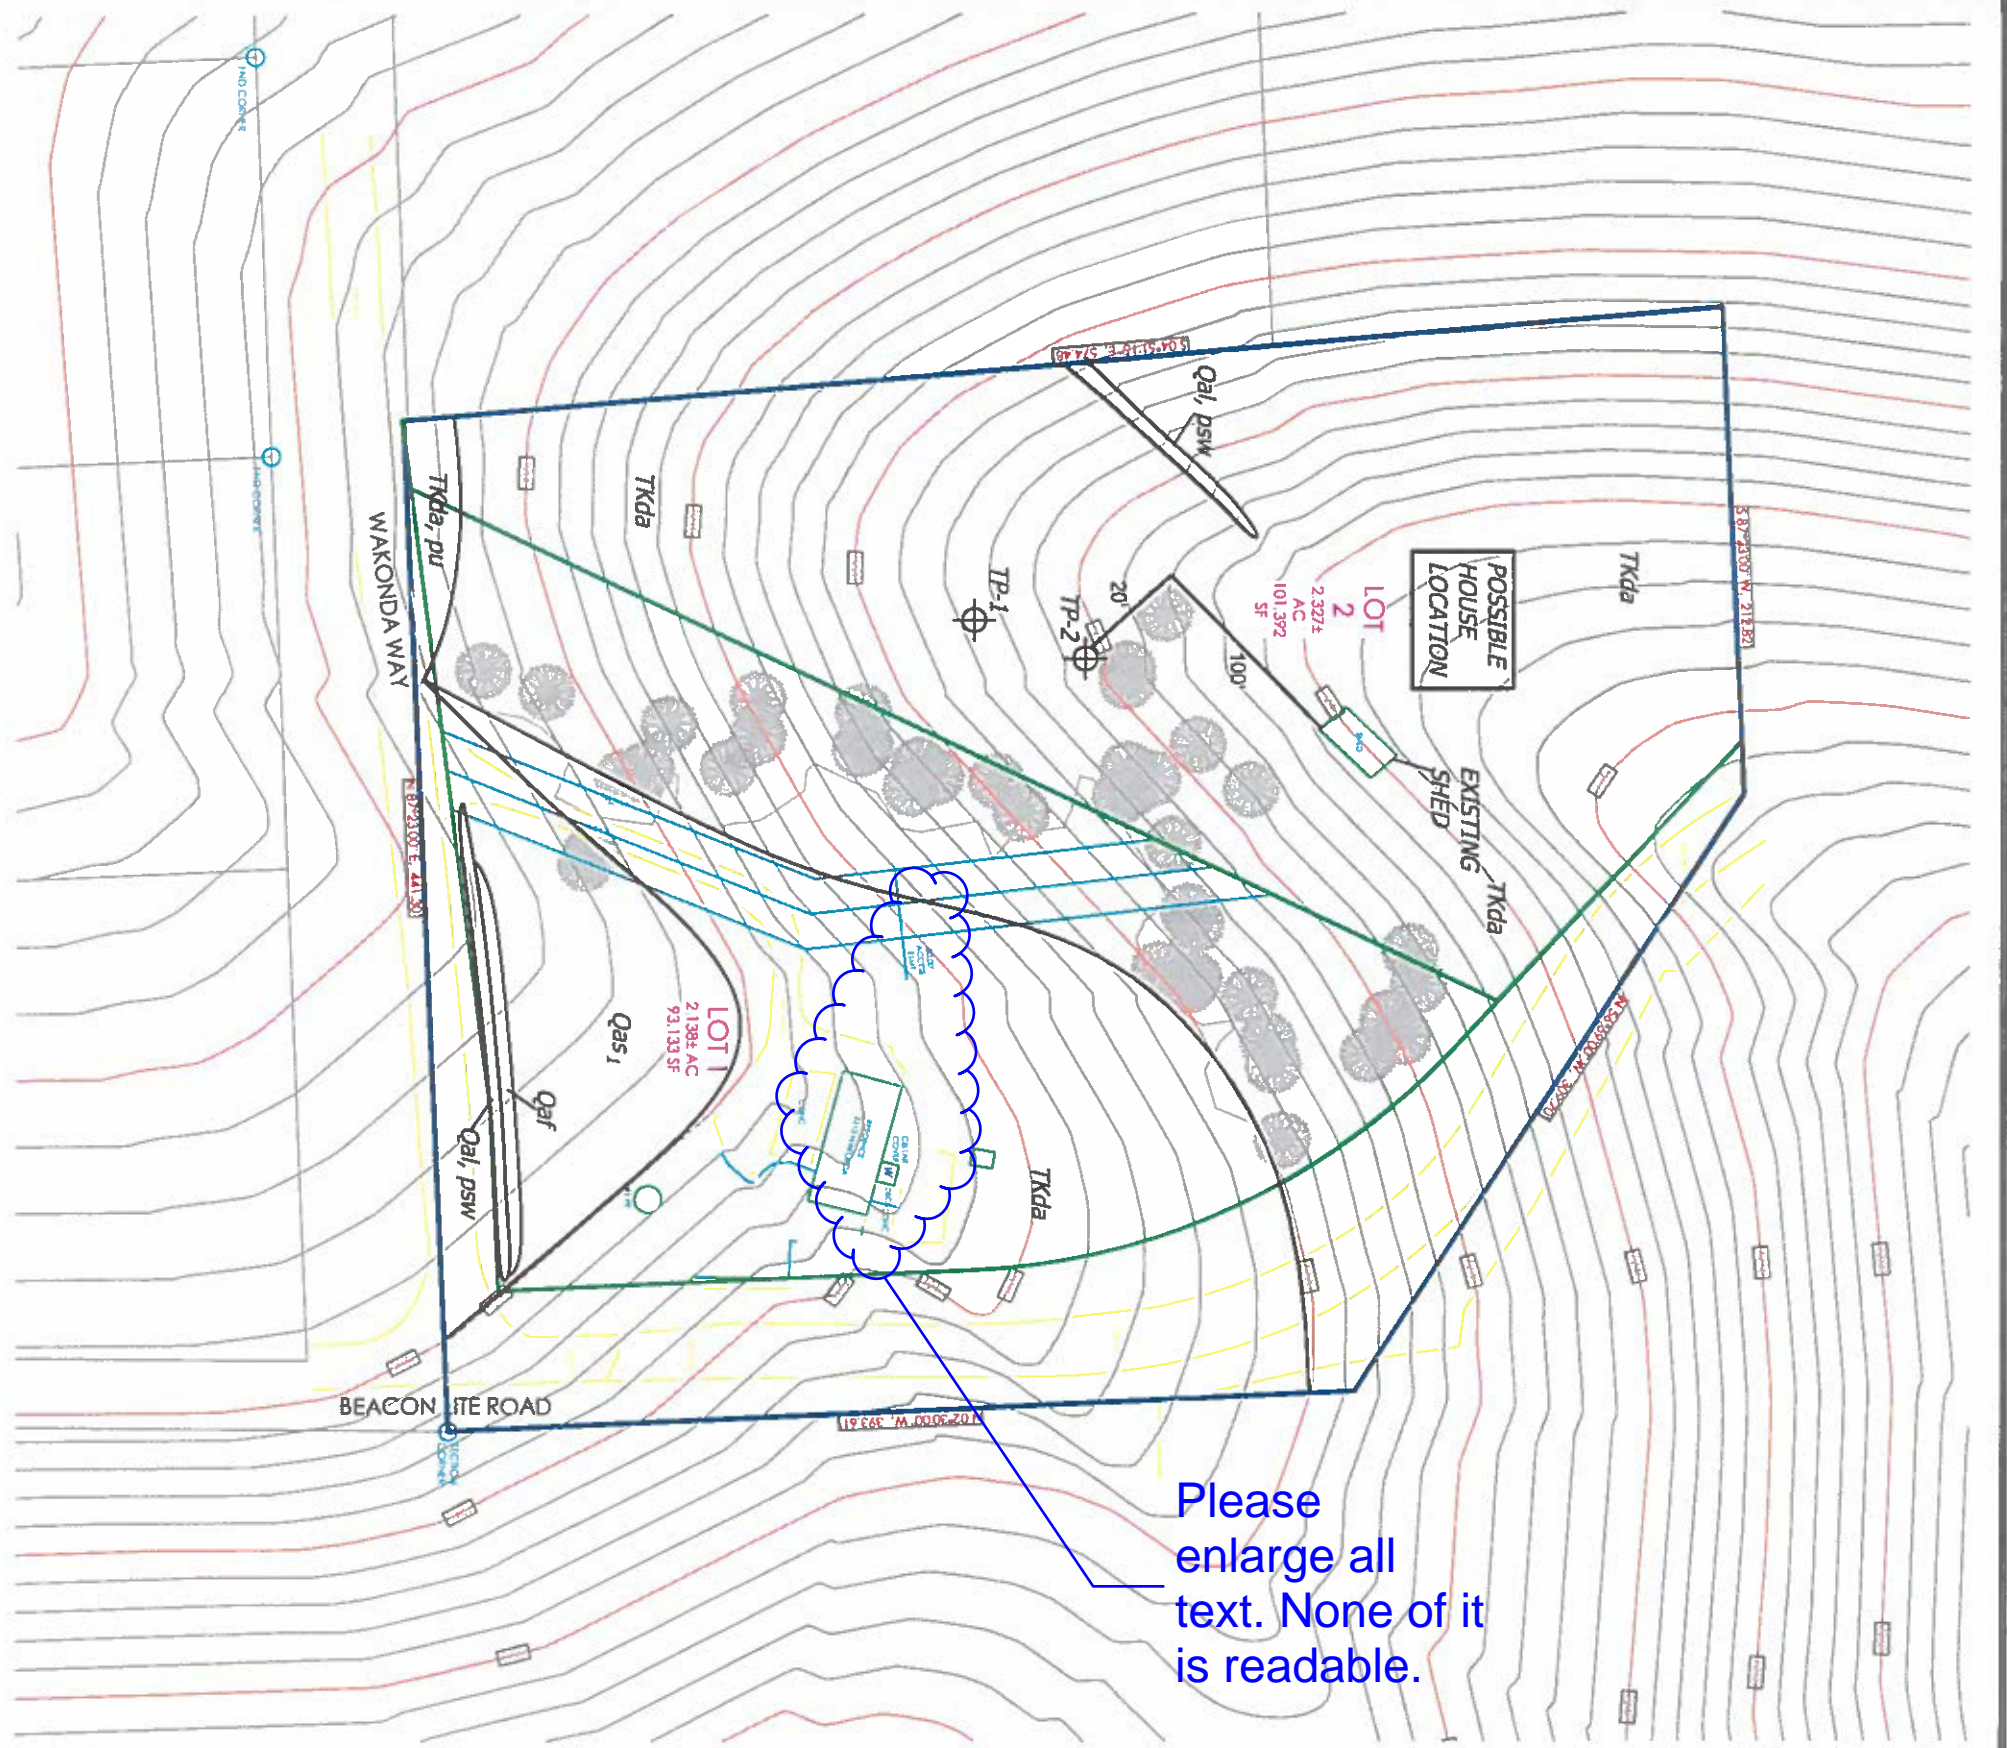
only soil types are shown,
please show other
constraints as listed in the
report.

Please enlarge all text. None of it is readable.

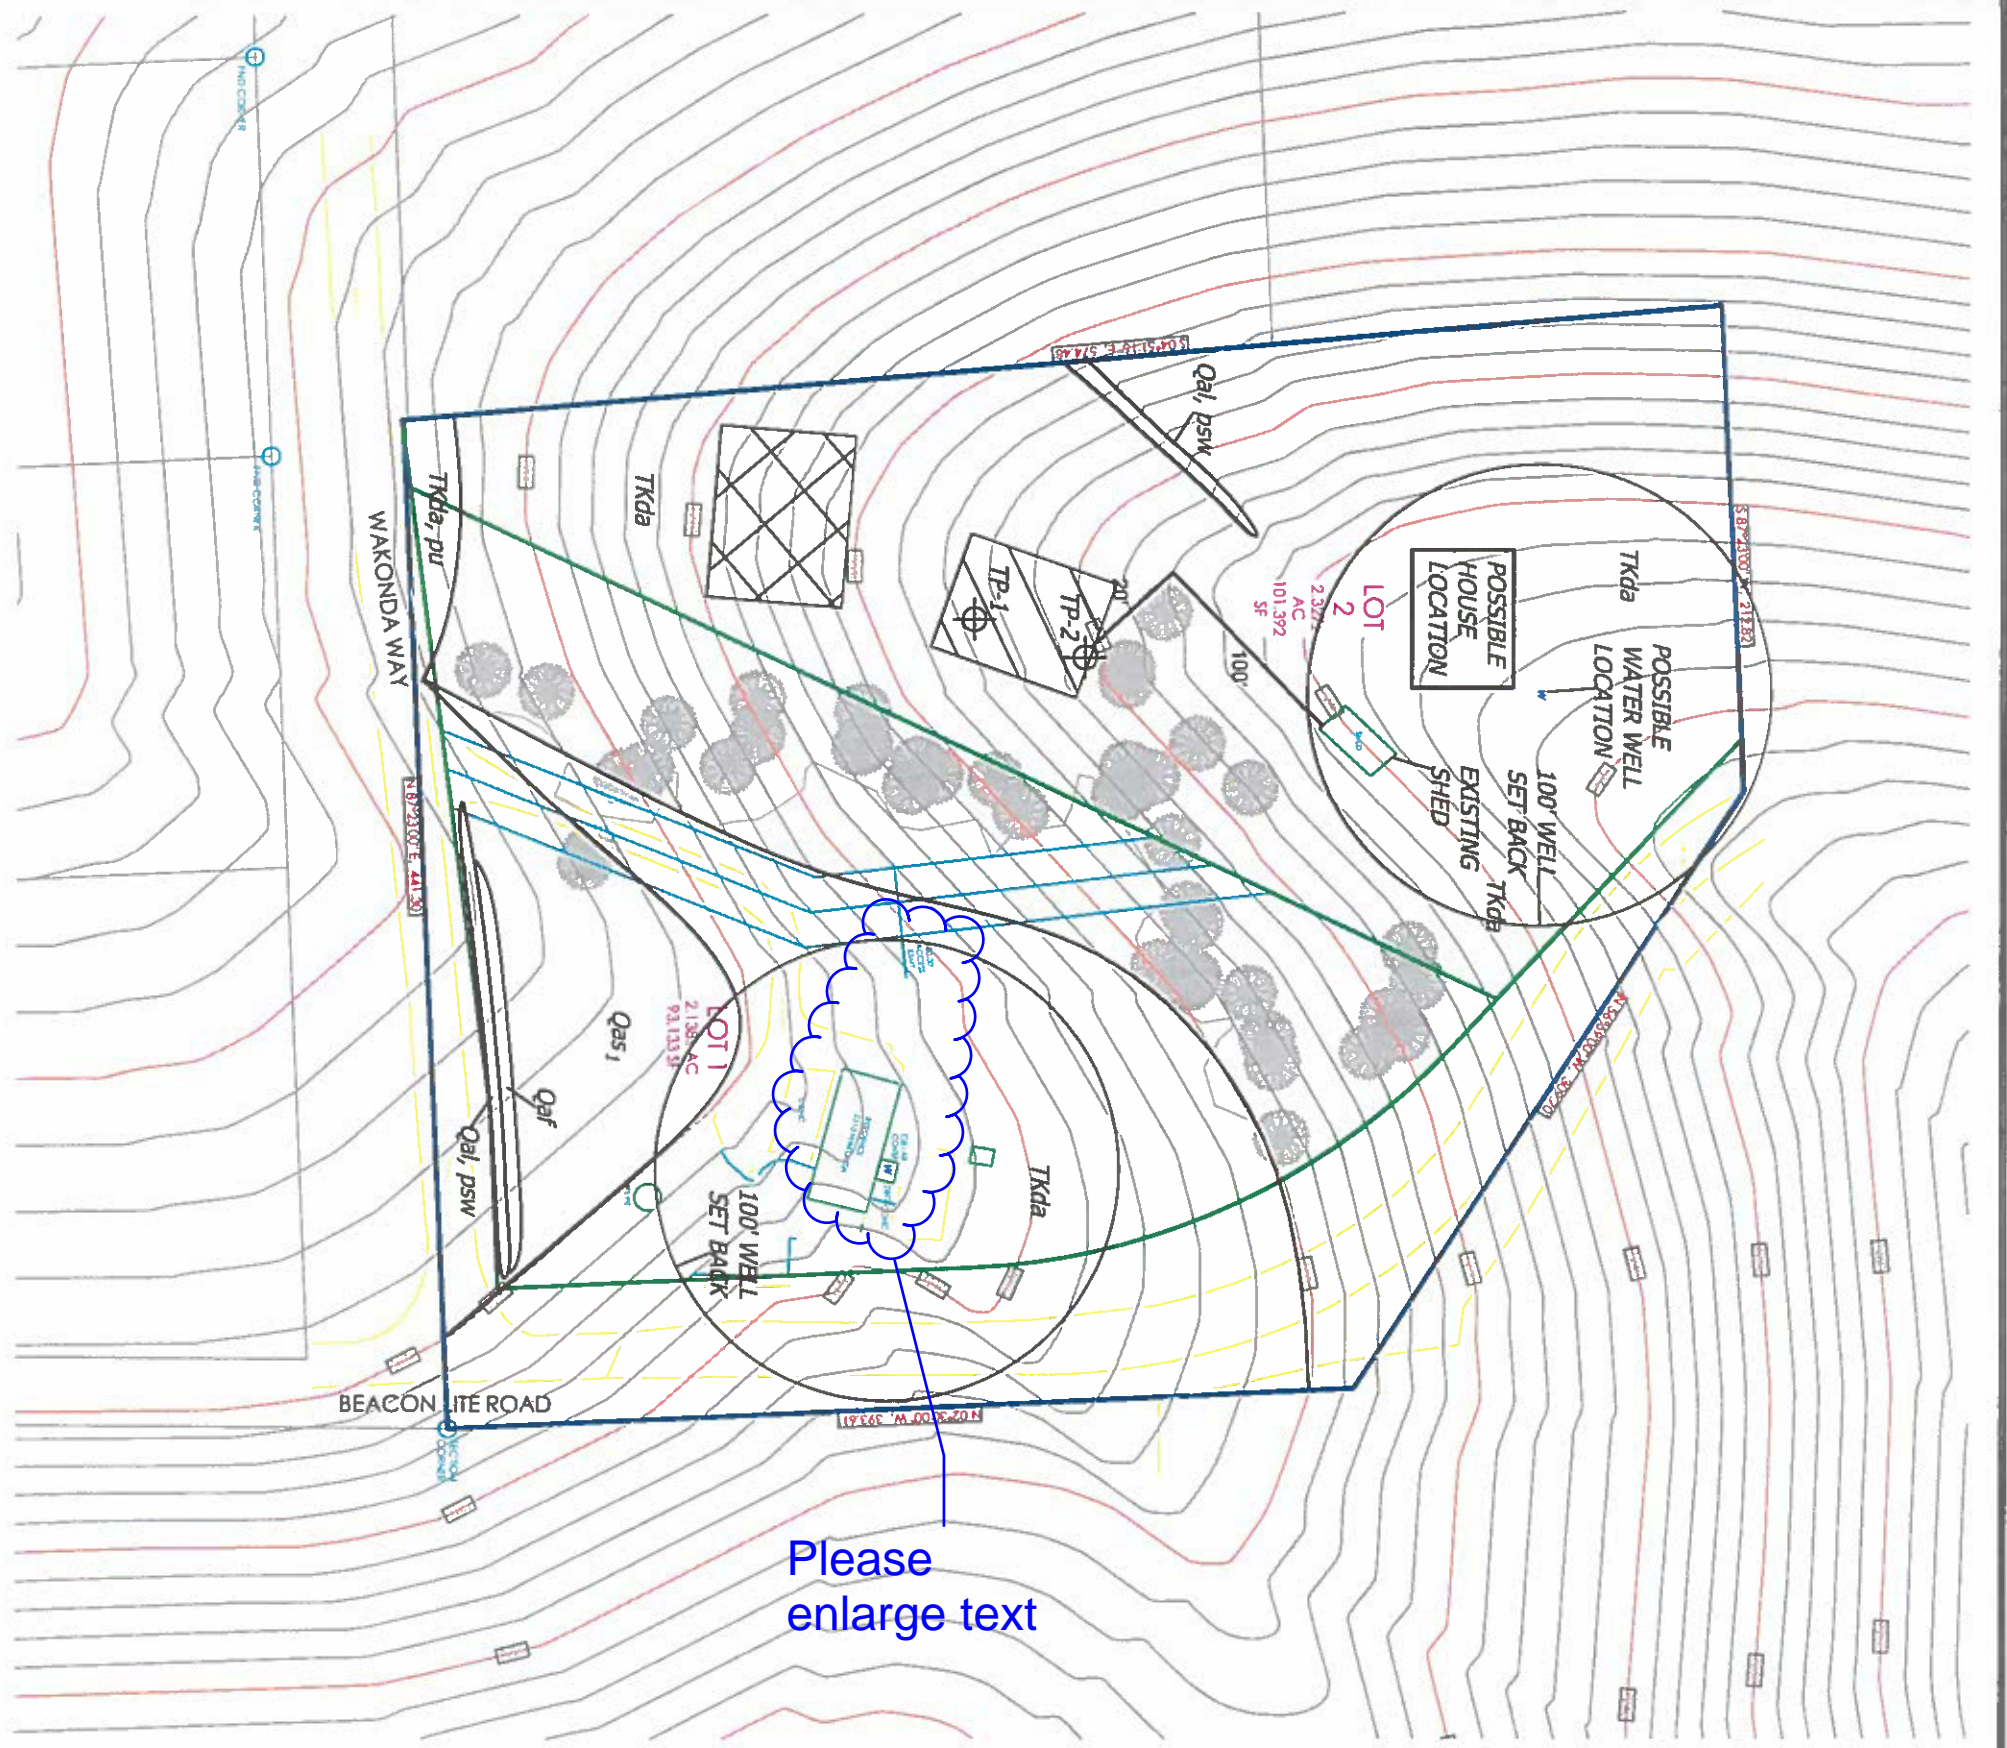
Please enlarge text

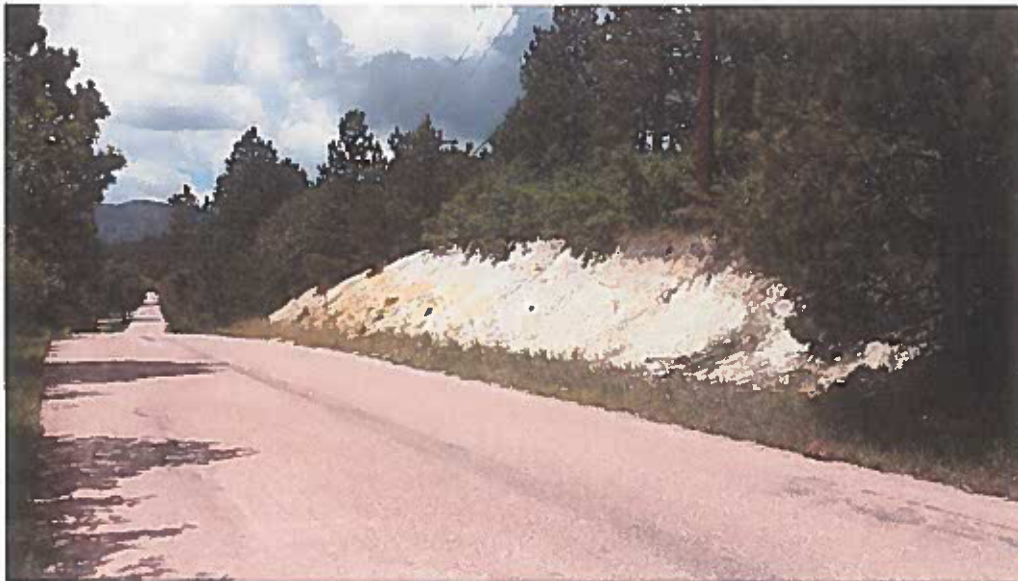
The slopes identified with this hazard exist along the road cut on the north side of Wakonda Way in the southern portion of the site. These slopes are stable in their present condition; however, considerable care must be exercised in these areas not to create a condition which would tend to activate instability.

**Looking northwest at
road cut along
Wakonda Way.**

Mitigation: These slopes lie along the southern property boundary, therefore, building from this project is not proposed on these slopes. The best mitigation for potentially unstable slopes is avoidance. The potential house location on Lot 2 is a sufficient distance away that potentially unstable slopes should not affect the proposed development.
