**SOIL, GEOLOGY, GEOLOGIC HAZARD,
AND WASTEWATER STUDY
ARVIDSON SUBDIVISION
2310 WAKONDA WAY
MONUMENT, COLORADO**

September 14, 2017

Entech Job No. 171248

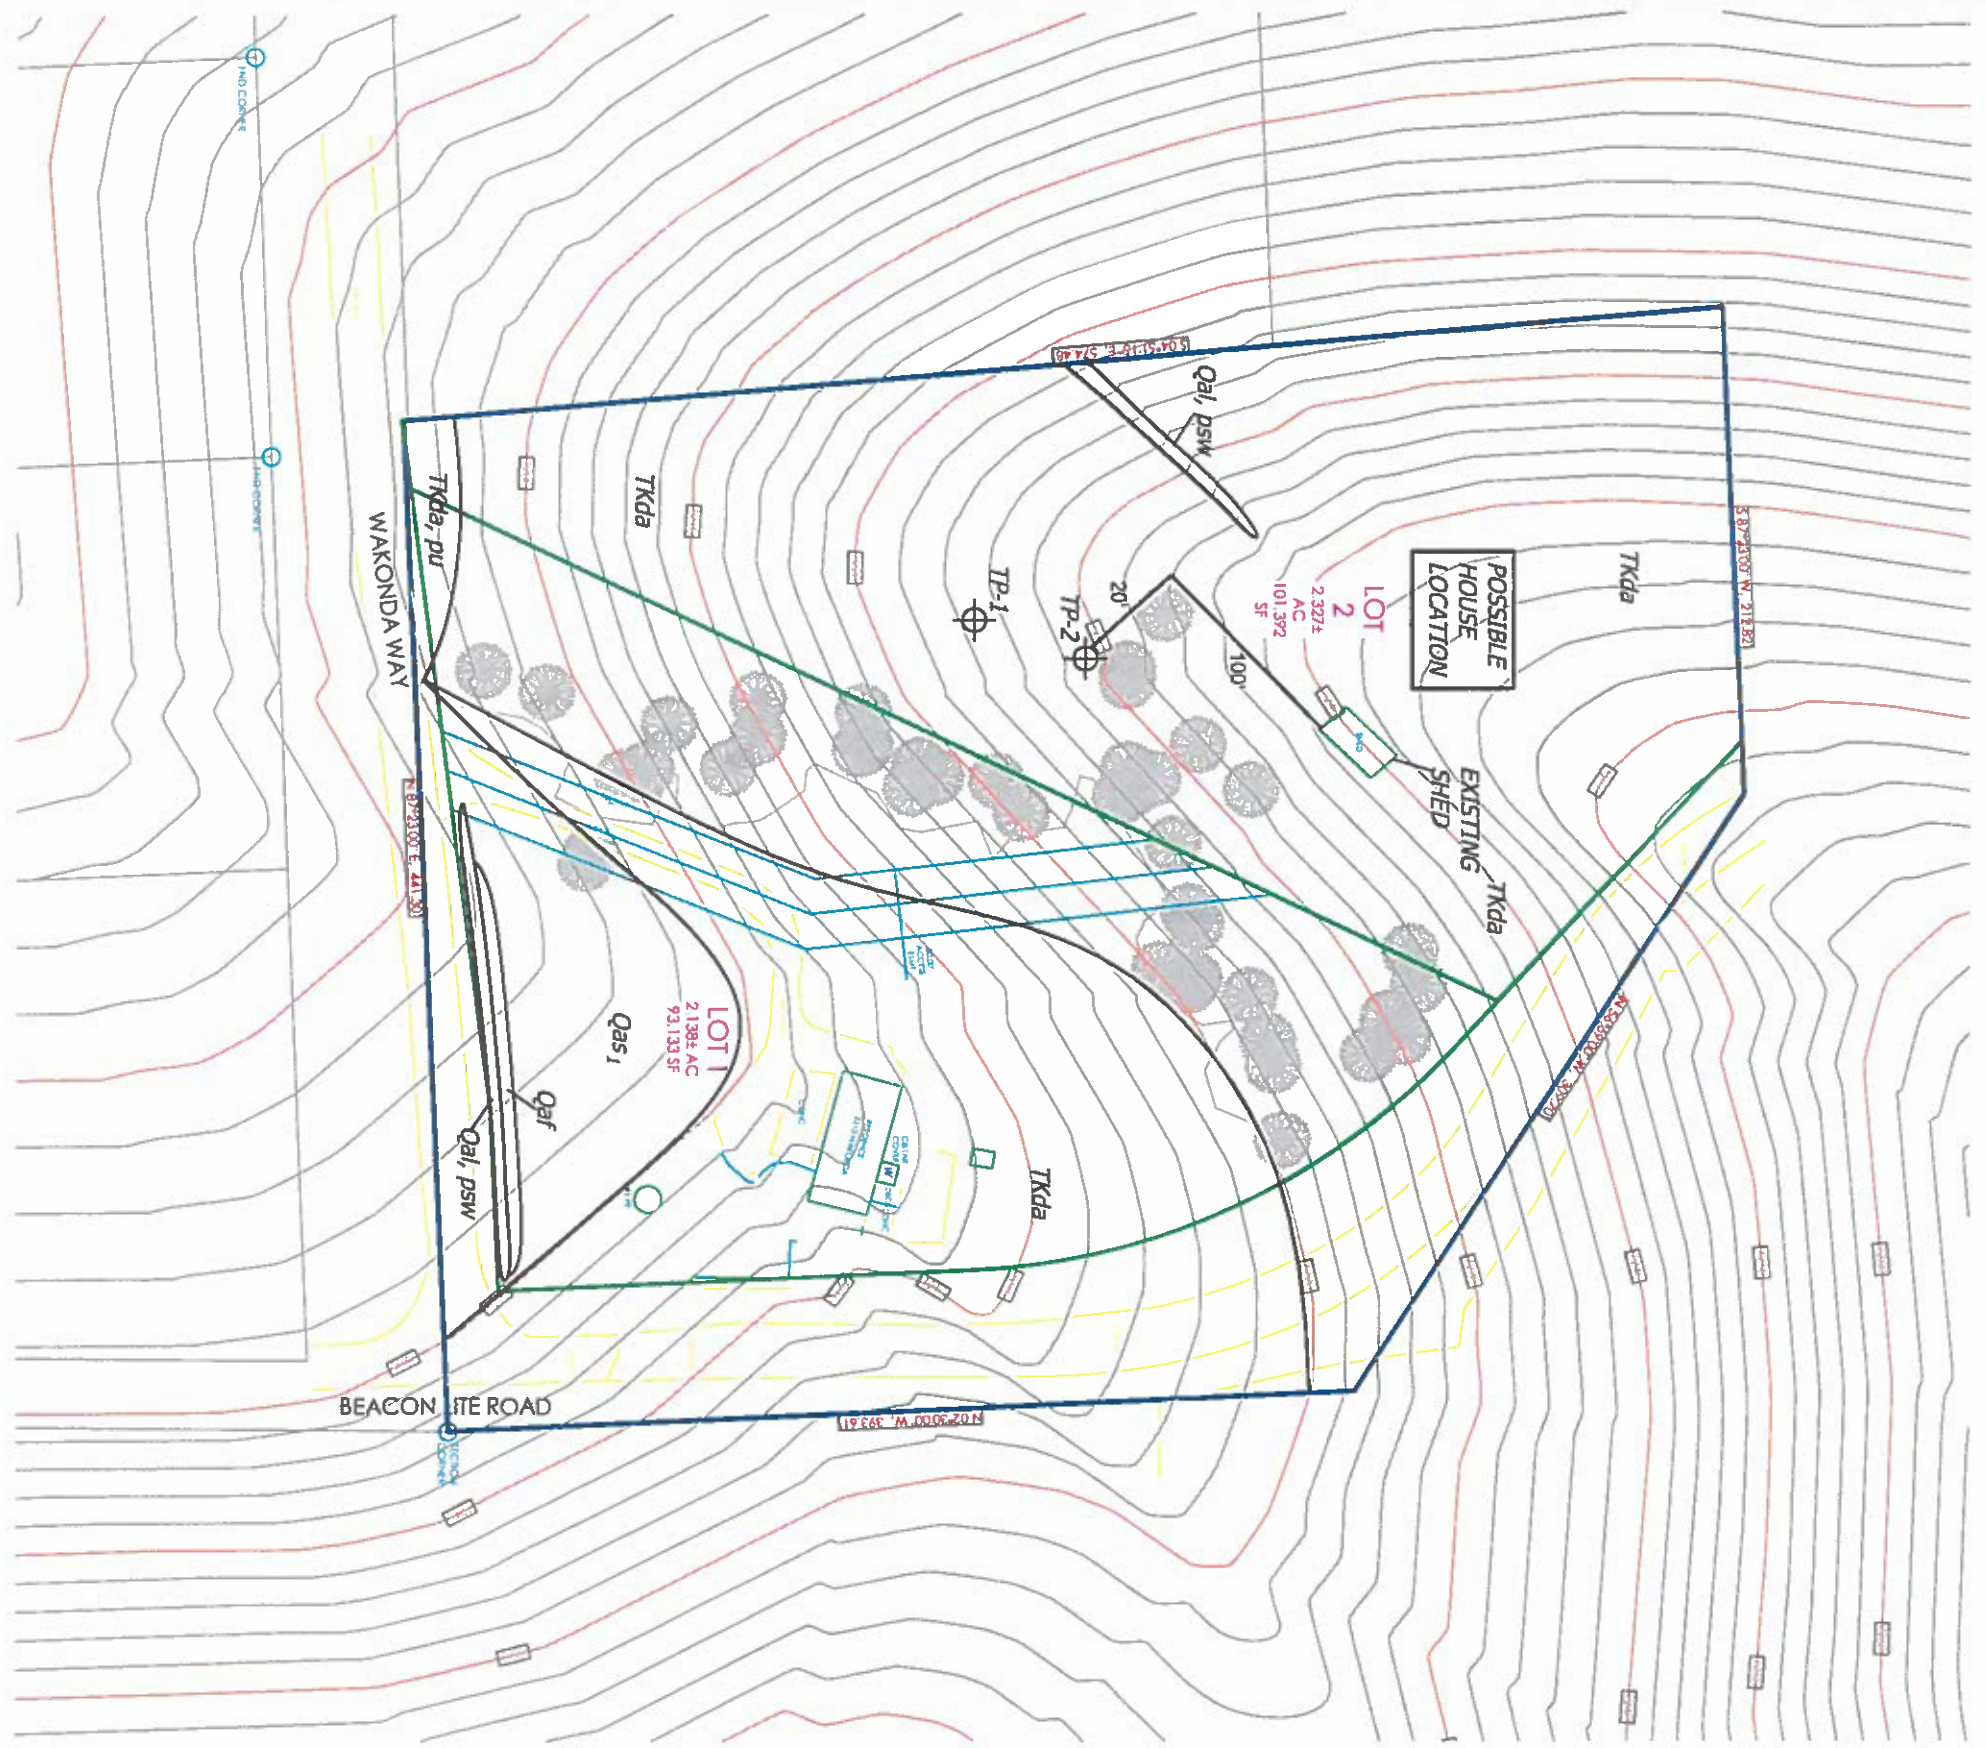
As mentioned previously, detailed mapping has been performed on this site to produce an Geology/Engineering Geology Map (Figure 6). This map shows the location of various geologic conditions of which the developers should be cognizant during the planning, design and construction stages of the project. These hazards and the recommended mitigation techniques are as follows:

The site is not mapped within any floodplains according to the FEMA Map No. 08041CO276F, dated March 17, 1997 (Figure 7, Reference 7). Areas of seasonal shallow groundwater were observed across the site. In these areas, we would anticipate the potential for periodically high subsurface moisture conditions and frost heave potential. These areas lie within low-lying areas

along the southern portion of the site and in the smaller drainages in the western portion of the site. Water was not observed in any of the drainages at the time of our site investigation. These areas can likely be avoided or properly mitigated by development. The potential exists for high groundwater levels during high moisture periods and should structures encroach on these areas the following precautions should be followed:

Mitigation: Foundations must have a minimum 30-inch depth for frost protection. In areas where high subsurface moisture conditions are anticipated periodically, subsurface perimeter drains are recommended to help prevent the intrusion of water into areas below grade. Typical drain details are presented in Figure 8. Any grading in these areas should be done to direct surface flow around construction to avoid areas of ponded water. All organic material would be completely removed prior to any fill placement. Specific drainage studies are beyond the scope of this report.

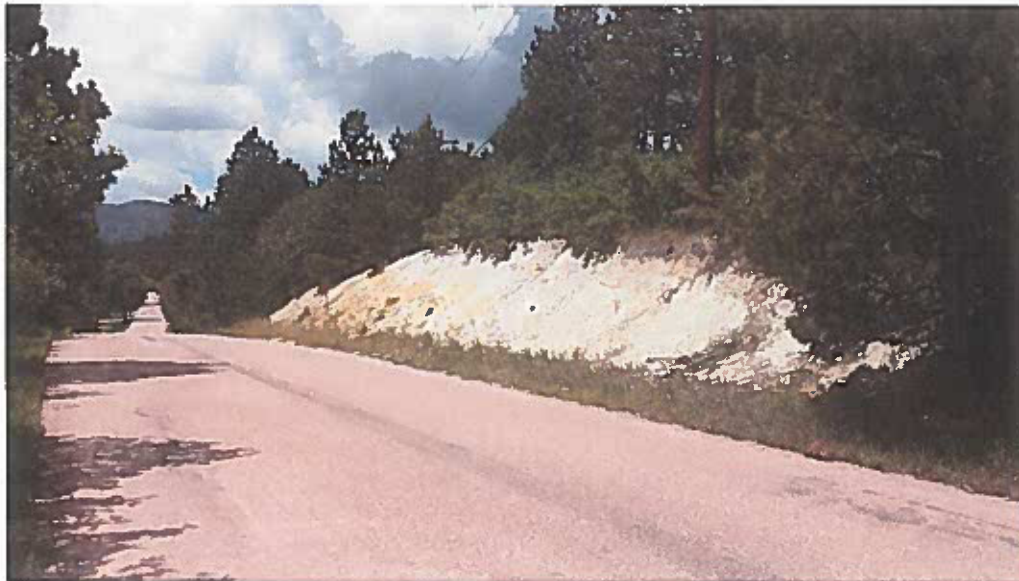
The slopes identified with this hazard exist along the road cut on the north side of Wakonda Way in the southern portion of the site. These slopes are stable in their present condition; however, considerable care must be exercised in these areas not to create a condition which would tend to activate instability.

**Looking northwest at
road cut along
Wakonda Way.**

Mitigation: These slopes lie along the southern property boundary, therefore, building from this project is not proposed on these slopes. The best mitigation for potentially unstable slopes is avoidance. The potential house location on Lot 2 is a sufficient distance away that potentially unstable slopes should not affect the proposed development.
