NATURAL FEATURES AND WETLANDS REPORT

U-Haul at Falcon Development Project El Paso County, CO

Bristlecone Ecology, LLC
2023 W. Scott Place
Denver, CO 80211
Contact: Dan Maynard
Phone: 971.237.3906

September 15, 2022

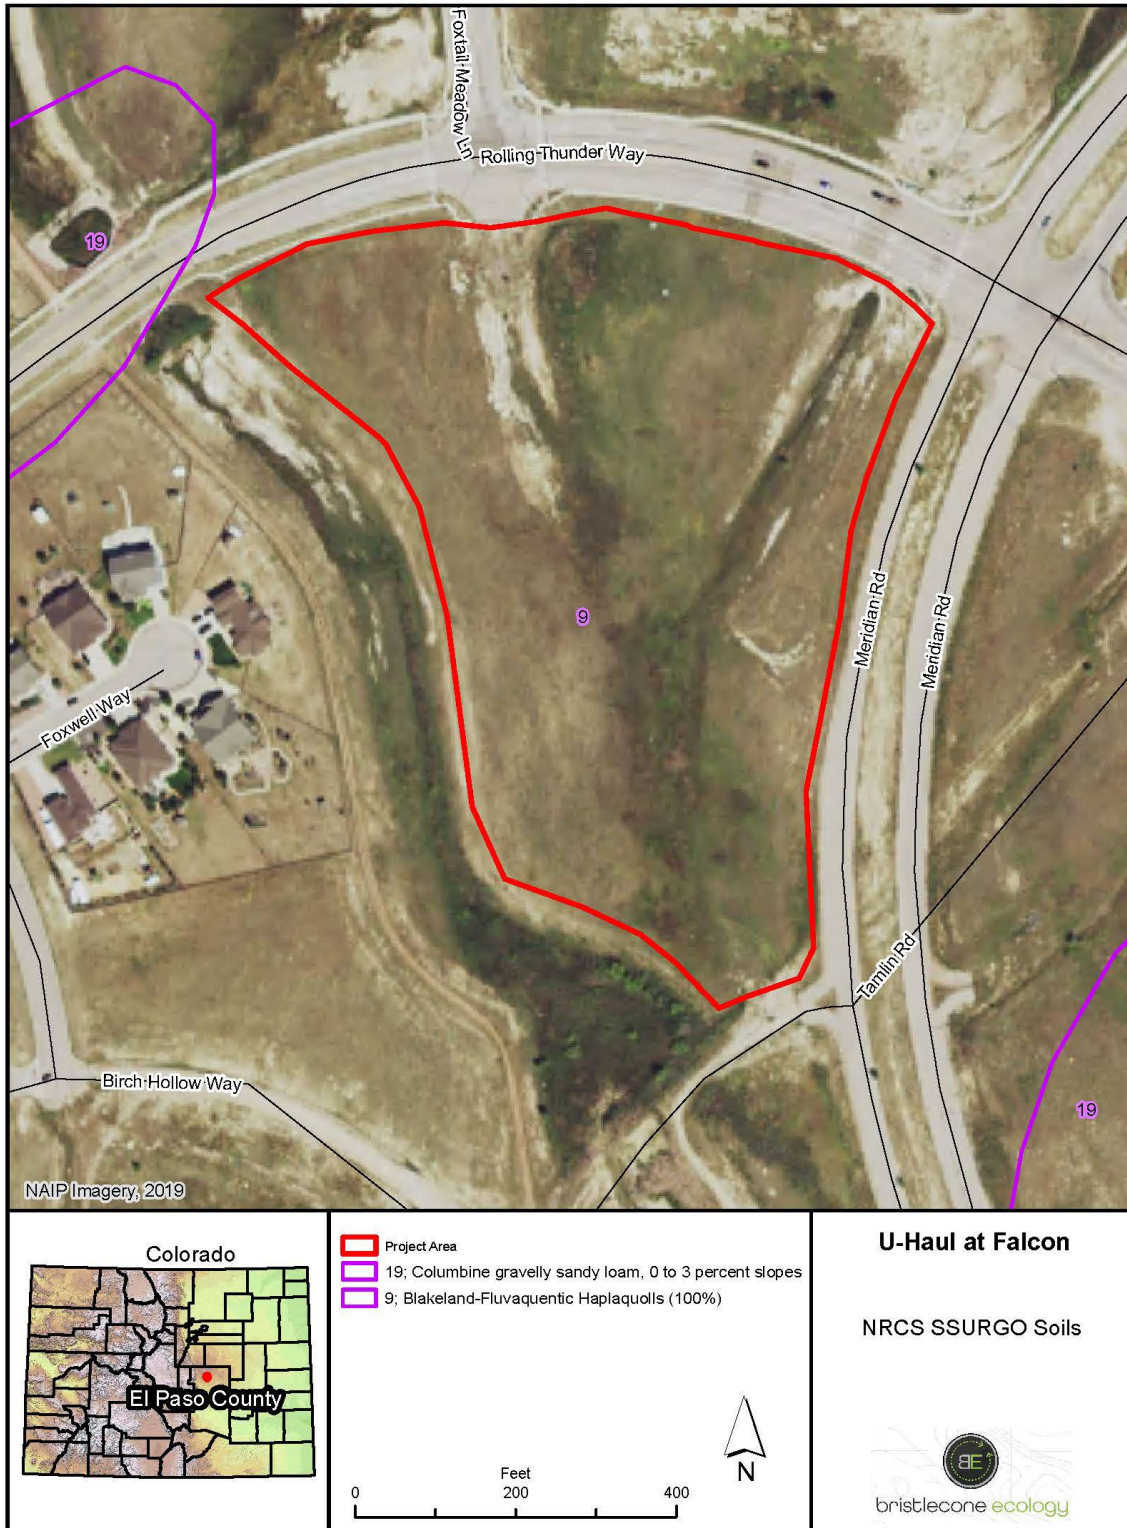
Figure 2: NRCS SSURGO Soils

Soil survey data and reports were reviewed to determine the potential for the presence of geologic hazards within the Project (NRCS 2022a). NRCS soil survey data indicate that the site is composed entirely of the Blakeland-Fluvaquentic Haplaquolls consociation (**Figure 2: NRCS SSURGO Soils Map**), generally consisting of loamy coarse sand (NRCS 2022a). The Blakeland series is typically found on sandy foothills and flats while Fluvaquentic Haplaquolls are typically associated with drainages, meaning the site is likely entirely composed of Blakeland loamy sand. While these two soil types are the dominant series occupying the Project area, there are minor components (called “inclusions”) within each series or consociation that could contribute to the overall soil composition at the site.

The Blakeland-Fluvaquentic-Haplaquolls consociation is grouped into Hydrologic Group A, according to NRCS soils data (NRCS 2022d). The ‘A’ grouping includes soils that have a high infiltration rate, which results in the soil having a corresponding high rate of surface and ground water transmission. Additional, detailed soil data for the Project will be presented in a soils/geology/geotechnical report that will be submitted separately.

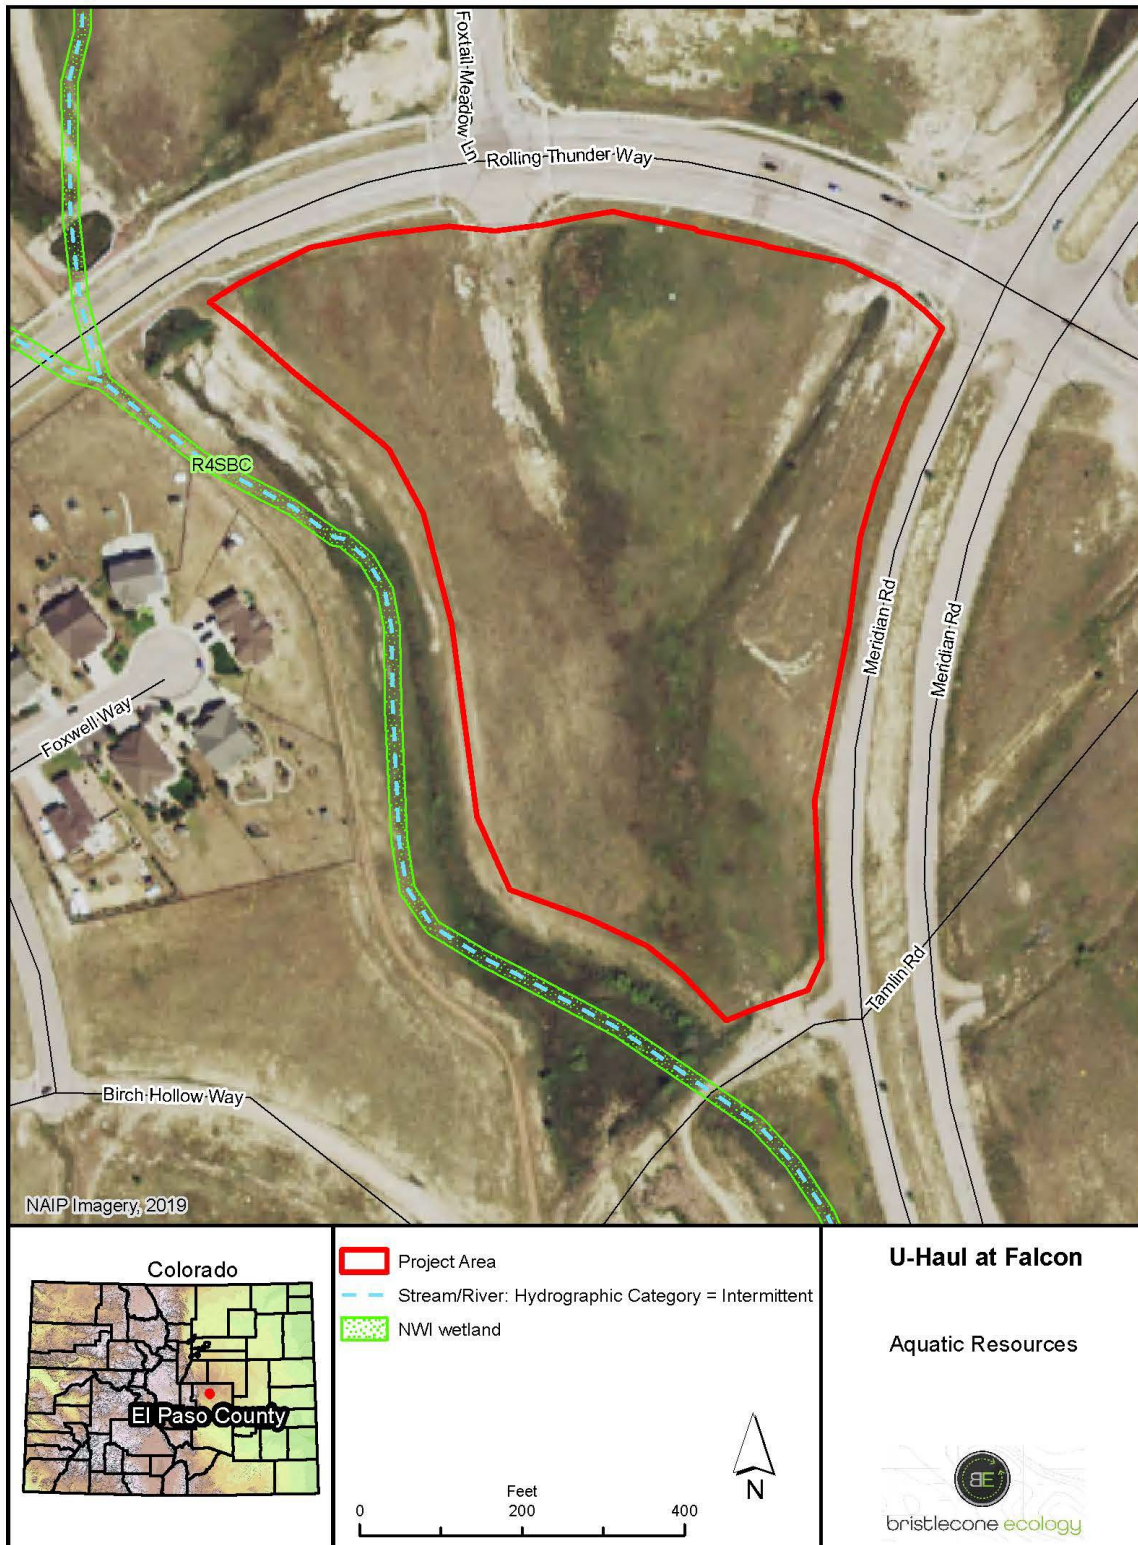
Figure 3: Aquatic Resources Desktop Review

Based on the information obtained from the site reconnaissance, it is unlikely there are wetlands on the site associated with the current Project that would be considered jurisdictional by the USACE. Wetland 1 is an artificial wetland because its hydrologic source is entirely anthropogenic. Wetland 2 may be naturally occurring, but likely does not connect to downstream WOTUS and thus would not be jurisdictional. The riverine wetland depicted in the NWI data is confirmed as a wetland, but it lies to the west of the site boundary. The unnamed tributary running west of the site appears to maintain hydrologic connection to downstream tributaries/wetlands and is therefore likely jurisdictional. There are extensive wetlands associated with the unnamed tributary to the west, but these will not be affected by development of the site. While only the USACE may determine the regulatory status of aquatic features under the CWA, it is B.E.'s professional opinion that there are no jurisdictional wetlands or other jurisdictional aquatic resources on the site, and that the only jurisdictional aquatic resources are in the drainage to the immediate west of the site.

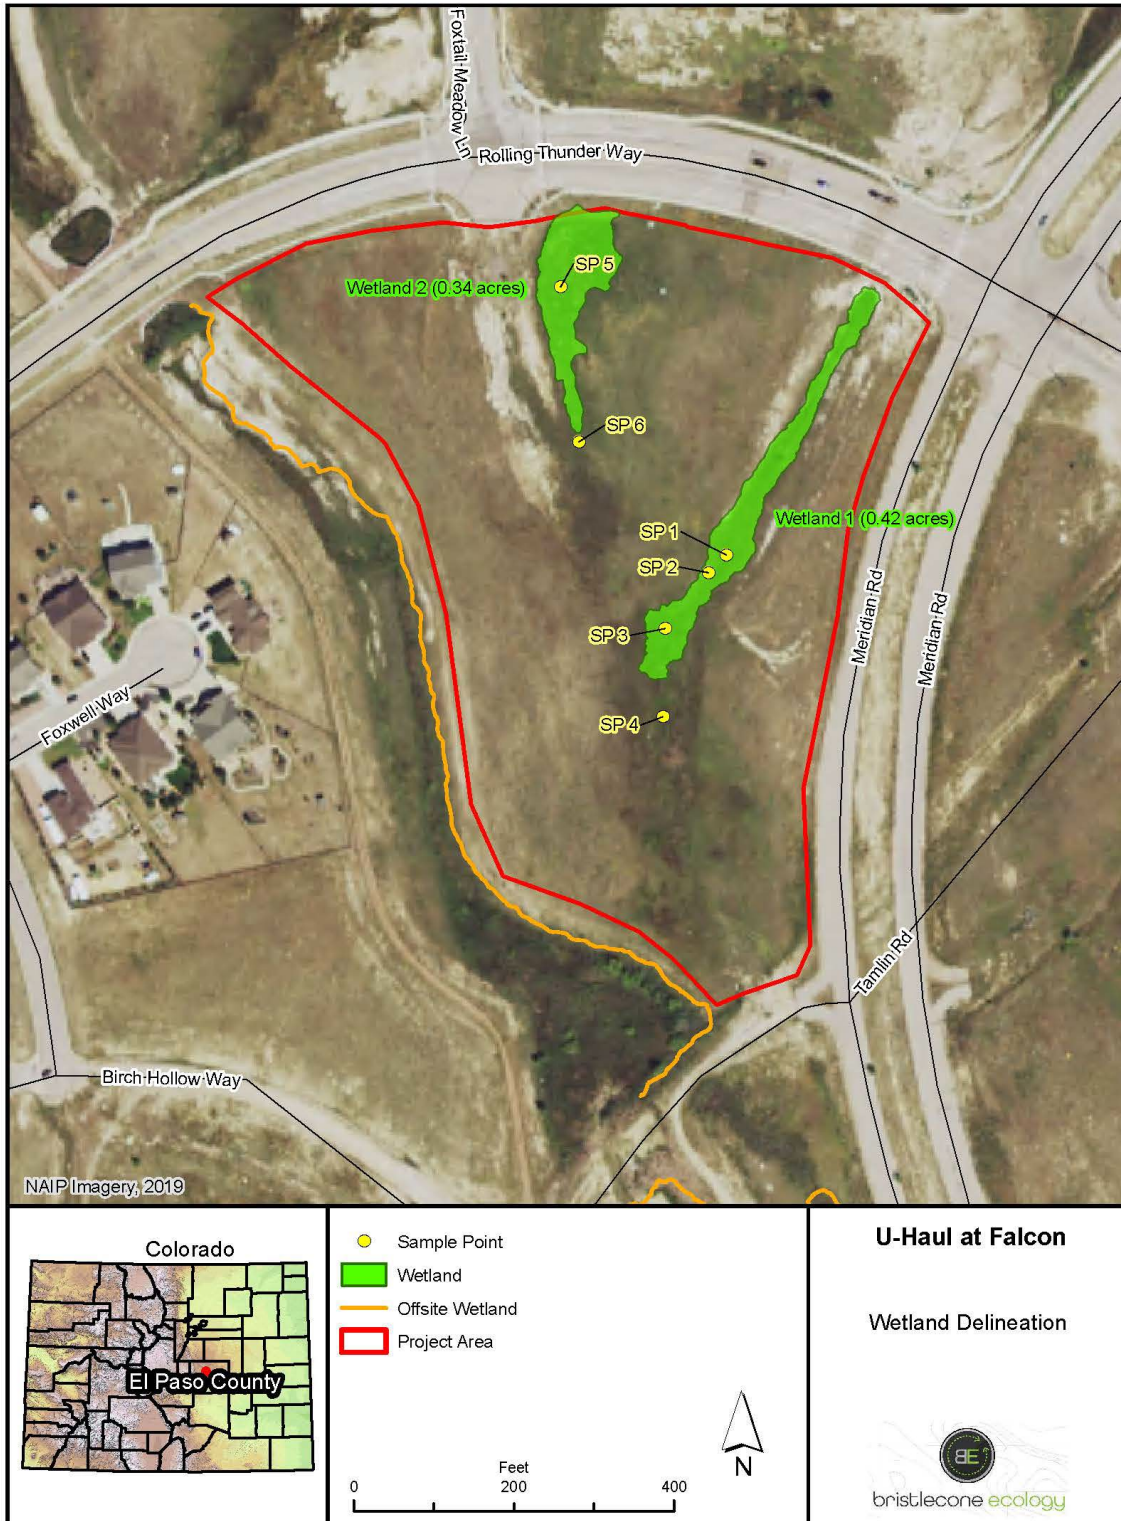
Figure 4: Wetland Location Map

There are no aquatic resources on the site, and all wetlands and streams observed were located outside of the Project boundary, to the immediate west of the site along the drainage containing the unnamed tributary to Black Squirrel Creek No. 2. Wetlands mapped in NHD/NWI data were generally confirmed during the wetland delineation to be in the same locations as depicted (see **Appendix B** and **Figure 4**). All field-delineated wetlands shown in **Figure 4** are expected to be considered isolated by the USACE. Since these resources will not be disturbed by Project construction, a Section 404 permit from the USACE is not expected to be necessary.

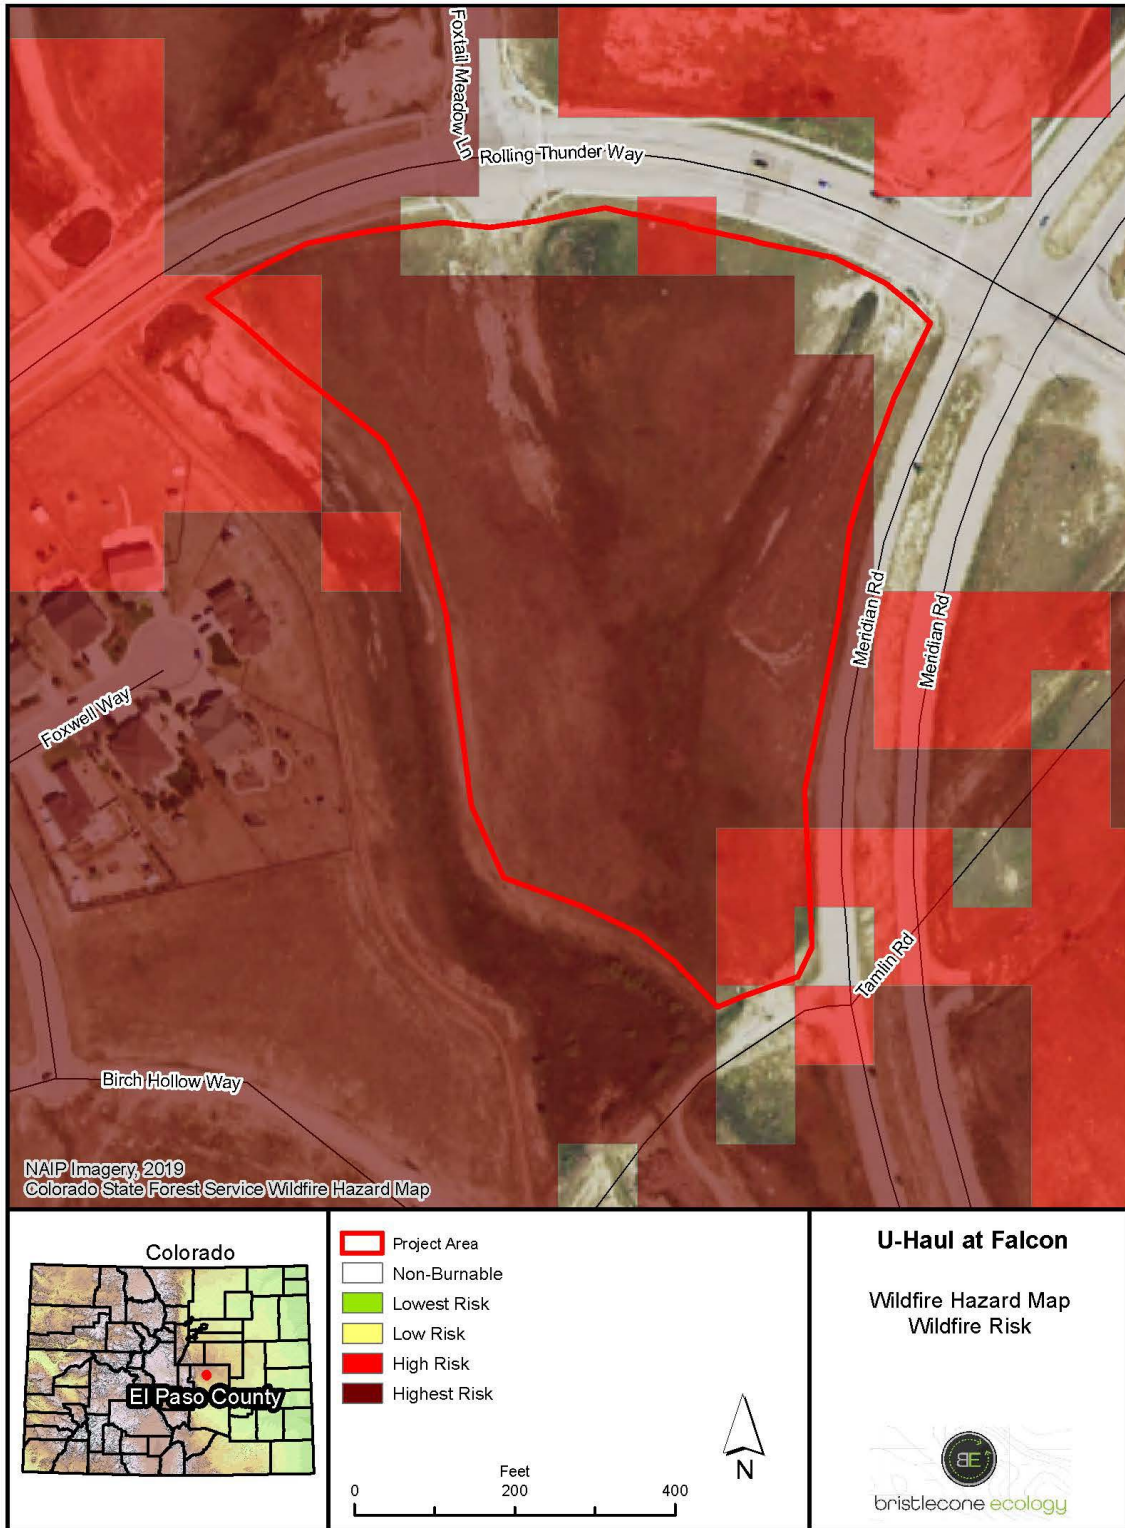
Figure 5: Wildfire Hazard Map – Wildfire Risk

Wildfire hazard for the Project site was evaluated using the Colorado State Forest Service's (CSFS) online Wildfire Risk Assessment Portal (WRAP; CSFS 2020). WRAP allows professionals, planners, and the public to access the best scientific information regarding wildfire risk and establish prevention and mitigation measures accordingly. According to WRAP, the wildfire risk for the Project site is approximately 80% "Highest Risk" and approximately 20% "High Risk", (CSFS 2020; **Figure 5: Wildfire Hazard Map – Wildfire Risk**). "Wildfire Risk" is determined by CSFS by combining the burn probability rating of a site with the values-at-risk rating. While the Project site has a low rating of values and assets that would be adversely impacted by wildfire, the burn probability for the entire site is rated as "High" (CSFS 2020; **Figure 6: Wildfire Hazard Map – Burn Probability**). The areas rated for higher burn probability and higher risk are generally those furthest from previously developed nearby areas. Based on field observations, the site is generally uniform in vegetation density and type except the drainageway along the unnamed tributary to the west, which had denser vegetation but was also more mesic, and thus potentially less of a burn risk.

Roughly 80% of the Project area is mapped as “Highest” wildfire risk while the remaining 20% is mapped as “High” risk. The “High” risk areas of the site are generally around the perimeter of the property where nearby development has already limited available fuels. The site is rated low in terms of values and assets present that could be lost to wildfire; it is rated “High” in terms of burn probability based on the available fuels at the site, nearly all of which are grasslands. The nearest fire response is Station 3 in the Falcon FPD, which is located 0.41 miles from the site; the second closest station is Station 1 in the Falcon FPD, which is 2.89 miles away.

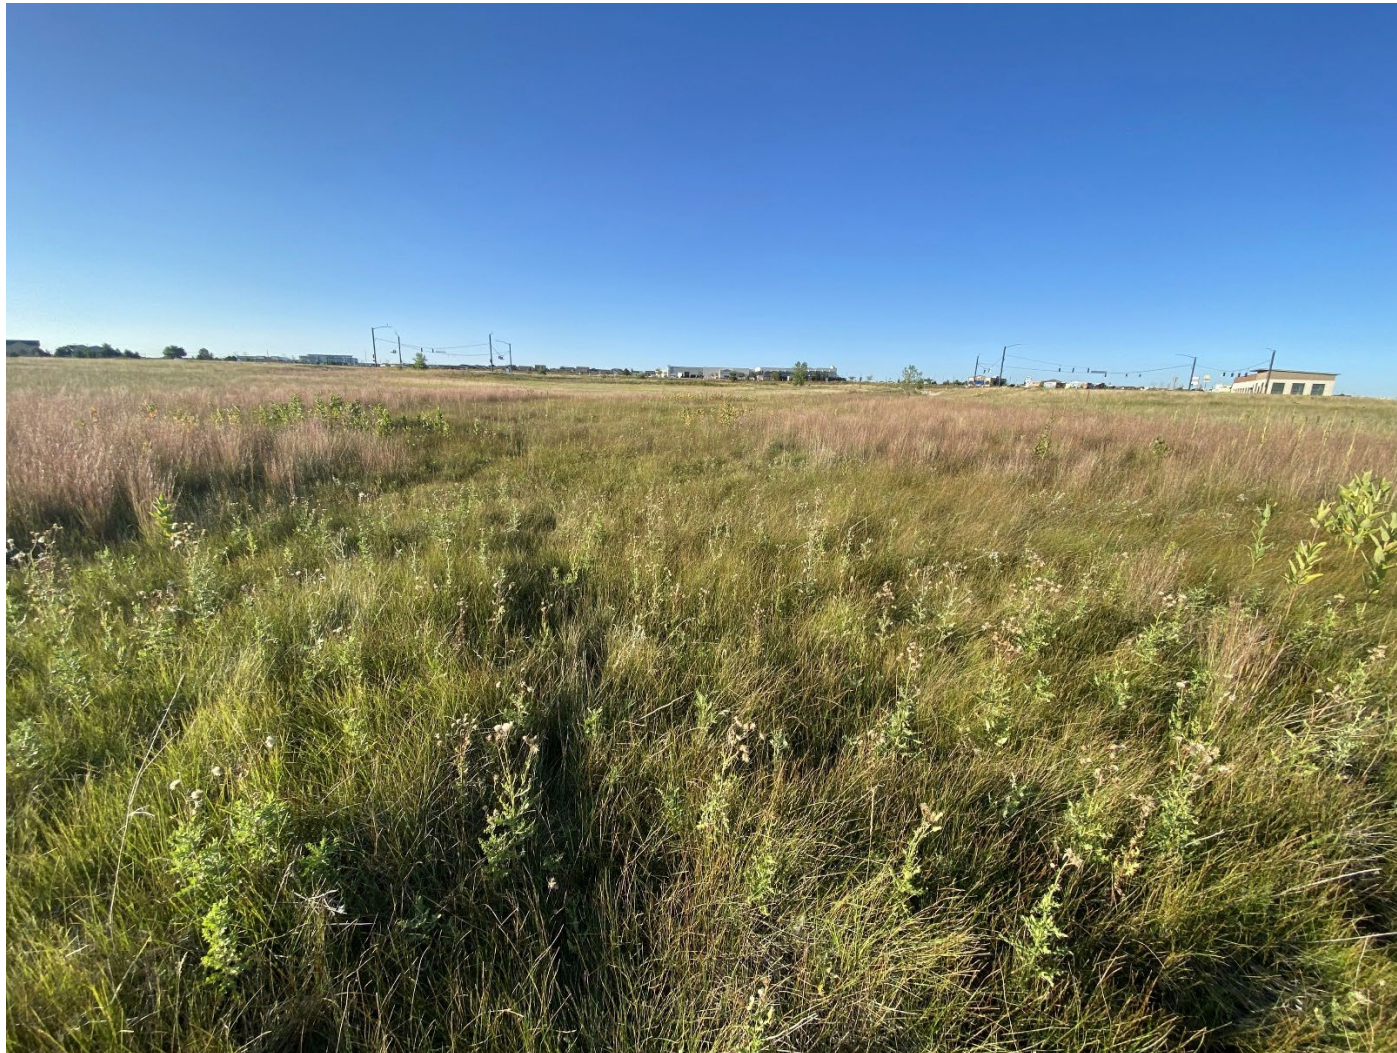
PHOTO 1 – Overview of typical habitat taken from the central portion of the site, facing north. Vegetation at this location is an odd mix of typical grassland species such as little bluestem (visible on the left and right as taller, redder grasses) and blue grama, invasives such as Canada thistle (scattered throughout) and wetland plants such as Baltic rush (at center, codominant). This point marks the furthest south extent of Wetland 1.

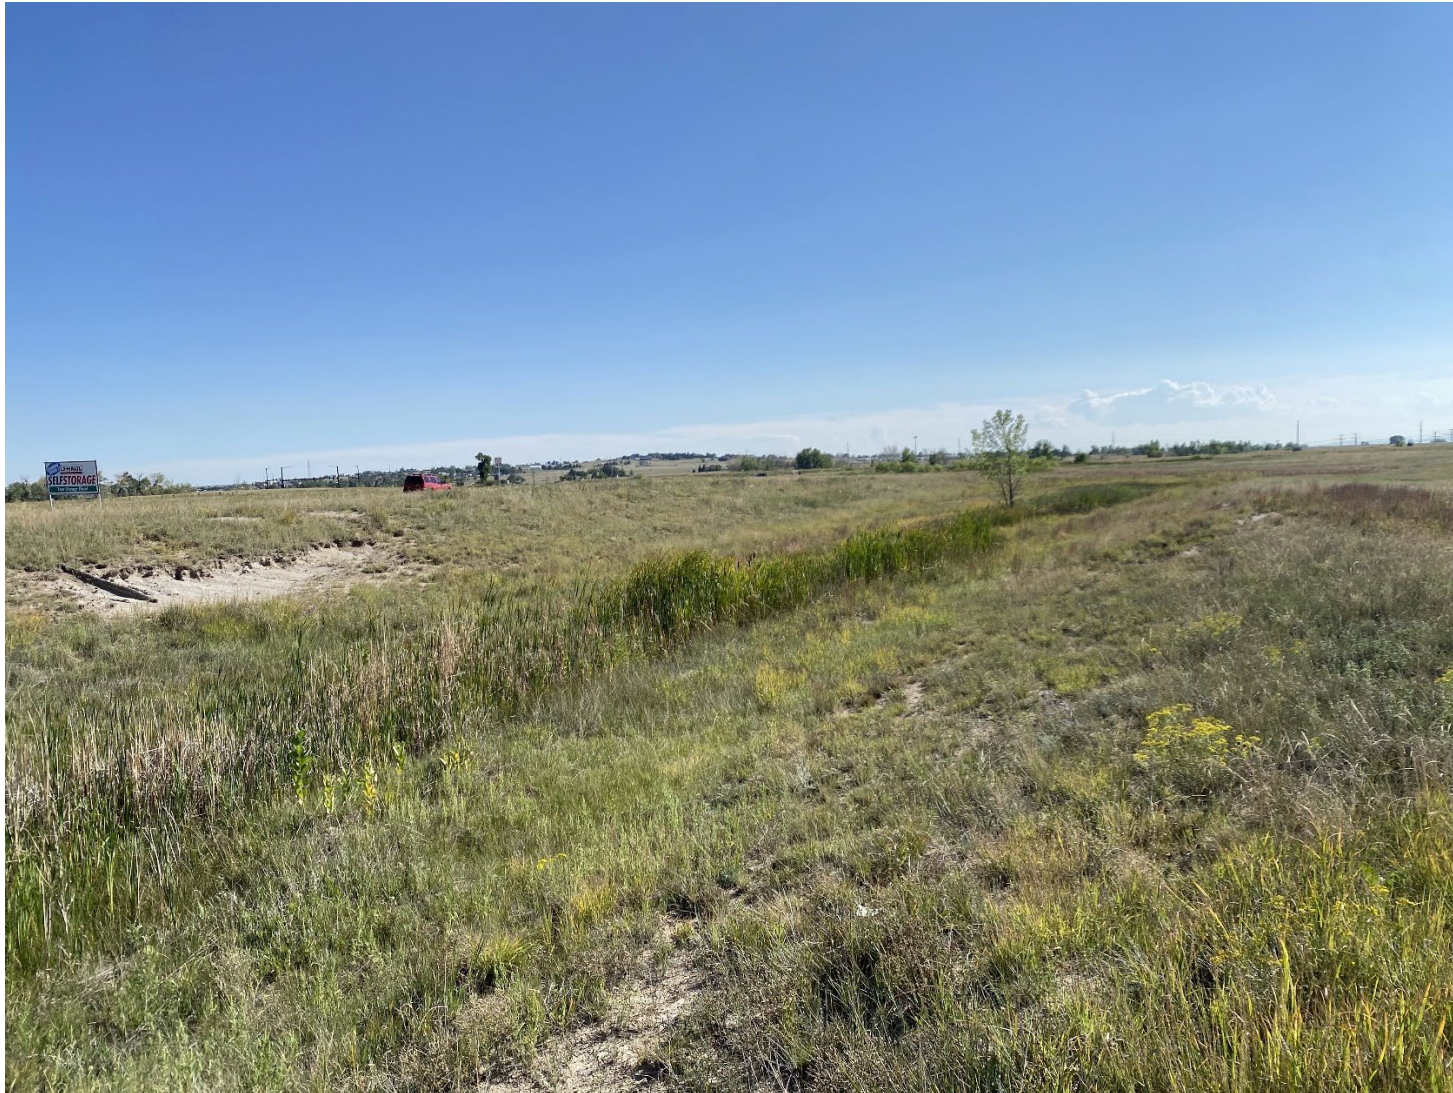
PHOTO 2 – View of Wetland 1 south of the culvert under Rolling Thunder Way that supplies its hydrology. The altered nature of the area is evident as a graded swale that is lower than the surrounding areas, supporting wetland plants that normally would not be present (darker vegetation).

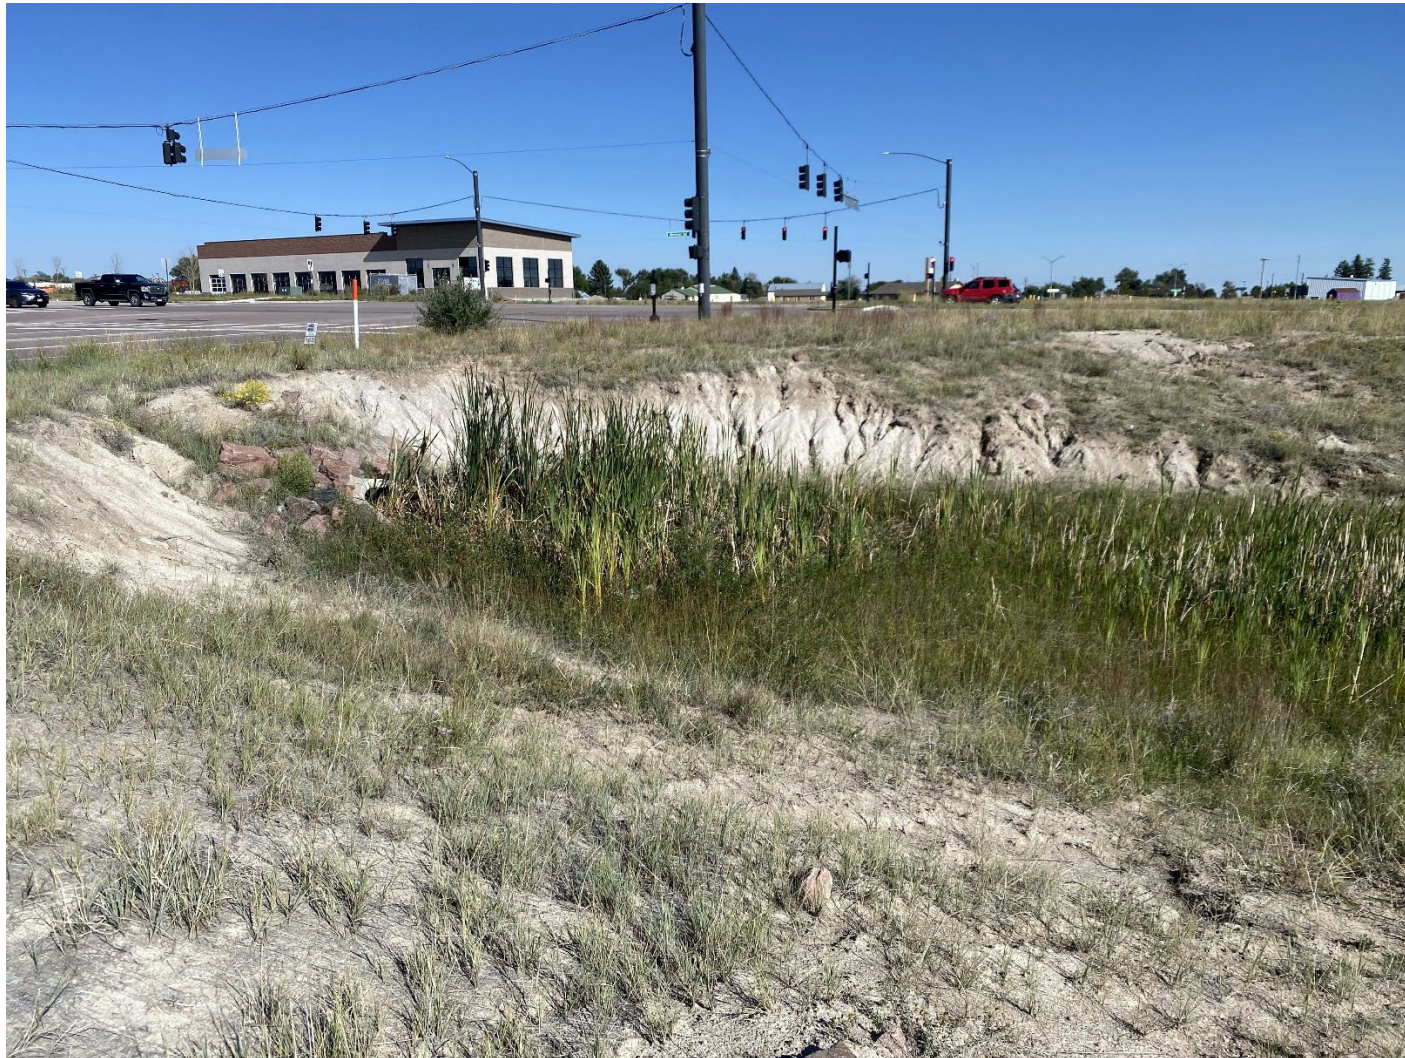
PHOTO 3 – Photo of Wetland 1 and the culvert under Rolling Thunder Way near the intersection with Meridian Road. Narrowleaf cattails, three-square bulrushes, sedges, rushes, and other wetland plants are obvious. This area would naturally support prairie grasses similar to the rest of the site if not for this artificial source of hydrology.

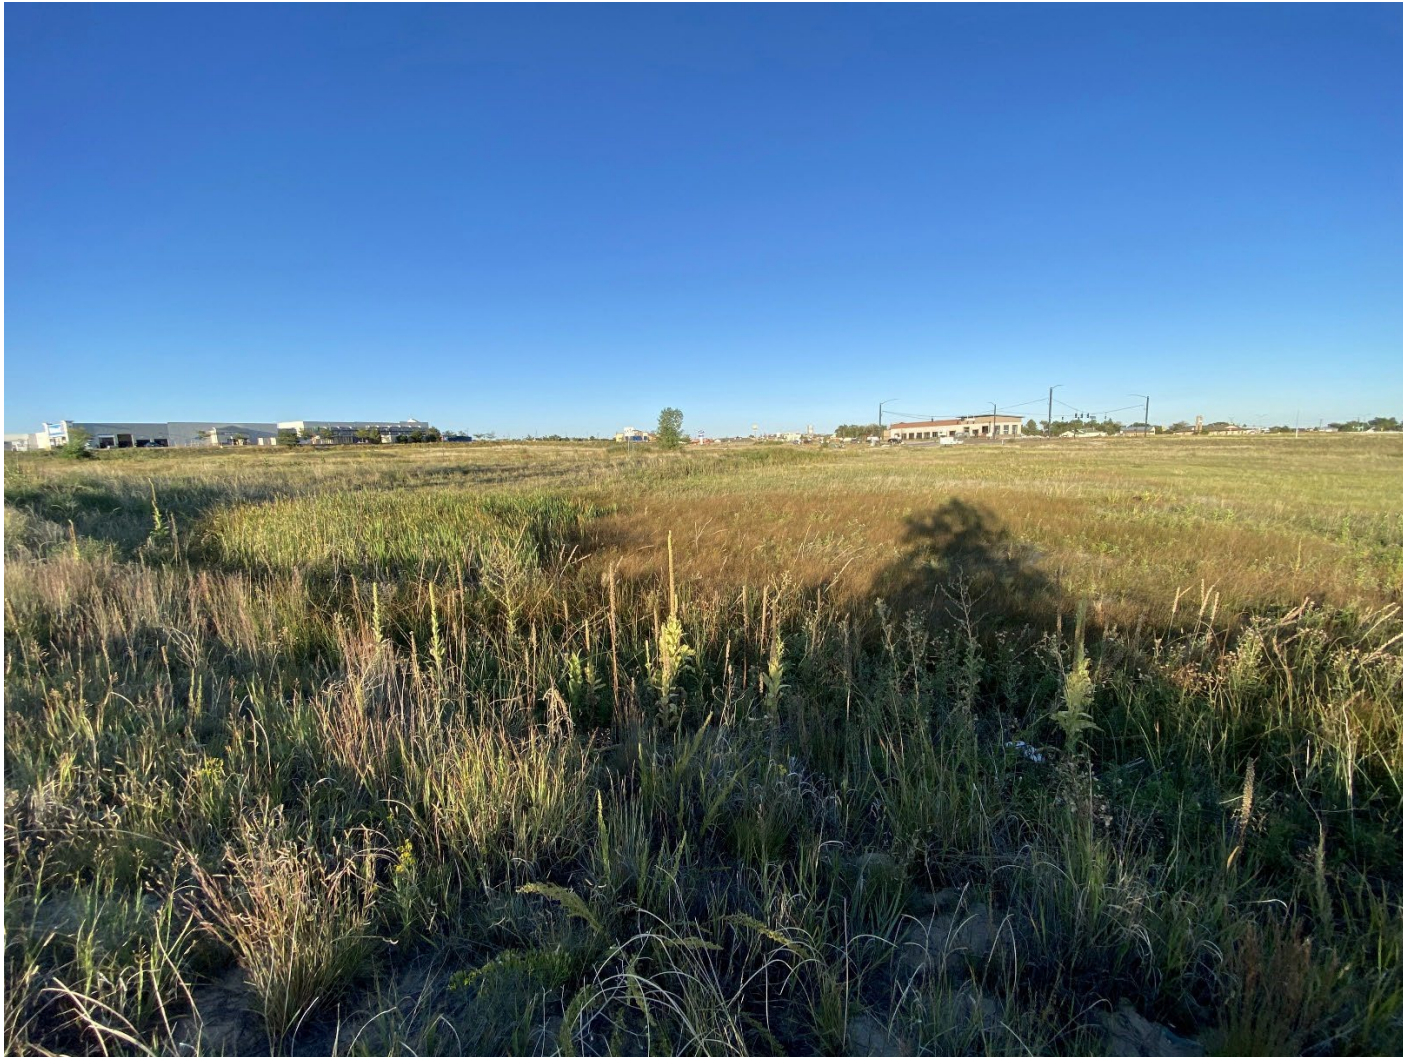
PHOTO 4 – View of Wetland 2, another odd feature, facing east. The extensive cattails are obvious at the lefthand side of the photo in the lowest area that is subject to ponding. Aerial photos from 2006 show that the higher area where the photographer is standing was constructed, probably as a future roadway, creating the low lying area in the photo where ponding now regularly occurs and wetlands have formed.

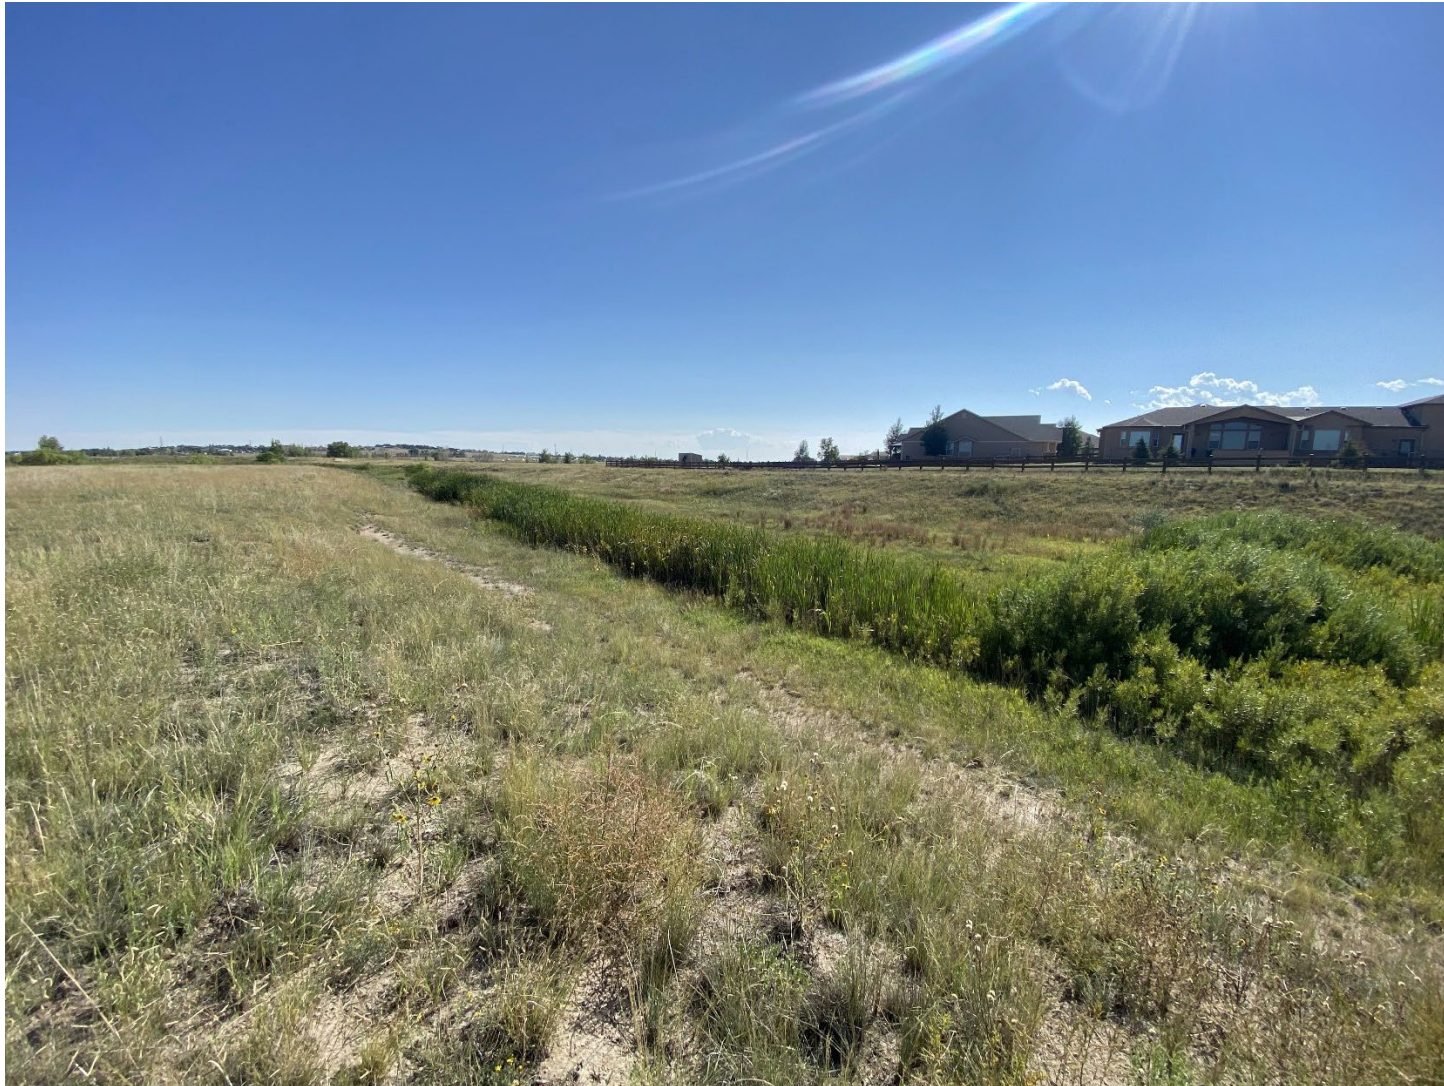
PHOTO 5 – View of the western boundary of the site and the drainage just to the west where the healthy riparian and wetland corridor exists. Note the topographic similarities between this humanmade drainageway and the one containing Wetland 1 (see PHOTO 2).
