Revised December 19, 2018

**Wetland Delineation Report
The Ranch Development Project
El Paso County, Colorado**

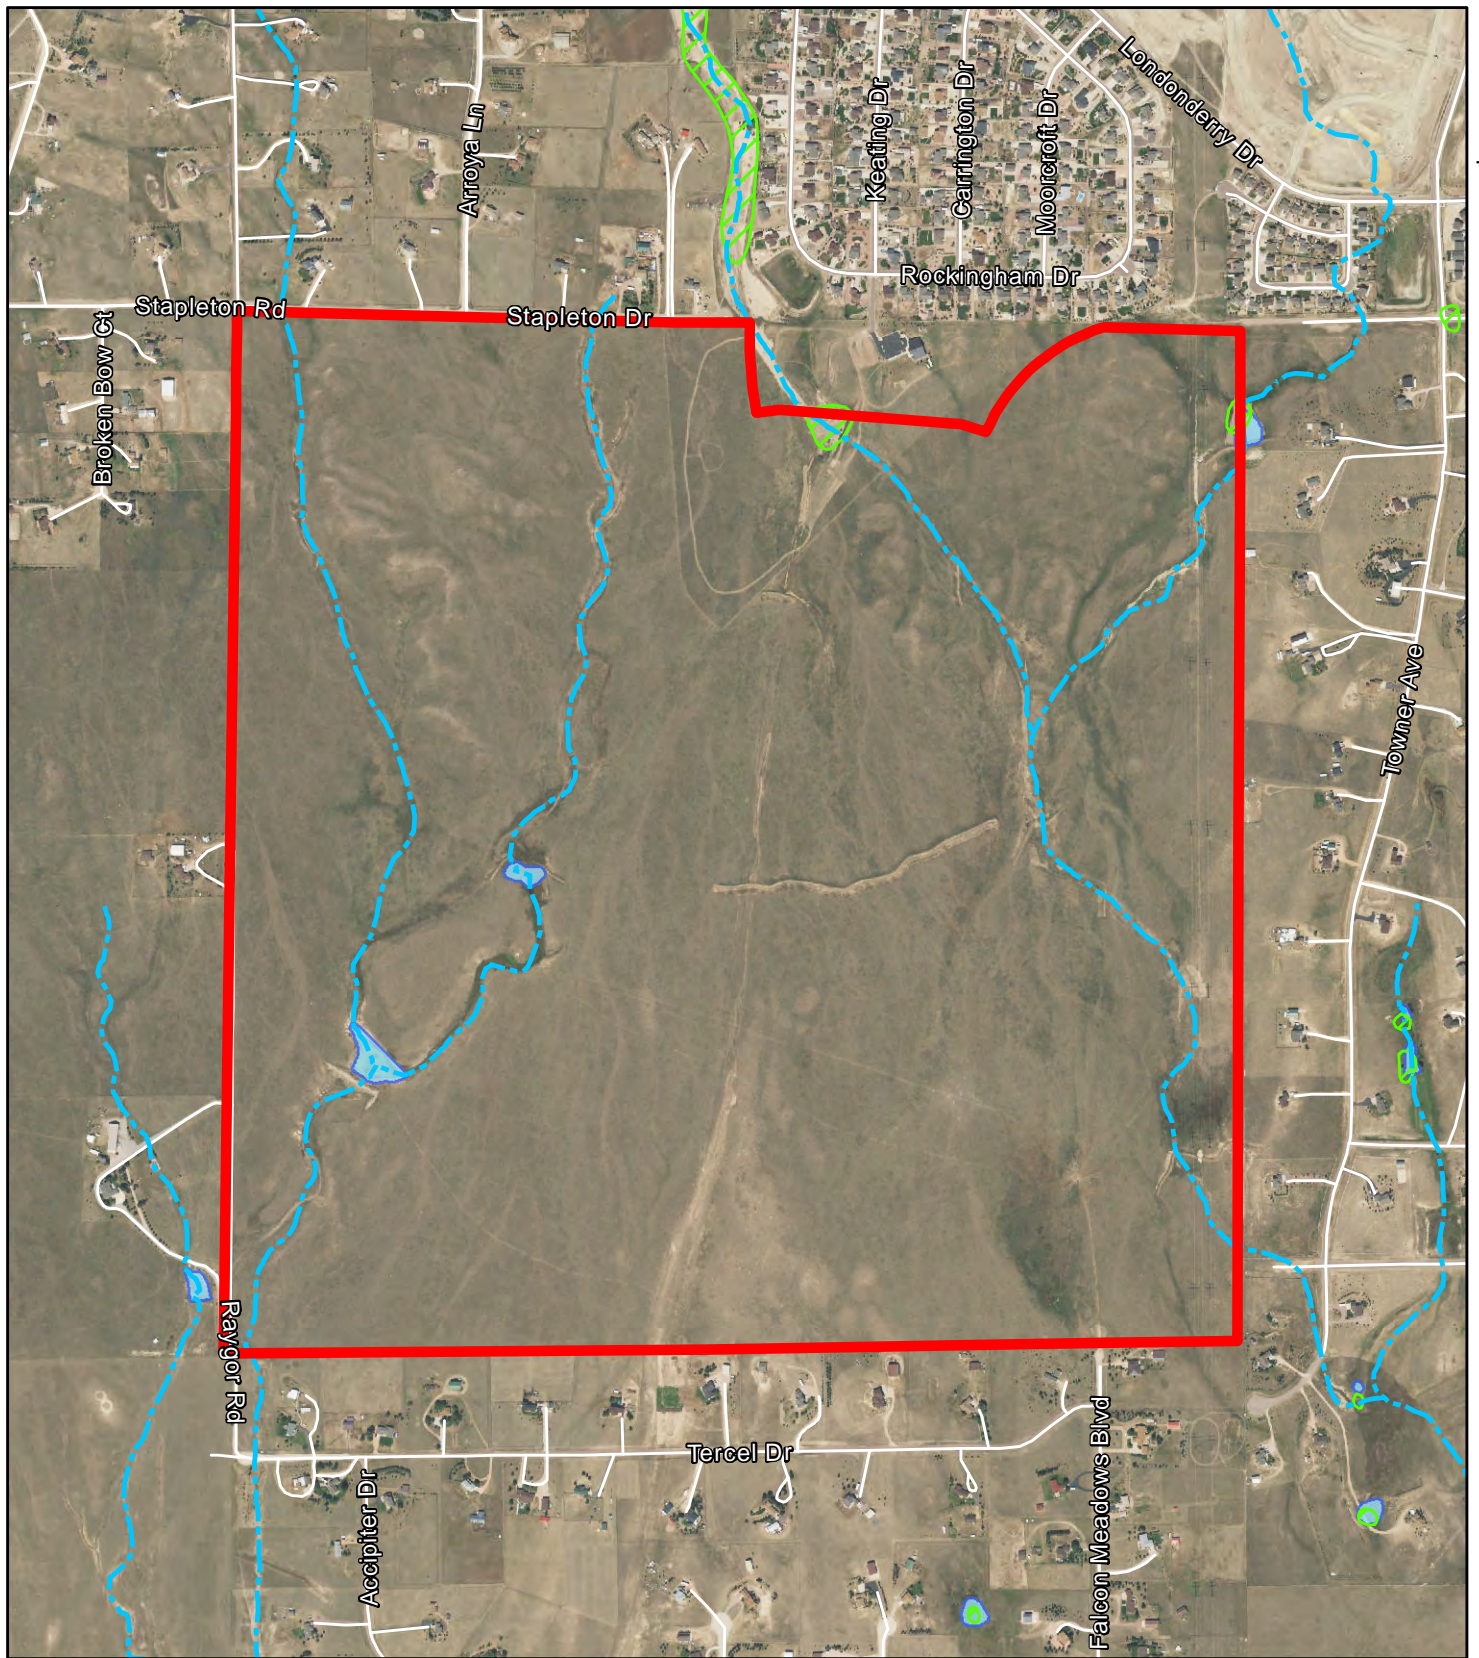
National Wetland Inventory Map

A review of NWI maps (USFWS 2018) was conducted to determine the potential presence, location, size, and type of wetlands located within the study area. The USFWS generates NWI maps through aerial photograph interpretation. NWI maps may not accurately depict the extent or existence of wetlands or other aquatic features, nor do maps consistently and accurately identify wetland type. As such, the maps were used for preliminary analysis only. Field reconnaissance was conducted to determine the true extent and type of wetlands located within the study area, and to verify the information gathered through NWI data review. NWI data depicted as many as eight wetlands within the study area, all within or associated with streams in the Project area (**Attachment III: National Wetland Inventory Map**). Types and locations of NWI wetlands included:

- Four R4SBC (Riverine, Intermittent, Seasonally-flooded Streambed) wetlands, representing the majority of four depicted stream channels on the site
- One PUBF (Palustrine, Unconsolidated Bottom, Semipermanently Flooded) wetland, a pond on the eastern boundary of the site
- One PUSA (Palustrine, Unconsolidated Shore, Temporarily Flooded) wetland, a pond in the north-central portion of the site
- Two PEMIA (Palustrine, Persistent Emergent, Temporarily Flooded) wetlands within the east and west forks of the westernmost stream

The information gathered from the desktop review indicated that as many as eight potentially-jurisdictional aquatic features may be located within the study area (**Attachment III**). Four NHD blue-line streams are depicted within the study area, all of which eventually drain into the Arkansas River (**Attachment III**). The streams depicted in the NHD data were determined to be ephemeral, only conveying water following precipitation events; in addition, these channels did not consistently possess defined streambeds or banks and would not likely be considered jurisdictional by the USACE. The NWI dataset depicts seven wetlands in the study area, all associated with the stream channels depicted in the NHD. Some of these wetlands were accurately depicted in the NWI dataset, though the PUSA pond and the two eastern stream channels in the NWI dataset were not in evidence during the site visit. The other four NWI wetlands – two ponds and two R4SBC streams – were accurately depicted (**Attachment III**). However, it is unlikely these wetlands would be considered jurisdictional by the USACE based on their lack of adjacency or significant nexus with other WOUS. The two NHD streams on the eastern half of the study area that coincide with two of the R4SBC wetlands did not possess wetland soils or vegetation, and did not display defined streambeds or stream banks. In addition, the two streams on the western half of the study area were not as extensive as shown in the NHD and NWI data. The entire study area is outside of Zone A 100-year floodplains (**Attachment IV**).

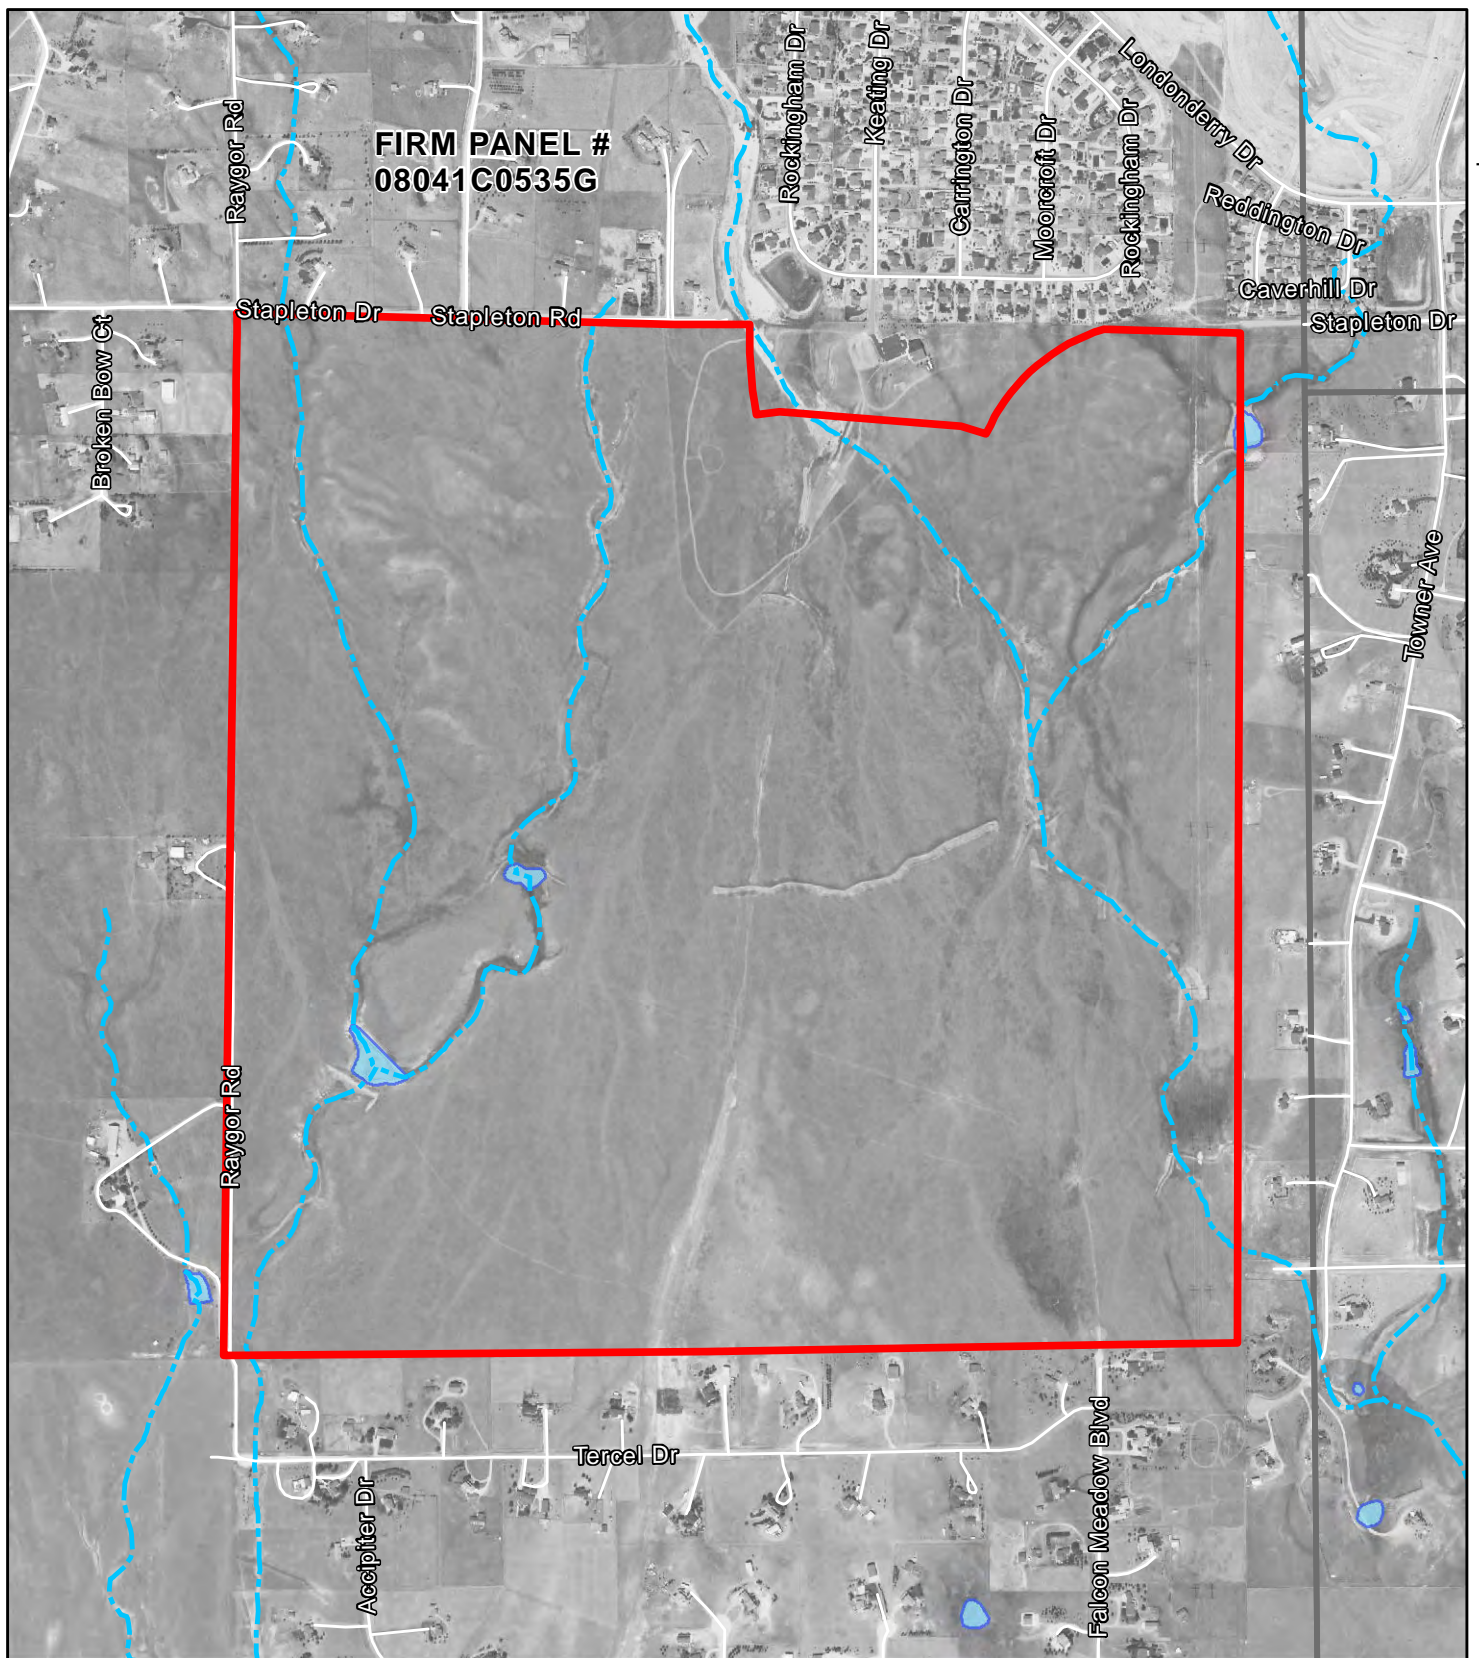
FEMA Flood Insurance Rate Map

Flood Elevations), and risk premium zones developed from topographical information across a floodplain. FEMA generates FIRM floodplain maps for flood insurance purposes. A review of El Paso County FEMA FIRM panels indicates that the entire study area is identified as Zone X, which is outside of any 100-year or 500-year flood zones (FEMA 2017). The study area is located within FEMA FIRM panel 08041C0535G (**Attachment IV: Flood Insurance Rate Map**).

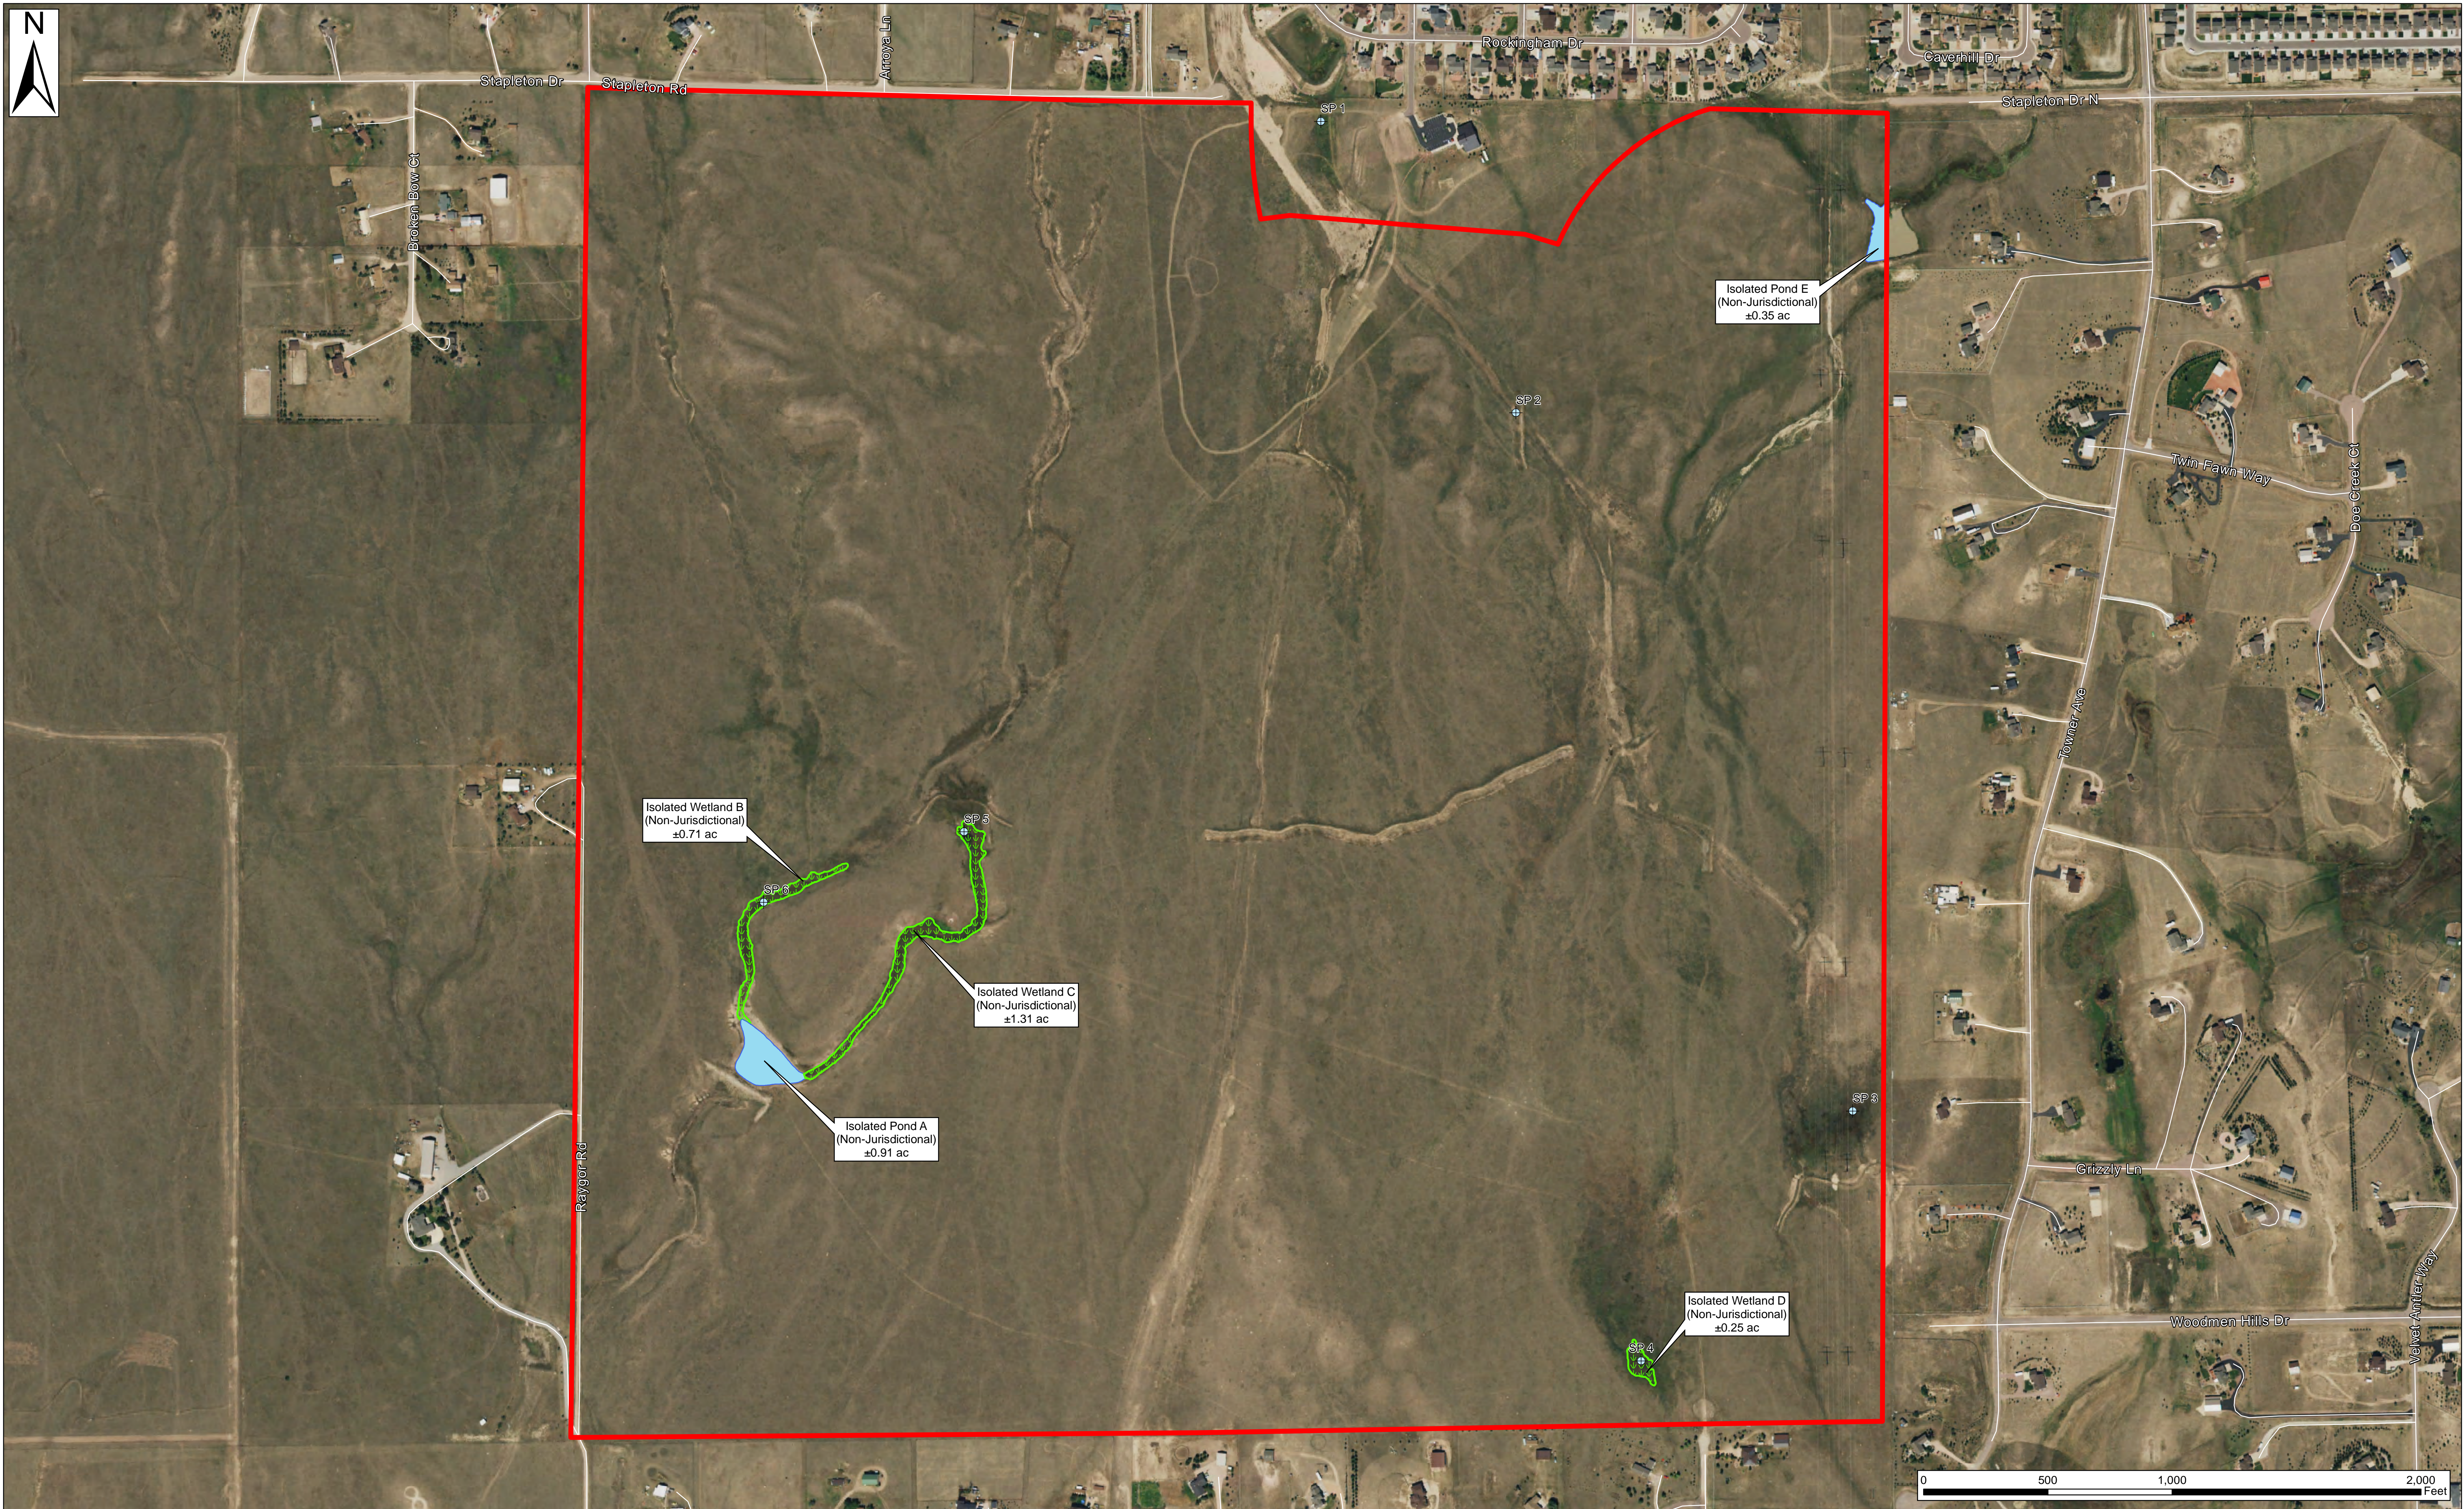
WETLAND LOCATION MAP

During the field assessment, six total wetlands were confirmed in the field. The westernmost streams both contained wetlands within significant portions of the stream channels; the only wetland associated with the eastern streams was the PUBF pond on the eastern boundary of the study area (**Attachment VI: Wetland Location Map**). One additional wetland not depicted in the NWI or NHD datasets was delineated in the field near the southeast corner of the study area (**Attachment VI**). This wetland (Isolated Wetland D) and the PUBF wetland (Isolated Pond E) were not associated with any other aquatic

features and appear to be isolated wetlands, presumably not jurisdictional (**Attachment VI**). Potentially jurisdictional streams in the western half of the study area possessed a well-defined streambed and banks capable of conveying significant volumes of water, but the streams are ephemeral and dry the majority of the year, and therefore likely non-jurisdictional. Portions of both tributaries of the western NHD streams were well-defined, but neither was as extensive as depicted in the NHD or NWI datasets (**Attachment III; Attachment VI**). All of the watercourses observed in the survey area were determined to be ephemeral and were considered to be likely non-jurisdictional. This included the entirety of both eastern stream channels, and the portion of the western channel below the stock pond (Isolated Pond A). Because none of these streams connect with WOUS, all the aquatic features of the site are likely non-jurisdictional. **Table I** below lists the wetlands and stream segments found within the study area.

Hydrology at the Project consists primarily of natural stream flows, slope runoff, and naturally occurring events (e.g. precipitation). Artificial sources of hydrology such as runoff from agricultural irrigation are not present. No additional natural or artificial sources of hydrology were identified (**Attachment III**). Flows in Sand Creek vary widely in accordance with precipitation events. The historic NHD-identified streams on the Project site no longer carry significant hydrologic flows, and generally do not possess a defined streambed or banks. The exceptions are the western channels upstream of their confluence at Isolated Pond A, which form a defined streambed upstream of Isolated Pond A that contains Isolated Wetlands B and C, though these channels do not connect to WOUS (**Attachment VI**).

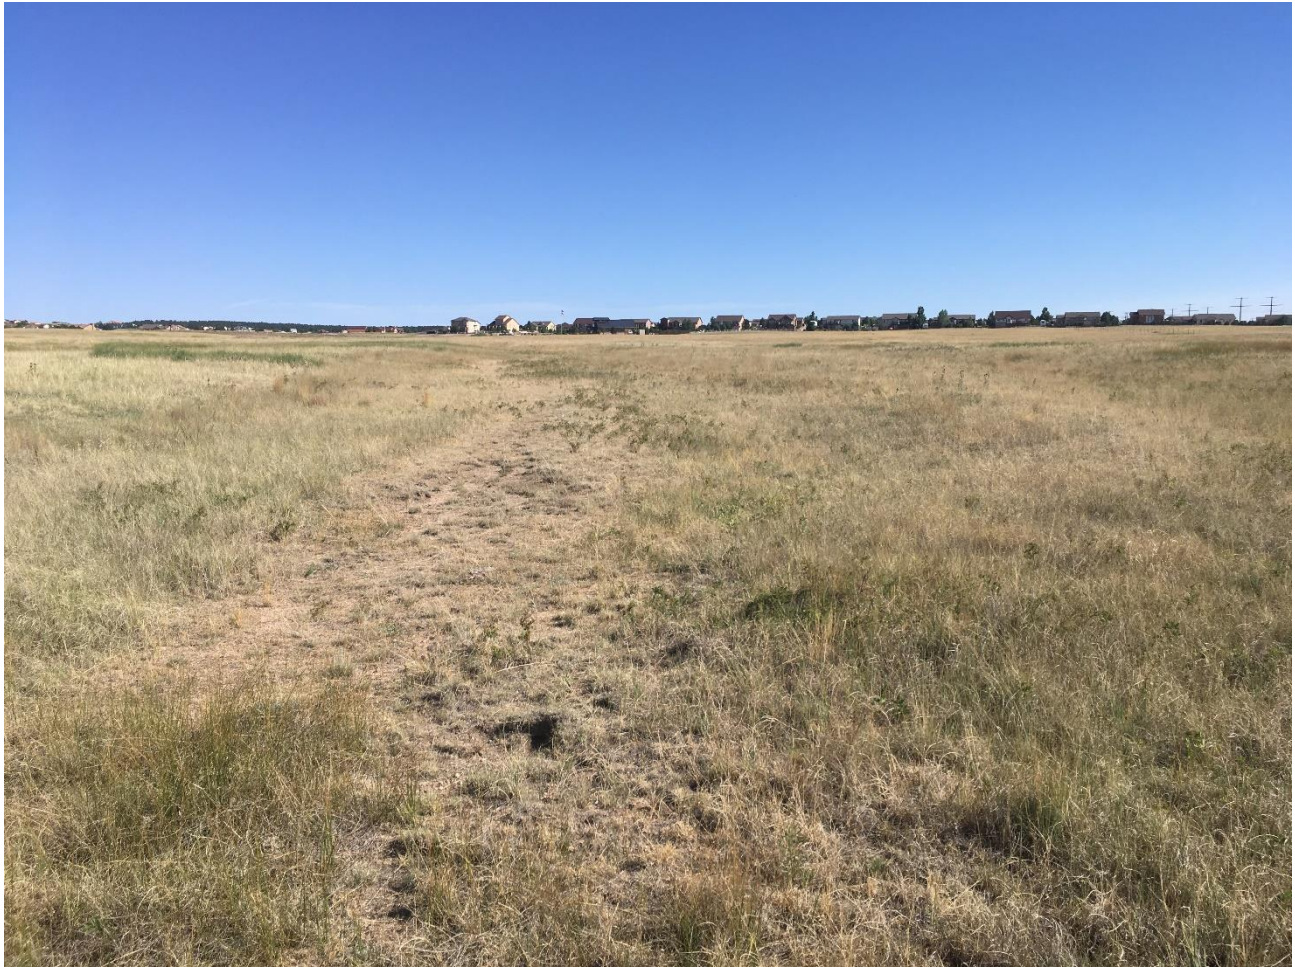
View of the eastern drainage that is depicted as an NHD watercourse and a riverine NWI wetland in the datasets. Neither of the eastern drainages displayed the characteristics of a stream channel – lacking defined bed and bank and lacking significant hydrological conveyance. This drainage is best characterized as an upland swale.
