Revised December 19, 2018

Mr. Loren Moreland
Classic Homes
6385 Corporate Drive, Suite 200
Colorado Springs, CO 80919

**Wetland Delineation Report
The Ranch Development Project
El Paso County, Colorado**

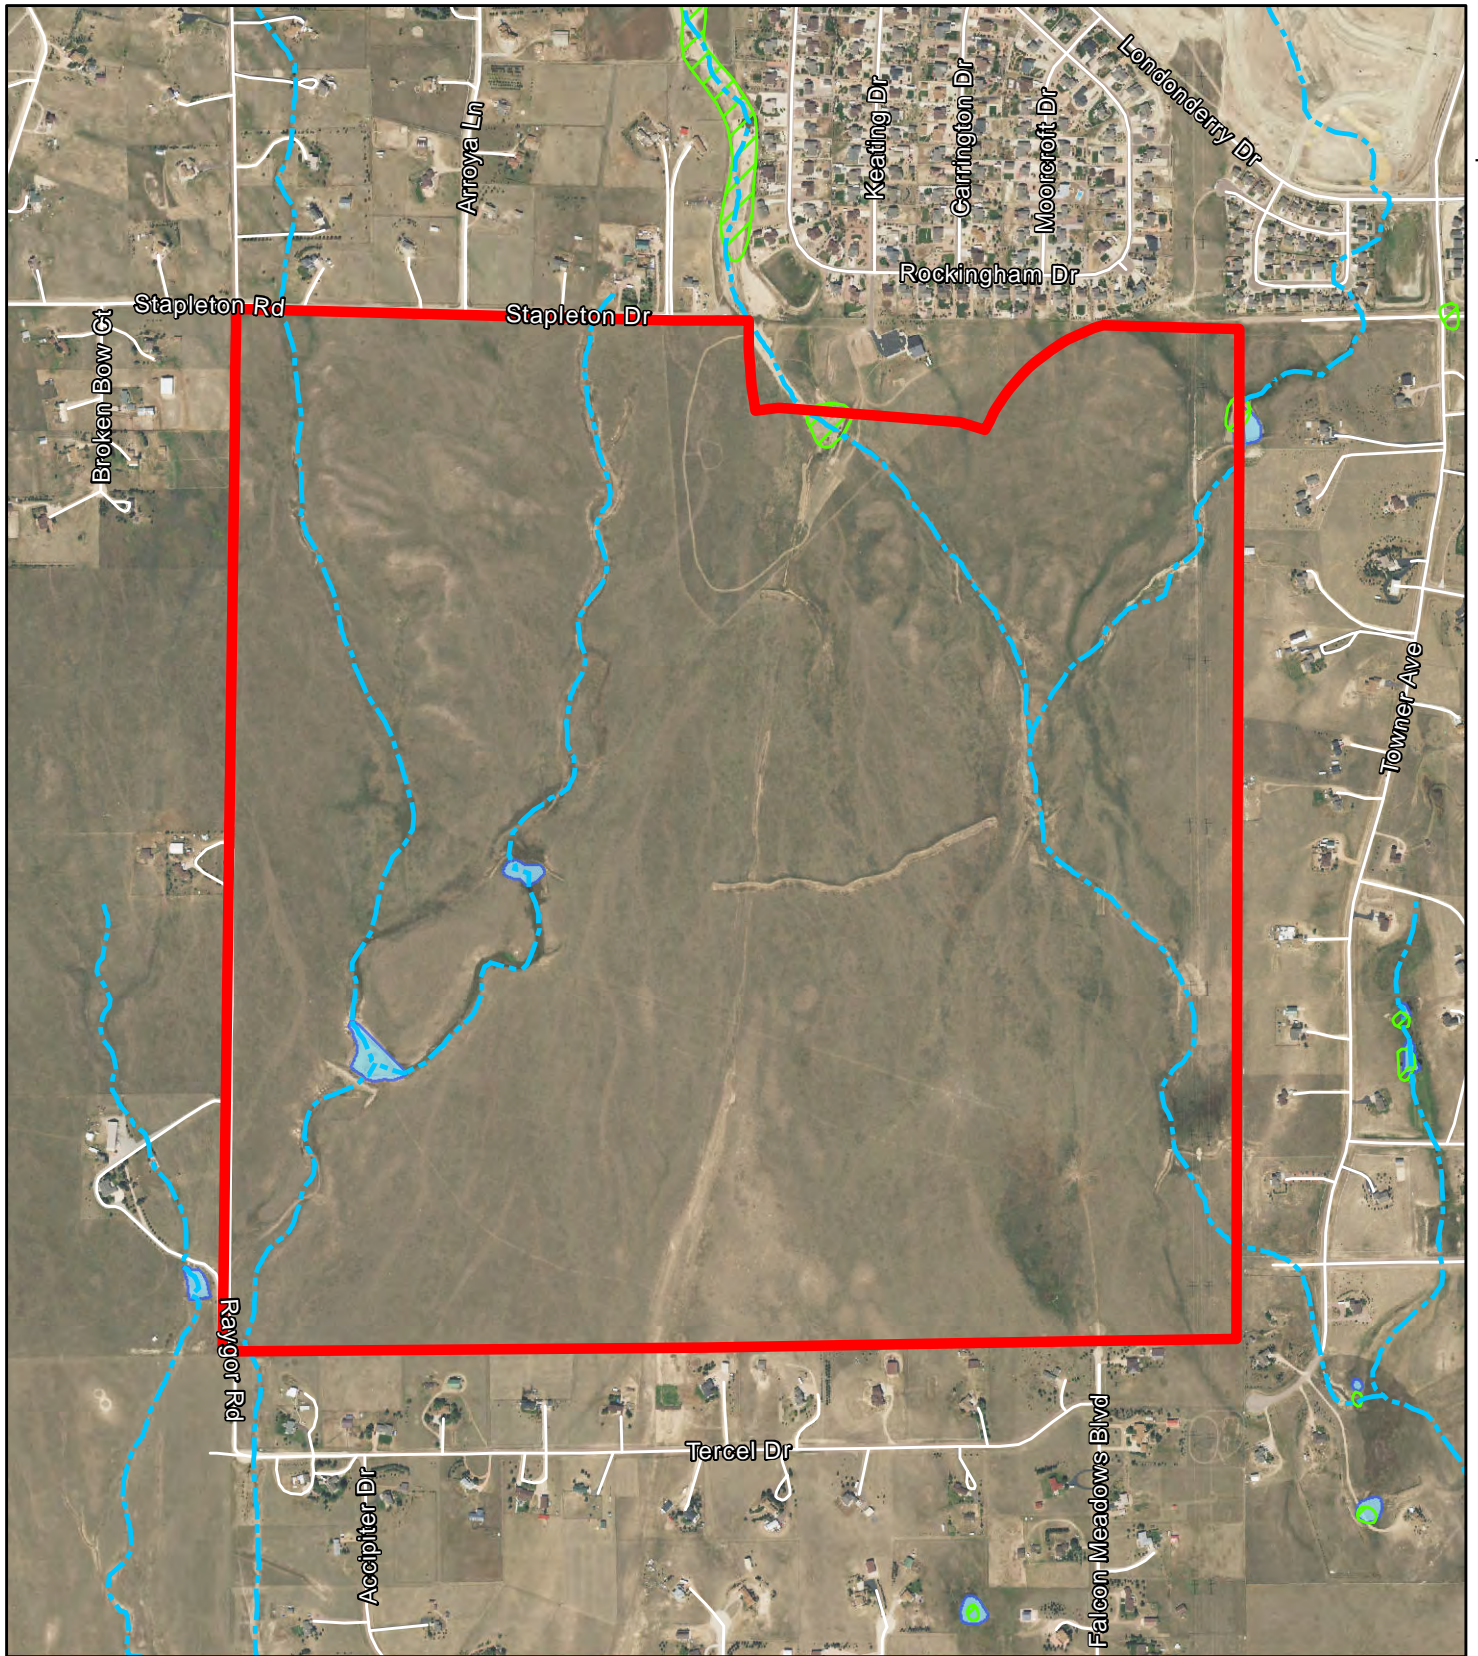
NATIONAL WETLAND INVENTORY MAP

A review of NWI maps (USFWS 2018) was conducted to determine the potential presence, location, size, and type of wetlands located within the study area. The USFWS generates NWI maps through aerial photograph interpretation. NWI maps may not accurately depict the extent or existence of wetlands or other aquatic features, nor do maps consistently and accurately identify wetland type. As such, the maps were used for preliminary analysis only. Field reconnaissance was conducted to determine the true extent and type of wetlands located within the study area, and to verify the information gathered through NWI data review. NWI data depicted as many as eight wetlands within the study area, all within or associated with streams in the Project area (**Attachment III: National Wetland Inventory Map**). Types and locations of NWI wetlands included:

- Four R4SBC (Riverine, Intermittent, Seasonally-flooded Streambed) wetlands, representing the majority of four depicted stream channels on the site
- One PUBF (Palustrine, Unconsolidated Bottom, Semipermanently Flooded) wetland, a pond on the eastern boundary of the site
- One PUSA (Palustrine, Unconsolidated Shore, Temporarily Flooded) wetland, a pond in the north-central portion of the site
- Two PEMIA (Palustrine, Persistent Emergent, Temporarily Flooded) wetlands within the east and west forks of the westernmost stream

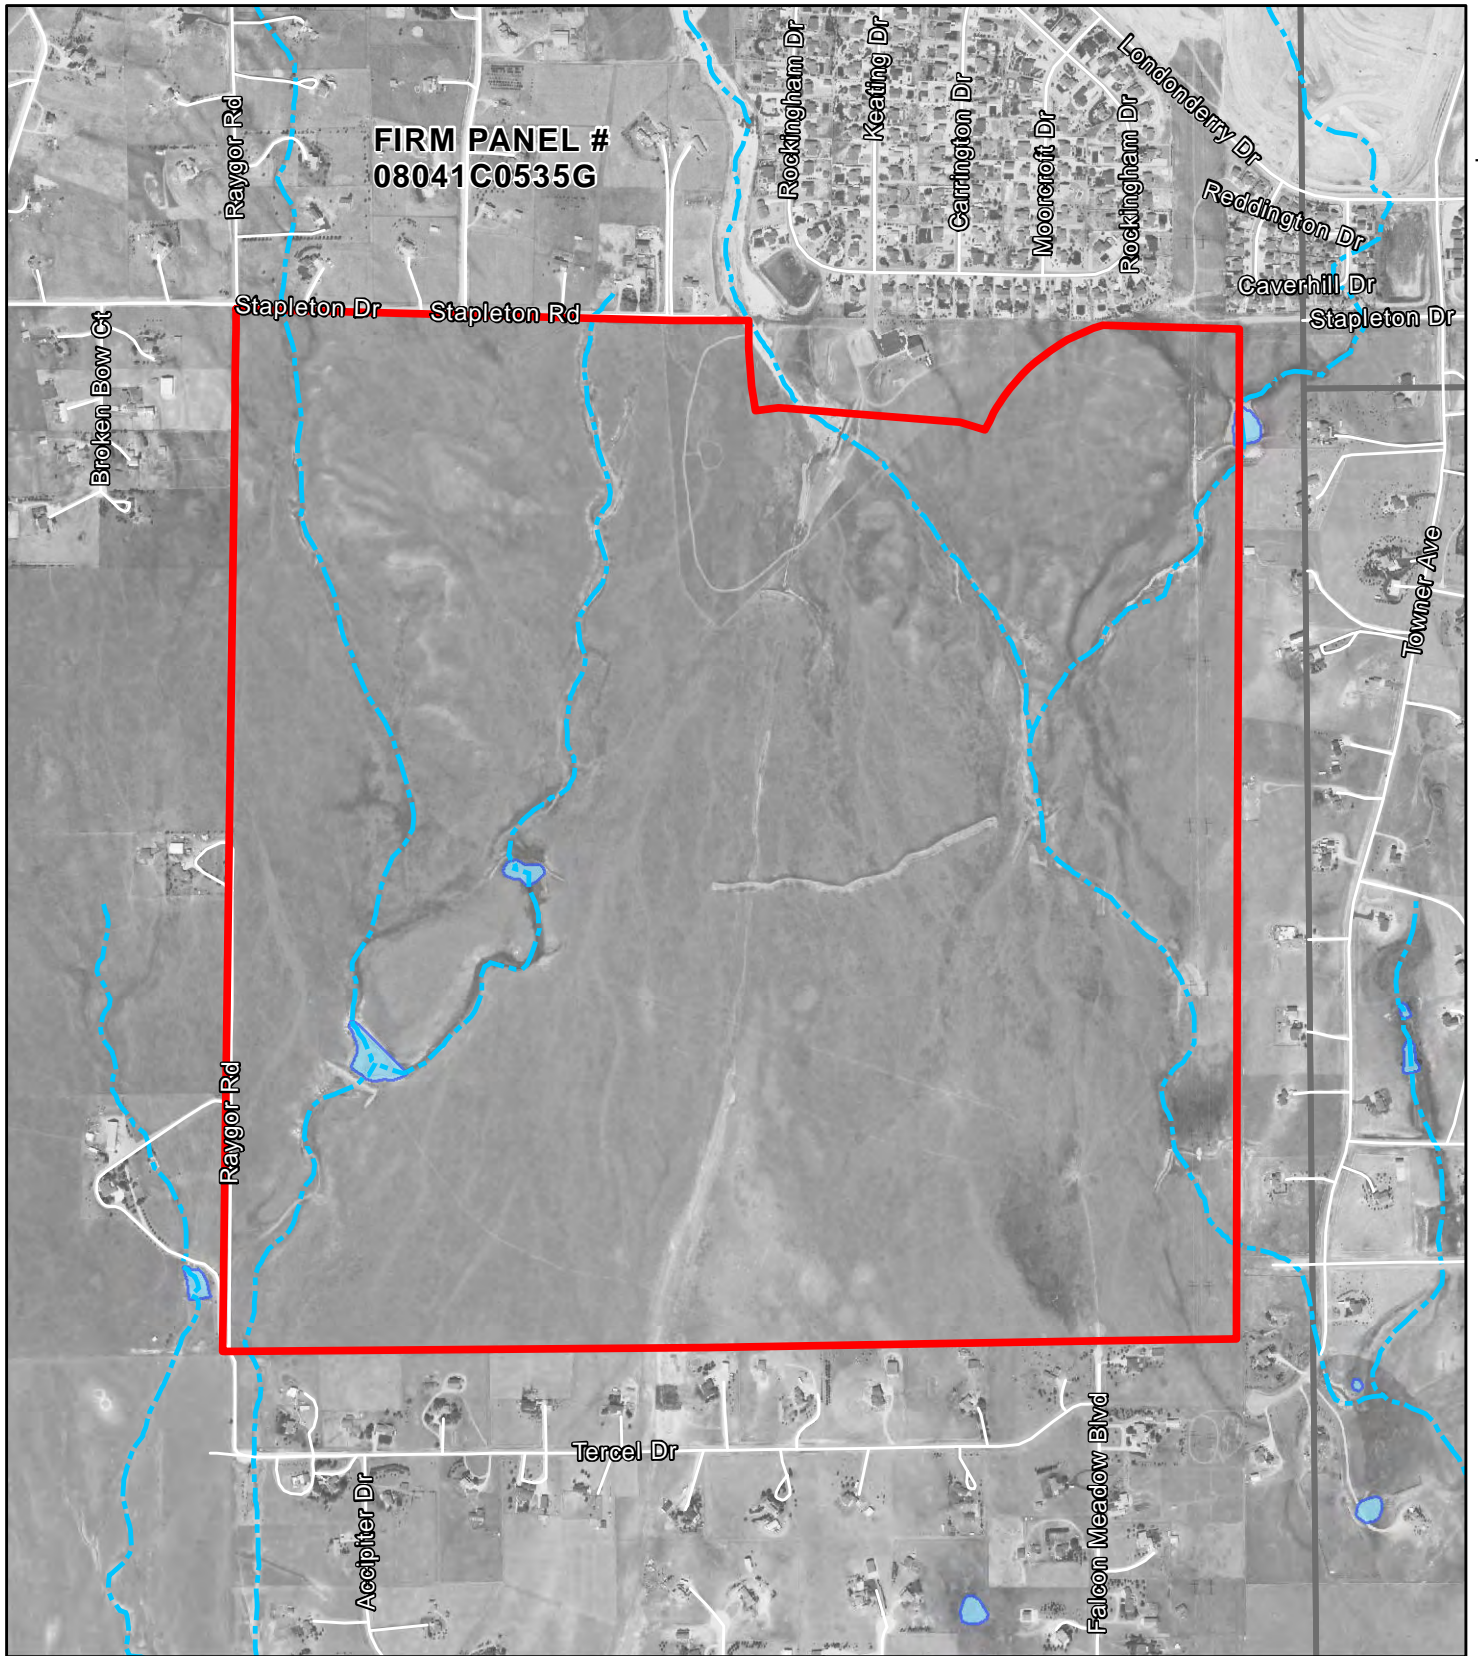
FEMA FLOOD INSURANCE RATE MAP

Flood Elevations), and risk premium zones developed from topographical information across a floodplain. FEMA generates FIRM floodplain maps for flood insurance purposes. A review of El Paso County FEMA FIRM panels indicates that the entire study area is identified as Zone X, which is outside of any 100-year or 500-year flood zones (FEMA 2017). The study area is located within FEMA FIRM panel 08041C0535G (**Attachment IV: Flood Insurance Rate Map**).

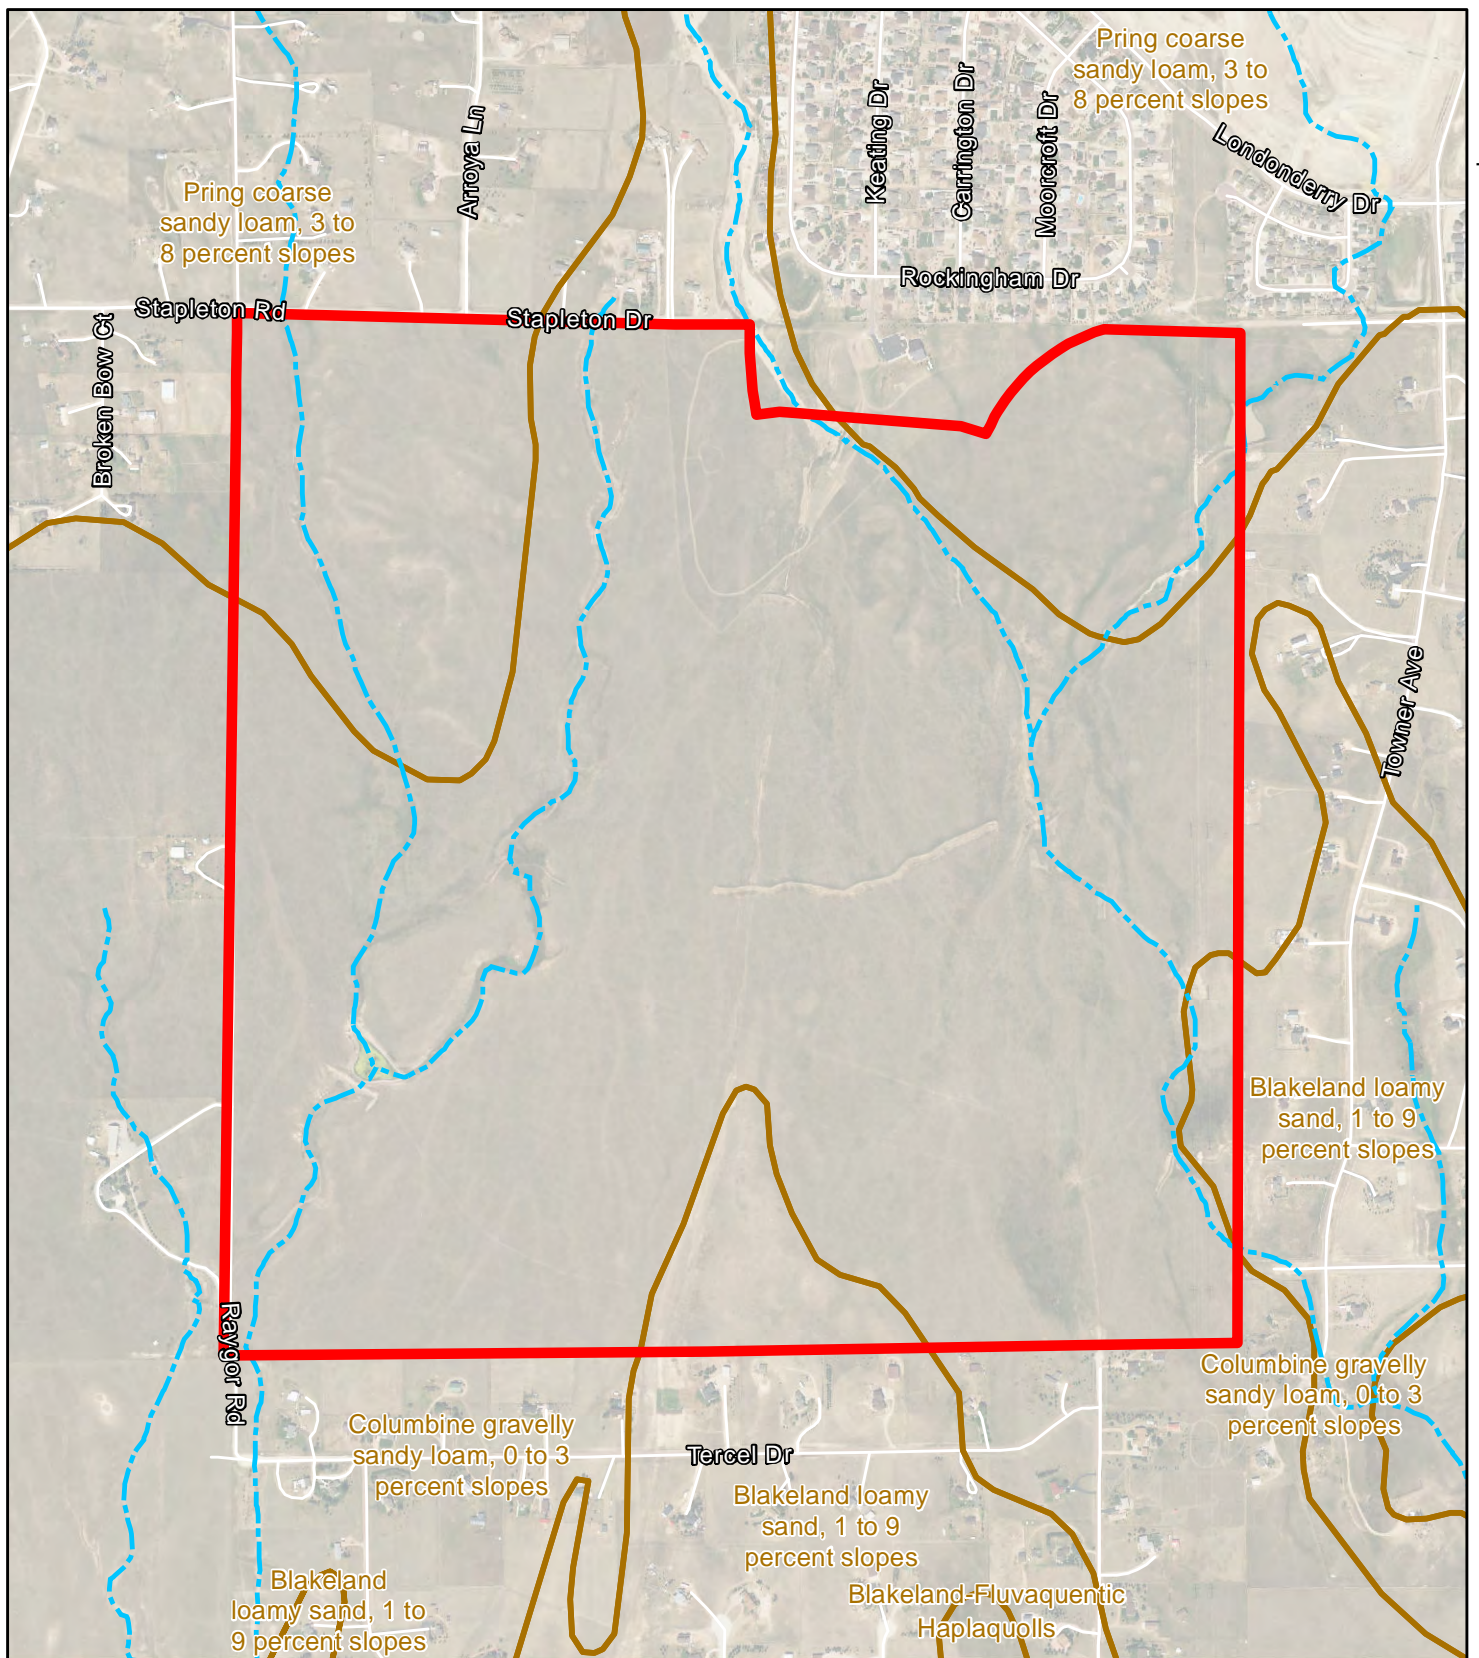
COUNTY SOIL SURVEY MAP

The El Paso County Soil Survey indicates the study area is located within three soil associations: Columbine gravelly sandy loam (0 to 3% slopes), Pring coarse sandy loam (3 to 8% slopes), and Blakeland loamy sand (1 to 9% slopes; **Attachment V: County Soil Survey Map**). The Columbine soil series is the predominant series within the study area, comprising approximately 76% of the study area, while the Pring and Blakeland series make up roughly 19% and 5% of the study area, respectively (**Attachment V**). All three series are classified by the Natural Resources Conservation Service (NRCS) as hydric soils in El Paso County (NRCS 2015).

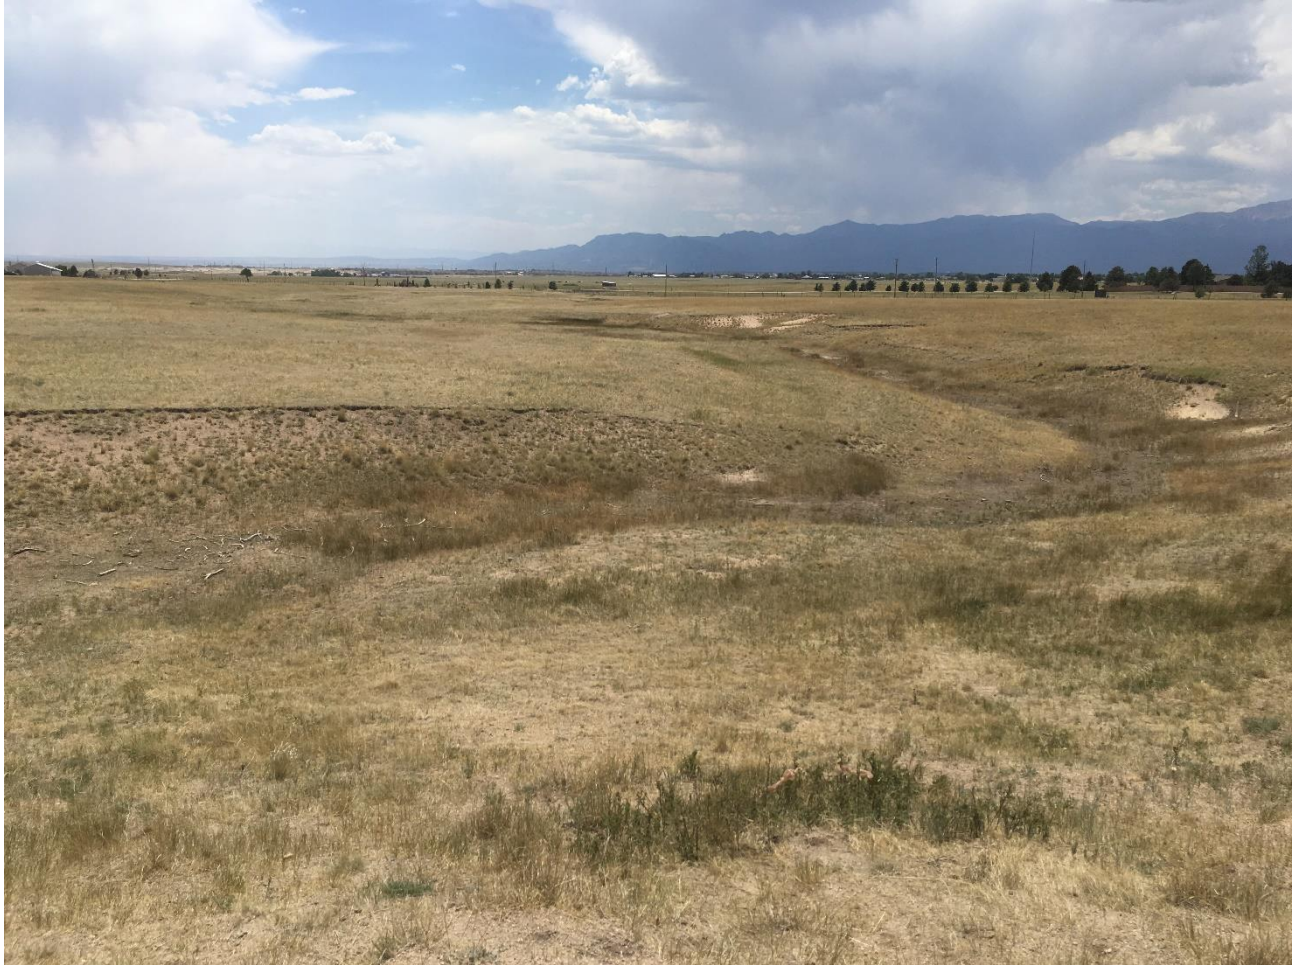
Ephemeral stream channel from the berm below Pond A, facing southwest. Though there are a few captive populations of rushes (*Juncus arcticus*) in the channel, this stream lacks wetland vegetation, hydric soils, and hydrology. Although the stream does retain a defined streambed and defined stream banks briefly below the berm, it quickly becomes an undefined upland swale, and eventually loses all definition as a drainageway.

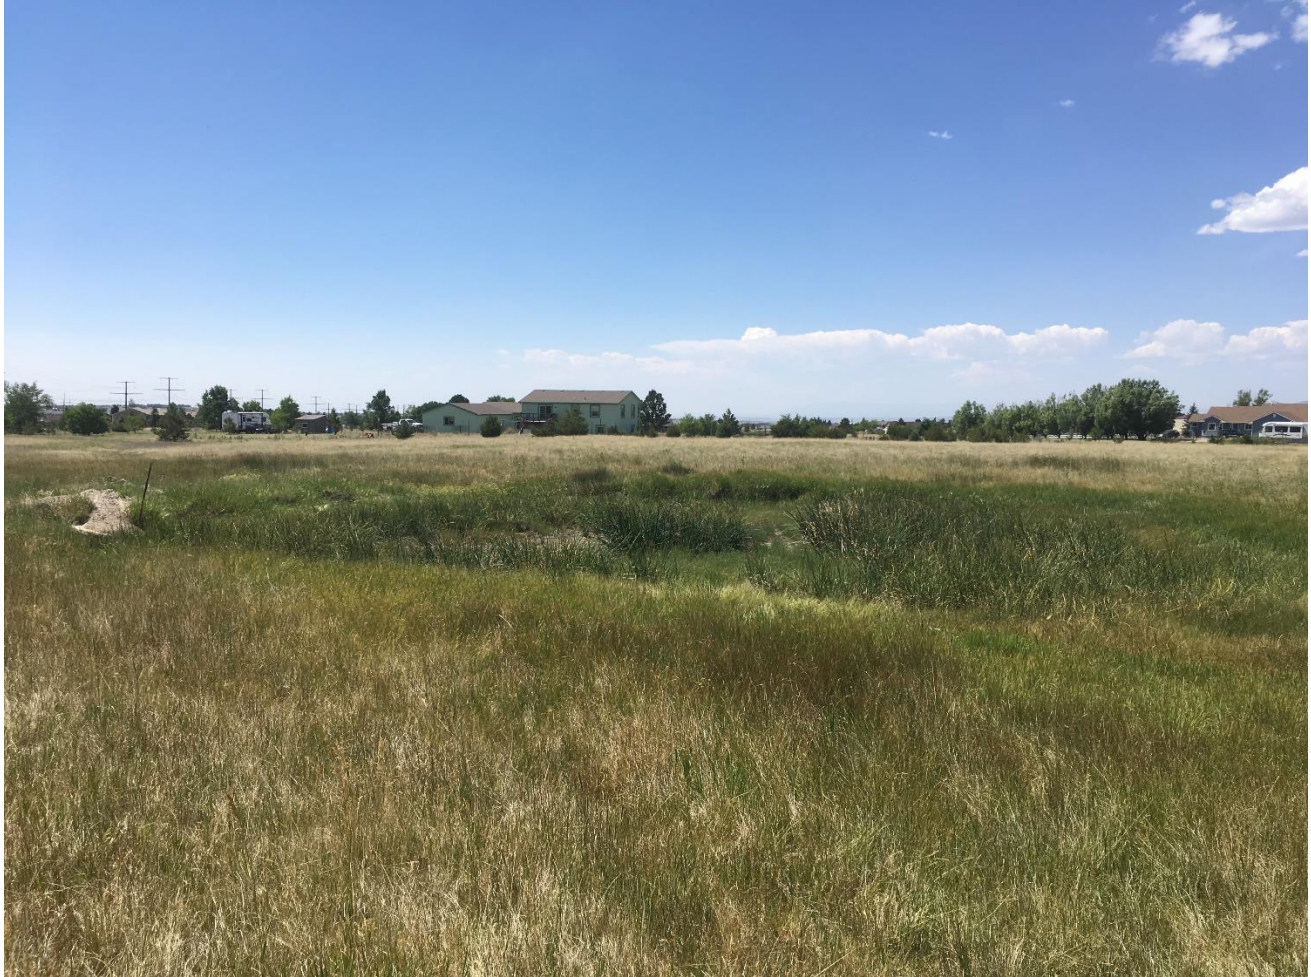
Looking southwest at Wetland D, an isolated depressional wetland near the southeast corner of the site that is expected to be considered non-jurisdictional by the USACE. Impacts to non-jurisdictional wetlands do not require permitting under Section 404 of the Clean Water Act at the time of this writing.

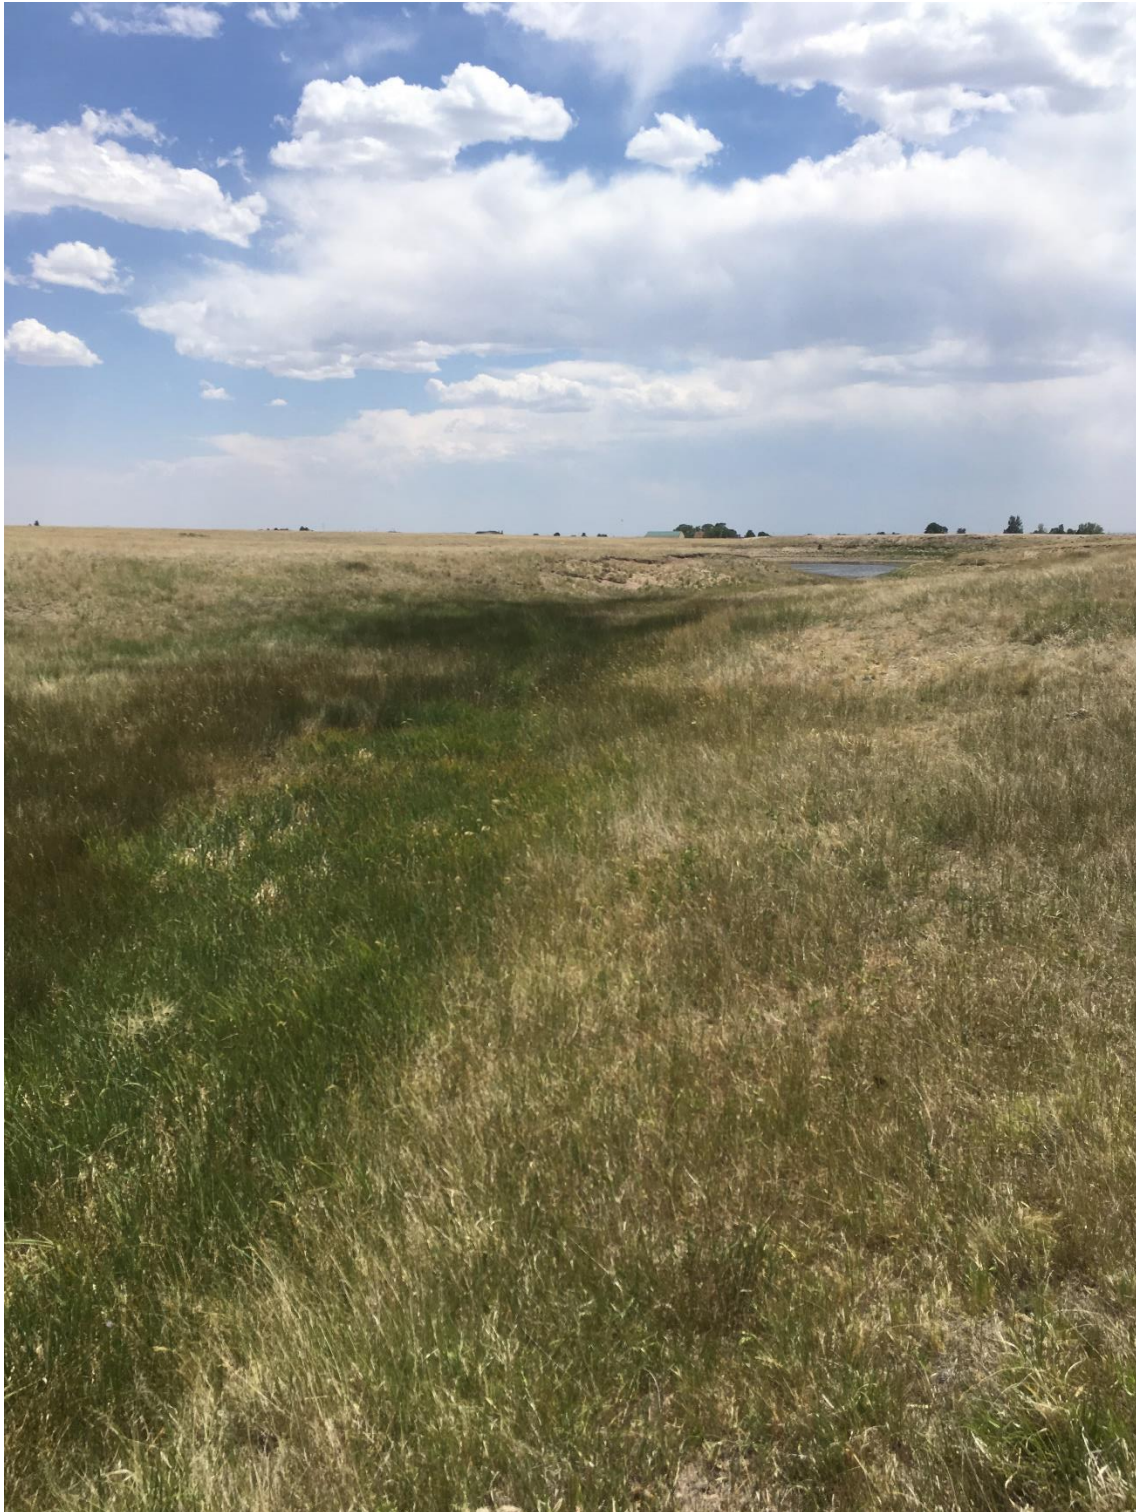
View of Isolated Wetland B facing south, showing the in-channel wetland vegetation and Pond A. Seasonally, the vegetated channel is expected to retain hydrology for portions of the year, and the pond is expected to remain flooded relatively permanently. However, the channel is not connected hydrologically to any WOUS.

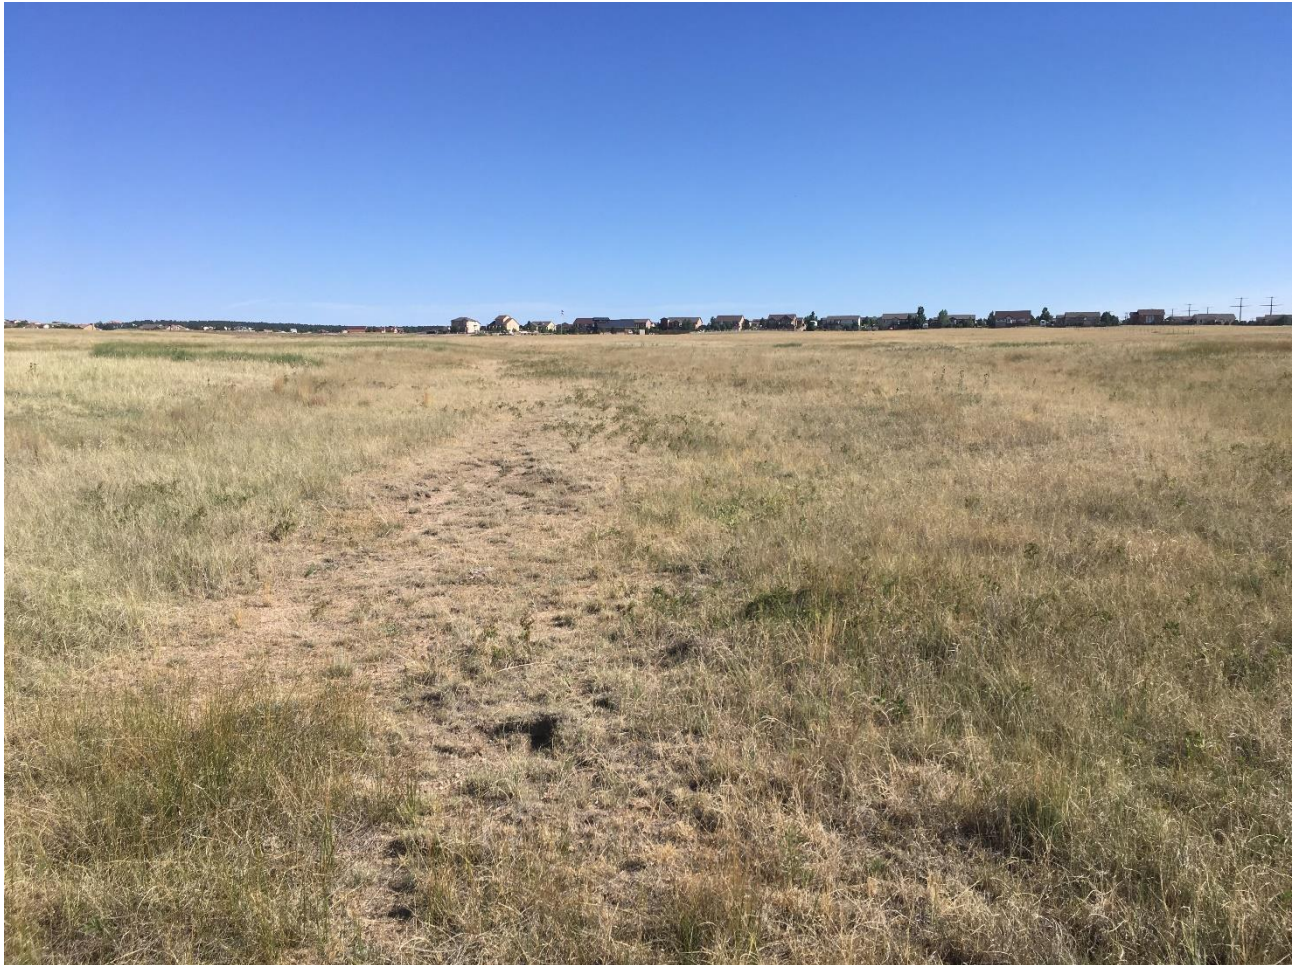
View of the eastern drainage that is depicted as an NHD watercourse and a riverine NWI wetland in the datasets. Neither of the eastern drainages displayed the characteristics of a stream channel – lacking defined bed and bank and lacking significant hydrological conveyance. This drainage is best characterized as an upland swale.
