**Wetland, Wildlife and Natural Features Report
for
Esteban Rodriguez Subdivision in El Paso County, Colorado**

June 19, 2023

Project Number: 2022-23-1

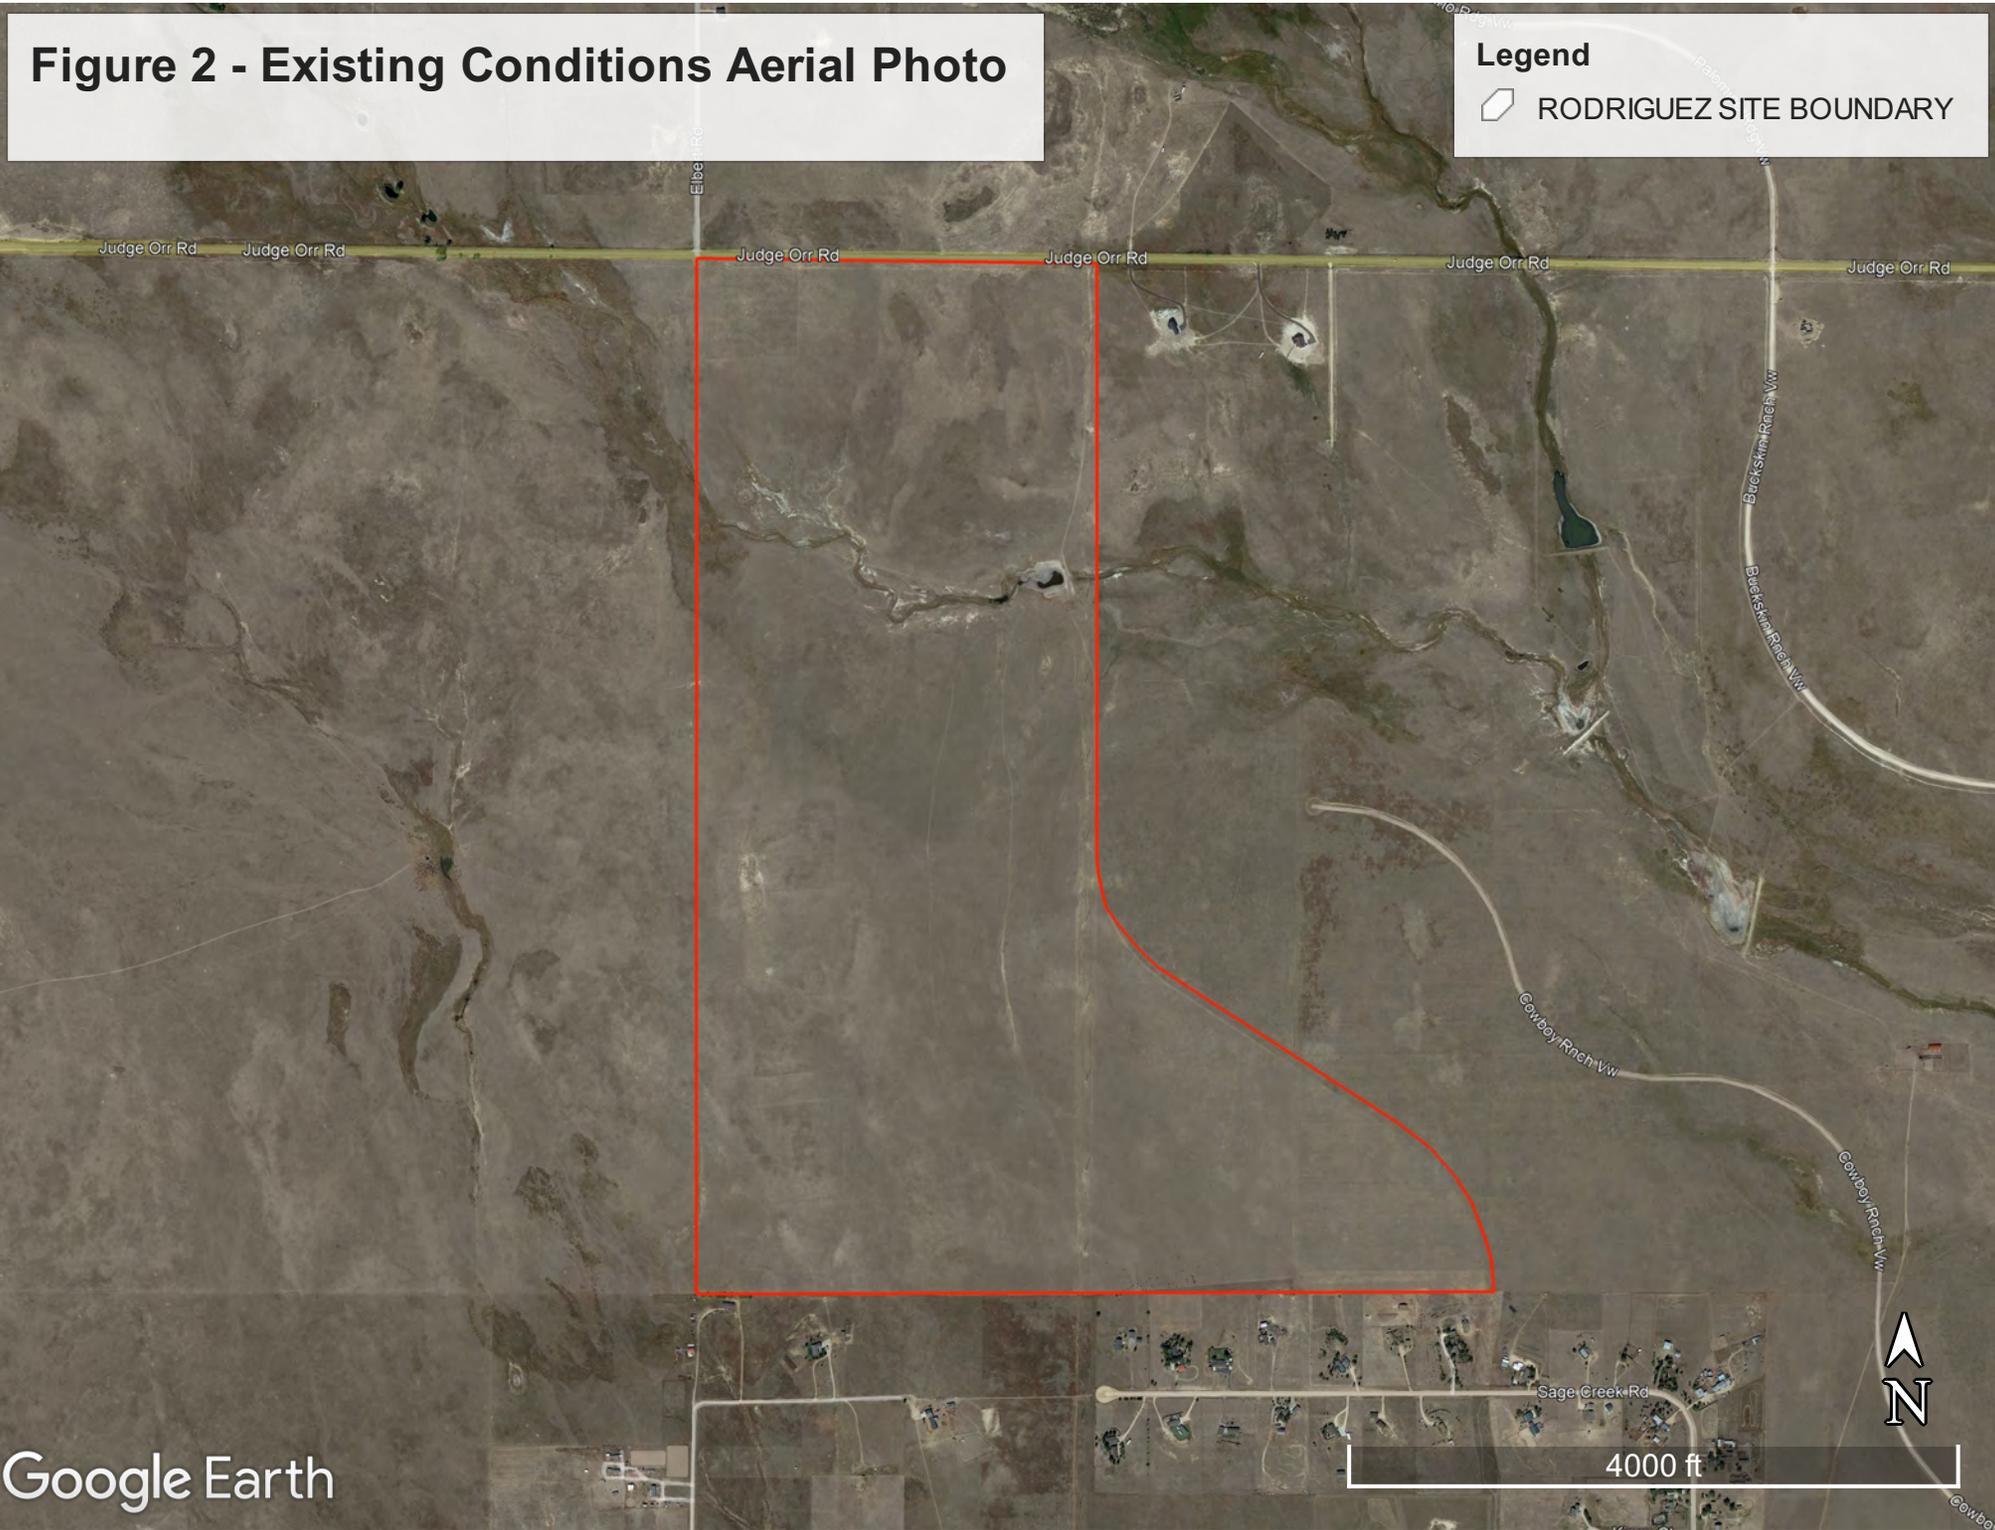
Figure 3
Sketch Plan

The Applicant proposes to develop a Sketch Plan for a combination of rural residential and commercial service uses. Please refer to Figure 3, Sketch Plan provided by the Applicant (dated June 7, 2023) and the development application for specific details and descriptions of the Project.

ESTEBAN RODRIGUEZ SUBDIVISION SKETCH PLAN

Based on the current Sketch Plan, Residential Parcels D, F, I and K contain WOTUS. Detention Pond Parcel E will likely result in minor loss/impact of WOTUS from the construction of the outfall into the North-Central drainage. The internal Residential Collector road system as currently laid out will have a "crossing" impact on North-Central drainage unless it is free-spanned by a bridge. It is highly likely that "drainage improvements" like drop or grade control structures will be required by the County to decrease velocity and shear stress within the North-Central drainage which will result in additional impacts to WOTUS. Refer to Figure 3, Sketch Plan and Figure 7, WOTUS Survey Map.

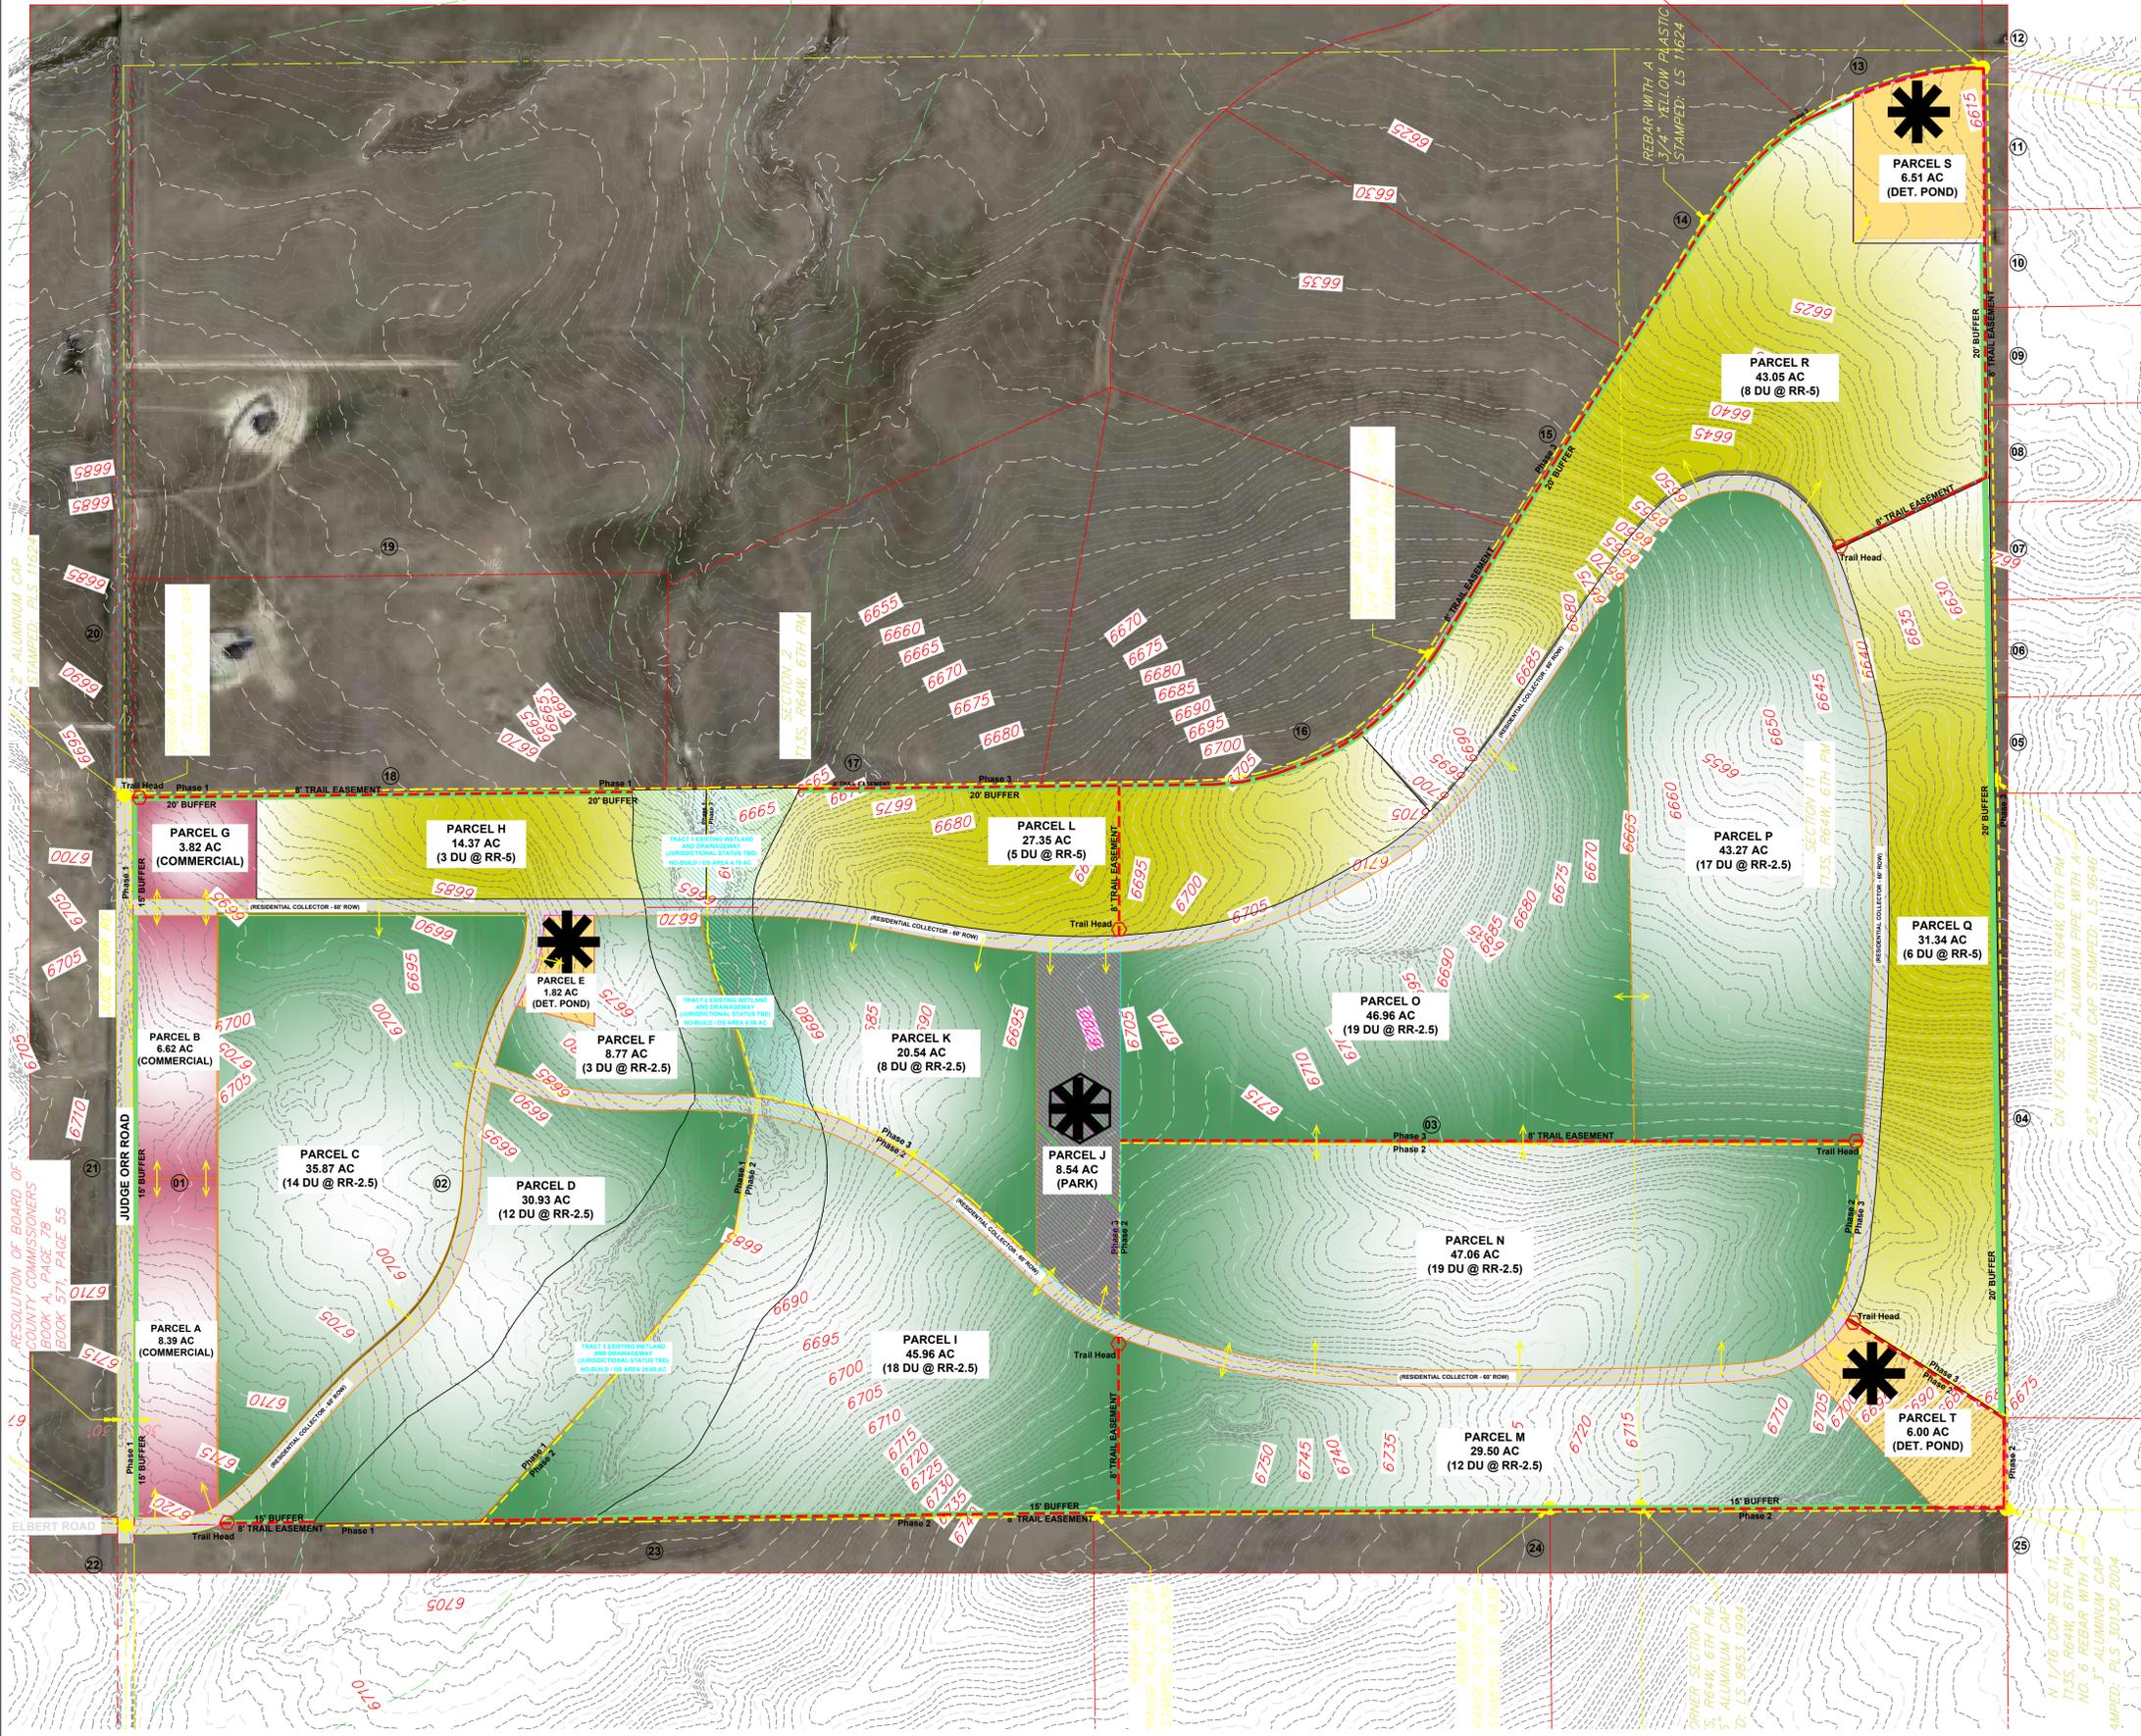
A PARCEL OF LAND BEING A PORTION OF THE SECTION 2 AND SECTION 11, TOWNSHIP 13 SOUTH,
RANGE 64 WEST OF THE 6TH PRINCIPAL MERIDIAN
EL PASO COUNTY, COLORADO

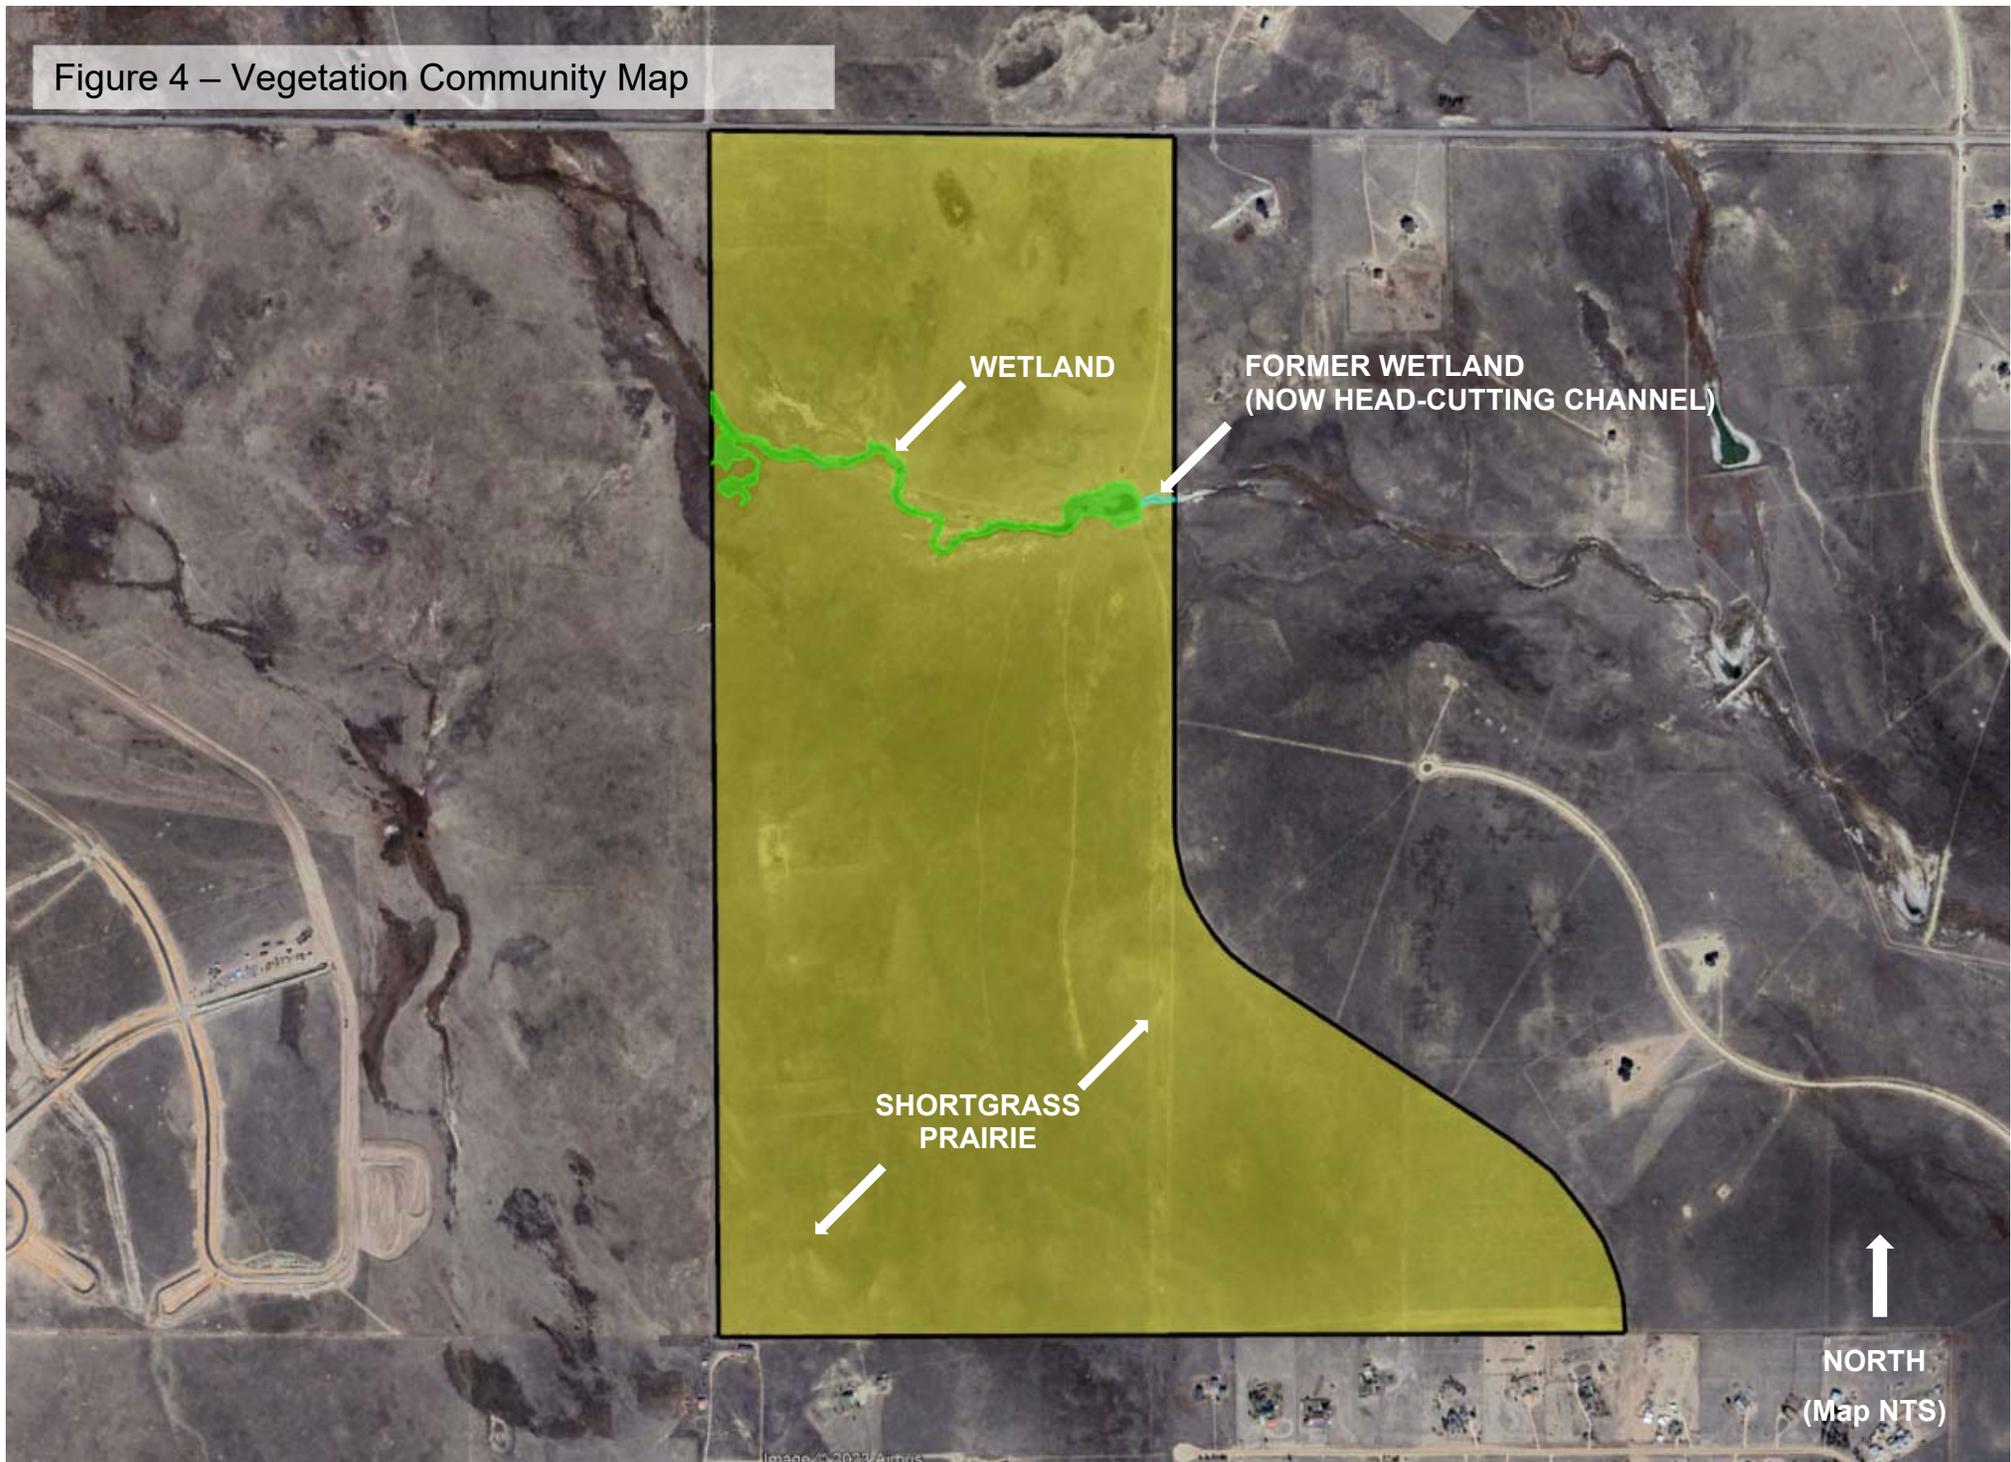
Figure 4 – Vegetation Community Map

Source: Google Earth Aerial Image, 10/31/2022 & Ecosystem Services, LLC Site Assessment, 5/23/2023

The vegetation within the Site is primarily comprised of herbaceous short-grass prairie species with herbaceous wetland vegetation in the drainages and ephemeral swales flowing through the Site. Given the presence of certain mid-grass prairie species mixed throughout the shortgrass prairie, we have referred to the vegetation community as “short- and mixed-grass prairie” (refer to Figure 4, Vegetation Community Map). The dominant prairie grass species is blue grama (*Bouteloua gracilis*), with occasional little bluestem (*Schizachyrium scoparium*) and Western wheatgrass (*Pascopyrum smithii*). The other most common associative prairie species are prairie aster (*Machaeranthera tenacetifolia*), smooth brome (*Bromus inermis*), fringed sage (*Artemisia frigida*), yucca (*Yucca spp.*) and prickly pear cactus (*Opuntia sp.*). Other species include Wood’s rose (*Rosa woodsii*), false indigo bush (*Amorpha fruticosa*), sticky geranium (*Geranium viscosissimum*) and yarrow (*Achillea millefolium*). The Site is moderately grazed and there are scattered weeds, including Canada thistle (*Cirsium arvense*), musk thistle (*Carduus nutans*), Scotch thistle (*Onopordum acanthium*), common mullein (*Verbascum thapsus*), horseweed (*Conyza canadensis*) and field bindweed (*Convolvulus arvensis*).

Discontinuous patches of hydrophytic vegetation (wetland vegetation) is present within the North-central ephemeral drainage where saturated (hydric) soils are present. Dominant wetland vegetation includes Nebraska sedge (*Carex nebrascensis*), common threesquare bulrush (*Schoenoplectus americanus*) and spikerush (*Eleocharis palustris*) with inclusions of Baltic rush (*Juncus balticus*), water mint (*Mentha aquatica*), narrowleaf cattail (*Typha angustifolia*) and Canada thistle (*Cirsium arvense*). Willow is notably absent. Dominant upland vegetation at the margin of the wetland boundary includes little bluestem and blue grama (*Bouteloua gracilis*), upland grasses, fringed sage and other miscellaneous upland weeds.

Riparian habitat within the Site is limited to one single drainage in the North-central portion of the Site which consists of more robust short-grass prairie where moist, mesic soils are present adjacent to wetlands (described above). This North-central drainage does not support any riparian trees or shrubs.

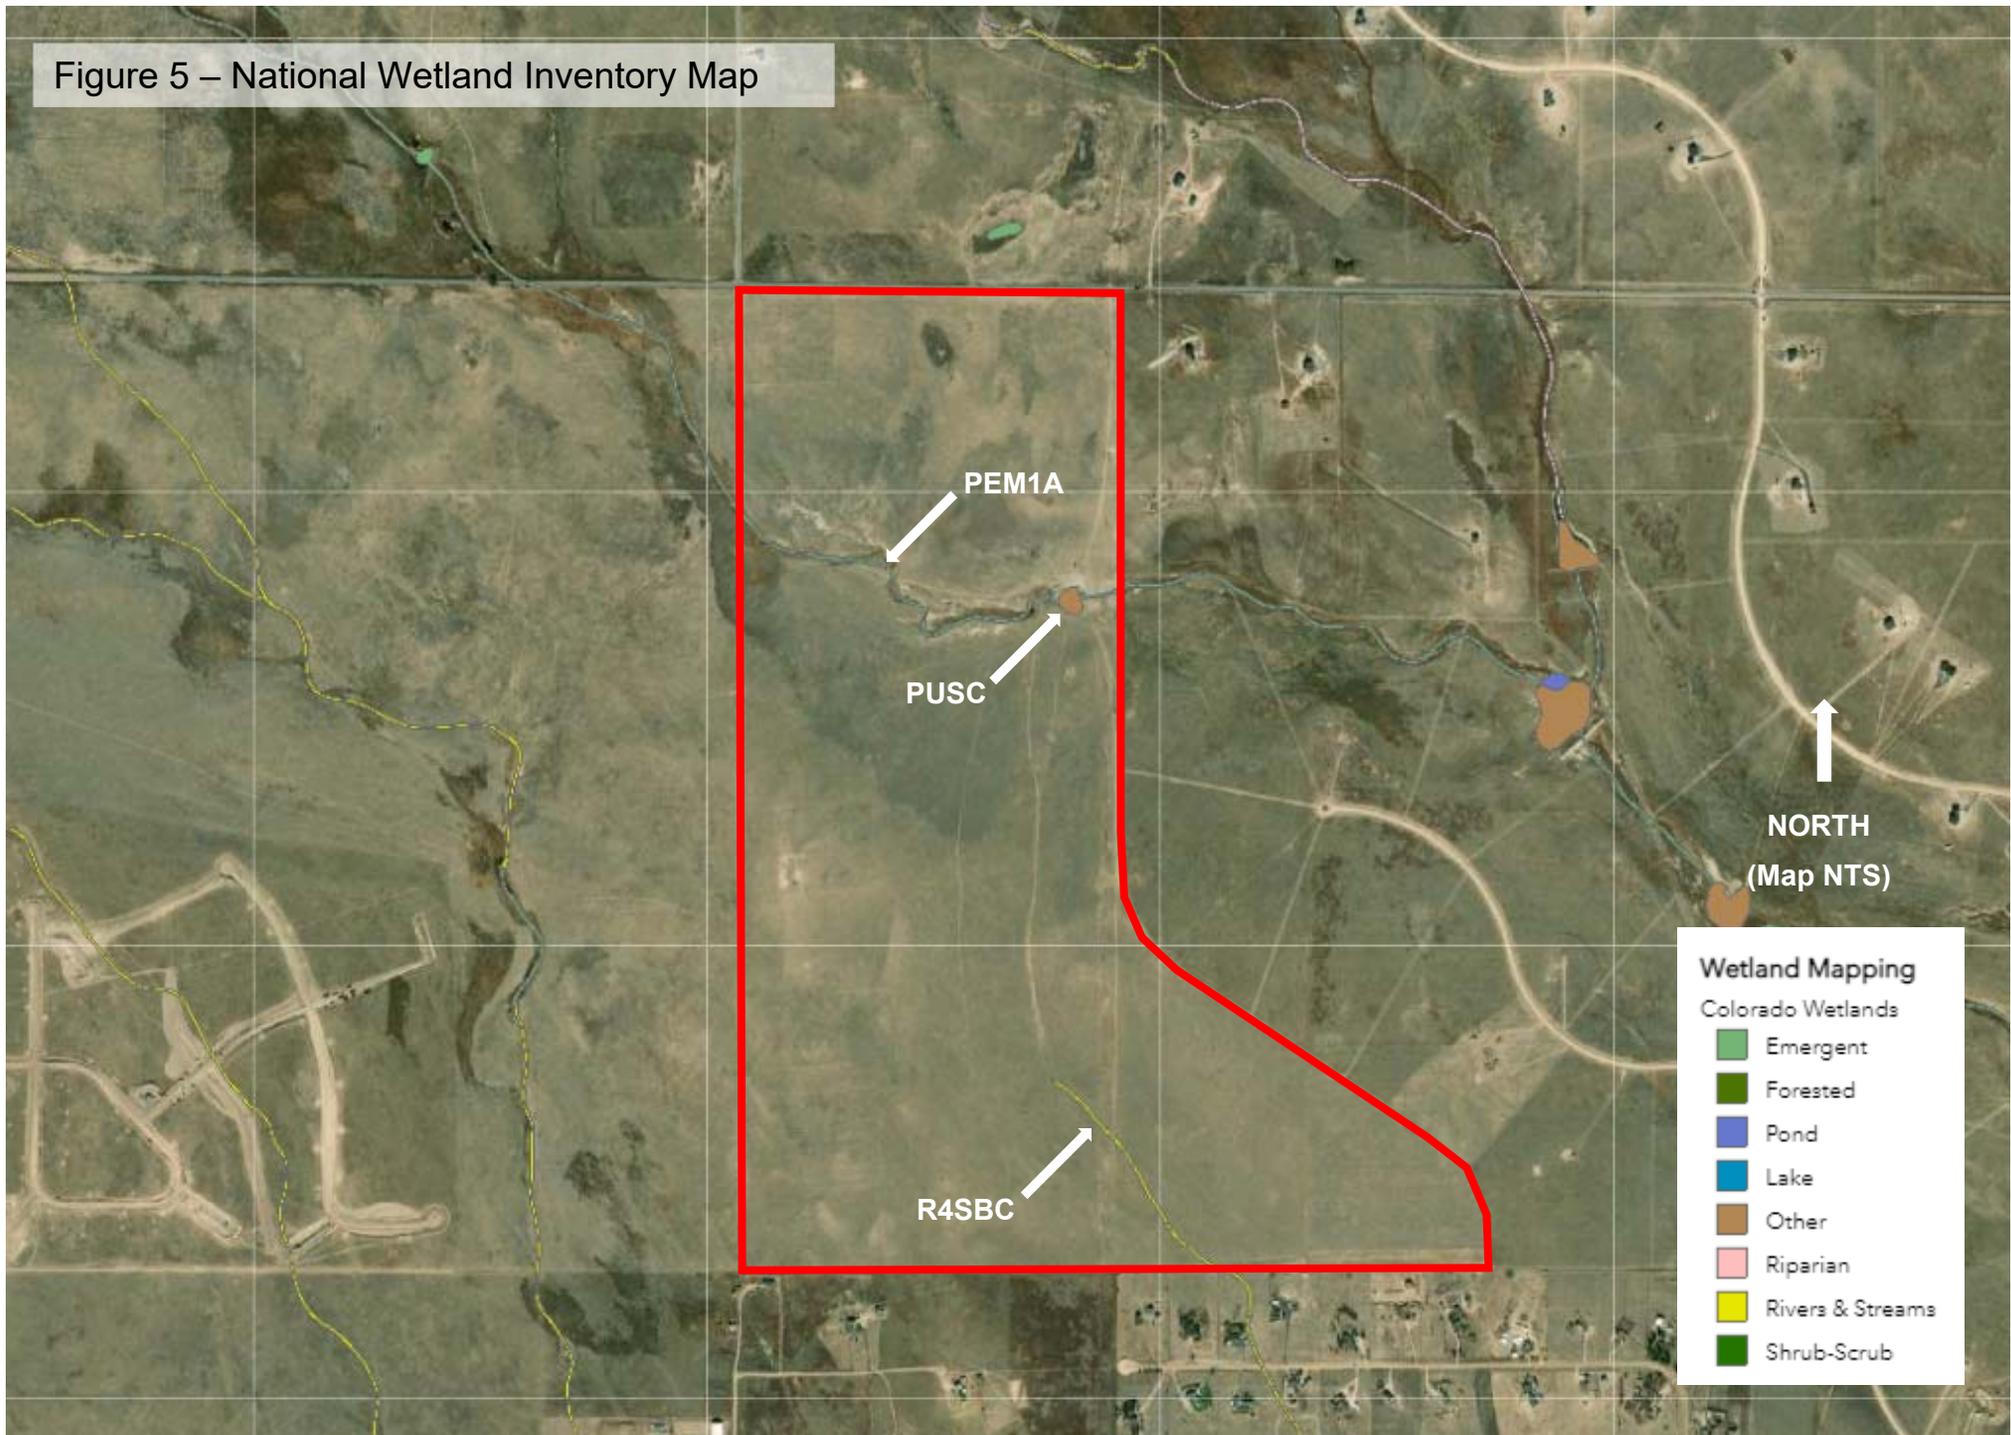
Figure 5
National Wetland Inventory Map

Figure 5 – National Wetland Inventory Map

Source: Colorado Natural Heritage Program (CNHP) Wetland Mapper / U.S fish and Wildlife Service National Wetland Inventory (NWI)

Refer to Figure 5, National Wetland Inventory Map.

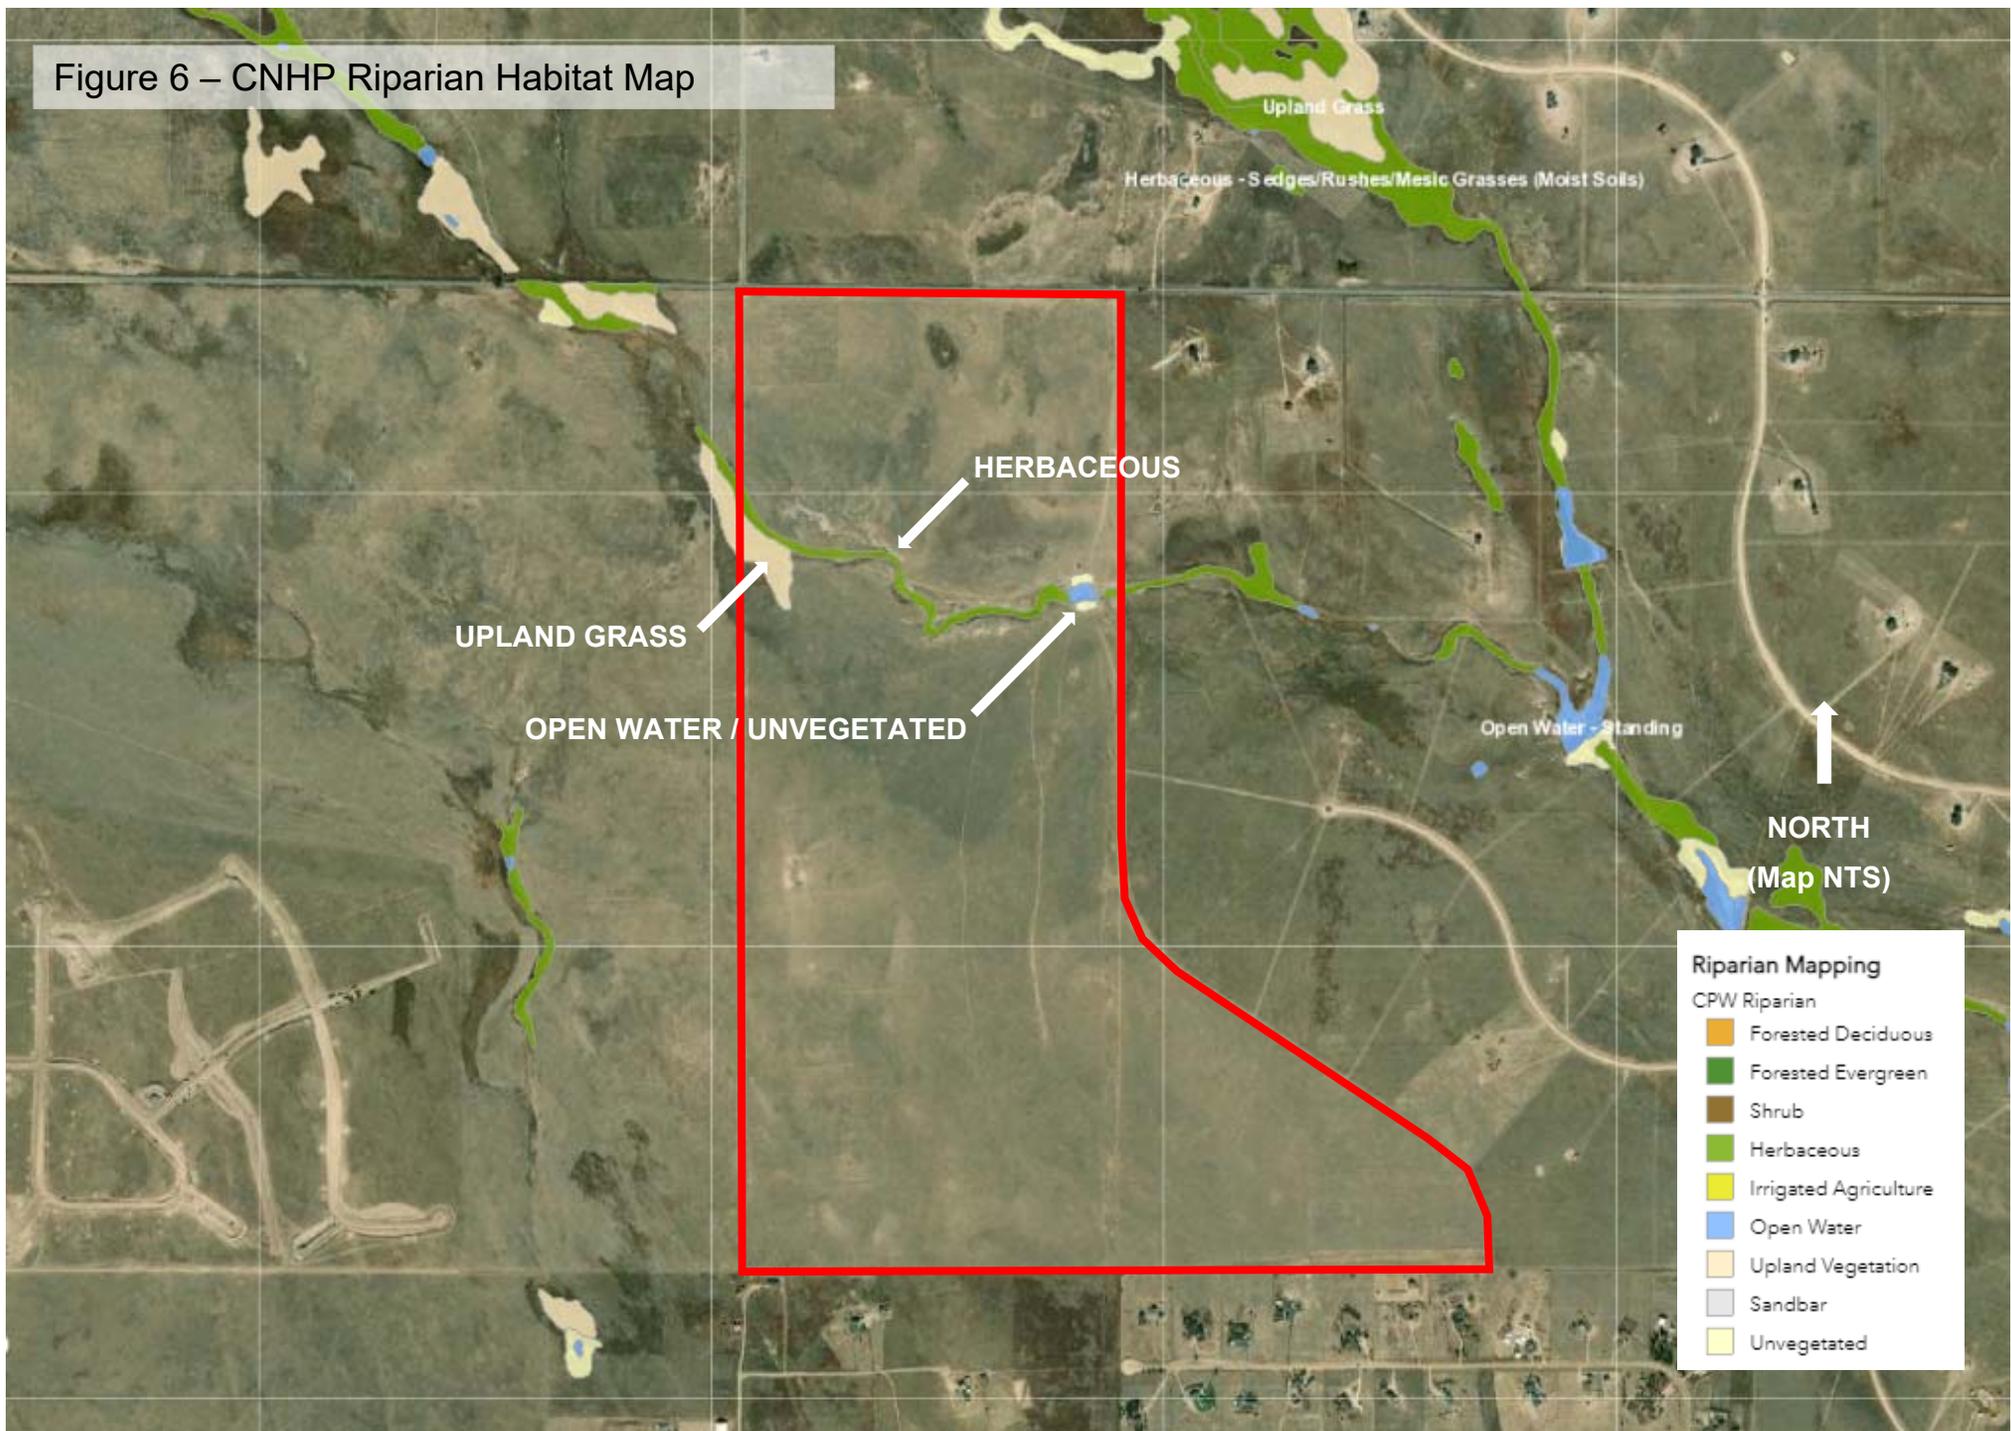
FIGURE 6
CNHP Riparian Habitat Map

Figure 6 – CNHP Riparian Habitat Map

Source: Colorado Natural Heritage Program (CNHP) Wetland Mapper

- North-Central drainage: The CPW data indicate the potential presence of:
 - Herbaceous Sedges/Rushes/Mesic Grasses (Moist Soils) along the length of this drainage;
 - Upland Grass adjacent to the upstream, western end of the drainage; and
 - Open Water within the pond at the eastern end of this drainage flanked by Unvegetated land.
- Southeastern drainage: The CPW data do not identify potential riparian habitat along this drainage.

ECOS found the CNHP data to be accurate during the field assessment except the patch of Upland Grass located on the upstream, south side of the North-Central drainage consists of a lush mosaic of Herbaceous Sedges/Rushes/Mesic Grasses (i.e., Wetland) and Upland Grasses supported by high groundwater.

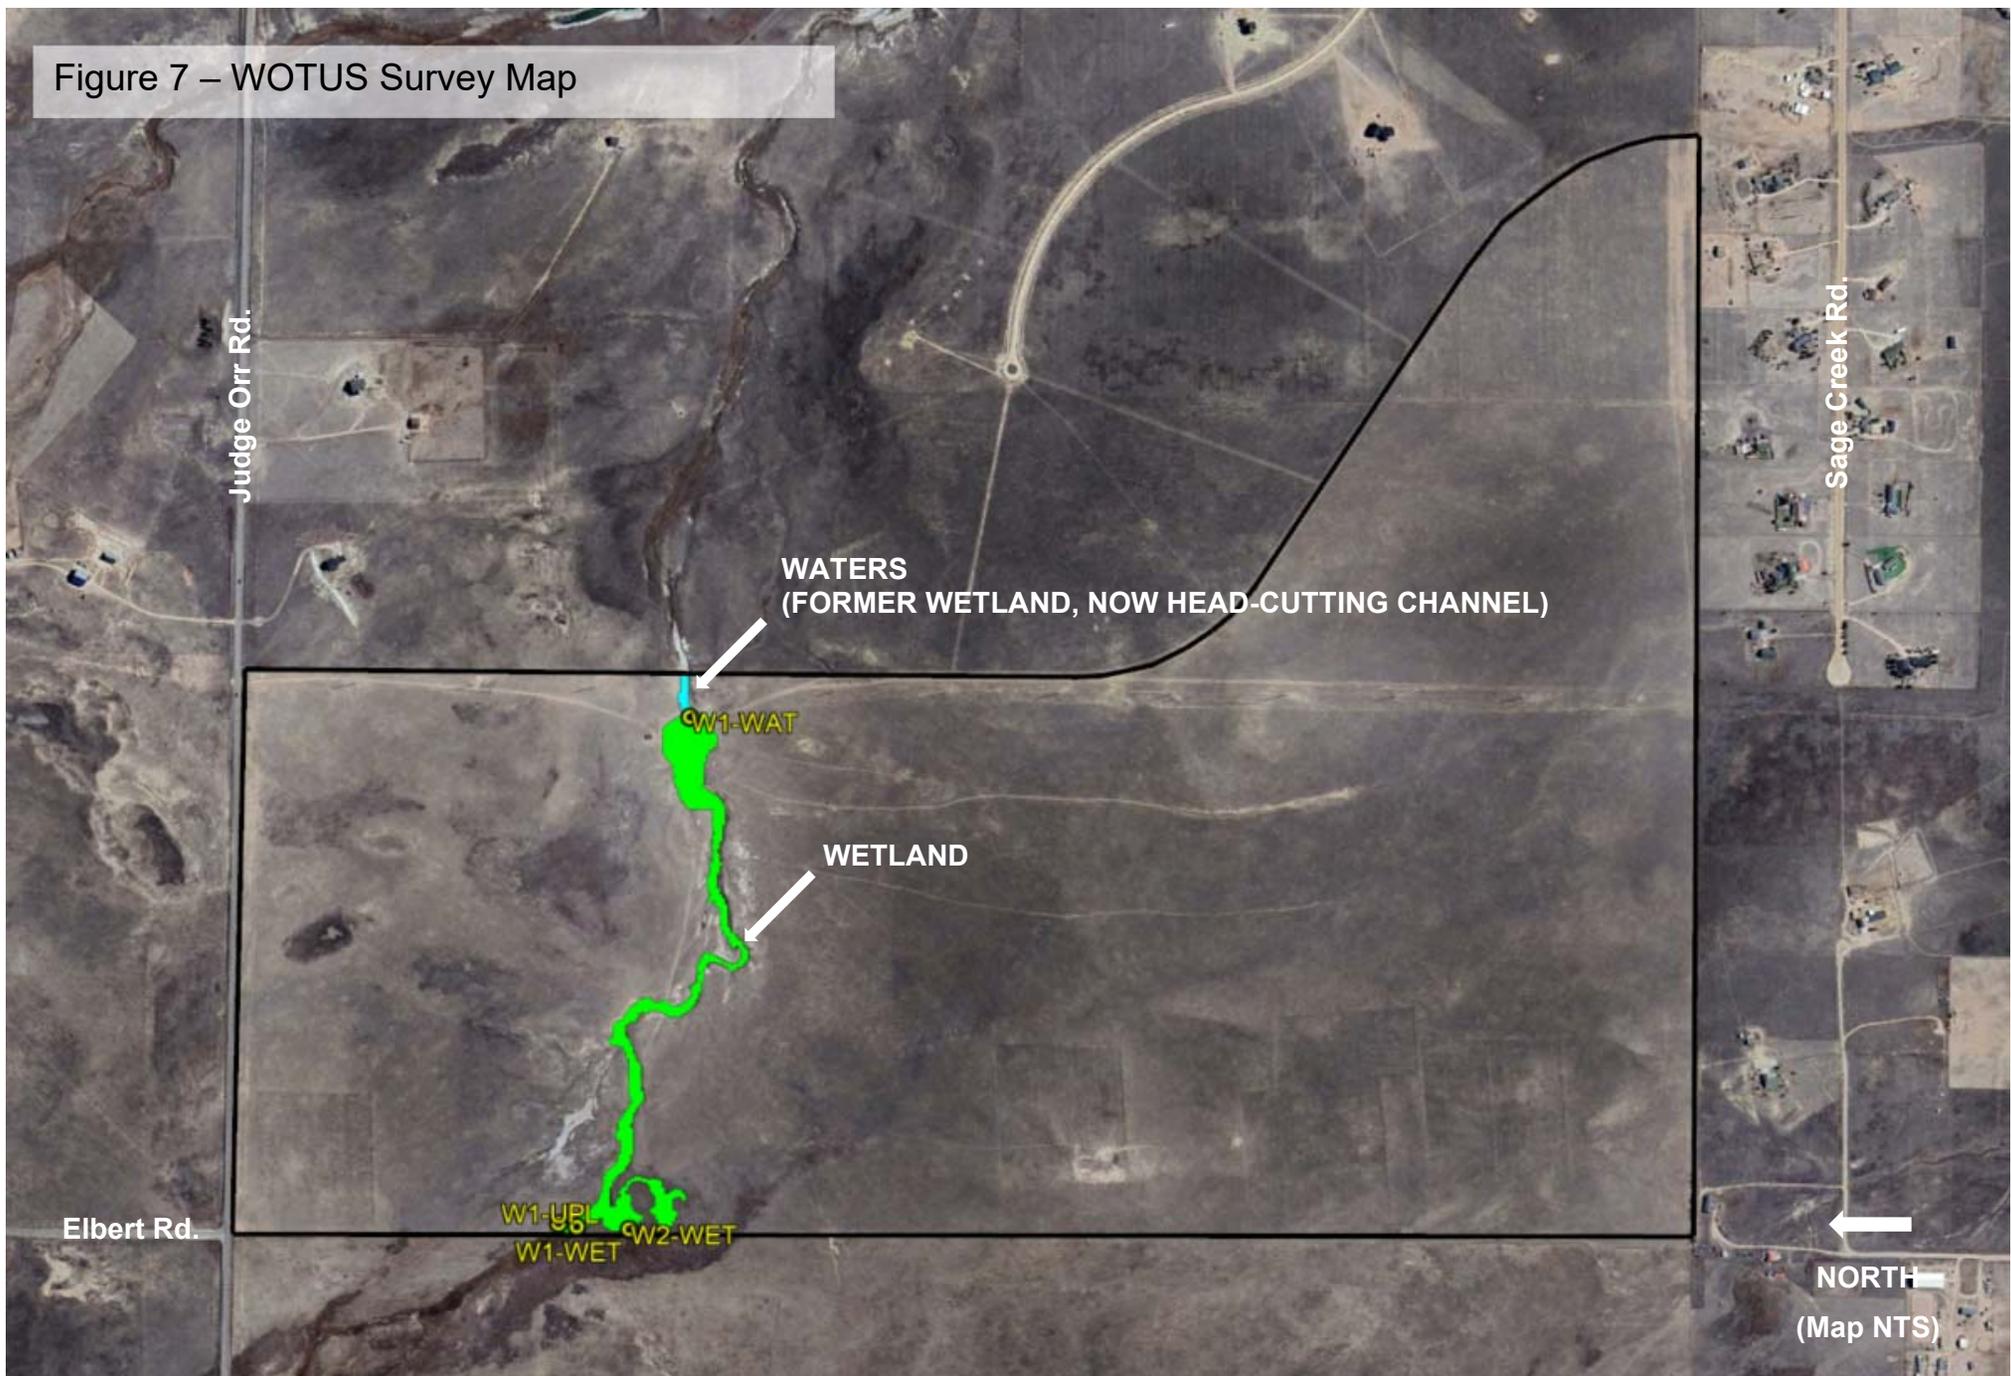
FIGURE 7
WOTUS Survey Map

Figure 7 – WOTUS Survey Map

Source: Google Earth Aerial Image, 10/31/2023 & Ecosystem Services, LLC Wetland Delineation, 5/23/2023

ECOS utilized the USGS 7.5-minute topographic mapping, historic and current Google Earth aerial photography; the National Wetland Inventory (NWI) Wetlands Mapper (USFWS 2023) and the Colorado Wetland and Information Center – Wetlands Mapper (CNHP, 2022); and detailed Project topographic mapping (if available) to preliminarily identify potential wetland habitat and waters of the U.S. (WOTUS) on the Site. Refer to Figure 5, National Wetland Inventory Map and Figure 6, CNHP Riparian Habitat Map. Additionally, ECOS performed a jurisdictional delineation with GPS survey to identify WOTUS boundaries. Refer to Figure 7, WOTUS Survey Map.

Google Earth aerial imagery review: ECOS reviewed the Site using the time-lapse function in Google Earth (GE) to get a look back in time to 1985. The timeline review indicates the presence of a stock pond on the east side of the north-central drainage, as well as vegetation signatures that appear to be indicative of herbaceous wetland vegetation. No other potential wetland habitat or water bodies (natural or manmade) are evident on the aerial imagery. Refer to Figure 2, Rodriguez Existing Conditions Aerial Photo and Figure 7, Rodriguez WOTUS Survey Map.
