**RE: Wetland Delineation Technical Memorandum
Hay Creek Ranch
El Paso County, Colorado**

ATTACHMENT D:
PHOTOGRAPHIC LOG

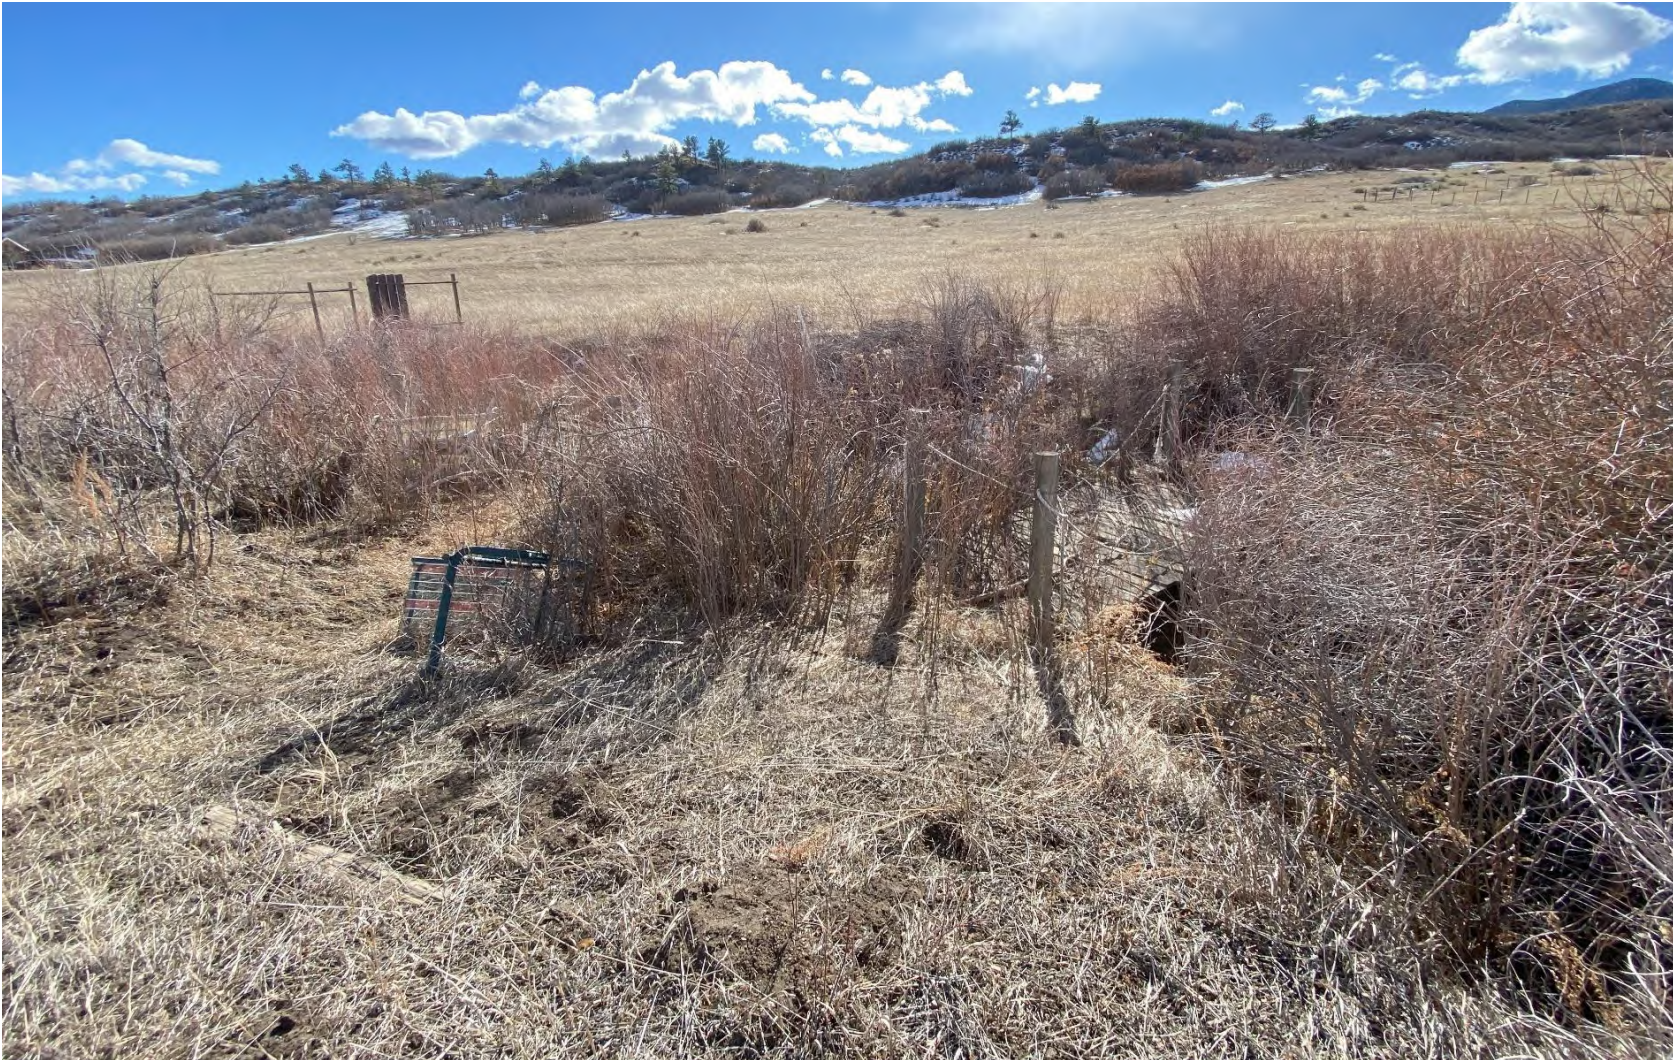
Photo 1: Overview facing south of the vegetation surrounding the existing Hay Creek crossing. The surrounding shrub-scrub wetland (Wetland 1) is dominated by sandbar willow, paniced bulrush, and clustered field sedge.

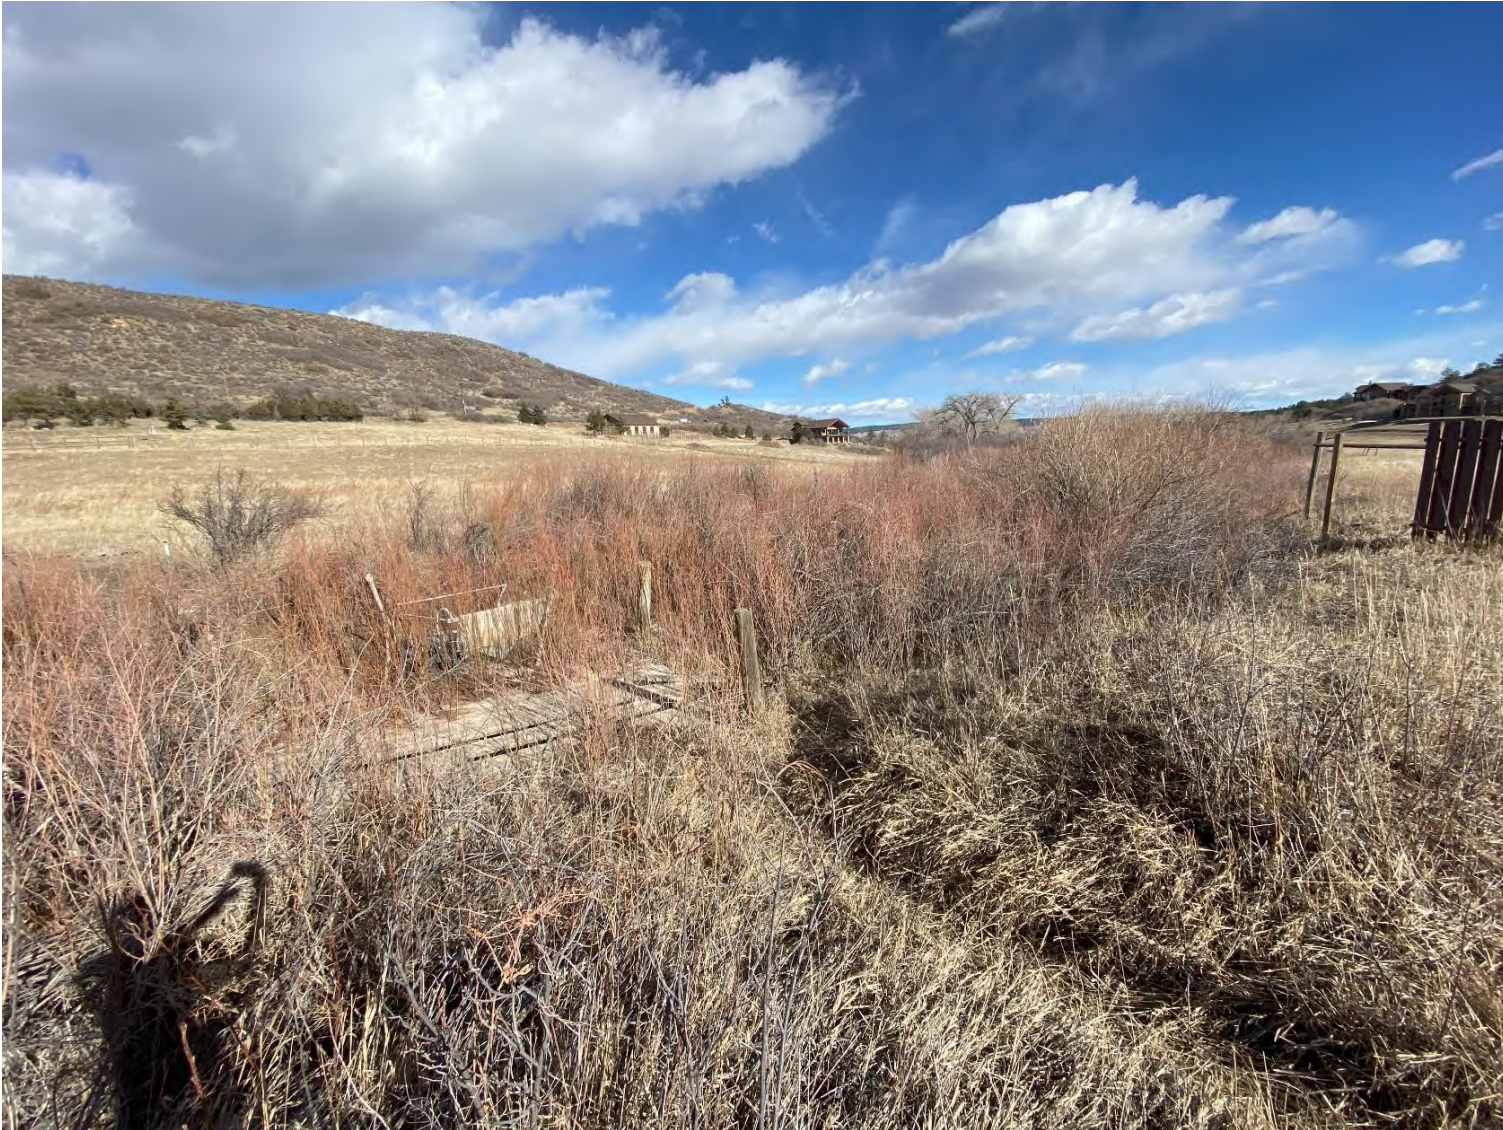
Photo 2: View facing east of the existing Hay Creek crossing. Wetland 1 is visible along the stream crossing, with sandbar willow and paniced bulrush the dominant plants present. SP2 was taken near the edge of the willow stand.

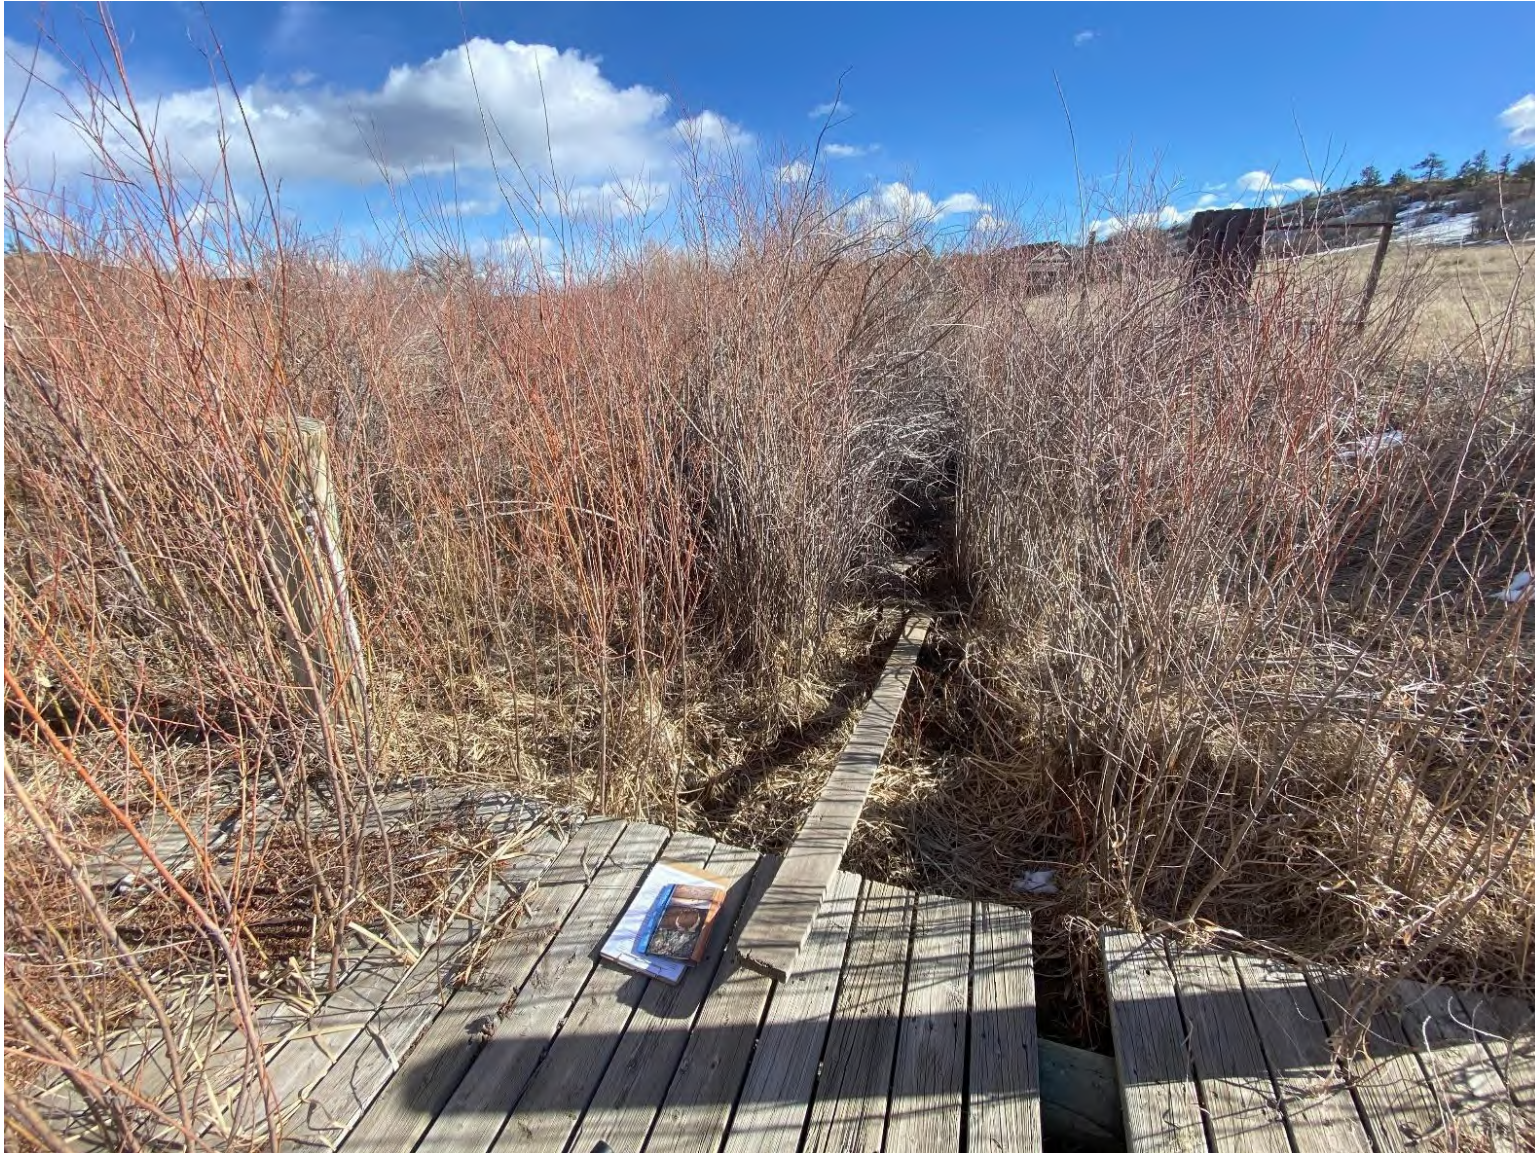
Photo 3: Closeup view facing southeast of the existing Hay Creek crossing – no more than a footbridge as shown in the photo. Sample Point 1 was taken just off the edge of the footbridge.
