**Wetland, Wildlife and Natural Features Report
for
Canyon Creek Ranch Development in El Paso County, Colorado**

December 18, 2024

Project Number: 2024-2-1

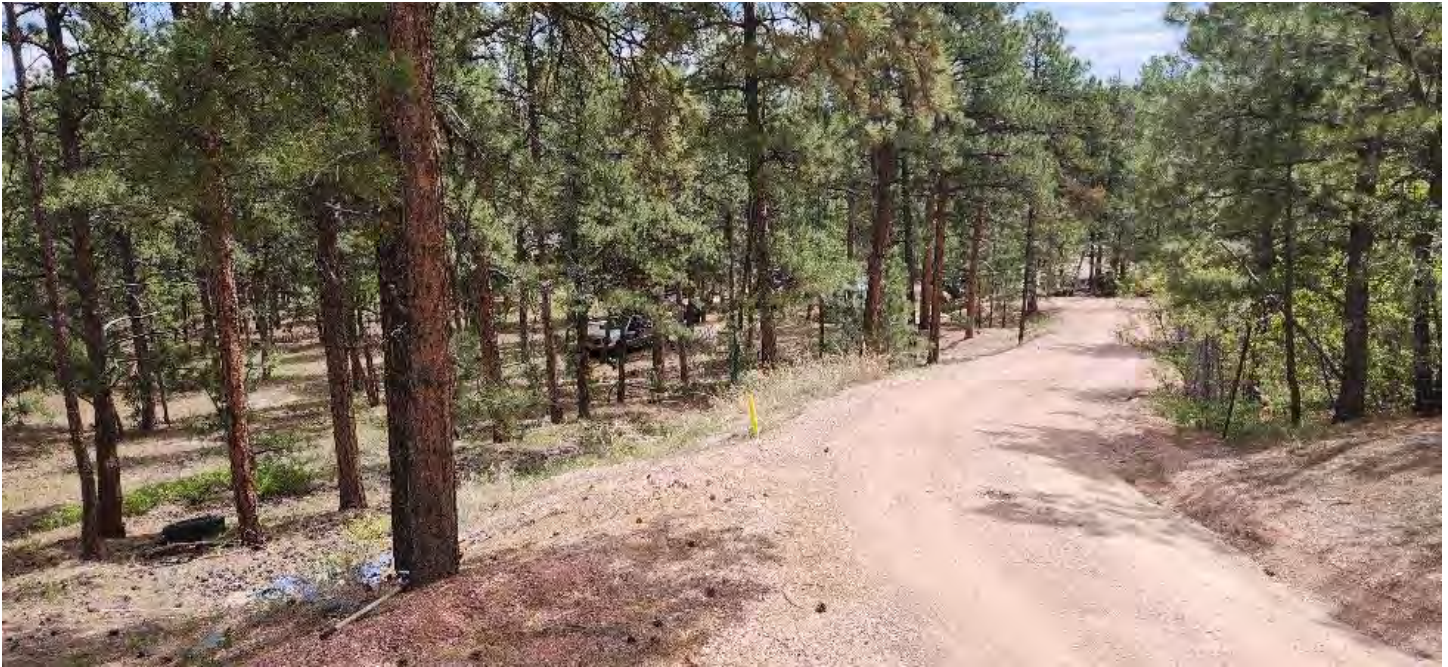
Photo Point 1 – View east of driveway to existing house and ponderosa pine forest along the south property line.

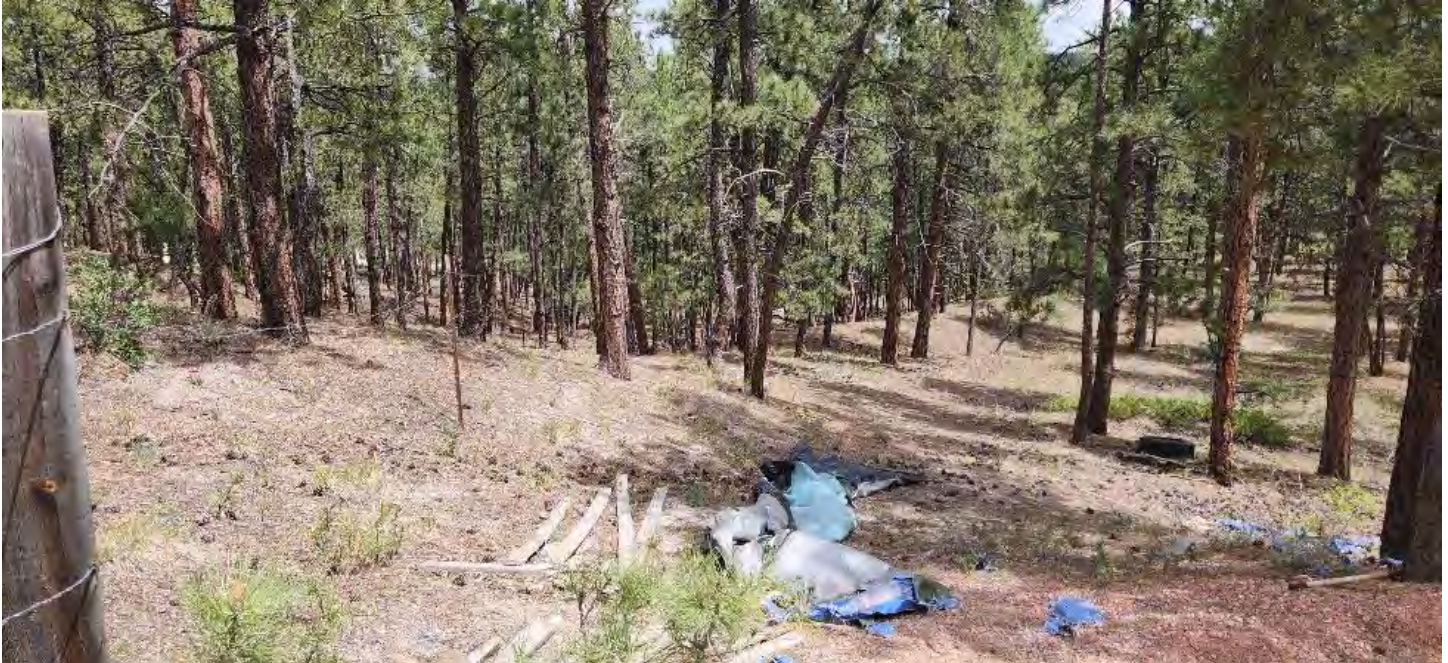
Photo Point 1 –View north of ponderosa pine forest along the west property line.

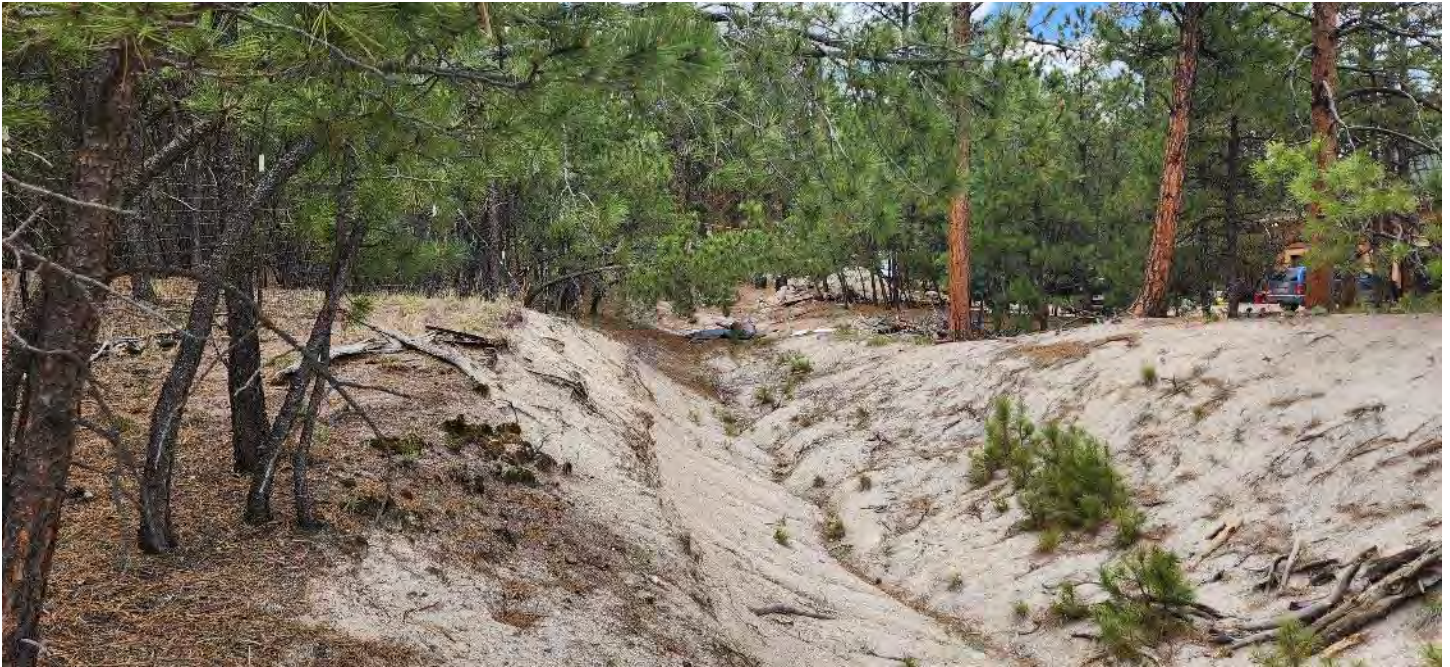
Photo Point 2 – View west of ponderosa pine forest and upper reach of dry tributary to Drainage 2 along the south property line.

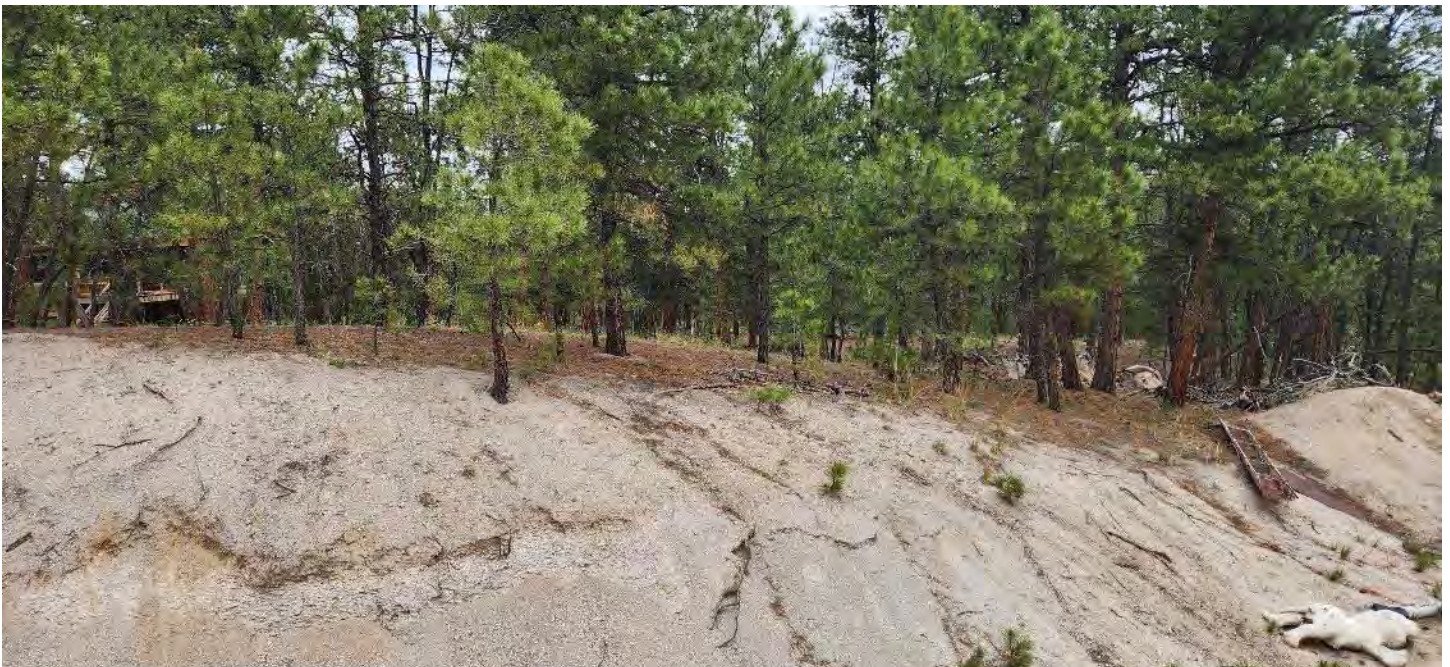
Photo Point 2 – View north of ponderosa pine forest along rim of upper reach of dry tributary to Drainage 2.

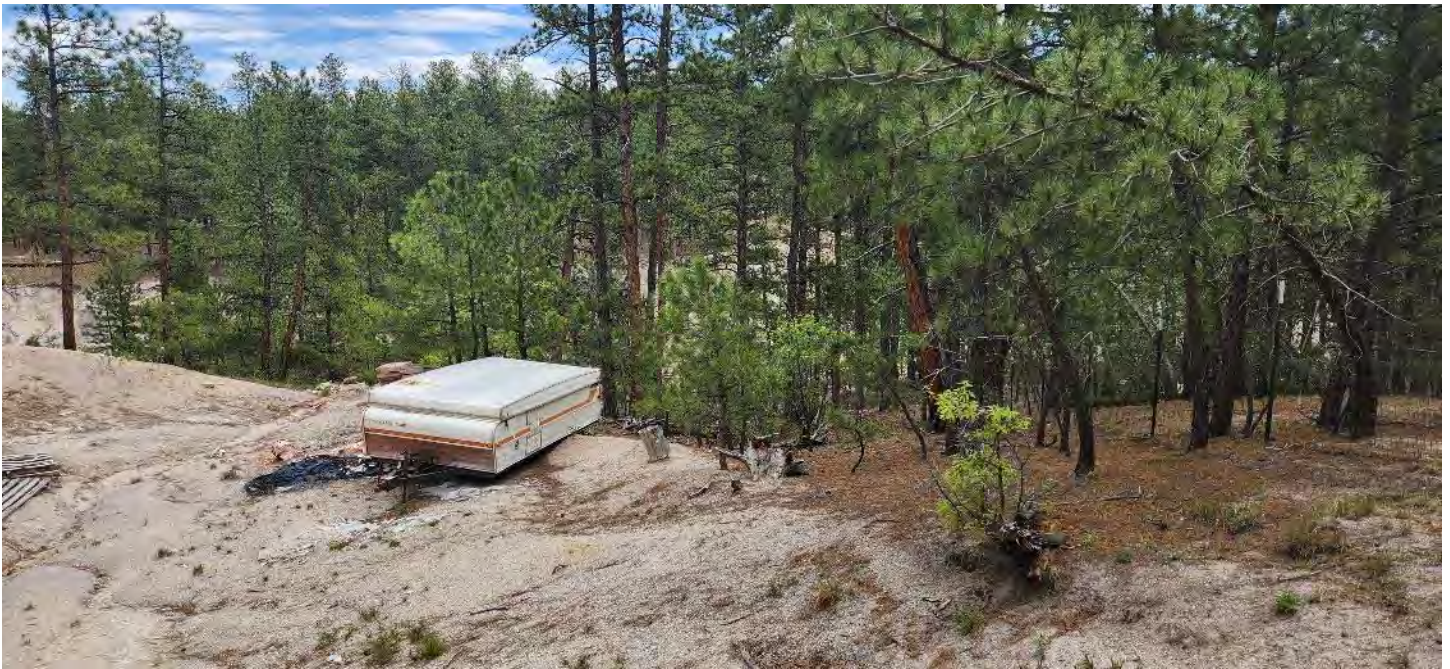
Photo Point 2 – View east of ponderosa pine forest and upper reach of dry tributary to Drainage 2 along the south property line.

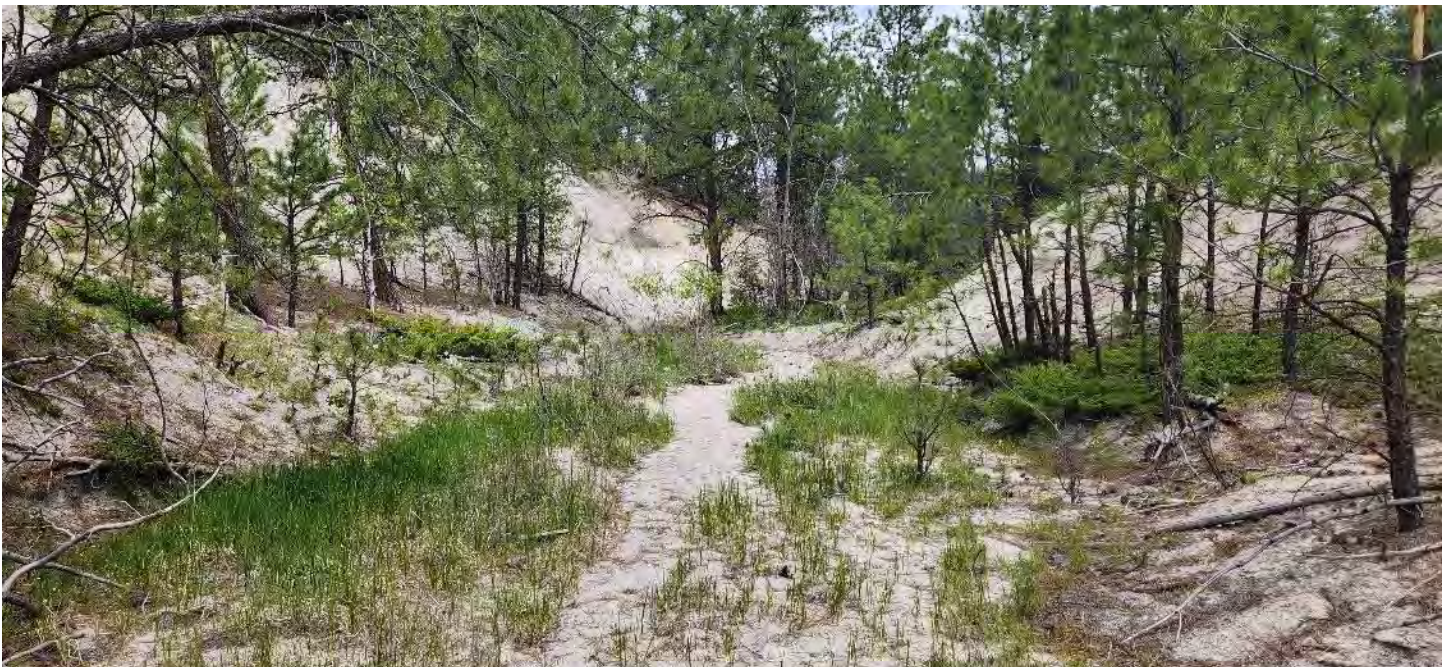
Photo Point 3 – View south and upstream (offsite) of upper reach of Drainage 2.

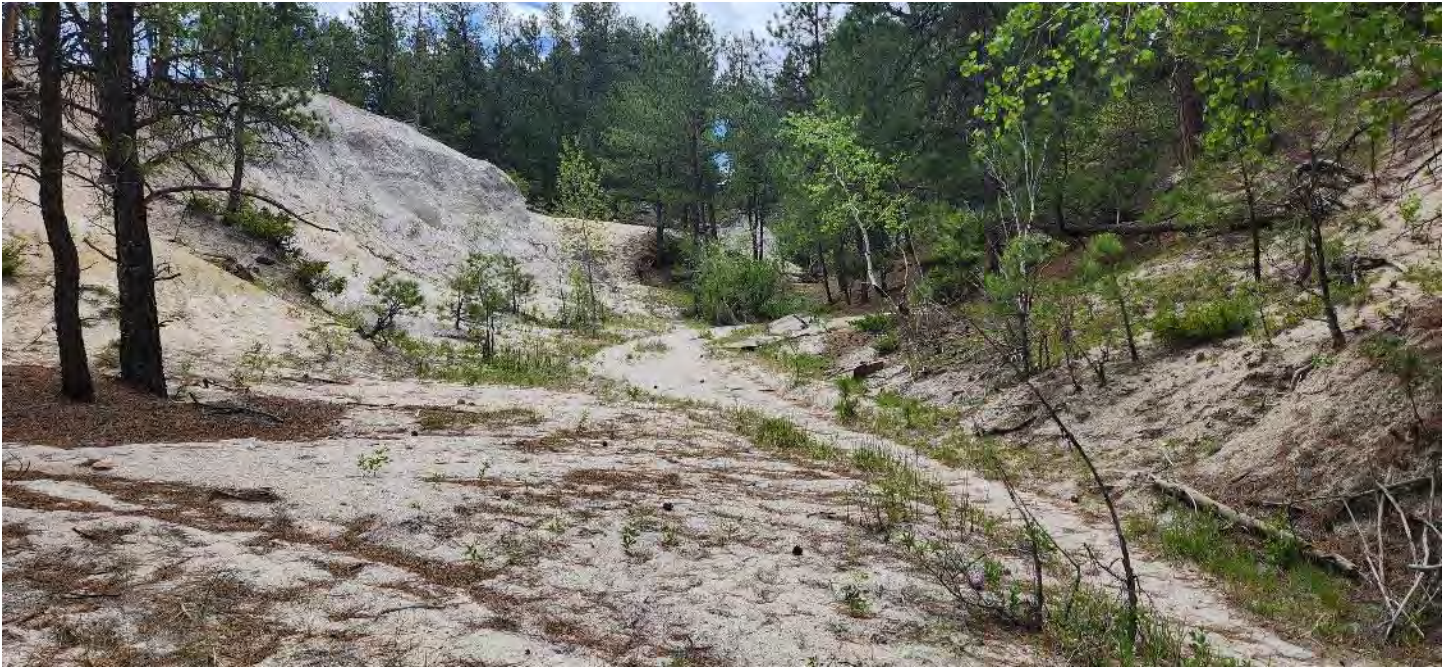
Photo Point 3 – View north and downstream (onsite) of upper reach of Drainage 2.

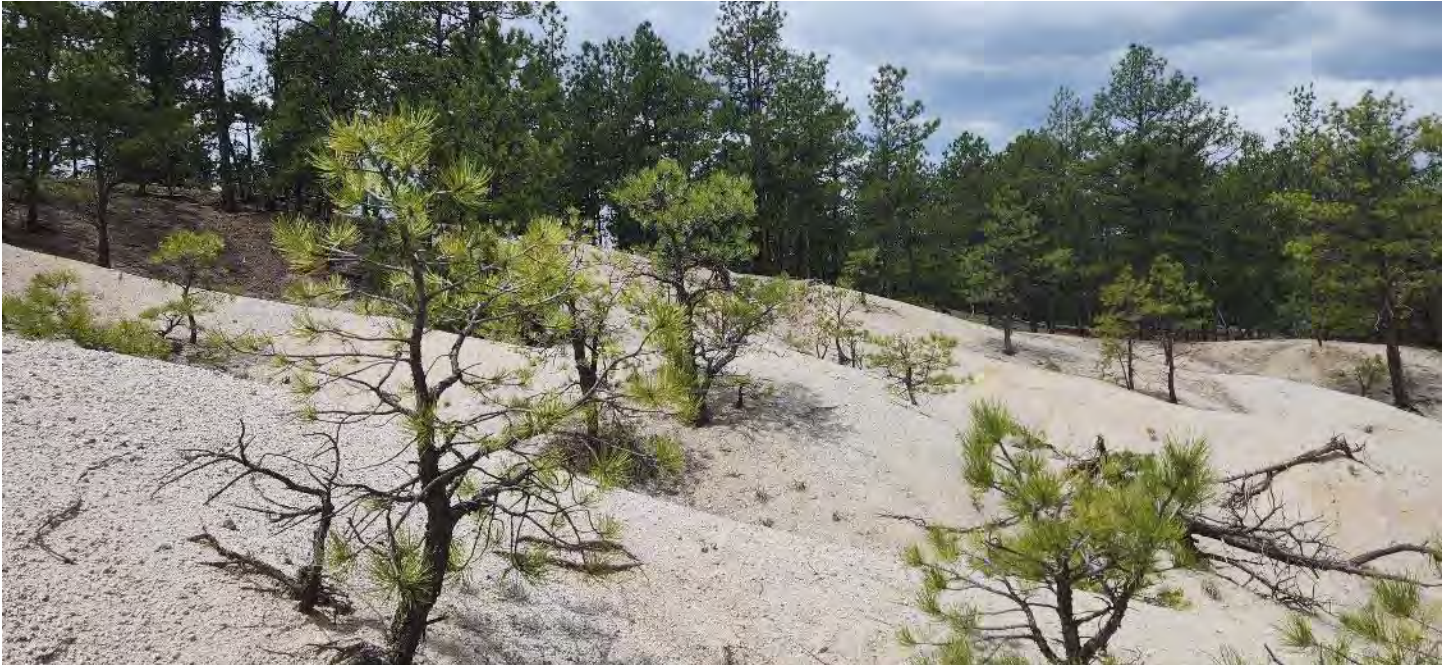
Photo Point 4 – View west of Drainage 3 “badlands” along the south property line.

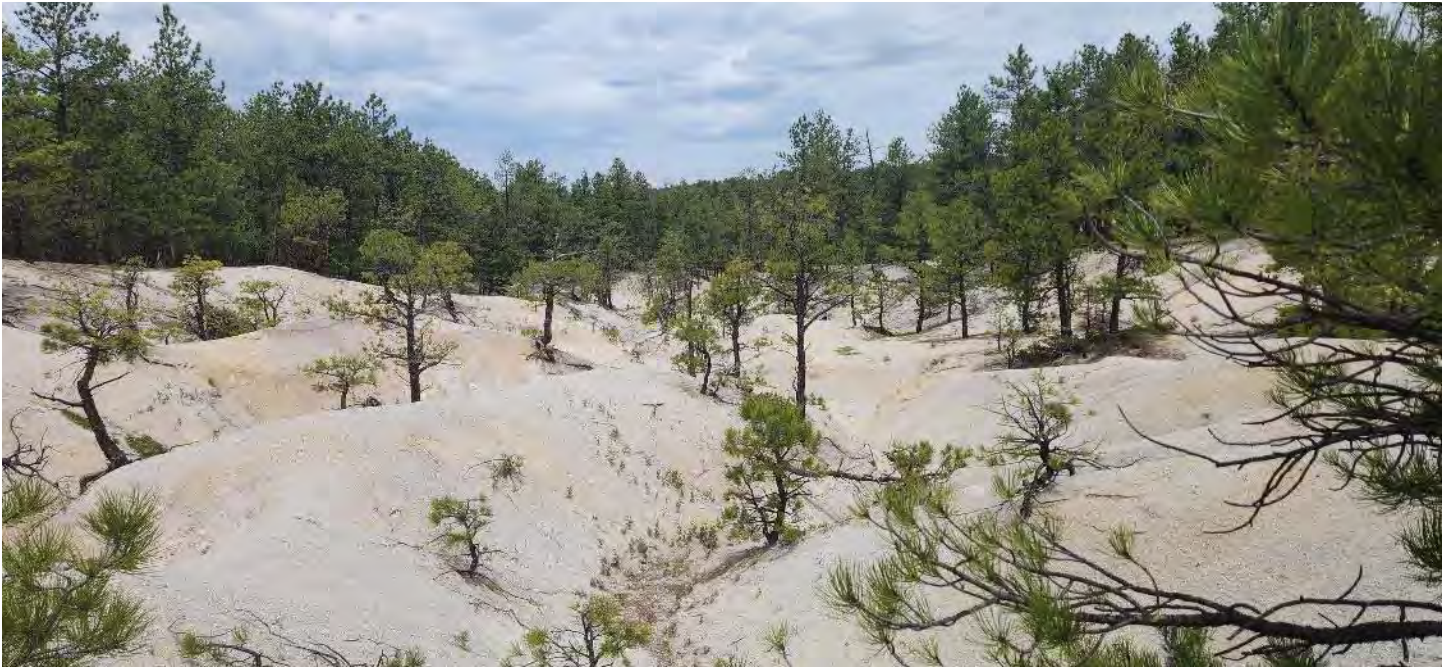
Photo Point 4 – View north and downstream of Drainage 3 “badlands” along the east property line.

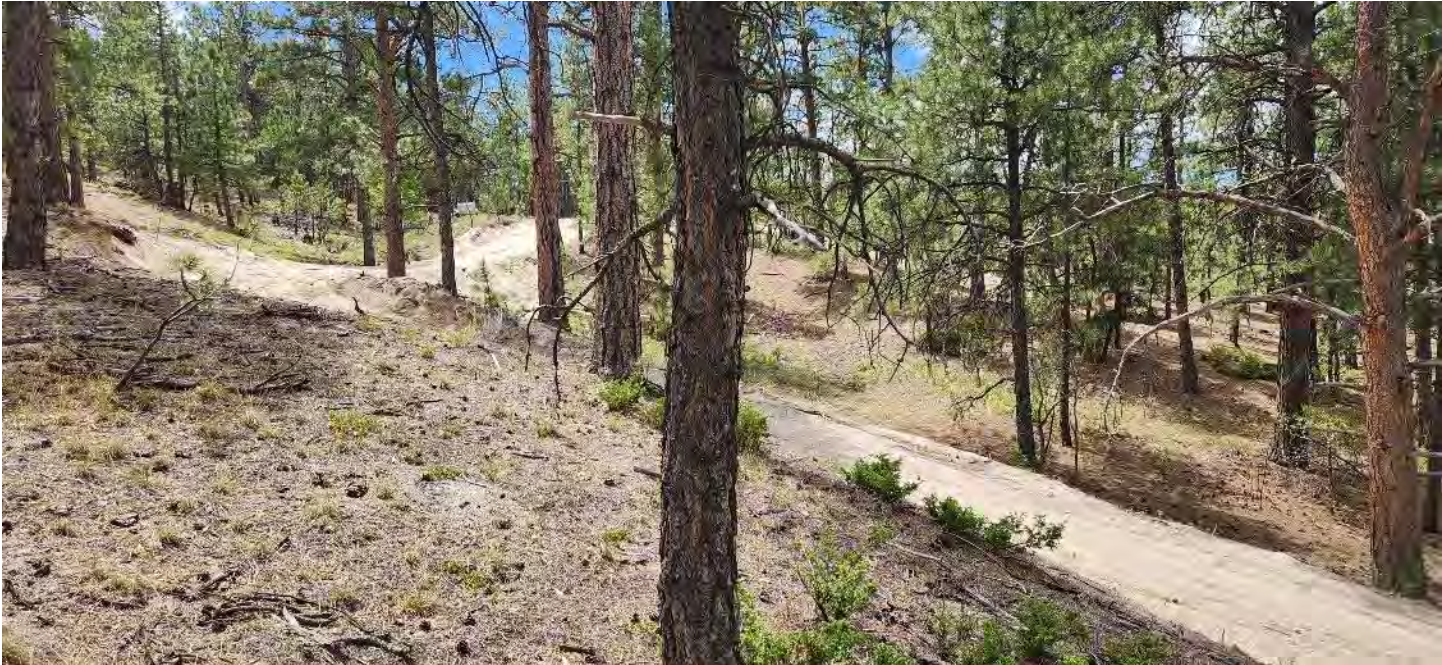
Photo Point 5 – View south (upslope) of existing road and adjacent ponderosa pine forest.

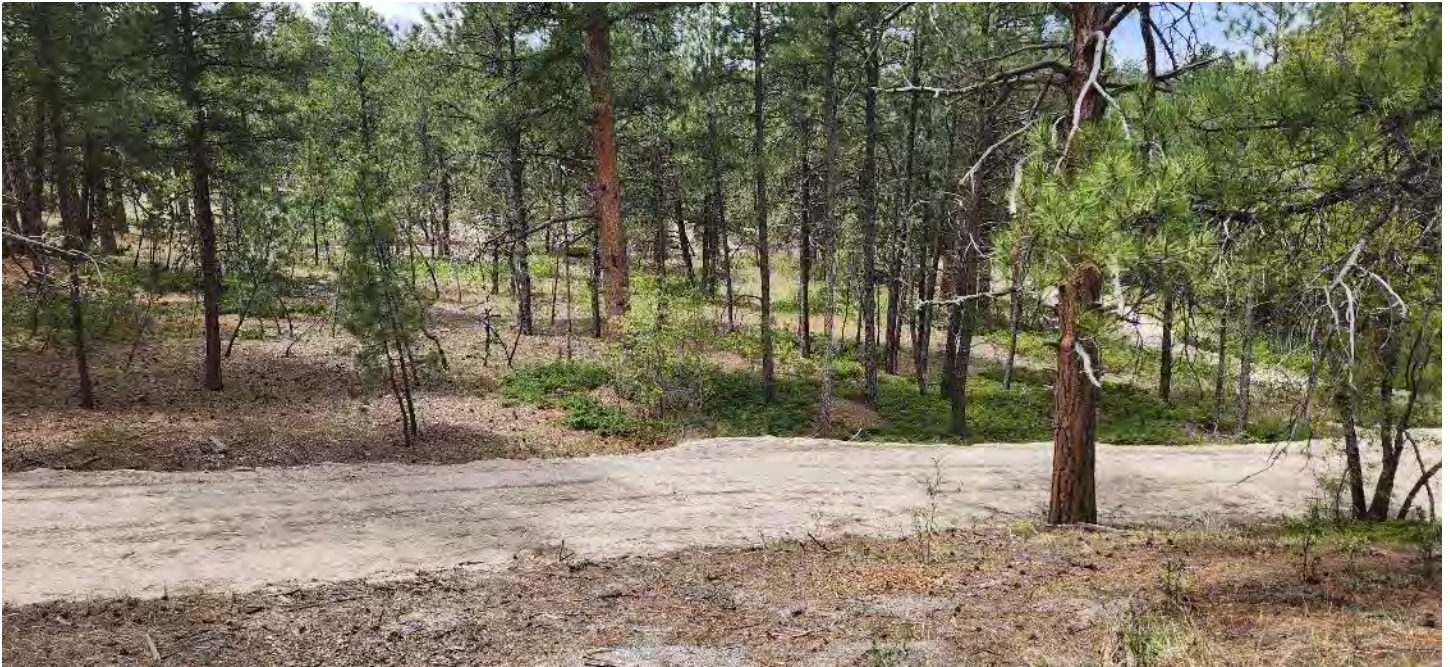
Photo Point 5 – View west (cross slope) of existing road and adjacent ponderosa pine forest.

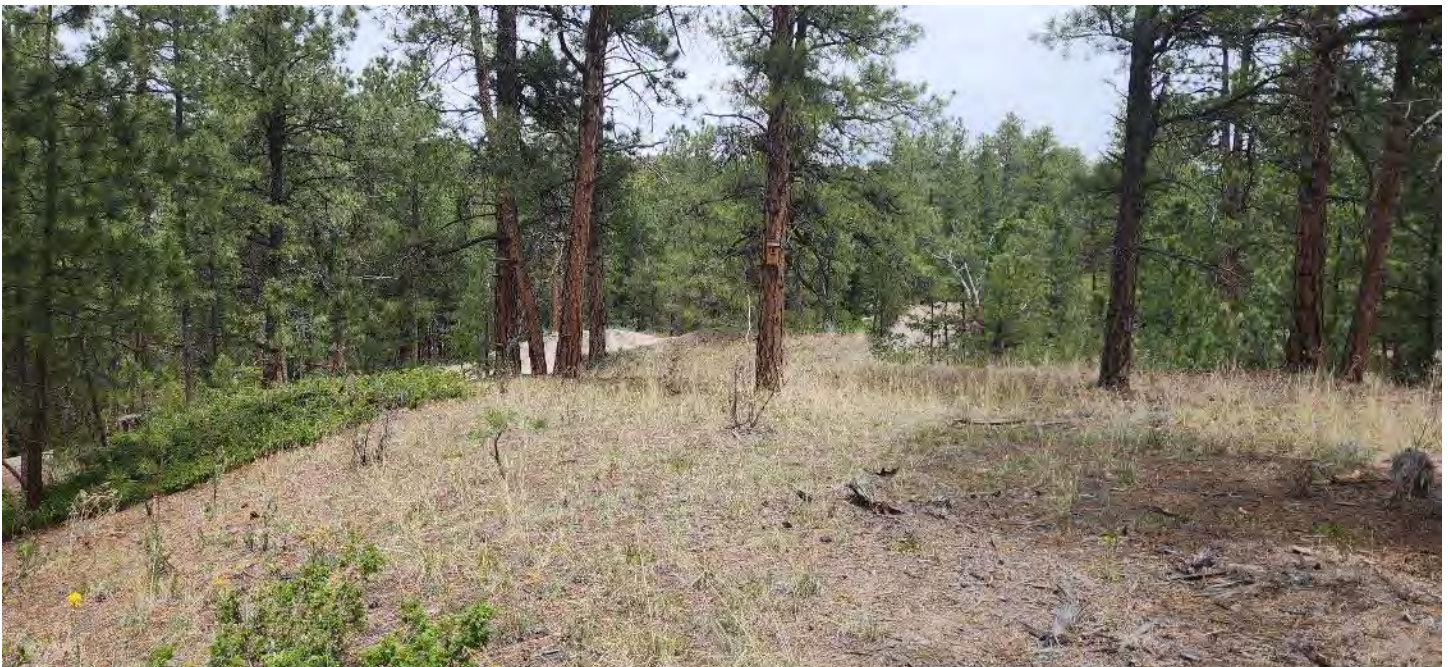
Photo Point 5 – View north (cross slope) of open area within ponderosa pine forest. The east entrance/exit to the site the other side of this hill (to the right).

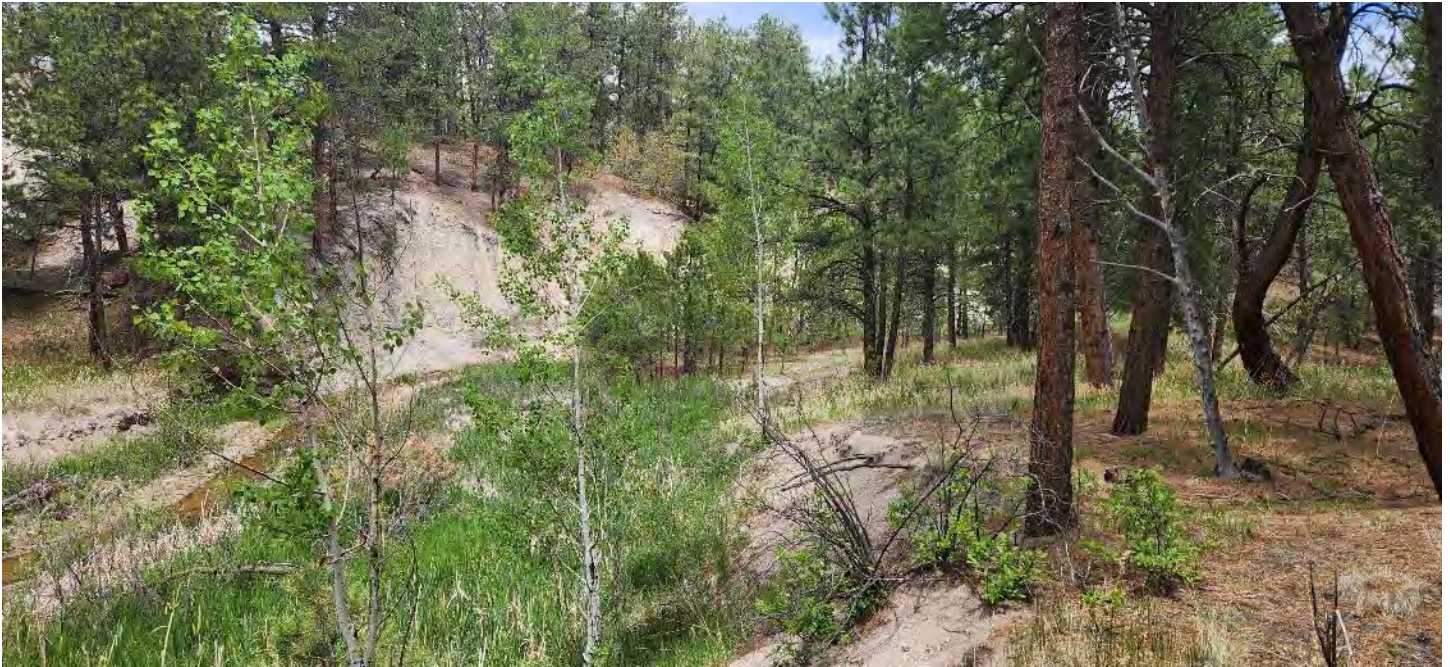
Photo Point 7 – View northeast (upstream and offsite) of Kettle Creek and adjacent ponderosa pine forest along north property line.

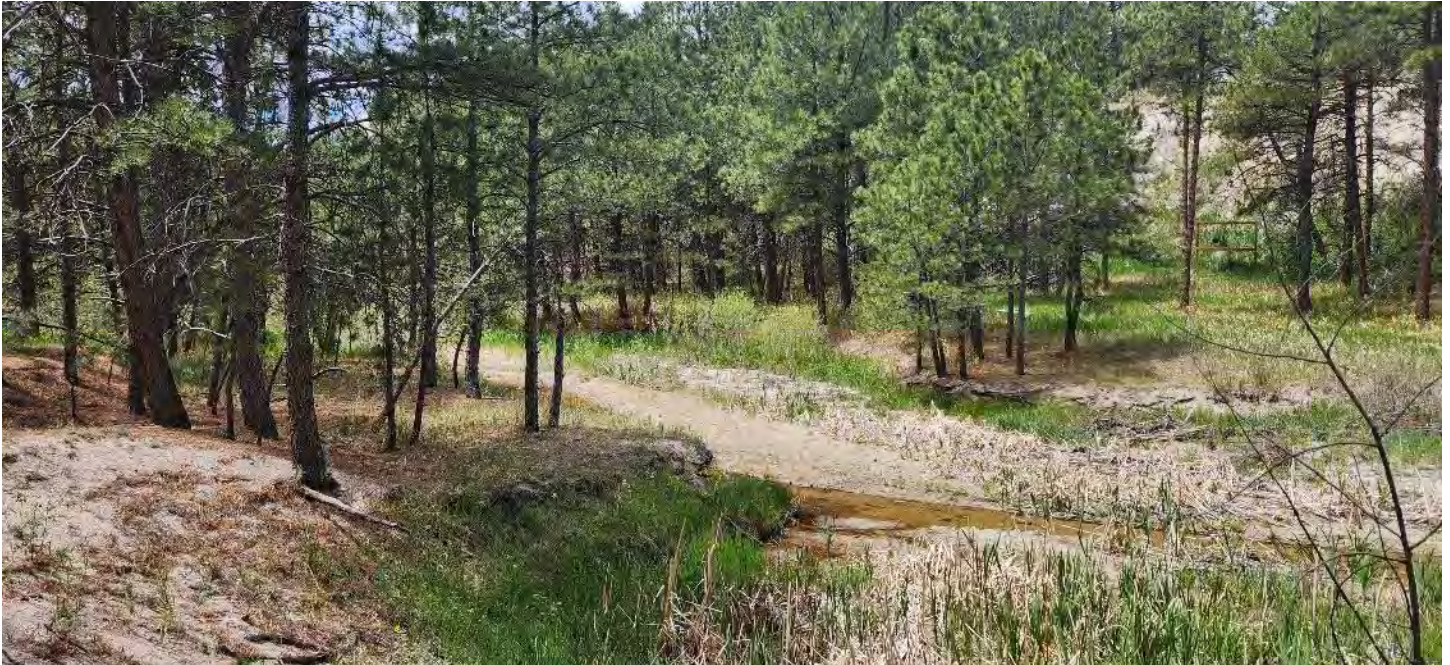
Photo Point 7 – View southwest (downstream and onsite) of Kettle Creek and adjacent ponderosa pine forest along north property line.

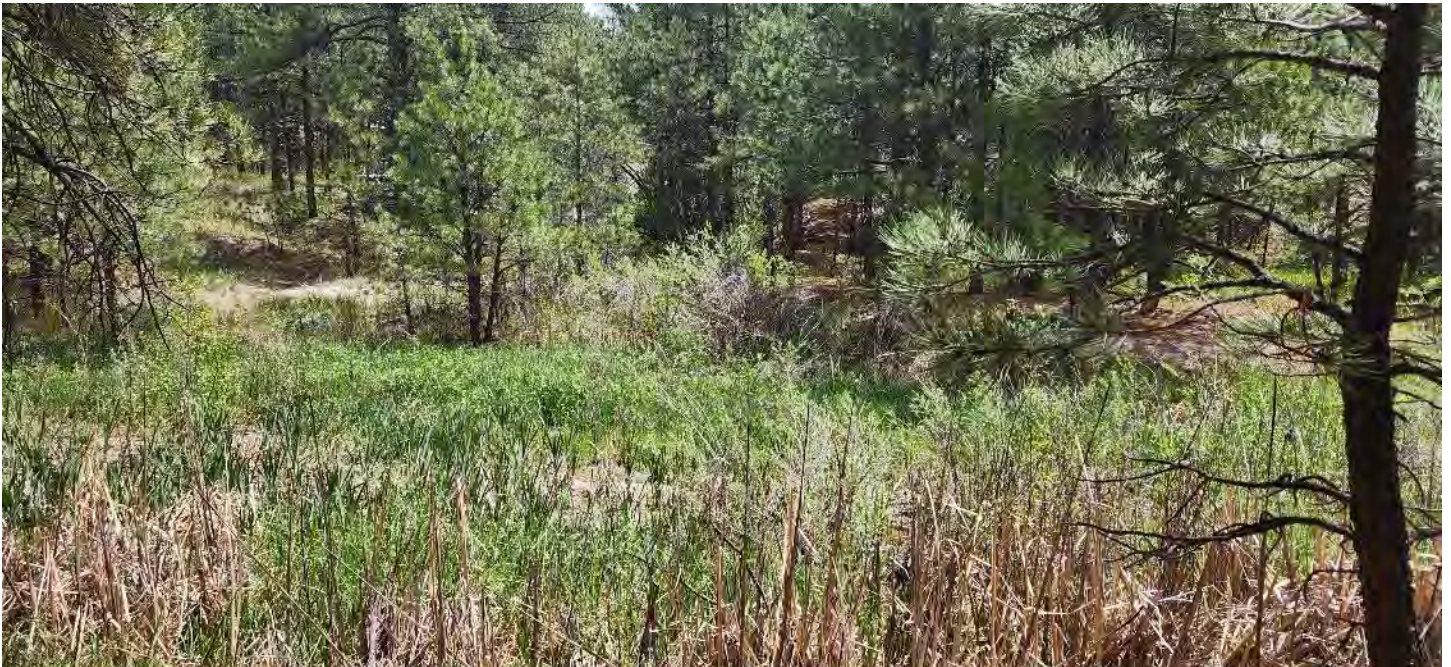
Photo Point 8 – View east across Kettle Creek wetlands toward mouth of Drainage 4.

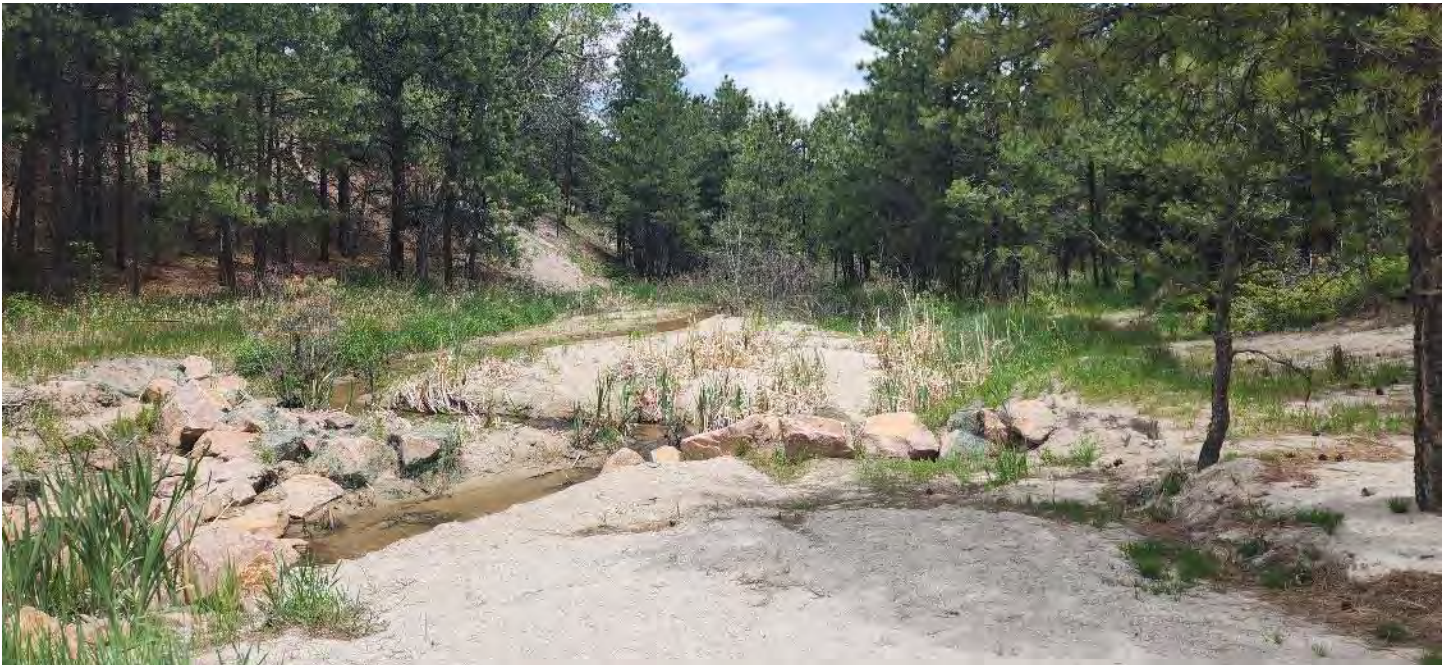
Photo Point 9 – View northeast (upstream) of wetlands and boulder grade control structure (historic open water pond) on Kettle Creek and adjacent ponderosa pine forest. Drainage 3 drops sediment in this location.

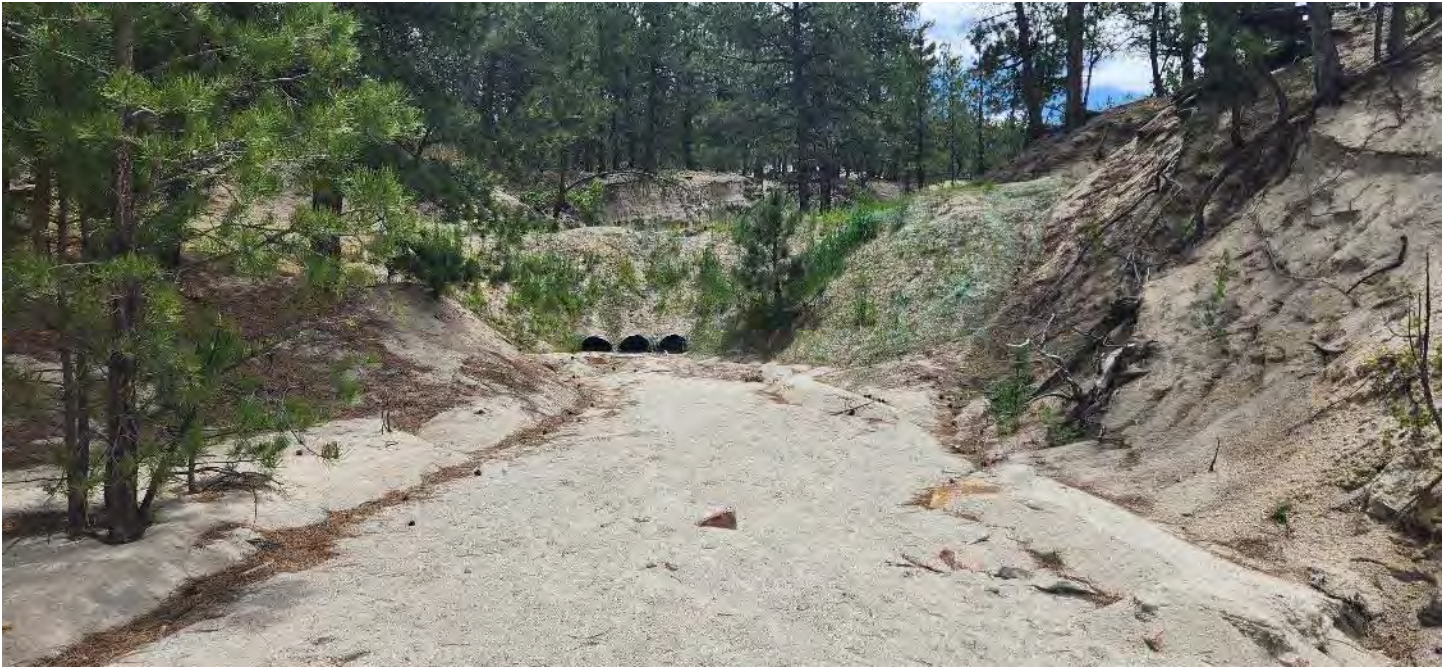
Photo Point 9 – View southeast (upstream) of Drainage 3 near confluence with Kettle Creek.

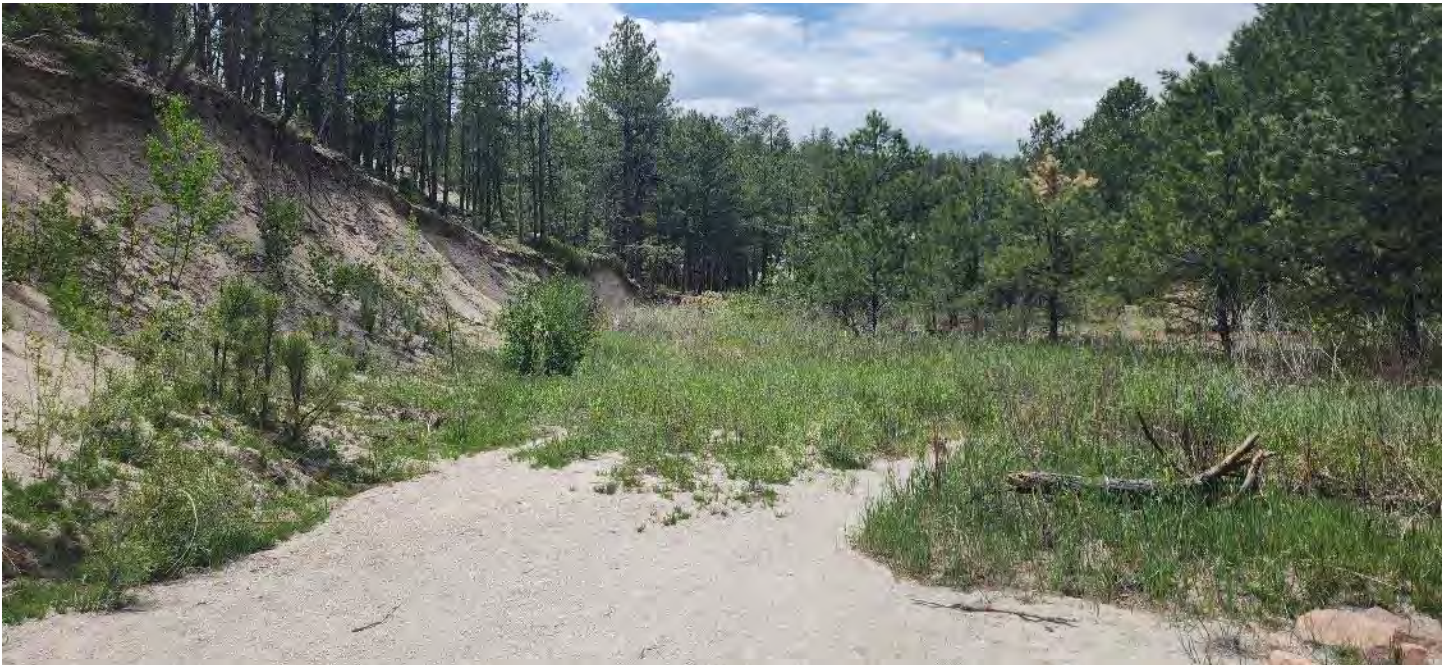
Photo Point 9 – View southwest (downstream) of Kettle Creek wetlands and adjacent ponderosa pine forest. Drainage 3 drops sediment in this location.

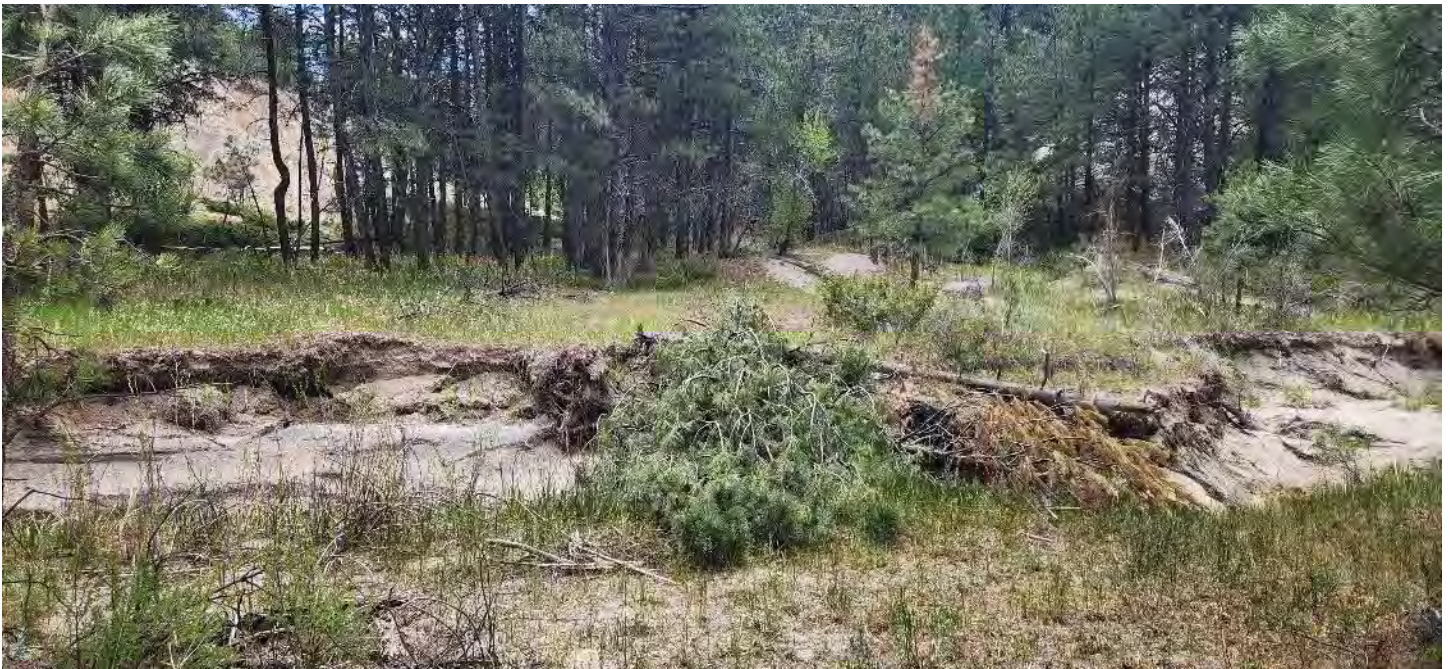
Photo Point 10 – View south across Kettle Creek (down-cutting in this location) of ponderosa pine forest within toward mouth of Drainage 2.

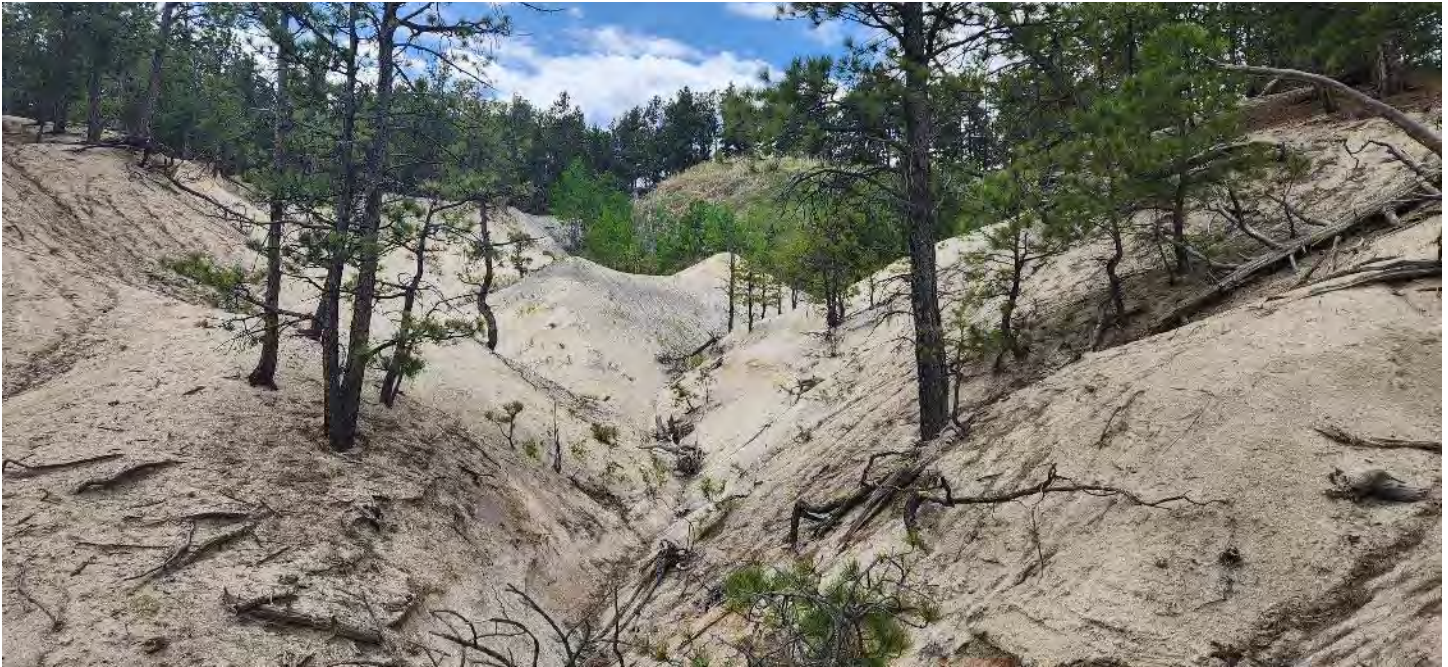
Photo Point 12 – View southwest of Drainage 1 and adjacent “badlands” from intersection of Parcels 1 and 2.

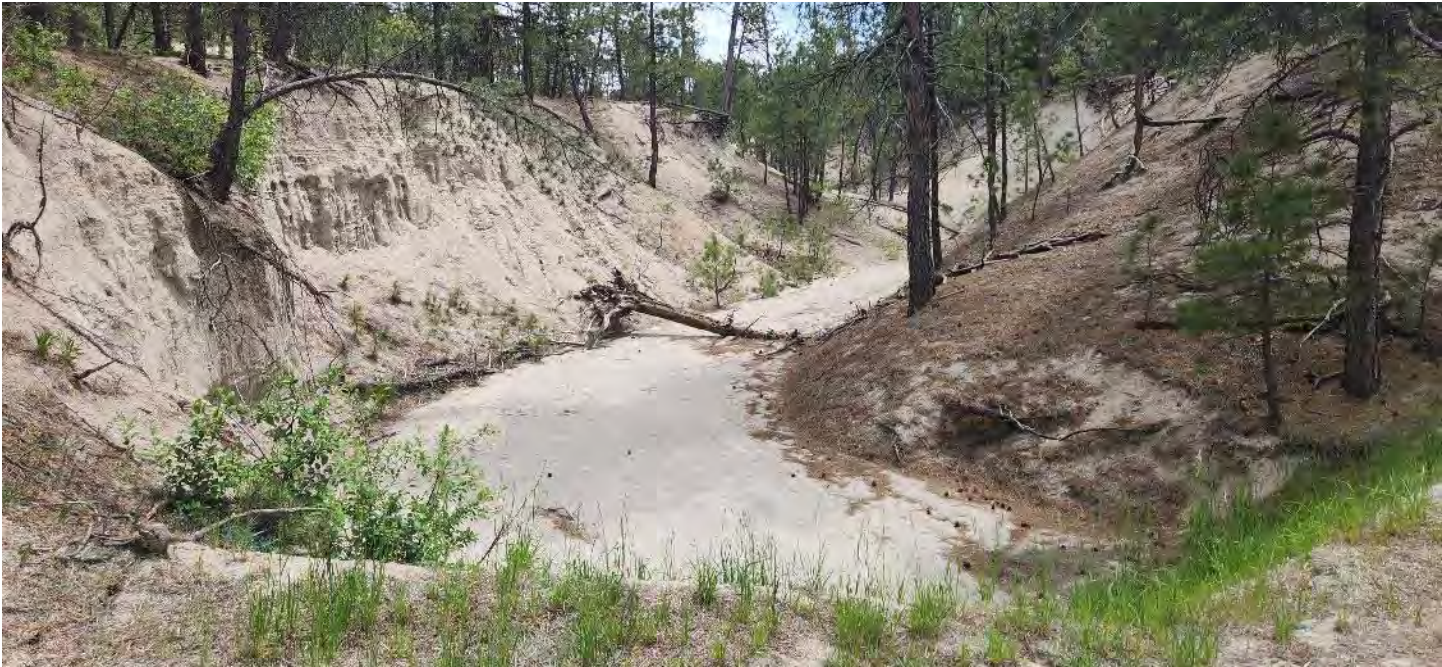
Photo Point 17 – View upstream of Drainage 3 from existing access road.

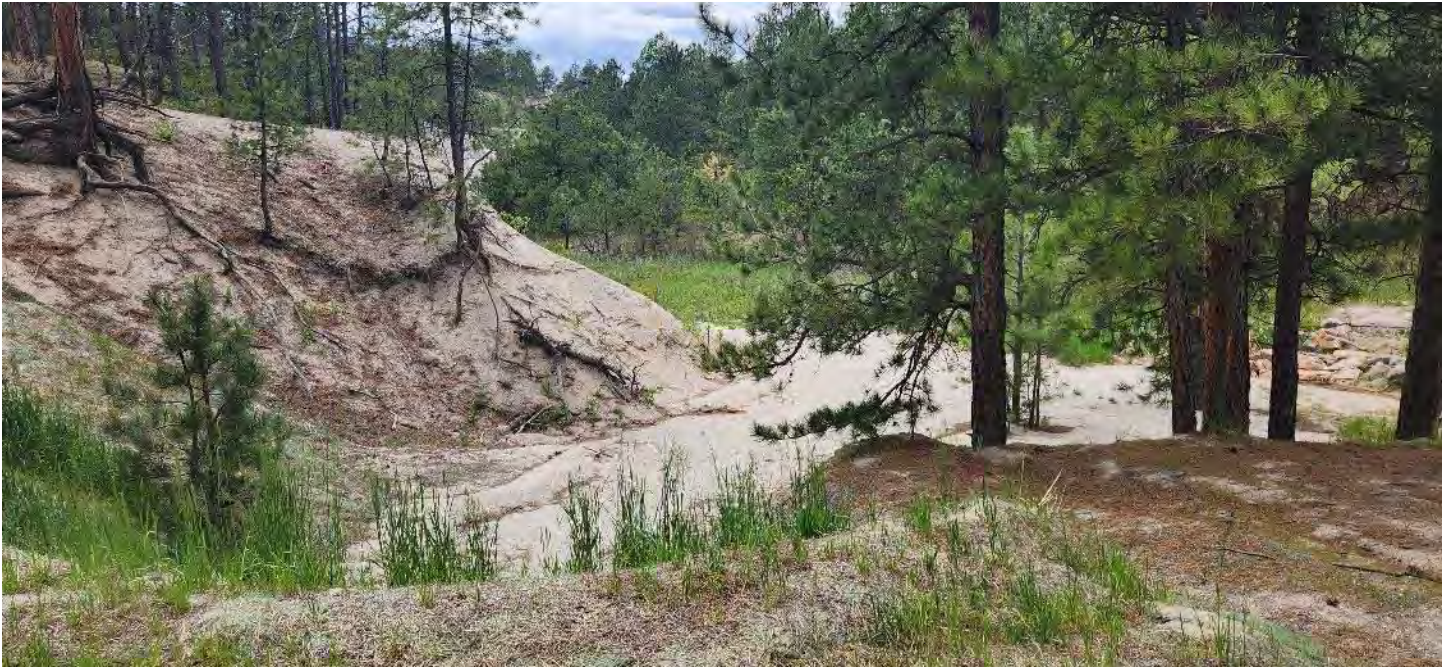
Photo Point 17 – View downstream of Drainage 3 near confluence with Kettle Creek from existing access road.

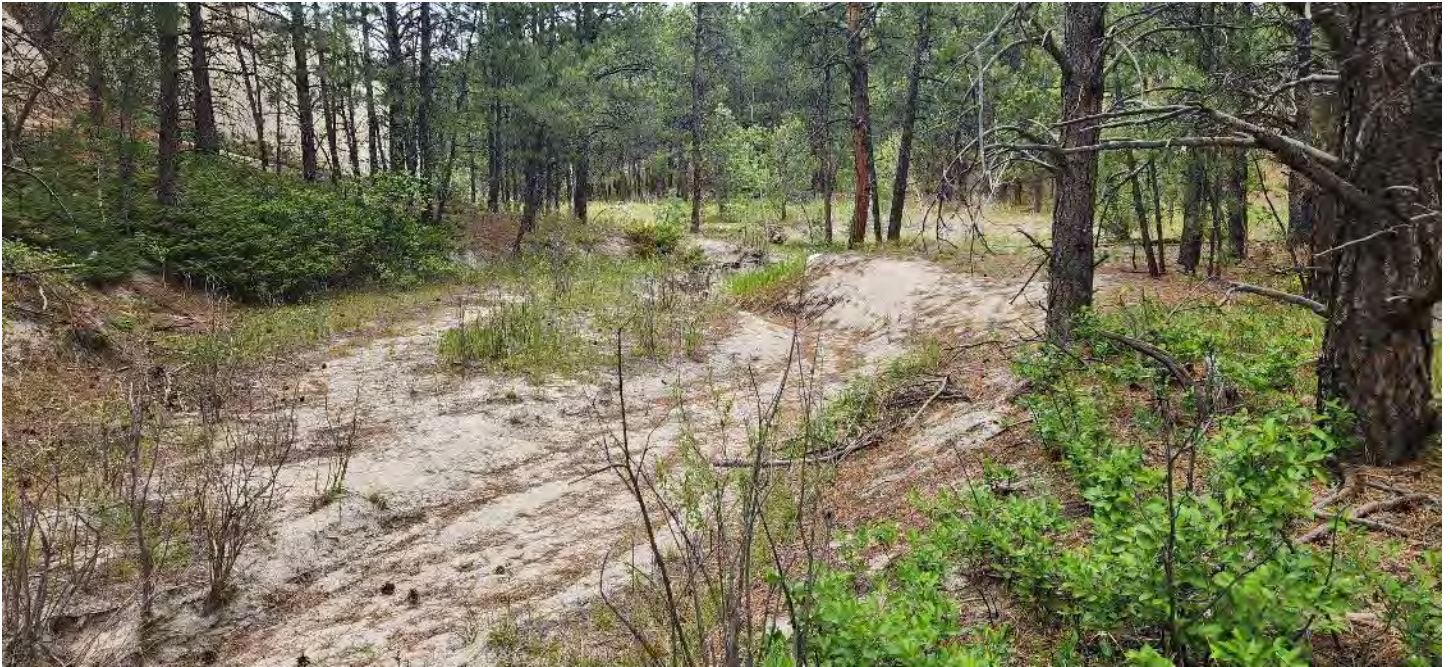
Photo Point 18 – View downstream of Drainage 2 near confluence with Kettle Creek.
