**Wetland, Wildlife and Natural Features Report
for
Canyon Creek Ranch Development in El Paso County, Colorado**

December 18, 2024

Project Number: 2024-2-1

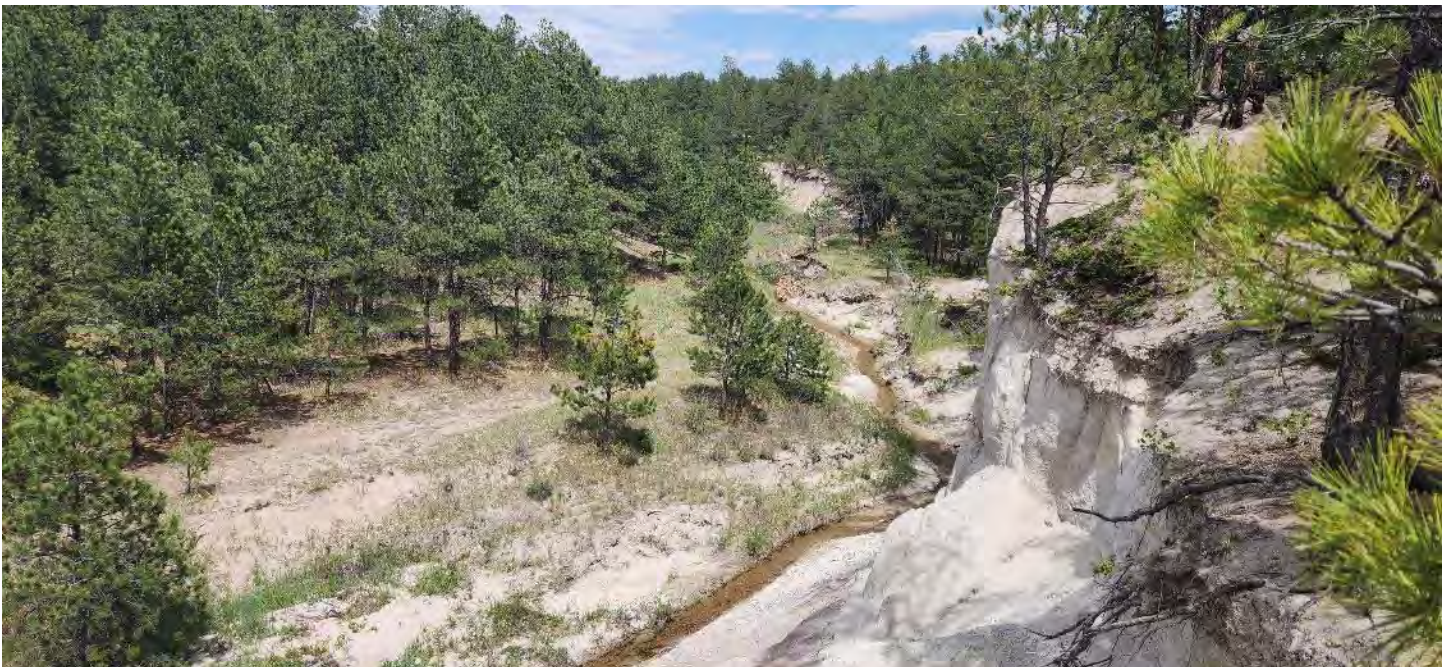
Photo Point 19 – Overview (upstream) of Kettle Creek valley showing floodplain, creek, wetlands and ponderosa pine forest in the floodplain and above the barren cliffs and slopes.

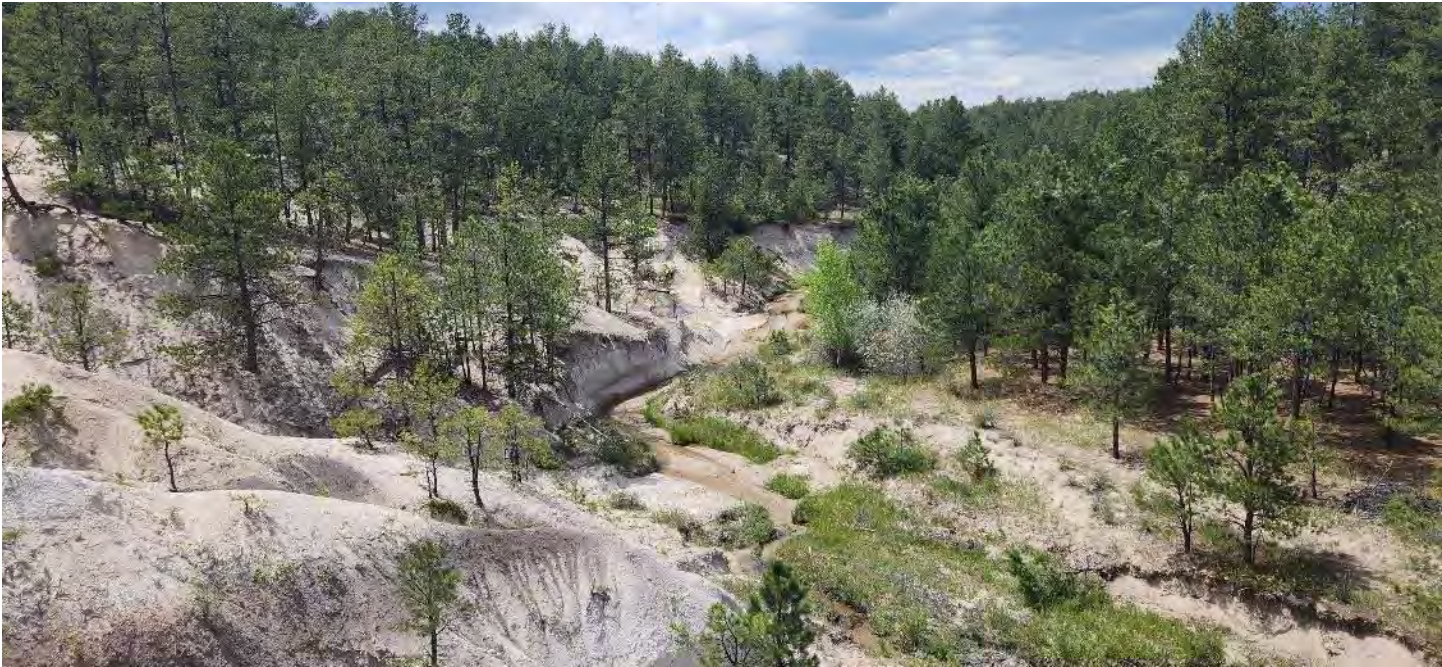
Photo Point 19 – Overview (downstream) of Kettle Creek valley showing floodplain, creek, wetlands and ponderosa pine forest in the floodplain and above the barren cliffs and slopes.

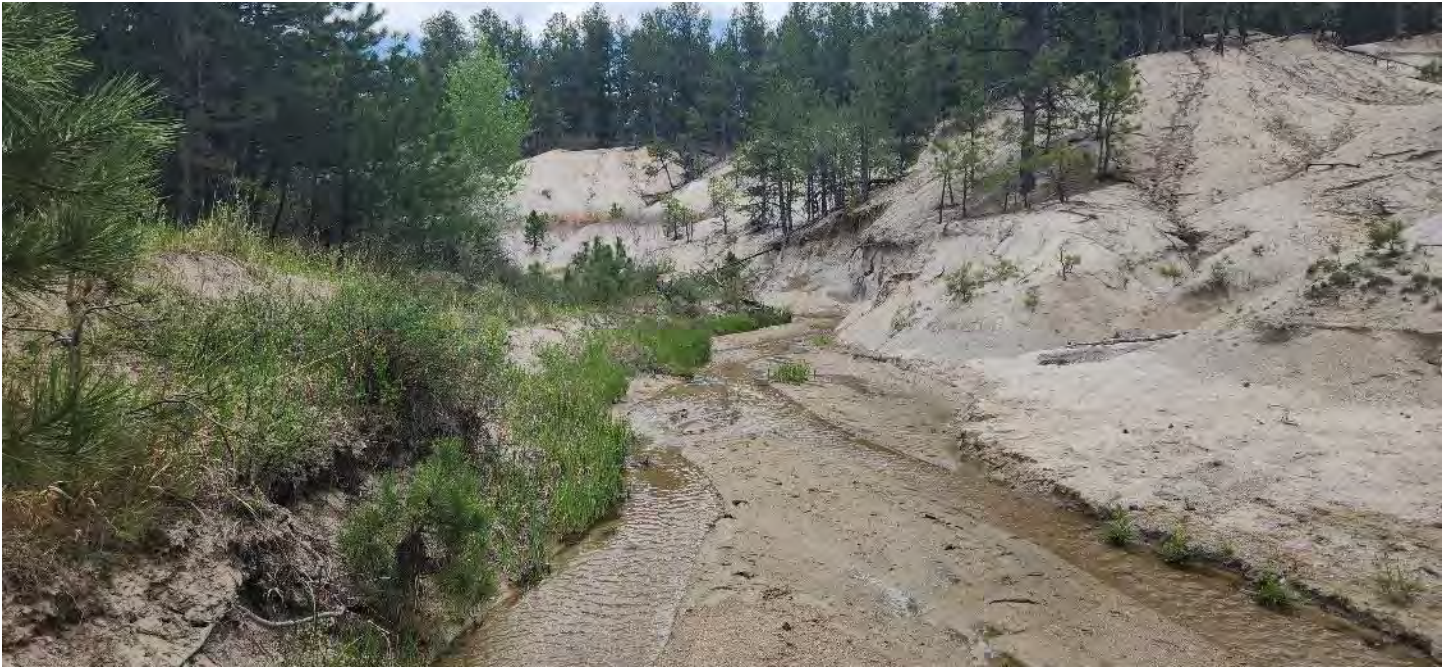
Photo Point WET SP1 – View upstream of Kettle Creek and associated wetlands at downstream end of the Site at Wetland Sample Point 1.

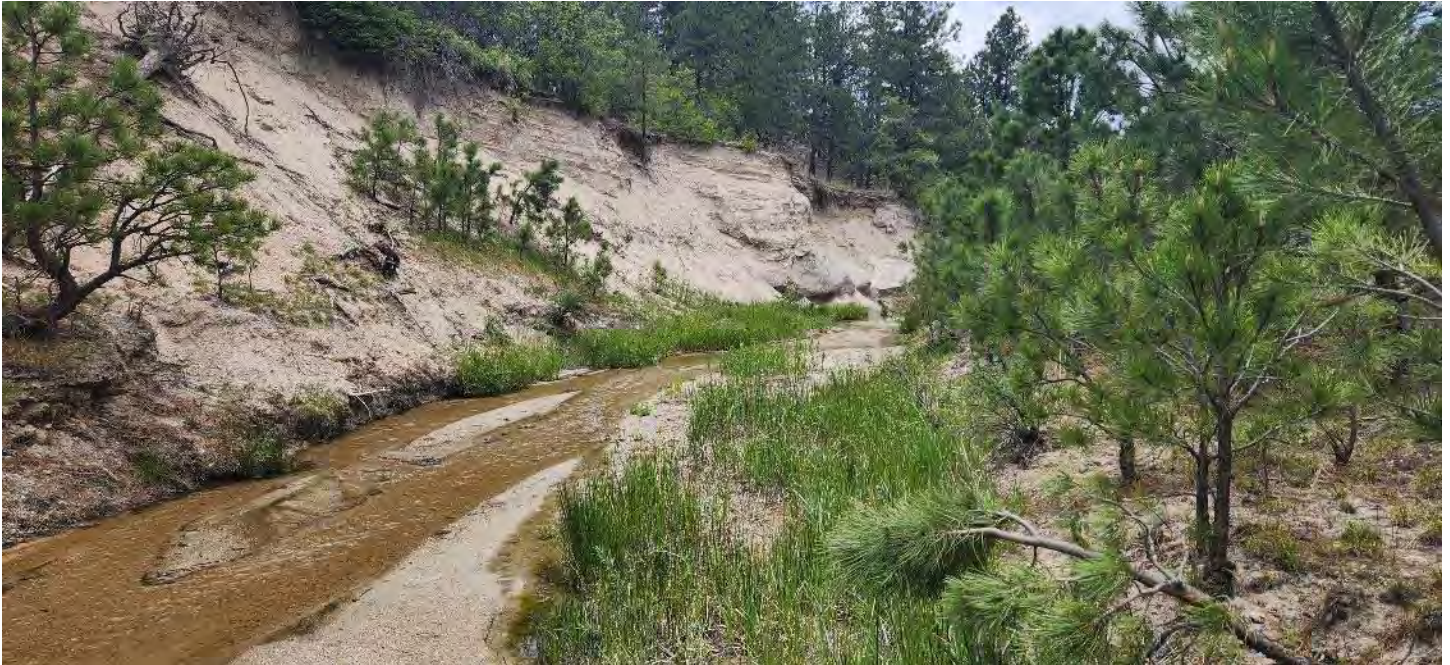
Photo Point WET SP1 – View downstream of Kettle Creek and associated wetlands at downstream end of the Site at Wetland Sample Point 1.

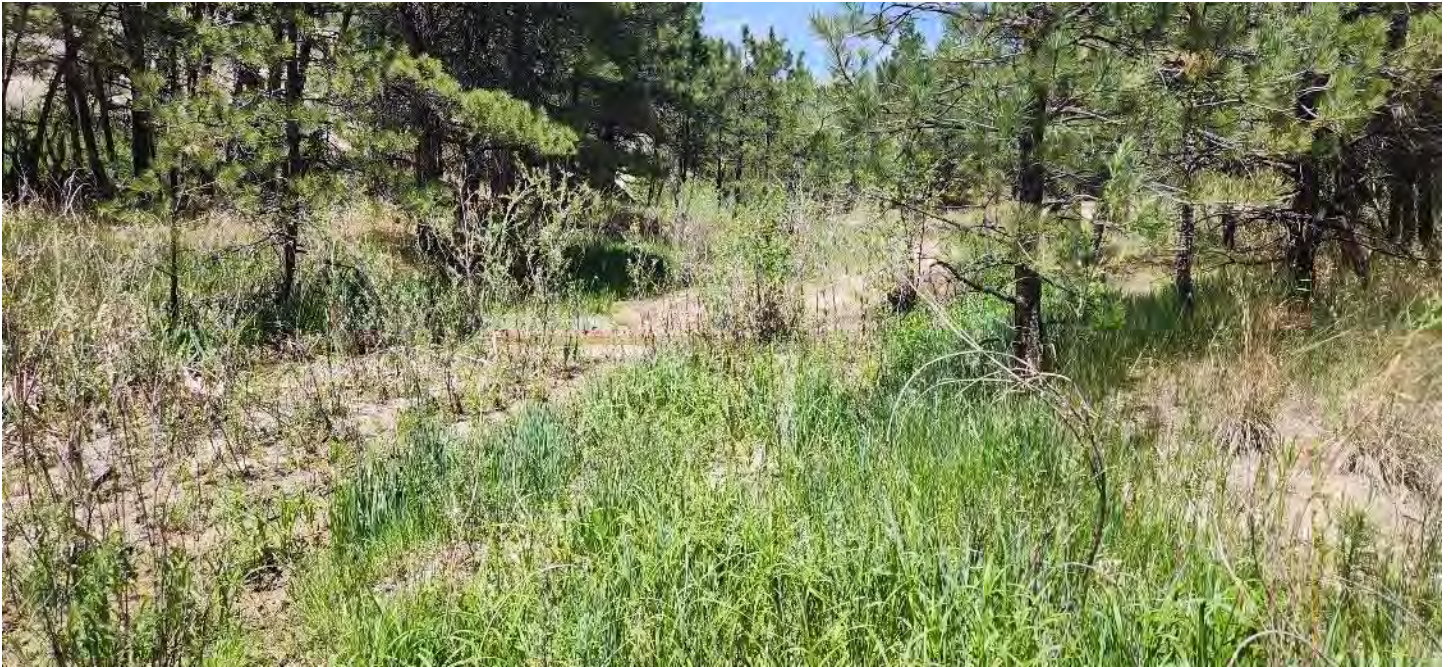
Photo Point WET SP2 – View upstream of Kettle Creek and associated wetlands at upstream end of the Site at Wetland Sample Point 2.

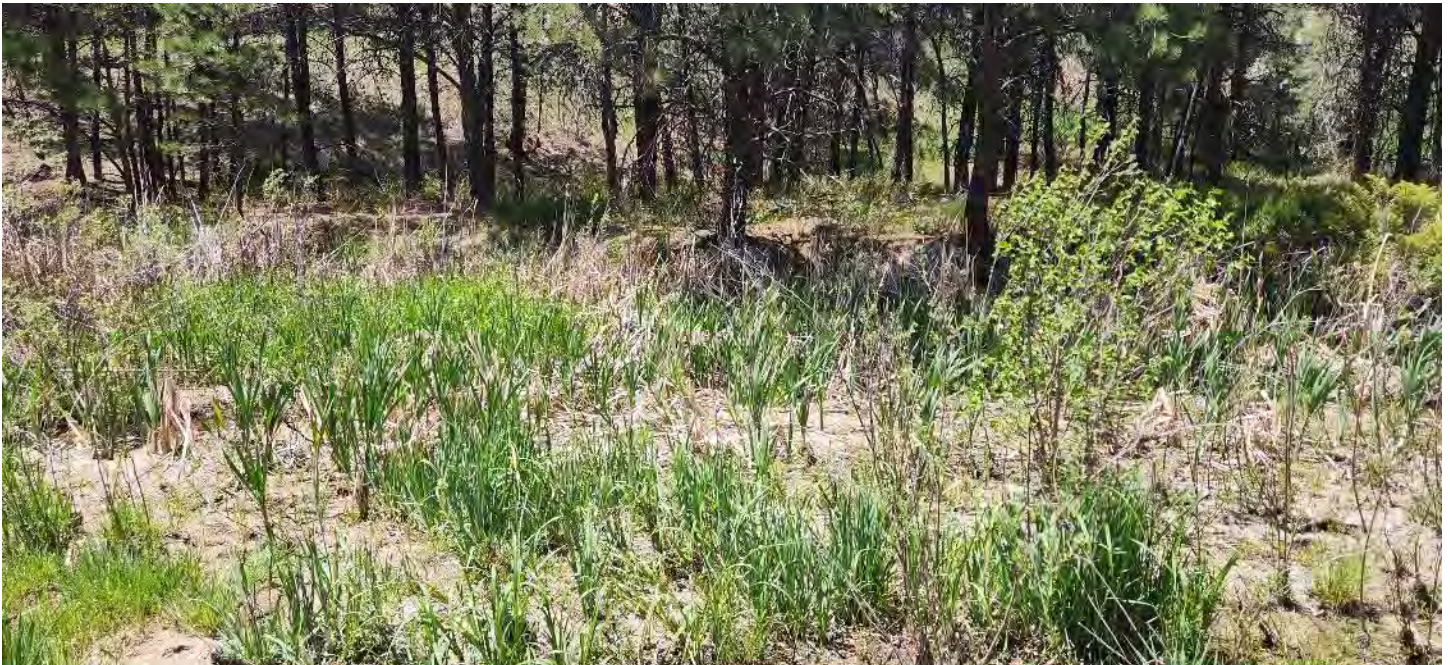
Photo Point WET SP2 – View across Kettle Creek and associated wetlands at upstream end of the Site at Wetland Sample Point 2.

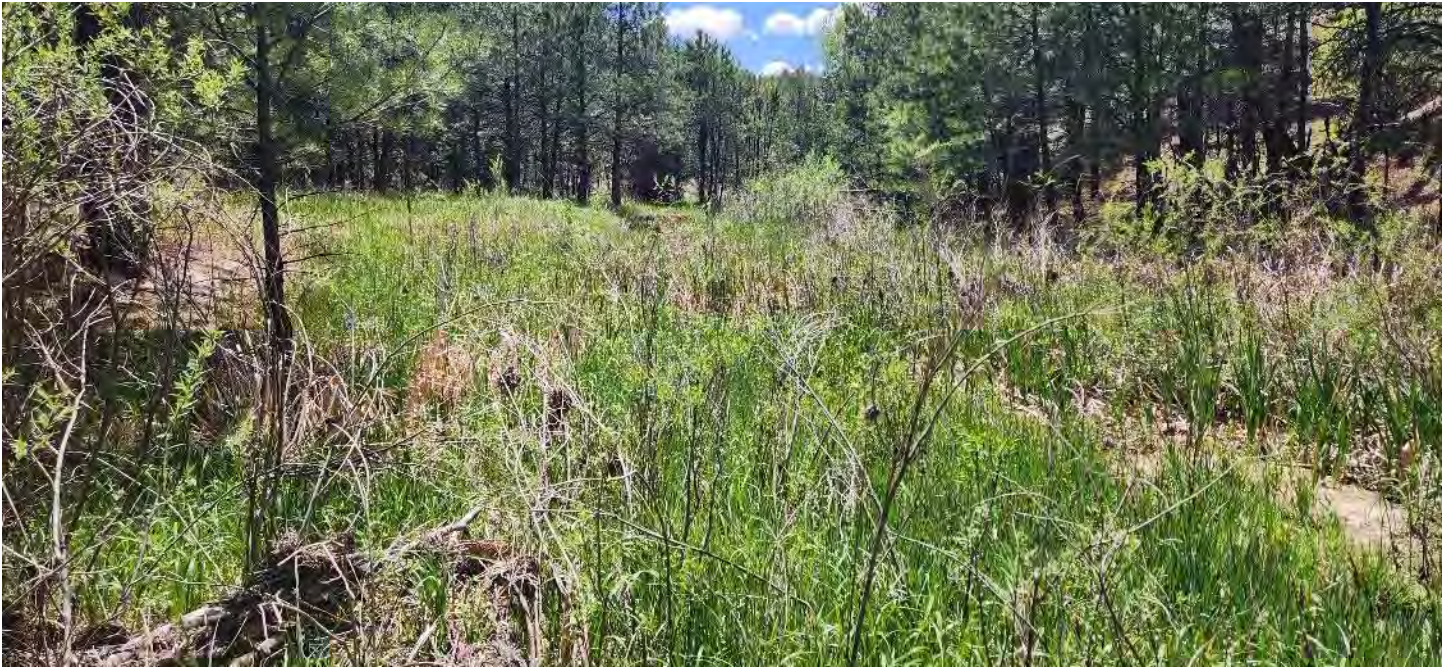
Photo Point WET SP2 – View downstream of Kettle Creek and associated wetlands at upstream end of the Site at Wetland Sample Point 2.

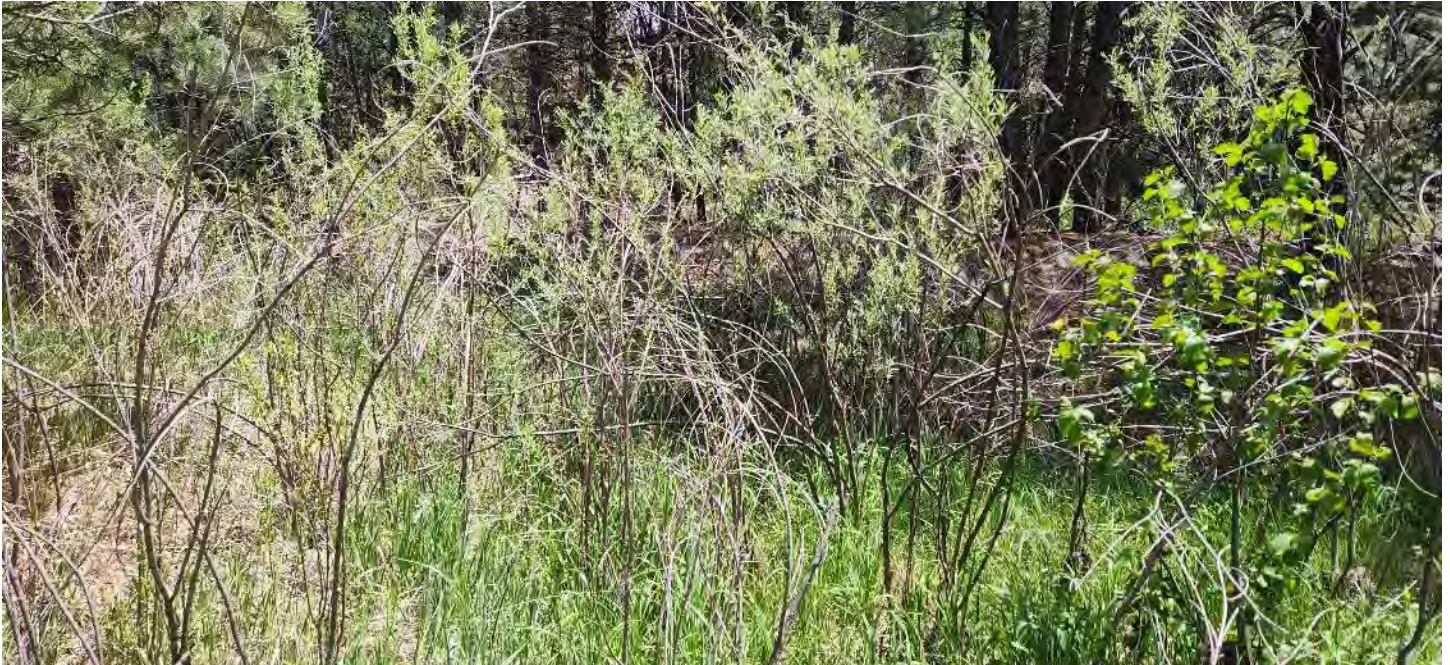
Photo Point WET SP2 – View of Kettle Creek and associated wetlands near the confluence with Drainage 1 at upstream end of the Site from Wetland Sample Point 2.

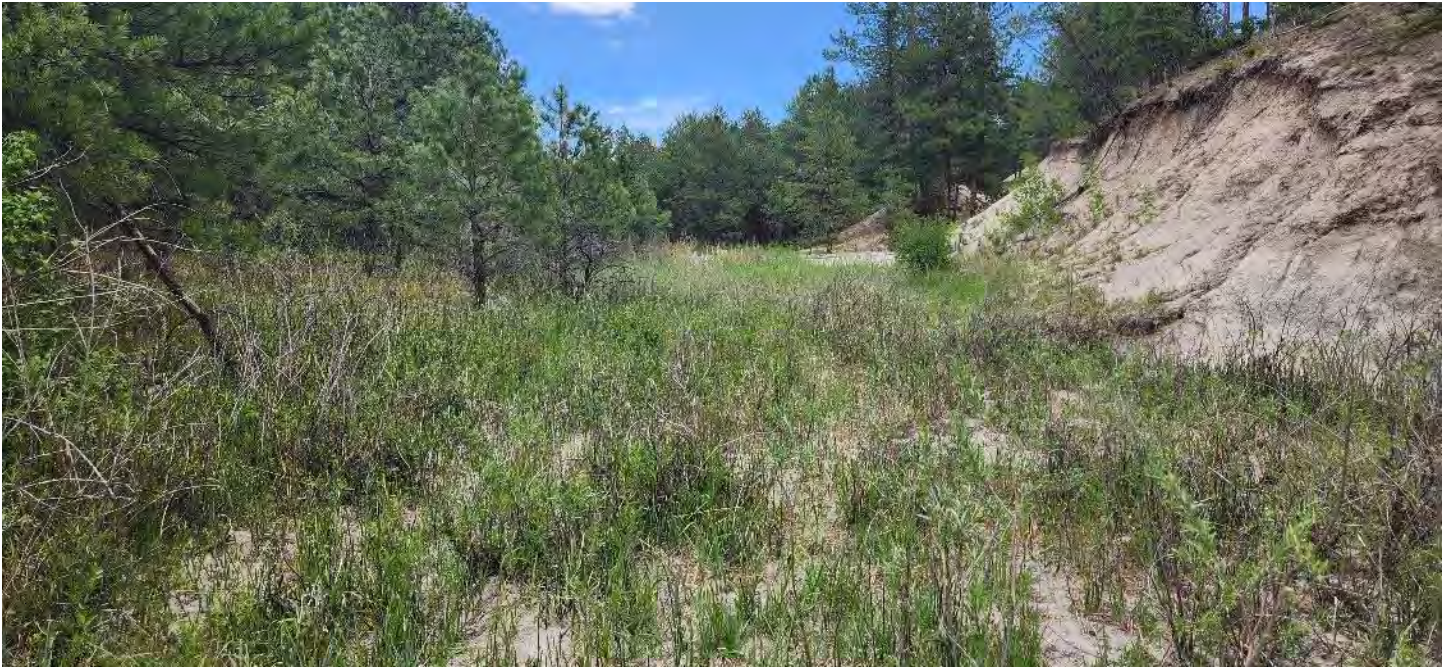
Photo Point WET SP3 – View upstream of Kettle Creek and associated wetlands at Wetland Sample Point 3.

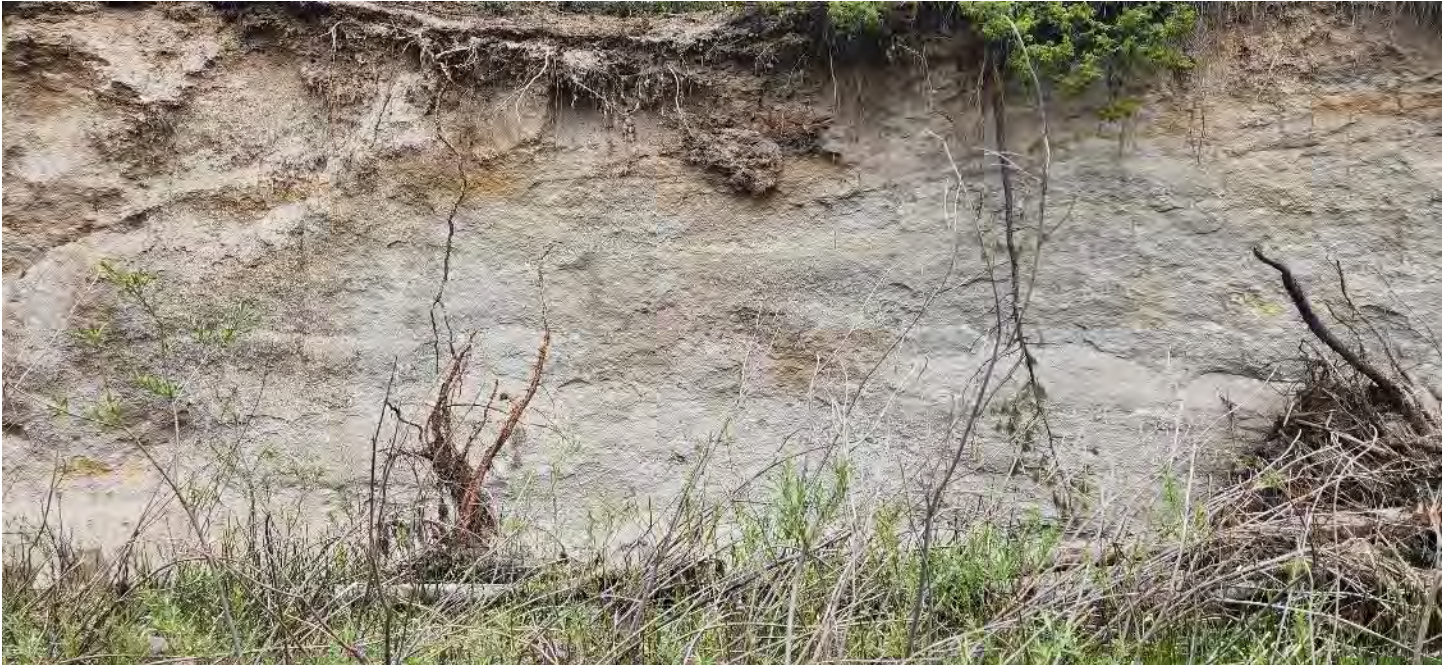
Photo Point WET SP3 – View south across Kettle Creek toward cliff face at Wetland Sample Point 3.

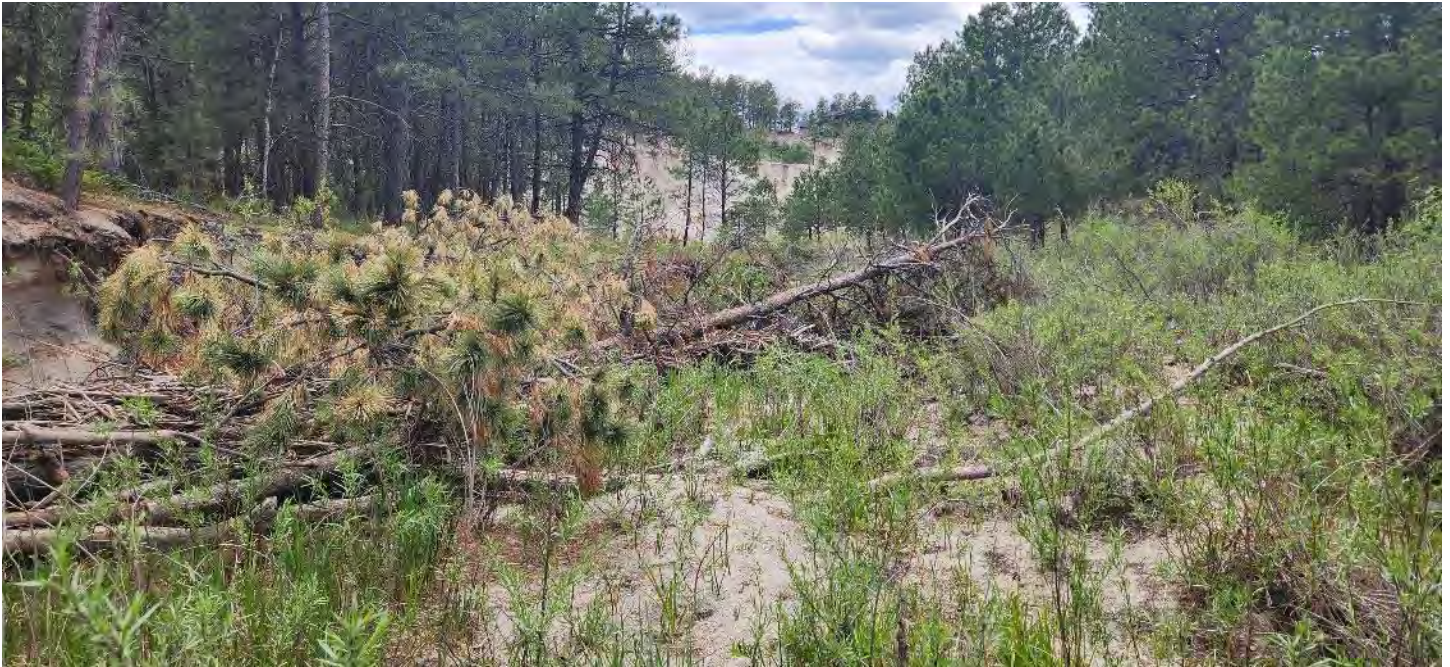
Photo Point WET SP3 – View downstream of Kettle Creek and associated wetlands at Wetland Sample Point 3.

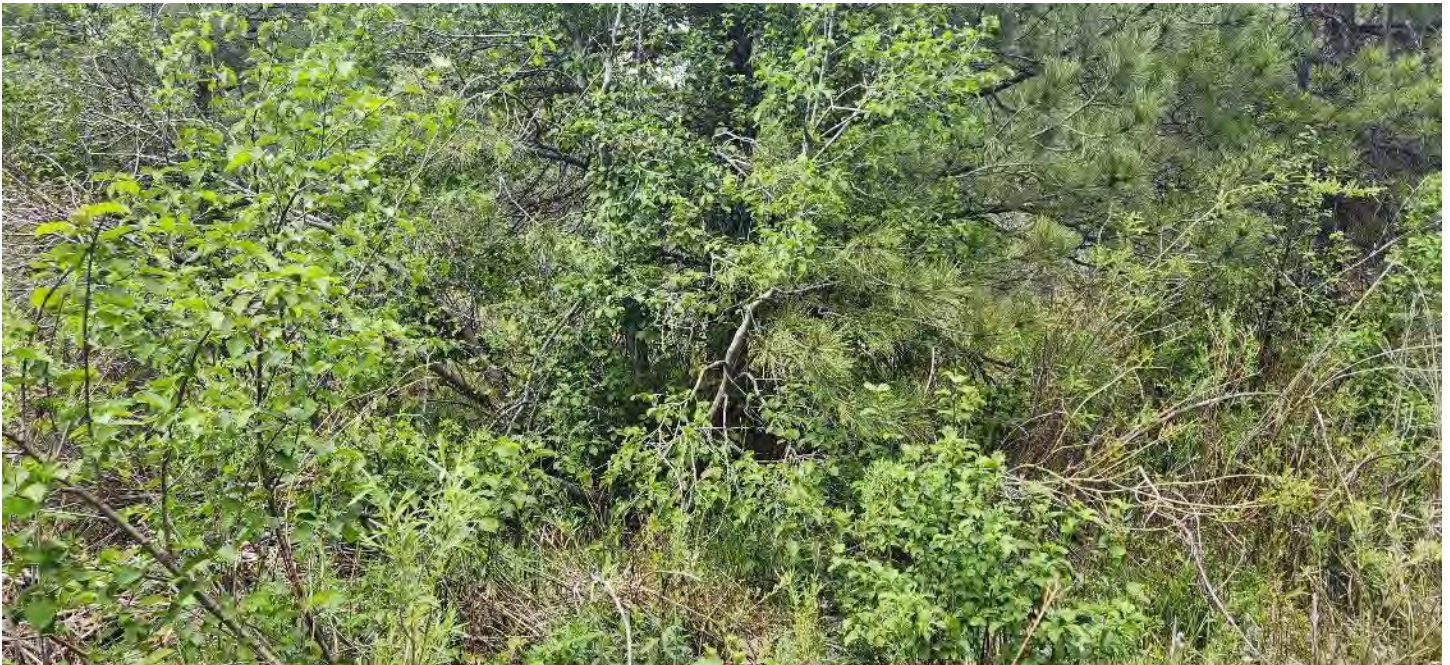
Photo Point WET SP3 – View north of Kettle Creek floodplain (opposite of the cliff) at Wetland Sample Point 3 where shrubby vegetation is the densest.
