Re: Initiation of Consultation for the Grazing Yak Solar Project, El Paso County, Colorado (HC#74926)

NextEra Grazing Yak Project, El Paso County, Colorado: Intensive Cultural Resources Inventory

History Colorado-Office of Archaeology and Historic Preservation
COLORADO CULTURAL RESOURCE SURVEY
 Cultural Resource Survey Management Information Form

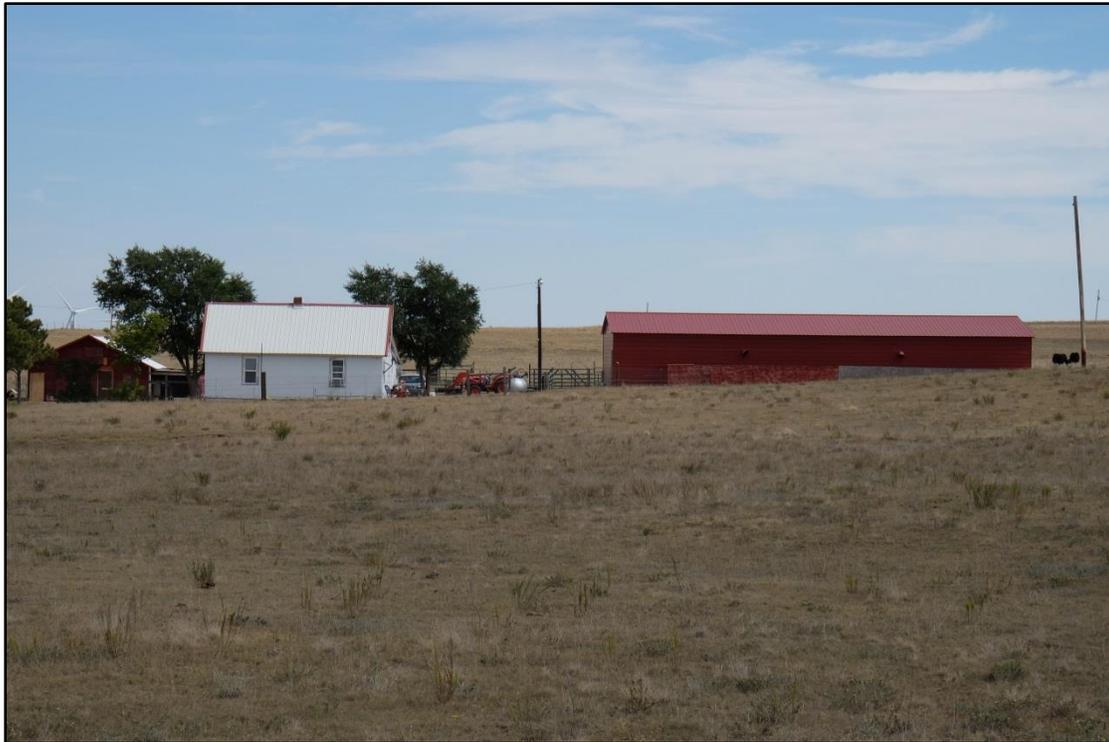
Site 5EP.8361 is a simple, one-story rectangular residence with a side-gabled roof (**Figures 5-1 and 5-2**). The east elevation has two shed-roof additions, which appear to be from differing constructions, and a porch was built at the entrance on the east elevation. The walls have vertical wood siding but the upper portion of the building has horizontal weatherboard. The shed-roof additions have vertical particleboard siding. The residence has two brick chimneys. The original chimney is aligned along the roof crest and is at the north end of the building. The second chimney is in the shed-roof addition at the northeastern corner of the building. The roof is sheathed with modern corrugated sheet metal. All of the original windows have been replaced with modern two-light, single-hung or casement-type closures. The north and west elevations have two sets of windows, the south elevation has three windows, and the east elevation has at least two but potentially more windows. A recently constructed rectangular wood barn and a small woodworking shed lie immediately south and east, respectively, of the residence. A short gravel road leads from Washington Road past the shed to the residence.

Figure 5-1. Site 5EP.8361, historic farmhouse and barn, overview looking east.

According to El Paso County Assessor records, the original building was constructed in 1919. The shed roof addition(s) and the porch were added more recently. The residence and outbuildings are a part of a large (one-half section) historic ranch, and the land features CCC-constructed water control and soil erosion features, which are described below as a separate site.

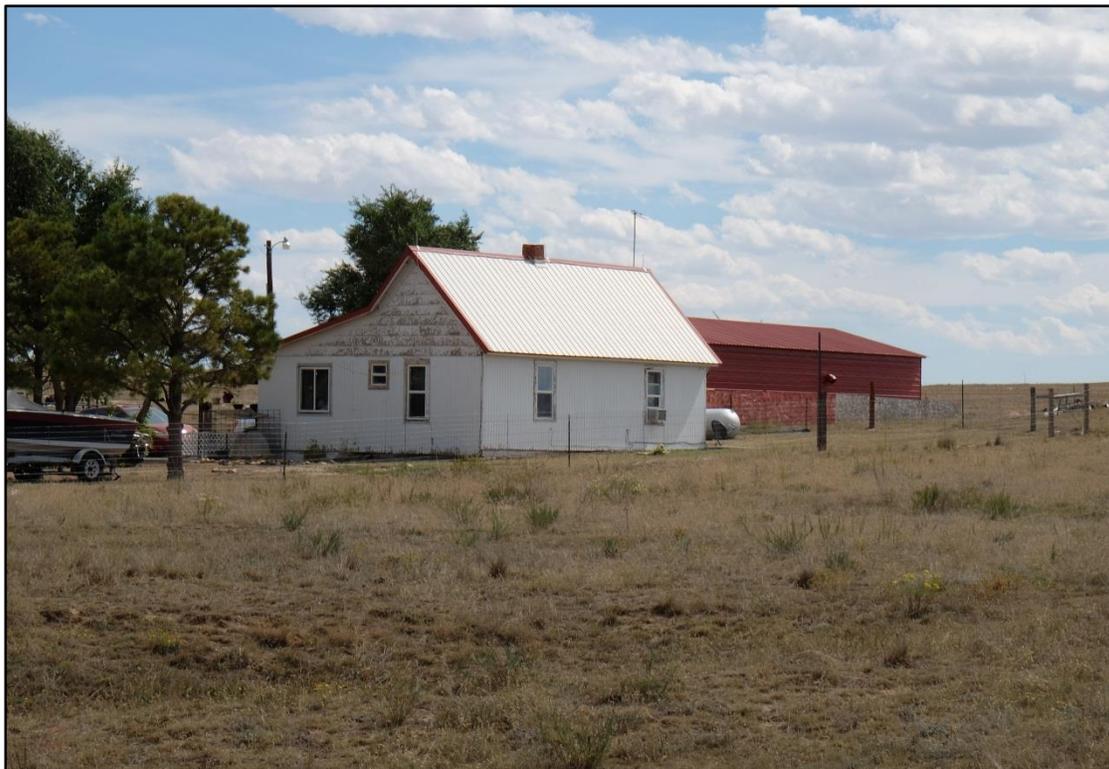
Figure 5-2. Site 5EP.8361, historic farmhouse and barn, detail view looking southeast.

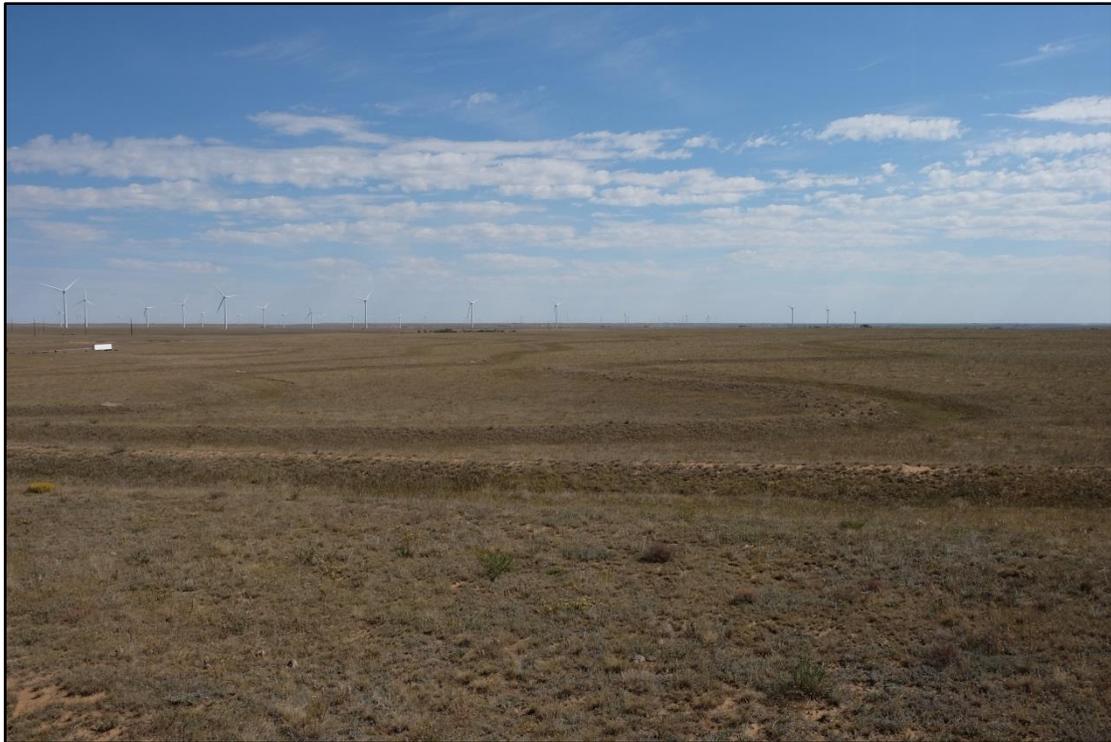
The flat-bottomed to shallow U-shaped bottomed contour furrows and round-topped berms are used as water spreaders to disperse runoff/storm water across the soil surface and increase infiltration of water into the ground. This was done mainly to diminish soil erosion of the rangeland and farmland located adjacent to rivers, creeks, drainages, or sloughs that have the potential to flood or have flooded in the past. The erosion control work was also done to rehabilitate the rangeland that had been severely affected by wind erosion during the Dust Bowl years in the 1920s and early 1930s, followed by major flooding along Kiowa Creek and adjacent drainages in 1935. The Jacob Sturm ranch on which these features were built is bisected by Horse Creek, a large and deeply cut intermittent drainage. The CCC built an earthen dam across the drainage channel, along with an excavated depression or stock tank on the upstream side, in order to collect and then redirect excess storm water from the drainage and onto the adjacent rangeland. The pooled water collects and then is diverted by the complicated system of zig-zagging furrows and terraces onto the adjacent lands to increase the infiltration of the water back into the water table and thus lessen the erosional impact of surface water along the drainage and ultimately the adjacent rangeland. Because floodwaters can carry heavy amounts of silt, settling ponds are added into the terracing system in order to allow these fine particulates to settle in specific locations and alleviate downstream silt deposition.

Figure 5-3. Site 5EP.8362, CCC constructed erosion furrows, overview looking east.

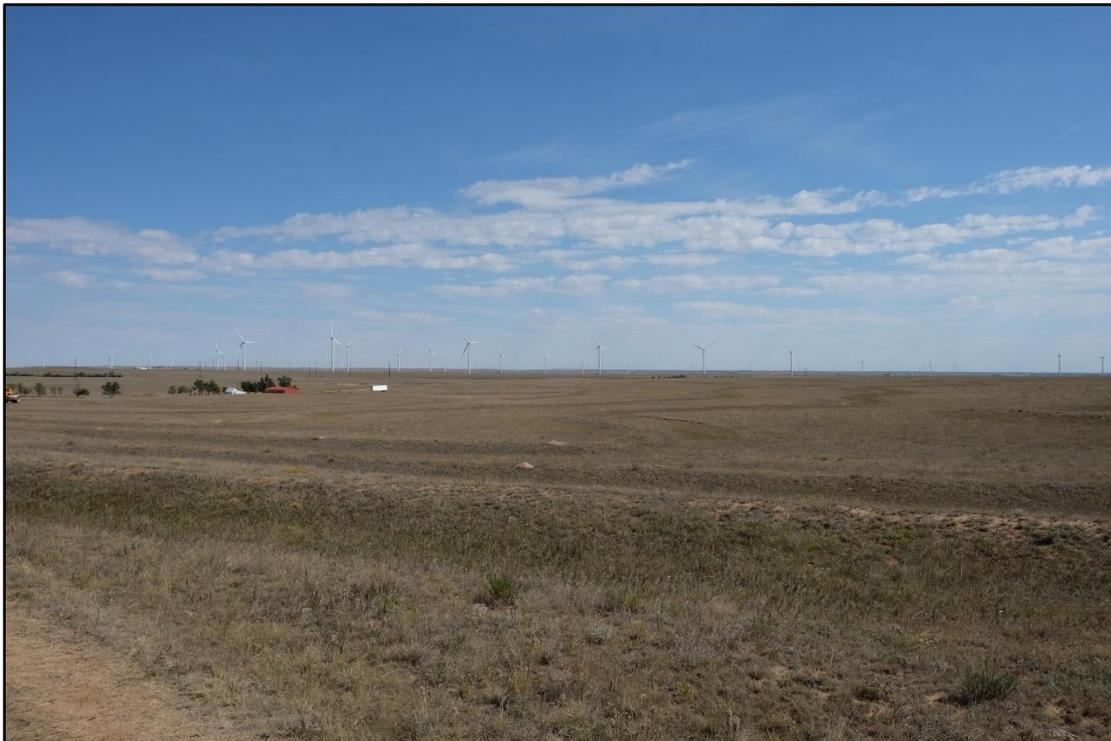
Figure 5-4. Site 5EP.8362, CCC constructed erosion furrows, overview looking northeast.

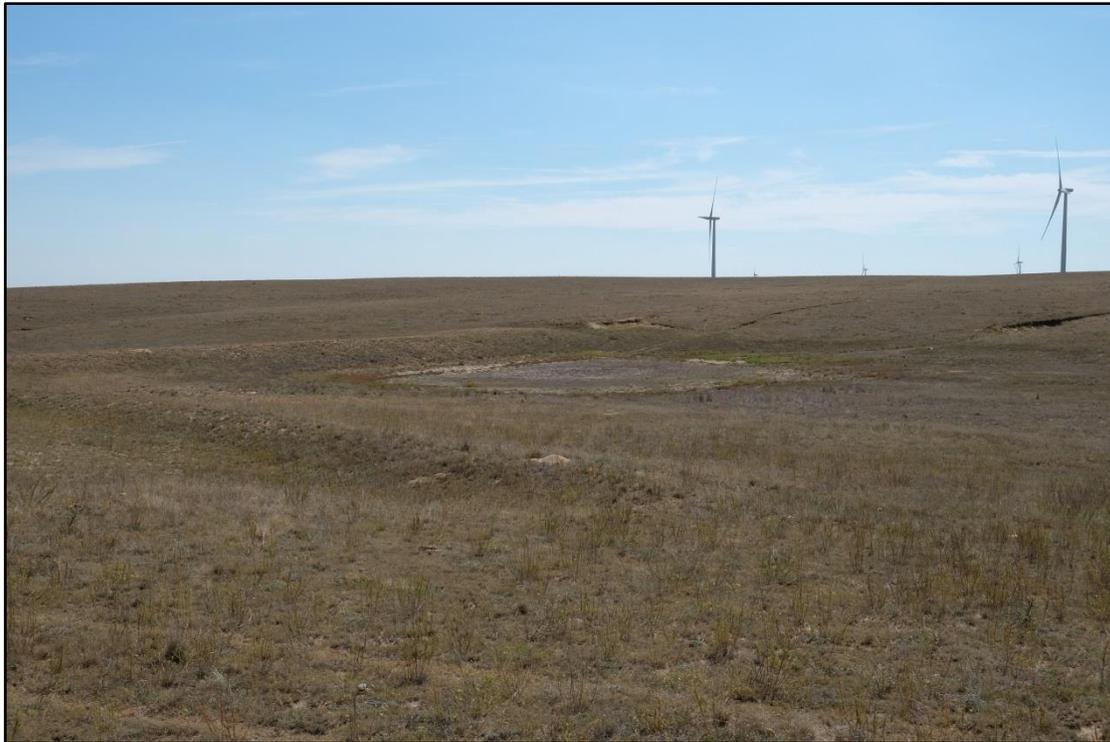
The earthen dam and stock tank are located along the bottom of an unnamed tributary of Horse Creek. The dam has a truncated triangular shape, the base measures 70 ft wide, and the crest measures 15 ft wide. The dam is 6 ft tall and 400 ft long, connecting one side of the tributary's bank to the other side. The south end of the dam has a small channel to direct water around the top of the earthen berm. Four rock blocks are aligned along the top of the dam for 10 ft. The rocks are imbedded into the dam, flush with the surface, and partially obscured by grass and dirt. The land on each side of the tributary contains the contour furrowing and settling ponds. South of Horse Creek, the land rises towards a flat top and contains 15 of the 43 contour furrows. The north side of the tributary also rises to a flat area before descending to the north and contains the remaining 28 contour furrows and the two small settling ponds. The settling ponds are in the northeastern quarter of the parcel and collect water that is introduced into the maze of water spreaders and allow some of the finer particulates (silt and sodium) to settle before the water is distributed through the rest of the maze of furrows, ultimately penetrating into the soil. At their high water mark, the ponds are approximately 80-100 ft in diameter. The furrows and berms (water spreaders) are consistently the same width and depth, with minor variations, across the entire site, and erosion has altered certain sections. The furrows typically measure 10-13 ft wide and the bottom of the U-shaped furrow is approximately 20 ft wide. In places, the upslope bank has eroded away slightly, creating a shallower and wider furrow channel. The berm is on the downslope side of the furrow and is made from the excavated dirt removed from the contour furrow. The berms generally measure approximately 2 to 3 ft high and approximately 10-12 ft wide at the base. Their shape is a truncated triangle and the crest is rounded or flat and measures approximately 1 ft wide.

Figure 5-5. Site 5EP.8362, CCC constructed dam and retaining pond, overview looking southeast.

44. Recorder's Management Recommendations: Although these features are associated with a historic event of national, state, and local significance, they are not unique to this area. Similar features abound in the area. The dam should be preserved intact, for both historic and functional reasons, but further cultural resources with the erosion control features is unnecessary.

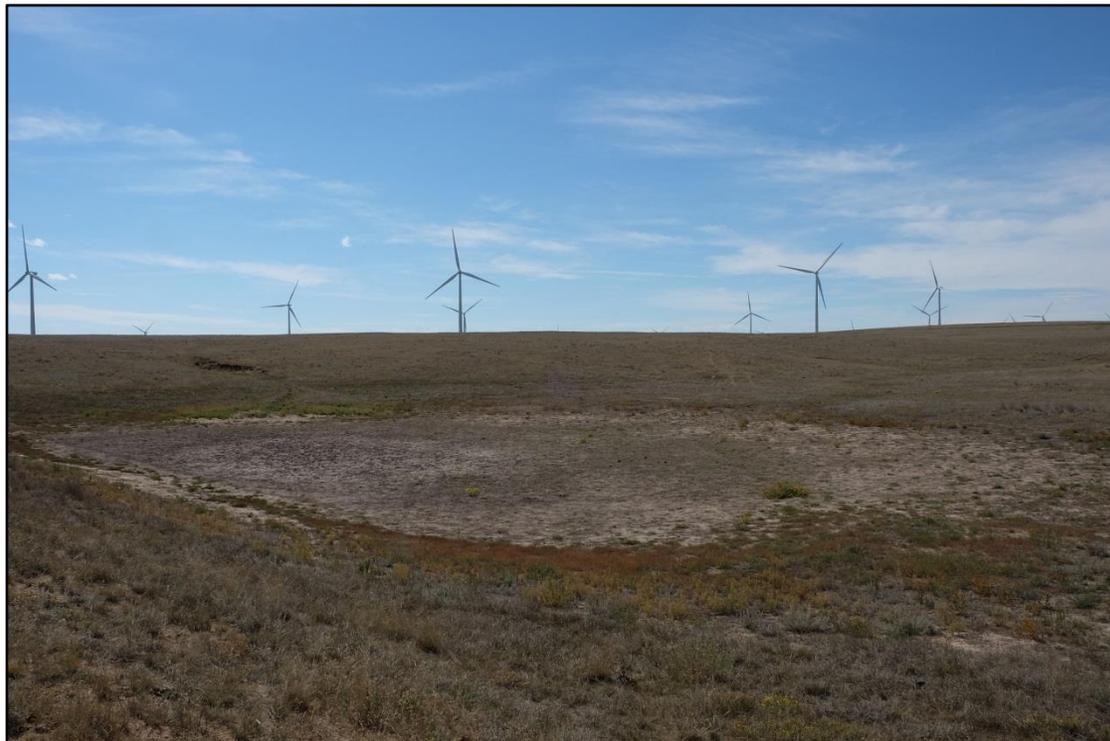
Figure 5-6. Site 5EP.8362, CCC constructed dam and retaining pond, detail view looking southwest.

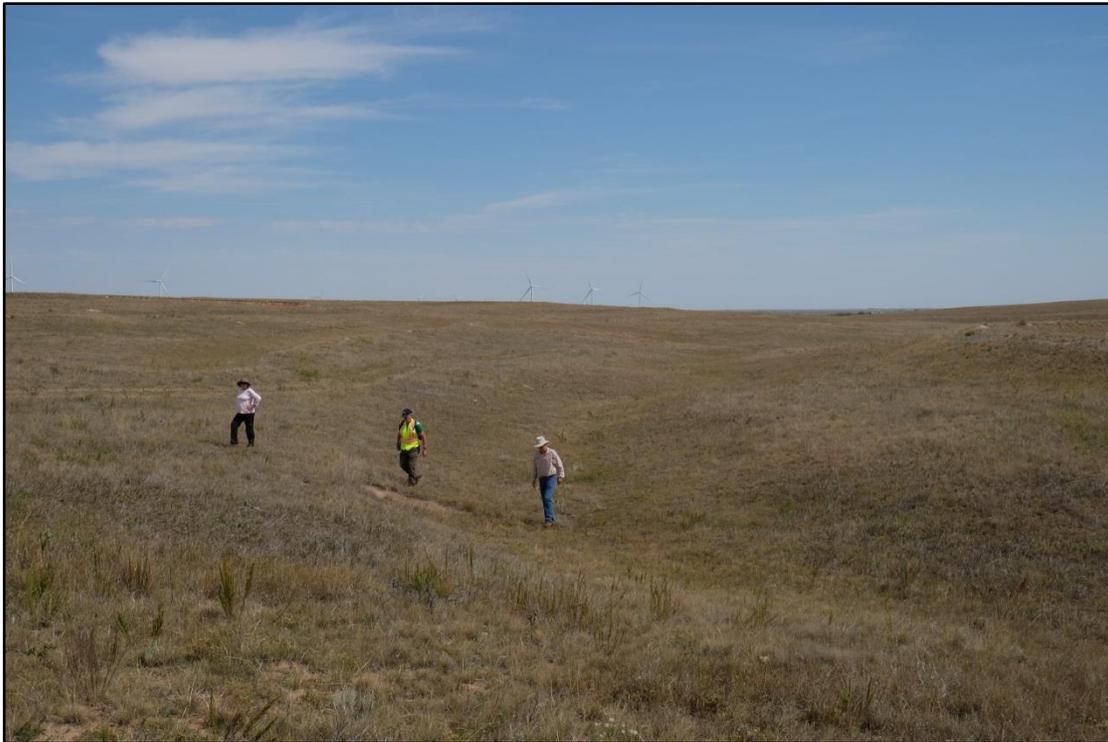
Figure 5-7. Site 5EP.8362, Project personnel at CCC constructed furrows and dam (at right edge), overview looking southeast.

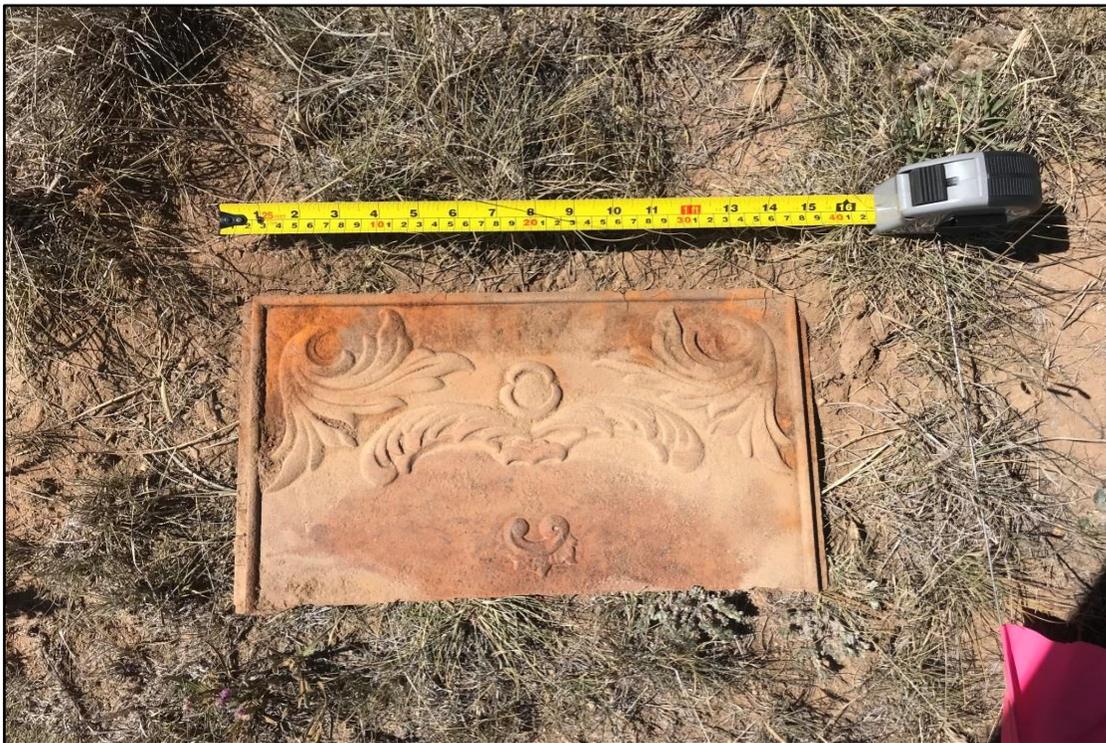
Isolated Find 5EP.8363 is an embossed cast iron stove door/panel fragment with no visible maker marks (**Figure 5-8**). The stove door is likely associated with the nearby farmstead (5EP.8361), located on the south side of Washington Road. The stove door was partially covered by soil and vegetation and was lying on the east side of a farm road that runs north-south, following the fence line (**Figure 5-9**).

Figure 5-8. IF 5EP.8363, embossed cast iron stove door/panel fragment.

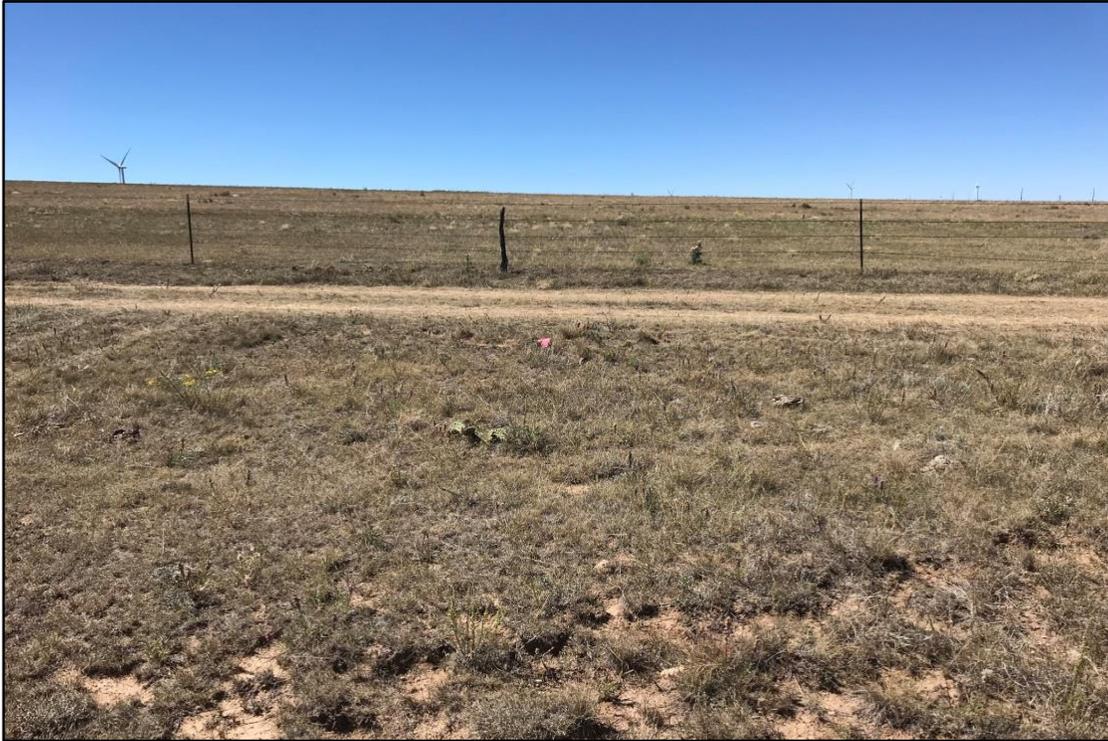
Figure 5-9. IF 5EP.8363, overview showing location, looking west. Fence line denotes western edge of the Project area.

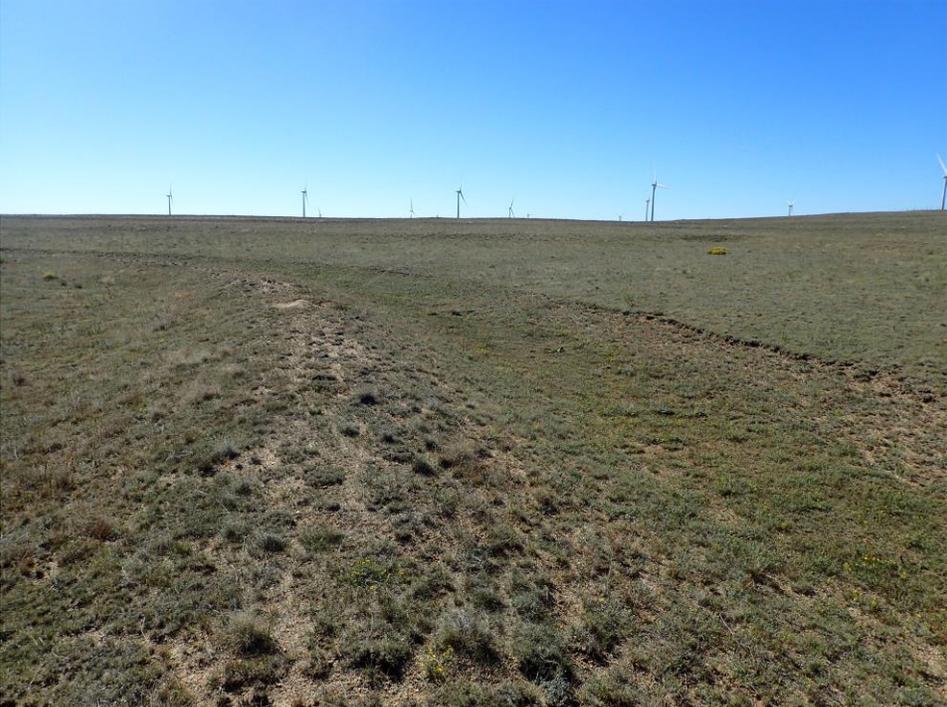
Client Name: NextEra Energy		Project: Grazing Yak Solar Facility and Collection Line	Project No.: 60586433
Photo No.: P9120002	Date: 09/10/18

Site Number: 5EP.8362			
Description: View of contour furrow and earthen berm water spreader erosion control feature built by the CCC in 1938 along an unnamed tributary of Horse Creek. Looking east.

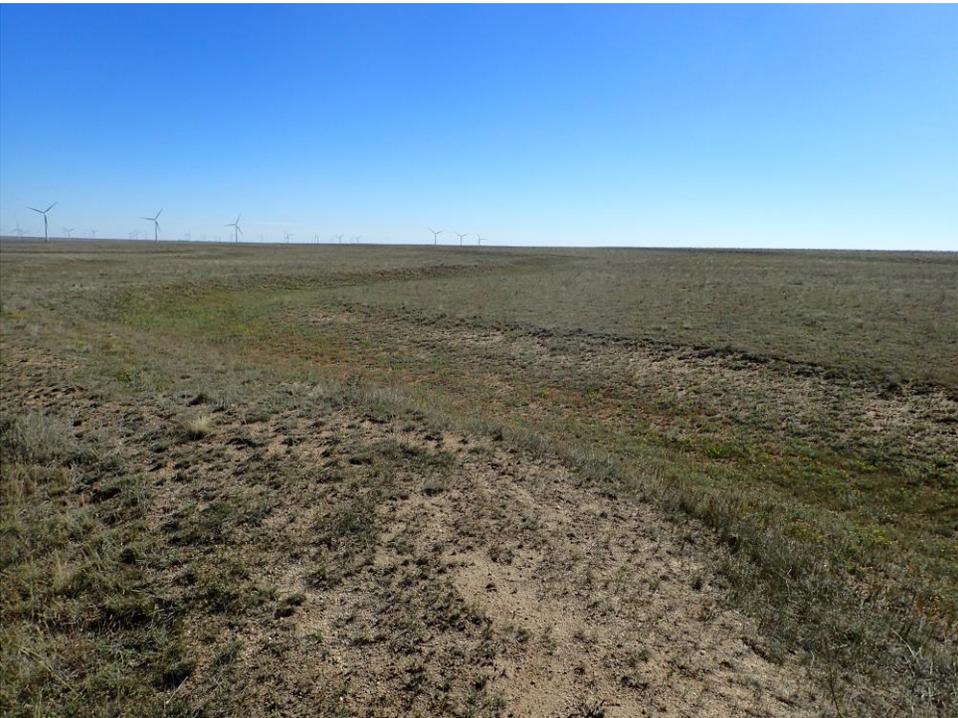
Client Name: NextEra Energy		Project: Grazing Yak Solar Facility and Collection Line	Project No.: 60586433
Photo No.: P9120003	Date: 09/10/18

Site Number: 5EP.8362			
Description: View of contour furrow and earthen berm water spreader erosion control feature. Looking east.

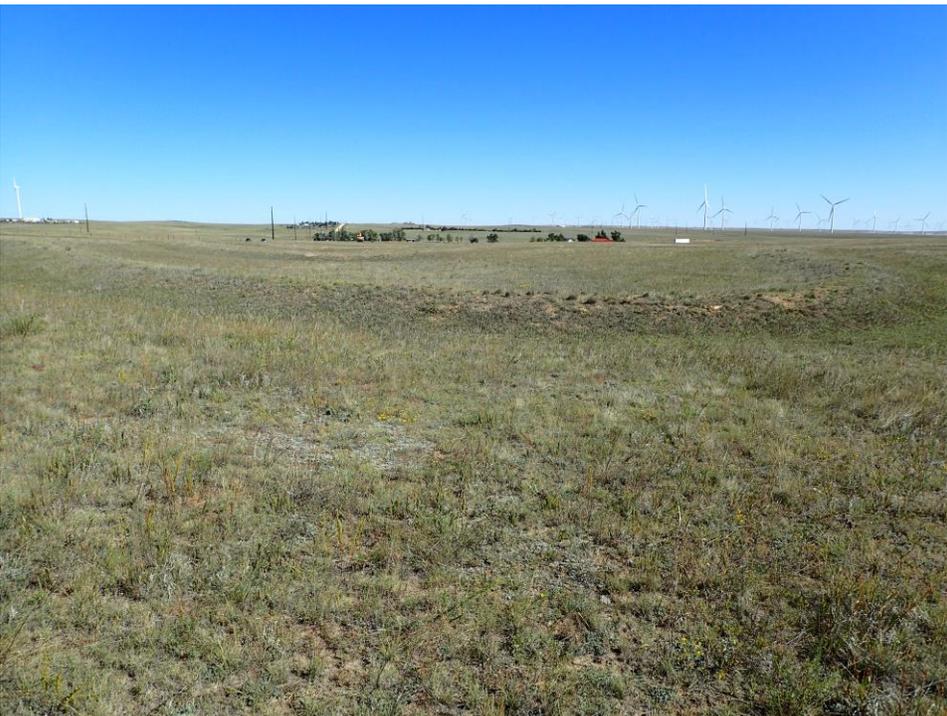
Client Name: NextEra Energy		Project: Grazing Yak Solar Facility and Collection Line	Project No.: 60586433
Photo No.: P9120005	Date: 09/10/18

Site Number: 5EP.8362			
Description: View of contour furrow and earthen berm water spreader erosion control feature. Historic Jacob (John) Strum farmstead at far right. Looking north.

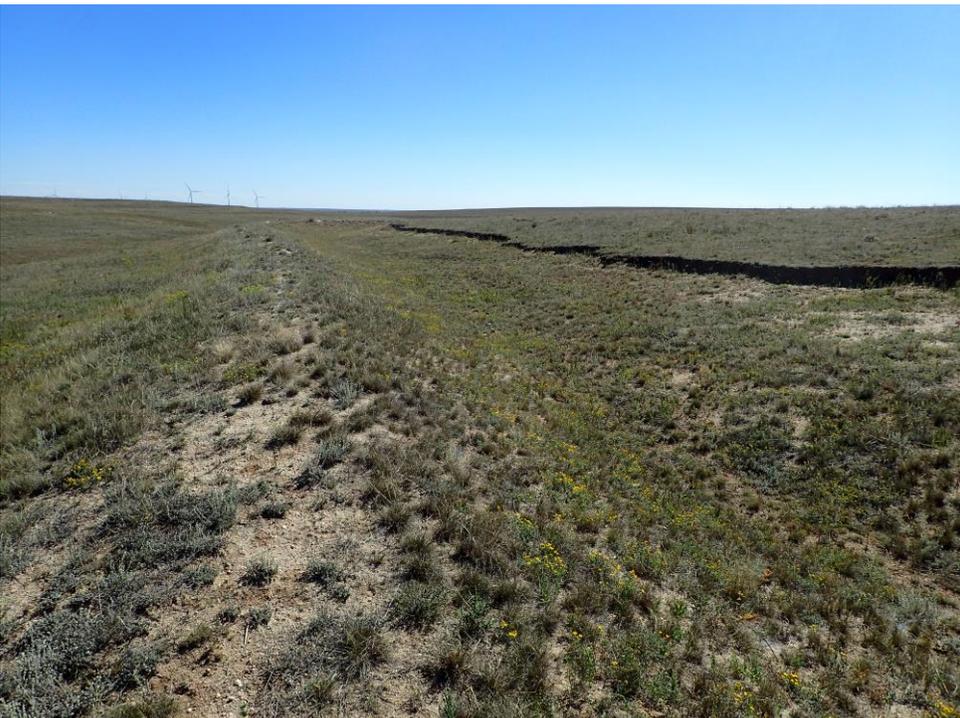
Client Name: NextEra Energy		Project: Grazing Yak Solar Facility and Collection Line	Project No.: 60586433
Photo No.: P9120006	Date: 09/10/18

Site Number: 5EP.8362			
Description: View of contour furrow and earthen berm water spreader erosion control feature. Looking east.

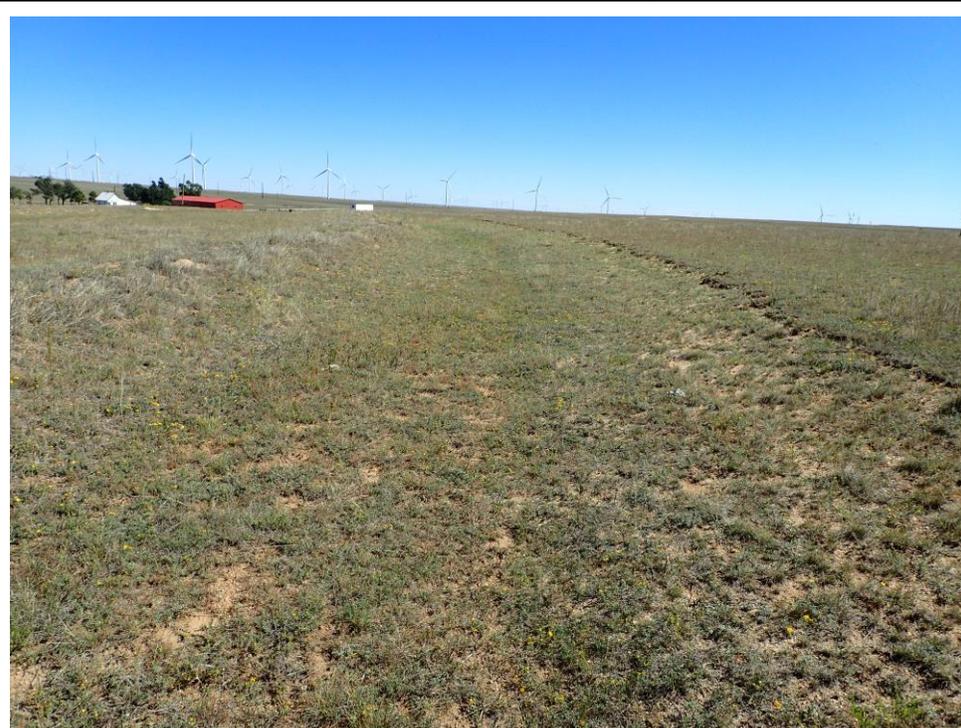
Photo No.:
P9120019

Description:
View of contour furrow and earthen berm water spreader erosion control feature. Historic Jacob (John) Strum farmstead at far right. Looking northeast.

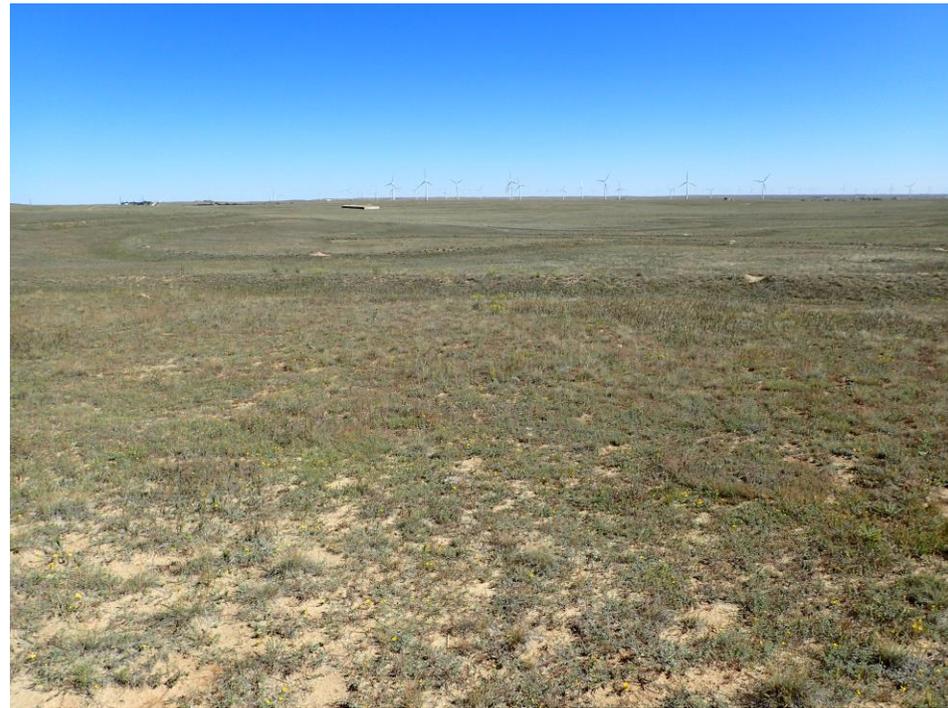
Photo No.:
P9120010

Description:
View of contour furrow and earthen berm water spreader erosion control feature. Note semi-circle furrow at center. Looking north-northeast.

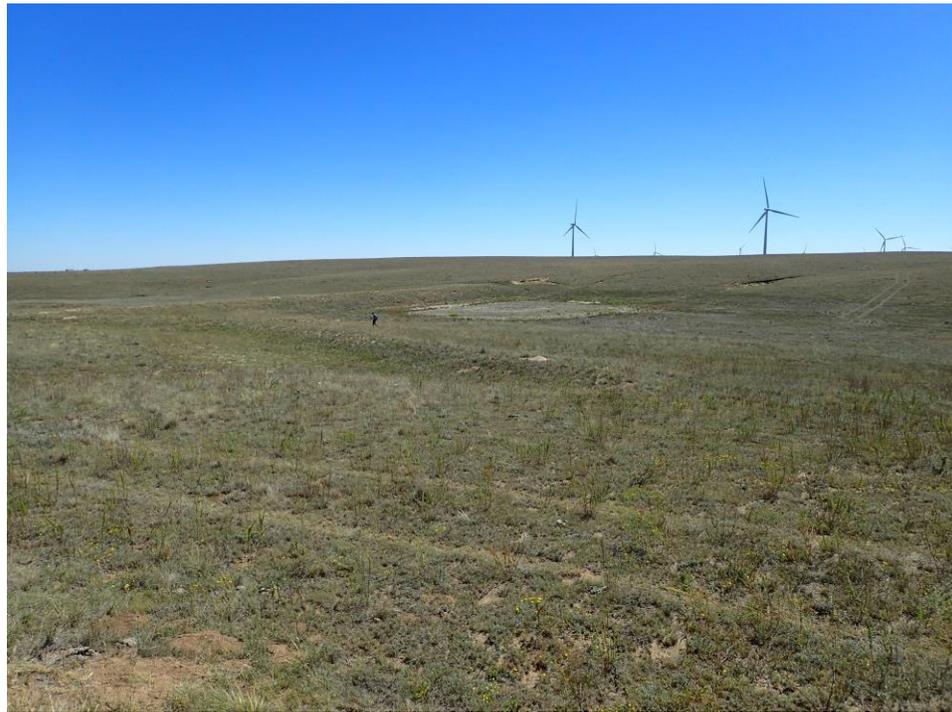
Description:
View of earthen berm dam with stock tank (excavated depression). Contour furrow and earth berm water spreader in foreground. Looking east-southeast.

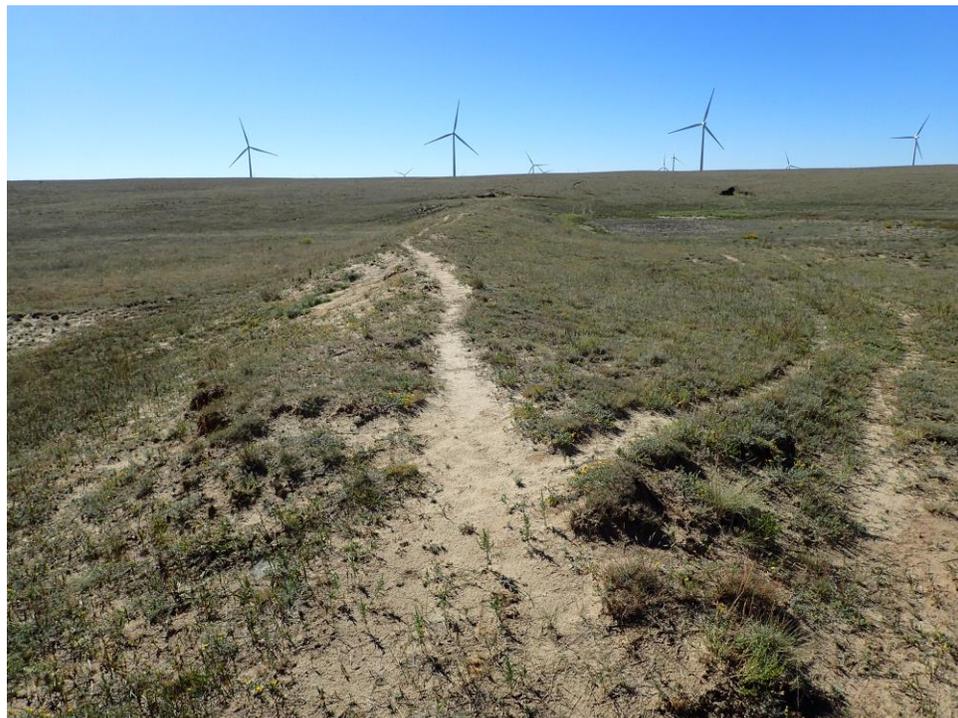
Description:
View of earthen berm dam with stock tank (excavated depression) at right. Looking southeast.

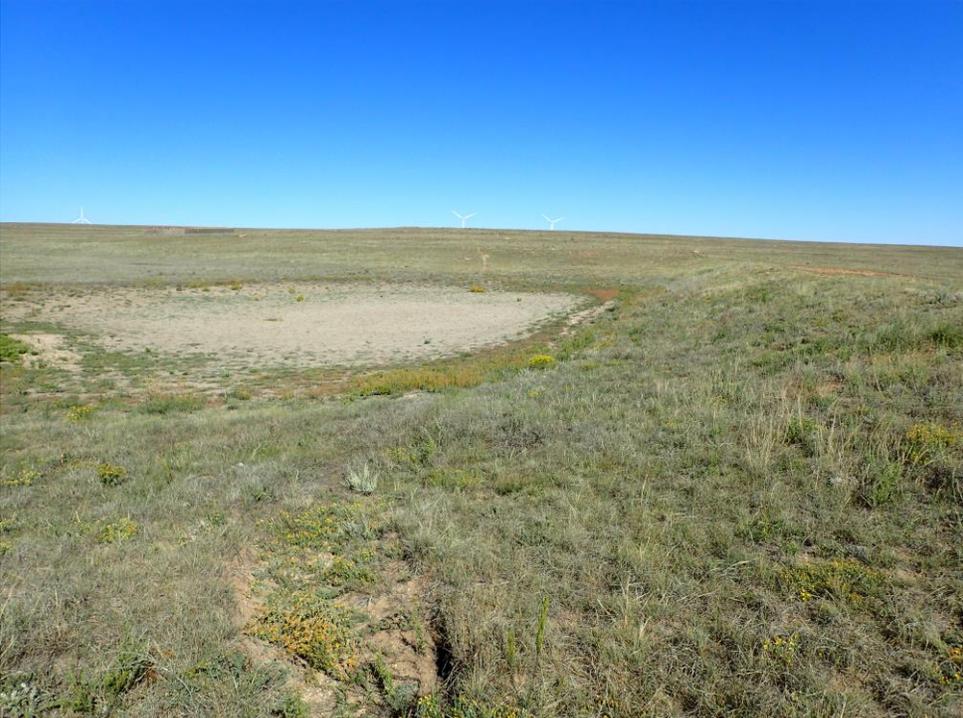
Client Name: NextEra Energy		Project: Grazing Yak Solar Facility and Collection Line	Project No.: 60586433
Photo No.: P9120056	Date: 09/10/18

Site Number: 5EP.8362			
Description: View of earthen berm dam with stock tank (excavated depression) at left. Looking north-northeast.

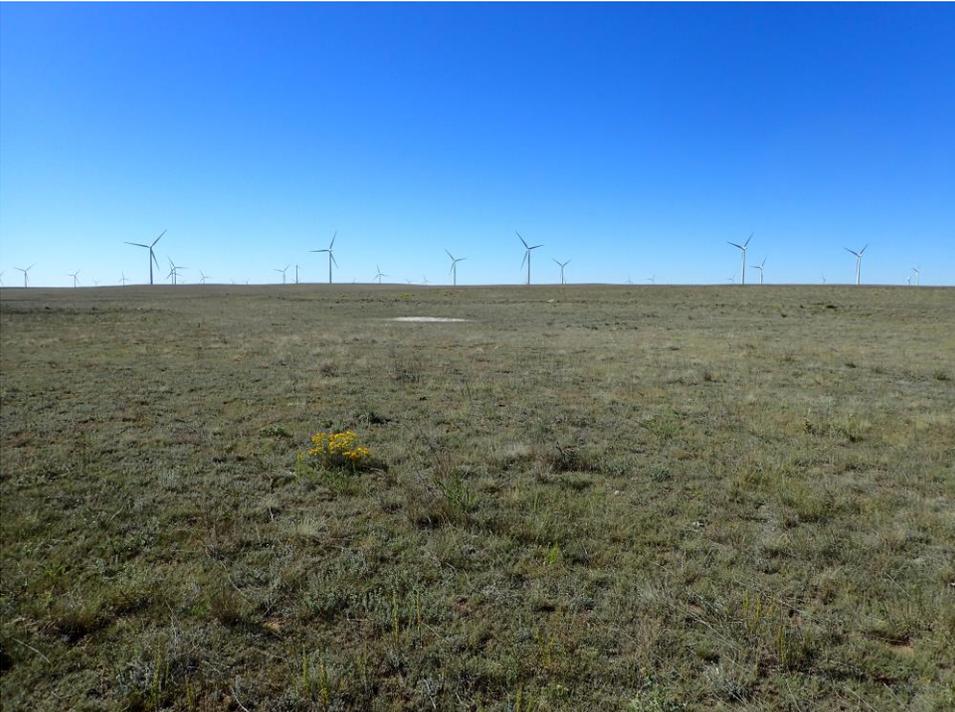
Client Name: NextEra Energy		Project: Grazing Yak Solar Facility and Collection Line	Project No.: 60586433
Photo No.: P9120040	Date: 09/10/18

Site Number: 5EP.8362			
Description: View of one of two settling ponds located within the maze of contour furrows and berms. White color is precipitated sodium chloride. Looking south.

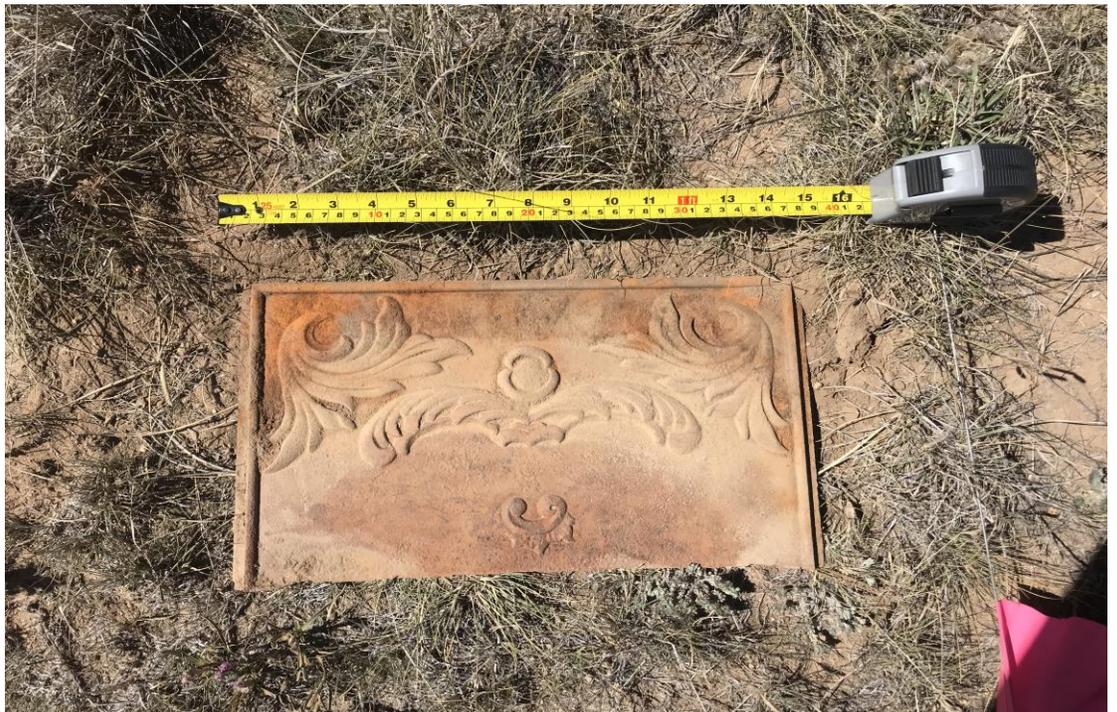
Description:
Close-up view of cast iron stove door/panel fragment. Looking down.
