## Final Acceptance (FA) – Punchlist from EPC Stormwater

Project Name:	Flying Horse North
PCD Filing Number:	SF-18-001
ESQCP #:	ESQ17-011
Attendees:	DPW: Molly Galloway Layshock, Natasha Grimaldo, Ben Jones PCD: Brad Walters, David Parkerson Developer: Austin Lenz
Date of Walk-Thru:	10/25/2022
Walk-Thru #:	FA walk #1

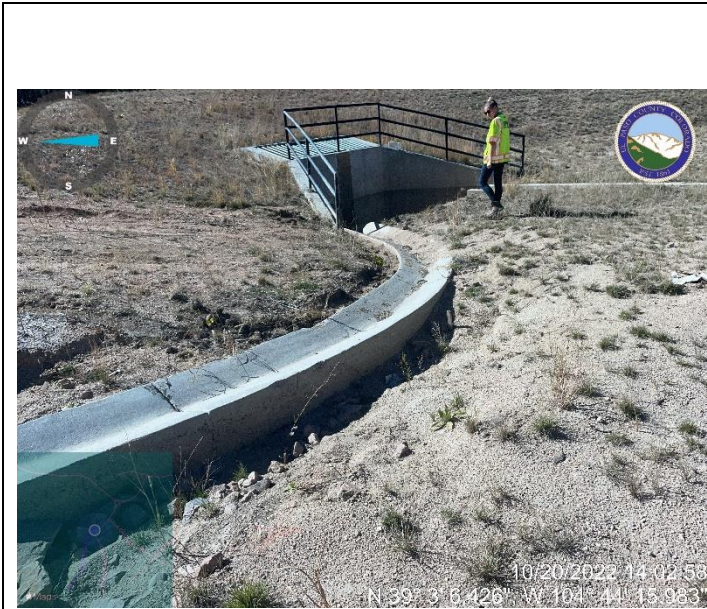
Photo 1: Raise pond bottom to meet top of trickle channel at Detention Facility 4

- Remove temporary control measures from pond embankment
- Remove weeds from pond embankments, pond bottom, and all riprap pads
- Raise pond bottom to top of trickle channel curb with a 3% slope towards trickle channel for positive drainage
- Extend the riprap around the southern trickle channel to match the detail on Sheet 14

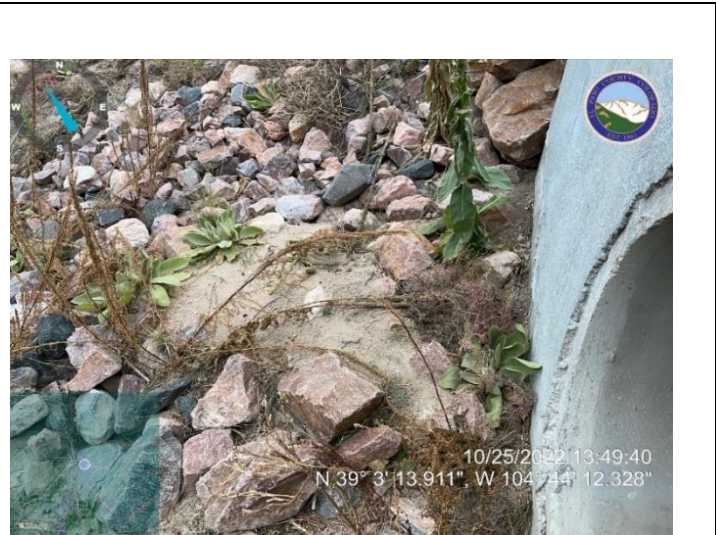
Photo 2: Remove sediment from riprap pad, southwest of culvert at STA. 46+70.97.

- Confirm soil riprap on southern side of triple barrel culvert
- Remove sediment from riprap pad at STA. 46+70.97 (Photo 2)

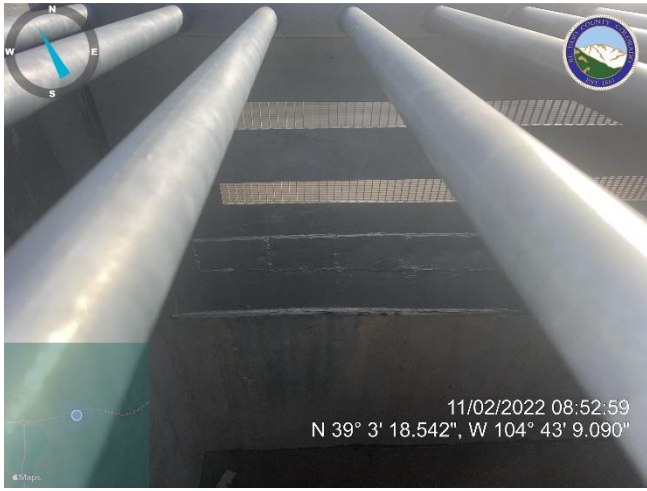
- Only 2 openings; bottom opening welded shut (Photo 3)

**Photo 3: Irrigation Reservoir Embankment  
(JD Pond 13) 8'x4' SWQ Outlet Box with flow control  
plate welded shut.**
