# El Paso County Planning and Community Development Department for a Special Use Permit for the additional principal use of a Recreation Camp (file #AL269)

Prepared by Stephen J. Spaulding, Consulting Forester, July 31, 2026

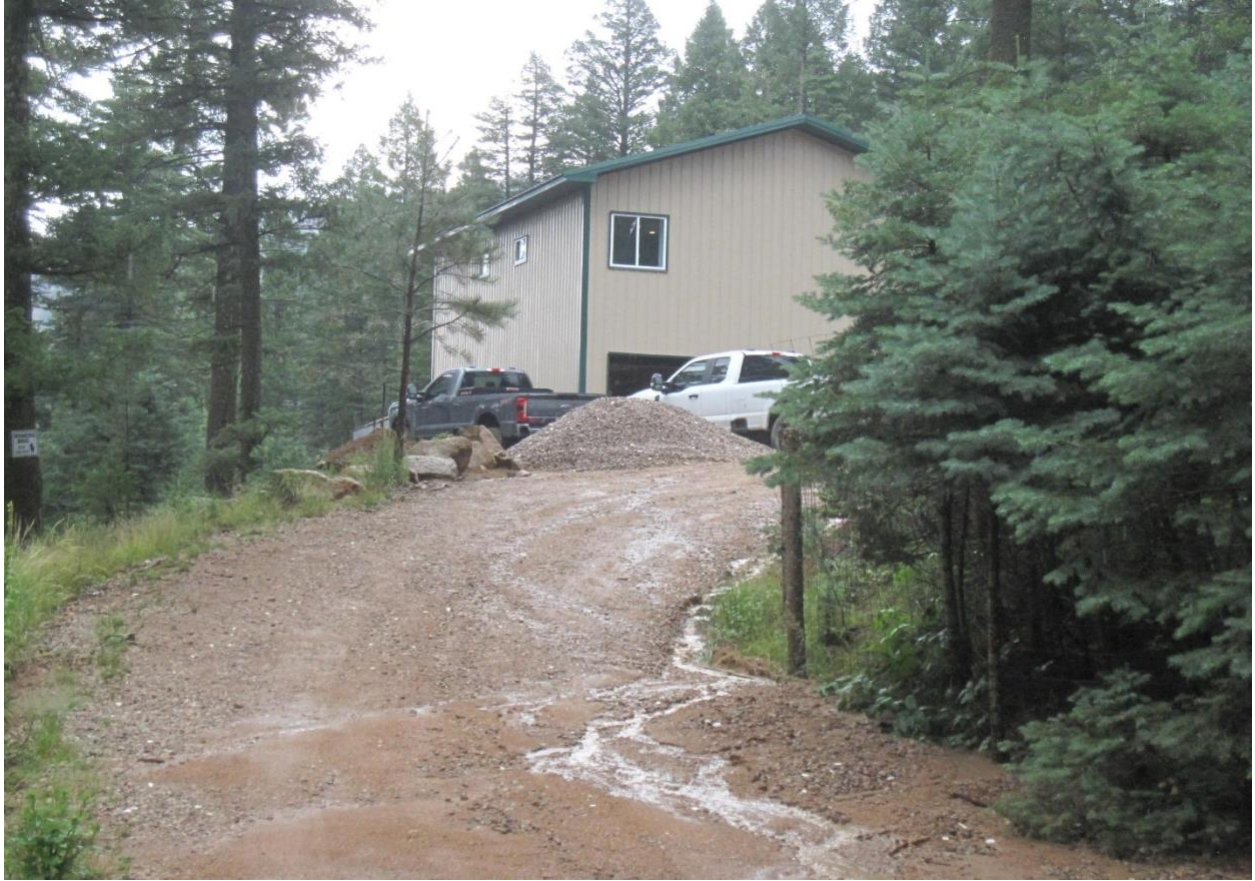
The largest structure currently found on the property is a garage measuring 30.3 feet by 40.3 feet and is approximately 25.5 feet in height. The garage is constructed with a non-flammable metal roof and siding.

***Photo 1. View of Garage structure from the lower end of the driveway. The west and south exterior walls can be reached well within the 150-foot requirement (6.3.4 B. General, 3 Access to Structures. ii.).***

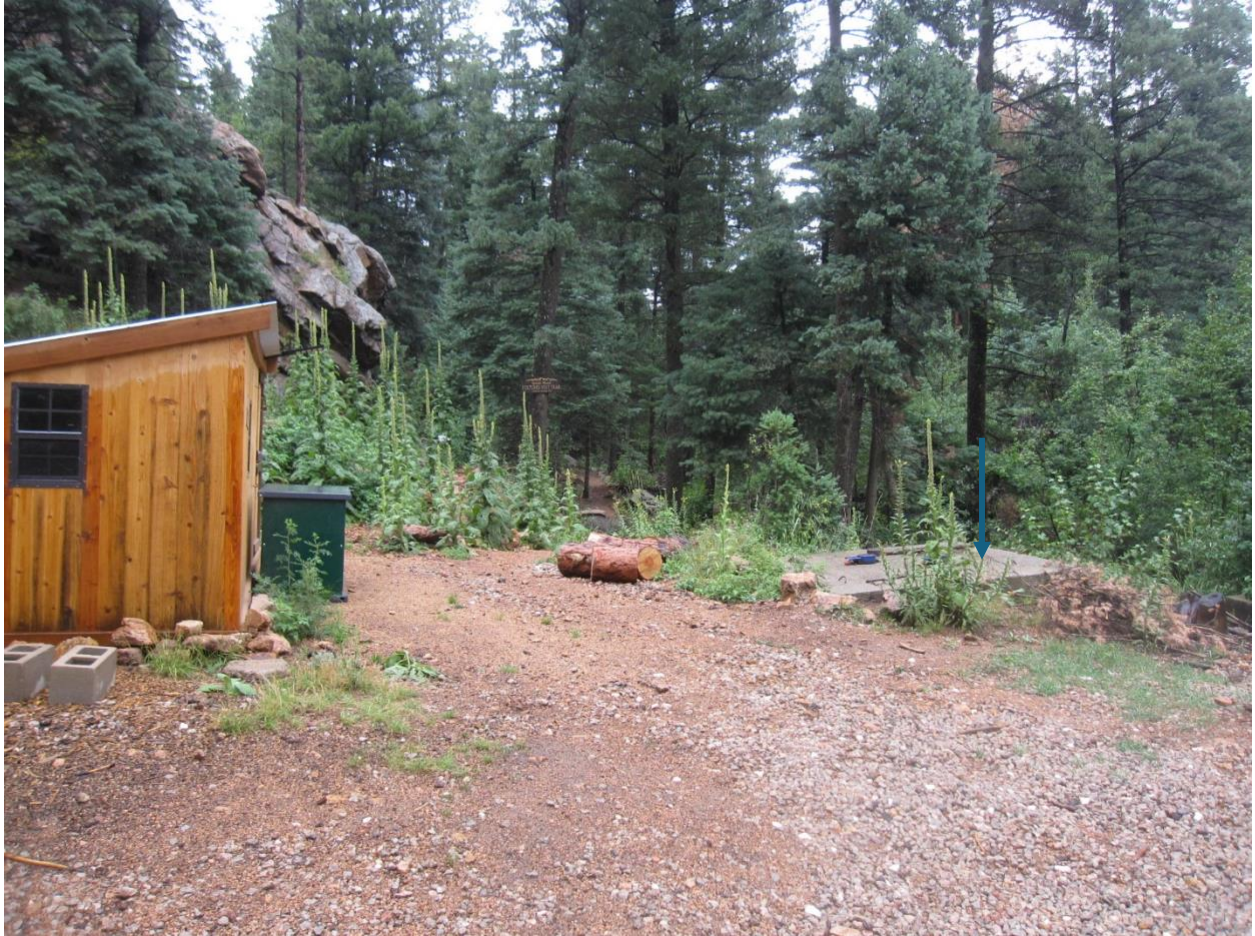
A second minor structure is in the parking area on the west side of Old Stage Road (see Photo 3). This structure is located near the cistern. It has a corrugated steel roof covering and wood siding. It is 6.75 feet wide and 14.75 feet long. It appears the current use is for miscellaneous storage.

**Photo 3. Side of the storage shed. The blue arrow indicates the location of the water cistern.**

There is a cistern of unknown capacity and flow rate. The concrete lid is 7x7 feet in size. The cistern would only need to be just over 8 feet in depth to contain a 3,000-gallon capacity. A visual inspection would suggest that the cistern could supply sufficient water to meet the code requirement. Colorado Spring Utilities has a lease that encompasses the location of the cistern. Discussions are being conducted to see if this is a feasible solution.

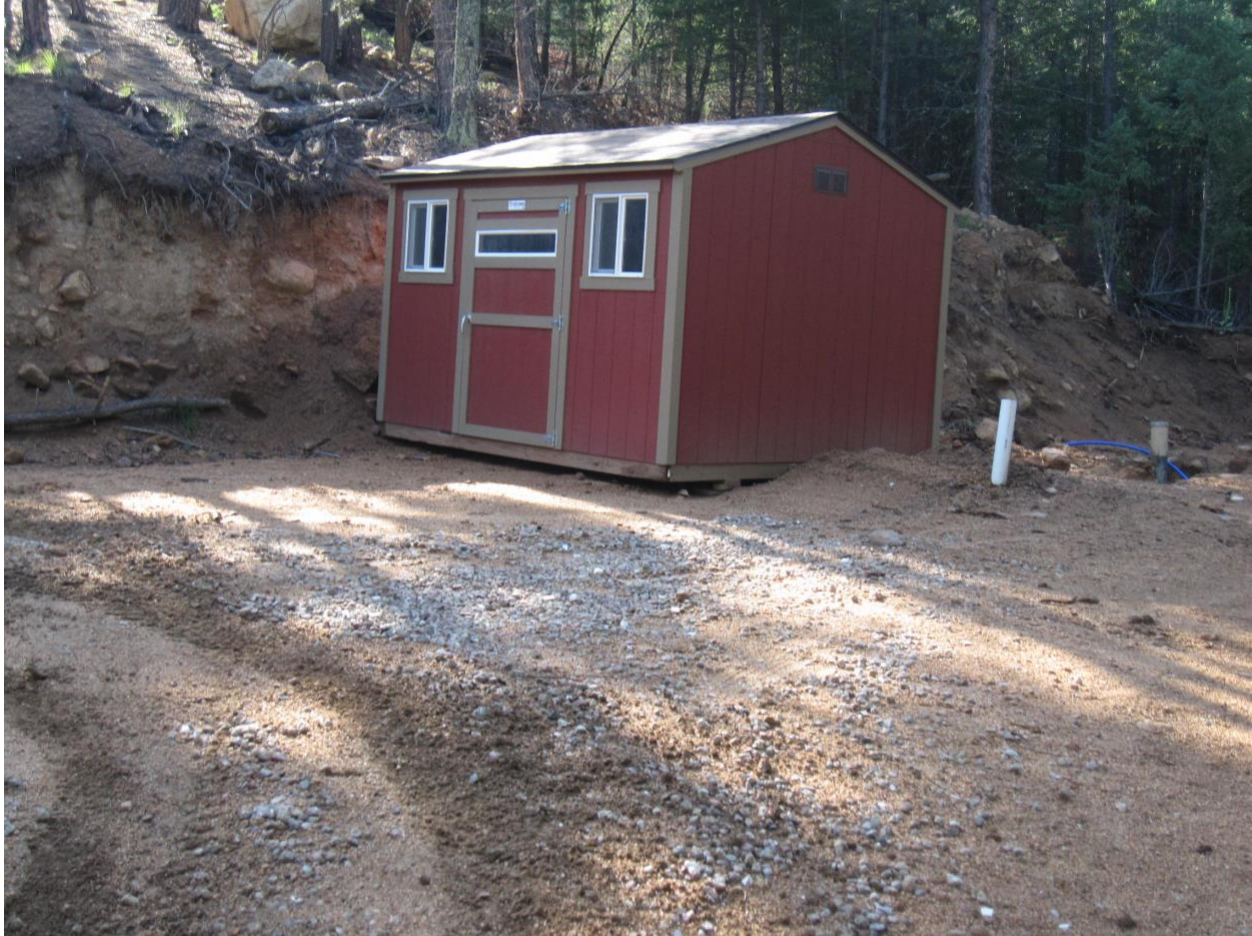
A third and minor structure as well is located uphill and south of the garage (see Photo 4). It is a 10x12 foot Tough Shed. At present it has no stated use but is assumed to be for future storage.

**Photo 4. A view of the Tough Shed. Note the positioning on and around the non-flammable soil surface.**

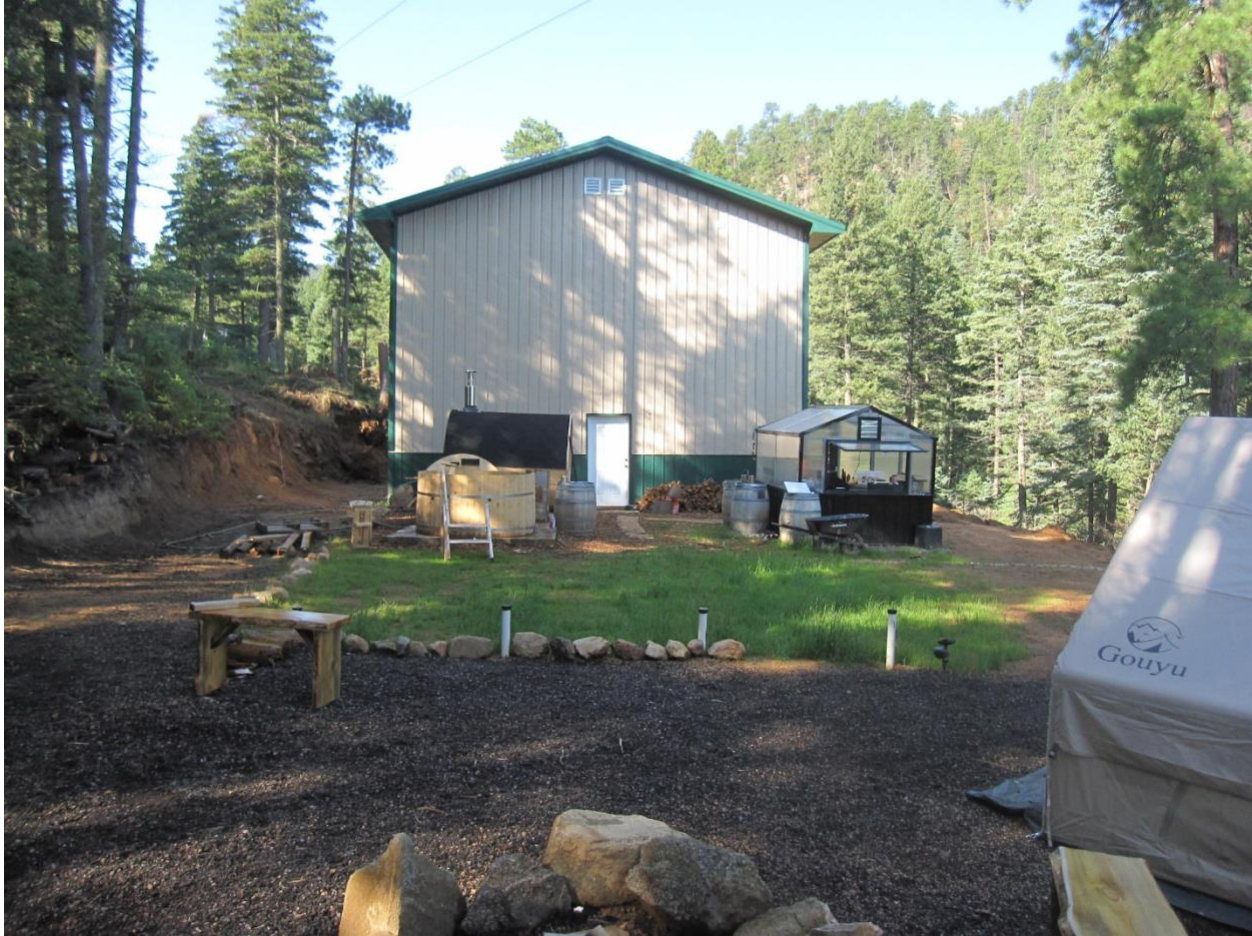
The vegetation immediately surrounding the garage structure has been modified initially from construction of the building pad. Additional modification has occurred to allow for access around the structure and an outdoor living space (see Photo 5).

**Photo 5.** *The view from the east edge of the living space back towards the garage. The distance is approximately 75 feet. This would represent Zone 1 (5-30 feet) & 2 (30-100 feet) as it relates to Defensible Space*

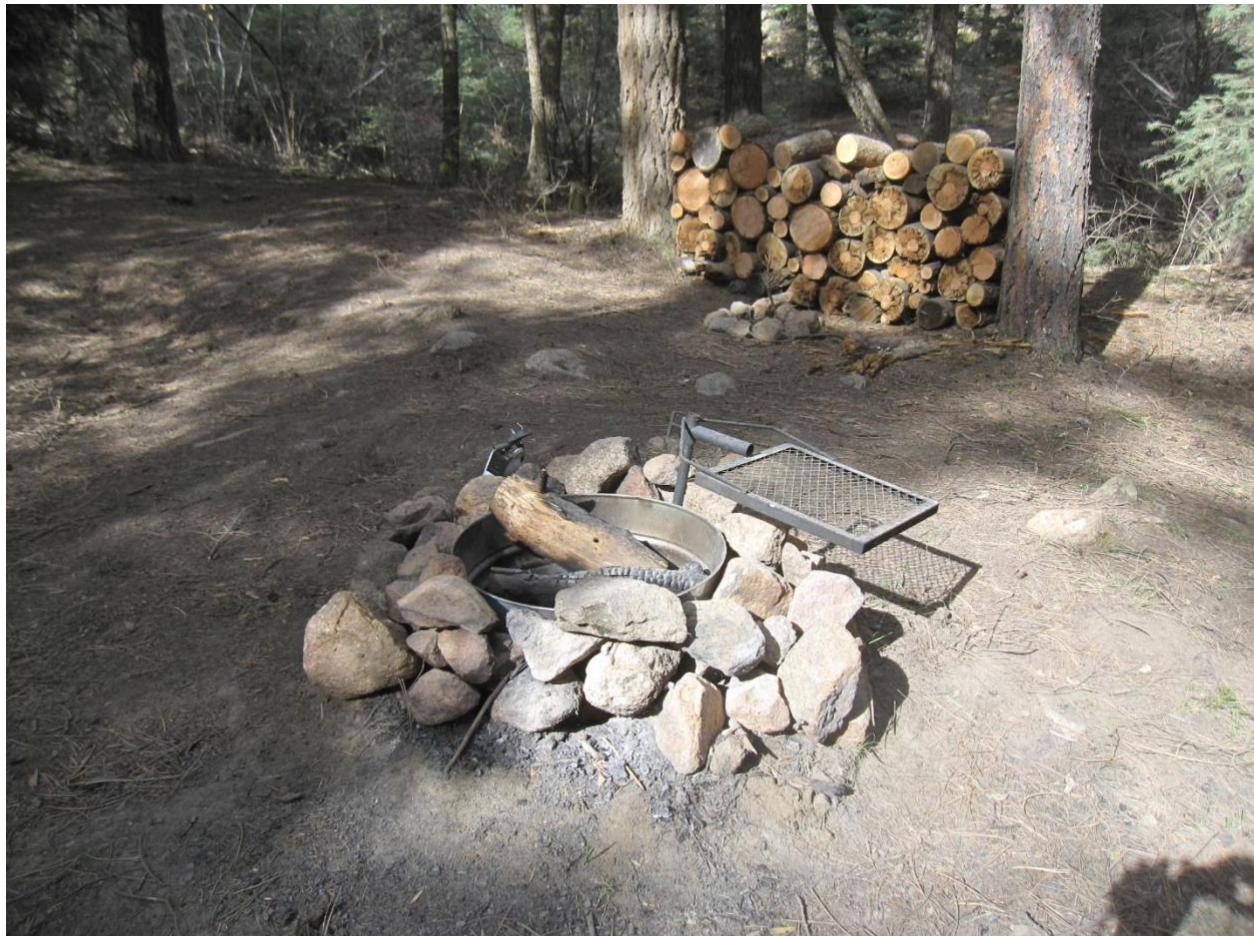
The campsites, there are sixteen noted on the site development plan, have a steel ring installed as a campfire pit (see Photo 6) . This step reduces the risk of a smoldering fire escaping. In addition, a fire extinguisher and pointed shovel are supplied at each occupied site.

As each campsite is used, the amount of fine fuels readily available to burn next to the fire pit are compacted into the soil. This result leaves a surface fuel that will not readily burn.

**Photo 6. An example of a steel ring used in a fire pit. Note the relative absence of fine fuels around the fire pit. Firewood is stacked over ten feet away.**

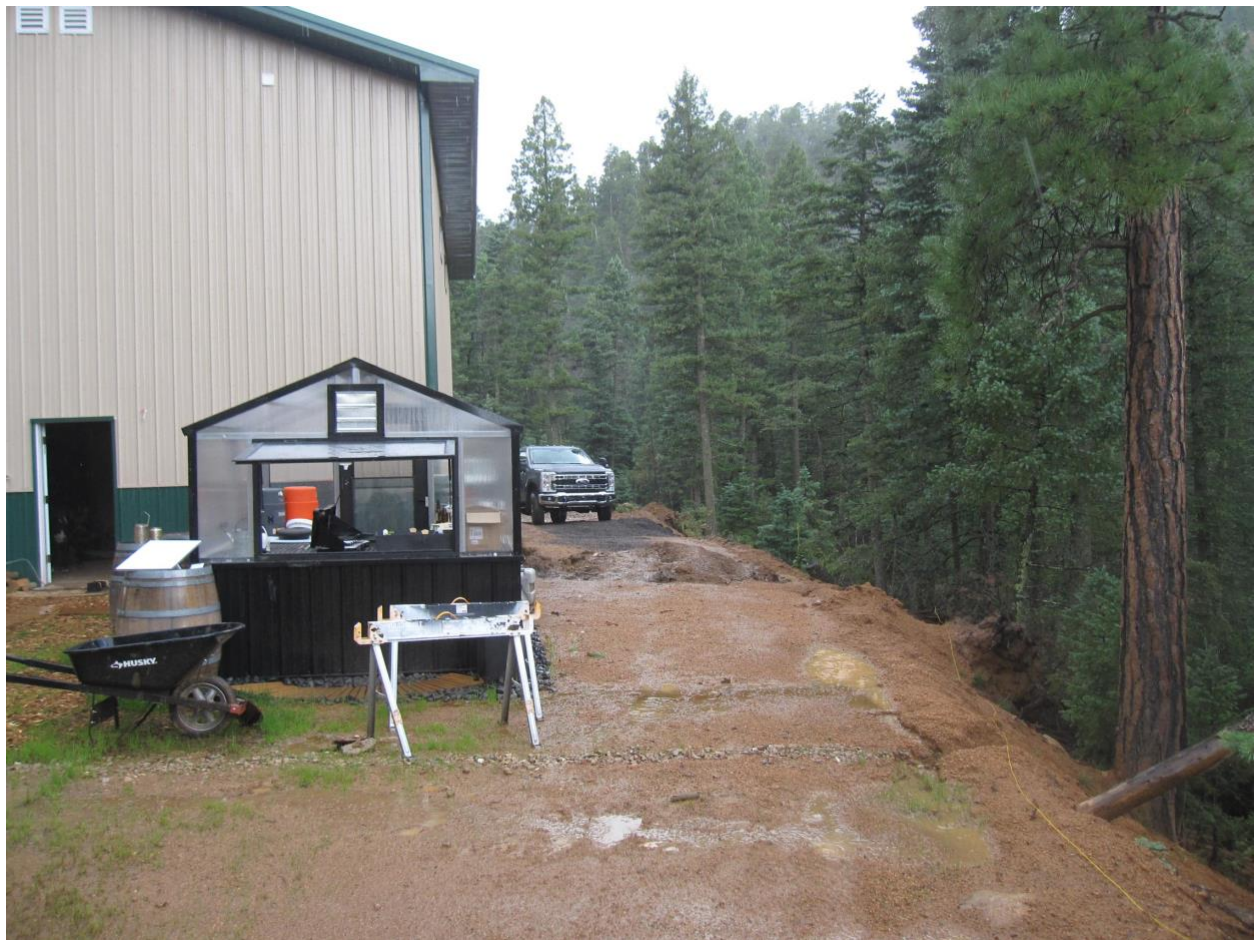
The south side of the garage structure has had complete vegetation removal from 11 to 12 feet (see Photo 7). Further mitigation is occurring on the slope above the defensible space.

***Photo 6. View along the south side of the garage structure. The distance to the tree line ranges from 15 – 16 feet.***

Live green trees should not be removed in this location unless necessary for forest health or the risk of falling. The intent is to retain as much screening as possible to keep a level of privacy from traffic on the road.

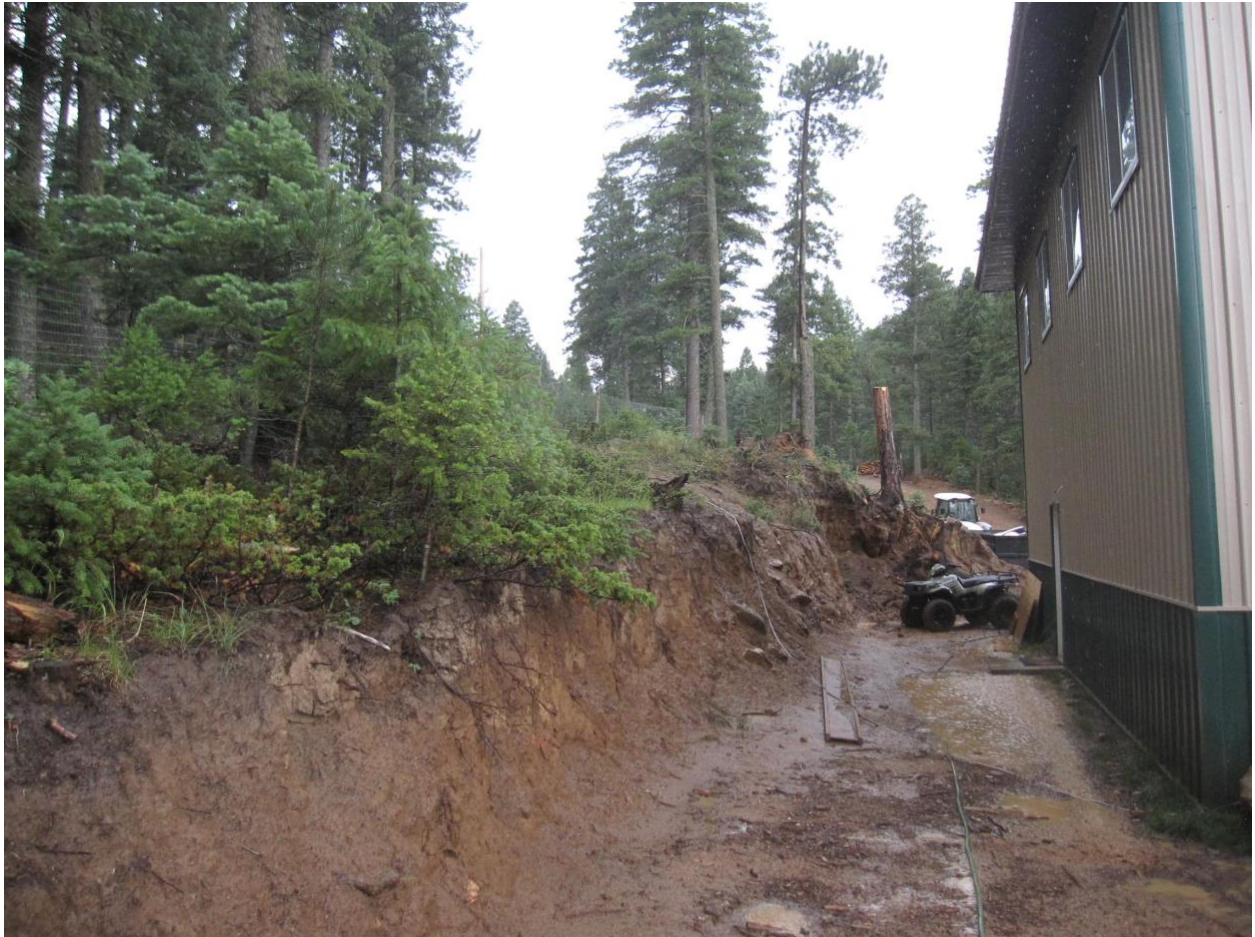
Zone 0 is 0 to 5 feet from the structure to be protected. It is the zone of the heaviest vegetation management, if not complete removal. The north side of the structure has had all vegetation removed for a length of 15 feet (see Photo 6).

***Photo 7. This represents the view from the northeast corner of the garage forward to the northwest corner. Additional trees uphill from the structure are being removed to prevent flames from touching the structure.***

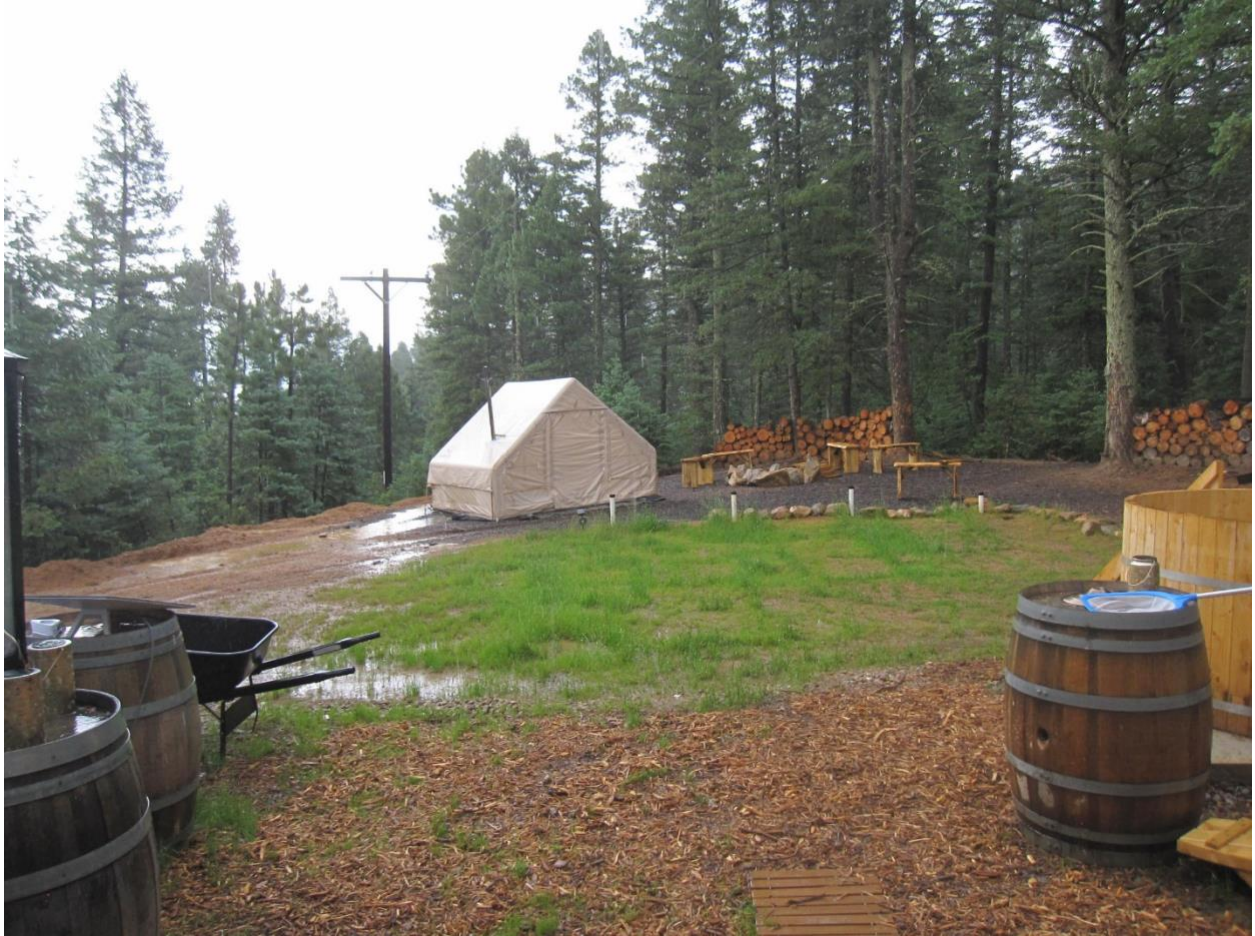
***Photo 8. The View from the back entry of the garage. Note that firewood is not stored in proximity to the structure. This is in accordance with Firewise recommendations.***
