CORE Consultants, Inc. Project Number 15-001

Subject: Individual Permit Application for the Sterling Ranch Residential Development Project

Appendix III:
Sterling Ranch Channel and Improvement and Mitigation Exhibits

Appendix IV:
Sterling Ranch Wetland Impact Location Map

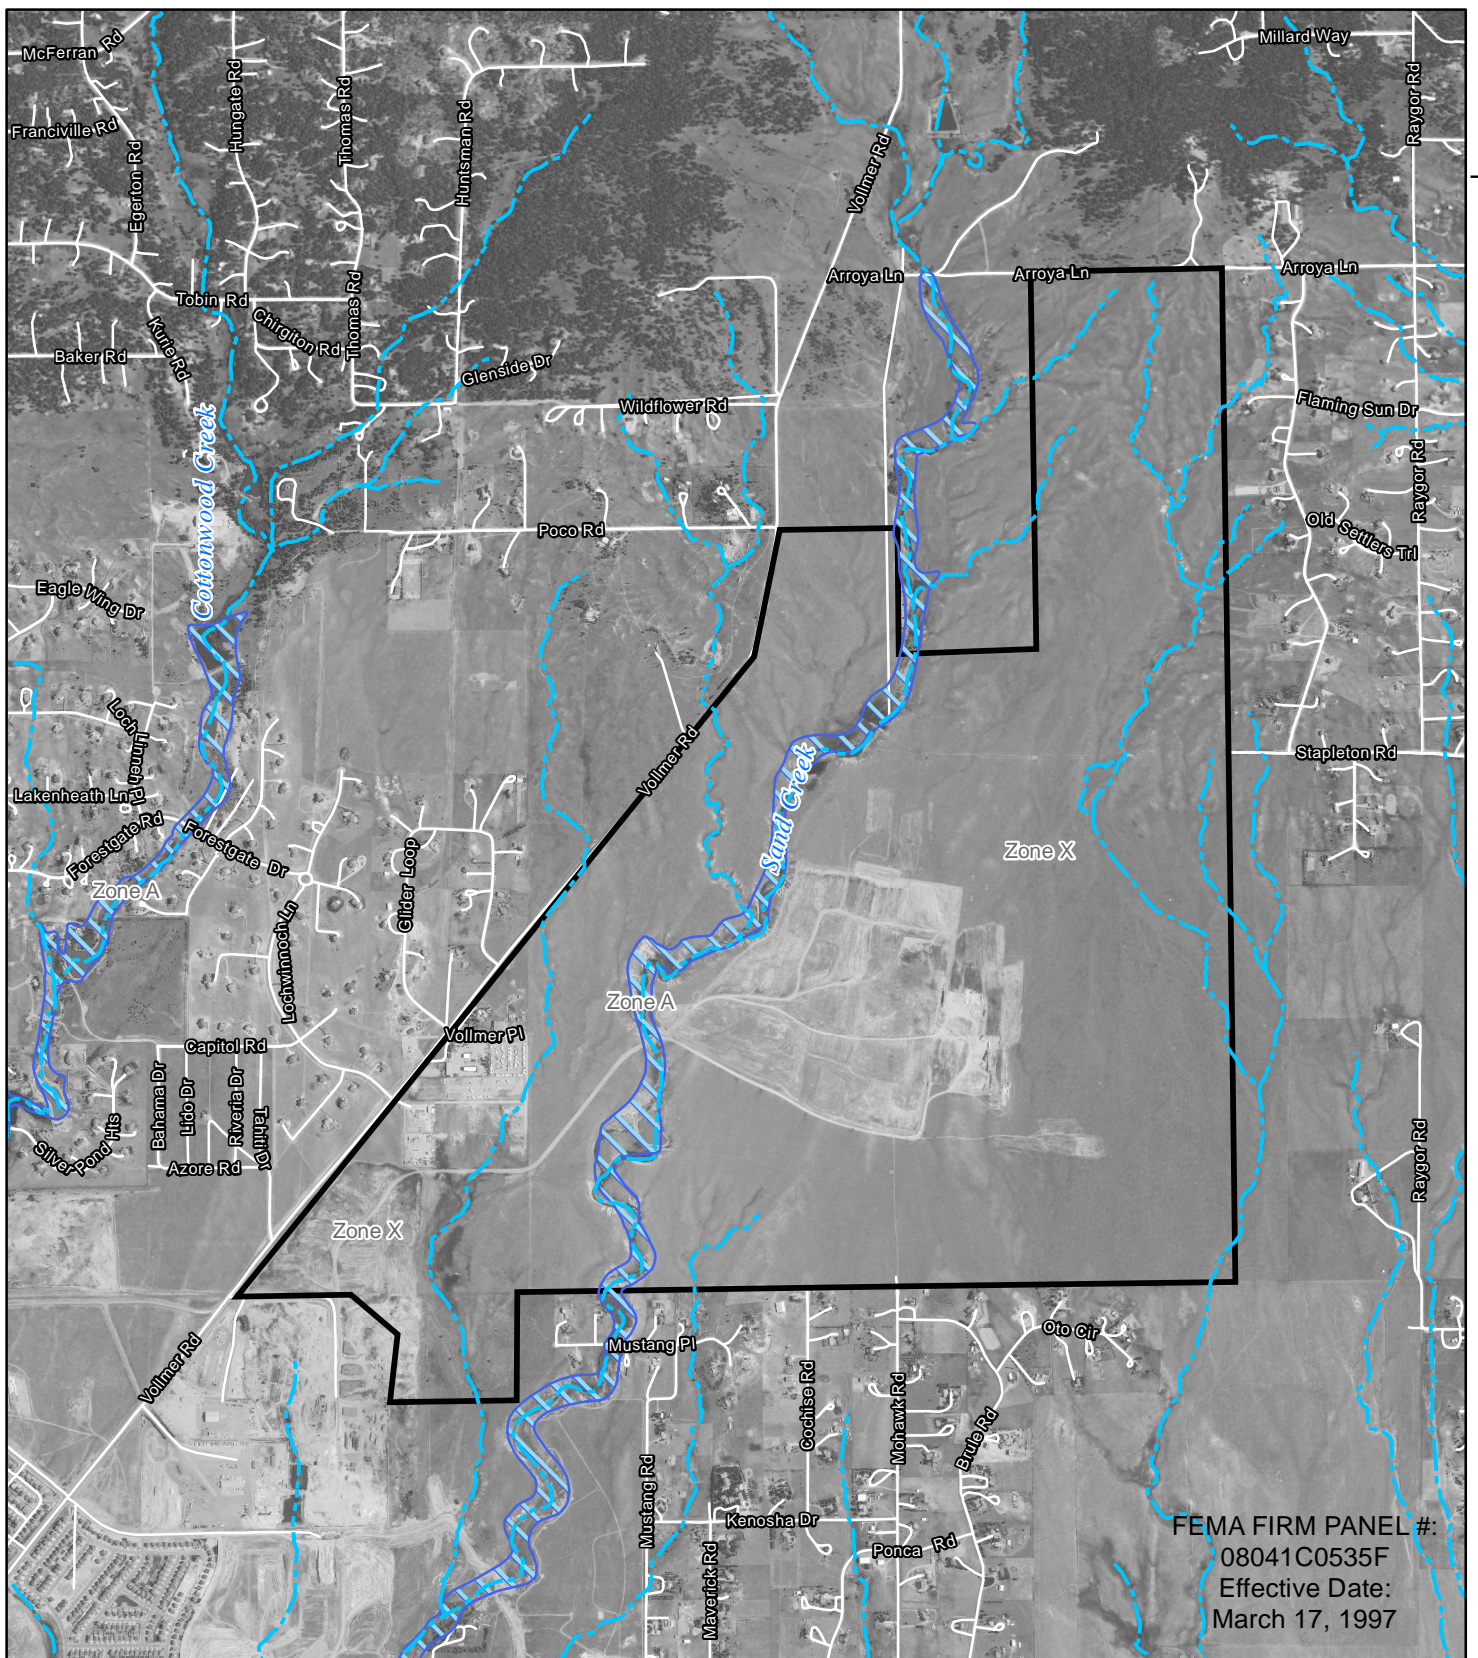
Sterling Ranch **FEMA Flood Insurance Rate Map** El Paso County, Colorado

FEMA FIRM PANEL #:
08041C0535F
Effective Date:
March 17, 1997

FEMA Floodplain maps for El Paso County (FEMA 2005) were reviewed and indicate portions of the Project Area within and adjacent to the main channel of Sand Creek are located within a designated Zone A Special Flood Hazard Area, and are at risk of inundation by a 100-year flood with base flood elevations undetermined. The remainder of the property is identified as Zone X flood zones, which consist of areas of minimal flood risk "outside the 1-percent and 0.2-percent-annual-chance floodplains" (FEMA 2005). The presence of a Zone A floodplain indicates that certain limited floodplain constraints may be anticipated for this project. Coordination with the local floodplain administrator is recommended to assess the extent of potential floodplain constraints and potential permitting requirements. Refer to the *FEMA Flood Insurance Rate Map* in **Appendix I** for additional information regarding floodplains located within the Sterling Ranch property.

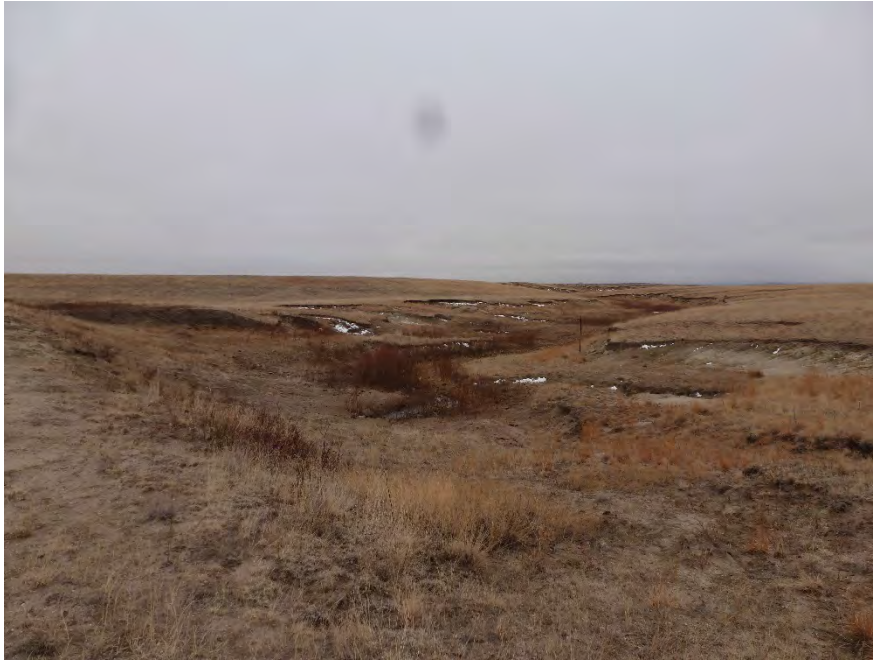
Sampling Point 1 (SP 1) Vicinity – Looking south down Sand Creek from just south of Pond 4. Typical Sand Creek stream channel characteristics and vegetation. 2/5/15

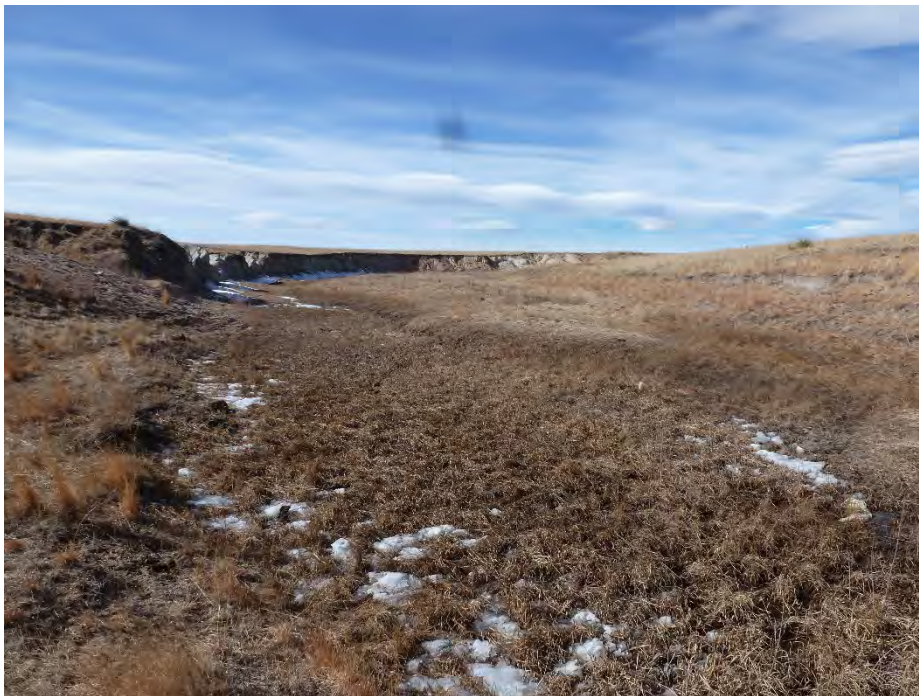
Sampling Point 2 Vicinity – Looking northwest (upstream) from proposed Sterling Ranch Road crossing. Typical Sand Creek stream channel characteristics and vegetation.

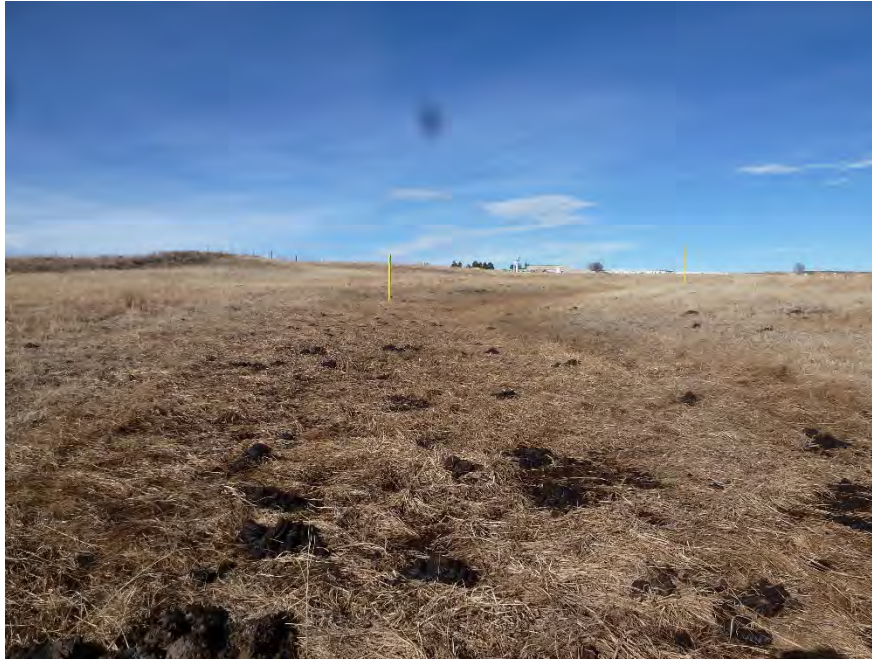
Sampling Point 3 Vicinity– Looking north along western tributary (Wetland 1) from proposed Sterling Ranch Road crossing. Area is typical of the northern half of the western tributary. Photo taken on 2/5/15 when cattle were still on the site.

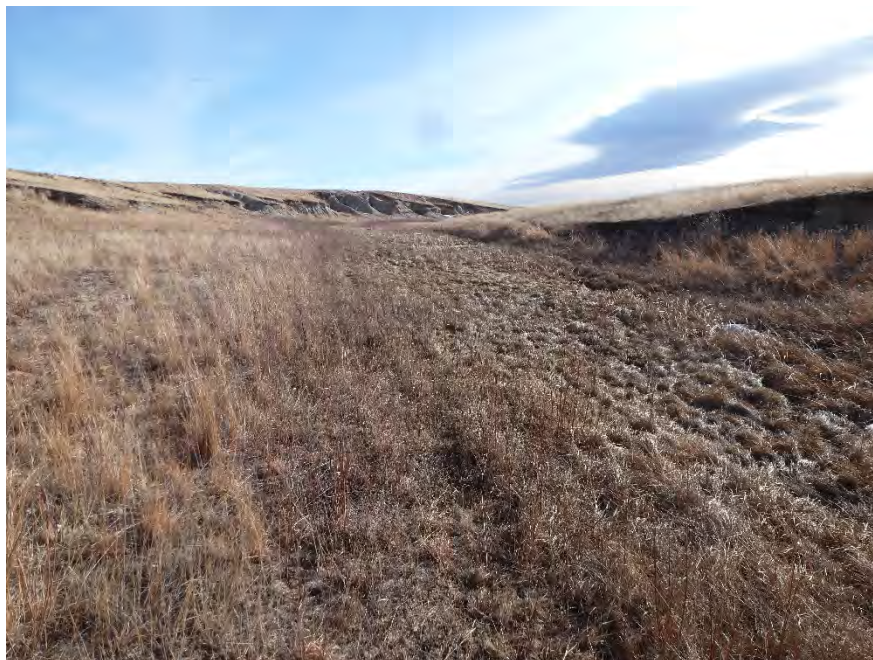
Sampling Point4 Vicinity – Near proposed Briargate Parkway crossing of Wetland 6. Typical Sand Creek stream channel characteristics and vegetation.
2/5/15

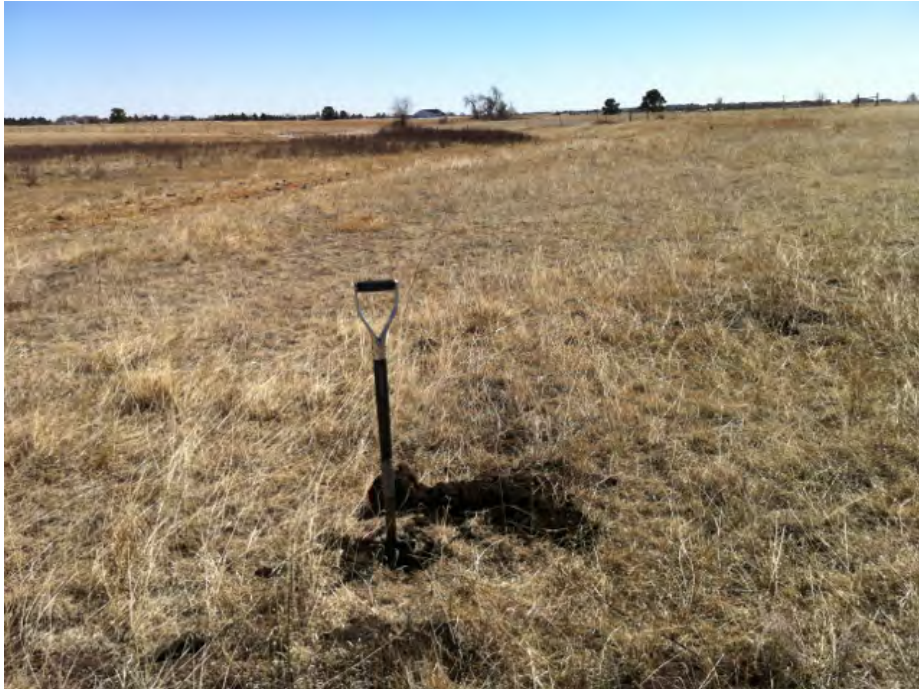
Sampling Point 5 – Upland near Western Tributary, facing southeast towards Western Tributary. 3/10/15

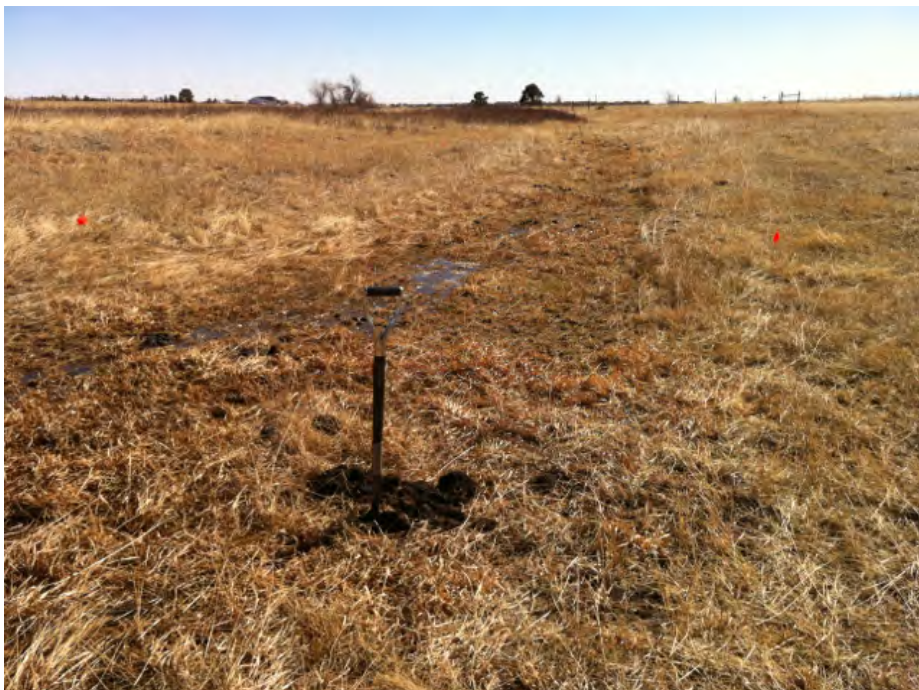
Sampling Point 6 – West side of Western Tributary wetland, looking south along Wetland 1 swale. Photo taken on 3/10/15; cattle had been removed 2-3 weeks earlier.

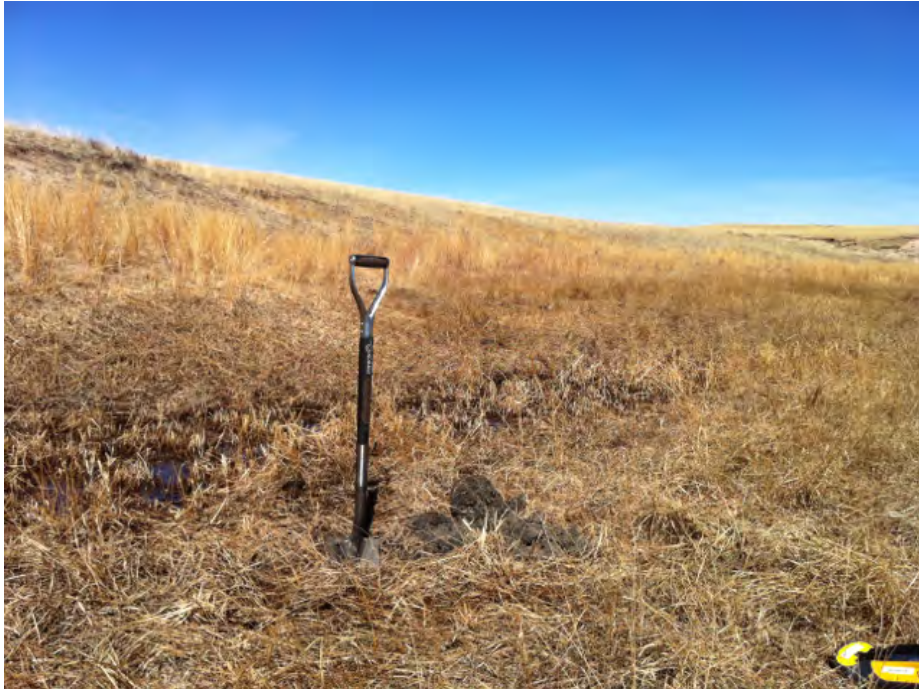
Sampling Point 7 – Wetland vegetation in Sand Creek, facing northwest. Note shallow, standing water on left side of photo. 3/11/15

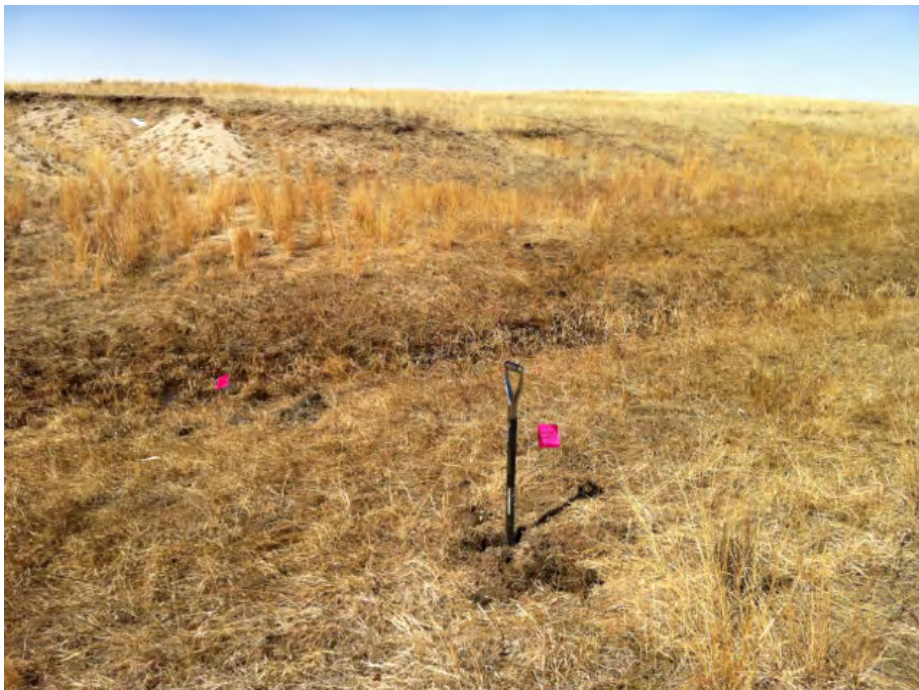
Sampling Point 8 – Wetland on low bench along east side of Sand Creek, facing west towards SP 7. 3/11/15

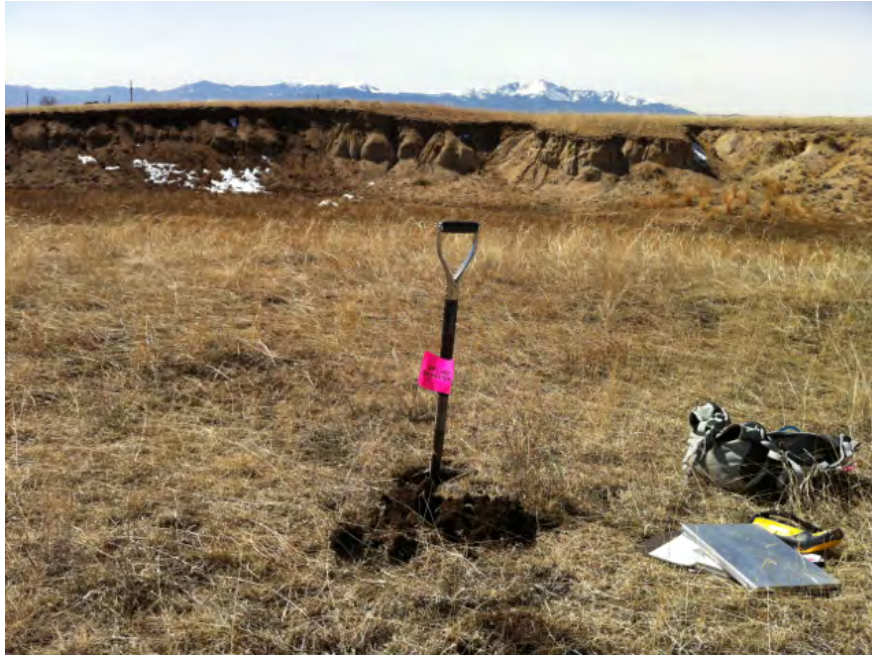
Sampling Point 8 – Upland above Sand Creek, facing west towards SP 7 and 8.
3/11/15

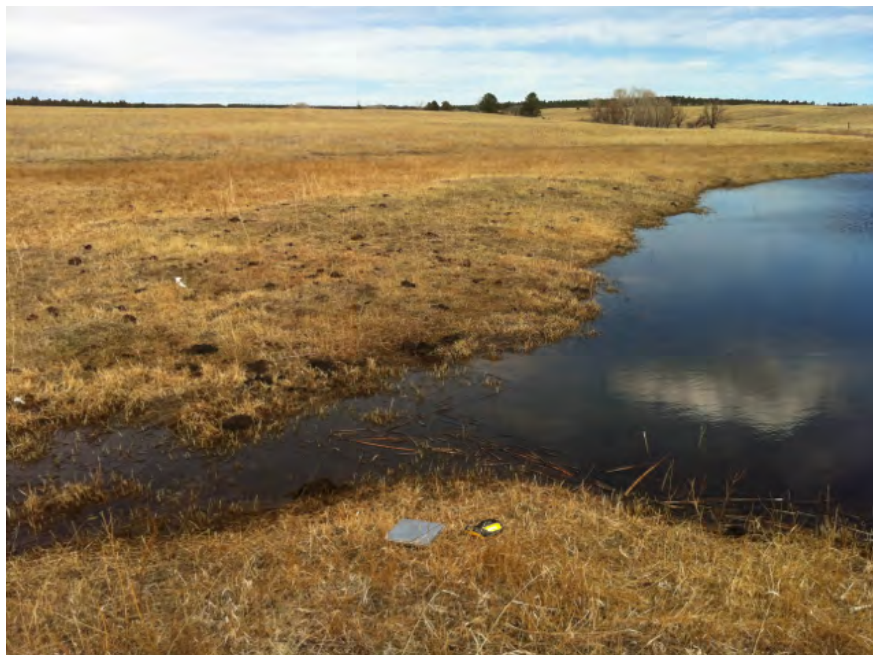
Pond 1 – Looking north from west end of the dam. Water flows out of the pond on this southwest corner and there is also a culvert in the dam center that drains south into the main channel of Sand Creek. The distant cottonwoods are growing along Sand Creek just north of the Project Area. 3/22/15

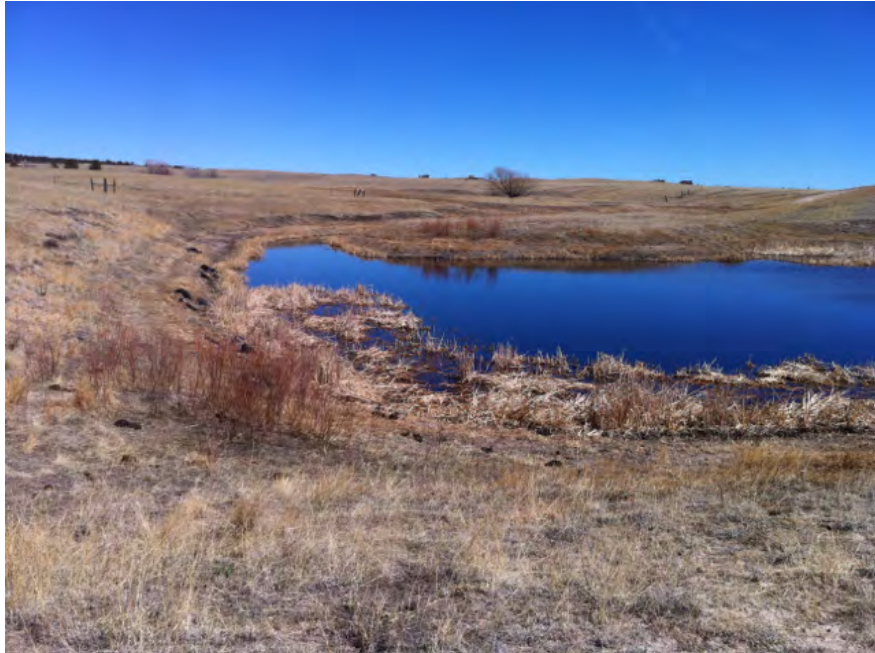
Pond 2 – Looking north from dam. Sand Creek enters the pond on left side of the photo. Pond has well-developed fringe of emergent vegetation. 3/16/15

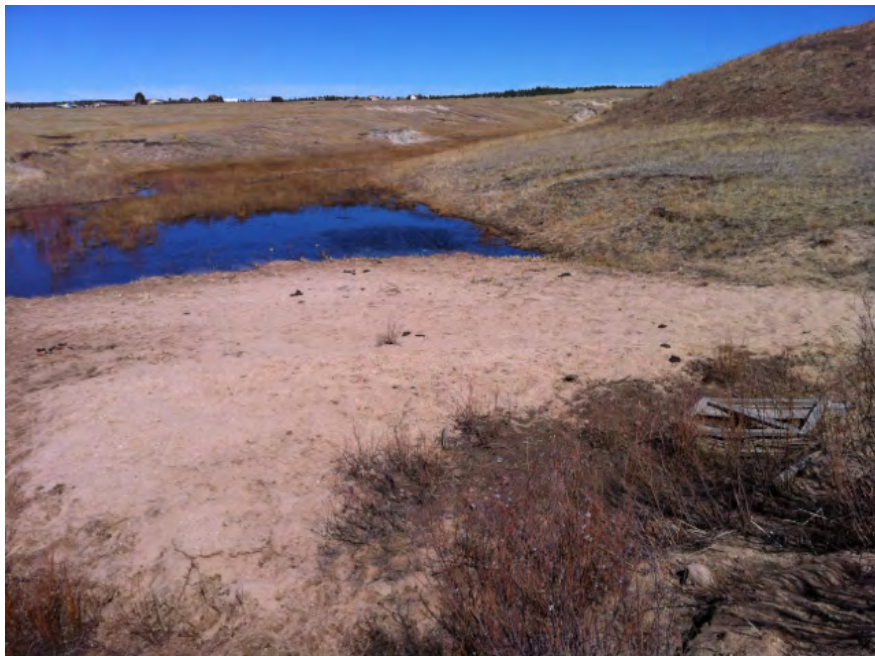
Pond 3 – Looking north from the road, across a shallow ponded area and up Sand Creek (Wetland 7). Water from the adjacent uplands flows into this area via a sandy channel partially visible on the right (east) side of the photo. 3/16/15

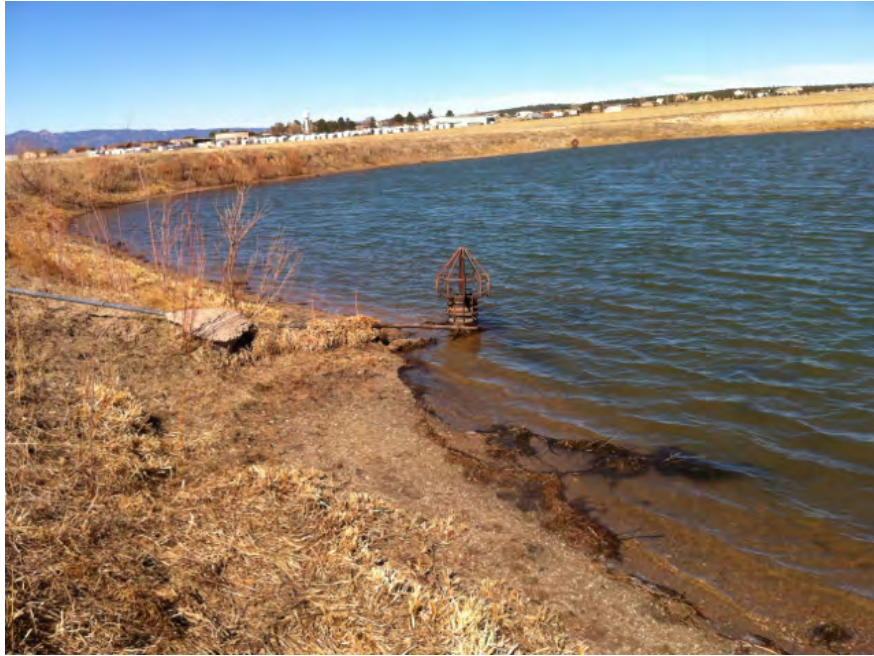
Pond 4 – Looking northwest from dam. This deep pond has a sparse, narrow wetland fringe. The pond drains via the standpipe, to a culvert under the dam, and into Pond 5. Pond 5 is a small open water area (~6' diameter). 3/16/15

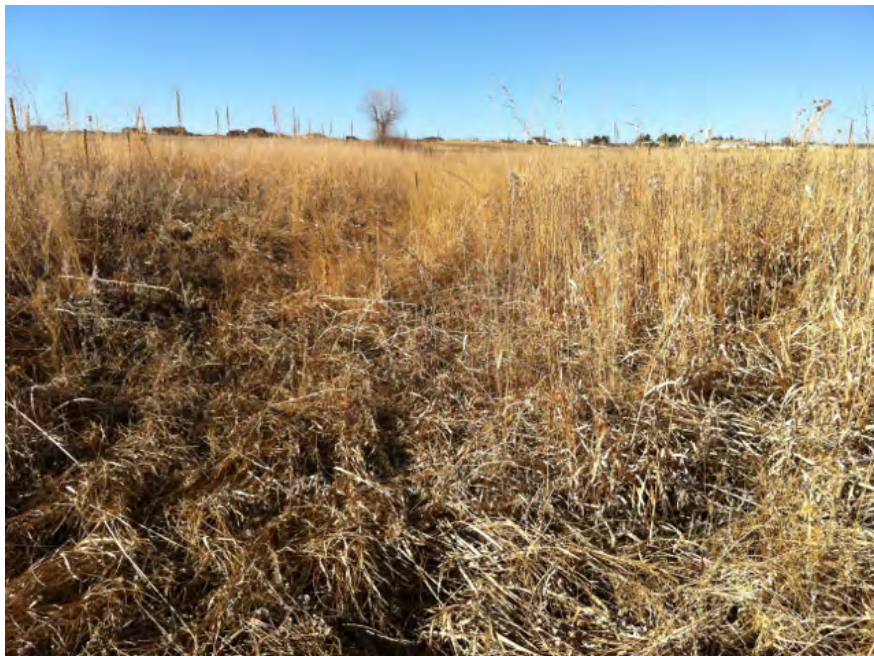
Western Tributary, Wetland 2 – Southern half of the western tributary to Sand Creek, facing north along the poorly defined channel with a narrow band of wetland vegetation. 3/10/15
