WETLAND DELINEATION REPORT

Forest Lakes Residential Development Project El Paso County, Colorado Project No. 16-038

December 22, 2016
Updated: November 16, 2018

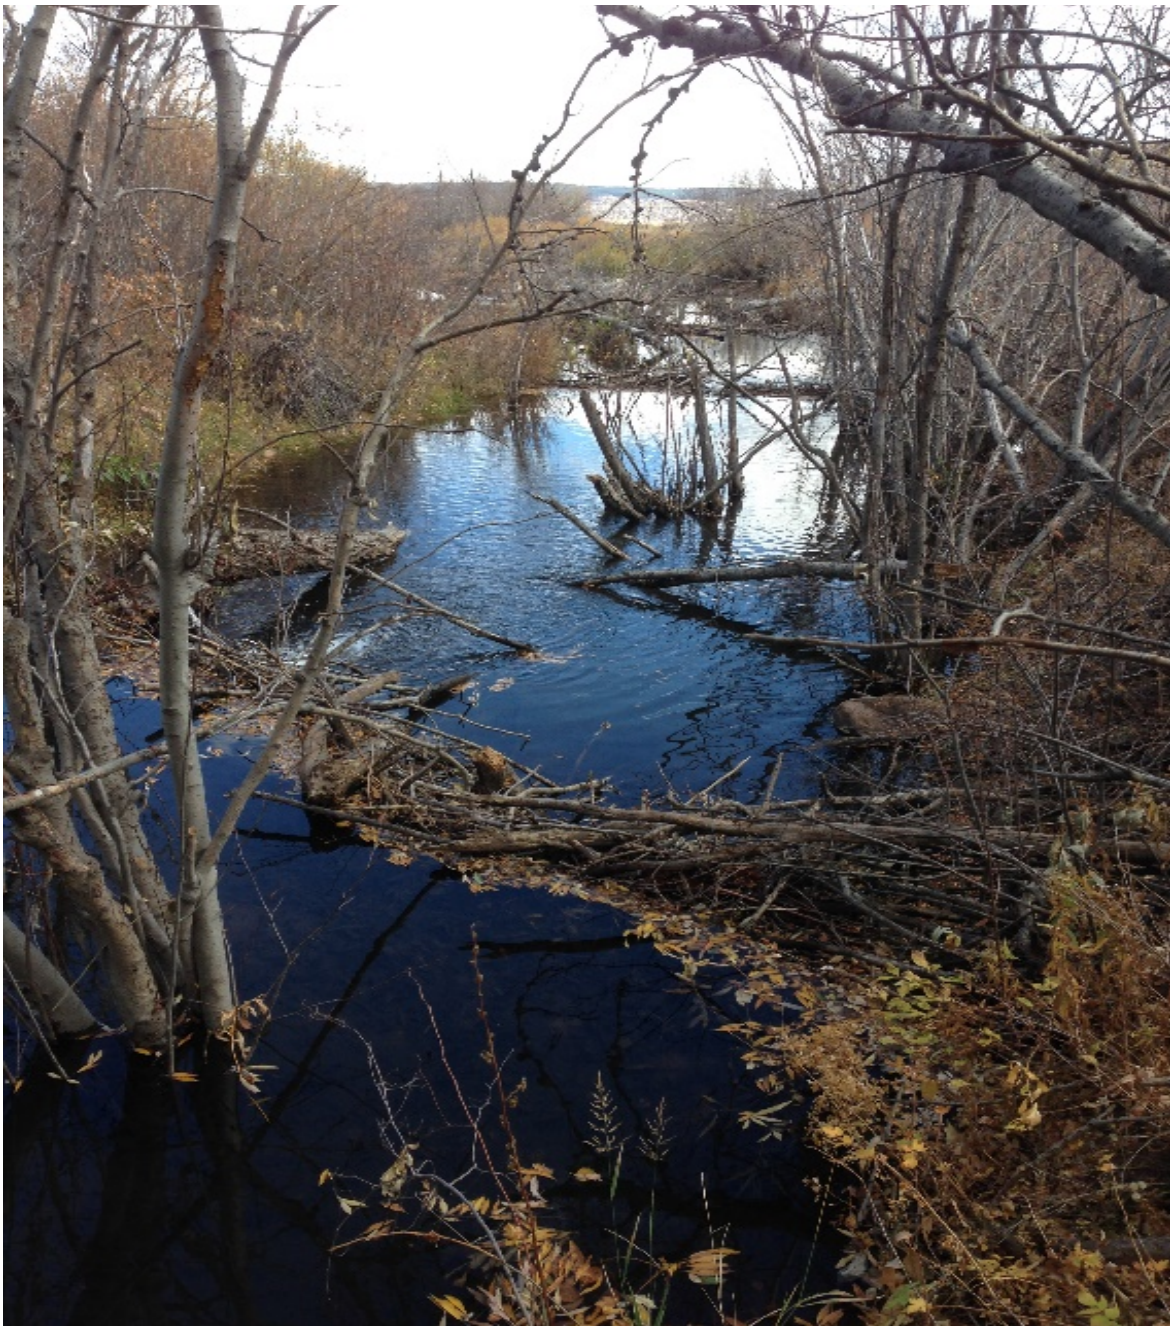
Beaver Creek Drainage facing east, showing one of many beaver dams in the main channel;
just east of confluence

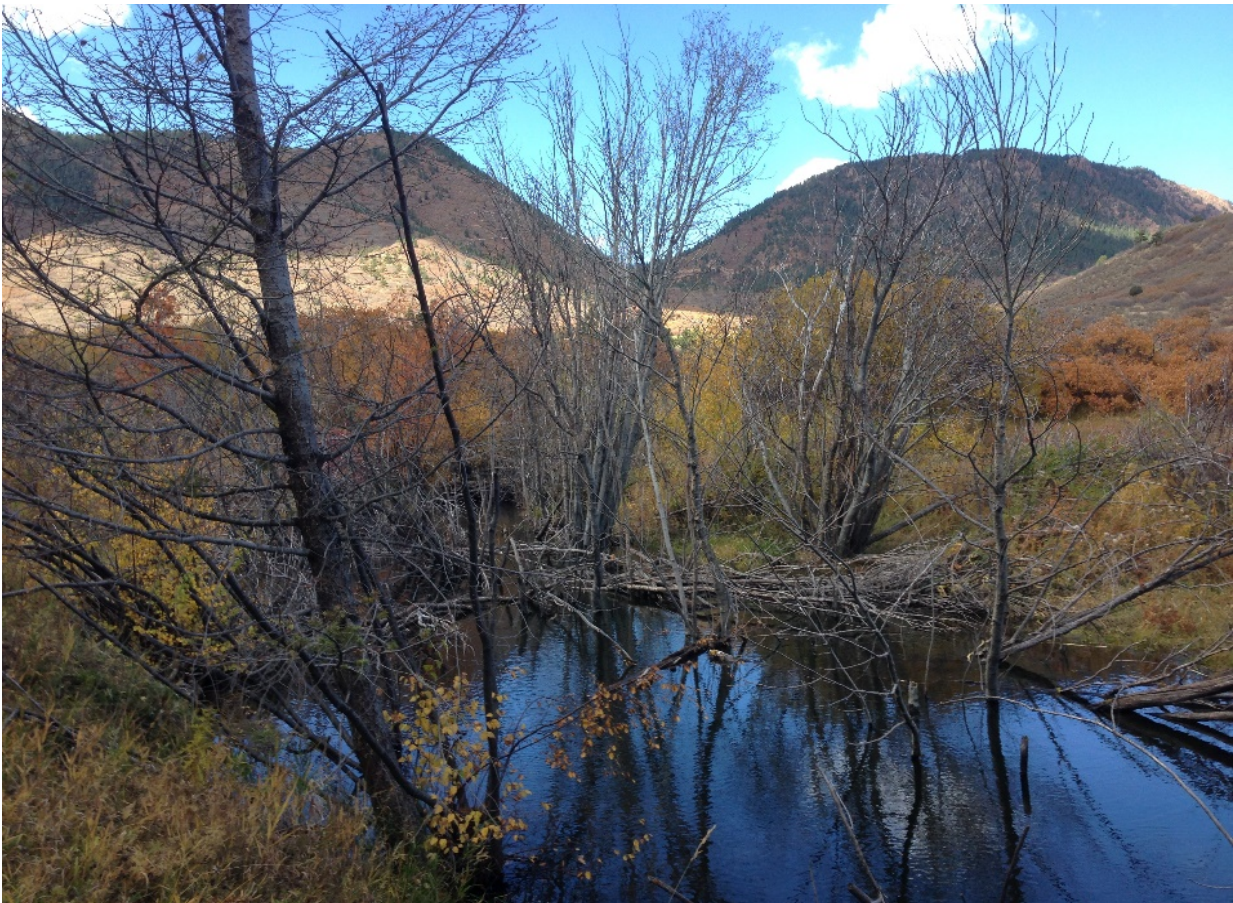
South Beaver Creek looking west; typical stream channel profile, showing dense scrub-shrub abutting wetland vegetation

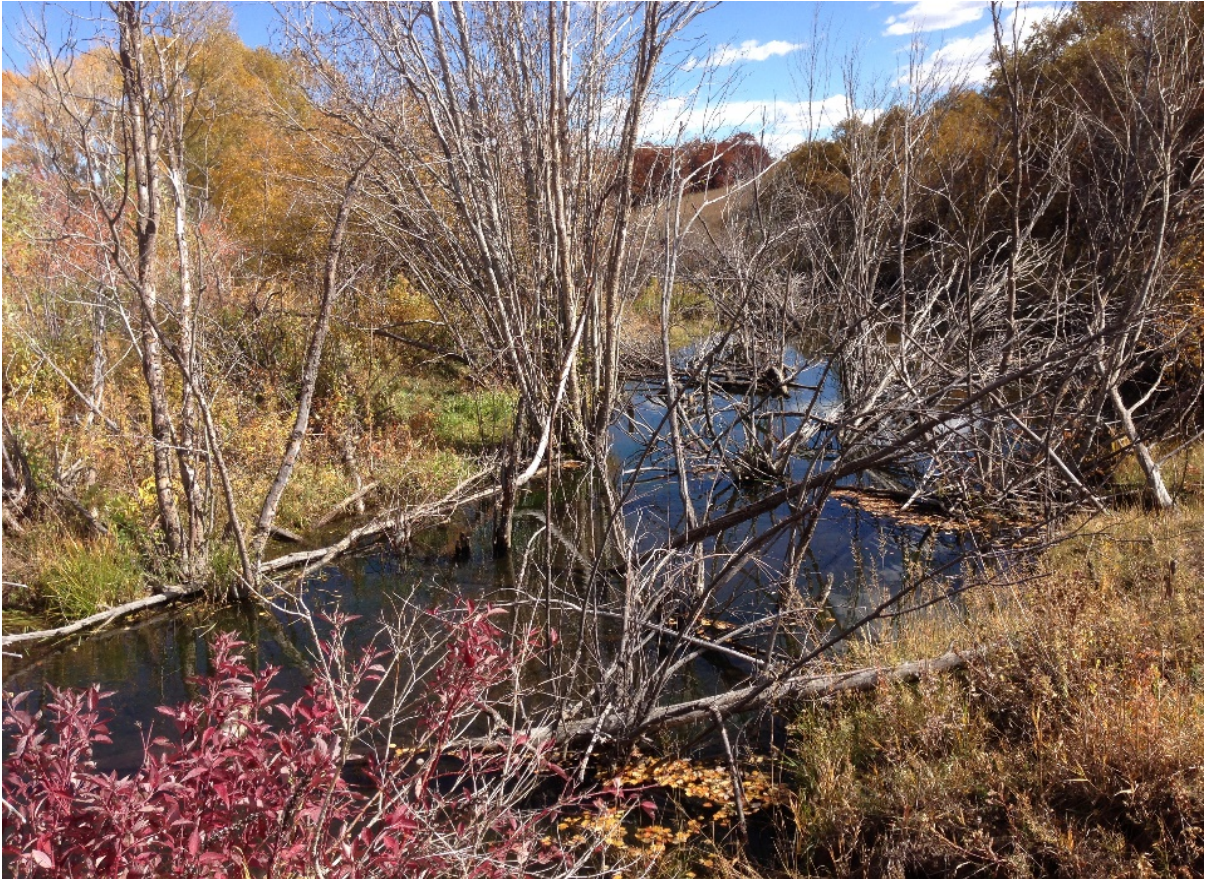
South Beaver Creek, with its well-developed riparian corridor

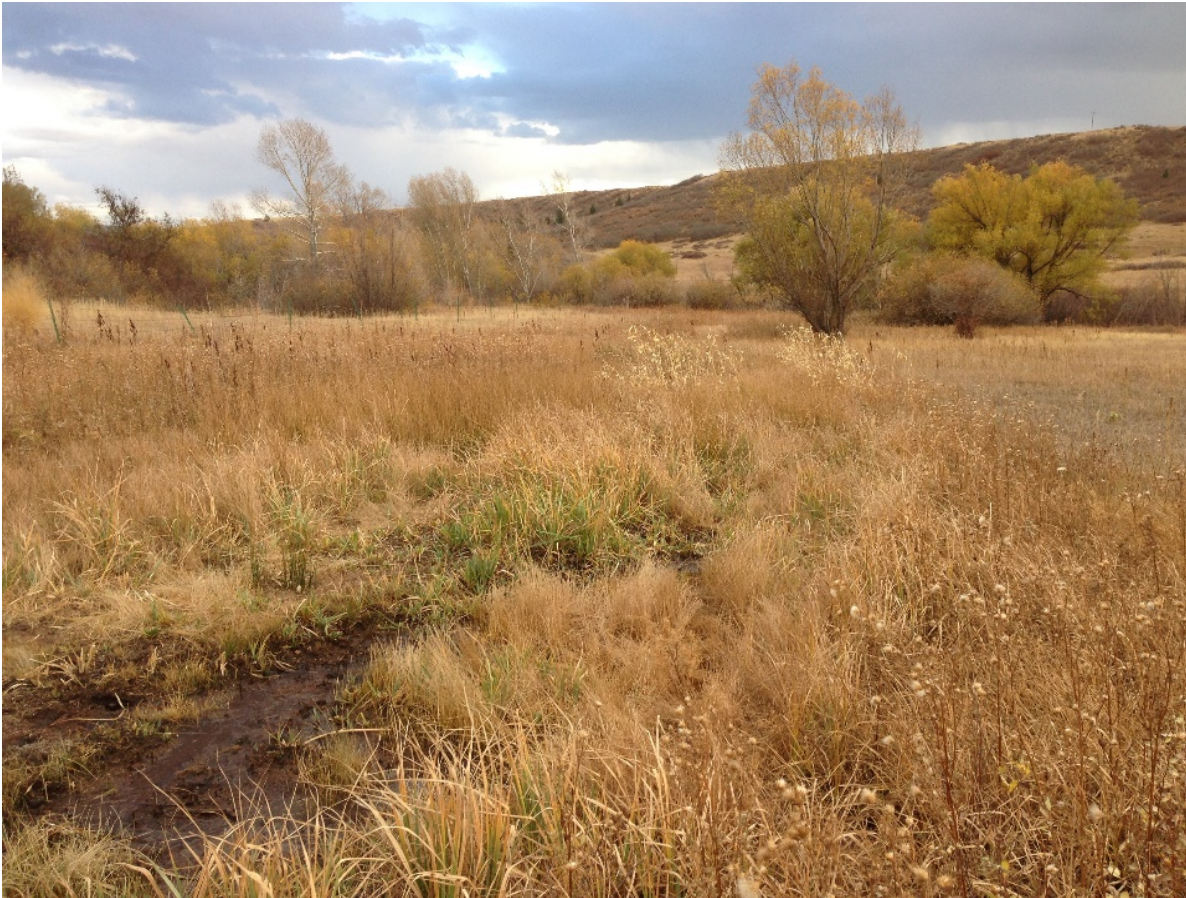
A portion of the wetland complex west of the South Beaver Creek-North Beaver Creek confluence, facing southeast. Much of the emergent wetland here is persistent, remaining standing even during the non-growing season
