Preliminary Acceptance (PA) Punchlist
EPC - DPW - Stormwater Section

| Project Name: | Dwire Storage Yard |
| Date of Walk-Thru: | 3/14/23 |
| Walk-Thru Number: | 2 nd |

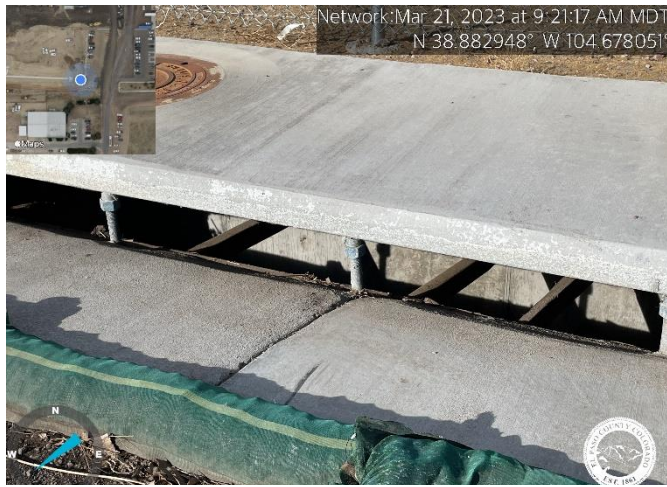
Photo 5: Remove forms and clean out sediment from curb inlet east of extended detention basin.

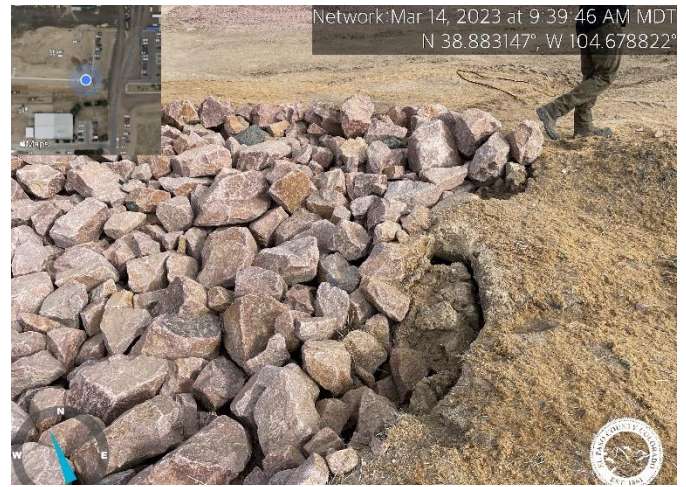
Photo 6: Address settling of riprap rundown at central forebay.

- Address settling of riprap rundown at central forebay.
- Repair rill erosion and implement final stabilization around eastern-most forebay.
- Low tailwater basin not installed per plan sheet ST03. Design engineer needs to provide revised design and calculations.

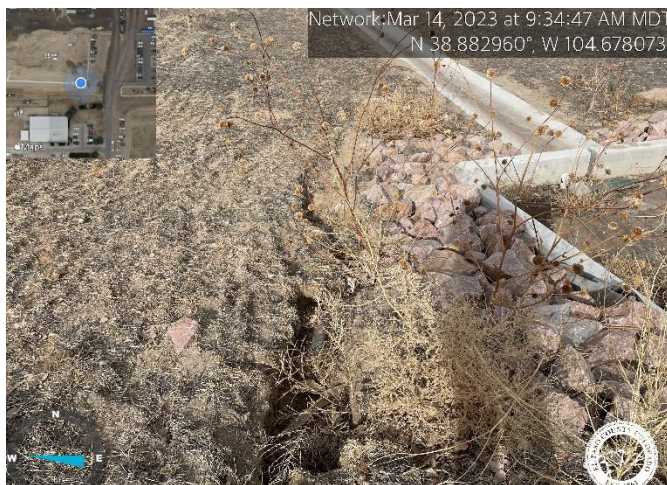
Photo 7: Repair rill erosion and implement final stabilization around eastern-most forebay.

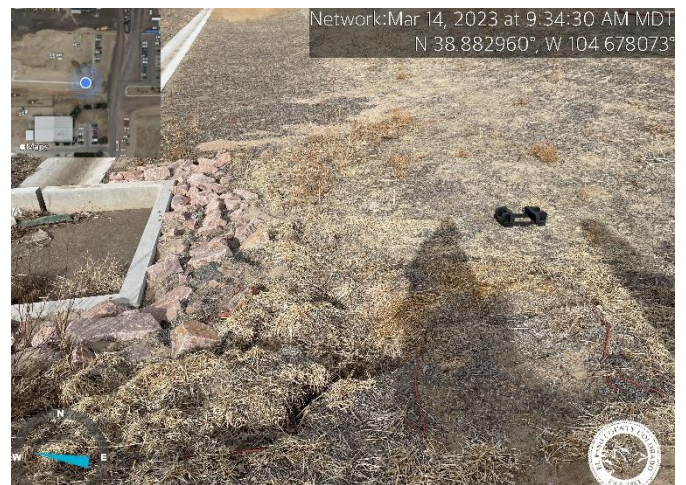
Photo 8: Repair rill erosion and implement final stabilization around eastern-most forebay.

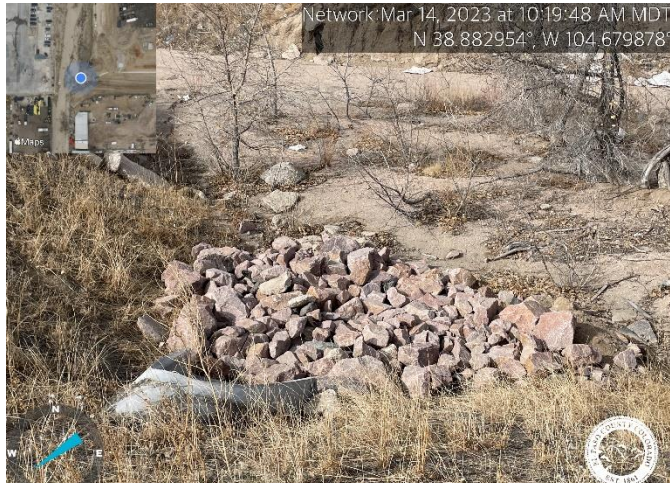
Photo 9: Low tailwater basin not installed per plan sheet ST03. Design engineer needs to provide revised design and calculations.
