To: El Paso County Planning and Community Development  
From: Allison Engineering, Jim Allison  
July 12, 2022

## INTRODUCTION

At the request of the property owners, Allison Engineering was asked to prepare this natural features report for the proposed Ohana subdivision. The location is delineated on two sides with black lines in 1 and otherwise by Jones and Murr Roads. On other diagrams the location is apparent by patterns of land use. In the course of the last 2 years this office has visited the project multiple times making observations of the natural features. The intent here is to collate information on the existing site such as any lakes, streams, significant topological features, and wildlife that might be impacted by the proposed subdivision. If mitigation is advised, to that end will this report will provide direction.

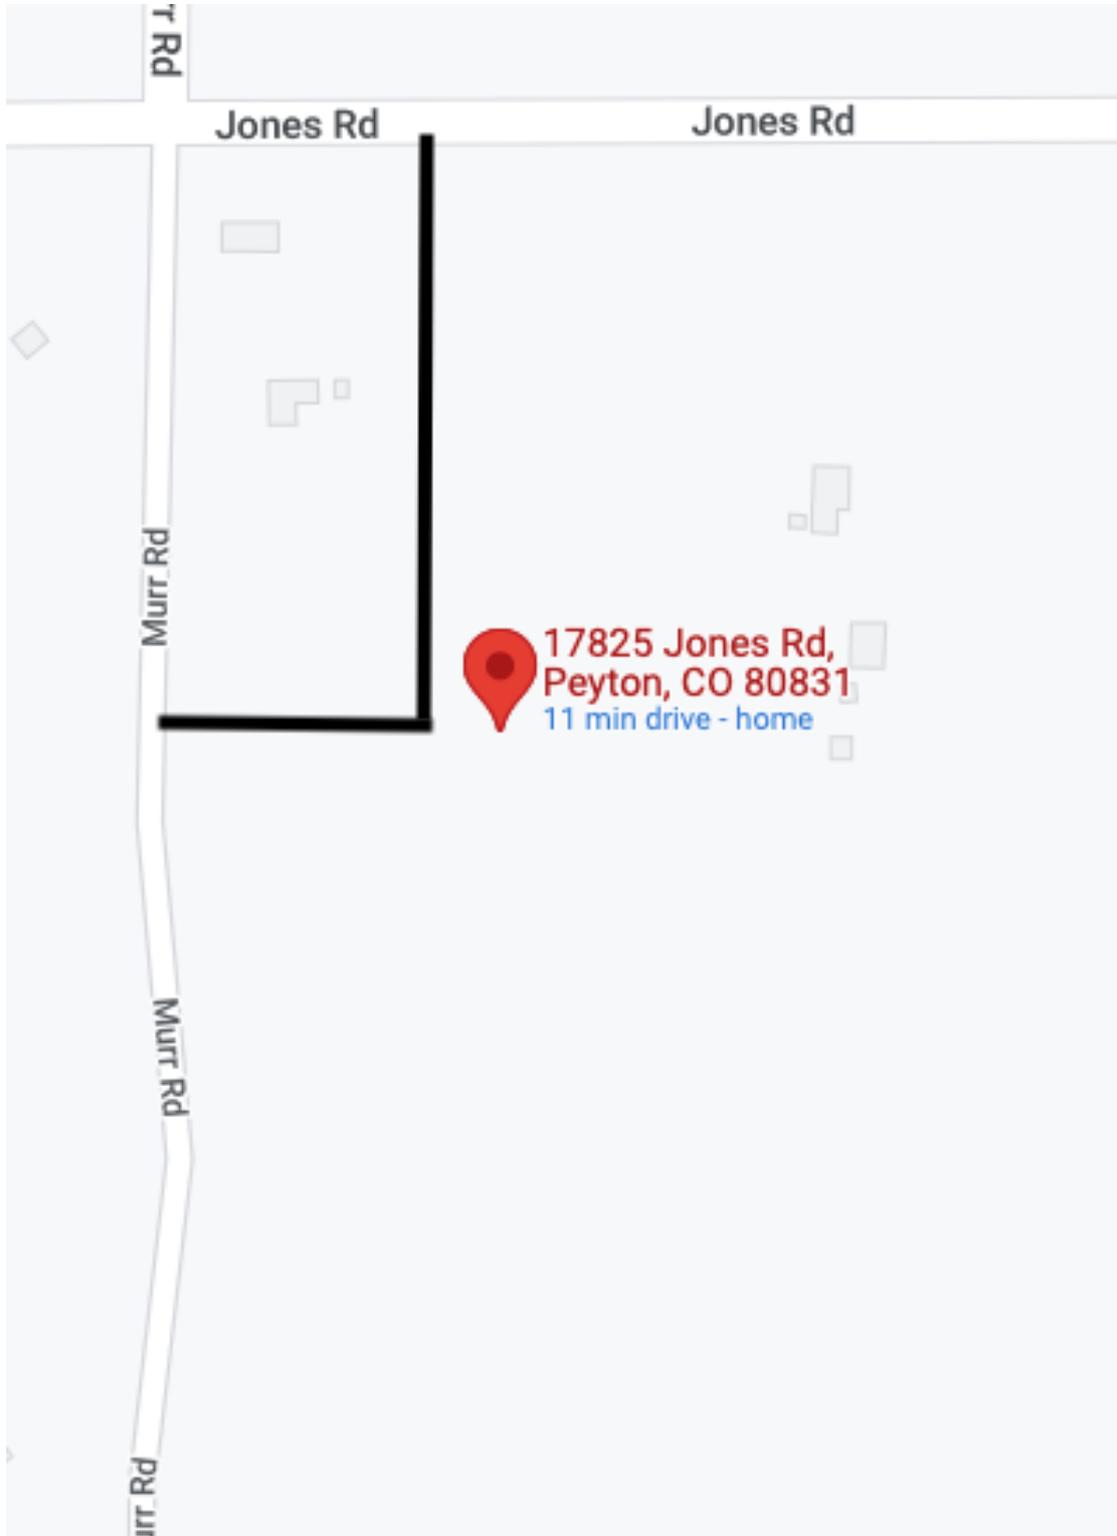
Figure 1: Project Site Location. On other maps of this report delineation of the subject property is apparent by patterns of land use,

This site is a 20-acre parcel situated at the southeast corner of the Jones Road and Murr Road intersection. The site is proposed to be subdivided into four 5-acre single-family residential lots. Each lot is to be accessible by a single private driveway, one of which, Lot 1 already is developed and has an existing driveway. The site is covered with prairie grass and does not include a single tree by native origin.

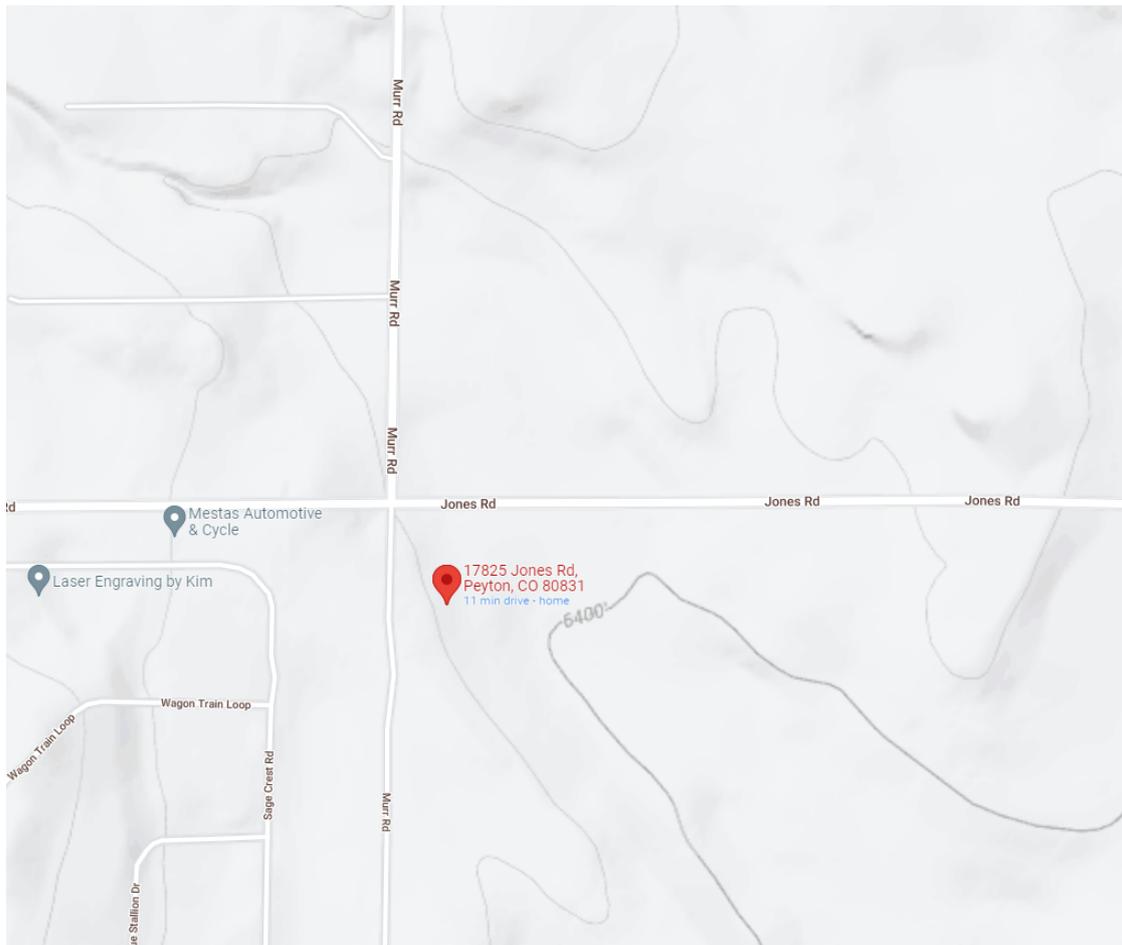
Figure 2: Topographic Map.

The topography is such that it rises from the east bounded on that side by a tributary in the Haegler drainage basin and peaks parallel to Murr Road which bounds the property on the west. In the course of 30-years of observation, no stream, pond or wetland has ever been observed.

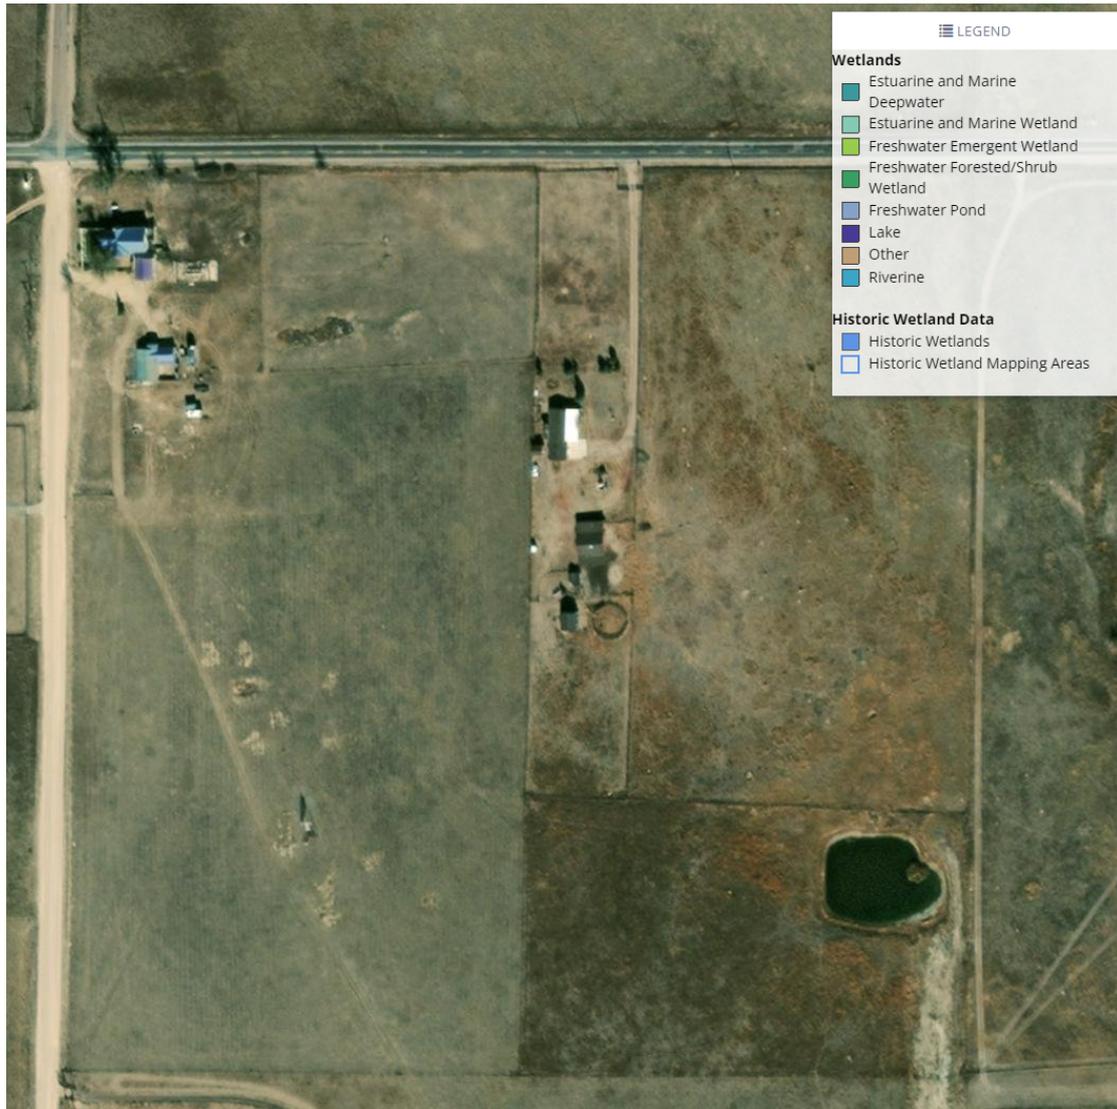
Figure 3: National Wetlands Inventory Map.

Review of the NWI maps did not find a Freshwater Emergent Wetland.

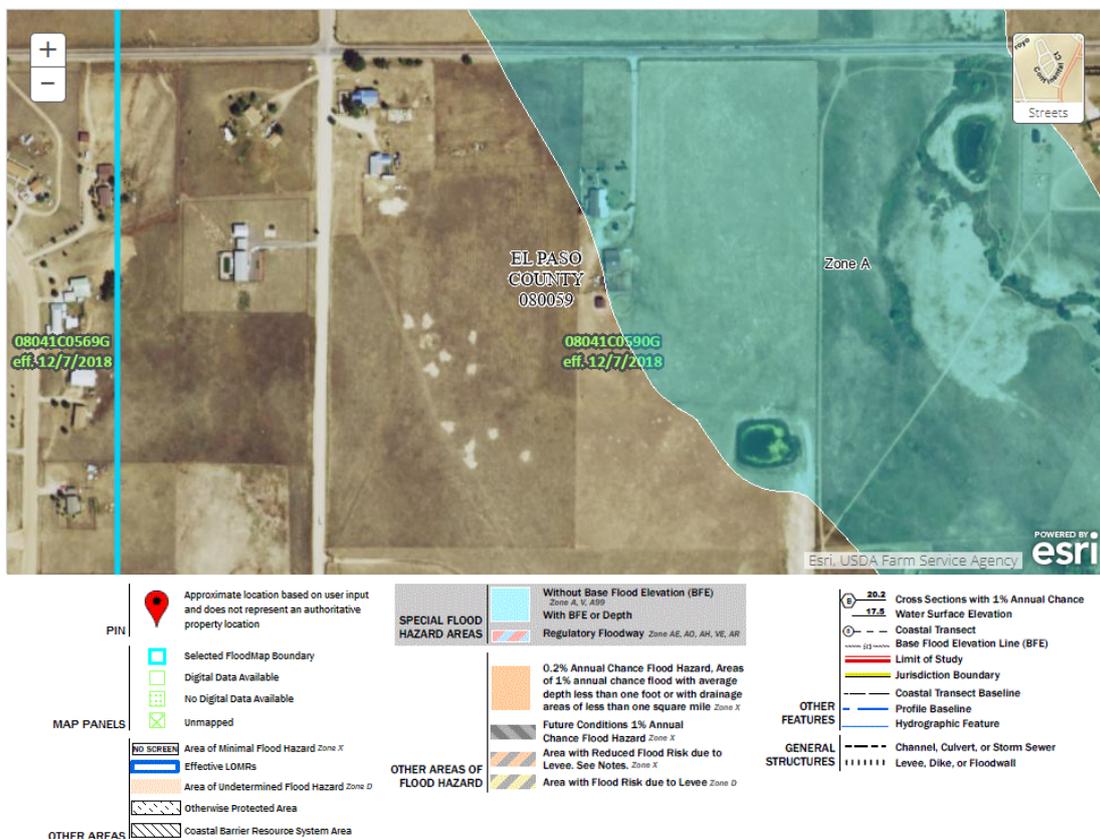
Figure 4: FEMA FIRM Map of Project Site.

The project is located within FEMA FIRM panel 08041C0590G in El Paso County, Colorado. Upon review of that panel we determined that all but the northeast corner of what is to be known as Lot 1 was in Zone X. The small area noted is a designated flood zone, Zone A, and contains no developemnt and none is planed for that corner.

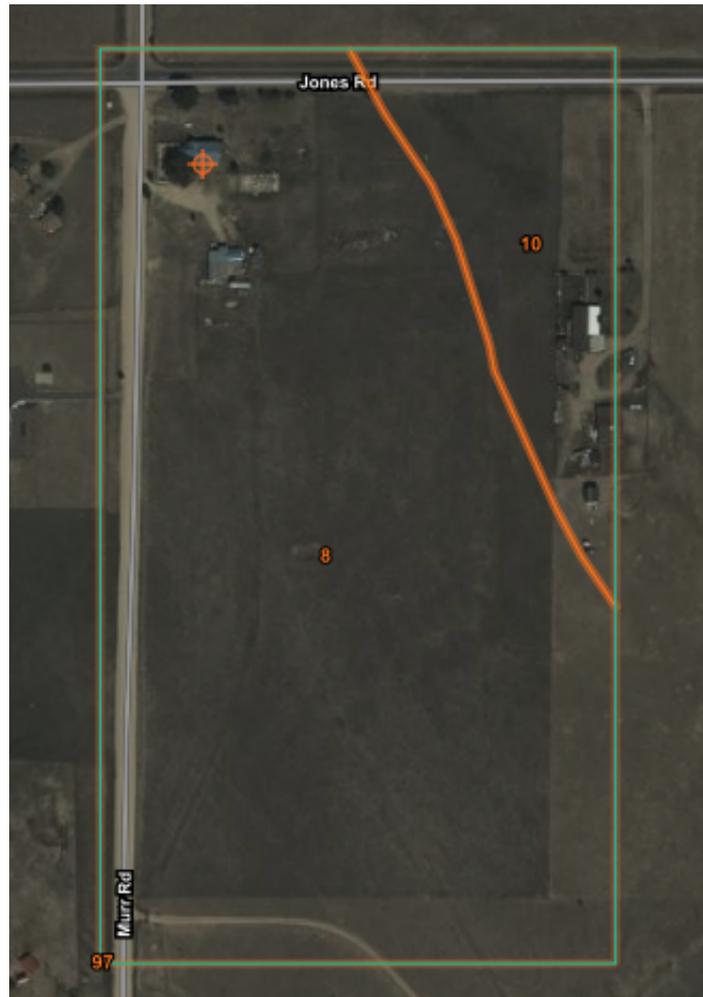
Figure 5: Soil Survey Map Showing Two Soil Types.

The NRCS Soil Survey Map shows there are two predominant soil types present.

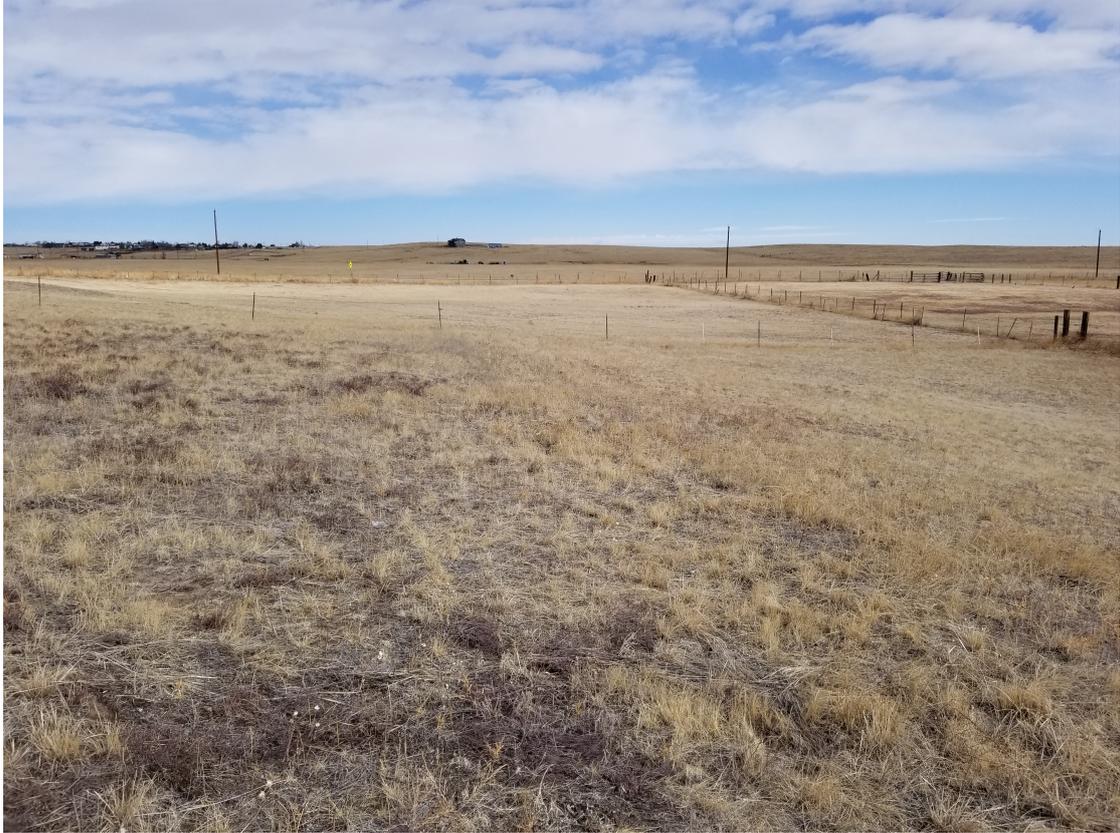
Figure 6: Views from within study area looking north across the area of concern for possible endangered species.

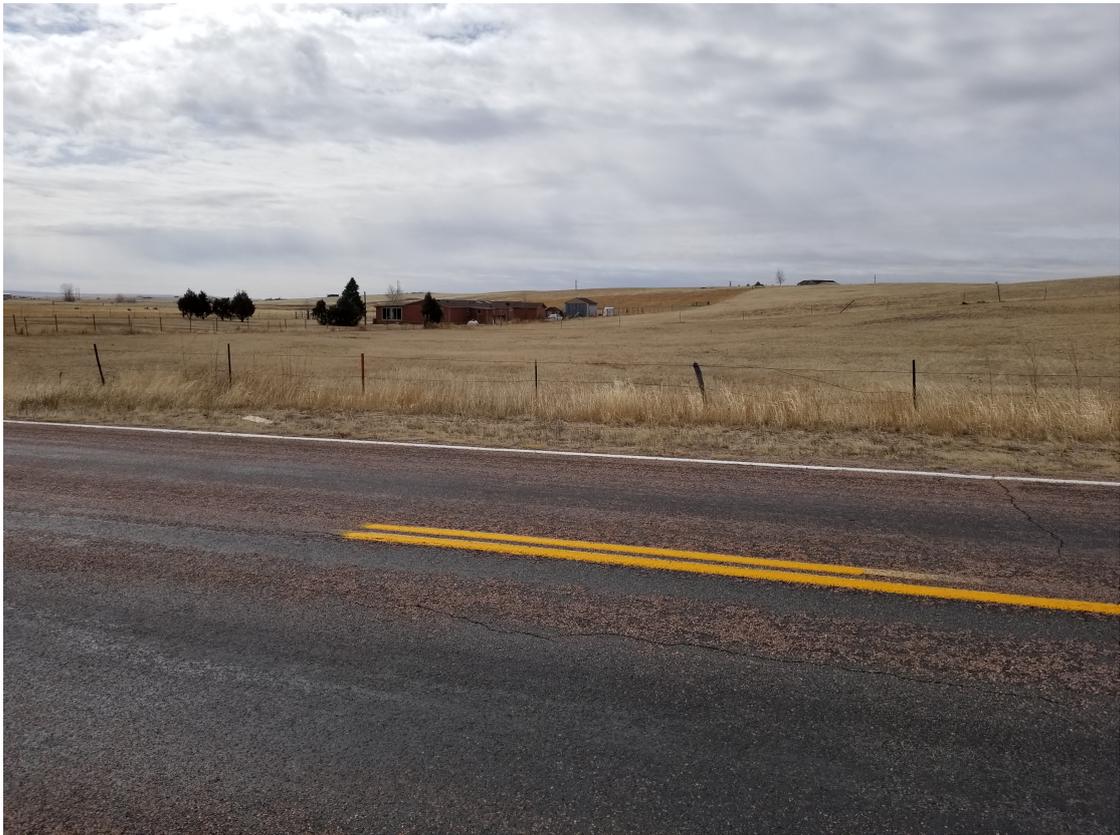
Figure 7: Views from within study area looking south across the area of concern for possible endangered species.

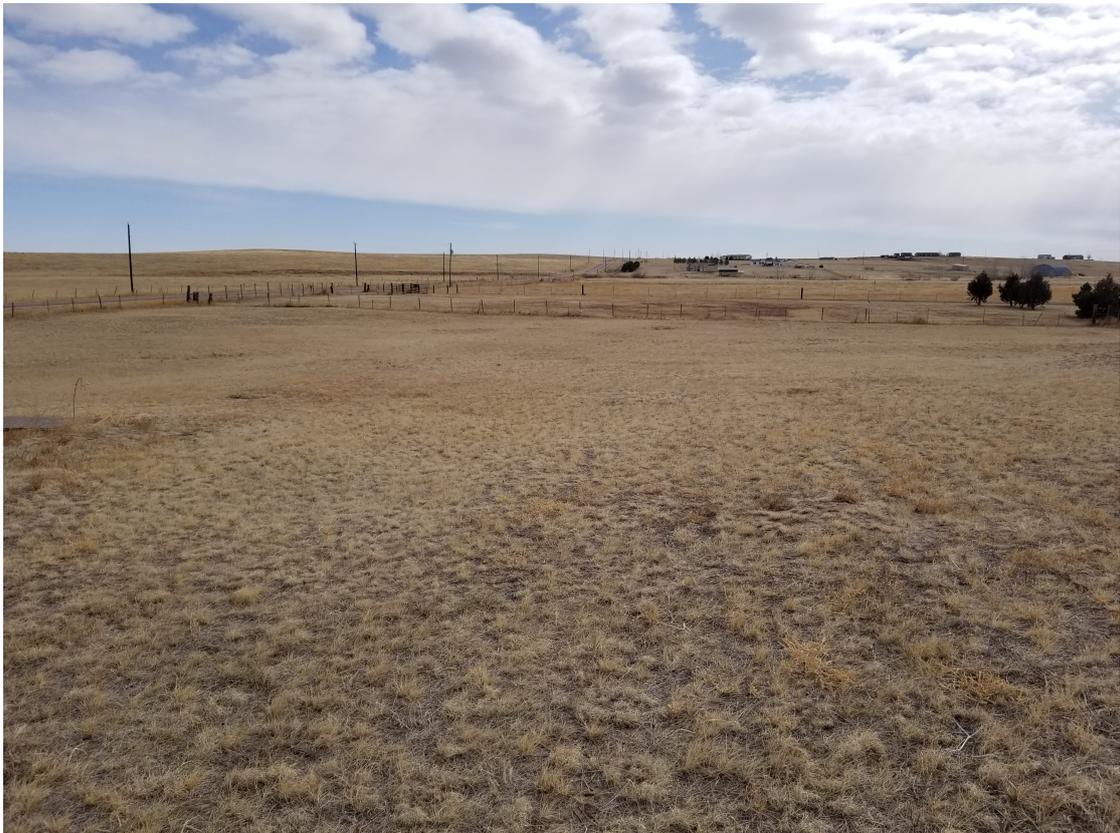
Figure 8: Views from within study area looking east across the area of concern for possible endangered species.
