## PAVEMENT DESIGN REPORT

### The Ridge at Lorson Ranch – Filing No. 1 El Paso County, Colorado

**JOB NO. 186386-1**

**October 3, 2022**  
**Revised April 26, 2023**

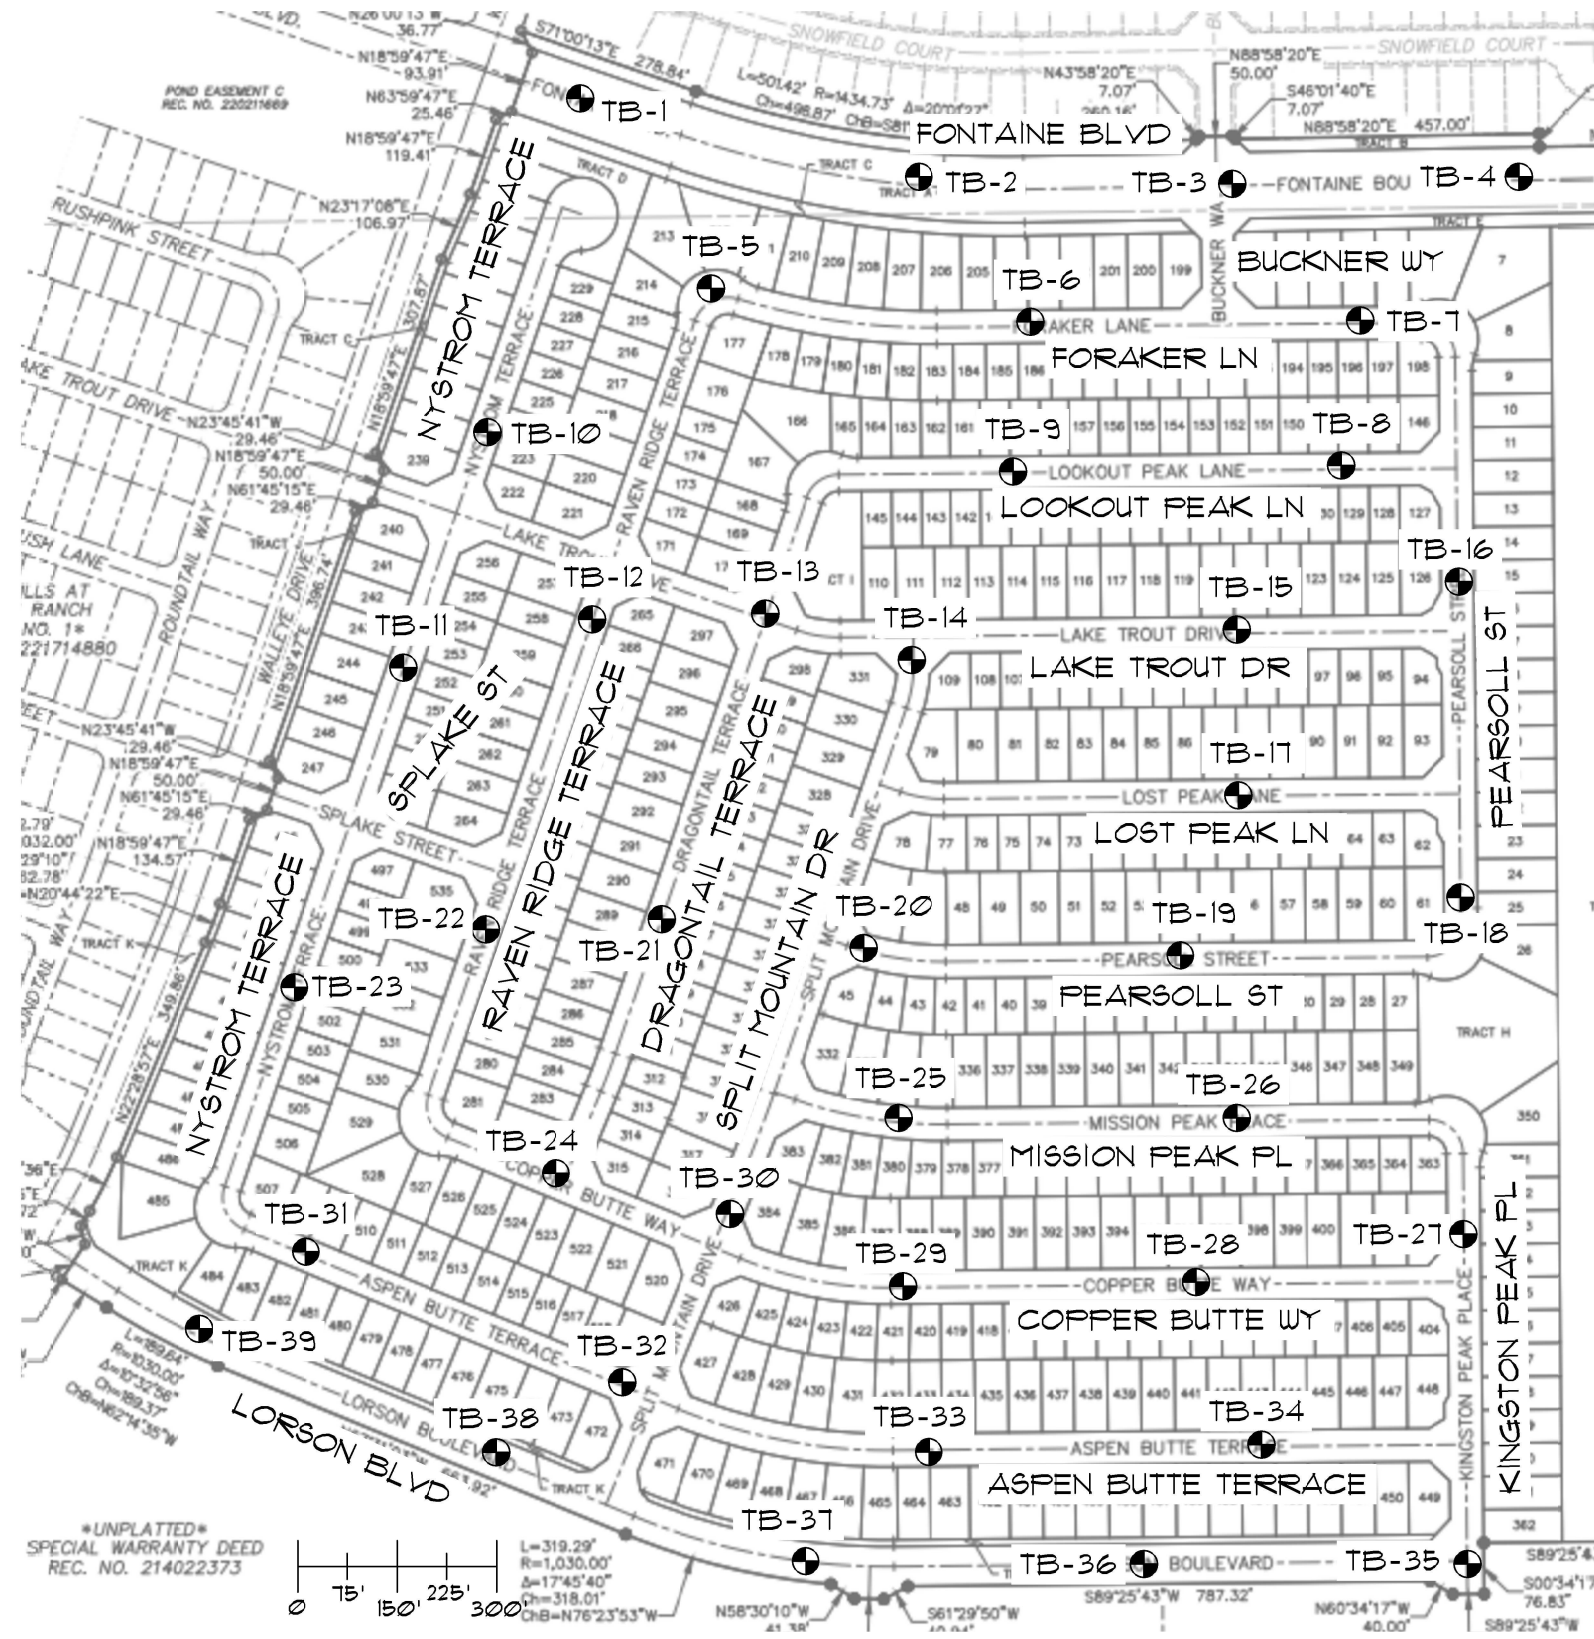
PAVEMENT RECOMMENDATIONS

Based on the design calculations, the recommended pavement section is presented below and on Figure 2.2.

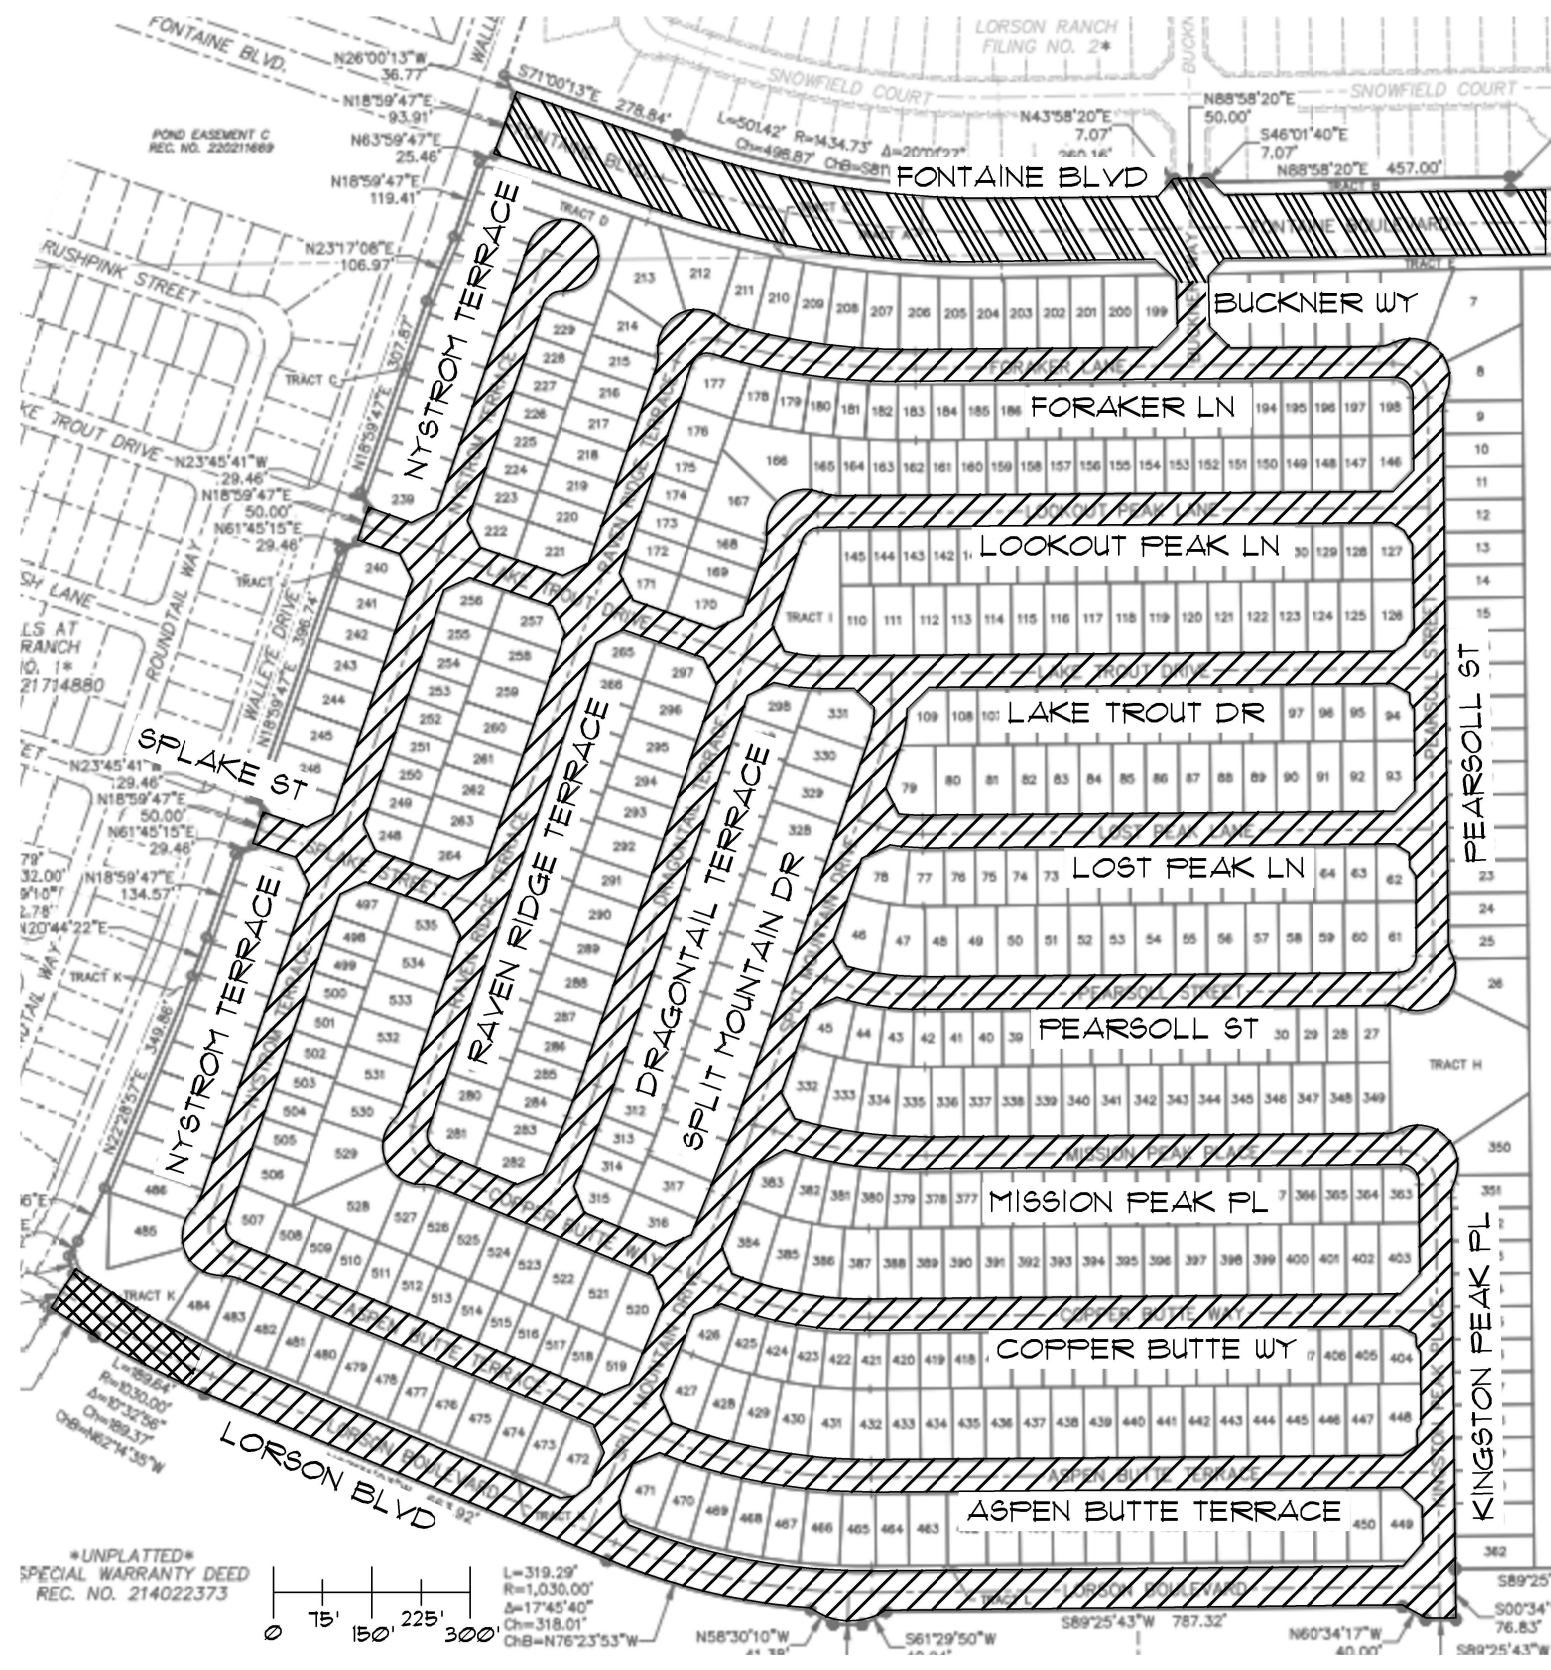
OPTION 1  
5.5" HMA  
OVER  
13.25" ABC
