Subject: Wetland Assessment and Delineation Report – Rolling Hills Development at Jimmy Camp Creek East Tributary, West of S Meridian Road and South of Drennan Road, El Paso County, Colorado

Rolling Hills Wetland Delineation

Photo Log
Wetland Delineation for Rolling Hills Development
Colorado Springs, Colorado

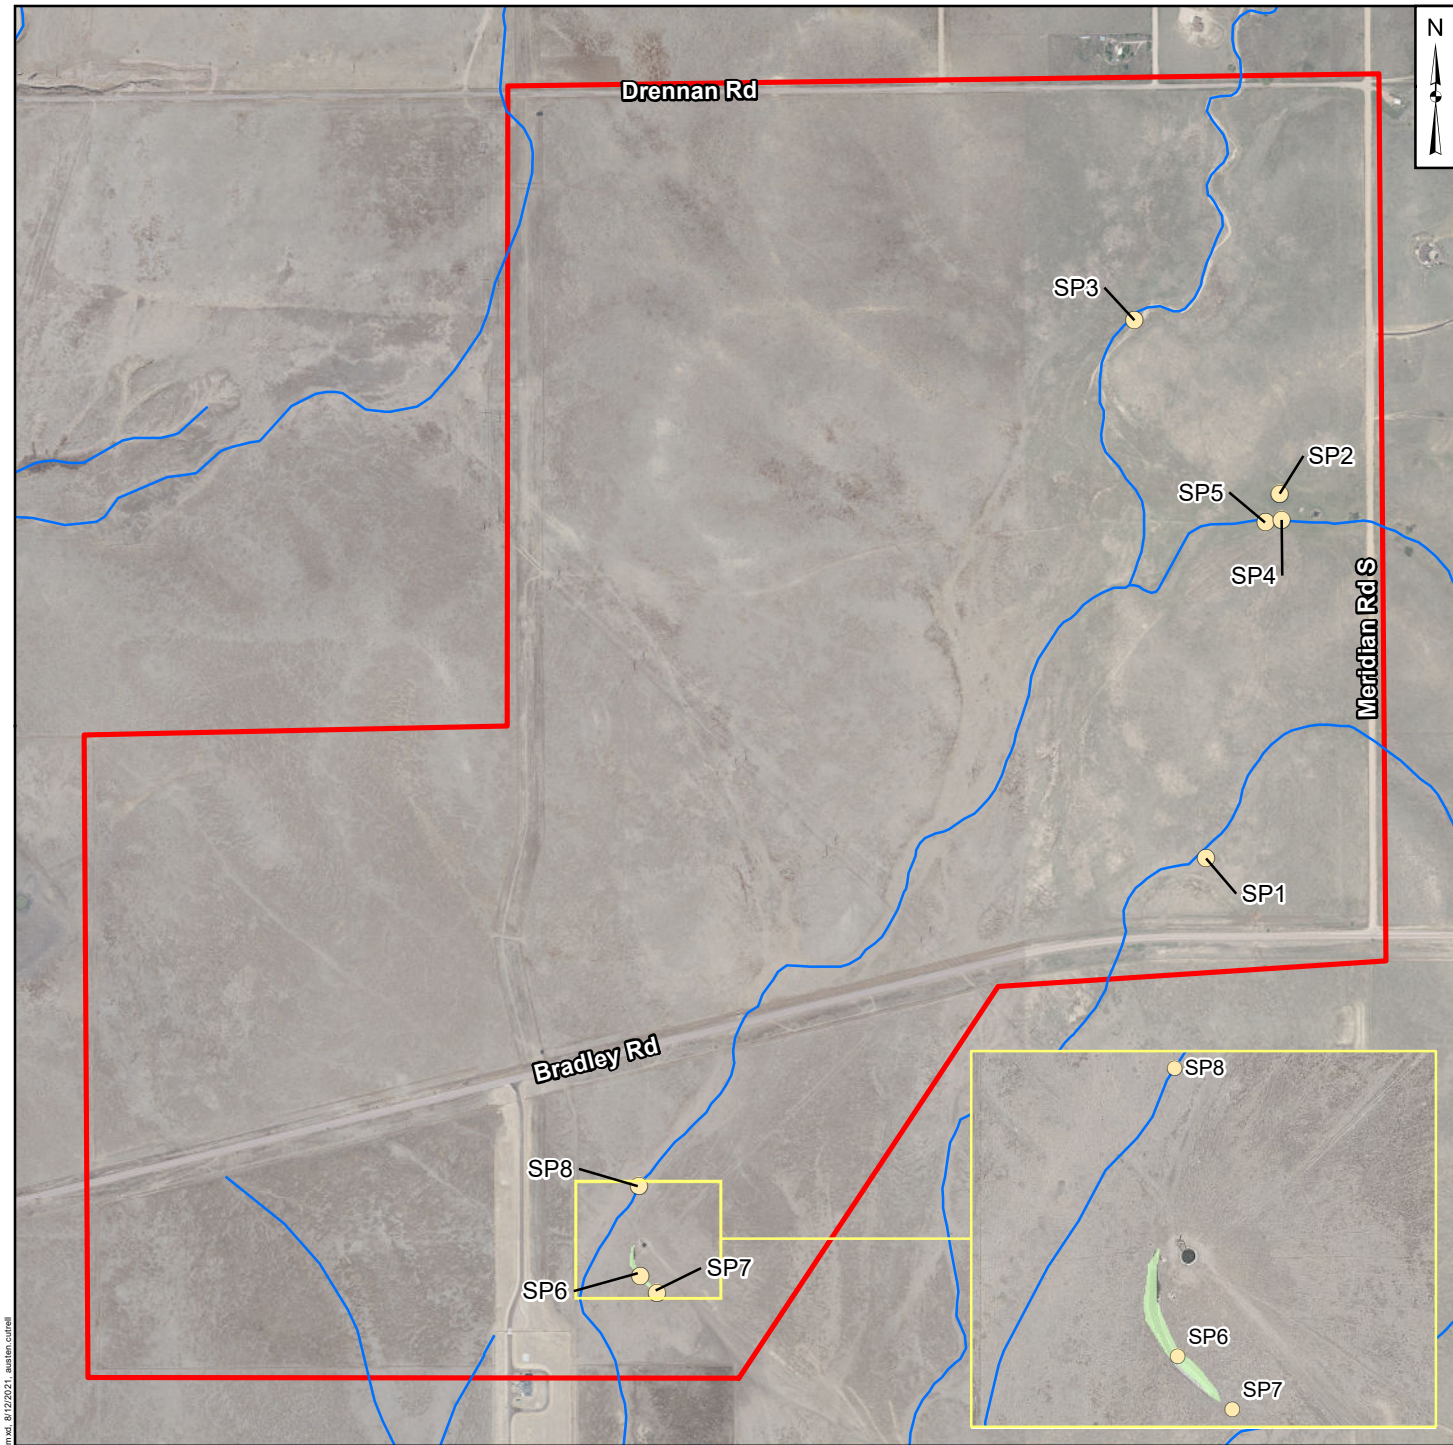
**Figure
1**

Flags were placed along the boundaries of areas identified as wetlands within the Site, which was limited to Community 6 as indicated in the attached figure.
