# Request for Approved Jurisdictional Determination for Rolling Meadows El Paso County, Colorado

**December 13, 2022**

Matrix Design Group, Inc. (Matrix) is submitting this request for an Approved Jurisdictional Determination (AJD) on behalf of the Landhuis Company for aquatic resources associated with six unnamed drainages on the Rolling Meadows property (Property) located in El Paso County, Colorado. The Property is approximately 1,869 acres and is located south of Drennan Road and north of the Grand Mountain School. Matrix visited the Property on October 12, 2022 and December 5, 2022, to evaluate the characteristics of the unnamed drainages and their potential connection to downstream waters subject to Clean Water Act (CWA) Section 404 jurisdiction. In the following request, we provide background on the Property location, field methodology, and details on the characteristics of the unnamed drainages and our evaluation of the potential jurisdictional status of aquatic resources on the Property. Please refer to the figures in Appendix A for a depiction of the Property and representative images in Appendix B.

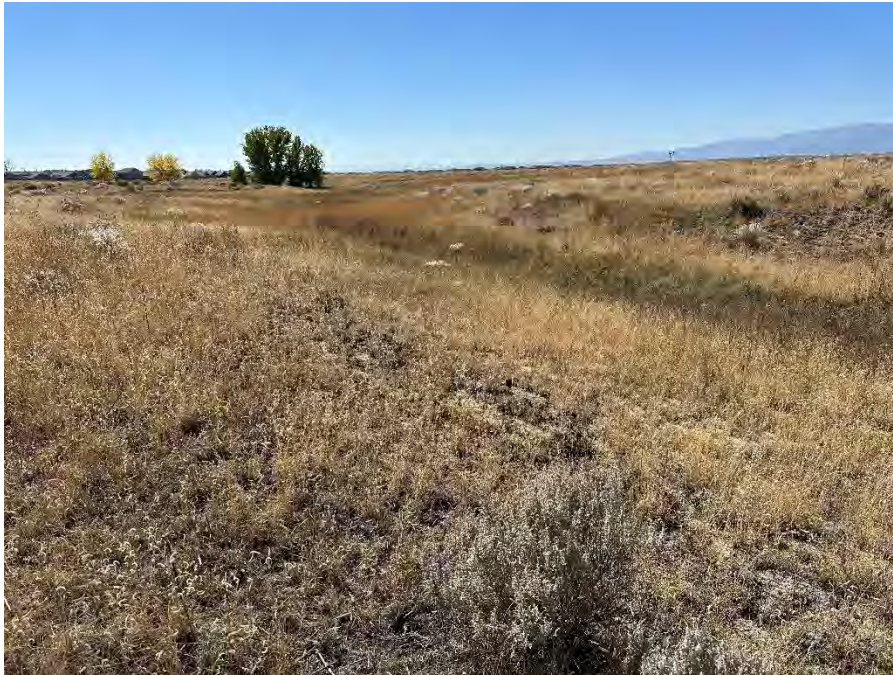
Photo 5: Representative of fully vegetated channel, near the center of the Property.

Vegetation within the Property has been practically undisturbed by the lack of access and activities within the Property. The drainage channels are almost entirely vegetated with upland species, except for the small depressions. The dominant species within the drainage channels include blue grama (*Bouteloua gracilis*, No Indicator [NI]), western wheatgrass (*Pascopyrum smithii*, Facultative Upland [FACU]), and Kochia (*Bassia scoparia*, Facultative [FAC]). Only subtle differences in dominant vegetation species were observed between the drainage channels and adjacent uplands which were dominated by blue grama, fetid marigold (*Dyssodia papposa*, NI), winterfat (*Krascheninnikovia lanata*, NI), and rubber rabbitbrush (*Ericameria nauseosa*, NI). Depressional features observed within the property are sparsely vegetated with a narrow emergent fringe. Dominant species within the depressions include mountain rush (*Juncus arcticus* ssp. *littoralis*, Facultative Wetland [FACW]), vine mesquite (*Panicum obtusum*, FACU), common spikerush (*Eleocharis palustris*, Obligate [OBL]), barnyardgrass (*Echinochloa crus-galli*, FAC), and Pennsylvania smartweed (*Persicaria pennsylvanicum*, FACW).

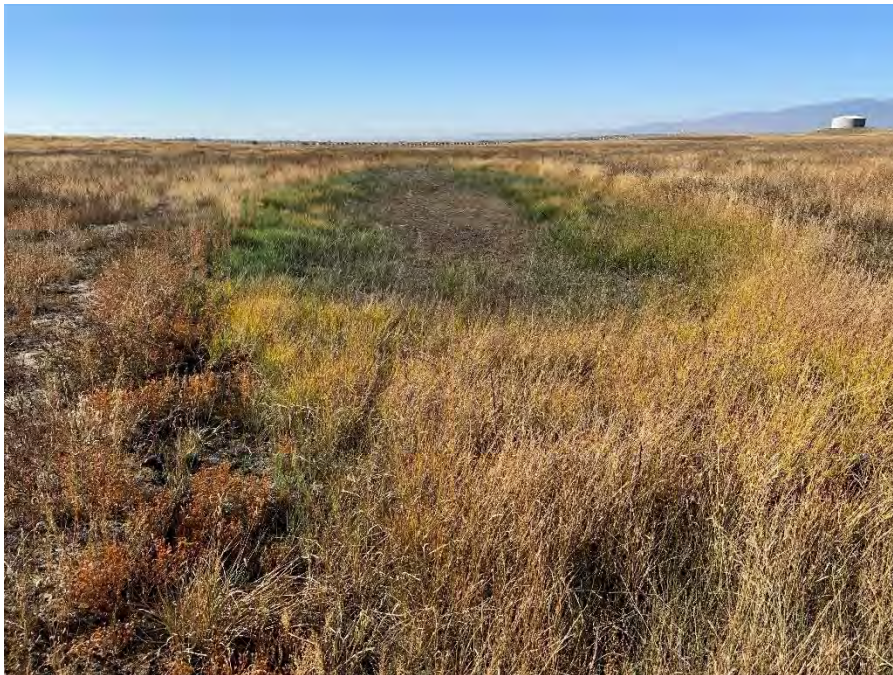
Photo 6: Representative photo of an isolated depression within the channel.

Several pocket depressions throughout the unnamed drainages support 26 areas of isolated wetlands, including hydrophytic vegetation, hydric soils, and indicators of wetland hydrology. No concentrated flow paths were observed on the downstream ends of the depressions and depressions may sever flows to downstream drainage features in normal years. These depressions were delineated in the field and are shown in Table 1 and on Figure 7A and Figure 7B. Wetland determination forms can be referenced in Appendix C. Though flows were not recently evident in the channel or at the time of the site assessment, nor were they observed on aerial imagery, it is believed that the drainages collect surface runoff from adjacent hillslopes and roadways in addition to direct precipitation. Based on field and aerial imagery observations, it is our professional opinion that the flow regime of the unnamed drainages may best be described as ephemeral, and largely driven by stormwater and overland flows. Table 1 describes the aquatic features found within the Property.

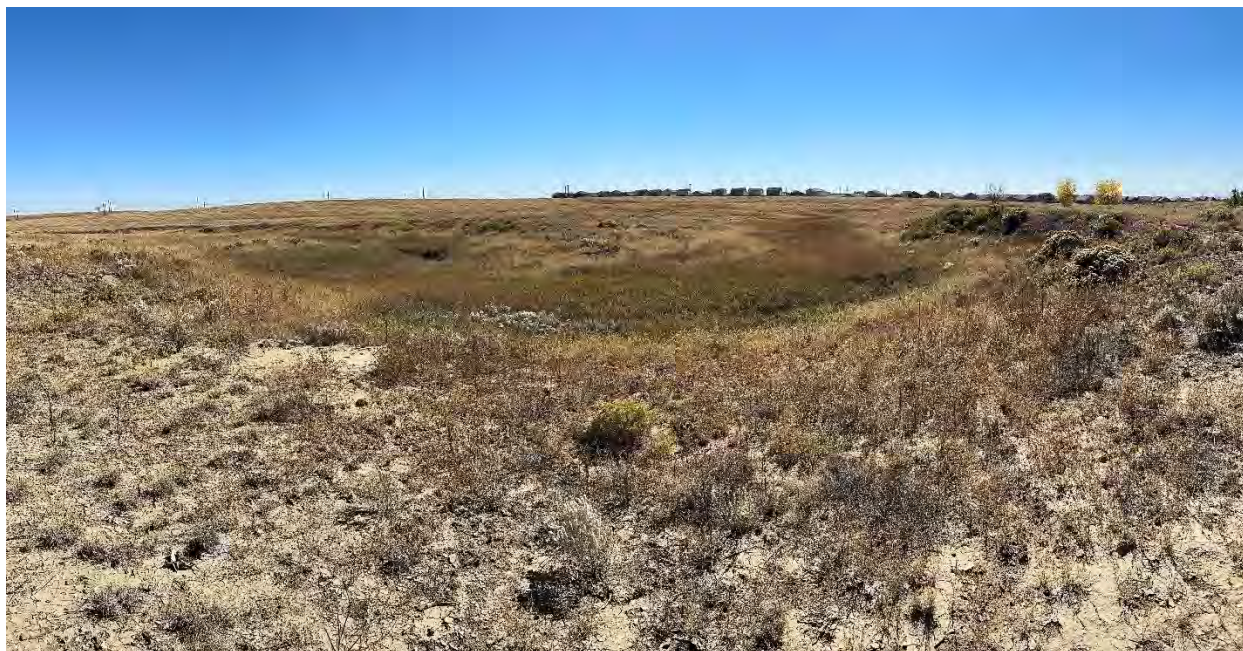
Photo 9: Depression within the channel.

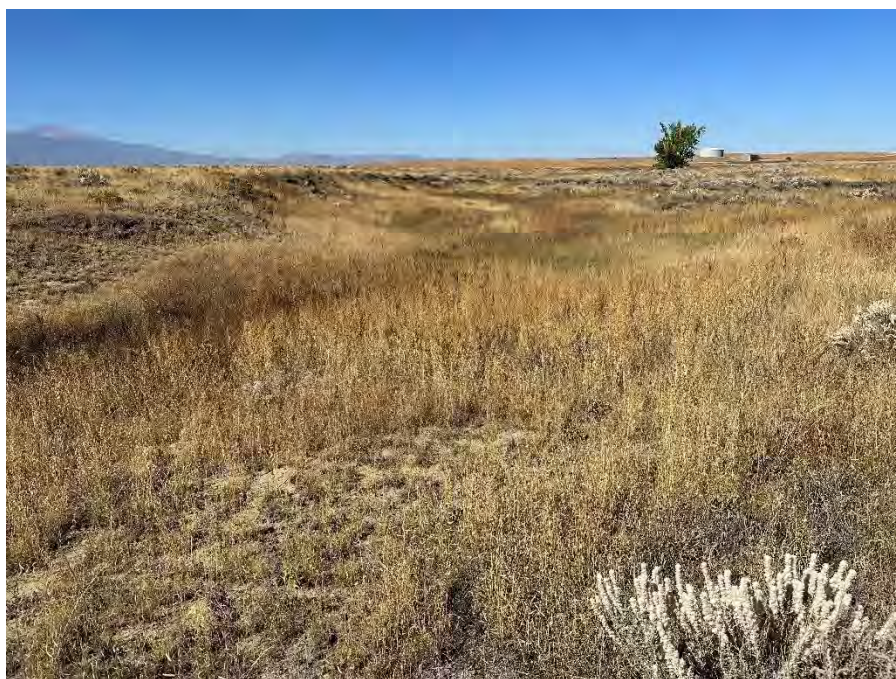
Photo 10: Standing in the channel, facing northwest, on the southern end of the Property.

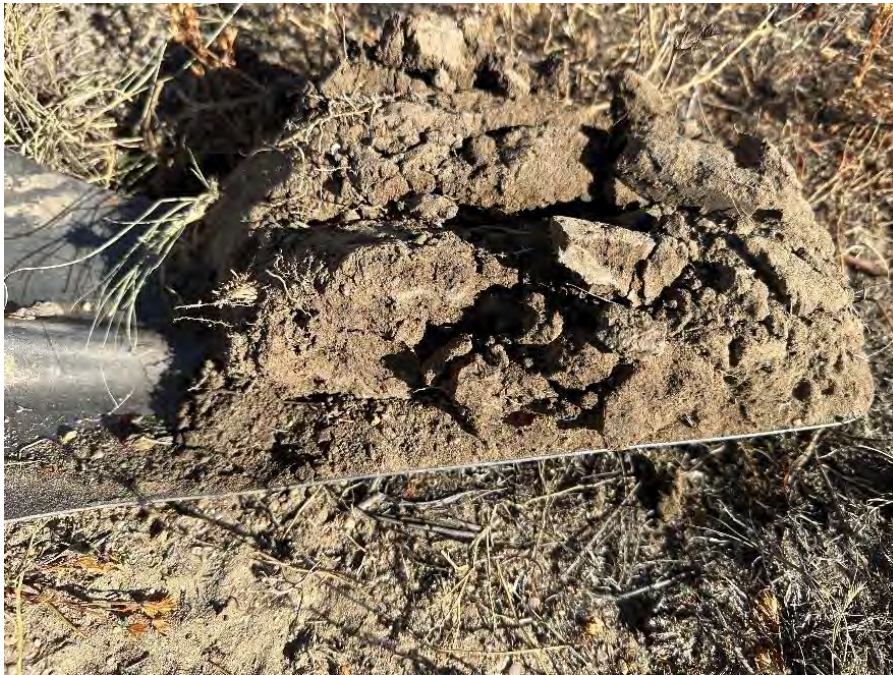
Photo 13: Representative photo of the upland soil profile, throughout the Property.

At the time of the field assessment, soil pits were sampled in various depressions and upland areas, to determine hydric soil indicators. Soils within the pocket depressions tended to be moist, dark in color, with redox depressions throughout the soil profile and upland soil samples tended to be lighter in color, dry and crumbly, with no hydric indicators.

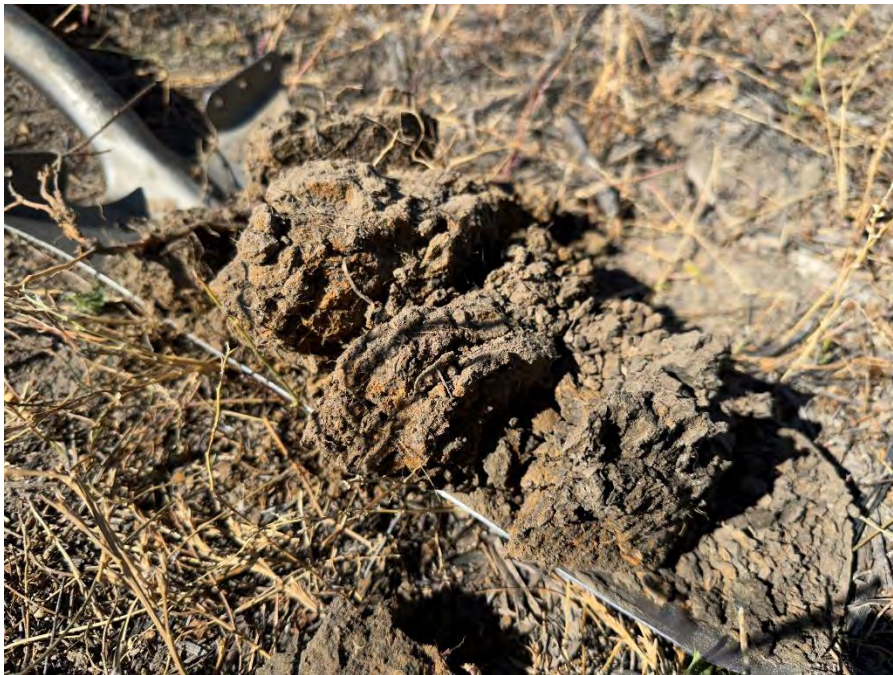
Photo 14: Representative photo of the isolated wetland depressional soil profile, throughout the Property.

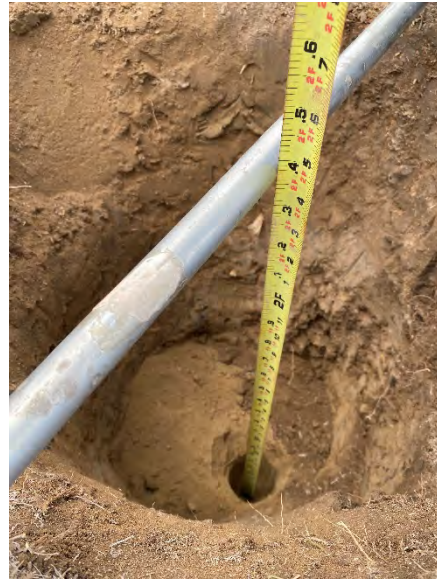
Photo 2 – Community 1's sandy clay soils didn't exhibit hydric soil indicators. Additionally, saturation and a water table were not encountered despite the soil pit extending to a depth of 28 inches.

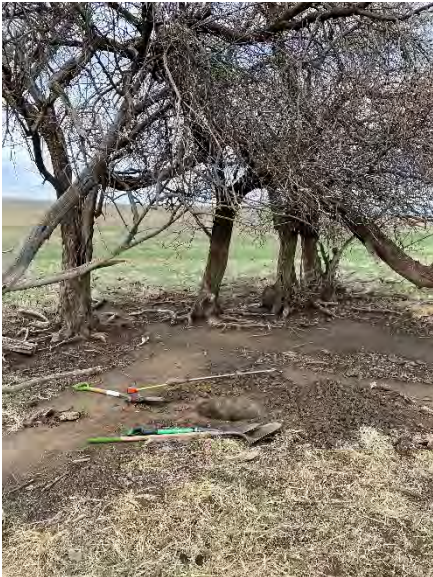
Photo 3 – Community 2 includes a small depression near the eastern boundary of the Site. Test pit is in the center of the middle ground.

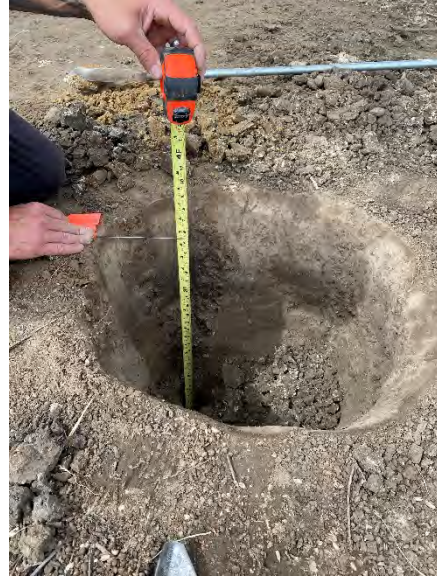
Photo 4 – Community 2's sandy clay loam and clay soils didn't exhibit hydric soil indicators. Additionally, saturation and a water table were not encountered despite the soil pit extending to a depth of 42 inches.

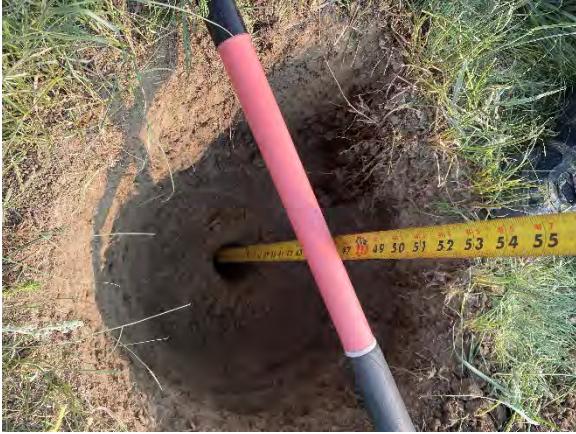
Photo 5 – Community 3 includes the drainage swale identified as Jimmy Camp Creek East Tributary. Test pit is in the center of the foreground.

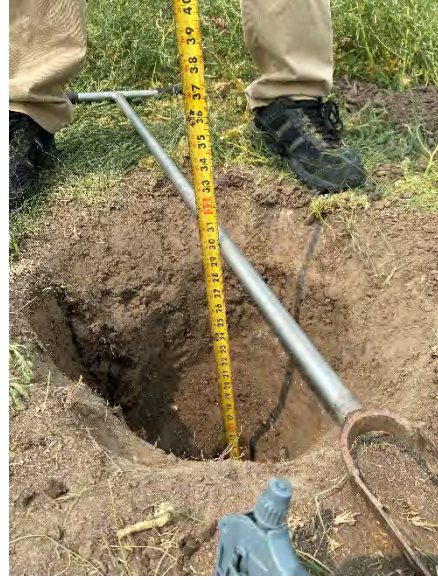
Photo 14 – Community 7's silty clay loam and sandy loam soils didn't exhibit hydric soil indicators, and saturation and a water table were not encountered despite the soil pit extending to a depth of 30 inches.
