Preliminary Acceptance Punchlist

El Paso County – Department of Public Works - Stormwater Section

Project Name:	Colorado Center Metro District
EDARP Filing Number(s):	PPR2151, CON2326
ESQCP Number:	ESQ2324
Attendees:	DPW SW: Benjamin Jones DPW Development Services: Brad Walters Developer: Monty Baldwin (T-Bone)
Date of Walk-through:	07/18/2024
Walk-through Number:	1st

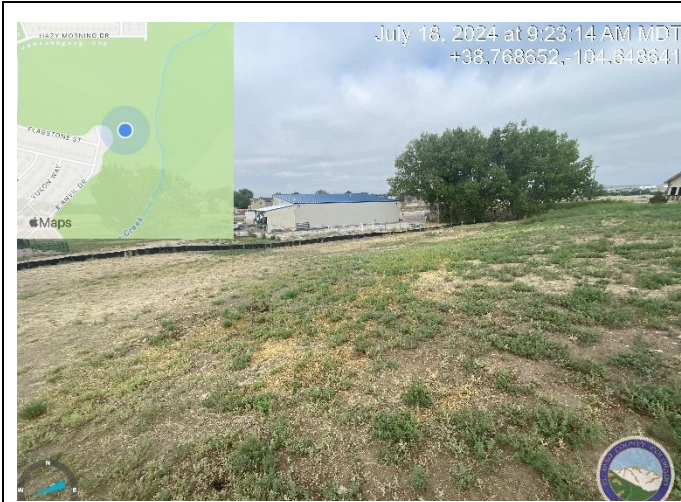
Photo 1: East side of site

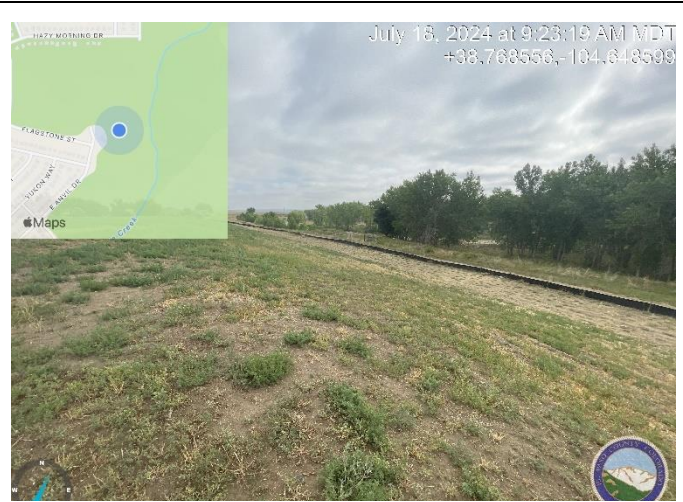
Photo 2: East side of site

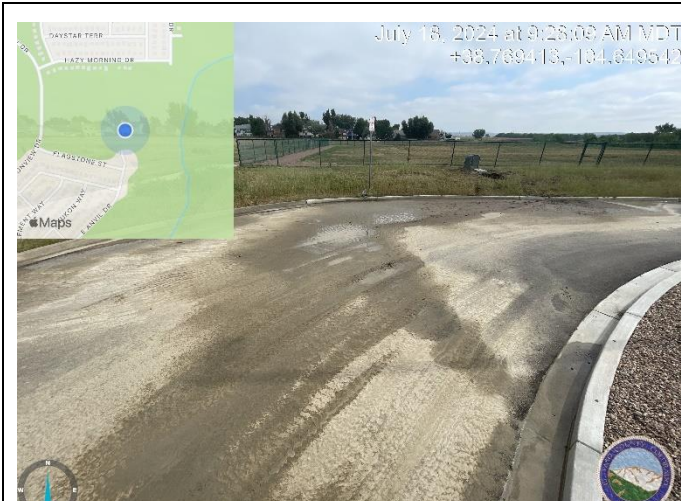
Photo 3: Remove sediment from driveway in front of building

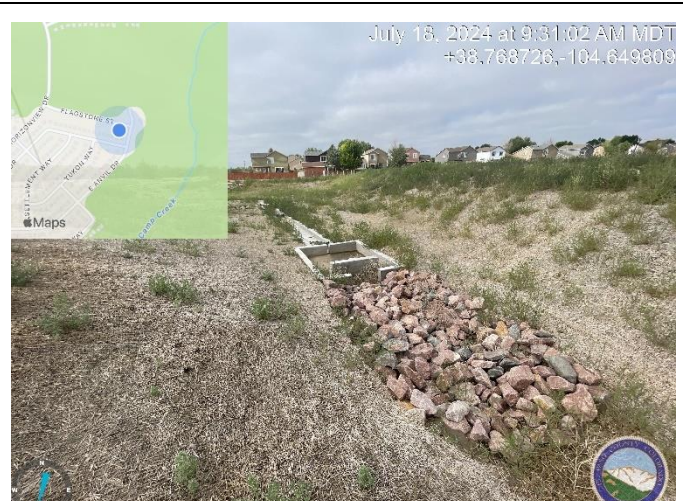
Photo 4: Riprap in front of forebay not on approved plans. Include on as built.

- Forebay
 - The riprap above forebay not on approved plans. Include on as-builts. See photo 4.
- Riprap Rundown
 - Small blowout on north side of riprap rundown. Reshape to eliminate the cause of erosion. There appears to be a hump towards the top of the riprap rundown which may be causing bypass. There should be a 2' wide flat bottom. See photos 5 and 6.

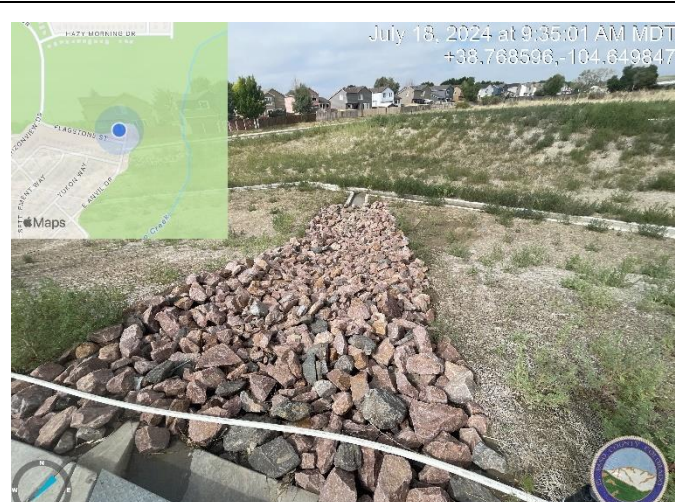
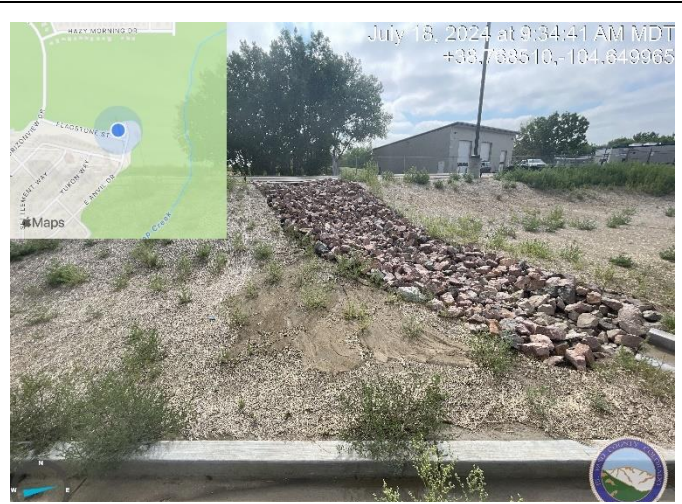
Photo 5: Small blowout on north side of riprap rundown. Eliminate the cause of erosion.

Photo 6: Small blowout on north side of riprap rundown. Eliminate the cause of erosion.

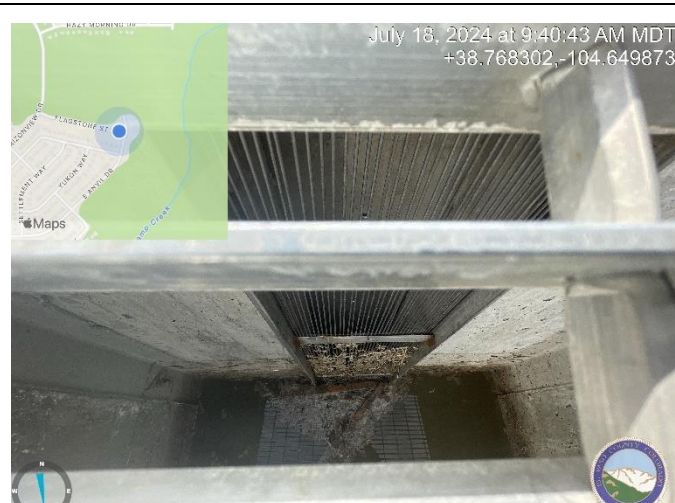
Photo 7: Microscreen not the correct material. Plans call for Johnson Vee Wire.

- Microscreen (Right)
 - Microscreen currently installed is not the correct material. Plans call for No. 93 Johnson Vee-Wire or equivalent with 0.14" gaps between bars. What is present is 0.25"-0.50" gaps and is not equivalent. See photo 7. See sheet C6 for detail on Trash Screen.

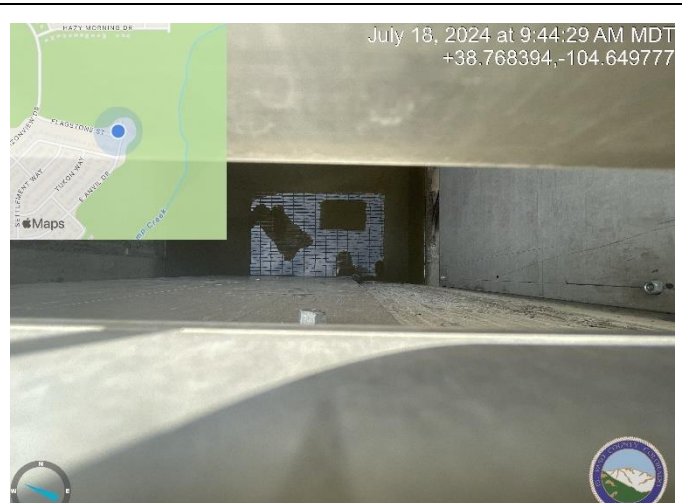
Photo 8: Gasket on orifice plate not sealed. Reinstall.

- Orifice Plate
 - The gasket at the orifice plate is not dislodged and is not creating a seal. Reinstalled. See photo 8.
- Restrictor Plate
 - Plans call for 6" from invert. Opening is 8" in the field. Include on as-builts.

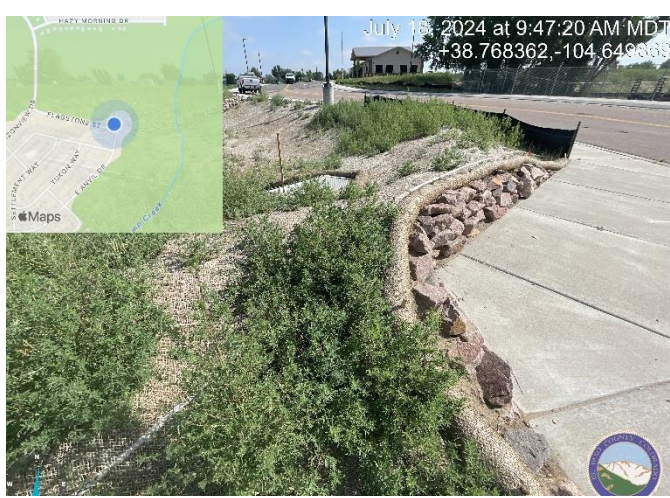
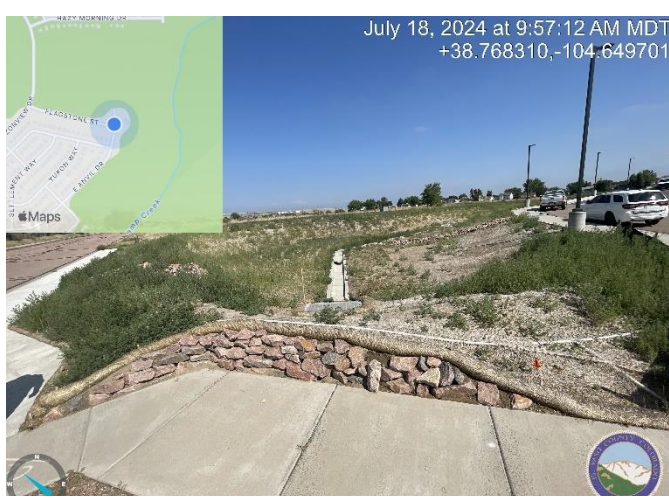
Photo 9: Retaining wall (Approx. 2'H x 22'L) not on approved plans. Include on as built.

Photo 10: Retaining wall (Approx. 2'H x 22'L) not on approved plans. Include on as built.

- Retaining wall adjacent to the sidewalk is not on approved plans. If design engineer recommends leaving in place, include justification and put on as-builts. See photos 9 and 10.

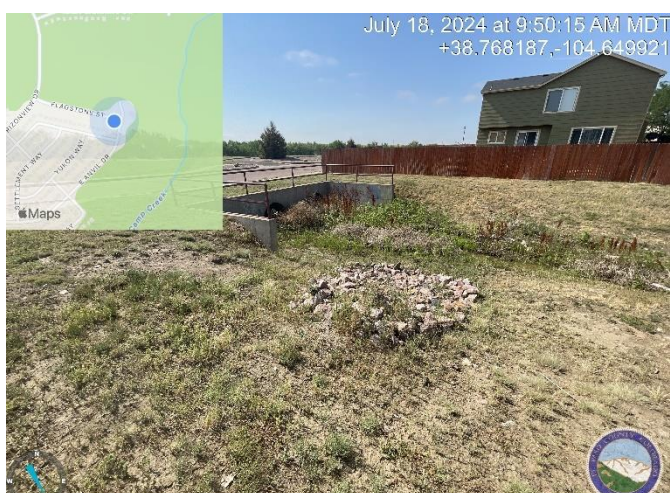
Photo 11: Pond outfall for reference.
