DEVIATION REQUEST AND DECISION FORM

Project Name : Eagle Rising
Schedule No.(s) : 52290-00-034
Legal Description : See Attached

A deviation from the standards of or in Section 6.5.2 & Table 10-4 of the Engineering Criteria Manual (ECM) is requested.

Section 6.5.2. Channel Velocity

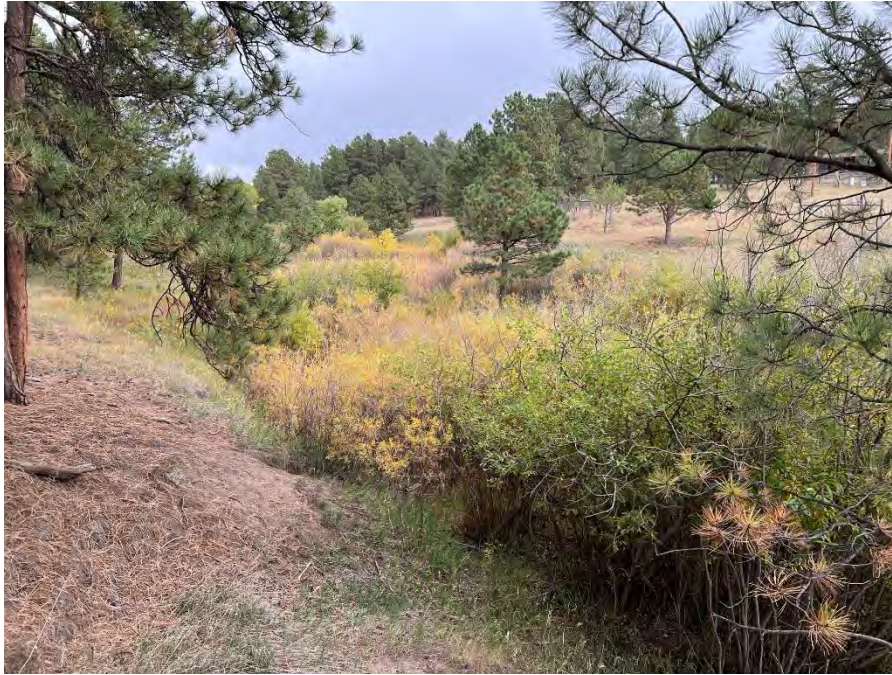
1

Looking downstream
from 250 feet
downstream of
Cottonwood Creek
DBPS Design Point
82.

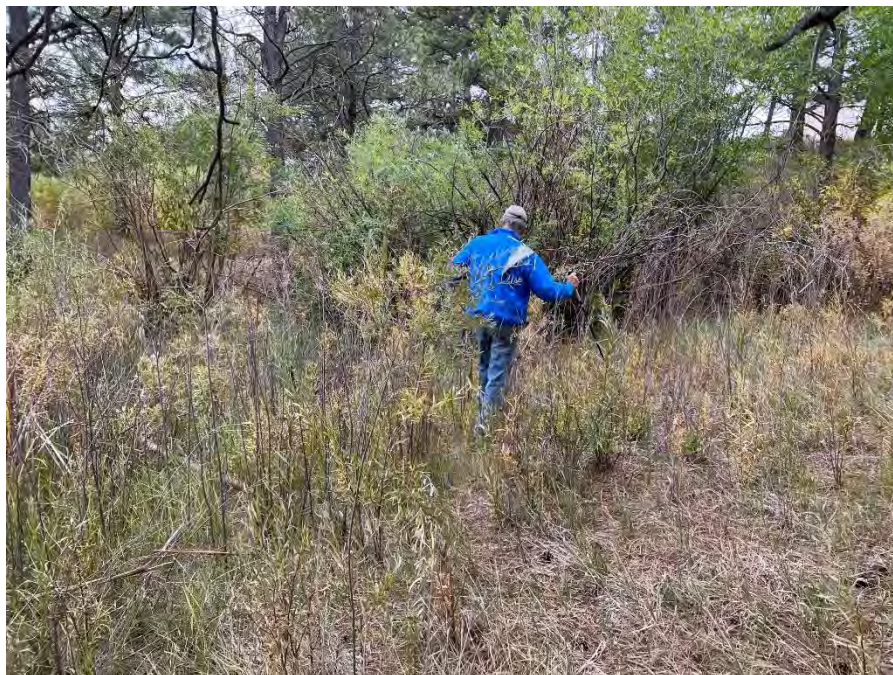
14

Looking at heavy vegetation downstream, from Design Point 6C.

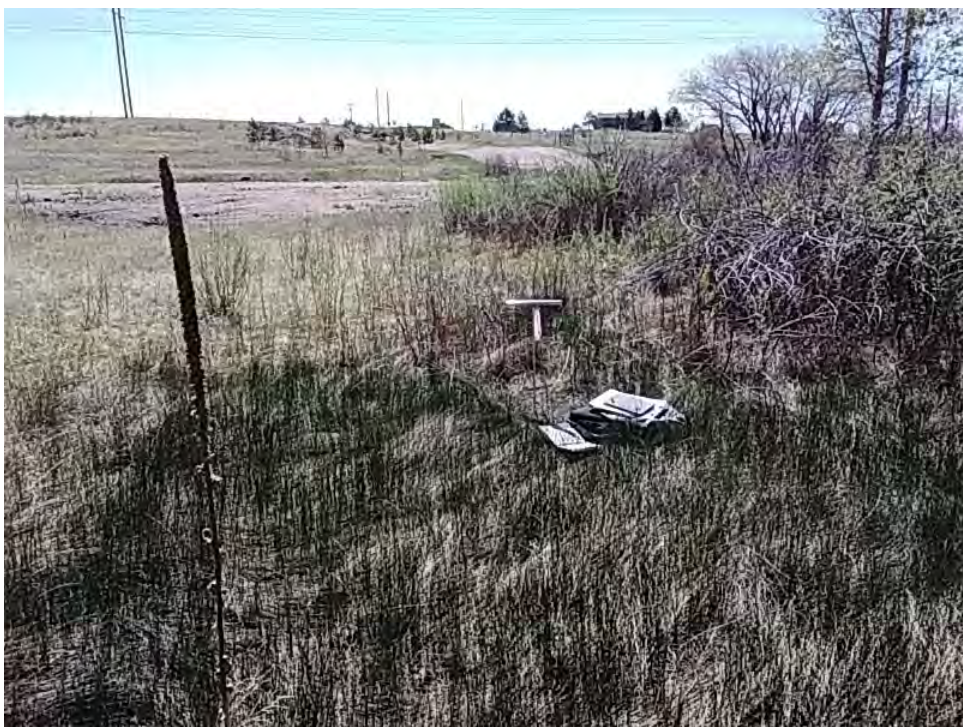
Photo W1-WET (West Drainage): View east of PEM/PSS wetlands at downstream end of West Drainage (upstream of remnant/removed stock pond embankment).

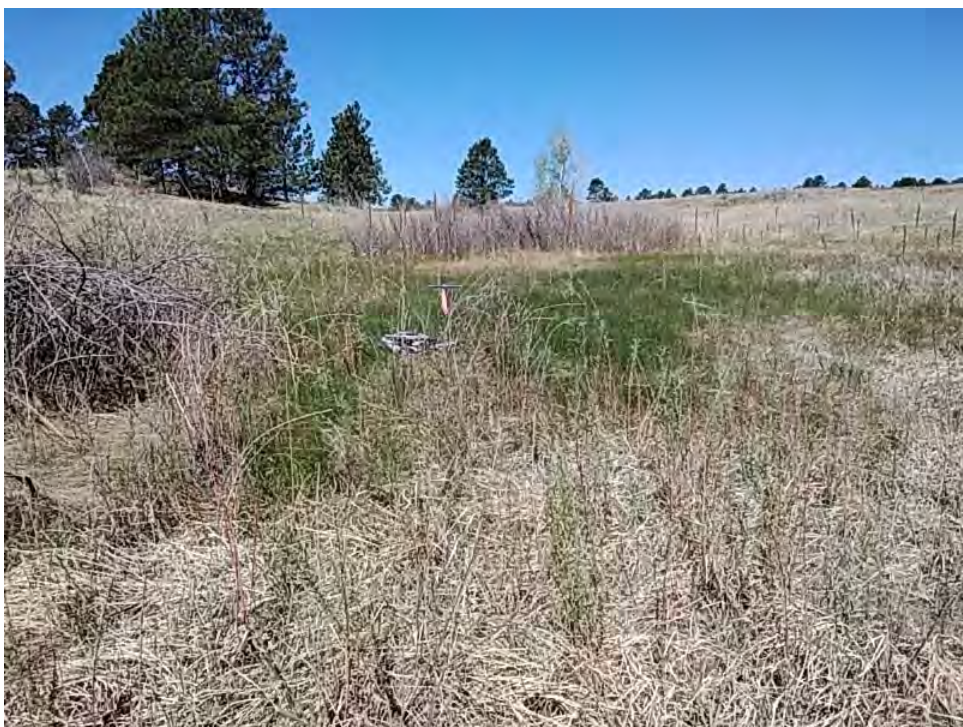
Photo W1-WET (West Drainage): View west of PEM/PSS wetlands at downstream end of West Drainage (upstream of remnant/removed stock pond embankment).

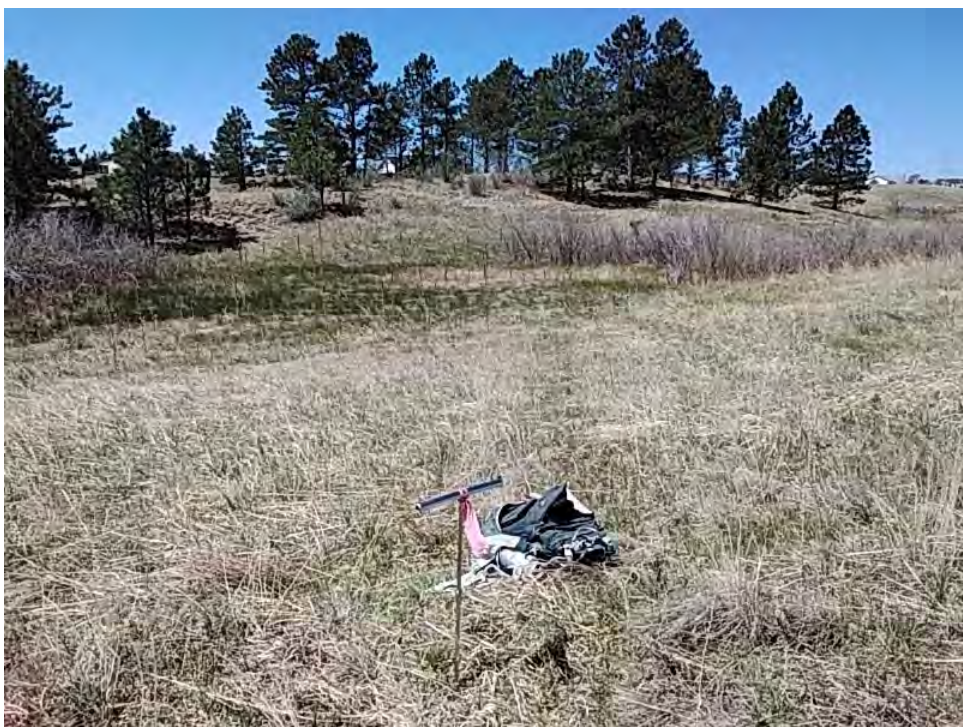
Photo W2-UPL (West Drainage): View west of PEM/PSS wetlands at downstream end of West Drainage (upstream of remnant /removed stock pond embankment).

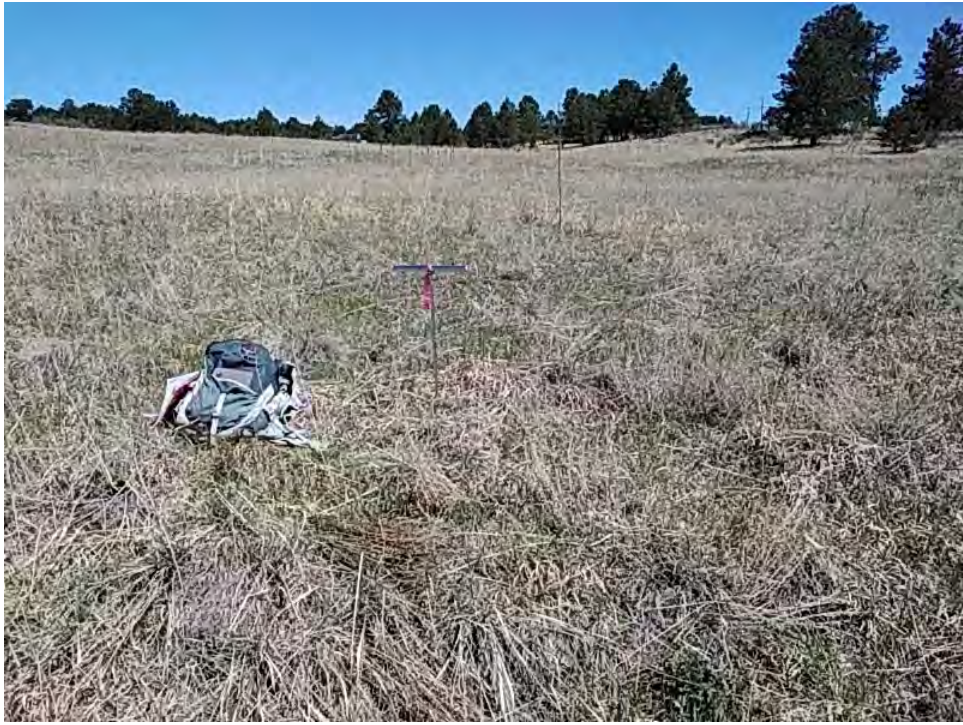
Photo W2-UPL (West Drainage): View north of uplands located north of PEM/PSS wetlands at downstream end of West Drainage (upstream of remnant/removed stock pond embankment).

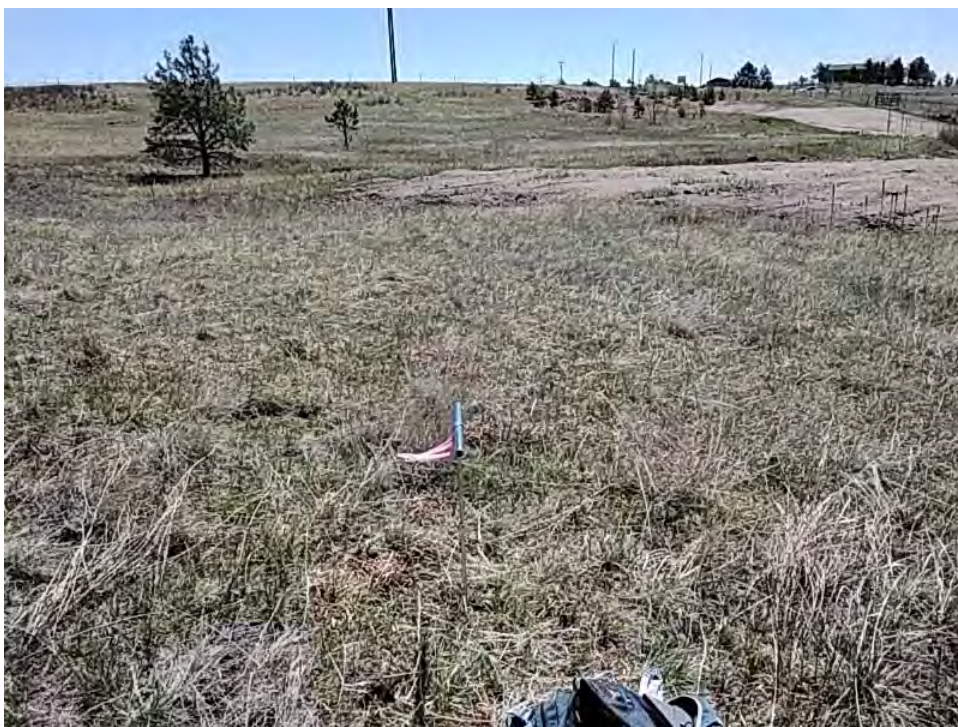
Photo W2-UPL (West Drainage): View east of PEM/PSS wetlands at downstream end of West Drainage within east lobe of remnant/removed stock pond embankment.

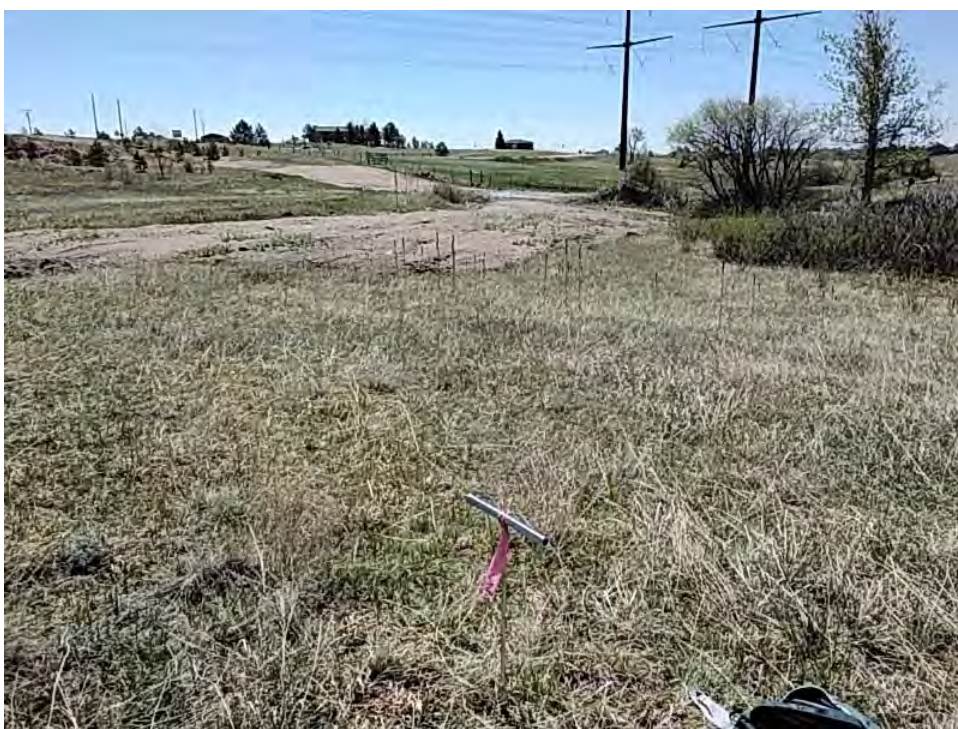
Photo W2-UPL (West Drainage): View southeast of PEM/PSS wetlands at downstream end of West Drainage within east lobe of remnant stock pond where embankment was removed.

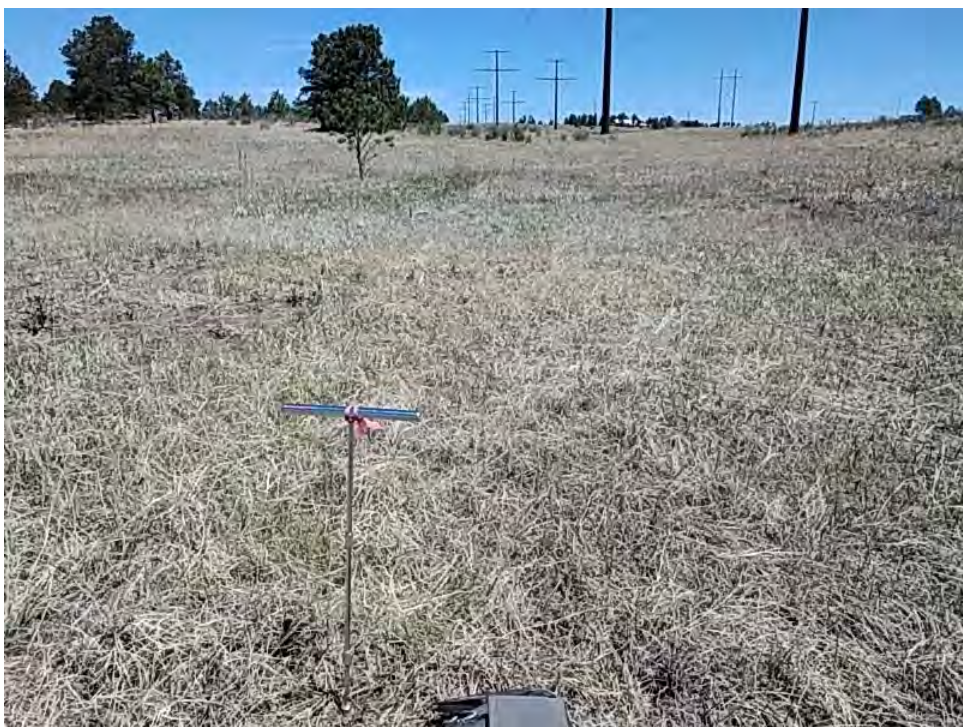
Photo W3-WET (West Drainage): View north of PEM wetlands at downstream end of West Drainage within east lobe of remnant/removed stock pond.

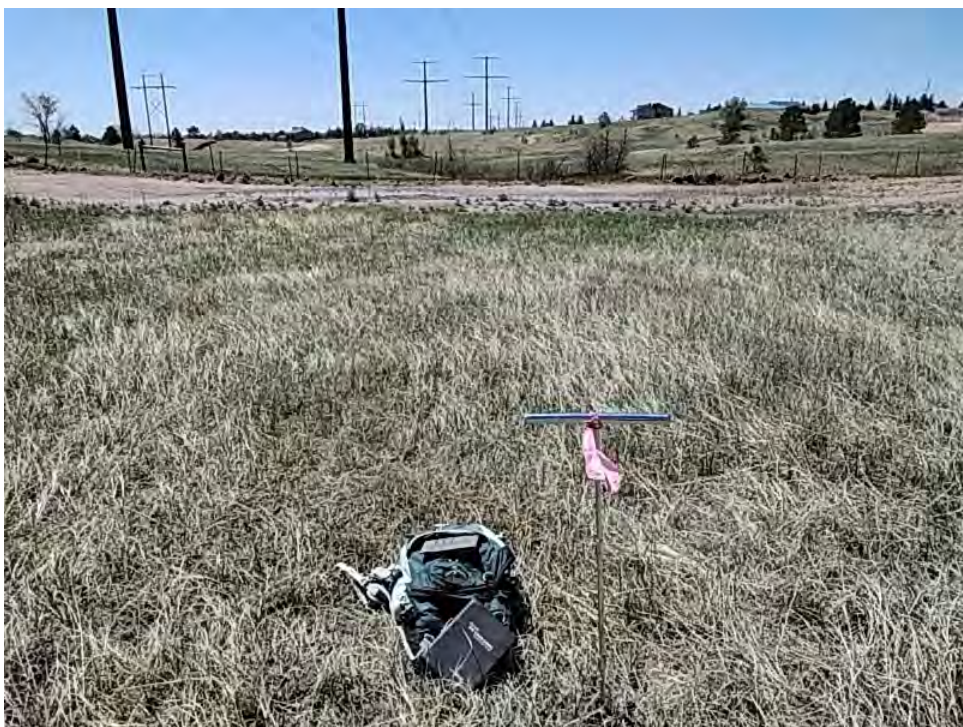
Photo W3-WET (West Drainage): View south of PEM wetlands at downstream end of West Drainage within east lobe of remnant/removed stock pond.

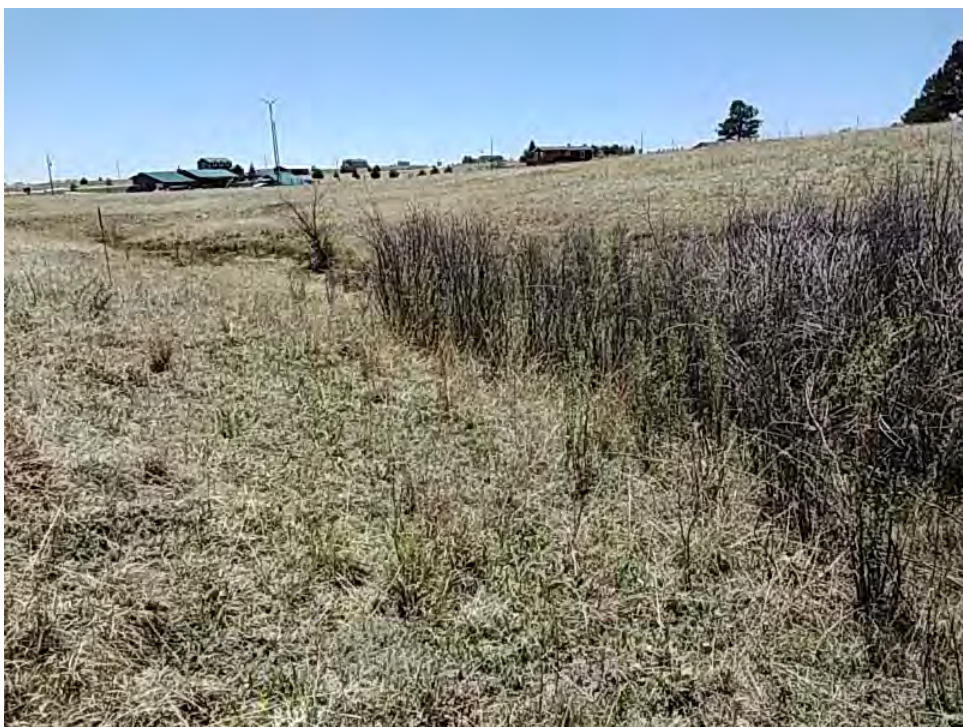
Photo W6-WET (West Drainage): View south of PEM/PSS wetlands within central reach of West Drainage.

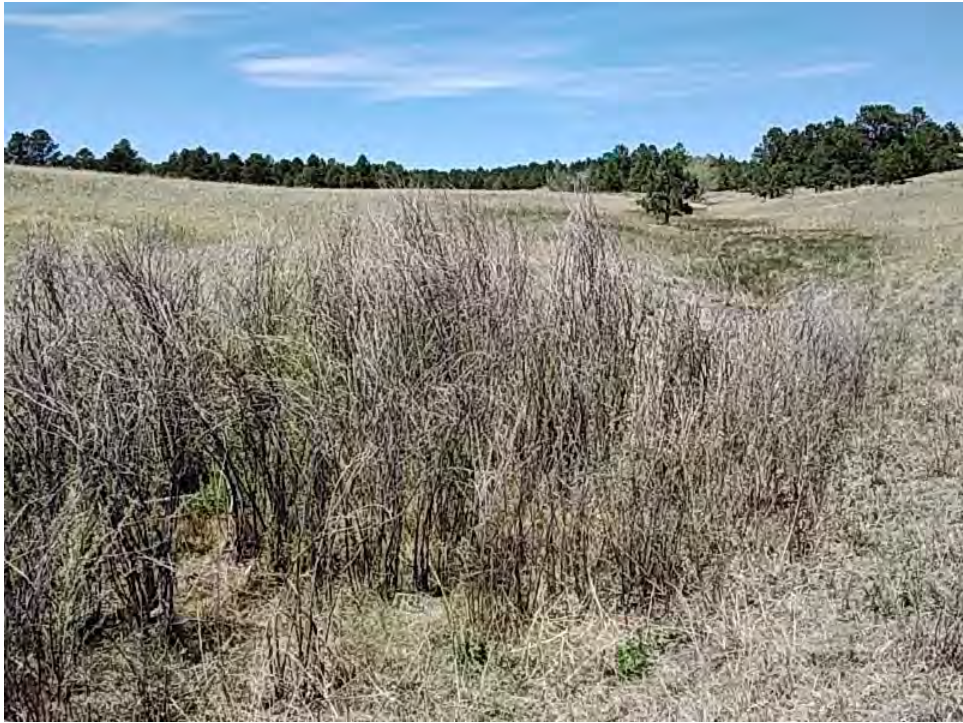
Photo W6-WET (West Drainage): View north of PEM/PSS wetlands within central reach of West Drainage.

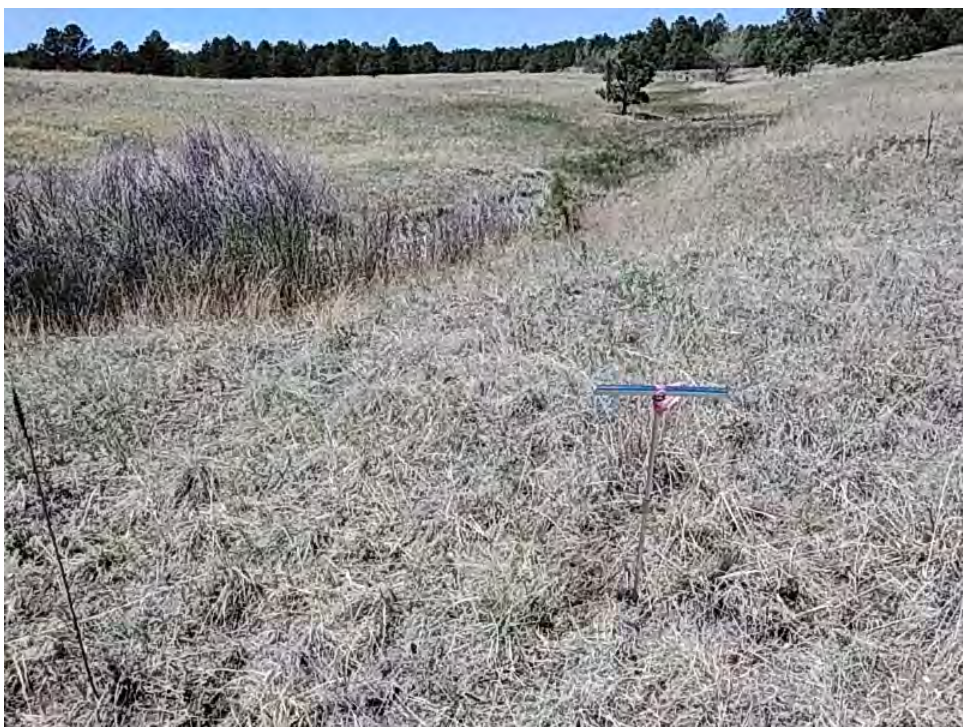
Photo W7-UPL (West Drainage): View north of PEM/PSS wetlands and adjacent uplands within central reach of West Drainage.

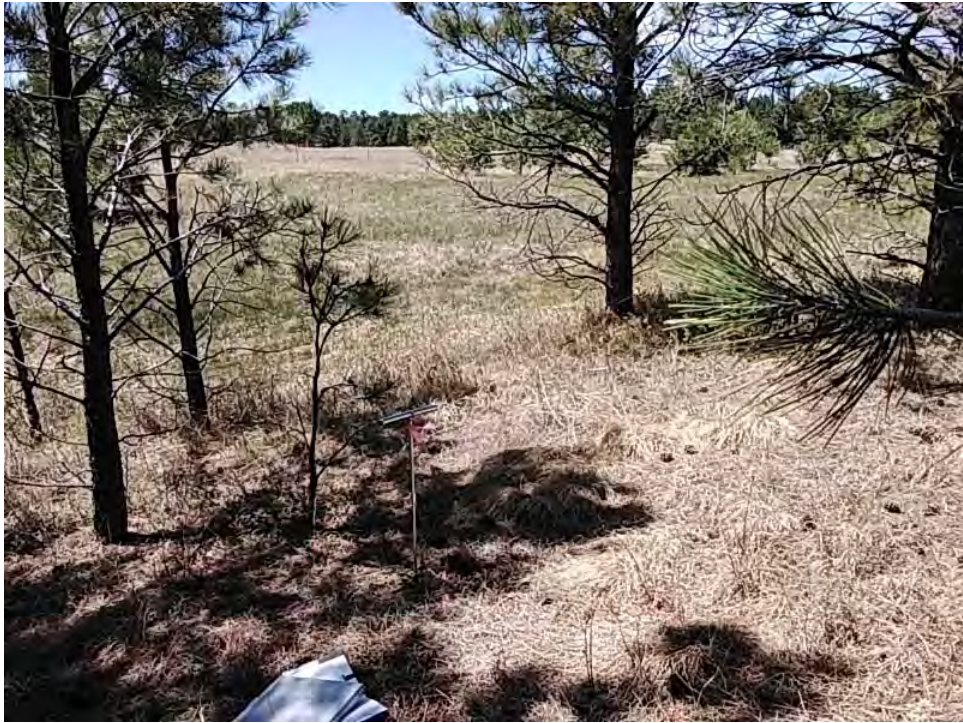
Photo W8-UPL (West Drainage): View west of PEM wetlands and adjacent uplands within upper central reach of West Drainage.

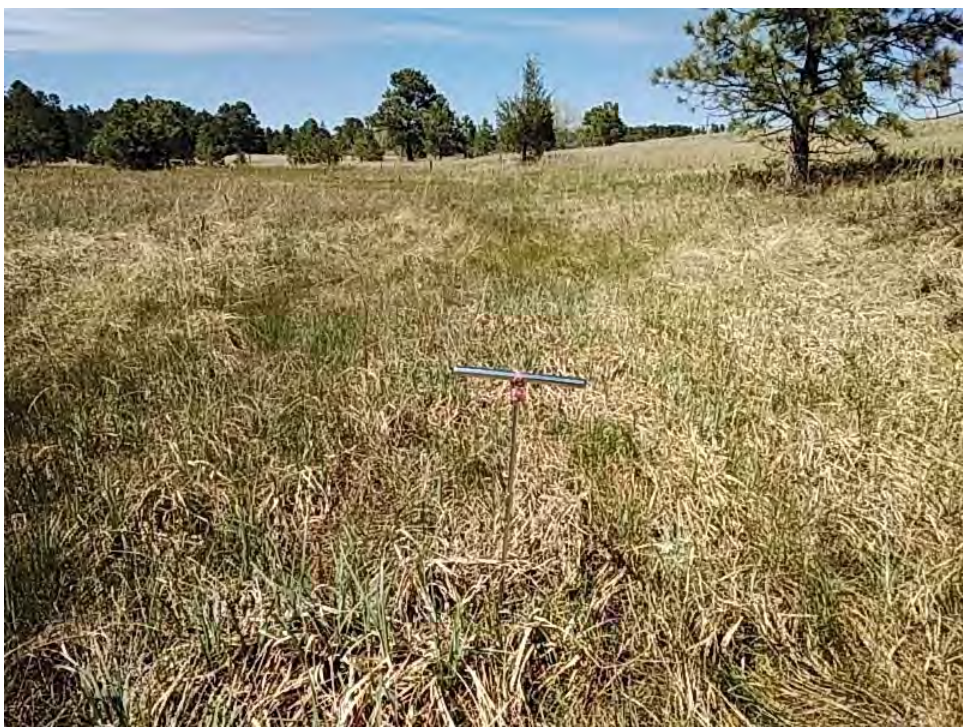
Photo W9-WET (West Drainage): View north of PEM wetlands within upper central reach of West Drainage.

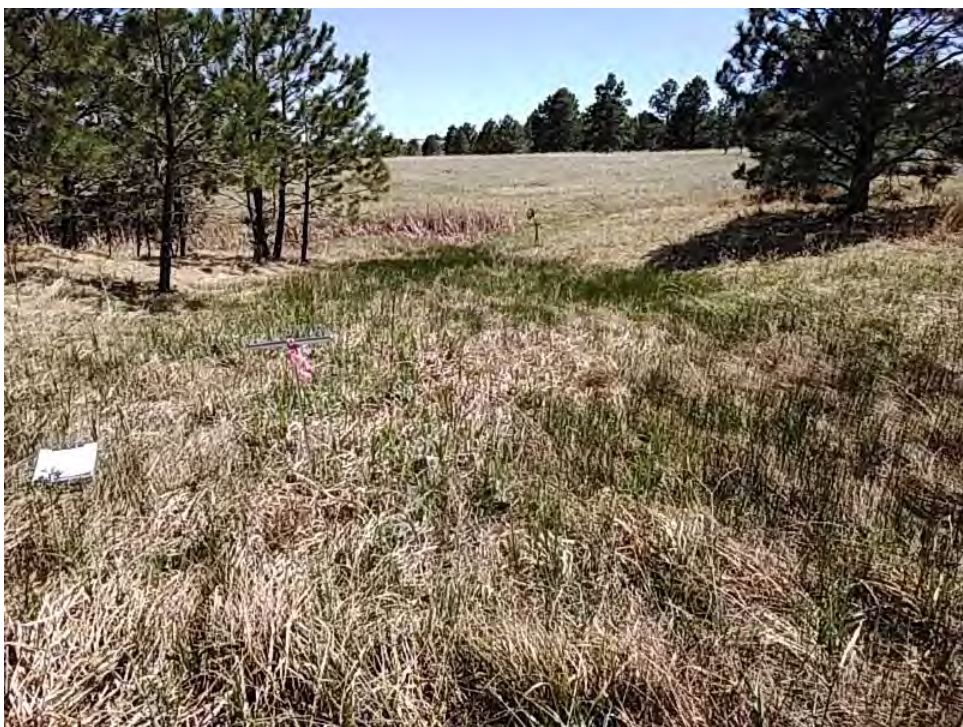
Photo W9-WET (West Drainage): View south of PEM wetlands within upper central reach of West Drainage.

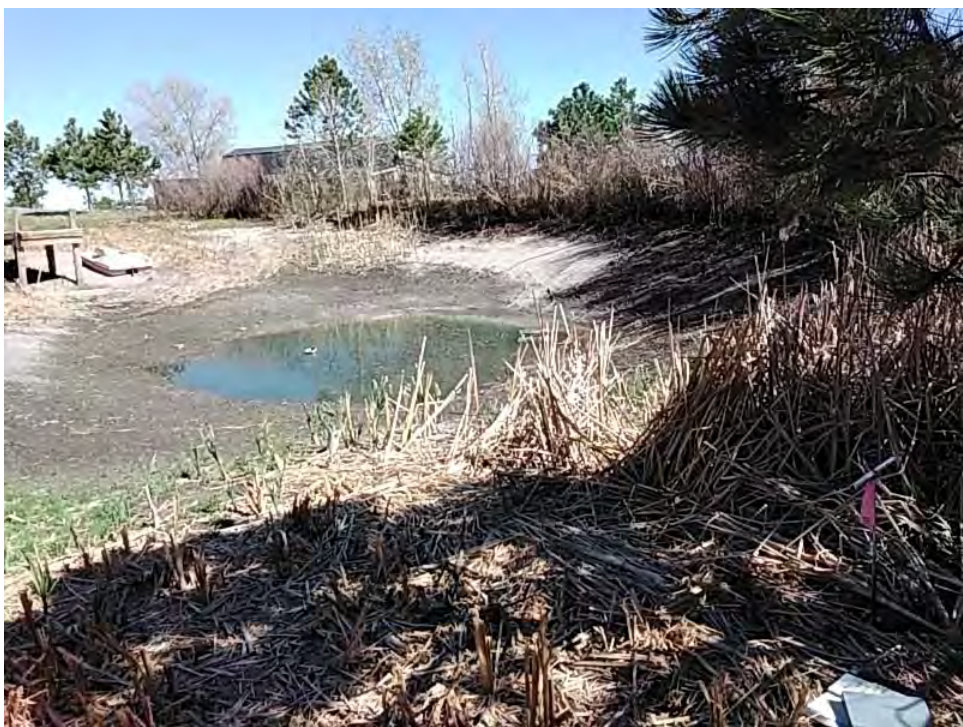
Photo W10-WET (West Drainage): View northeast of PEM/PSS wetland fringe around man-made pond at upper end reach of West Drainage.

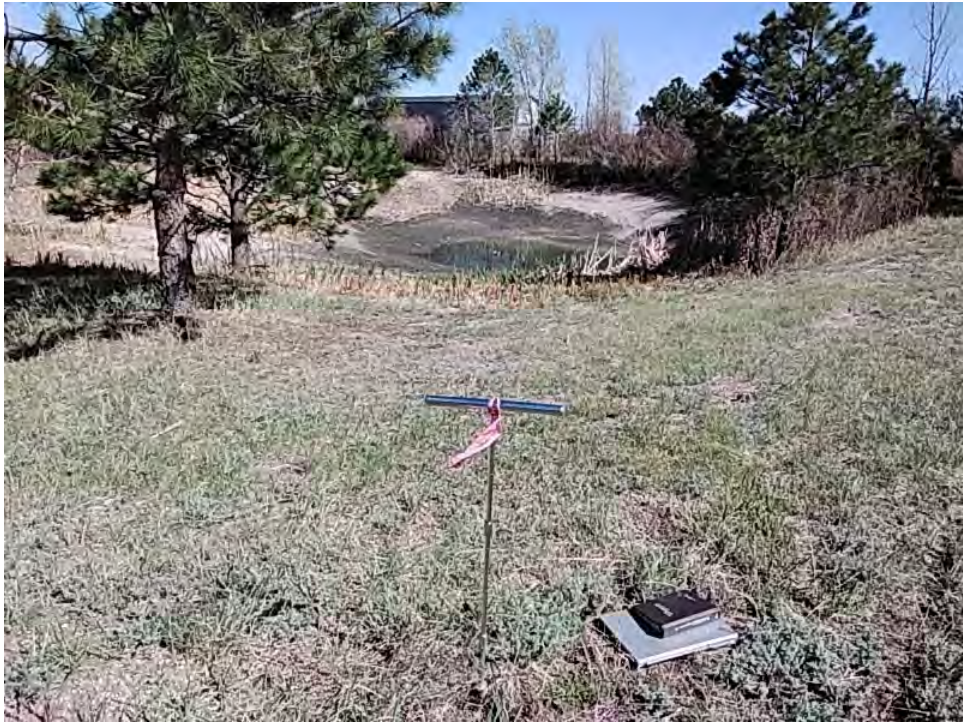
Photo W11-UPL (West Drainage): View southeast of PEM/PSS wetland fringe and adjacent uplands around man-made pond at upper end reach of West Drainage.

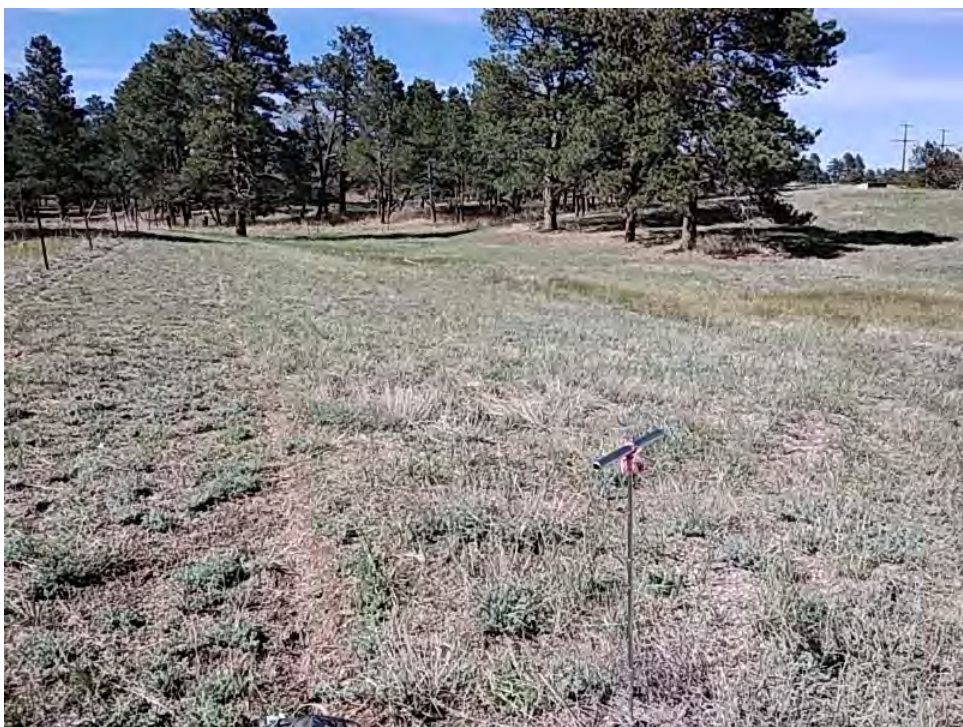
Photo W11-UPL (West Drainage): View north of onsite adjacent uplands upslope of man-made pond.

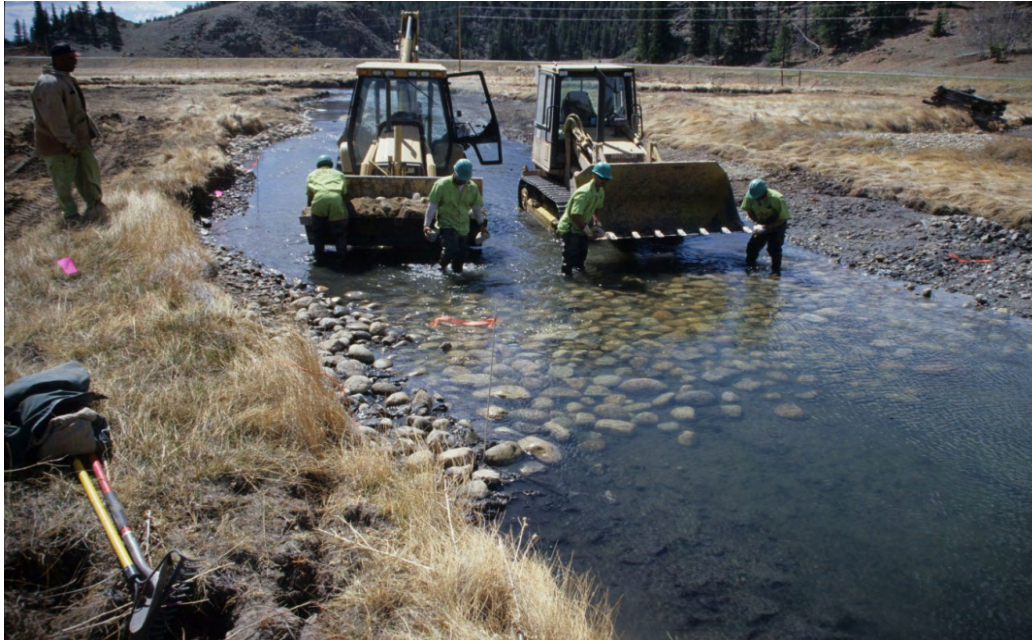
Figure A.2. Elevating riffle substrate.

Figures A.2–A.9 provide examples of the types of in-stream restoration activities that may be employed.

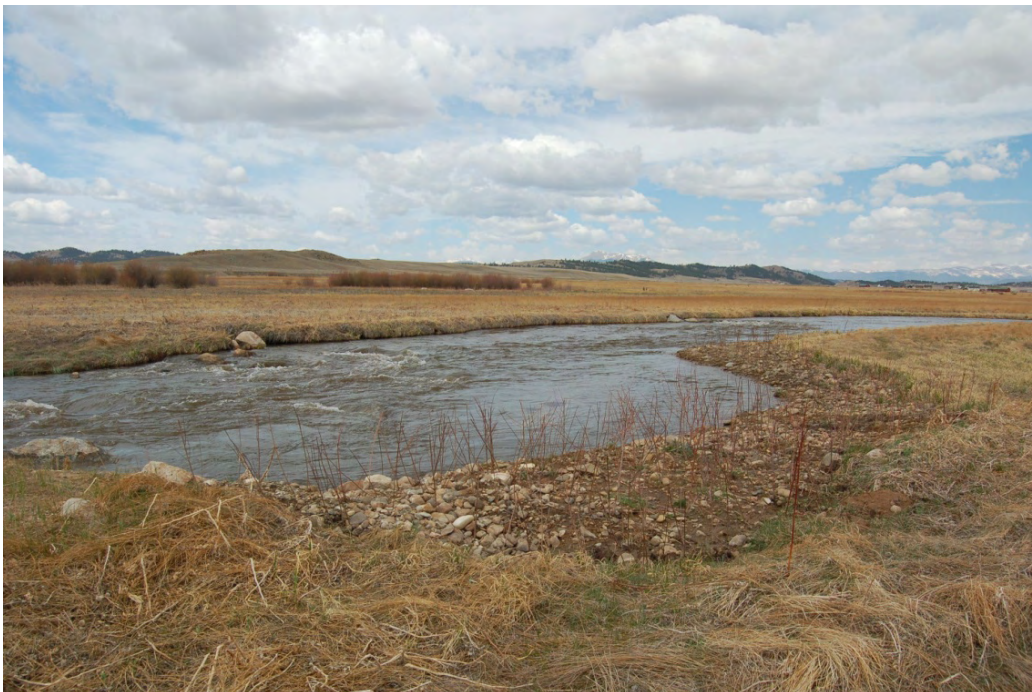
Figure A.3. Reducing channel width by adding fill.
