# DEVIATION REQUEST AND DECISION FORM

Project Name :	Eagle Rising
Schedule No.(s) :	52290-00-034
Legal Description :	See Attached

A deviation from the standards of or in Section **6.5.2 & Table 10-4** of the Engineering Criteria Manual (ECM) is requested.

Section 6.5.2. Channel Velocity

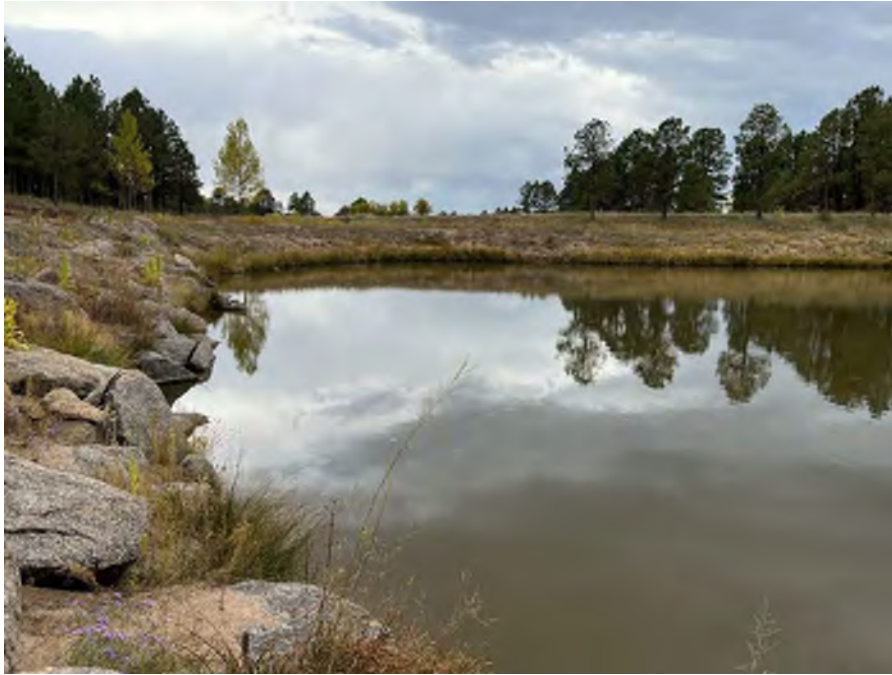
11

Looking downstream from 200 feet downstream of Cottonwood Creek DBPS Design Point 102. Emergency spillway on left corner of pond.

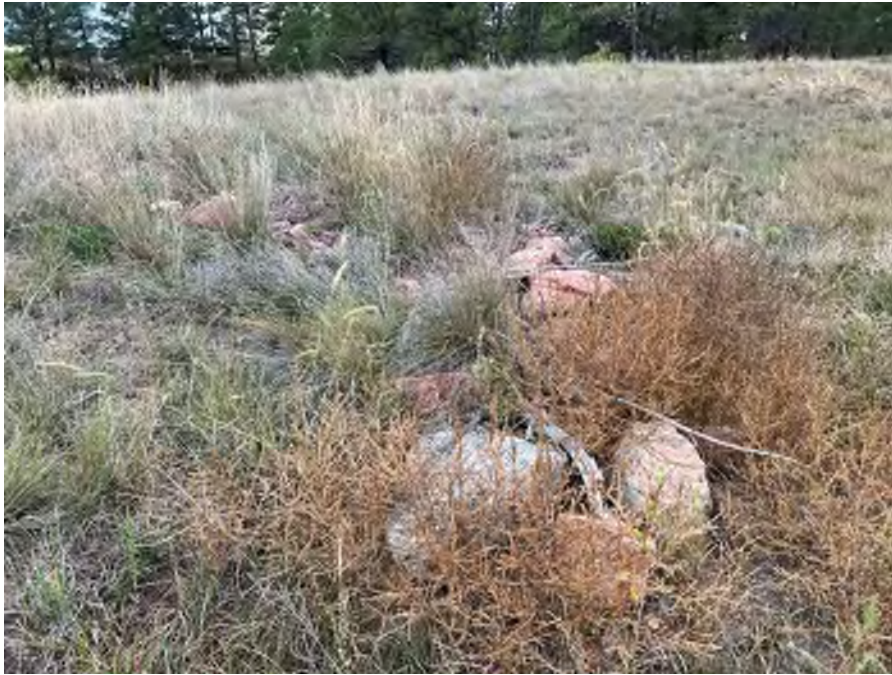
13

Buried and partially buried riprap at emergency overflow, from Cottonwood Creek DBPS Design Point 104.

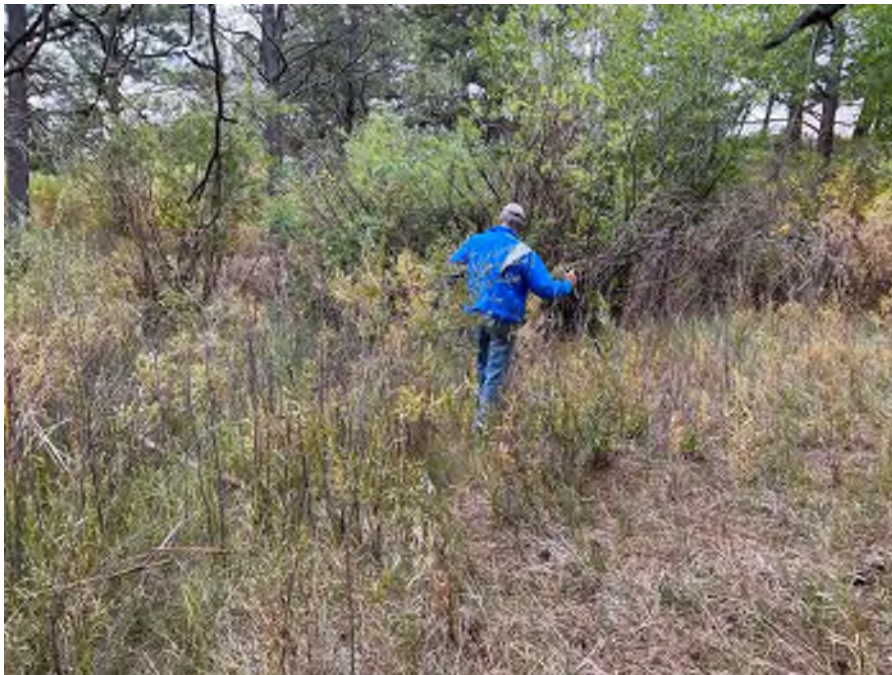
14

Looking at heavy vegetation downstream, from Design Point 6C.

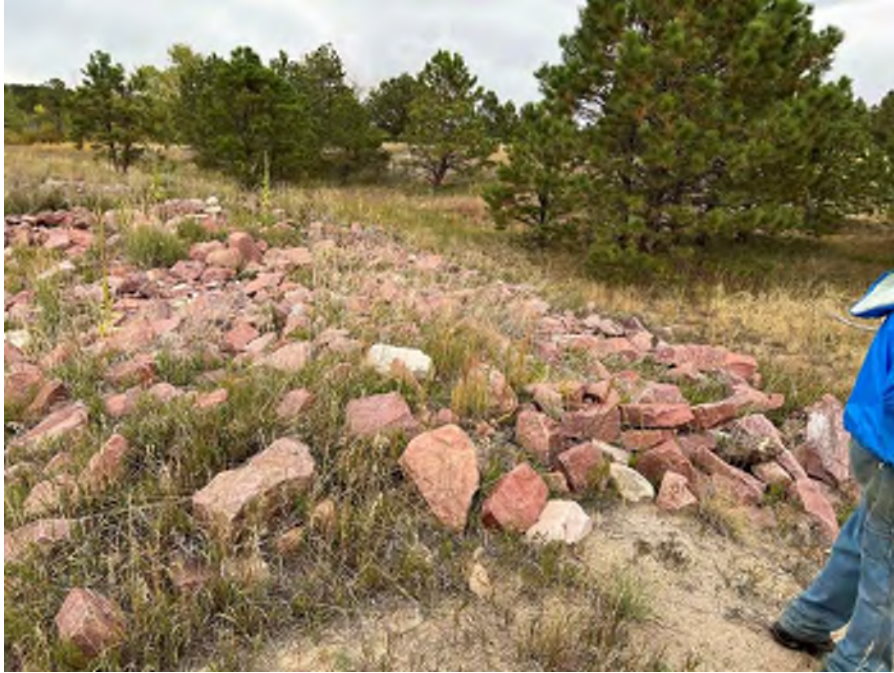
27

Looking upstream towards riprap for Pond 2 emergency overflow from east bank 550 feet downstream of Design Point 10.

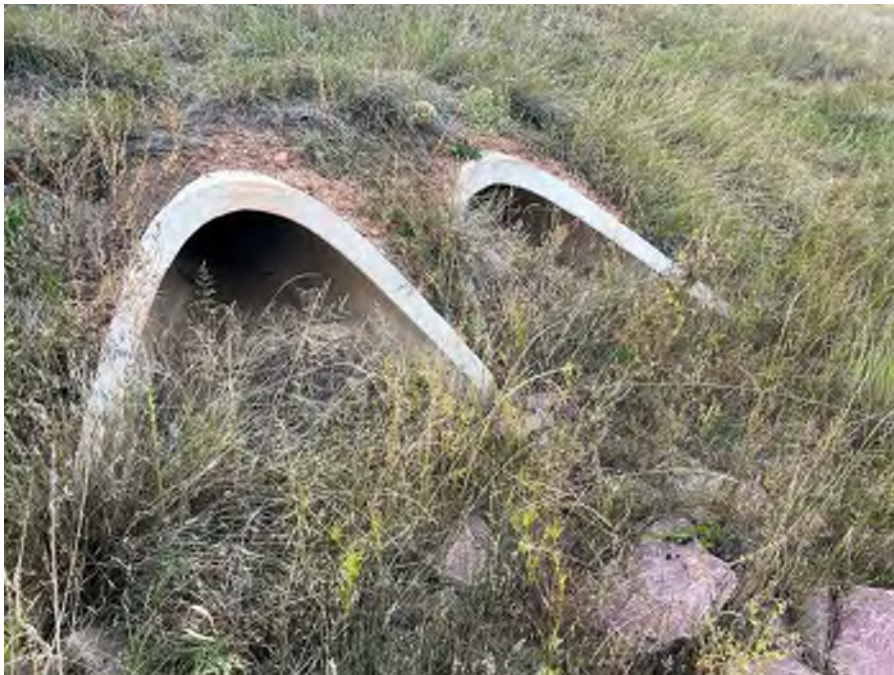
30

Looking north at culverts, on the east side of the road from 100 feet south of Design Point 8A.

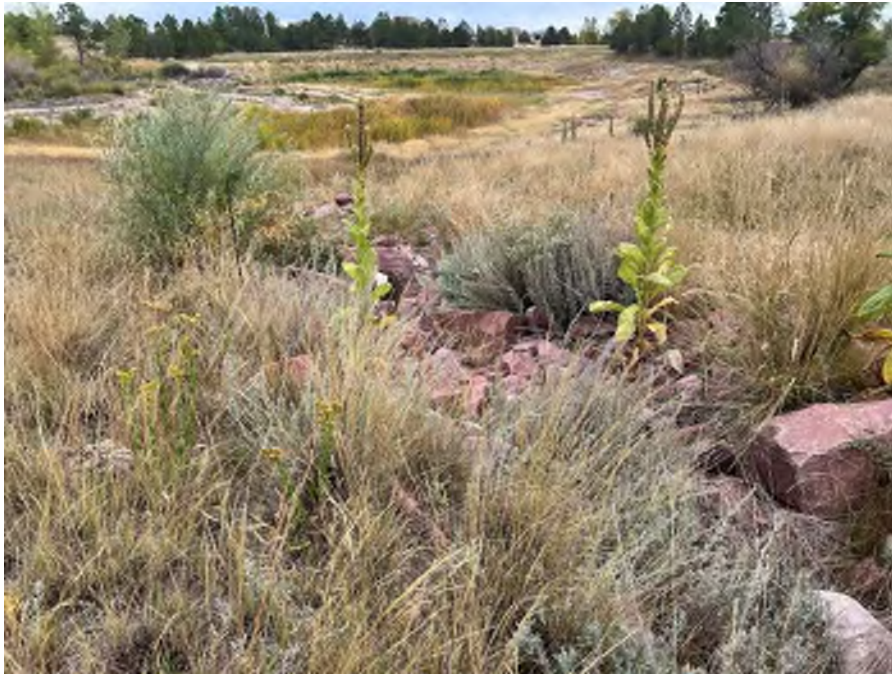
31

Riprap lining  
downstream from  
DP8A, from 100 feet  
north of Design Point  
12.

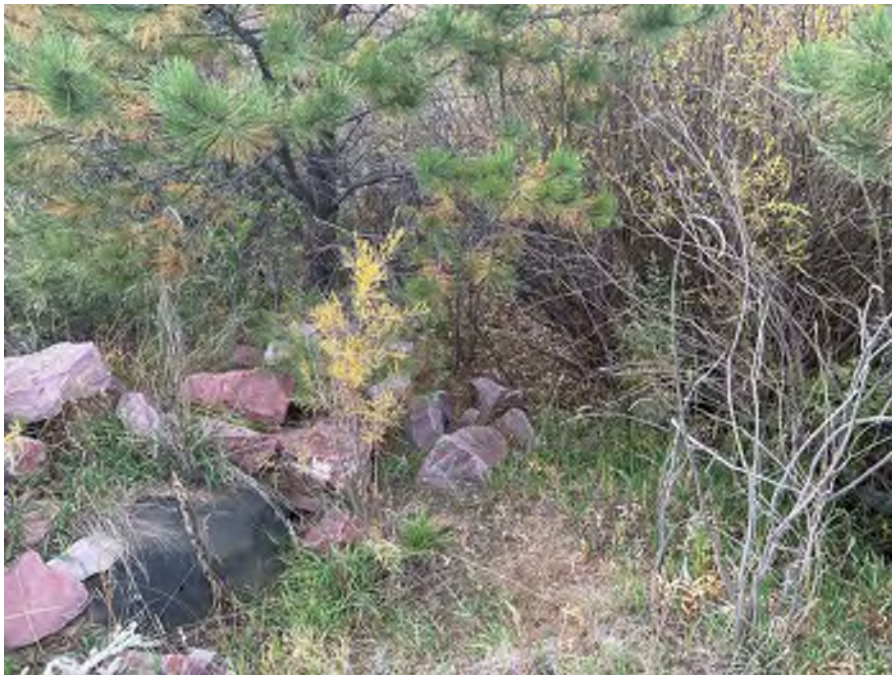
34

Riprap lined swale from barn area to creek, in need of additional riprap. Just west of Design Point 104.

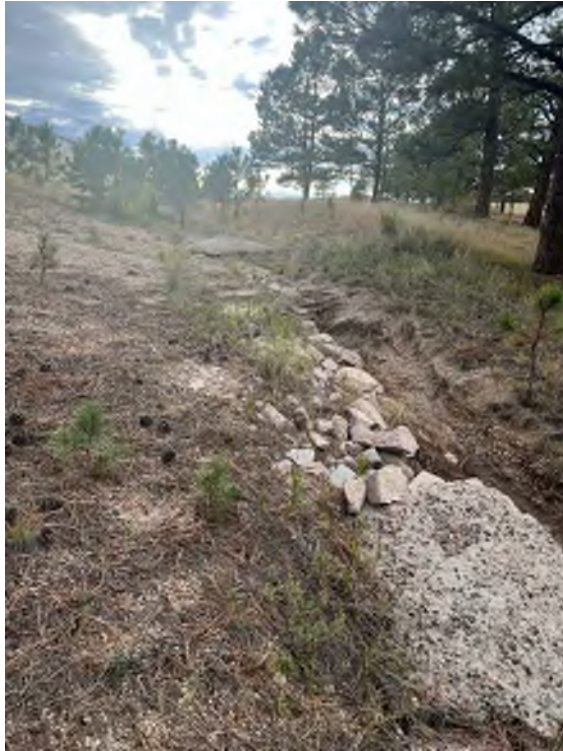
35

Looking west,  
existing riprap lined  
swale in need of  
additional riprap in  
area of Design Point  
6A.

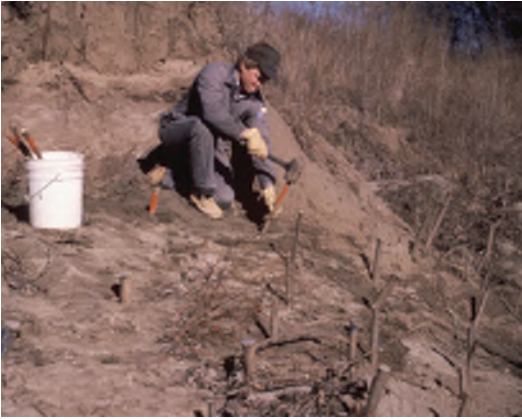
### Willow Stakes

Use stakes where materials need to be driven deeper to improve moisture supply to the stakes.

(1) Cut 1- to 3-inch diameter stems into 18- to 36-inch lengths with a hand saw or chainsaw and remove all lateral stems. (Note: Using an axe or knife to cut the stems may damage the plant.)

(2) Use dibble bar or drive stake with mallet until approximately 3 to 6 inches remain exposed or to refusal. **Do not force and split stake.**

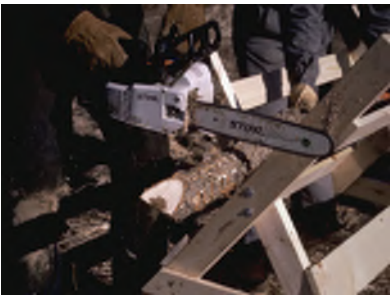
### Willow Posts

Posts can also be used to revegetate stream banks. They are most appropriate in situations where a stable moisture supply is deep in the soil and willow materials need to be driven deeper to reach it. This is a very labor intensive method, but posts can withstand relatively high flows.

(2) Set posts in post holes or drive with post driver so that at least half of the post is buried. Posts must be set deep enough to maintain contact with the water table, but not so deep that they are completely submerged in water year-round.

(3) The damaged top few inches of each post should be cut after planting if posts were driven.
