DEVIATION REQUEST AND DECISION FORM

Project Name : Eagle Rising PCD File No. SP205 & SF2225
Schedule No.(s) : 52290-00-034 & 52290-00-035
Legal Description : See Attached

A deviation from the standards of or in Section(s) **ECM 3.3.3 B and C** of the Engineering Criteria Manual (ECM) is requested.

HEC-RAS Cross Section Location and Photo Key Map

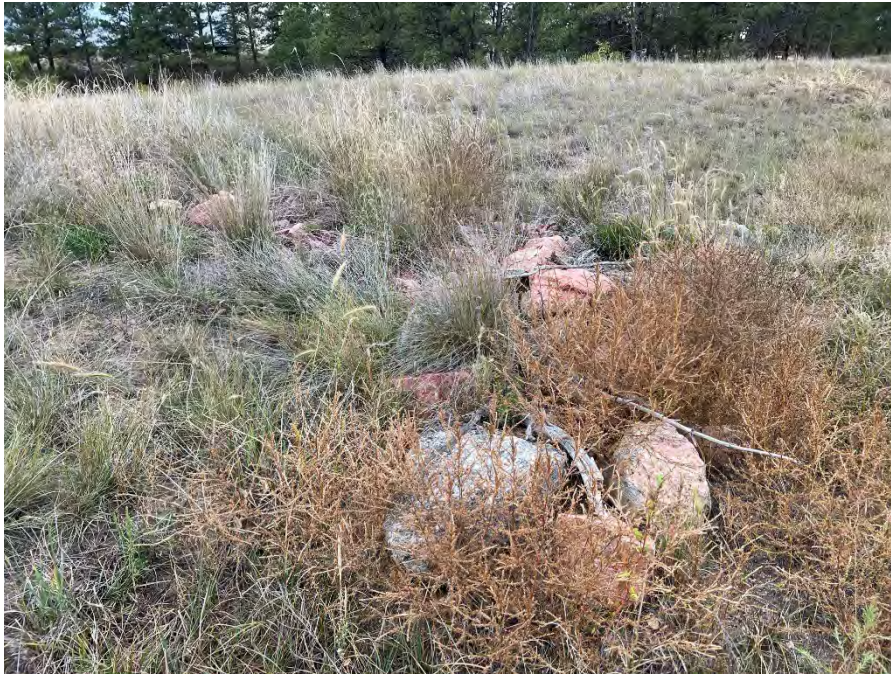
13

Buried and partially buried riprap at emergency overflow, from Cottonwood Creek DBPS Design Point 104.

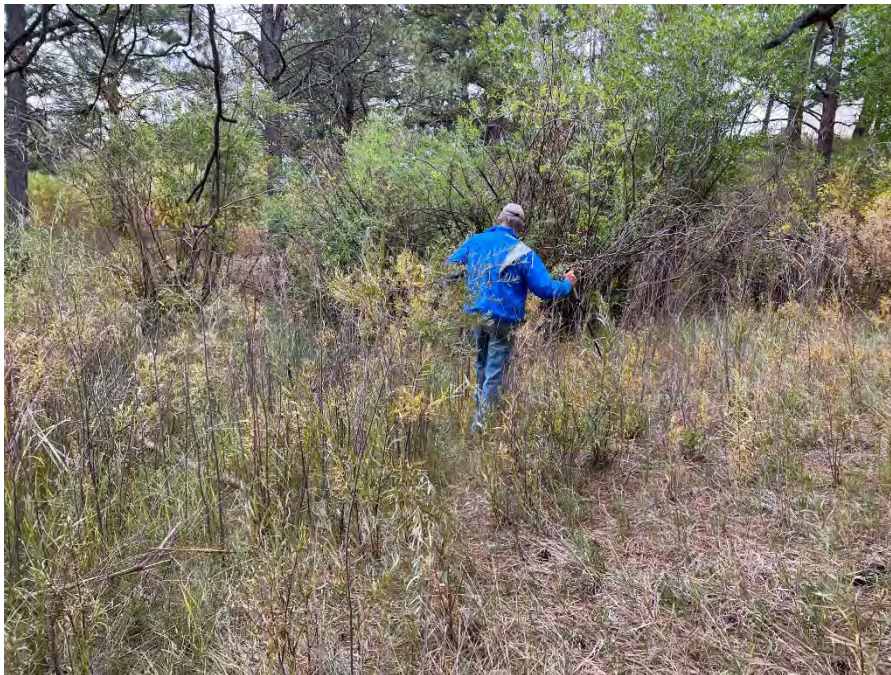
14

Looking at heavy vegetation downstream, from Design Point 6C.

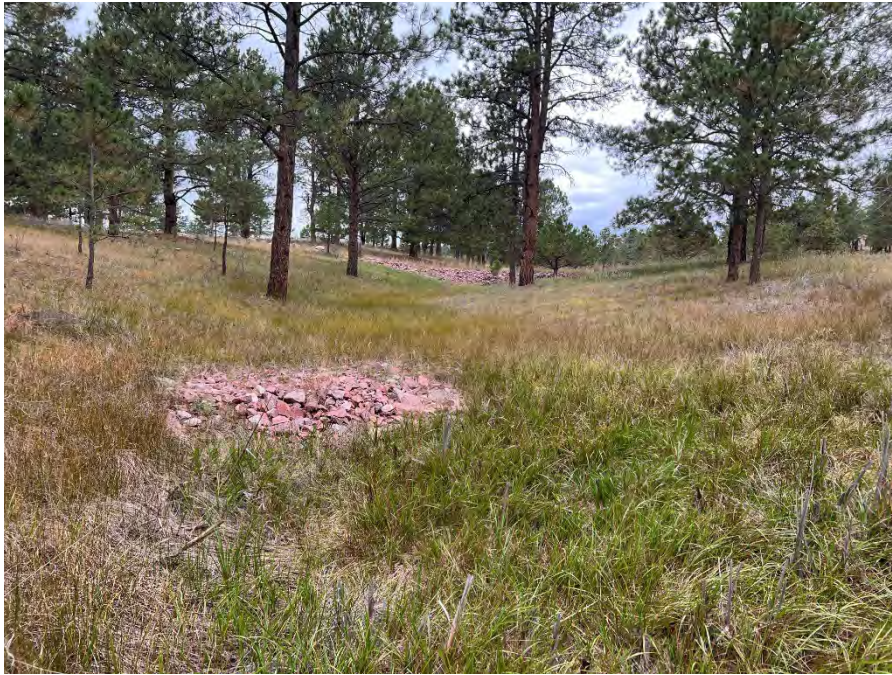
15

Looking at riprap
upstream tributary
flow, from Design
Point 6B.

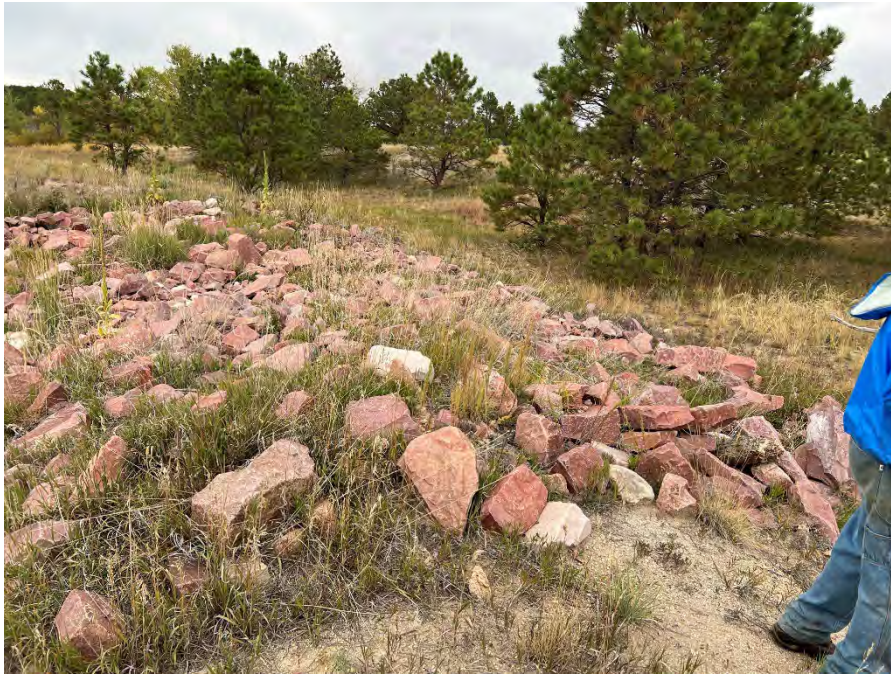
27

Looking upstream
towards riprap of
emergency spillway,
from east bank 550
feet downstream of
Design Point 10.

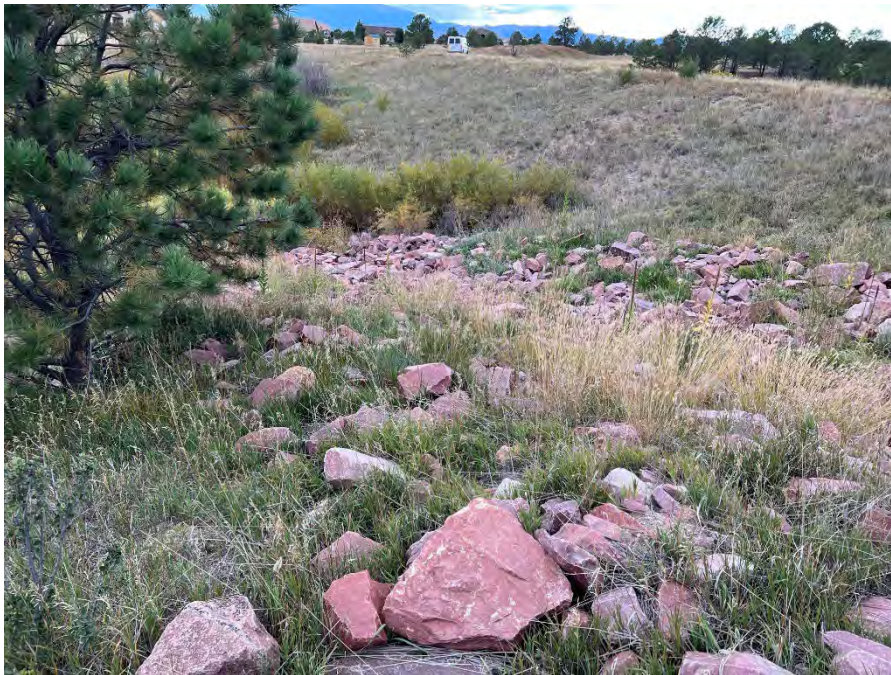
28

Riprap of
emergency spillway,
from east bank 550
feet downstream of
Design Point 10.

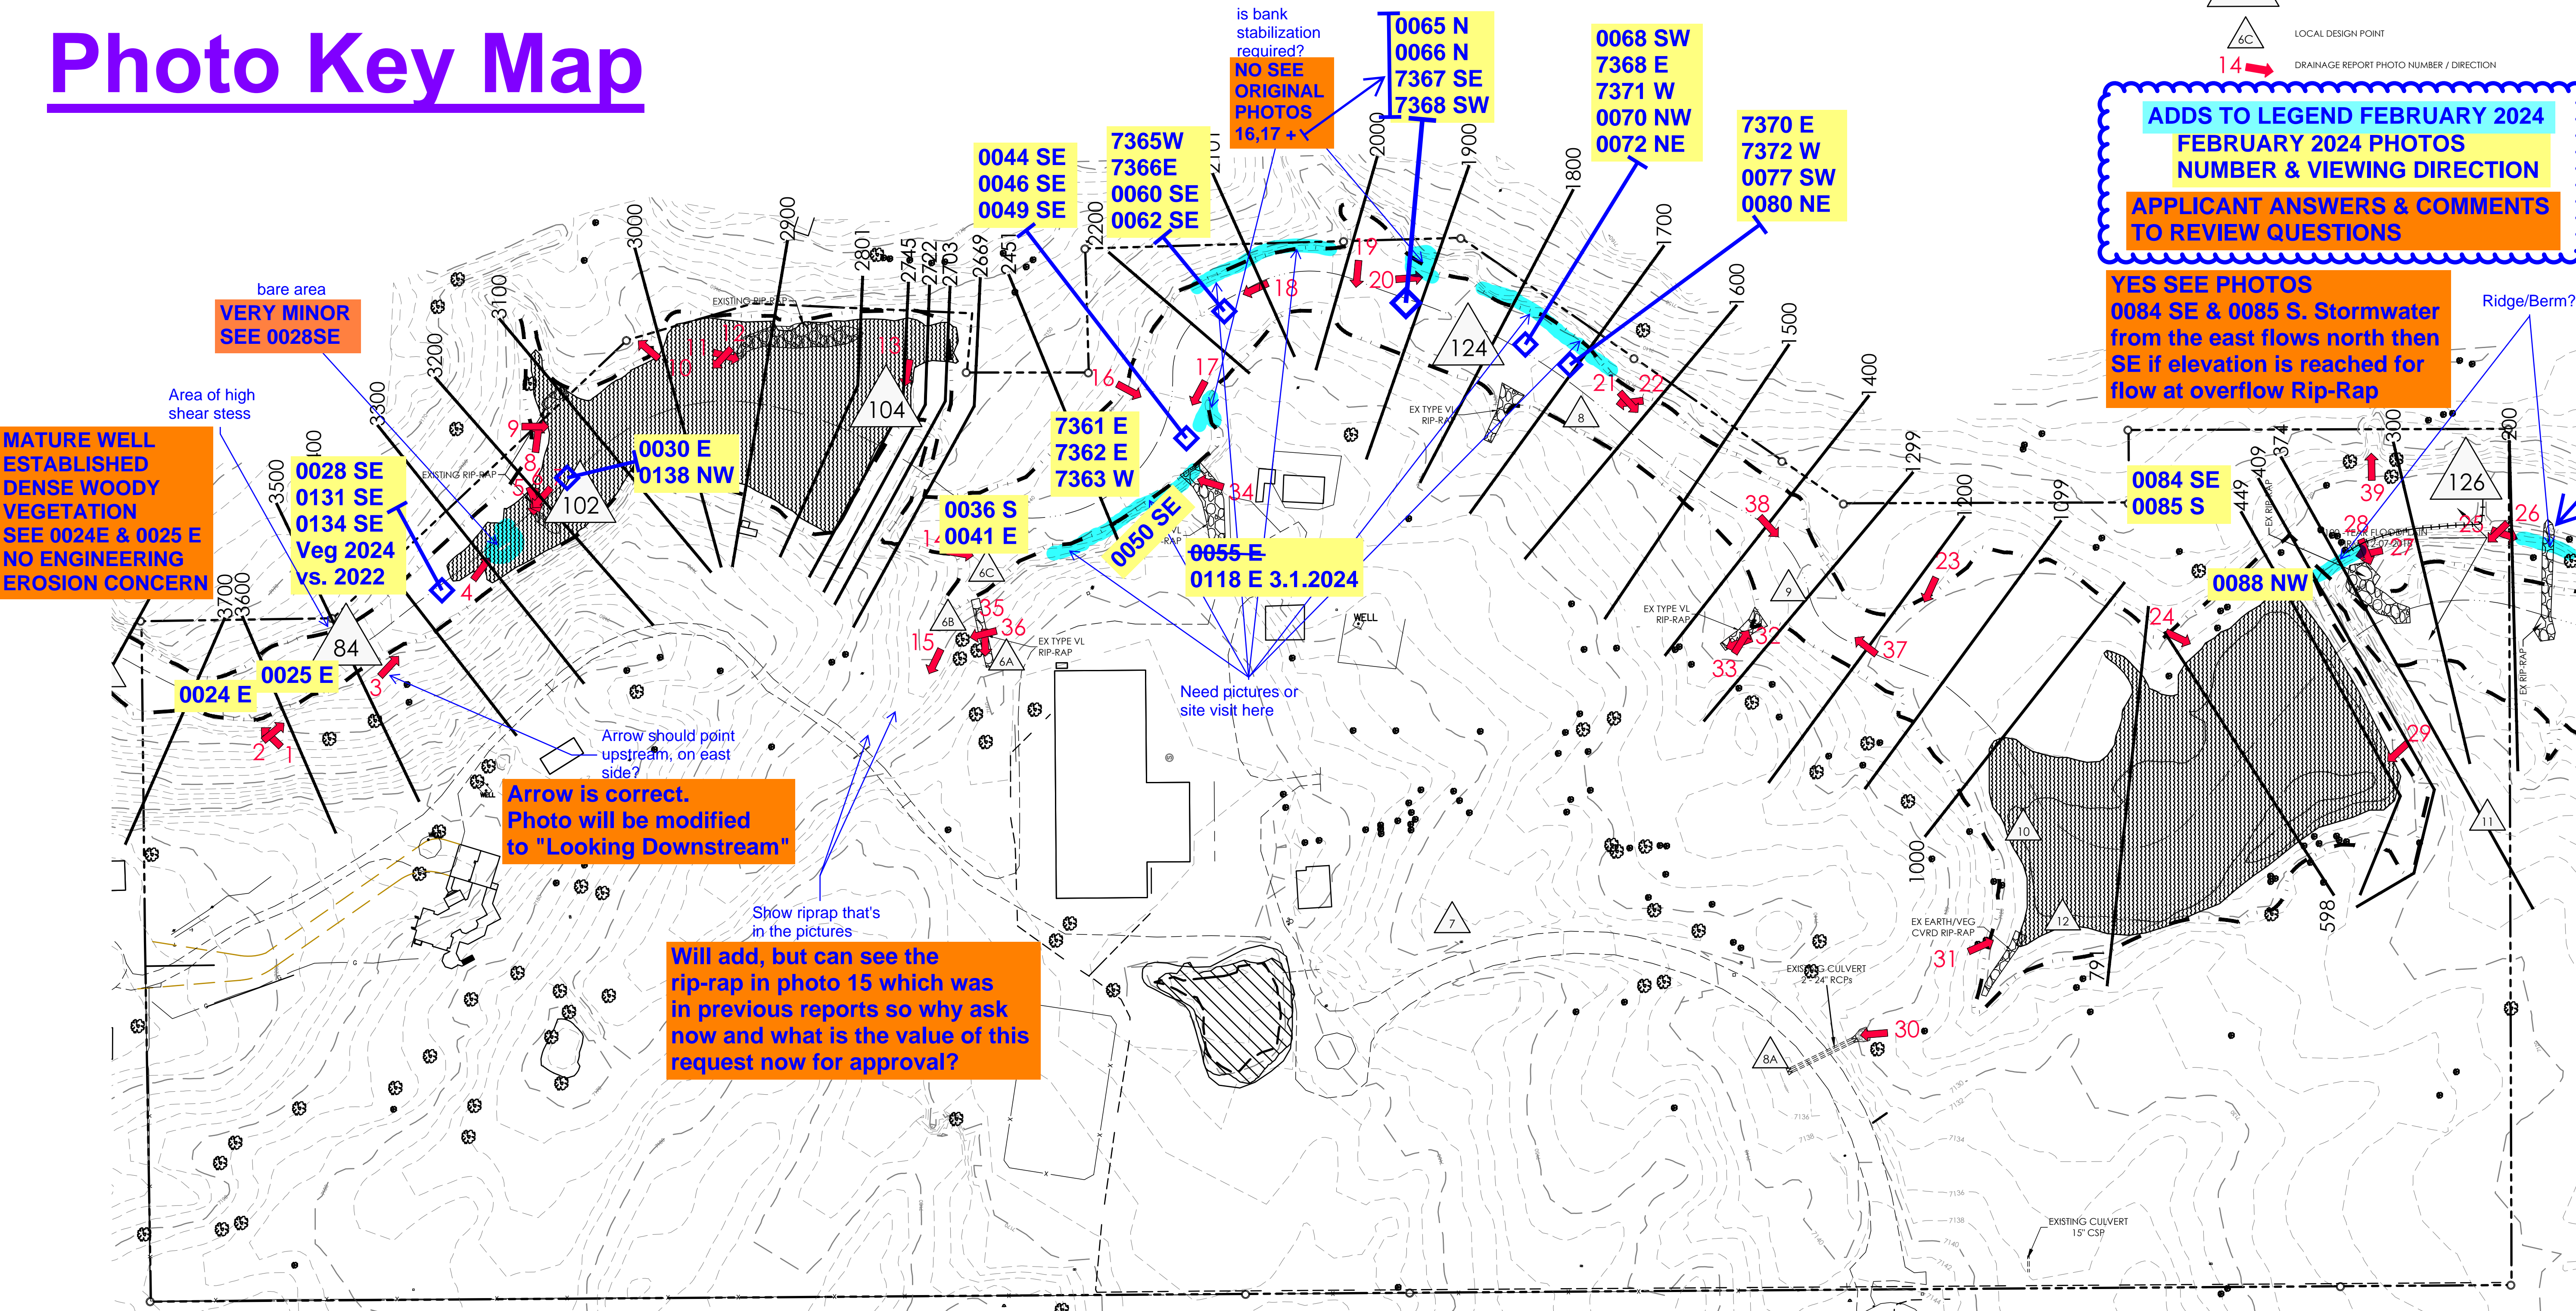
HEC-RAS Cross Section Location and Photo Key Map

SP205 + SF2225: DRAWING EXTRACTED FROM THE DEVIATION REQUEST SUBMITTED FOR EMC 3.3.3 B & C TO SHOW LOCATIONS OF THE ATTACHED ADDED PHOTOS JEFF RICE REQUESTED JANUARY 29, 2024

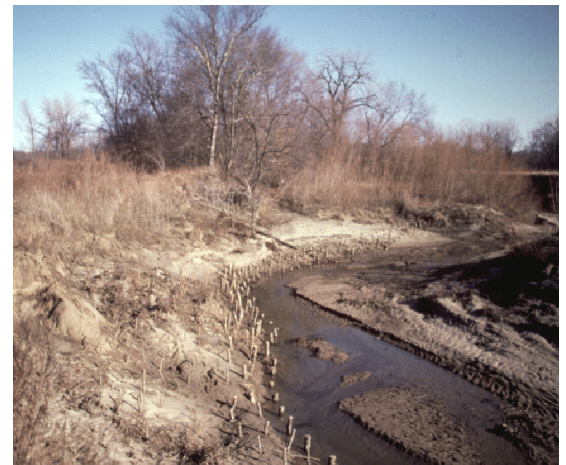
Willow Cuttings

Cuttings are used on small streams where flooding and erosion is minimal. This material is easy to obtain, requires few tools and little labor to plant.

- (1) Cut $\frac{1}{2}$ - to 1-inch diameter plants or stems and remove all lateral branches.
- (2) Cut the stems with a knife or pruning shears into 12- to 24-inch lengths.
- (3) Make a horizontal cut on the end which will remain exposed and a 45° angle cut on the end to be planted. This will prevent you from planting them upside down. Note: Buds on plant should face up.
- (4) Push cutting directly into soil or produce a pilot hole by pounding a piece of metal rebar into the soil and then push the cutting into the hole. A planting (dibble) bar may also be used. Plant so that only a few inches remain exposed.

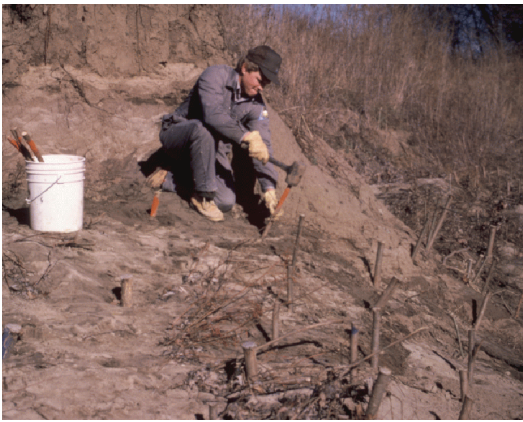
Willow Stakes

Use stakes where materials need to be driven deeper to improve moisture supply to the stakes.

(1) Cut 1- to 3-inch diameter stems into 18- to 36-inch lengths with a hand saw or chainsaw and remove all lateral stems. (Note: Using an axe or knife to cut the stems may damage the plant.)

(2) Use dibble bar or drive stake with mallet until approximately 3 to 6 inches remain exposed or to refusal. **Do not force and split stake.**

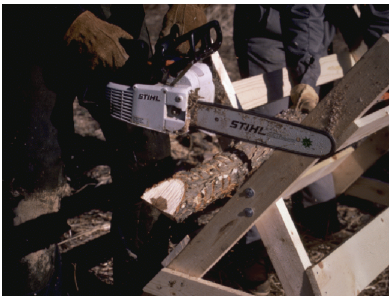
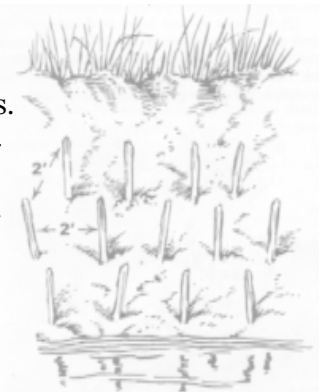
Wattles

Use wattles in slow-moving water areas to trap sediments and revegetate banks. This method is more labor intensive than planting cuttings or stakes.

- (1) Cut 1 1/2-inch or less diameter stems into a minimum of 3-foot lengths and remove all lateral branches.
- (2) Bundle stems with ends alternated. The bundle should be 1 to 2 feet longer than the longest stem cut.
- (3) Tightly compress bundle to a diameter of 8 to 10 inches and tie with two wraps of twine every 10 - 15 inches.
- (4) Beginning at the toe, dig a horizontal trench 8 to 10 inches wide by 5 inches deep. Do not dig the trench more than one hour prior to planting the wattle to minimize soil drying.
- (5) Drive a vertical stake (2 to 3 feet long) on done-hill side of trench every 2 feet.
- (6) Place wattles in trench and drive 2- to 3-foot long stakes through the bundle every 3 feet.
- (7) Cover with soil and tamp wattle so that no more than 20 percent of the wattle is exposed.
