DEVIATION REQUEST AND DECISION FORM

Project Name : Eagle Rising PCD File No. SP205 & SF2225
 Schedule No.(s) : 52290-00-034 & 52290-00-035
 Legal Description : See Attached

A deviation from the standards of or in Section(s) **ECM 3.3.3 B and C** of the Engineering Criteria Manual (ECM) is requested.

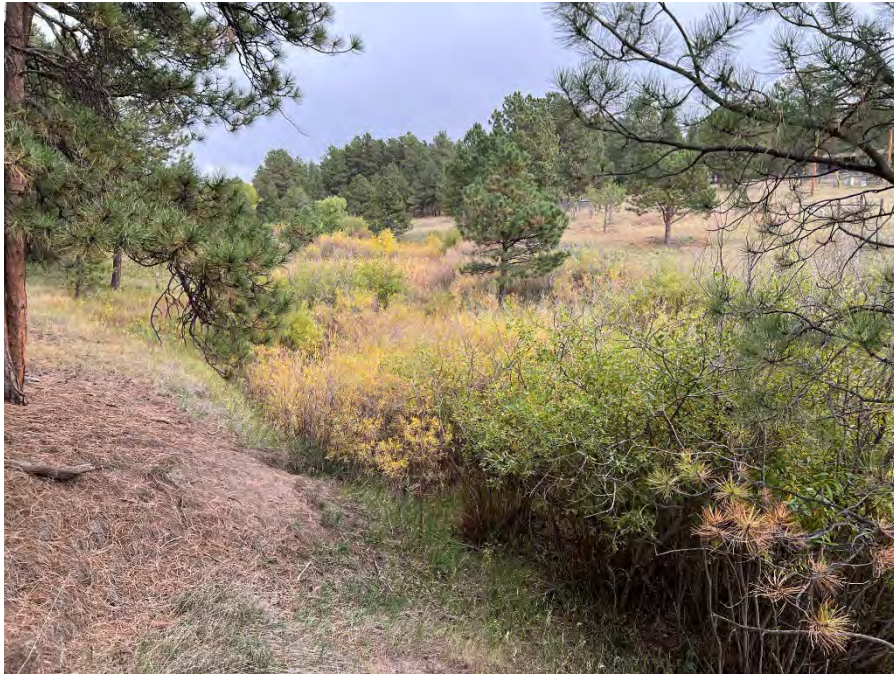
1

Looking downstream,
from 250 feet
downstream of
Cottonwood Creek
DBPS Design Point
82.

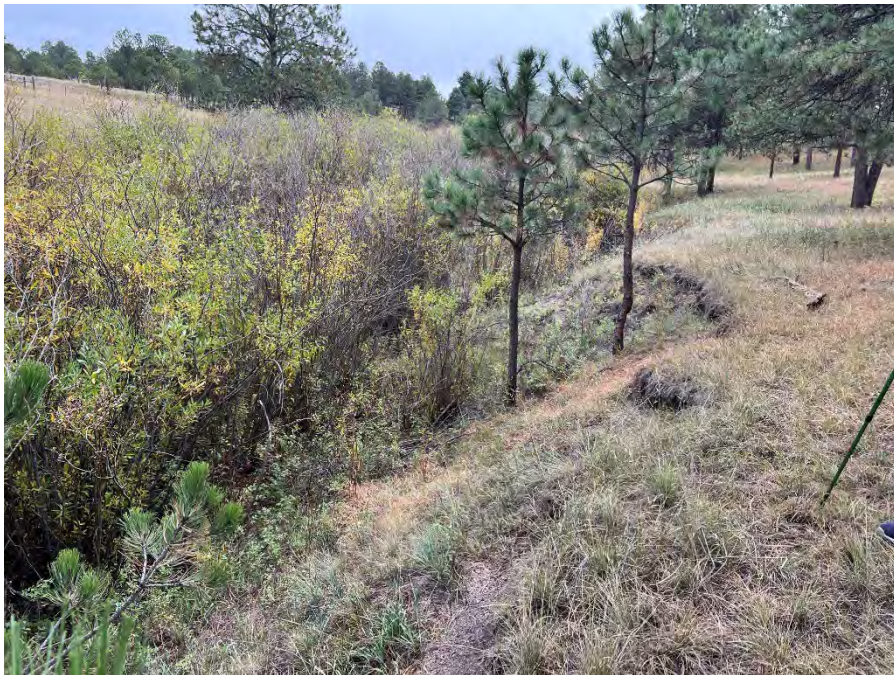
2

Looking upstream,
from 250 feet
downstream of
Cottonwood Creek
DBPS Design Point
82.

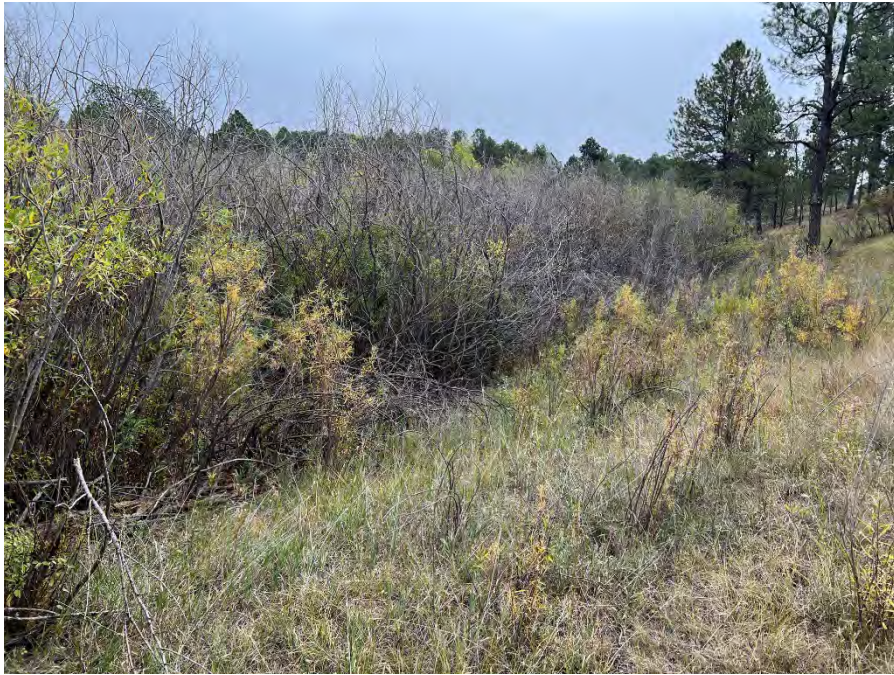
3

Looking
downstream, from
Cottonwood Creek
DBPS Design Point
84.

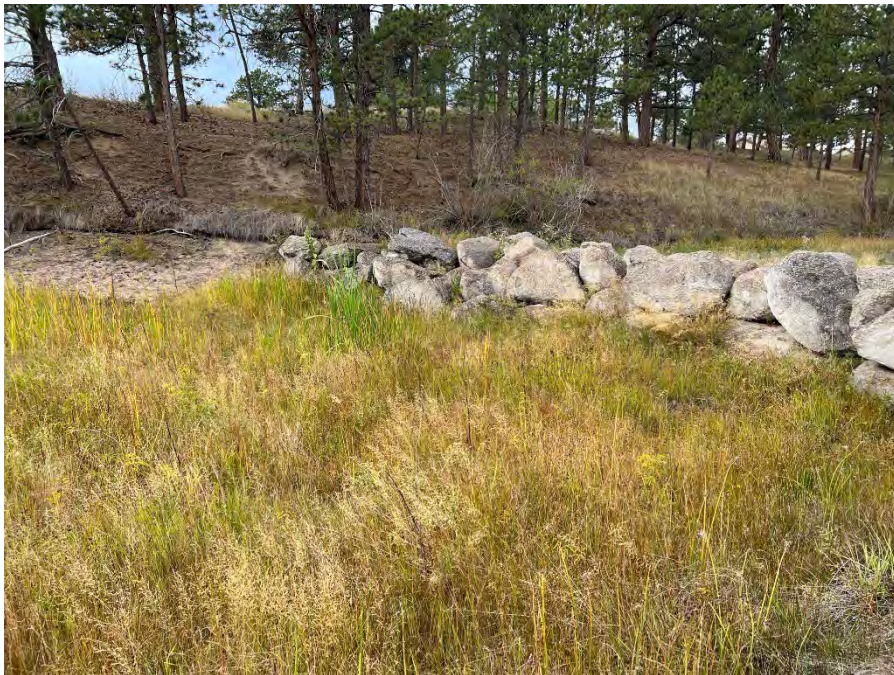
6

Looking upstream,
from Cottonwood
Creek DBPS Design
Point 102.

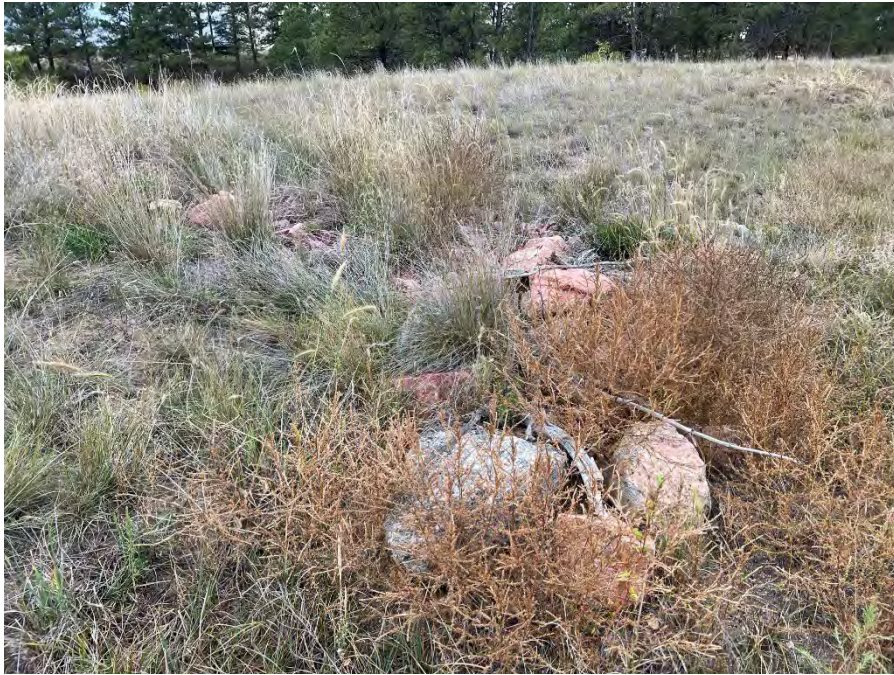
13

Buried and partially buried riprap at emergency overflow, from Cottonwood Creek DBPS Design Point 104.

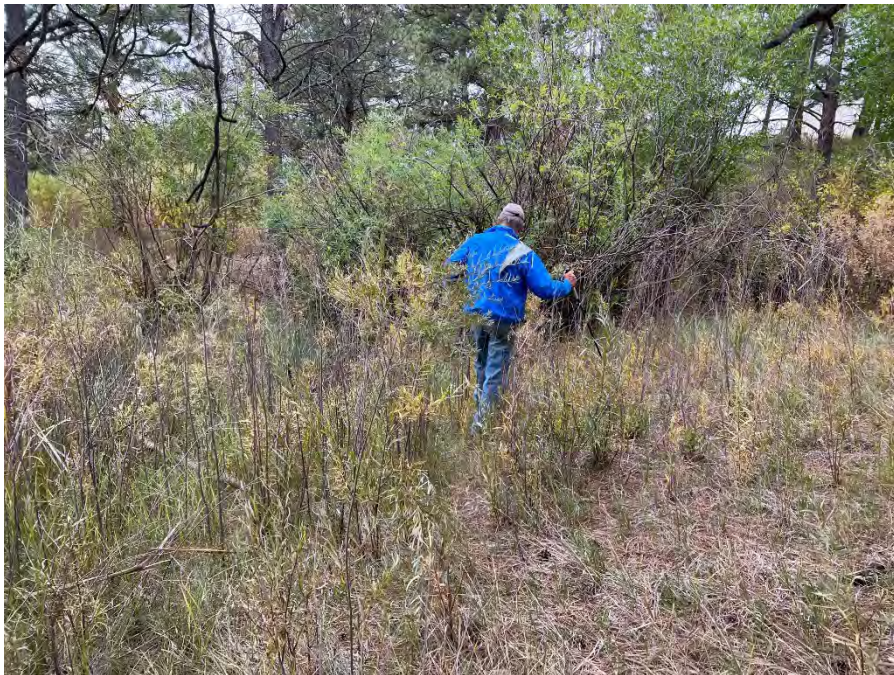
14

Looking at heavy vegetation downstream, from Design Point 6C.

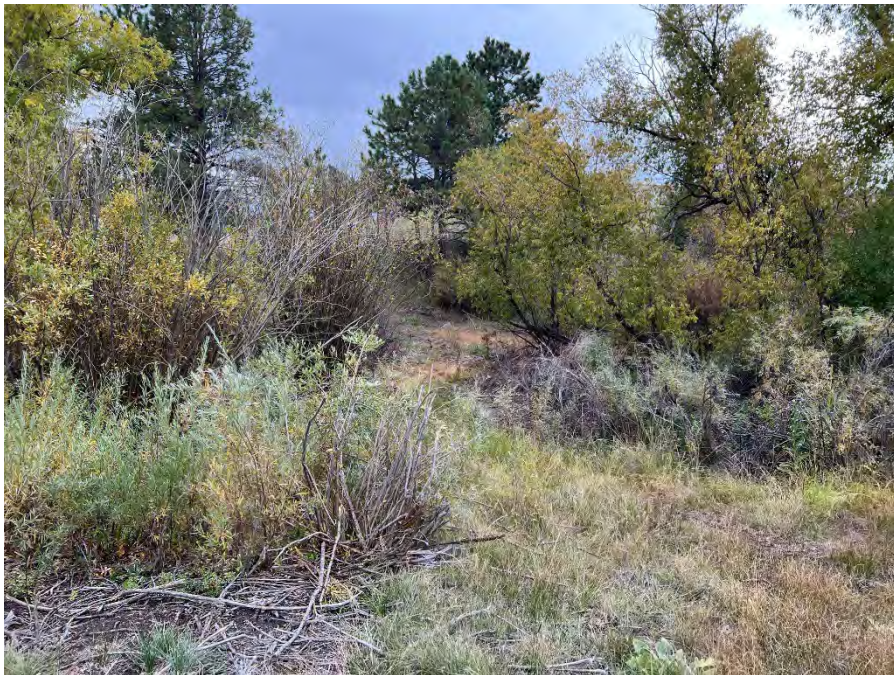
16

Looking southwest
across stream, from
450 feet downstream
of Cottonwood Creek
DBPS Design Point
104.

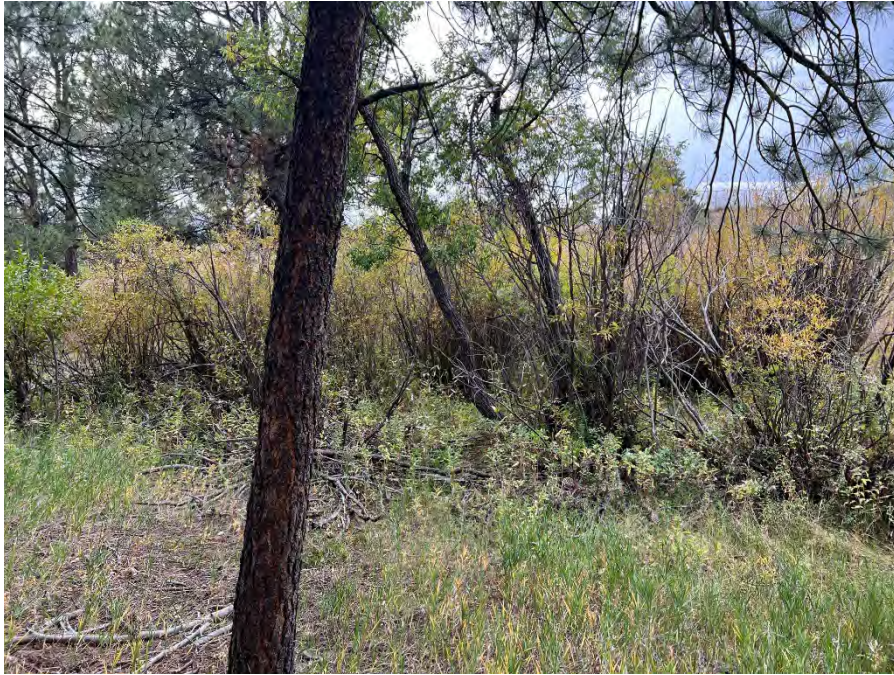
19

Looking west across channel, from 100 feet upstream of Cottonwood Creek DBPS Design Point 124.

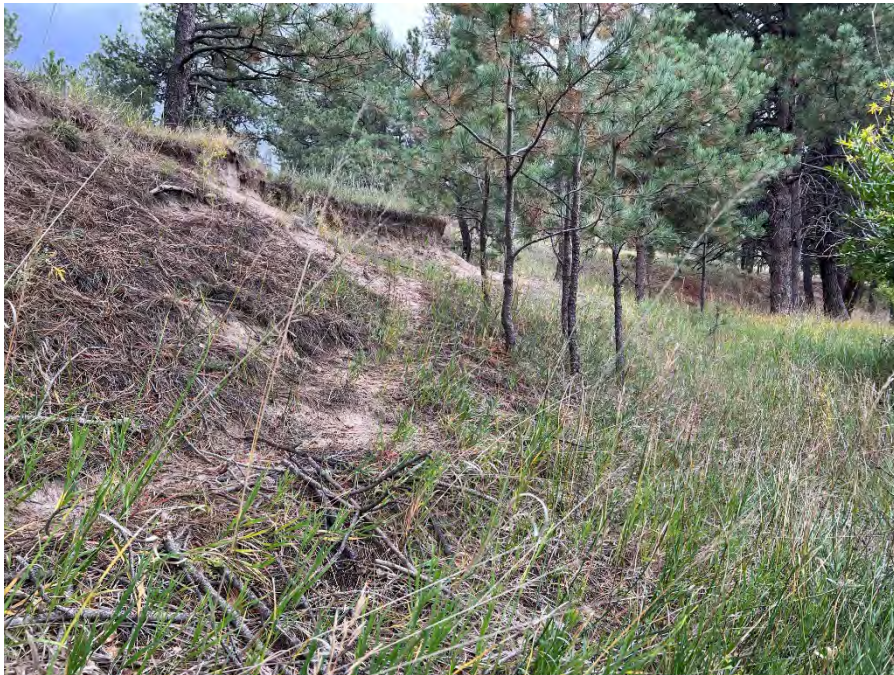
20

Looking downstream at the upper banks, from 100 feet upstream of Cottonwood Creek DBPS Design Point 124.

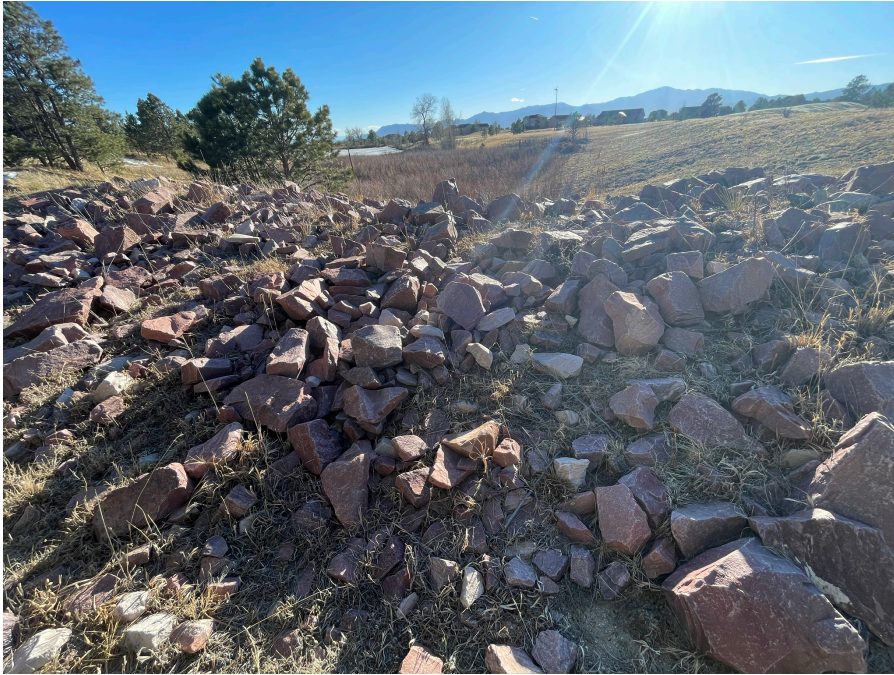
Pond 2 Emergency
Spillway Looking
downstream
(southwest)

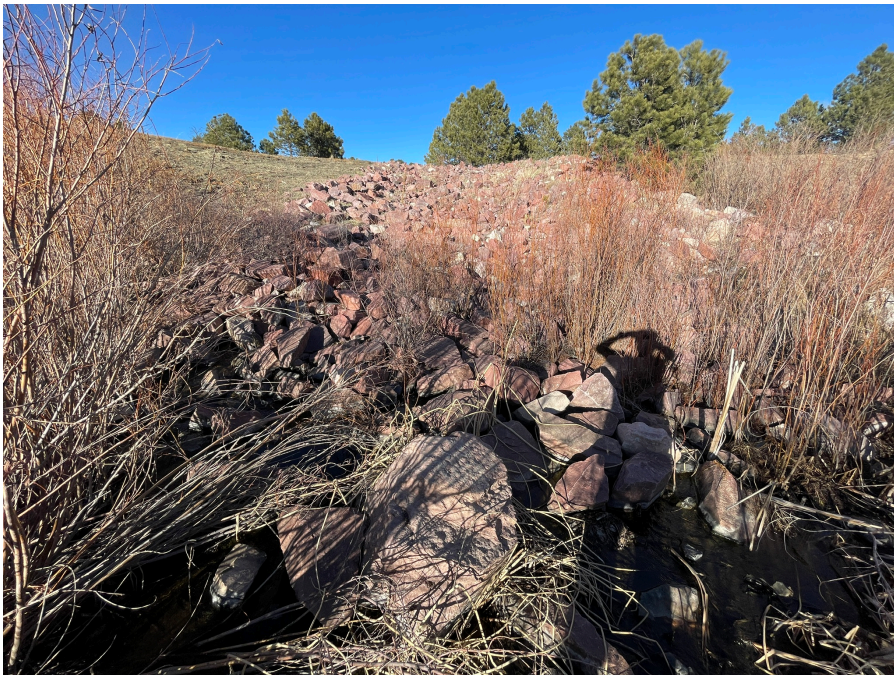
Pond 2 Emergency
Spillway Looking
upstream
(northeast)

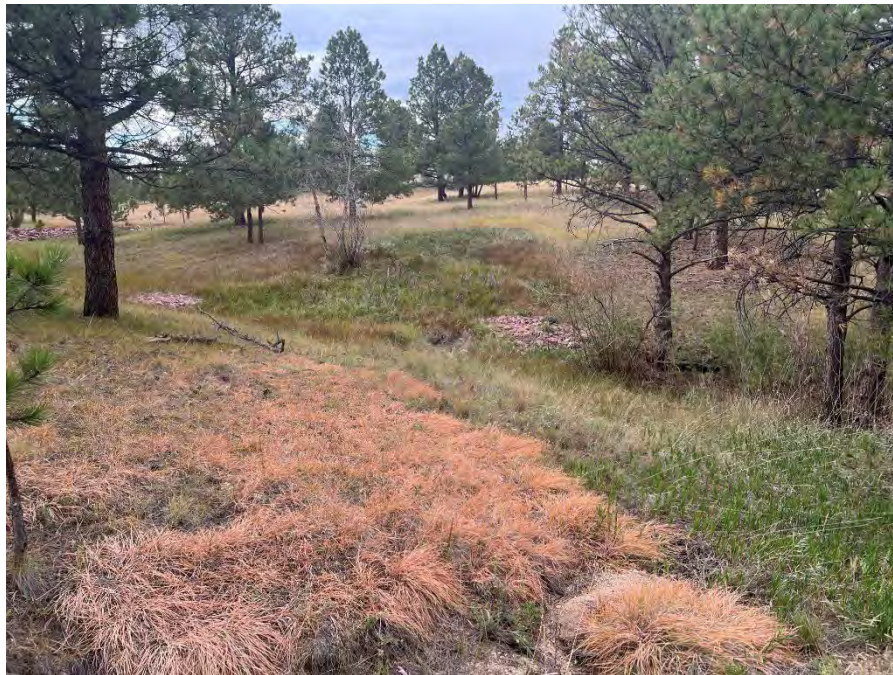
36

Looking at riprap on
tributary flow
upstream of DP6B,
from Design Point
6A.

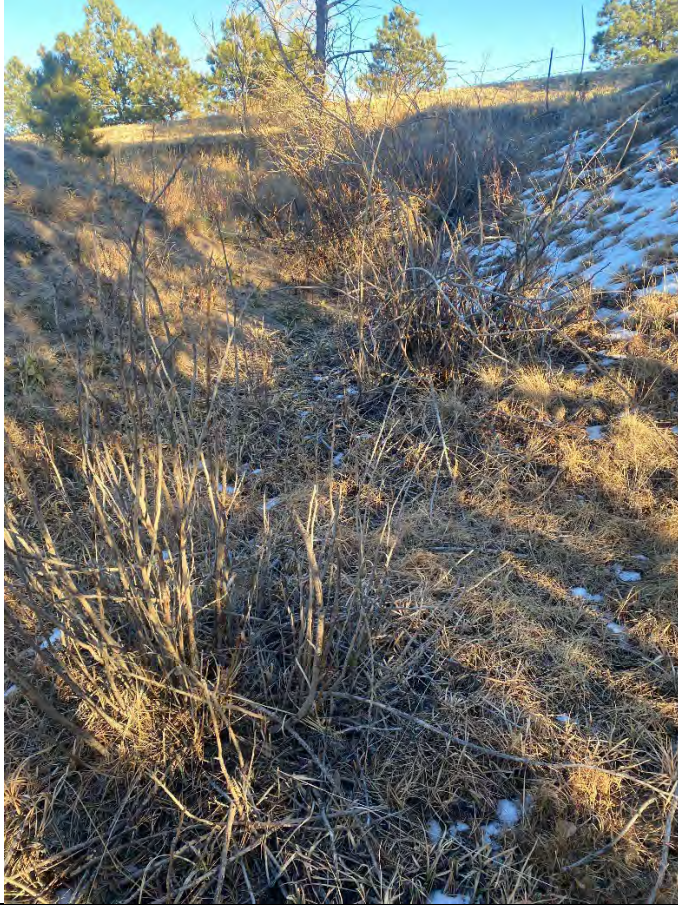
39

Looking east at east
property line at
approximately
HECRAS station
300.

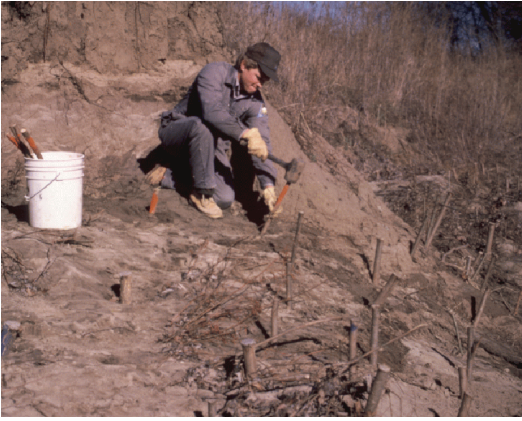
Willow Stakes

Use stakes where materials need to be driven deeper to improve moisture supply to the stakes.

(1) Cut 1- to 3-inch diameter stems into 18- to 36-inch lengths with a hand saw or chainsaw and remove all lateral stems. (Note: Using an axe or knife to cut the stems may damage the plant.)

(2) Use dibble bar or drive stake with mallet until approximately 3 to 6 inches remain exposed or to refusal. **Do not force and split stake.**
