Preliminary Acceptance Punchlist
El Paso County – Department of Public Works - Stormwater Section

Project Name:	Freedom Springs
EDARP Filing Number(s):	PPR1840, CON1917
ESQCP Number:	ESQ1916
Attendees:	DPW SW: Josh Augustenborg, Ben Jones, and Dylan Finley DPW Development Services: Brad Walters Developer: N/A
Date of Walk-Thru:	09/06/2023
Walk-Thru Number:	#1

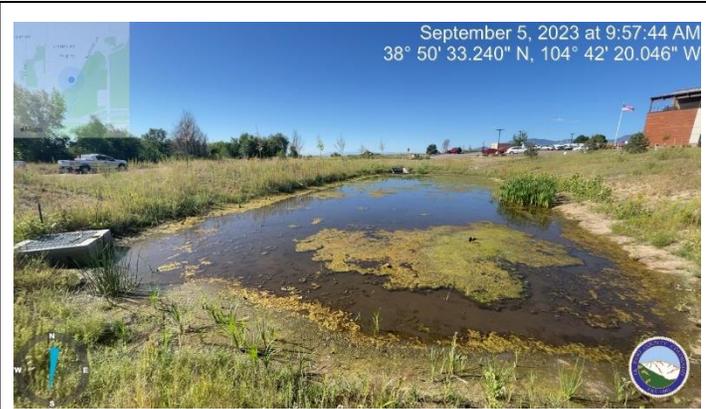
Photo 1: Detention Pond is holding water. Discrepancy in elevation at outfall structure. Reference notes above.

- Detention Pond is holding water. Discrepancies in elevation at forebay, orifice plate, and outlet pipe. This may be why the detention pond is holding water. Reference sheet C-3 and C-4 of the Grading and Erosion Control Plan. See photo #1.

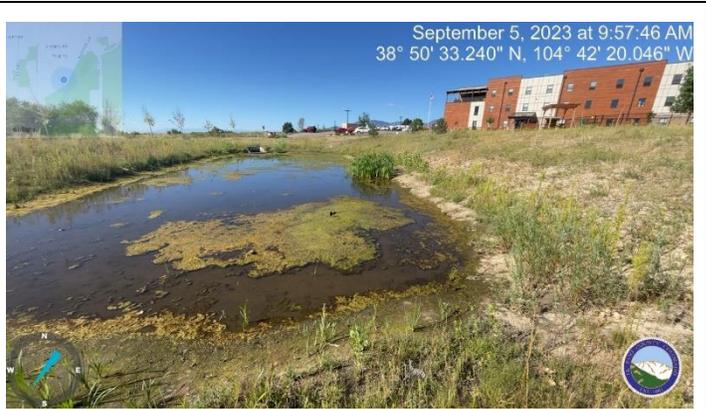
Photo 2: Detention Pond is holding water. Sediment from embankment has filled in floor of pond. Clean out and dispose of sediment throughout.

- Sediment from embankment has filled in floor of pond. Clean out and dispose of sediment throughout. See photo # 1 and 3.
- Detention Pond Forebay. Sediment needs to be cleaned out and disposed of. See photo #3.

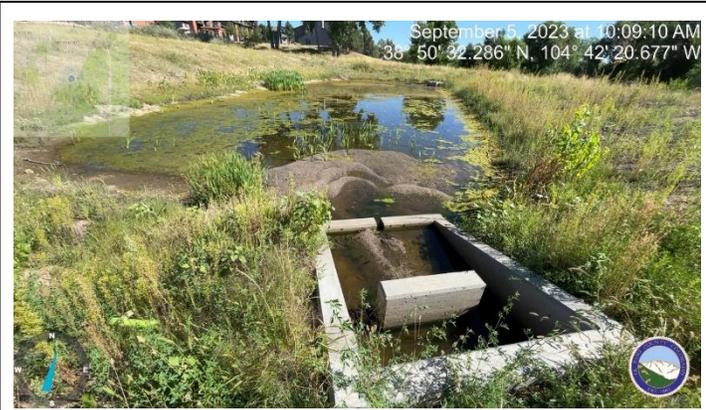
Photo 3: Detention Pond forebay. Sediment needs to be cleaned out and disposed of.

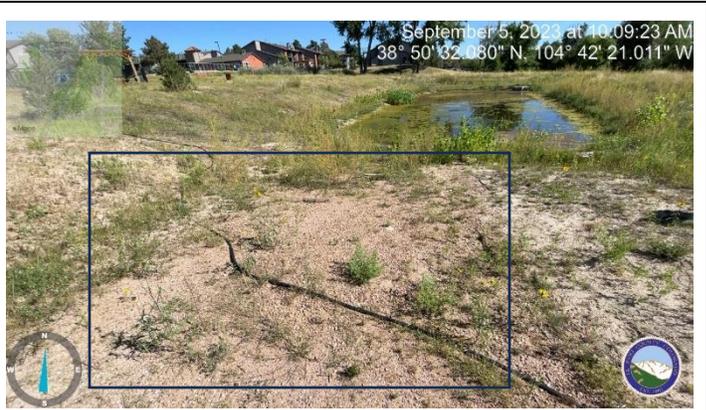
Photo 4: Maintenance access road. Per plan needs to be 11' wide and 1' thickness. Reestablish.

- Maintenance access road needs to be reestablished. Per plan needs to be 11' wide and 1' thickness. See sheet C-4 of the Grading and Erosion Control Plan. See photo #4.

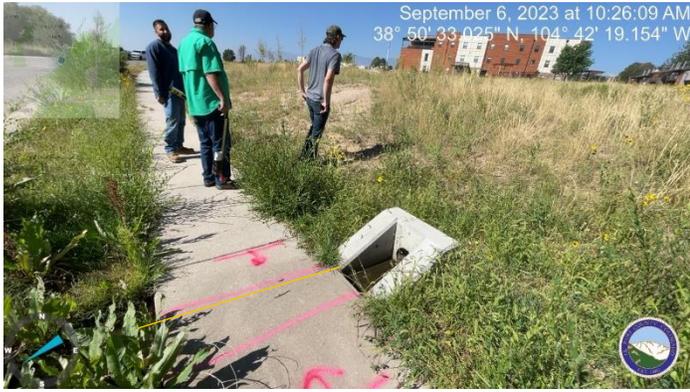
Photo 5: Concrete chase is not installed per plan.

- Concrete chase is not installed per plan. See sheet C-3 of the Grading and Erosion and erosion Control Plan. See photo #s 5 and 6.
- Outlet structure is missing the orifice plate and neoprene gasket per approved plans. Restrictor plate is also missing at outlet structure. Reference sheet C-4 of the Grading and erosion Control Plan. See photo #7.

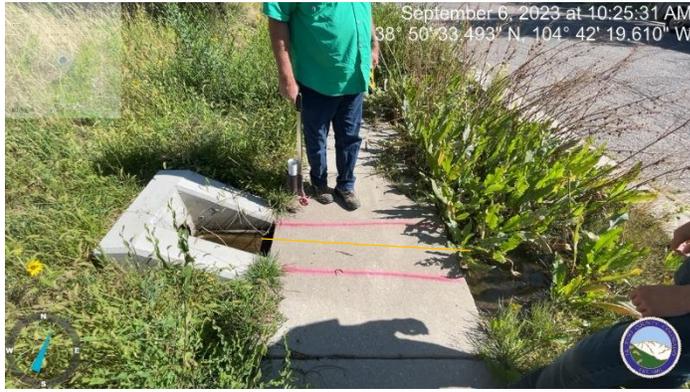
Photo 6: Concrete chase is not installed per plan.

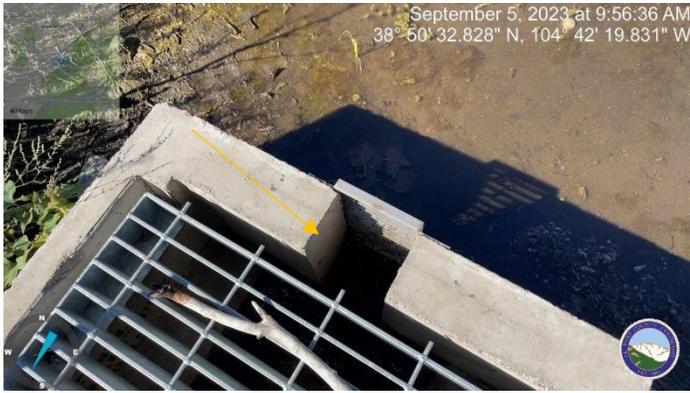
Photo 7: Outlet structure is missing the orifice plate and neoprene gasket per approved plans.

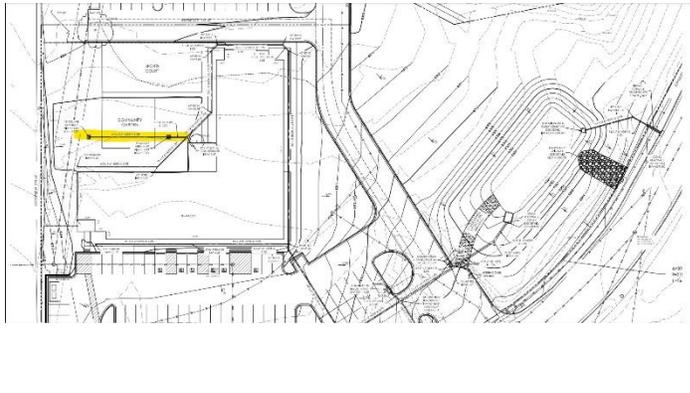
Photo 8: Area drains in community garden are not installed per plan. Reference yellow highlighted area.

- Area drains in the community garden are not installed per plan. See sheet C-3 of the grading and Erosion Control Plan. See photo # 8.
