Soil Profile Evaluation

Septic Soil Profile – 525 South Page Road

Page Road and Highway 94
Colorado Springs, Colorado
ProTeX Job No.: 14889

Re: **Soil Profile Evaluation**

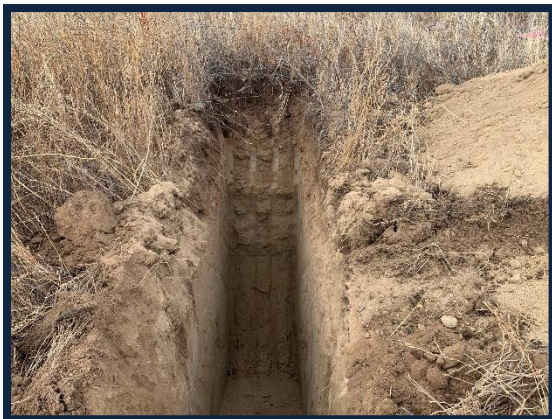
Figure 1: TP1

- 1) The test pits terminated at a nominal depth of approximately 8 feet in both TP1 and TP2.
- 2) Groundwater was not encountered in either TP1 or TP2.
- 3) Rock content does not exceed 35% (by weight and volume) in both test pits. A #10 (2 mm) sieve screen and a 1000 mL graduated cylinder were used to determine rock content for on-site soils. Refer to Appendix A for details.
- 4) Water and cultural features were not present at the time of our field investigation on December 20, 2023.
- 5) The weather was cold and partly cloudy.

Depth Below Grade	Sample Depth (ft)	USDA Soil Texture	USDA Soil Structure	USDA Soil Structure Grade	Soil Type	Redoximorphic Features present (Y/N)	Color of Soil
0-3"	-	Topsoil	-	-	-	-	-
3"-1'	0-1'	Sandy Loam (Horizon A)	Blocky – sub angular	Moderate (2)	Soil Type 2 LTAR=0.60	No	Brown
1'-3'	-	Sandy Loam (Horizon B)	Blocky – sub angular	Moderate (2)	Soil Type 2 LTAR=0.60	No	Tan
3'-8'	-	Sand	Granular – single grain	Structureless (0)	Soil Type 1 LTAR=0.80	No	tan

Comments: The most limiting soil on site is Soil Type 2, LTAR=0.60. Based on these conditions, a conventional system can be sized to Soil Type 2 LTAR=0.60 at any installation depth up to 4 feet.

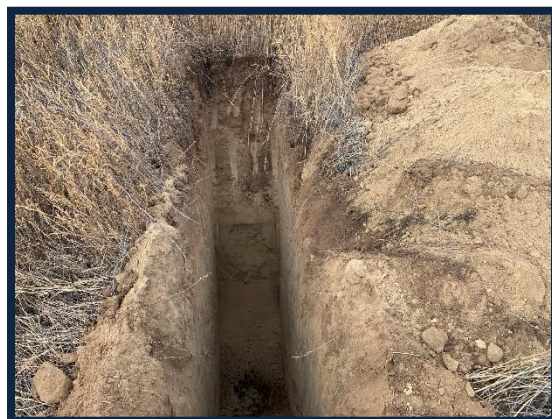
Figure 2: TP2

Depth Below Grade	Sample Depth (ft)	USDA Soil Texture	USDA Soil Structure	USDA Soil Structure Grade	Soil Type	Redoximorphic Features present (Y/N)	Color of Soil
0-3"	-	Topsoil	-	-	-	-	-
3"-2'	-	Sandy Loam (Horizon A)	Blocky – sub angular	Moderate (2)	Soil Type 2 LTAR=0.60	No	Brown
2'-4'	2-3'	Sandy Loam (Horizon B)	Blocky – sub angular	Moderate (2)	Soil Type 2 LTAR=0.60	No	Tan
4'-8'	5-6'	Sand	Granular – single grain	Structureless (0)	Soil Type 1 LTAR=0.80	No	tan

Comments: The most limiting soil on site is Soil Type 2, LTAR=0.60. Based on these conditions, a conventional system can be sized to Soil Type 2 LTAR = 0.60 at any installation depth up to 4 feet.

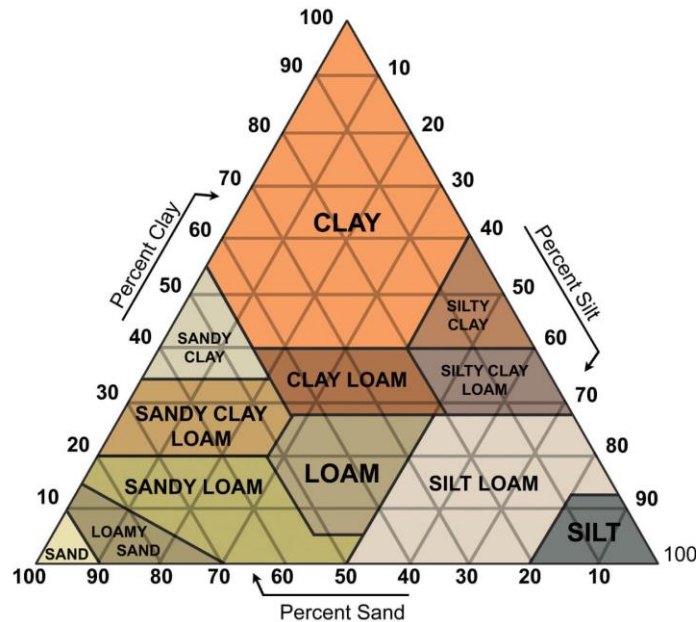
Figure 1: USDA Textural Soil Diagram

Based on field explorations and the U.S. Department of Agriculture (USDA) Textural Soil Classification System, soil characteristics are further identified using percentages of sand, silt and clay content in the soil. See figure below of the USDA Textural Soil Triangle diagram:

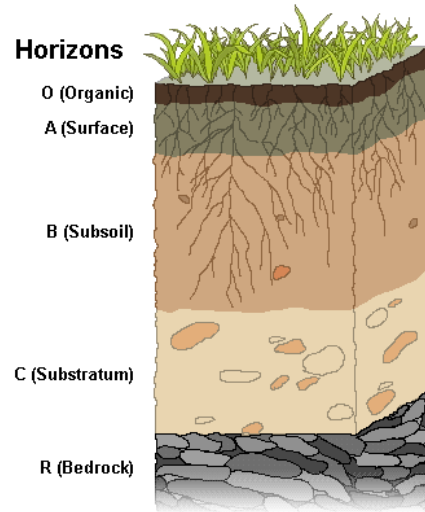
Figure 1: Typical Master Soil Horizon profile

Soil horizons are layers of soil whose physical, chemical and biological characteristics differ from the layers above and beneath. In the USDA Soil Texture Classification, horizons are used to define soil types. A soil layer can be further identified by a lowercase letter suffix that tells some trait of the layer, called *sub horizons*. The USDA Soil Taxonomy guidelines are followed for the purpose of this report. See figure below for a typical soil horizon profile. Also, when encountered, Master Soil Horizon ‘E’ (between A and B) designates eluviation or leaching of soil from the layer above.

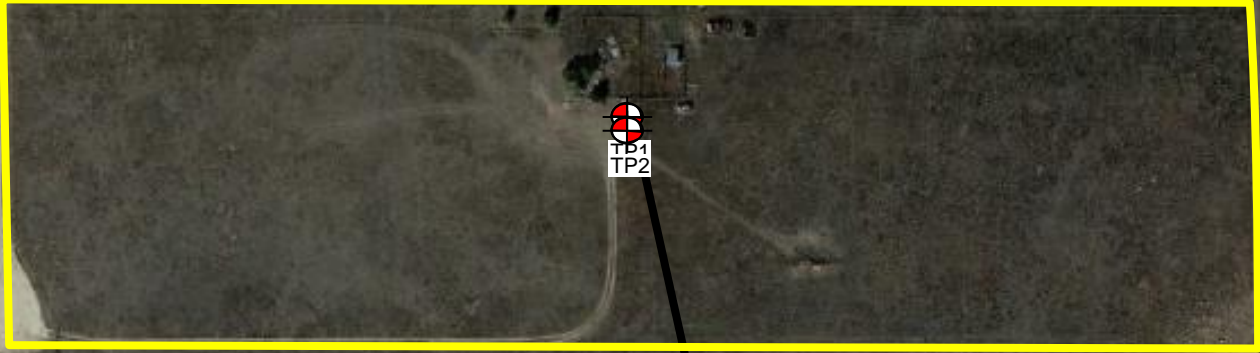
Site Plan

At each test pit location, the soils encountered were visually and physically observed, classified and logged. Refer to the site plan in Appendix B for approximate test pit locations.

Approximate Test Pit Location

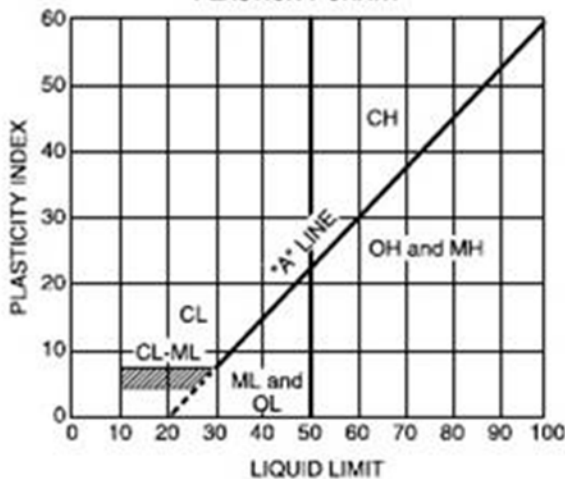
PLASTICITY CHART

Boulder	8.0" or Larger
Cobbles	3.0" to 8.0"
Coarse Gravel	0.75" to 3.0"
Fine Gravel	5.0 mm to 3.0"
Coarse Sand	2.0 mm to 5.0 mm
Medium Sand	0.4 mm to 2.0 mm
Fine Sand	0.07 mm to 0.4 mm
Silt	0.002 mm to 0.07 mm
Clay	Less Than 0.002
