Widefield PFC/PFAS Drinking Water Mitigation System Raw Water Pipeline, El Paso County, Colorado **Wetland Delineation and Biological Survey Report**

Prepared by:
AECOM
Greenwood Village, CO

Date:
December 2018

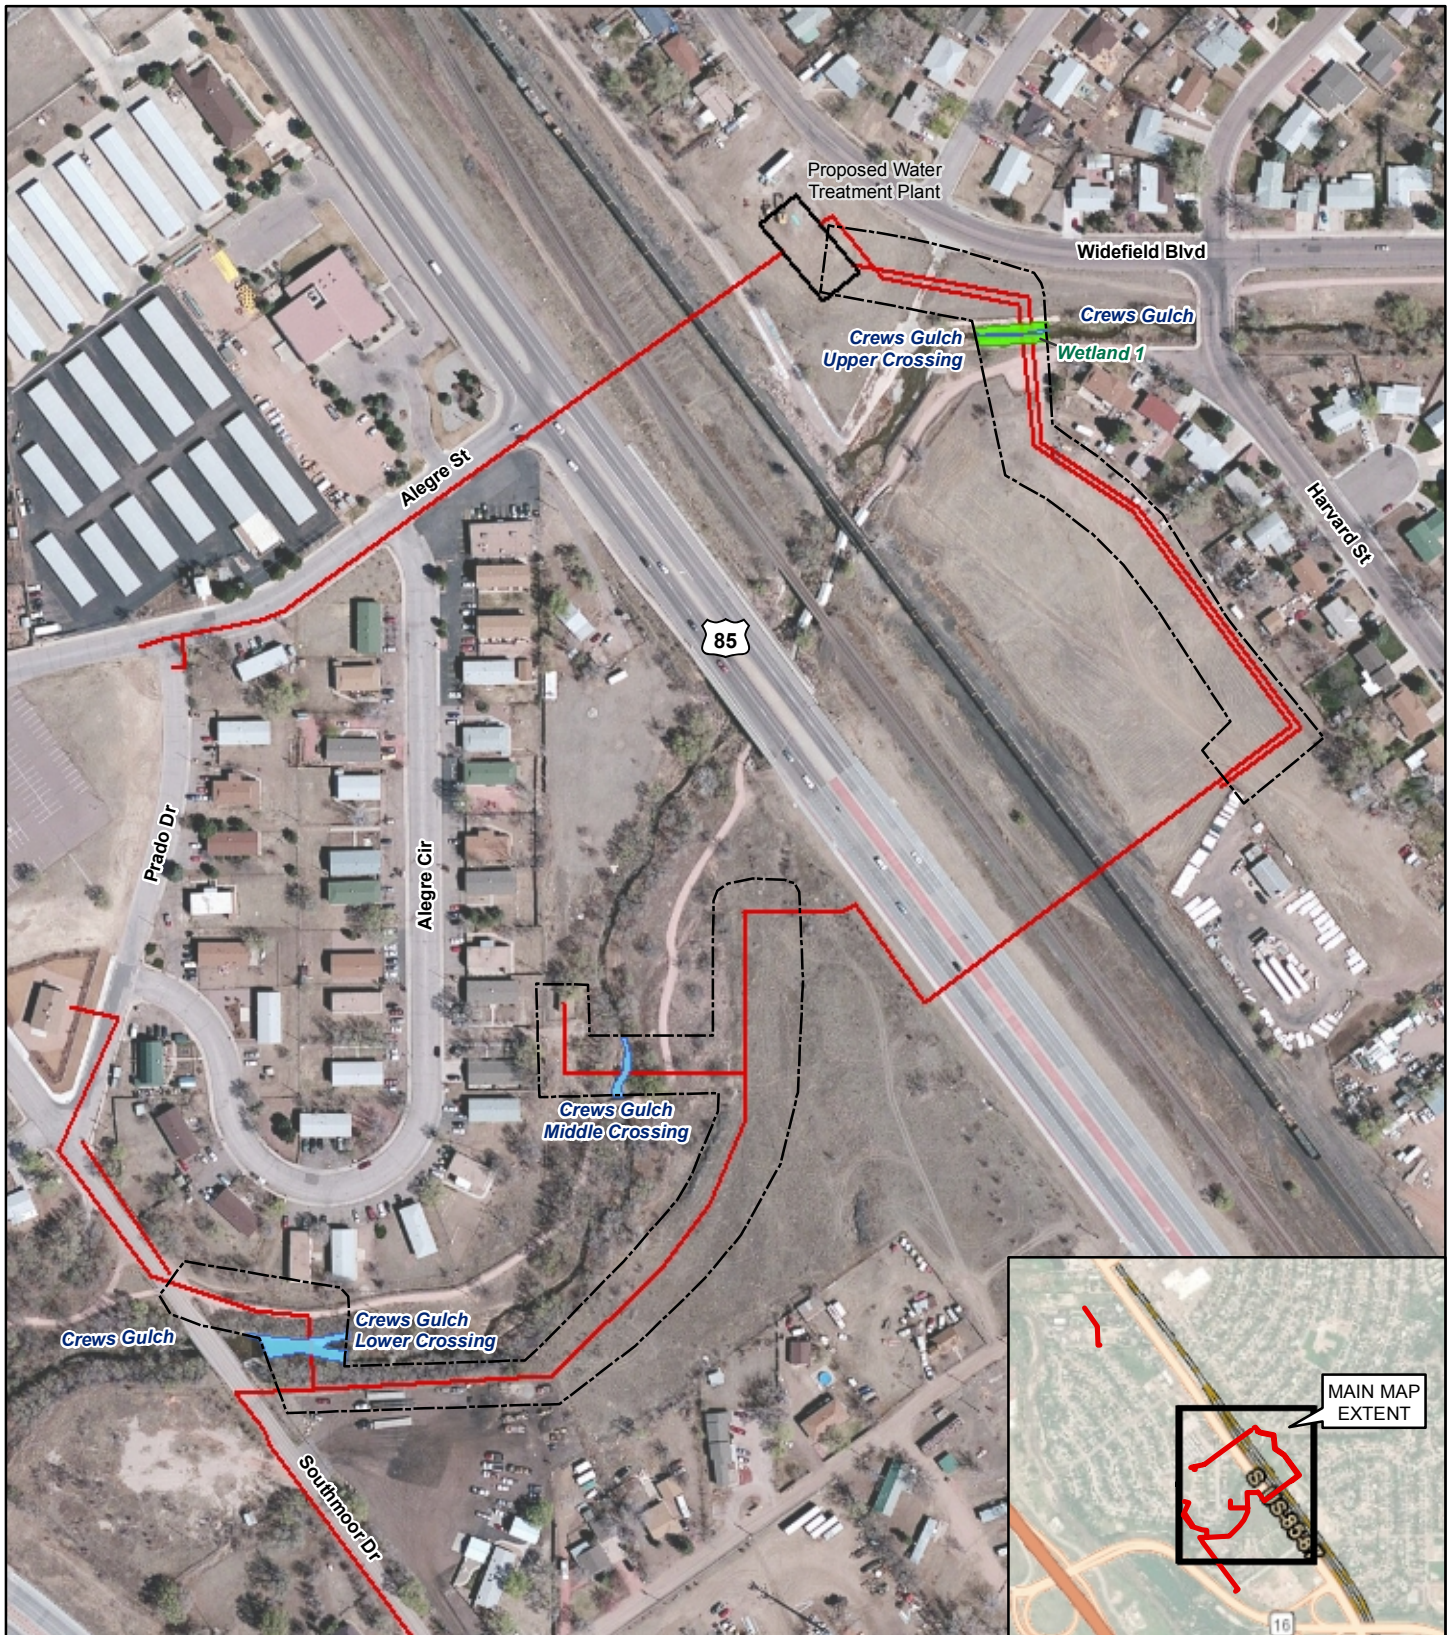
Figure 2
Wetlands and
Other Waters

Two aquatic resources were delineated in the study area (Figure 2, Table 1), including one wetland and Crews Gulch. Three crossings of Crews Gulch were delineated. Photographs are included in Attachment A, and wetland data forms are included in Attachment B.

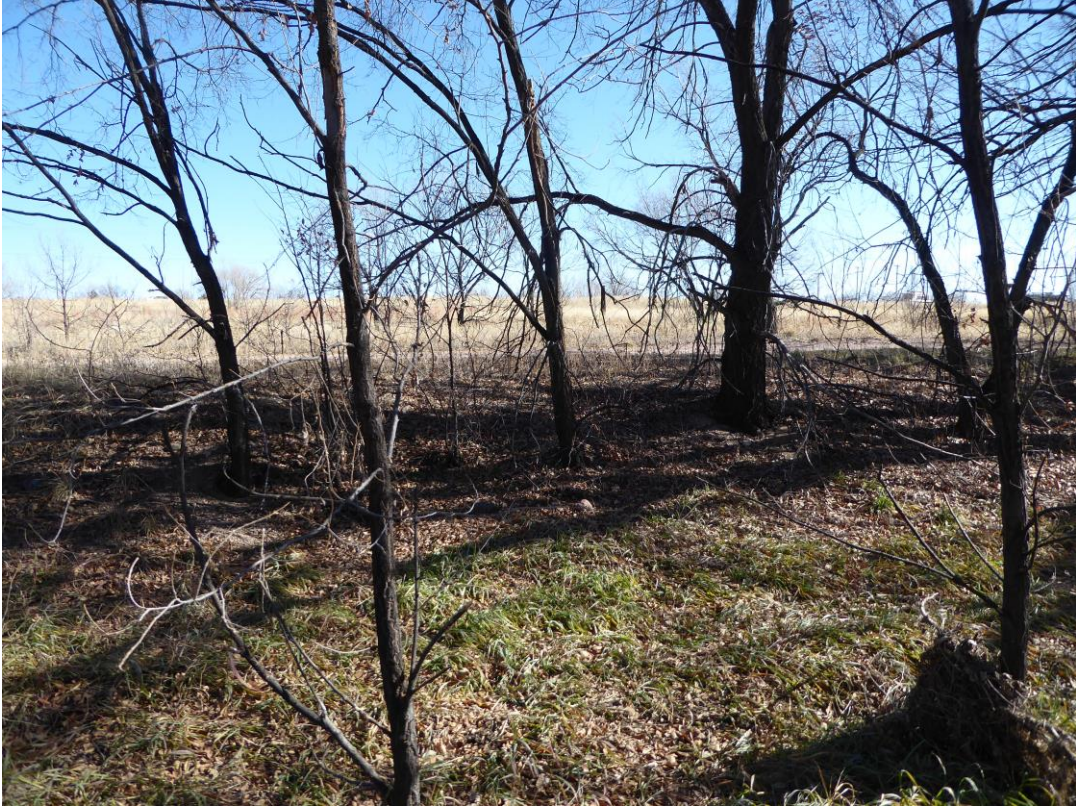
1. Siberian elm woodland. Looking west from near middle pipeline crossing of Crews Gulch.

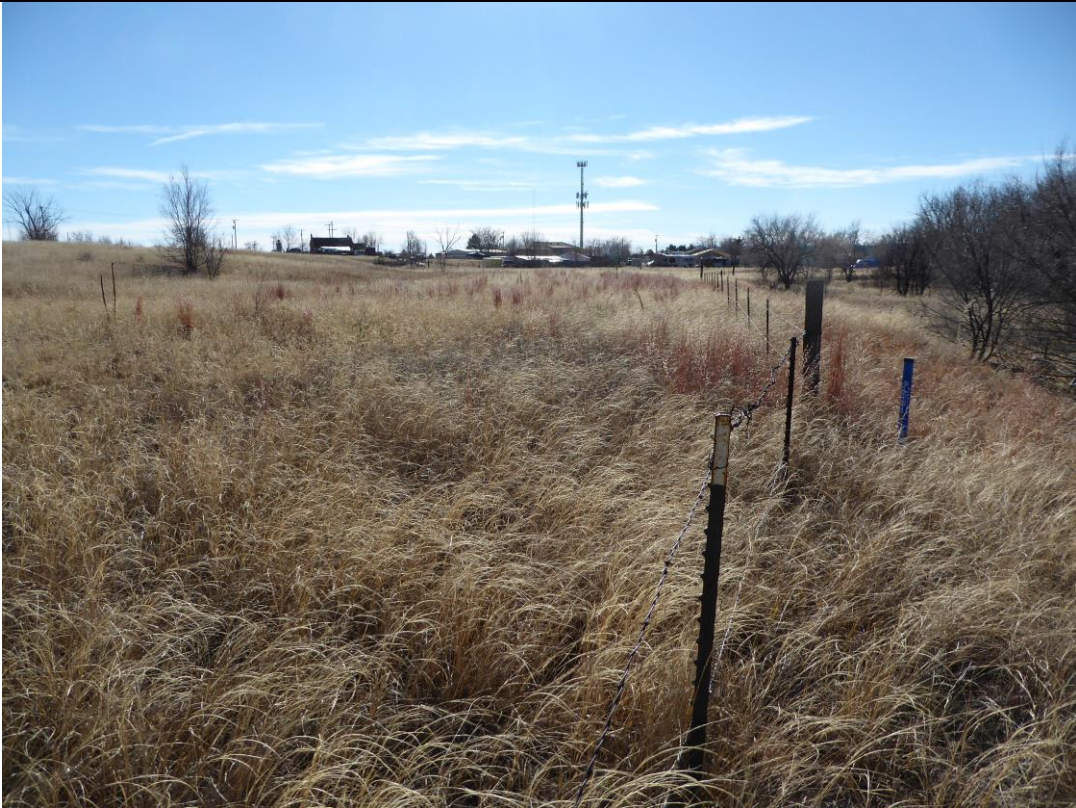
2. Mid-grass prairie dominated by sand dropseed. Looking south, west side of Crews Gulch.

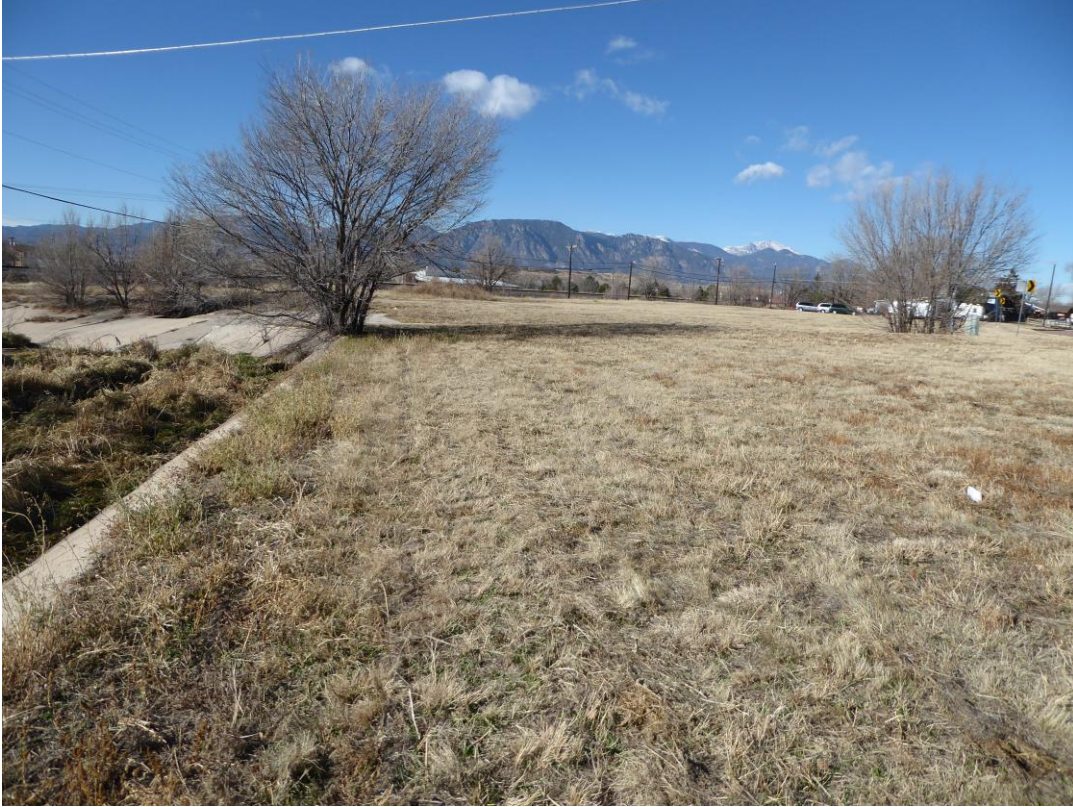
3. Mowed grassland. Looking southwest from upper pipeline crossing.

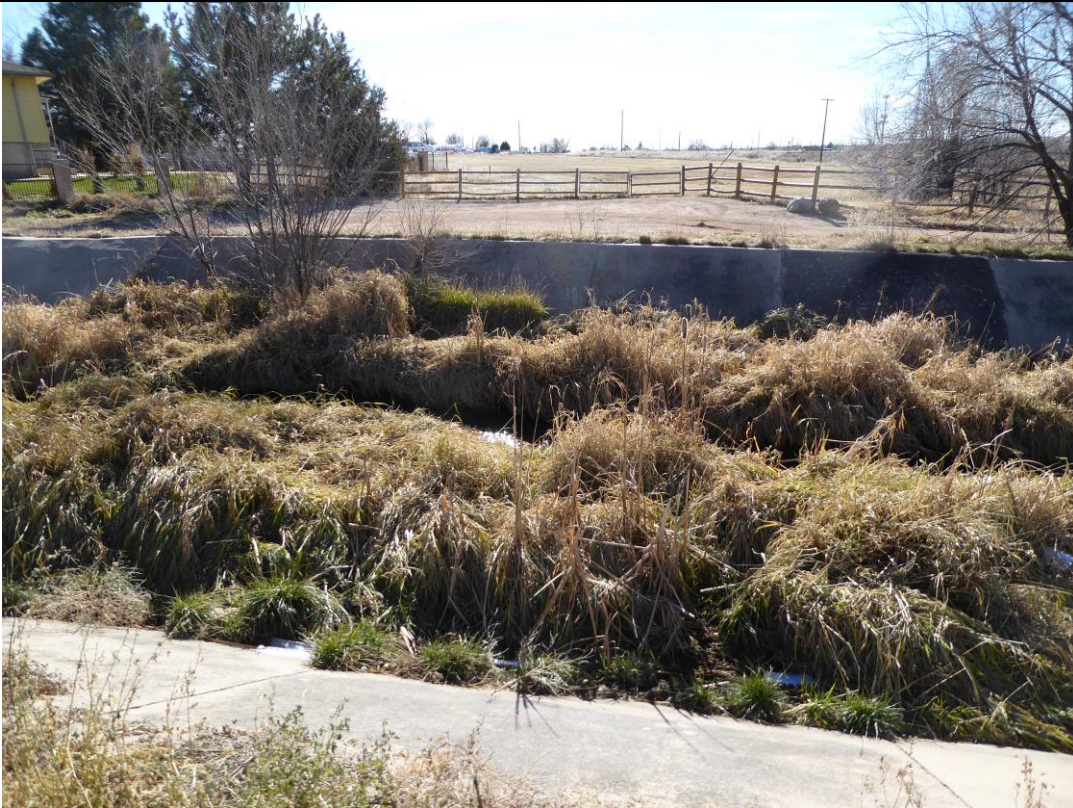
Wetland 1 (WL-1) is located within a concrete-lined channel of Crews Gulch at the upper crossing. WL-1 is dominated by emergent vegetation, primarily reed canarygrass. Other species present include broadleaf cattail (*Typha latifolia*) and Siberian elm. The creek was flowing at the time of the survey, and soils were saturated. The wetland has formed on soils deposited on top of the concrete bottom of the channel, and the only soils indicator present is hydrogen sulfide. The depth of the soil pit was 13 inches, limited by the depth of the concrete.

- At the upper (upstream) crossing, the creek was about 4 feet wide with a bankfull depth of about 8 inches. Water was about 2 inches deep at the time of survey and was flowing rapidly. The channel was bounded on both sides by emergent wetlands that filled the bottom of the trapezoidal channel and overhung the channel. The bottom of the stream channel was concrete, and the banks were clay loam in the wetland. Algae covered about 90 percent of the concrete in the stream channel.

4. Wetland 1 at upper pipeline crossing of Crews Gulch, looking south.

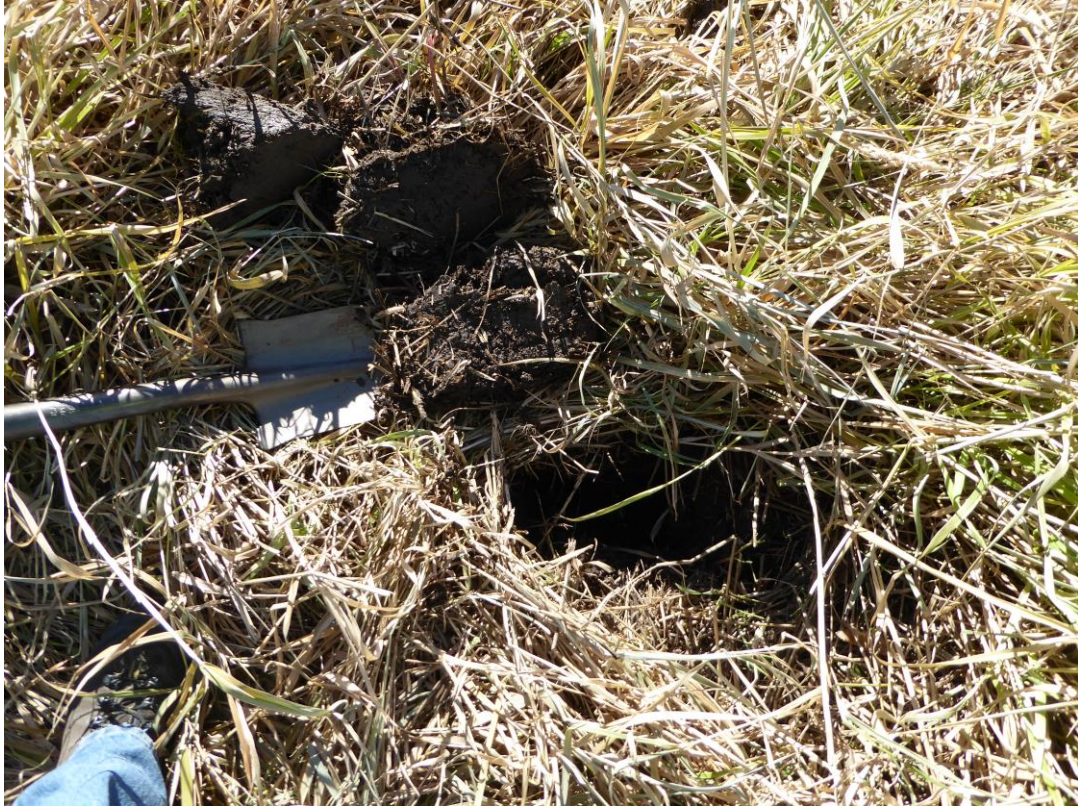
5. Soil pit in Wetland 1.

Depth (inches)	Matrix		Redox Features				Texture	Remarks
	Color (moist)	%	Color (moist)	%	Type ¹	Loc ²		
0-13	10YR3/2	100					clay loam	moist to saturated

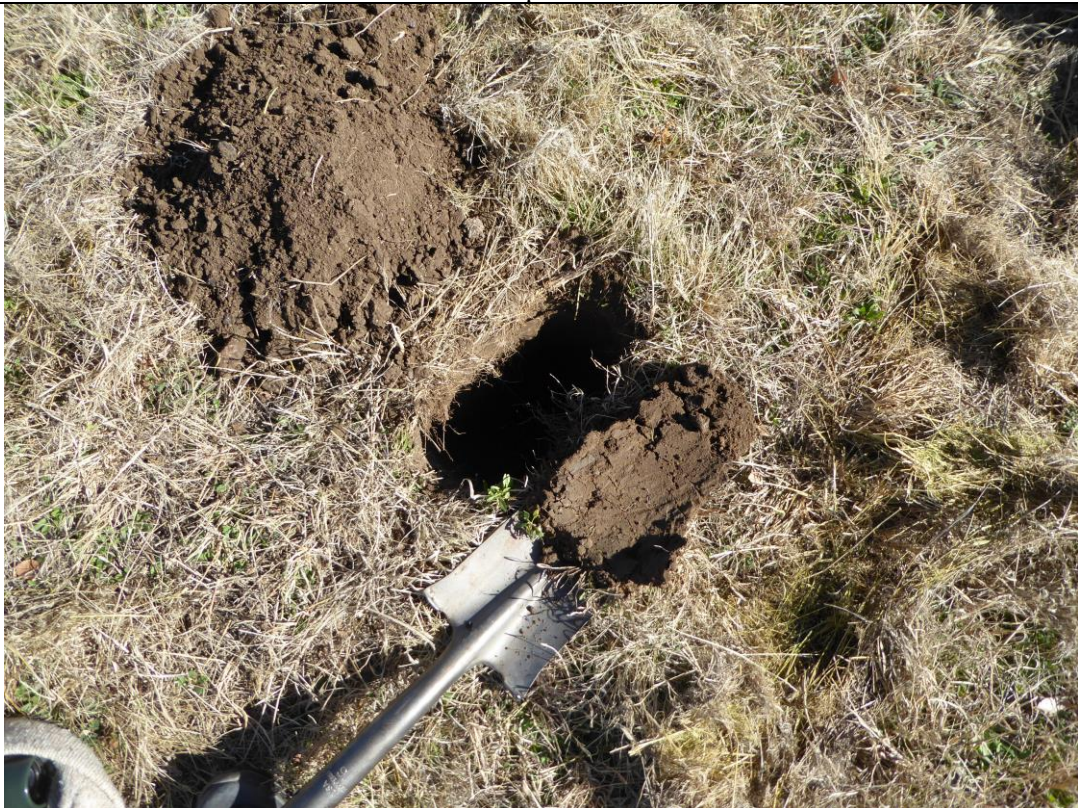
6. Upland soil pit for Wetland 1.

Remarks: Concrete at 13 inches, asphalt inclusions. Soil probably disturbed during construction of adjacent concrete-line channel.
No hydric soil indicators.

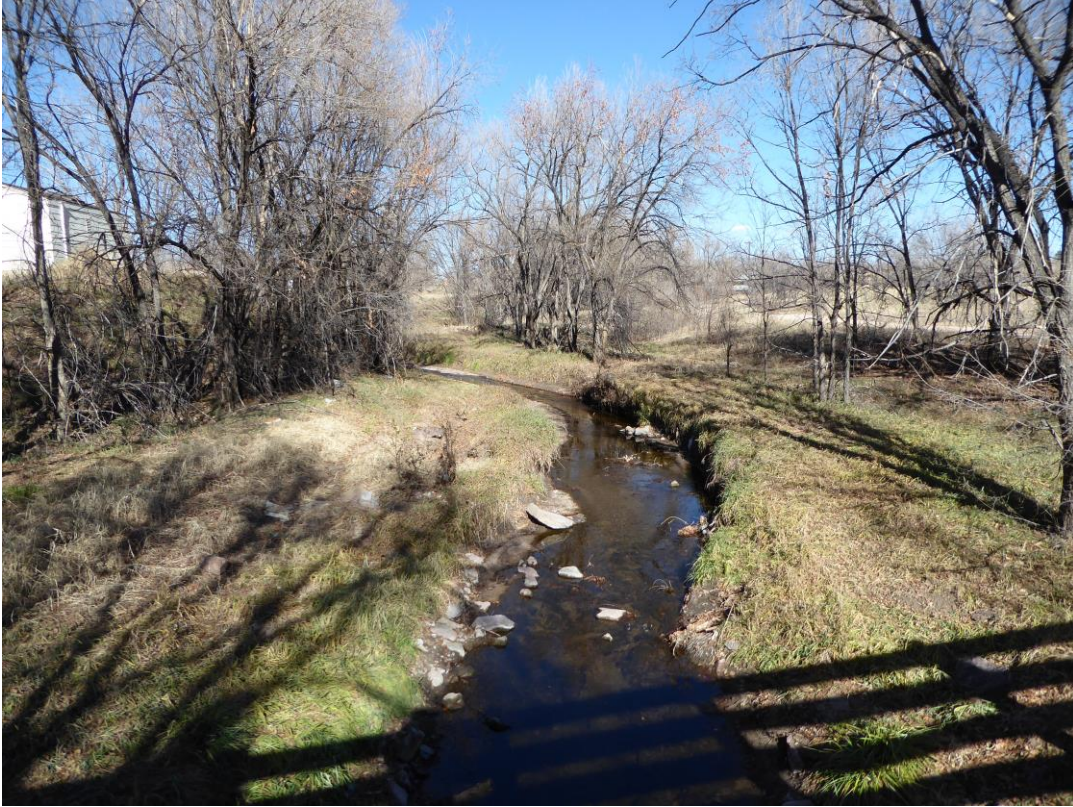
- At the middle crossing, the stream channel was 4 to 8 feet wide with a bankfull depth of about 10 inches. Water was about 4 inches deep at the time of survey. The bottom of the channel was mostly gravel with some chunks of concrete. The banks of the creek were sand and elevated 3 to 4 feet above the OHWM. The primary vegetation on the banks was Siberian elm and reed canarygrass.

7. Middle pipeline crossing of Crews Gulch. Looking north from pedestrian bridge.

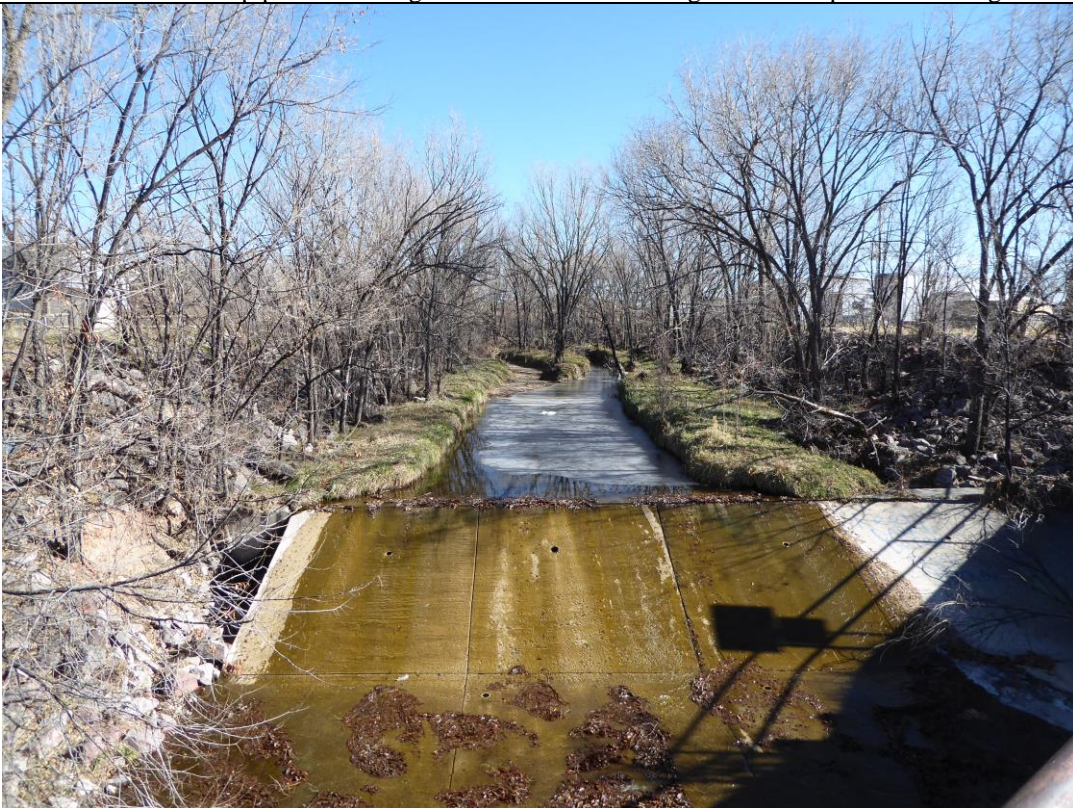
- At the lower crossing, the creek had an OHWM about 20 feet wide and at least 10 inches or more deep. The water was barely flowing and was backed up behind a dam just upstream of Southmoor Drive. The channel bed was gravel, and the banks were sandy and 2 to 3 feet above the river, with a vegetation cover of Siberian elm and reed canarygrass.

8. Lower pipeline crossing of Crews Gulch, looking east from Southmoor Drive bridge.
