Natural Features Report for the Cornerstone Estates Project

El Paso County, Colorado

December 7, 2021

Project Number: 2021-15-1

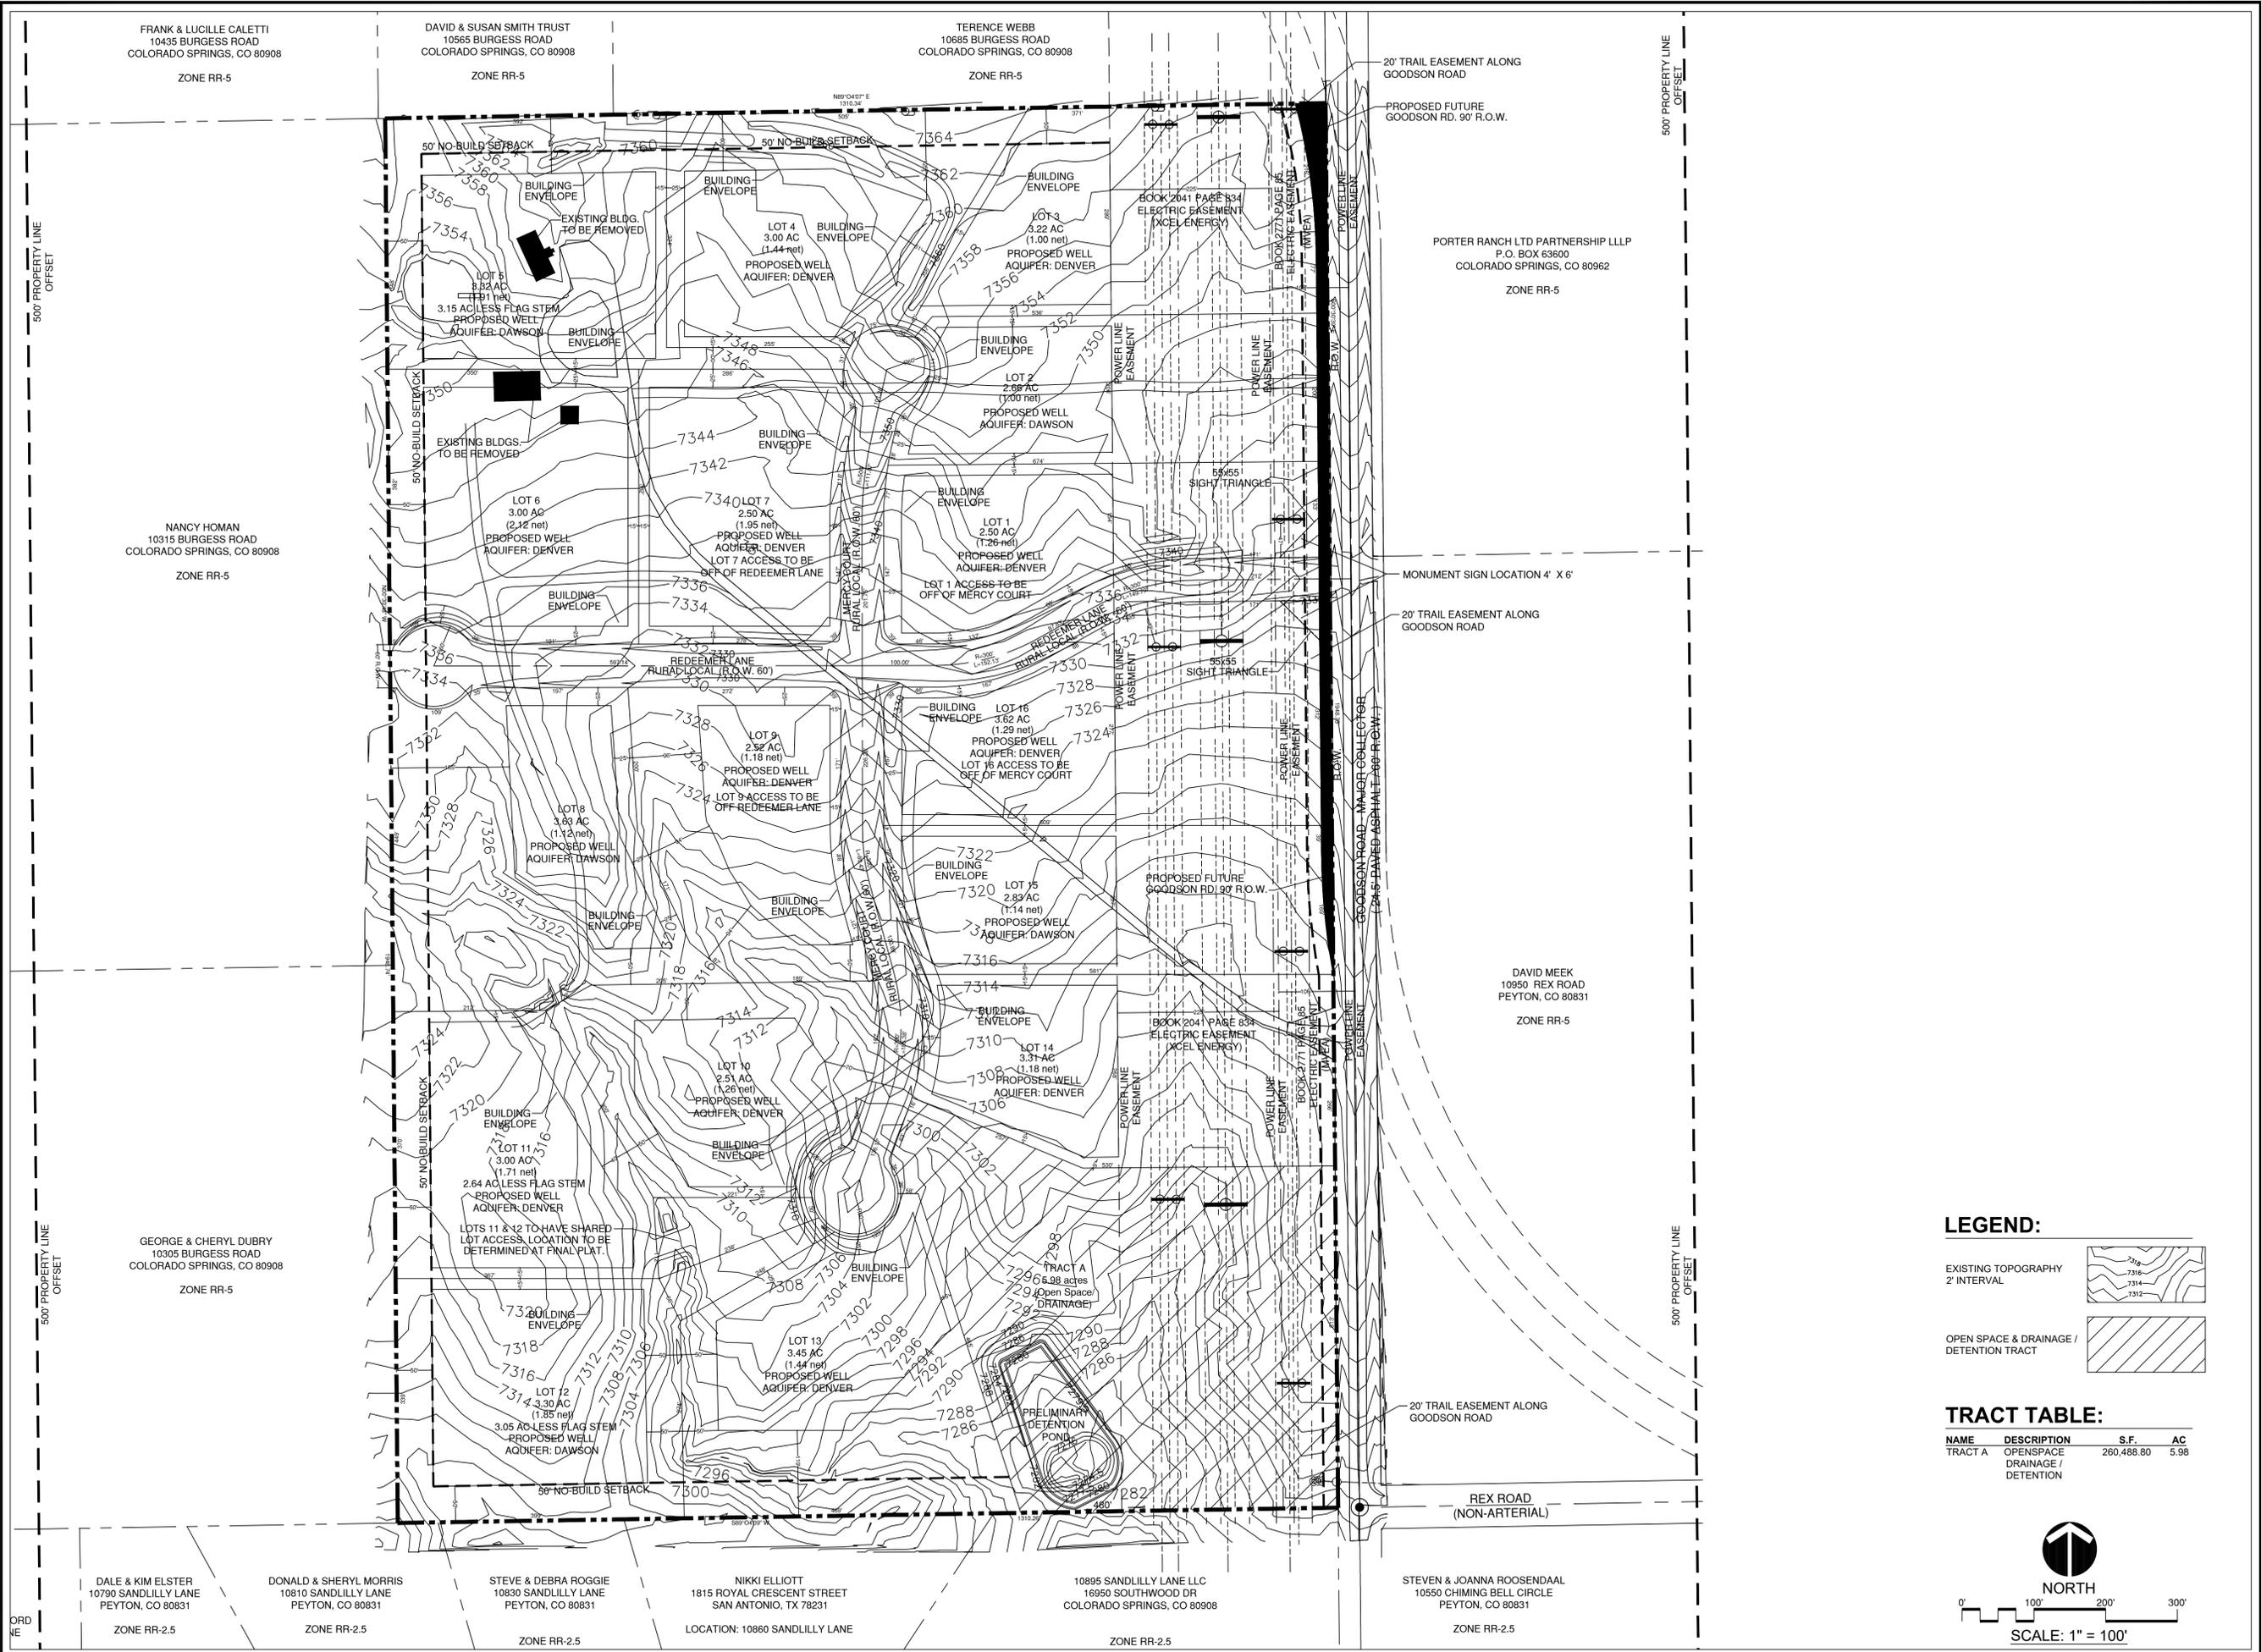
FIGURE 2
PROPOSED SITE PLAN

The Project proposes to divide the Site into 16 lots of approximately 2.5 to 3.6 acres each Refer to Figure 2, Proposed Site Plan. The Applicant would remove the existing buildings and construct infrastructure consisting of two roads, stormwater swales, and a large stormwater detention pond in the southeast corner (Tract A). The existing driveway and the northwest pond would remain. The eastern edge of the Site (~13.6 acres) would not be developed due to the existing power lines and associated easement. Homeowners would develop their own lots including grading, septic, water wells, and propane. Power would be provided by Mountain View Electric. Please refer to the development application for more details and plans.

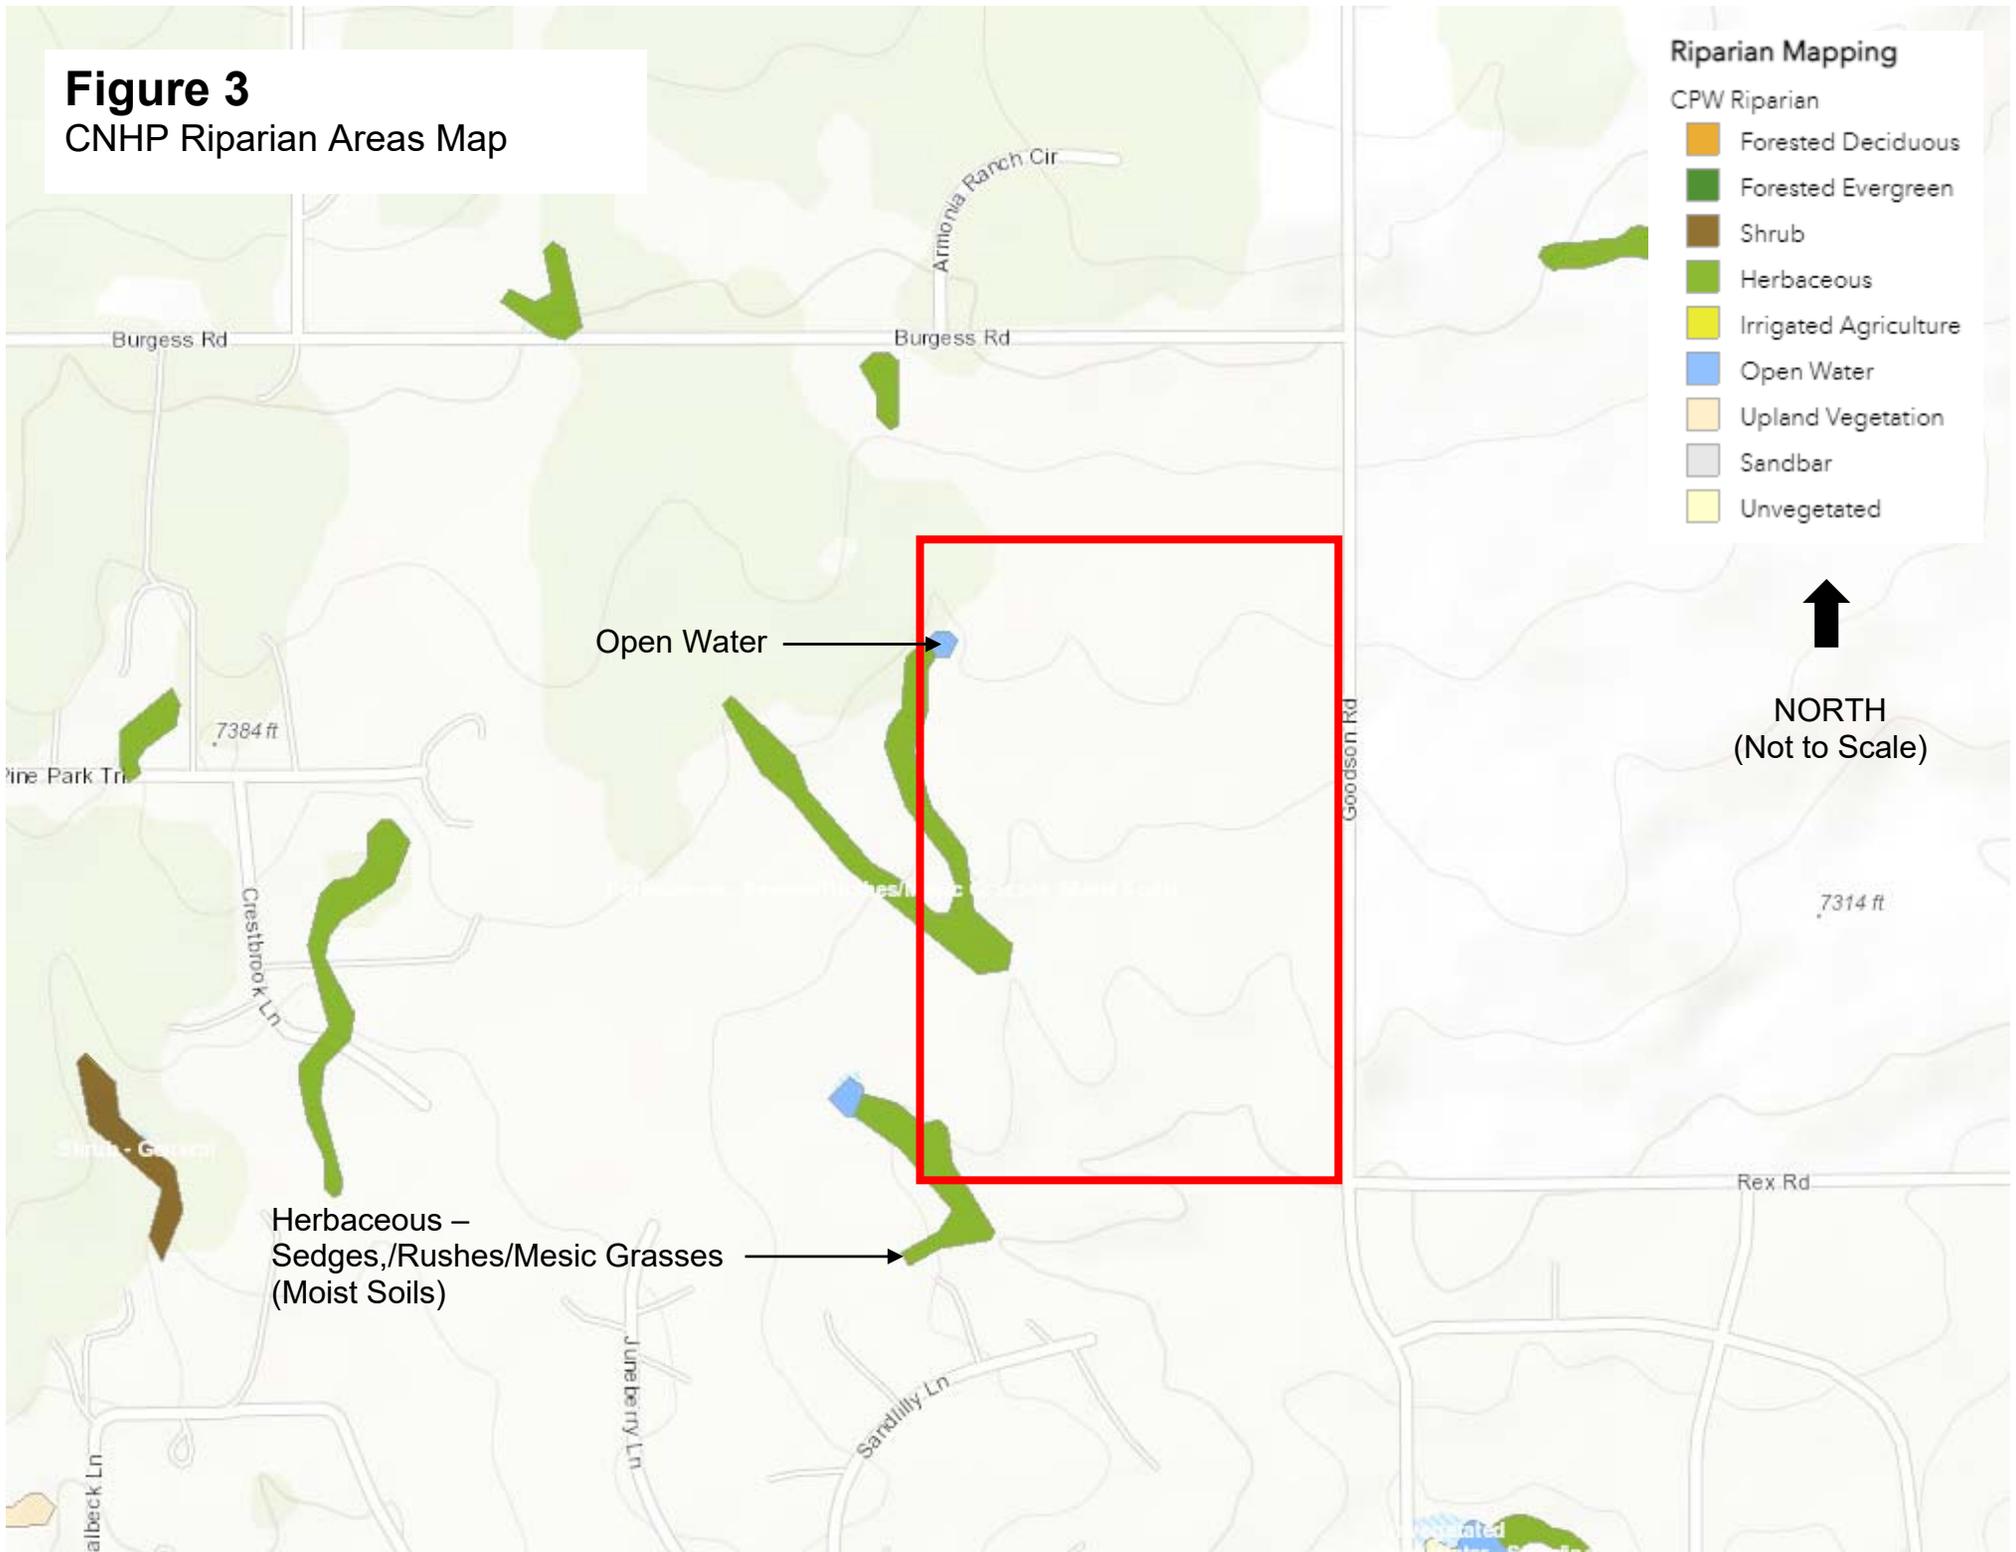
Figure 3
CNHP RIPARIAN AREAS MAP

Figure 3
CNHP Riparian Areas Map

Open Water →

Herbaceous –
Sedges, /Rushes/Mesic Grasses
(Moist Soils) →

Refer to Figure 3, CNHP Riparian Areas and Figure 4, Vegetation Community Map. Refer to Appendix E for a photo location map and representative photographs of site conditions.

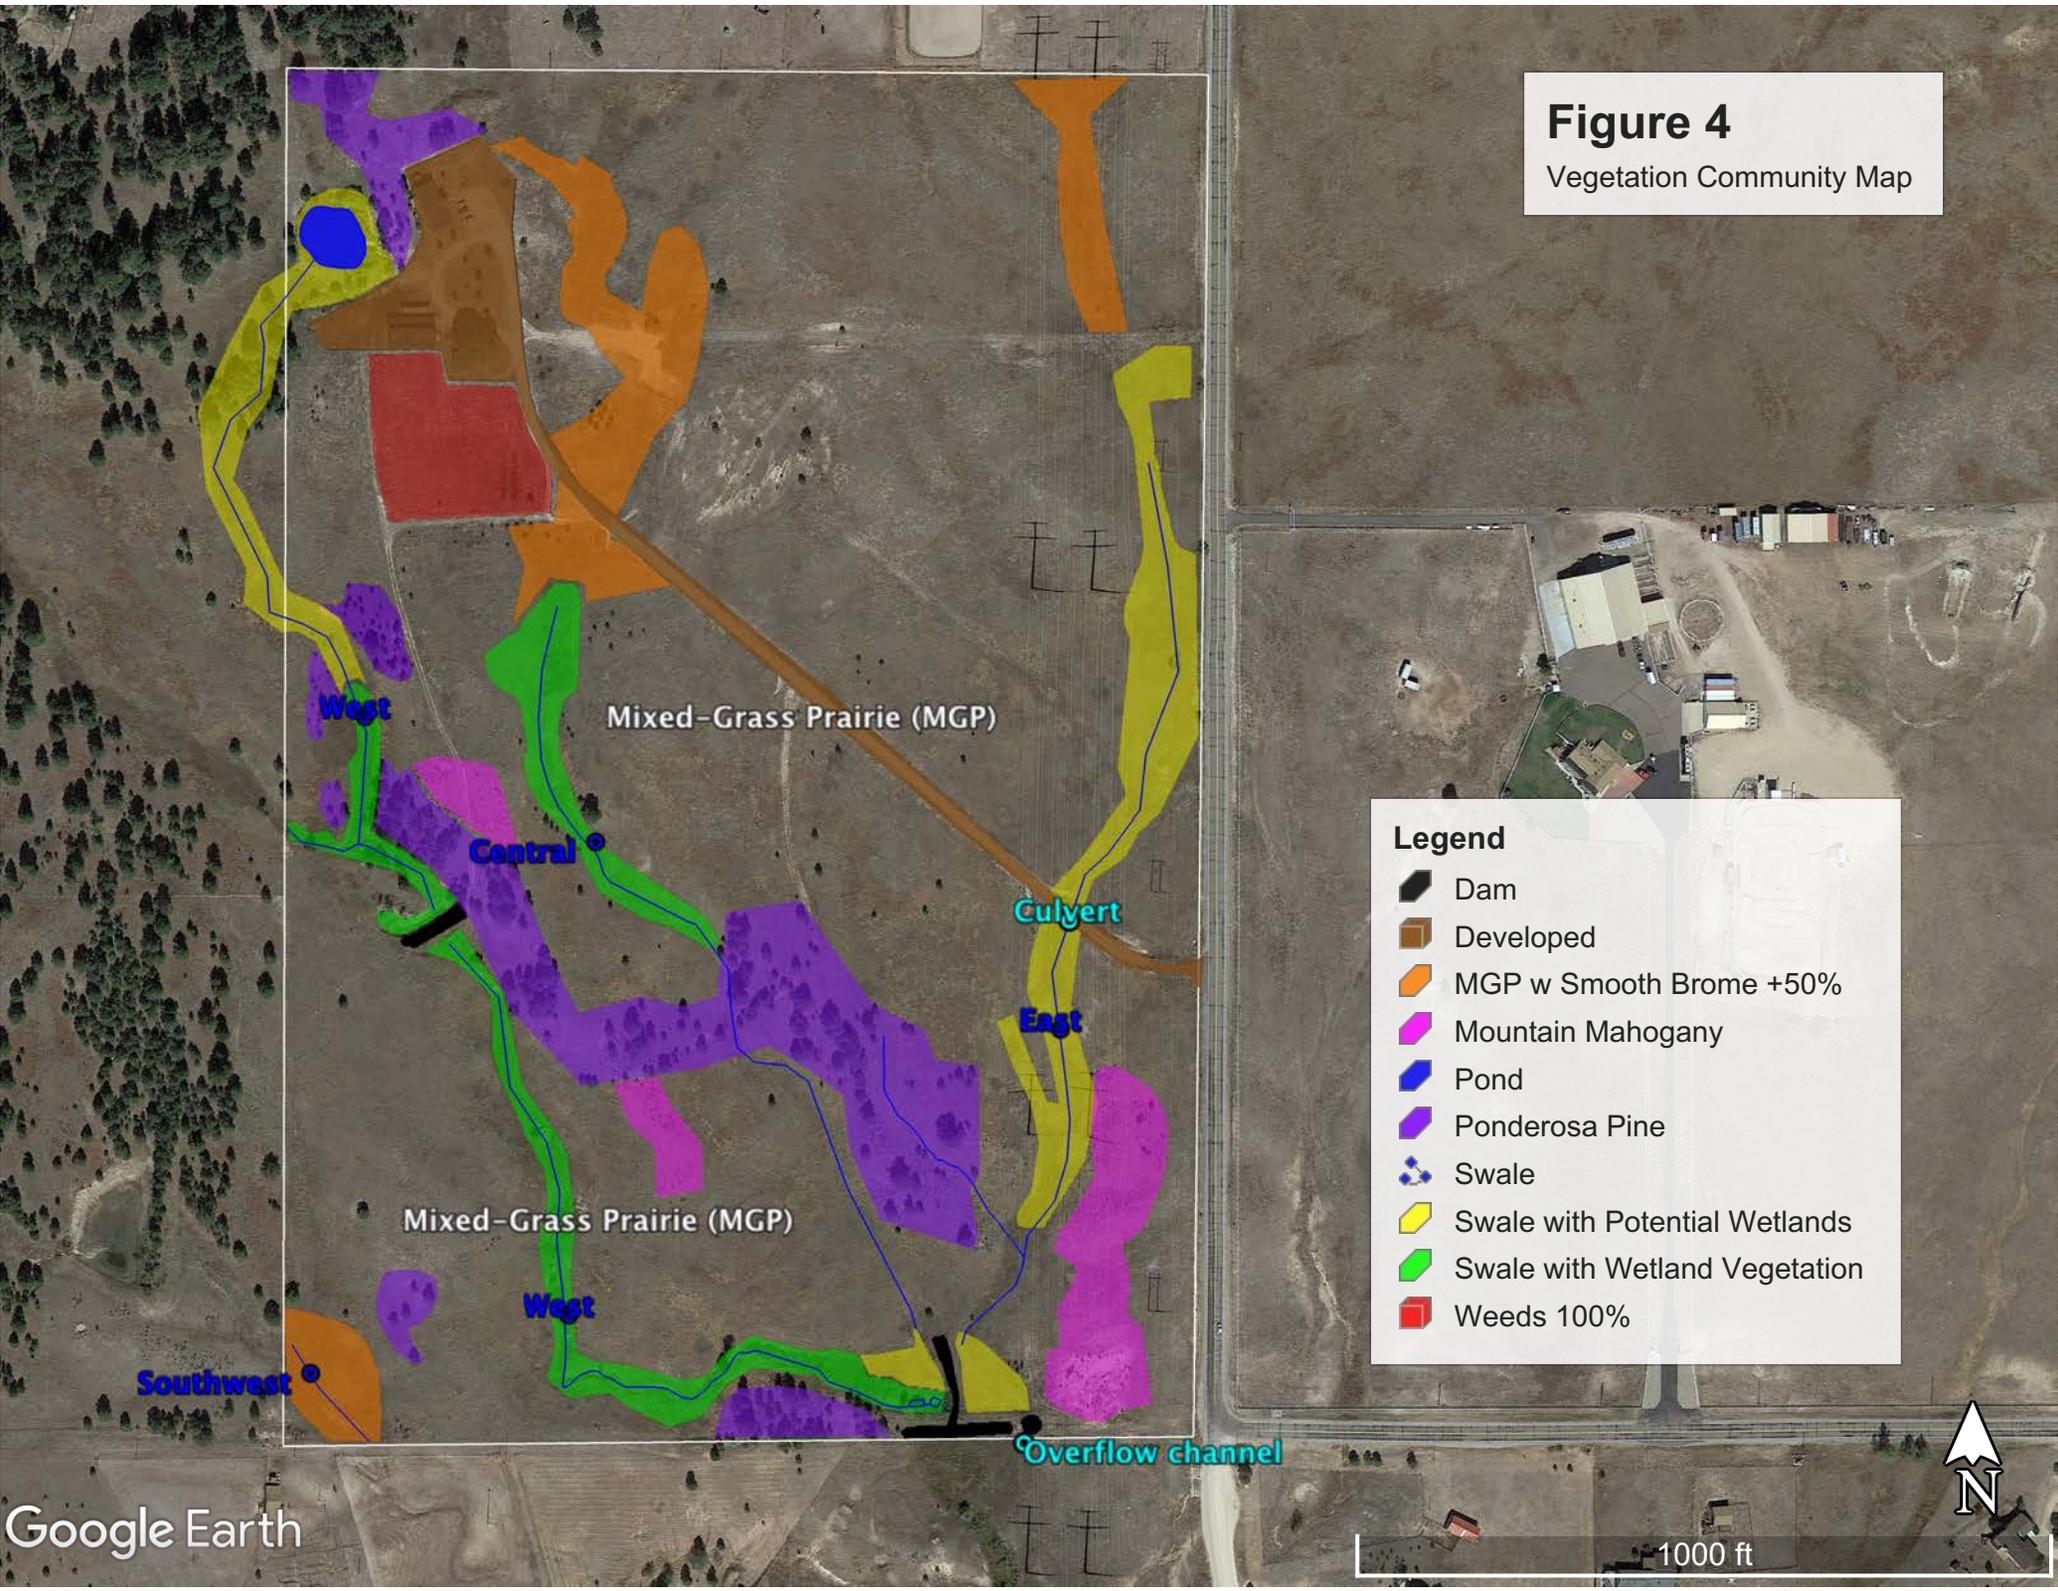
FIGURE 4
VEGETATION MAP

Most of the drainage swales converge in the southeast corner of the Site where there is a shallow detention basin behind a T-shaped dam (Figure 4). Flows from the West swale regularly pool in the lowest portion of the basin, as evidenced by two small ephemeral pools that appear to have held water earlier in the year and the adjacent wetland vegetation. The rest of the basin does not appear to flood in most years. It is vegetated with a mix of upland and wetland species and no signs of recent inundation were observed. The field observations are consistent with aerial photographs that show the basin as dry except in 2015 when vegetation was greener than surrounding areas and in 1999 when both basins held water. An overflow channel has been cut through the southeast end of the dam; it is approximately four feet above the bottom of the basin and there were no signs that water has ever flowed through the channel creating a downstream surface connection. A wetland channel reforms approximately 150 feet south of the dam, on an adjacent property. The area between the dam and the channel was mowed, but appears to be wetlands based on the relatively dense vegetation.

Figure 4
Vegetation Community Map

Vegetation within the swales includes both upland and wetland areas (Figure 4). The upland vegetation is similar to the previously described mixed-grass prairie species. As moisture increase, vegetation in the swales transitions from upland species to hydrophytic species with dominants species including (listed from upland species to obligate wetland species): smooth brome, Canada thistle (*Cirsium arvense*), Baltic rush (*Juncus balticus*), narrowleaf willow (*Salix exigua*), and Nebraska sedge (*Carex nebrascensis*). Swales containing a mix of upland and wetland species (i.e., mesic riparian areas) were mapped as potential wetlands. This typically included a mix Canada thistle and Baltic rush, sometimes with lesser amounts of smooth brome.

Field reconnaissance also included an initial assessment of wetlands and USACE jurisdiction to aid in planning. Along natural drainage swales the following were mapped on an aerial photo prior to the Site visit; channels, potential wetlands, and visible upland breaks. During the Site visit these areas were visited to confirm conditions. Vegetation within swales was noted as being upland, wetland (i.e. hydrophytic species are dominant, meet USACE wetland vegetation criteria), or mixed (i.e. both upland and wetland species were present). A full wetland delineation per USACE requirements, including soil sampling points, was not completed. The actual wetland extent will generally fall within (i.e. be less than) the preliminarily mapped areas shown on Figure 4, Vegetation Community Map.

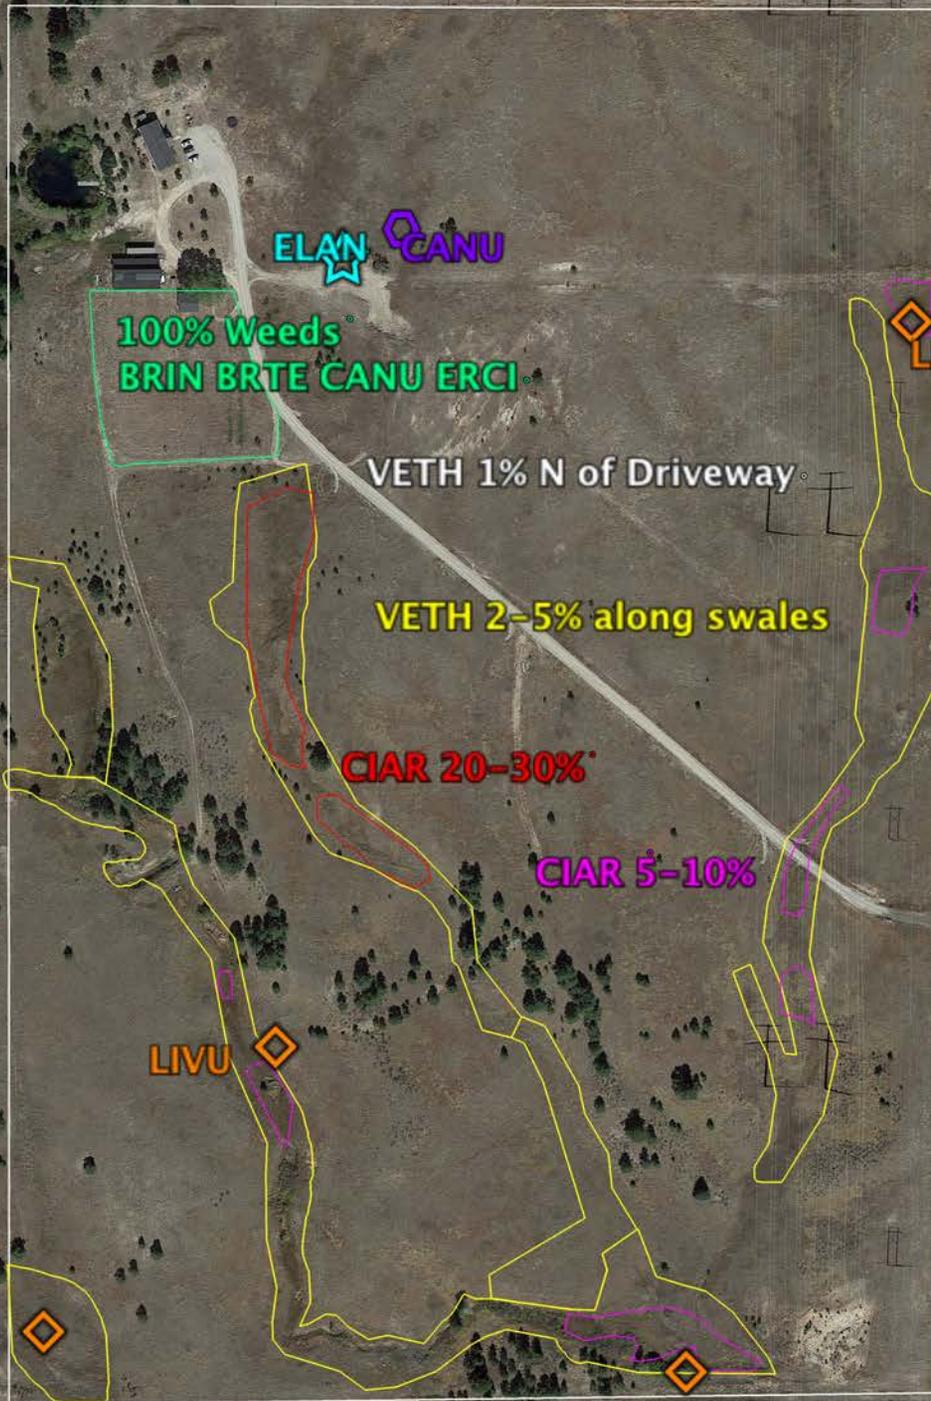
FIGURE 5
NOXIOUS WEED MAP

Figure 5
Noxious Weed Map

Most of the Site is in excellent condition with limited cover of noxious weeds or other nonnative species. Noxious weed concentrations are shown on Figure 5, Noxious Weed Map. Some generally weedy areas, including mixed-grass prairie with smooth brome are shown on Figure 4, Vegetation Community Map. Noxious weeds were associated with three main areas/situations.

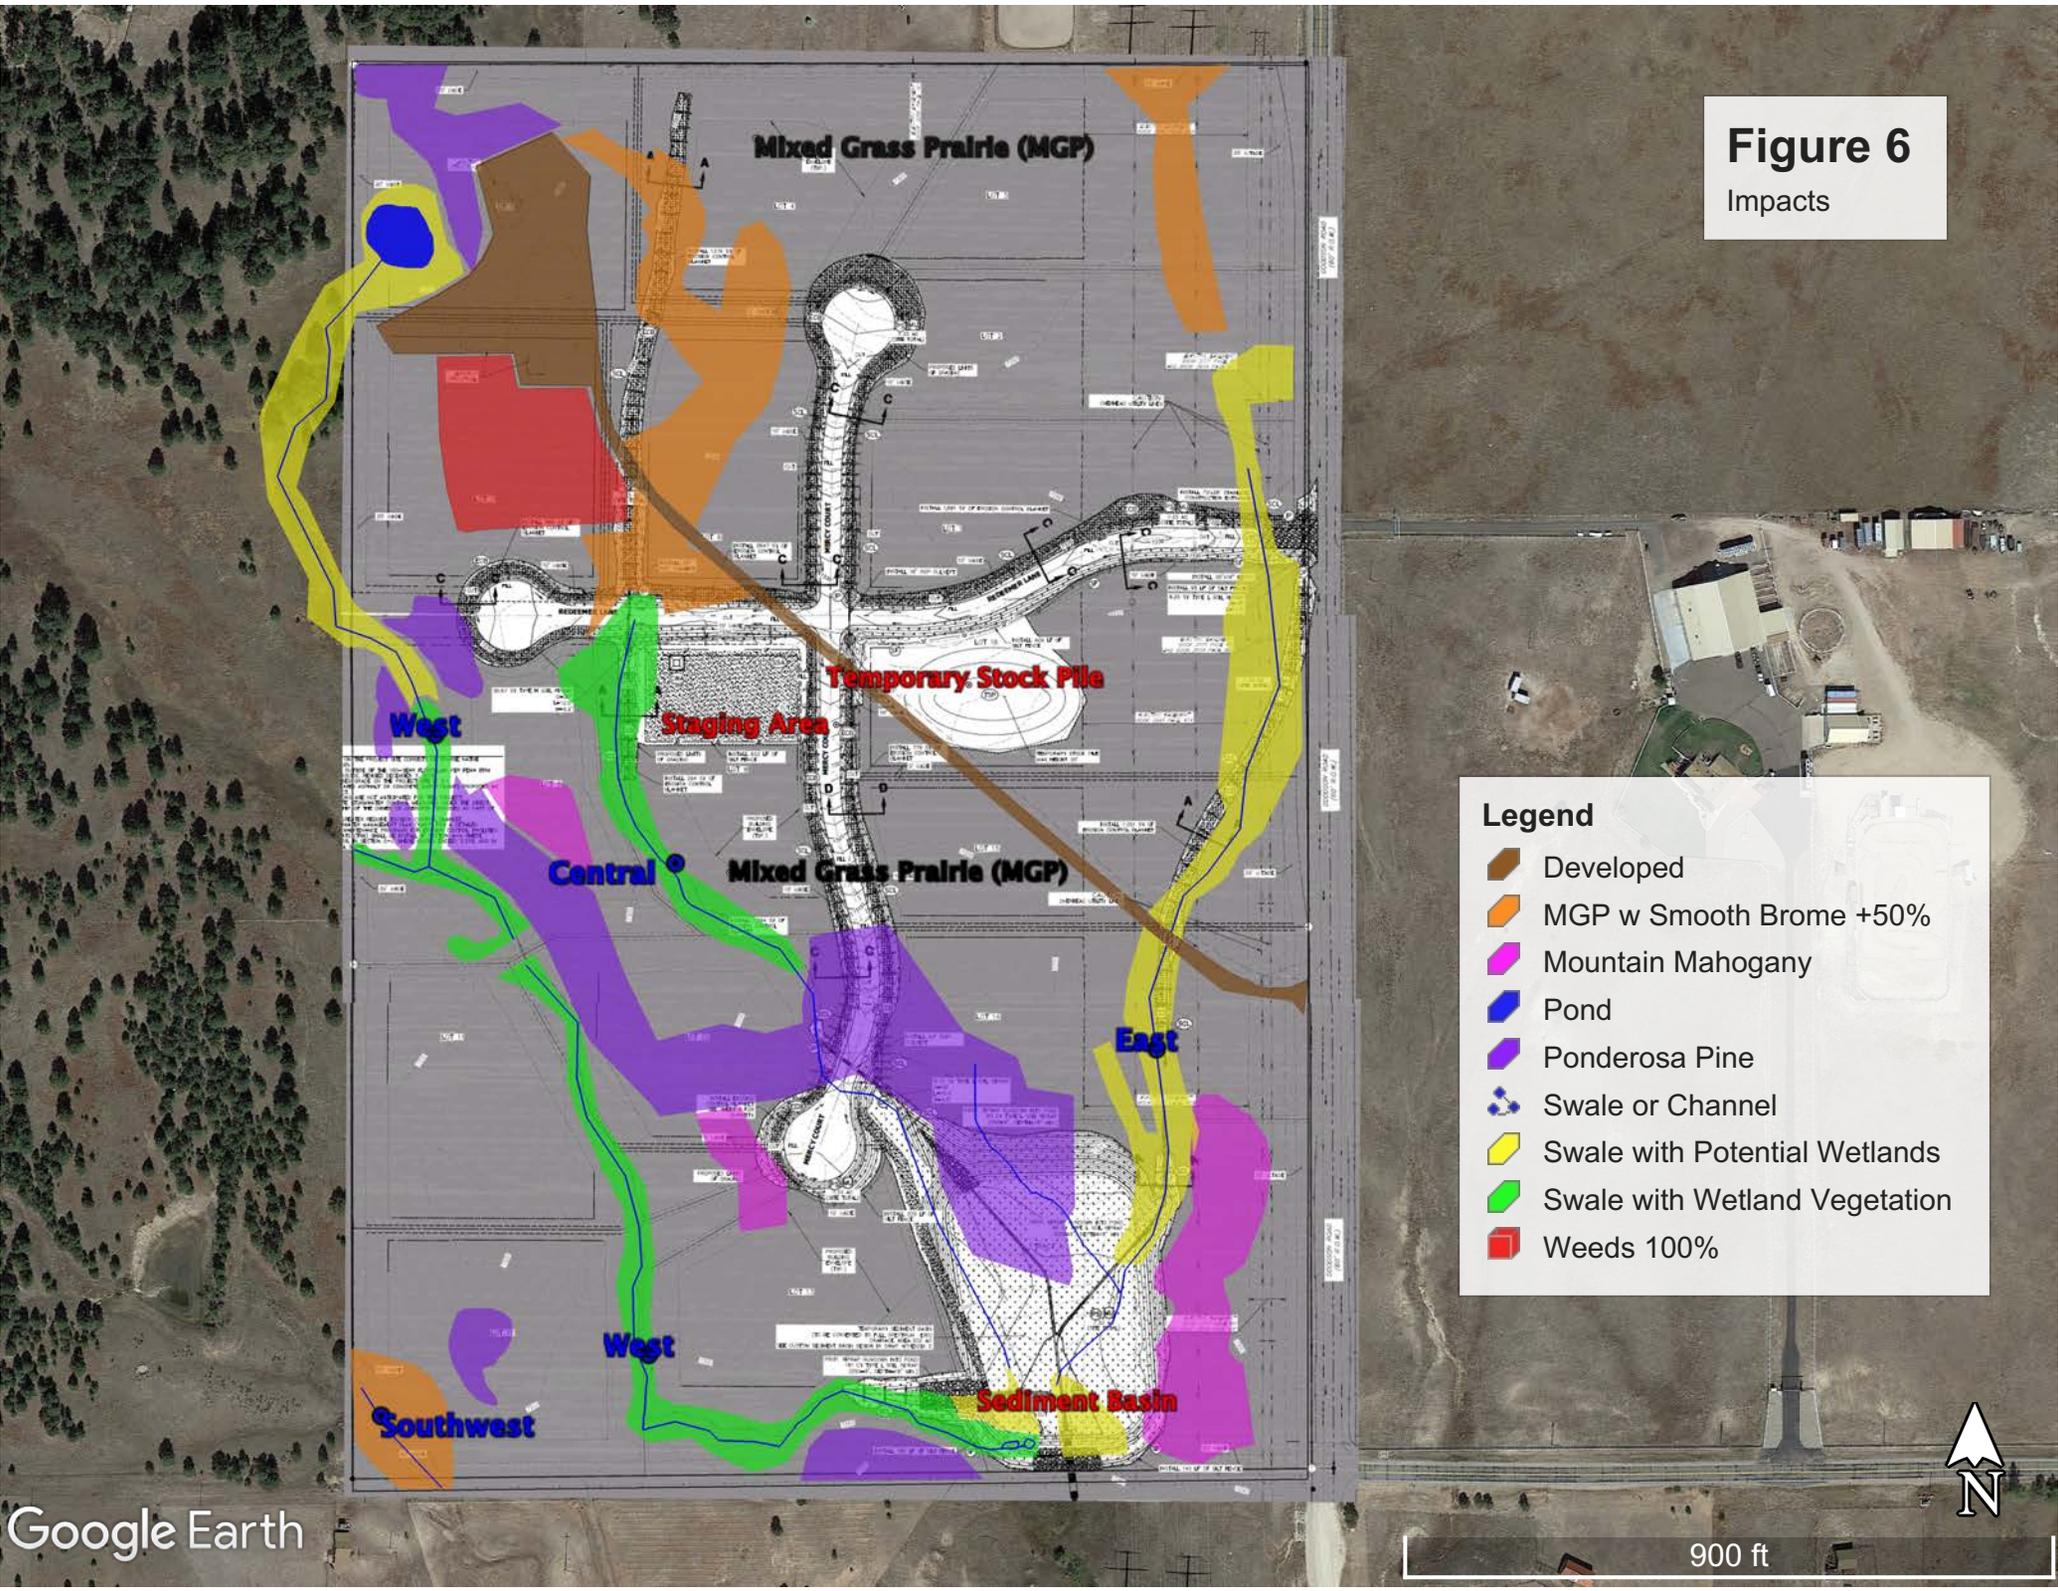
FIGURE 6
IMPACT MAP

Figure 6
Impacts

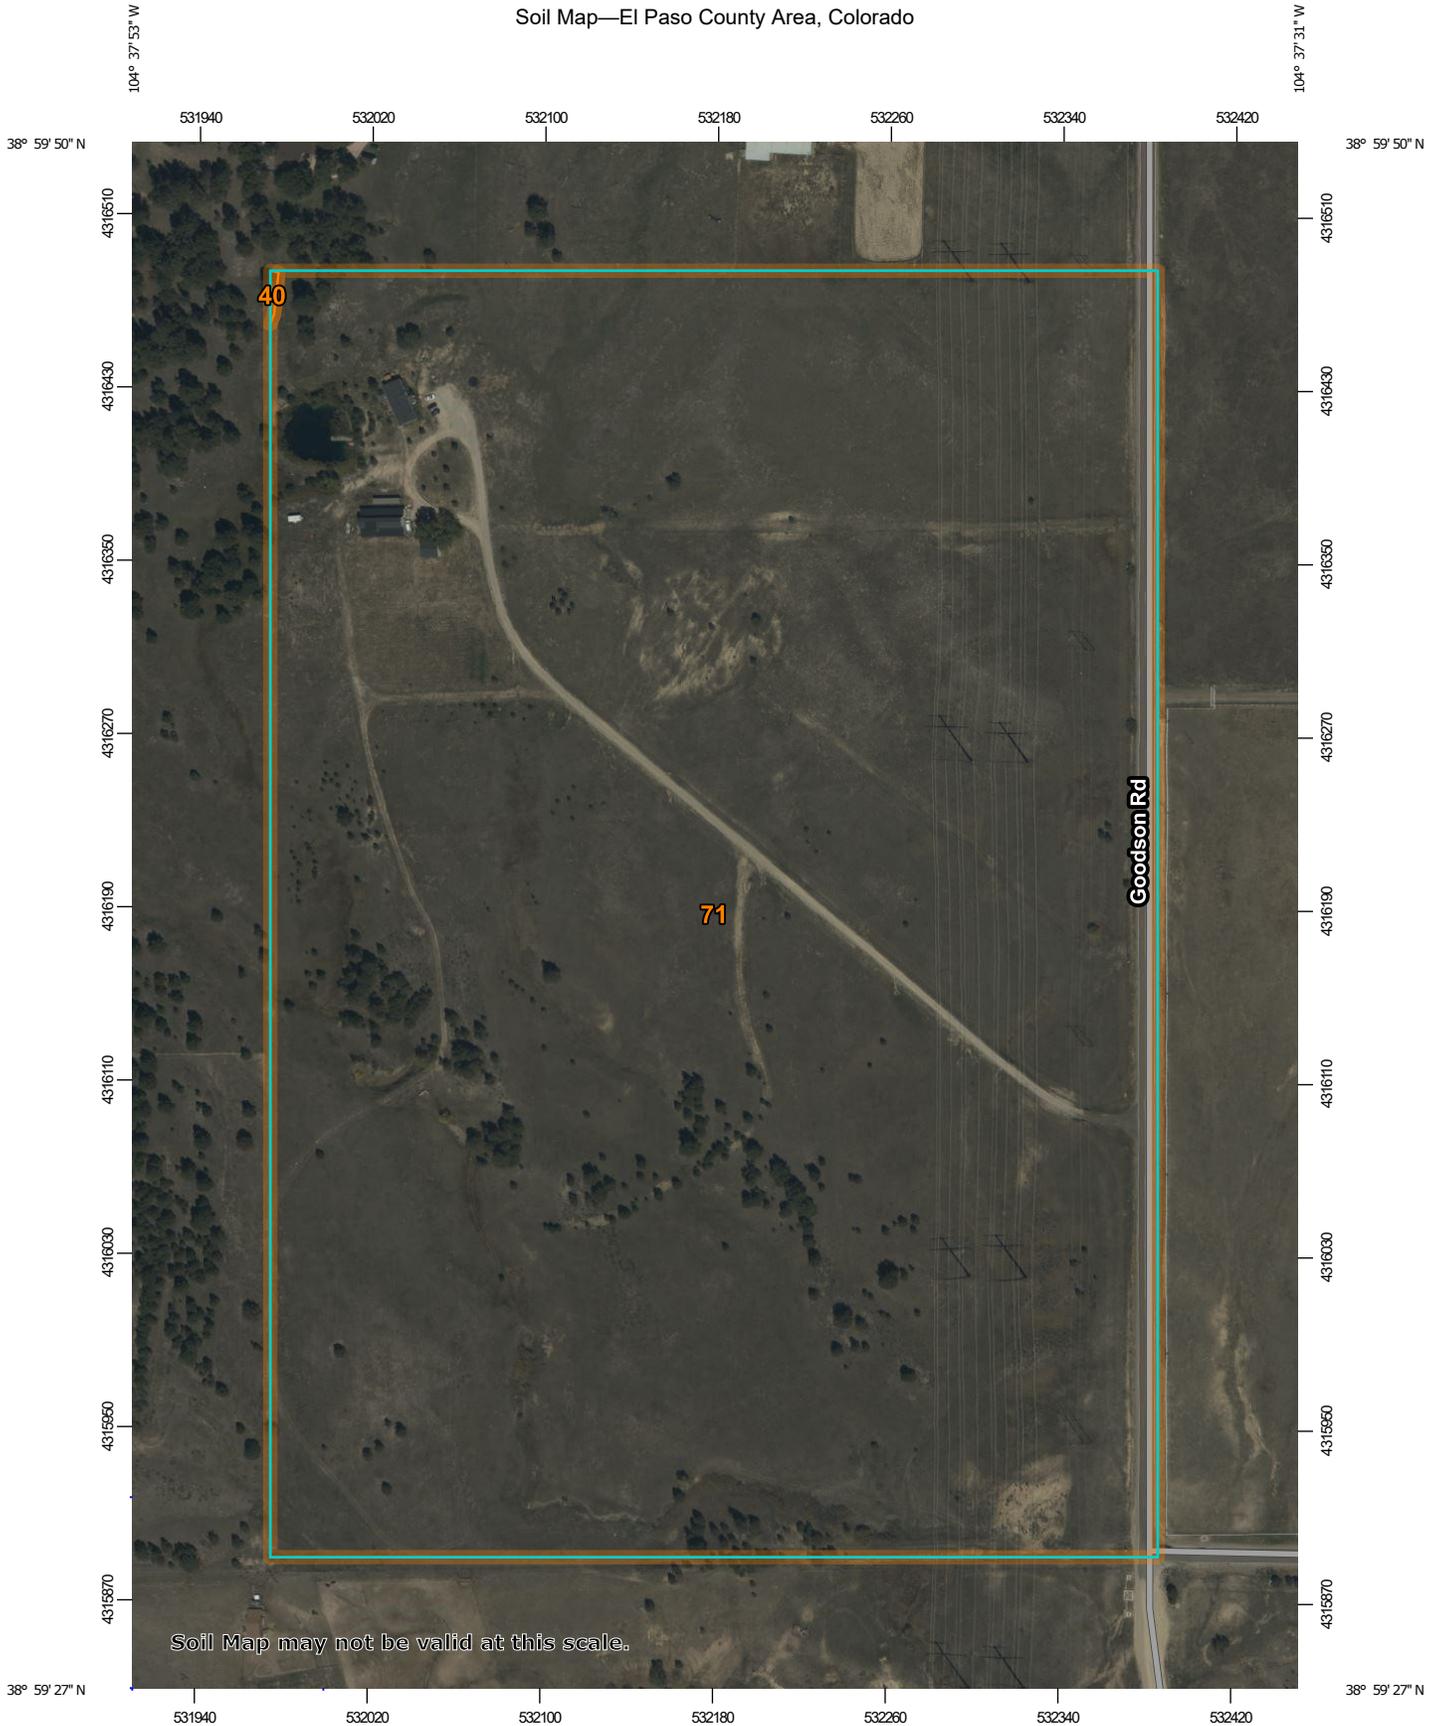
Soil Map—El Paso County Area, Colorado

Pring coarse sandy loam (Map Unit #71) is the soil type that underlies 100% of the Site. This well-drained alluvium occurs on alluvial fans, valley side slopes, hills, and ridges in the foothill and Black Forest areas of Colorado. Slopes range from 0 to 30 or more percent. This soil has rapid permeability with a low run-off class that is not frequently flooded. The available water capacity is low (about 6.0 inches). Pring soils are not classified as hydric.

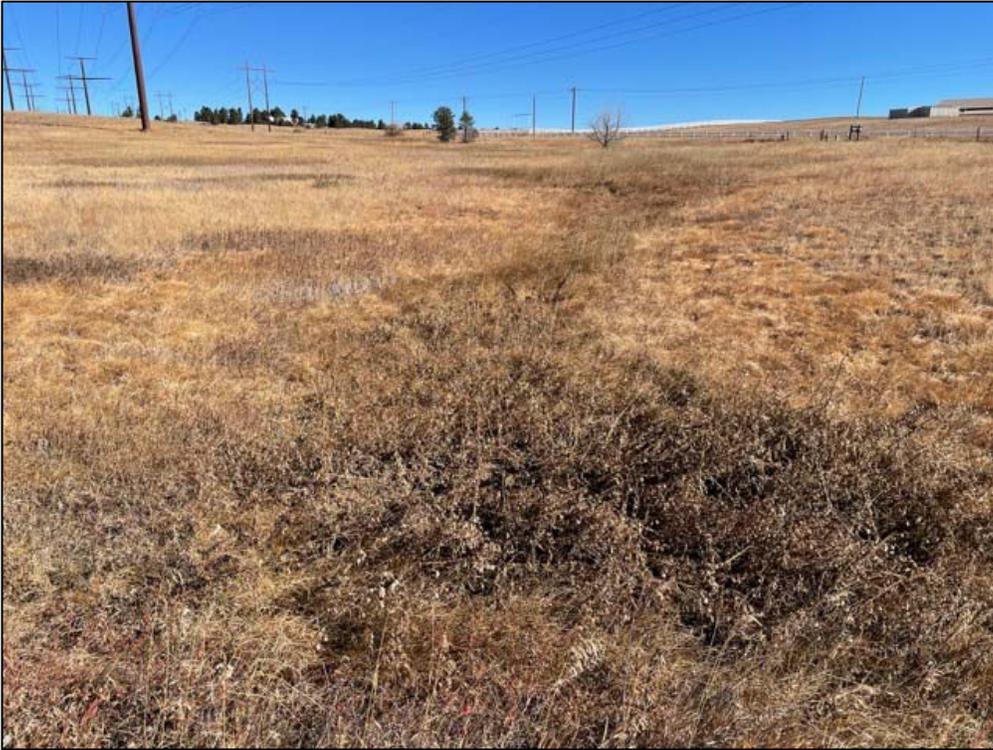
Photo 1 – East swale, facing north from the existing driveway. In the foreground are potential wetlands with upland and wetland species, including the dark-colored Canada thistle (List-B noxious weed).

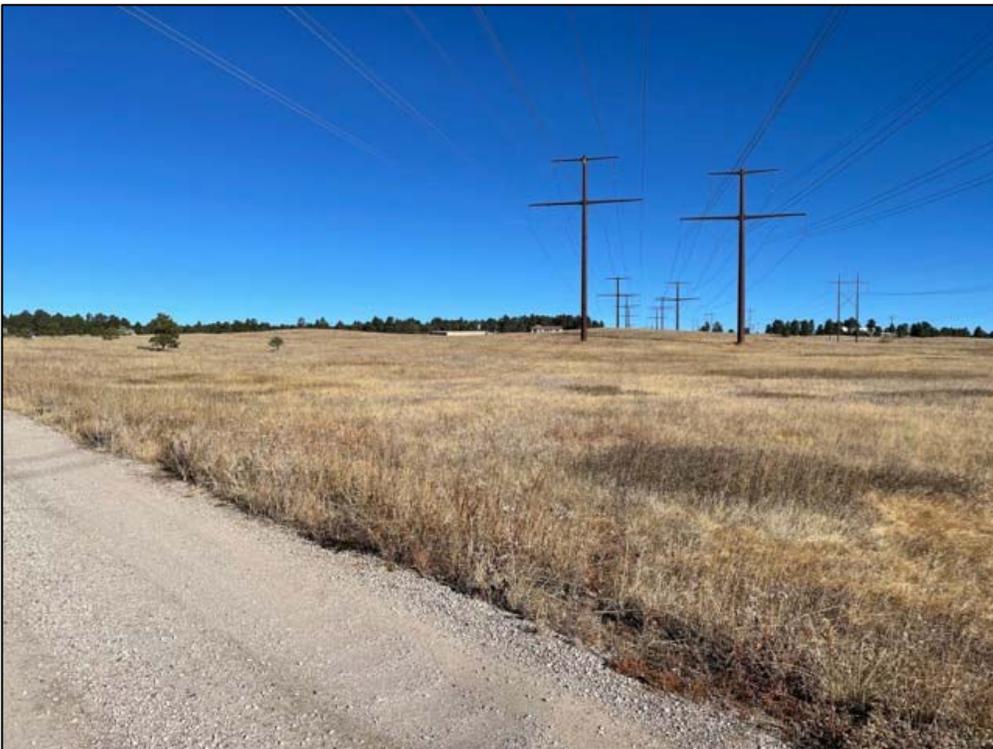
Photo 2 – Diverse mid- and tallgrass prairie, north of existing driveway.

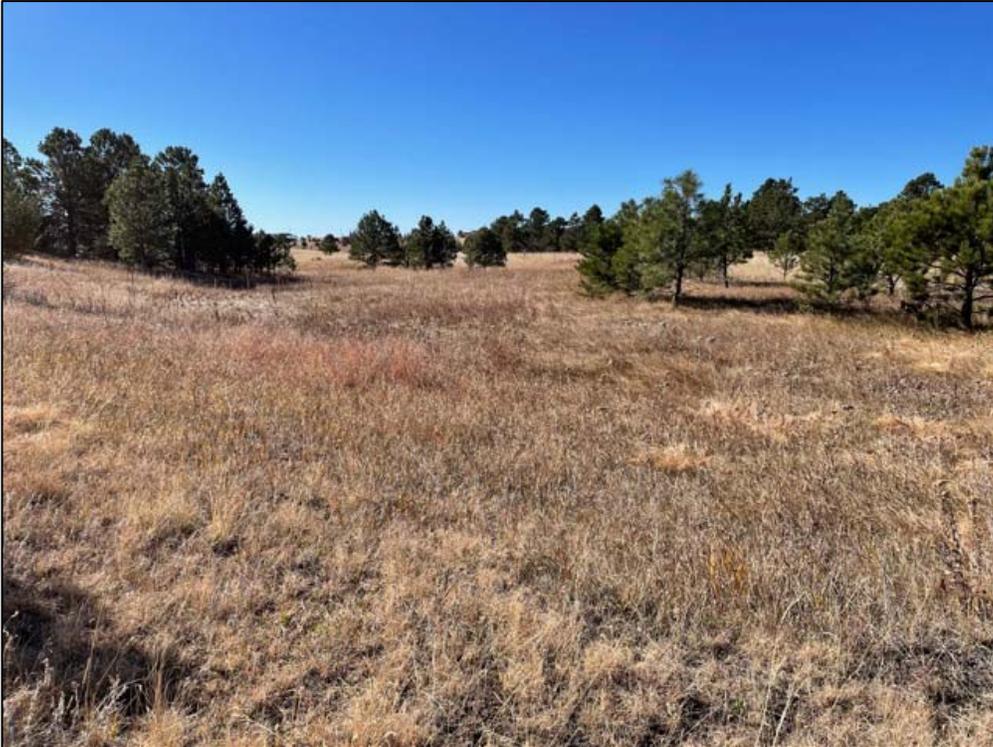
Photo 3 – West edge of Site, facing southeast along the West swale. These potential wetlands and tallgrass prairie are very high quality due to the lack of weeds and presence of big and little bluestem grasses.

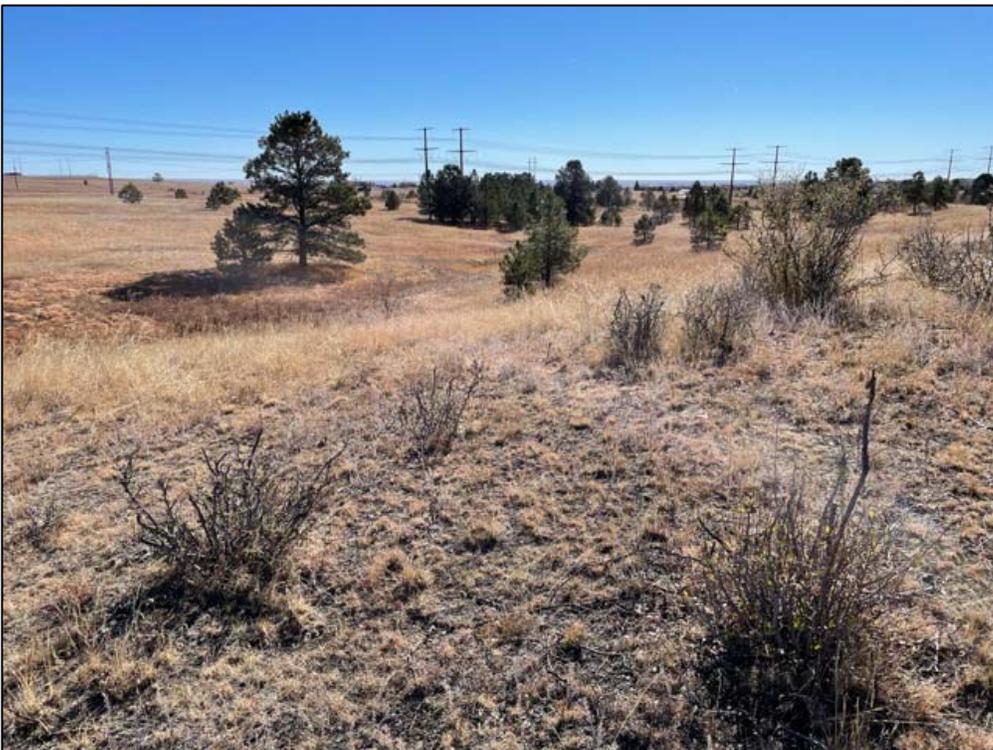
Photo 4 – Dry ridge with mountain mahogany shrubs and shortgrass prairie. Tallgrass prairie is on lower slopes. Facing southeast towards Central swale wetlands that are partially visible in front of the large ponderosa pine.

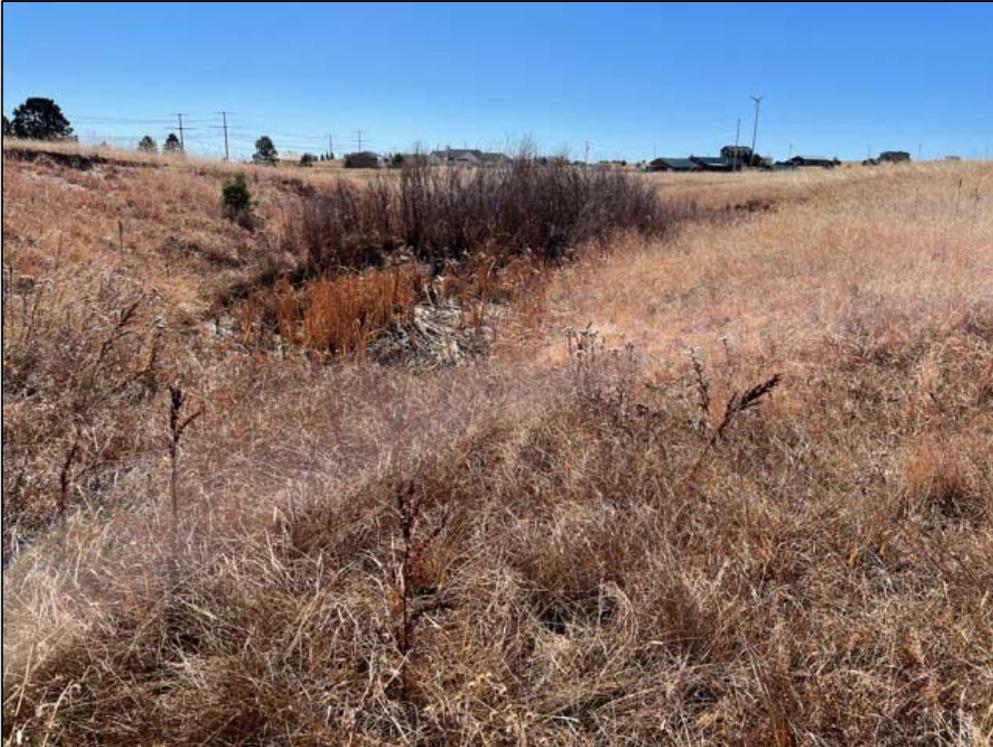
Photo 5 – West swale wetlands, patch of narrowleaf willows and cattails.
