Natural Features Report for the Cornerstone Estates Project

El Paso County, Colorado

December 7, 2021

Project Number: 2021-15-1

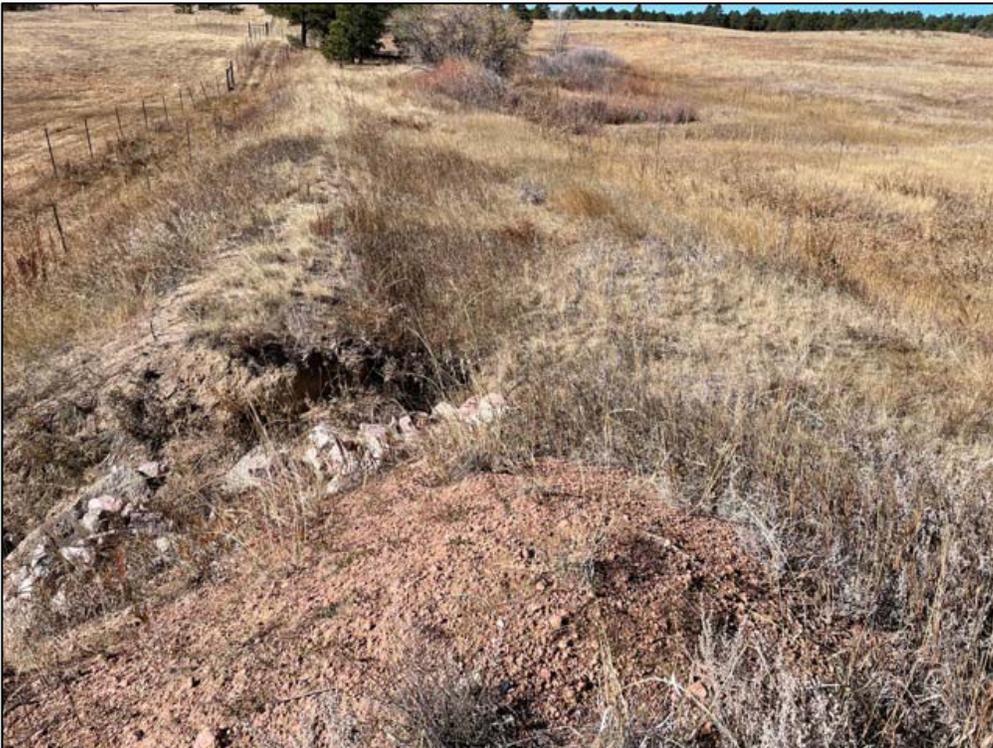
Photo 6 – Facing west from the southeast dam. Property line/fence is photo left, overflow channel is in the foreground, and detention area is photo right (no indicators of recent flow or flooding). A patch of sandbar willows behind the West swale dam is visible in the background. The Central swale edge is visible near the top right corner of the photo.

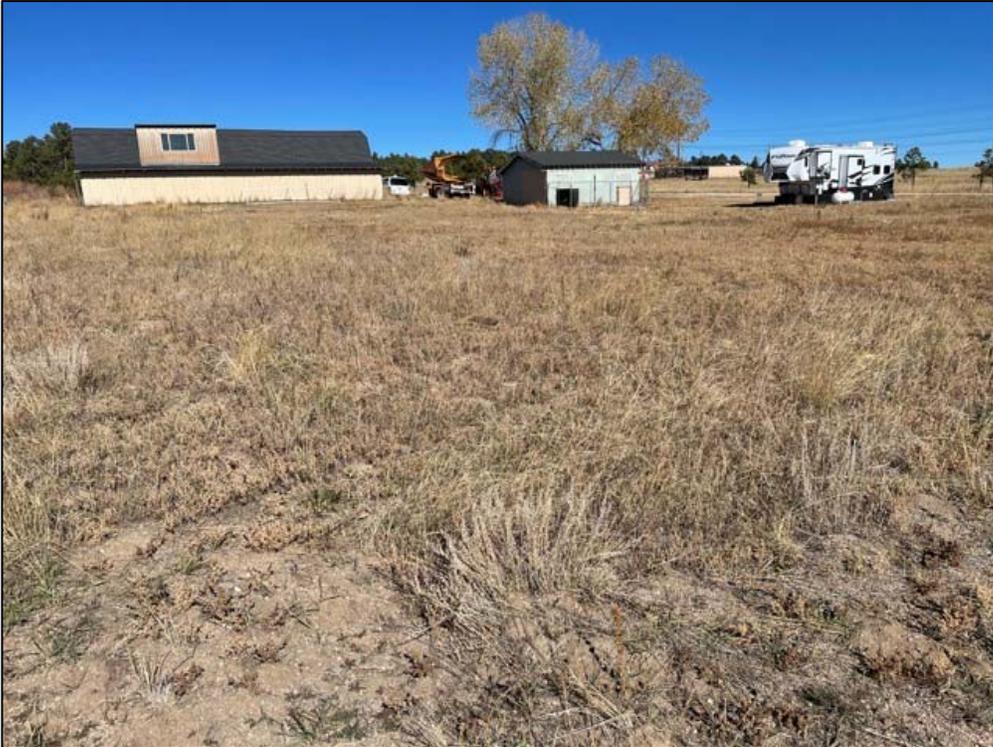
Photo 7 – Facing north across area mapped as “Weeds 100%” and towards the existing outbuildings mapped as “Developed.”

2. Alternatively, since the "Weeds 100%" area is already disturbed, it could be used for a staging area IF weeds are controlled by repeated soil sterilization with steam or chemicals (with a short half-life). Following sterilization and/or complete degradation of the chemicals, re-seed those areas (that the landowner wants to retain as native grassland) with a seed mix comprised of a sterile cover crop and native species until the lot is developed. If topsoil (4-6 inches) is removed from this area in lieu of sterilization, it must not be used elsewhere and should be disposed of by burying it beneath at least twelve inches on non-weedy topsoil. To ensure an adequate growth media is present to support a native stand of grass, weed-free topsoil and/or soil amendments will need to be imported to cover areas that have been stripped.
