RE: ENVIRONMENTAL INVESTIGATION
2875 Akers Drive
Colorado Springs, Colorado

Entech Engineering Inc. (Entech) has completed an Environmental Investigation for the site located at 2875 Akers Drive in Colorado Springs, Colorado (the Site) as recommended in the above referenced Phase I ESA. A map showing the Property location is presented as Figure 1. The Environmental Investigation was requested after the above referenced Phase I ESA identified several RECs on the Property during the reconnaissance portion of the above referenced ESA. The items of concern observed during the reconnaissance included the following:

Dillie and Kuhn, Inc.
2875 Akers Drive
Colorado Springs, Colorado

SITE MAP
DILLIE & KUHN, INC.
2875 AKERS DRIVE
COLORADO SPRINGS, COLORADO
FOR: GE JOHNSON CONSTRUCTION COMPANY

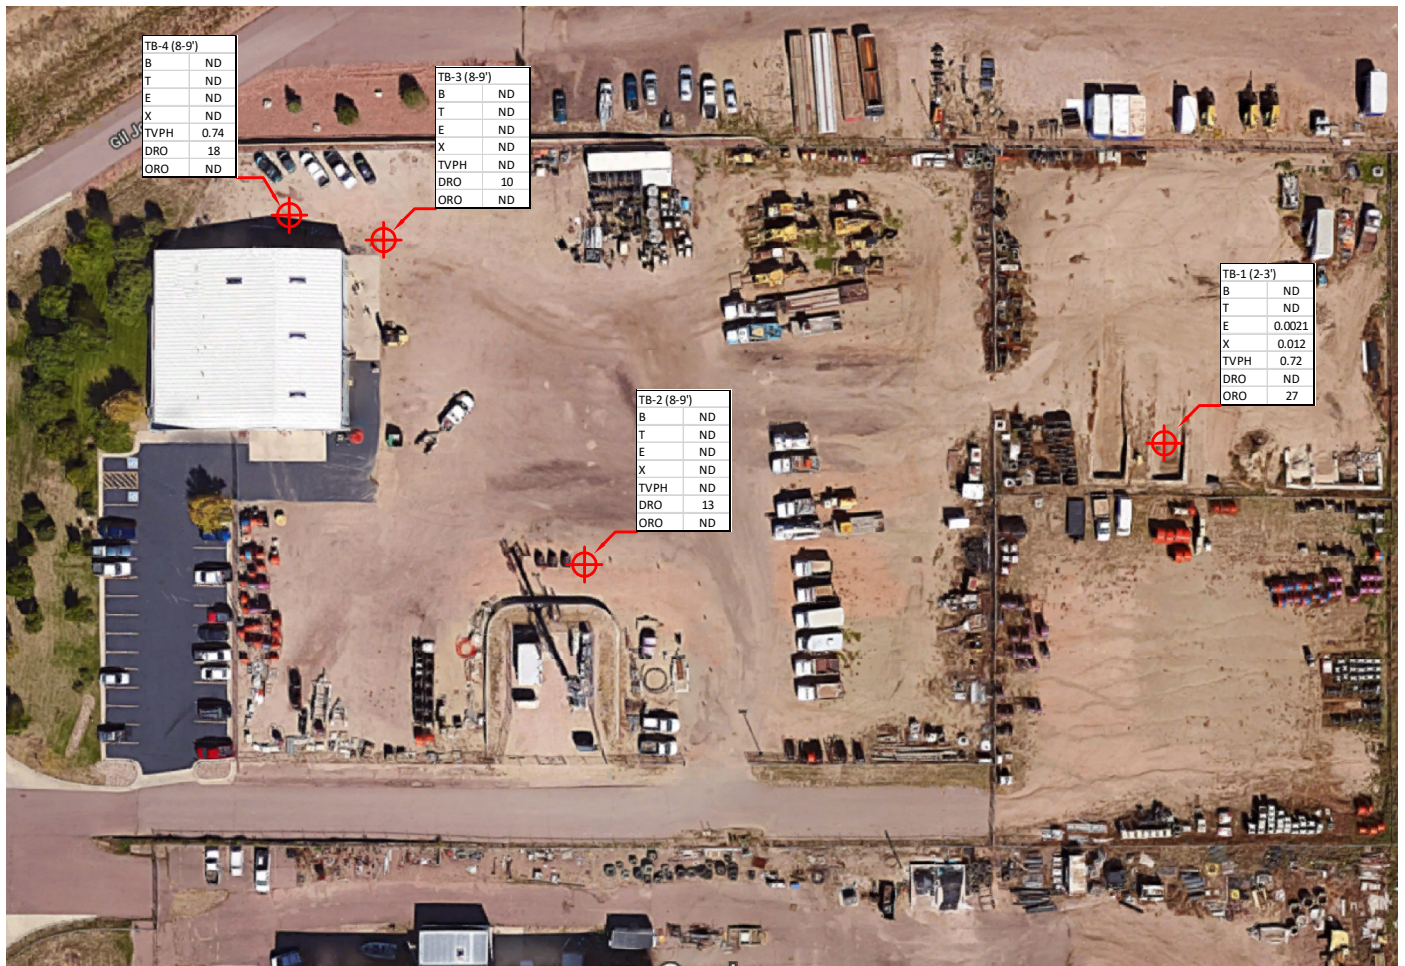
FIG NO.:
2

Personnel from Entech Engineering, Inc. coordinated and observed the drilling of four test borings at the Site on December 6, 2017. The purpose of the test borings was to evaluate what, if any, contamination may exist in the subsurface soils beneath the Site. Test Borings 1 through 3 were advanced using a SIMCO 2800 drilling rig operated by Entech Engineering, Inc. Test Boring 4 was advanced using hand augur methods. The test borings were drilled in the locations as shown on the Site Map\ Test Boring Location Plan (Figure 2).

Analytical results indicate very low levels of ethylbenzene, xylene, GRO, DRO and ORO in the subsurface soils on the Site. All analytical results are below state action levels (risk Based Screening Levels). The analytical results from the Environmental Investigation summarized in Table 1.

TB-1: NUMBER AND APPROXIMATE LOCATION OF TEST BORING

Based on the results of the site investigation conducted by Entech, no further environmental investigation is recommended. Care should be taken in the future to prevent spills and overfills of potentially hazardous materials stored and/ or used on the Site. Areas of surface staining should be excavated and disposed of in accordance with current regulations.
