ENTECH
ENGINEERING, INC.

Re: OWTS – Wastewater Study
Lot 1, Flying Horse North Filing No. 2
Quartz Creek Drive
El Paso County, Colorado

Re: OWTS Site Evaluation
Flying Horse North, Filing 2, Lot 1
El Paso County, Colorado

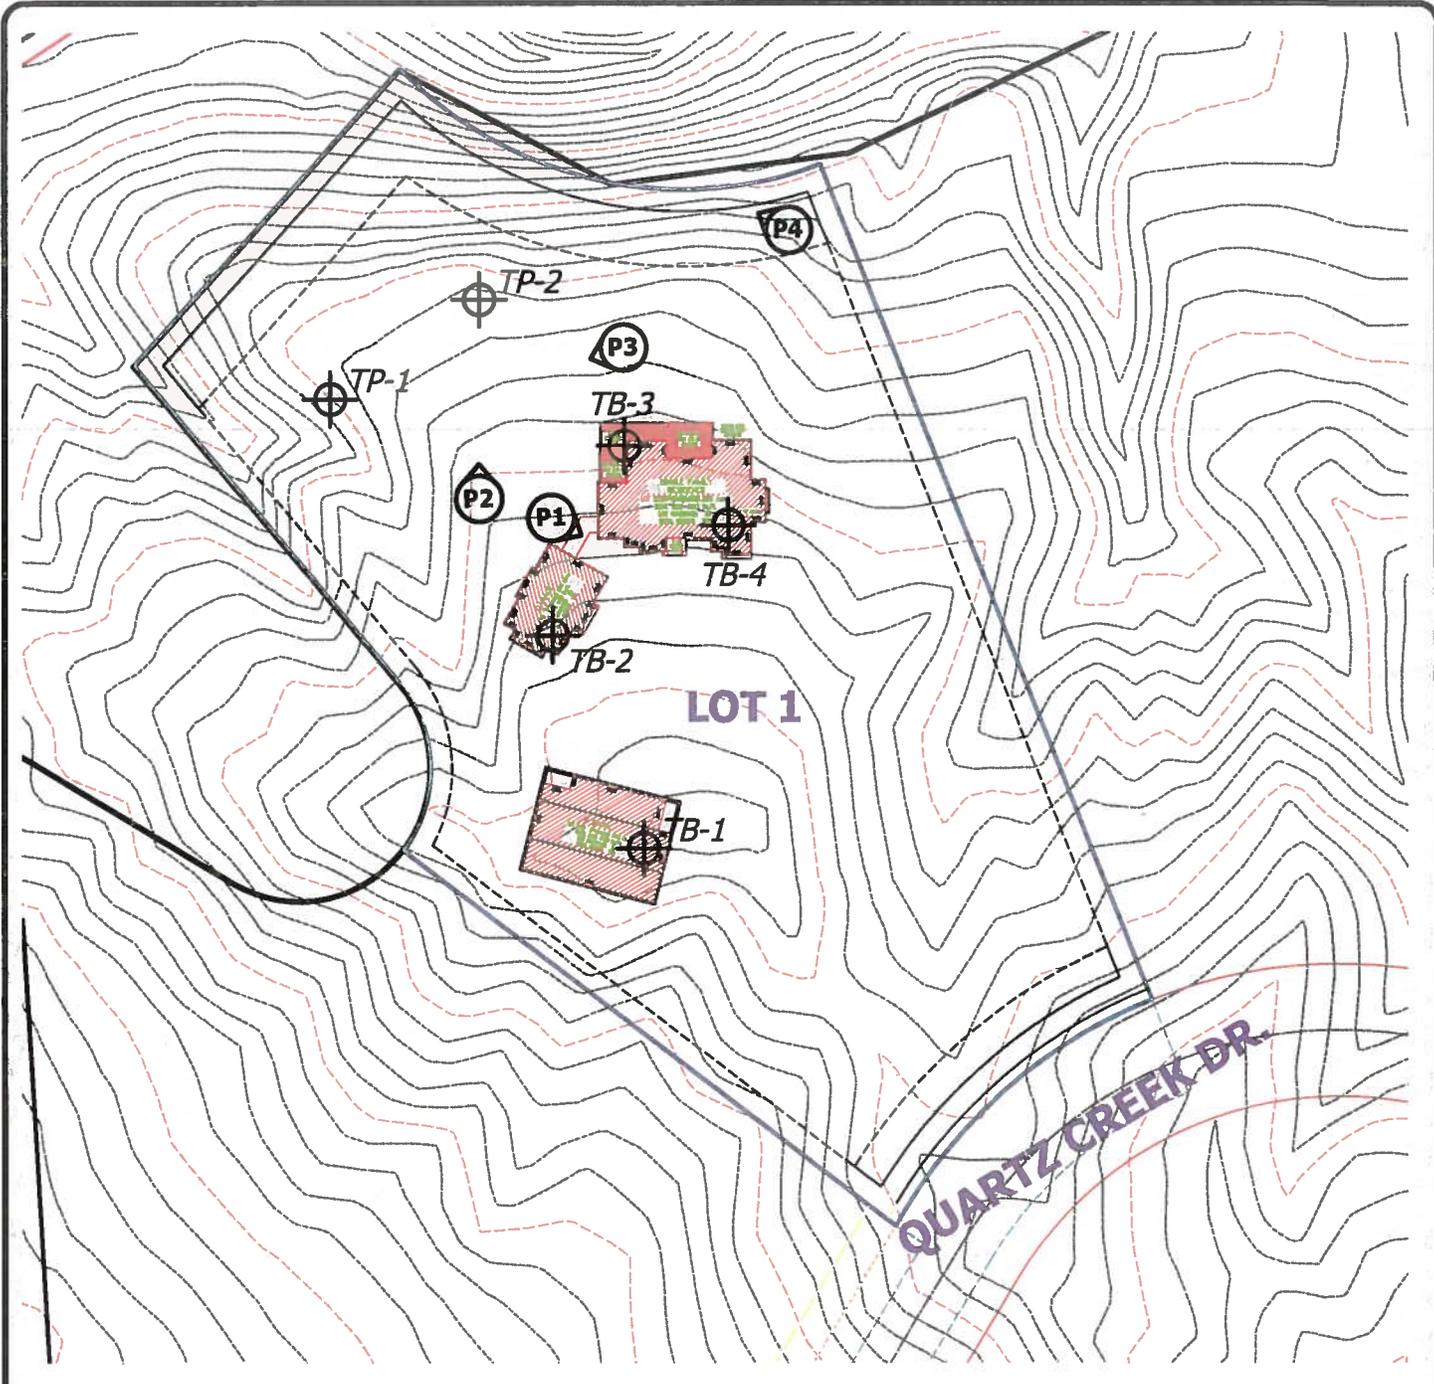
FIG NO.:
3

Four test borings were drilled and two tactile test pits were excavated on the site to determine general suitability of the soil characteristics for residential construction. The locations of the test borings and test pits are indicated on the Site Plan/Test Boring Location Map, Figure 3. The Test Pit Logs are presented in Appendix B. Results of this testing will be discussed later in this report.

SITE MAP/TEST BORING LOCATION MAP
FLYING HORSE NORTH FILING NO. 2
LOT 1, QUARTZ CREEK DRIVE
EL PASO COUNTY, CO.
FOR: JOE LOIDOLT

The proposed lot is 2.98-acres. One rural residential lot is proposed as part of the replat. The new lot will be serviced by an individual well and an on-site wastewater treatment system. The Site Plan with the proposed replat is presented in Figure 3.

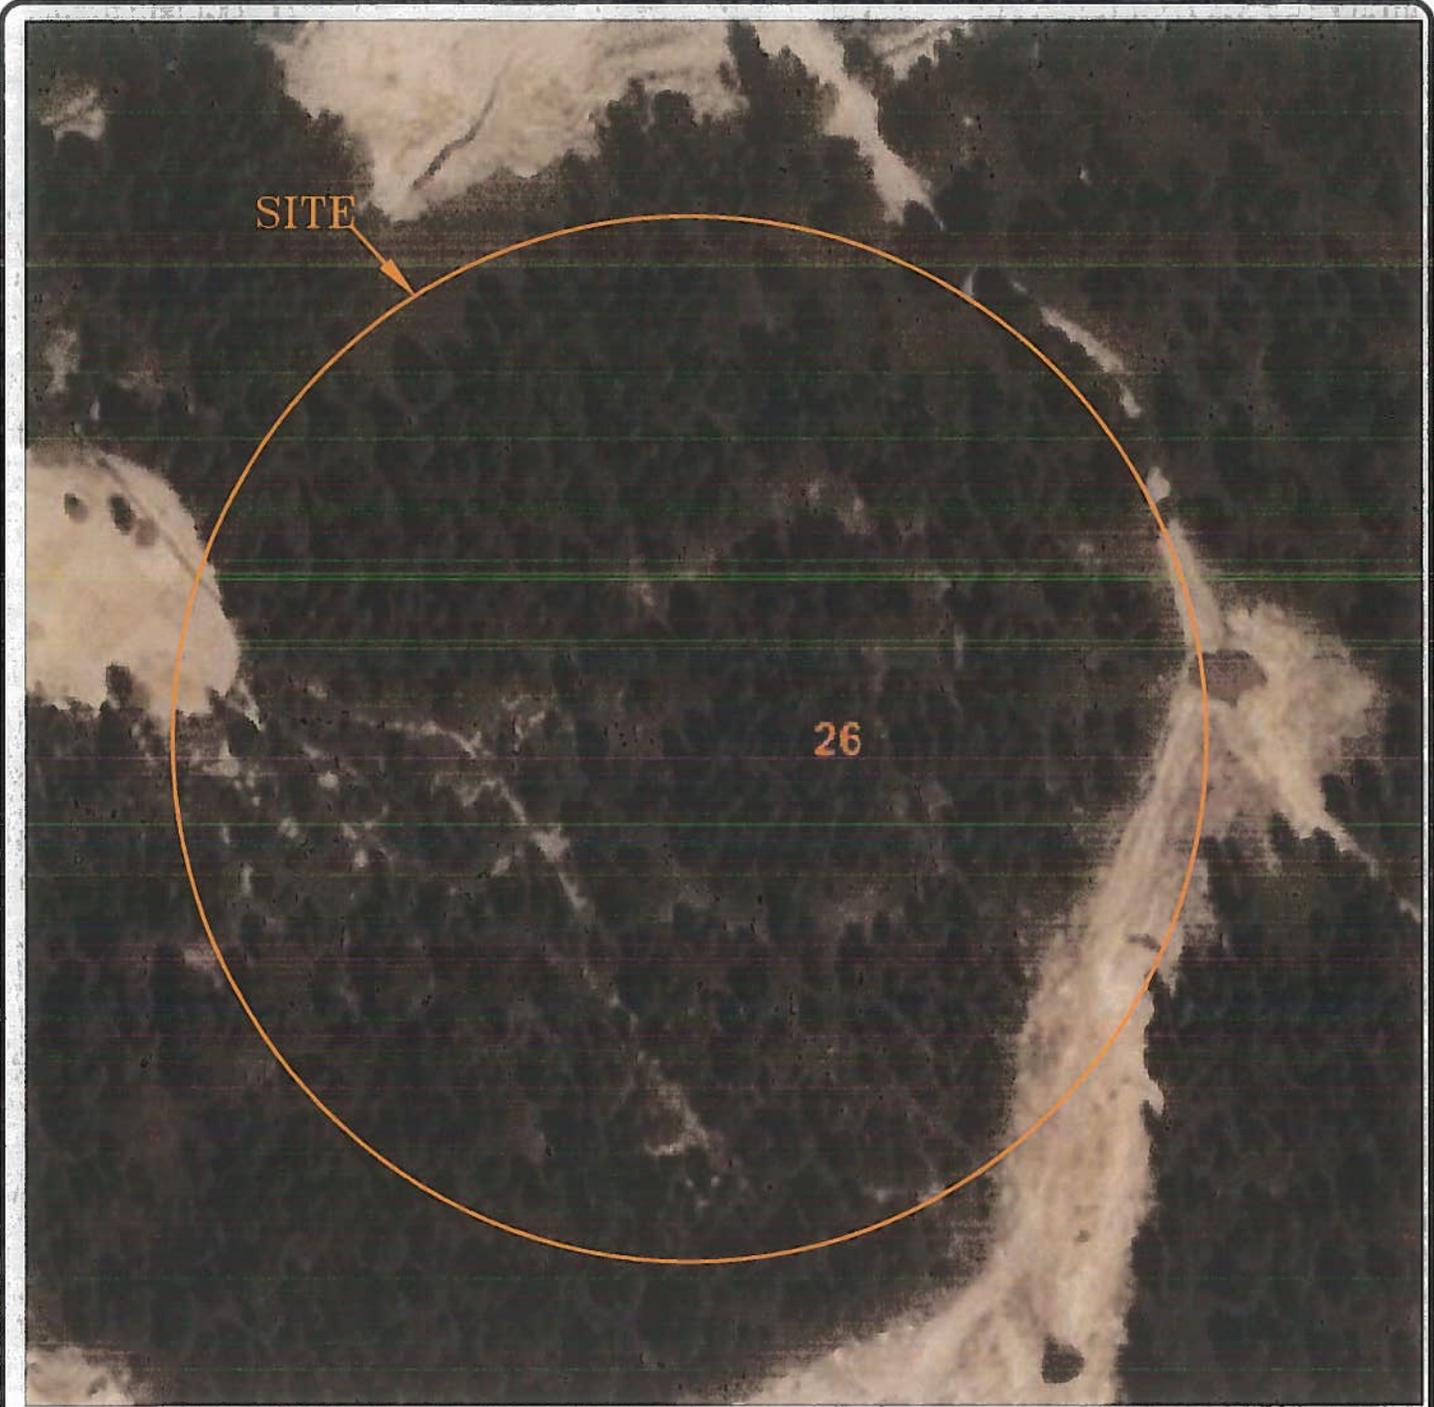
FIG NO.:
4

The Natural Resource Conservation Service (NRCS) (Reference 5, Figure 4), previously the Soil Conservation Service (Reference 6) has mapped one soil type on the site. Complete description of the soil type is presented in Appendix D. In general, the soils consist of sandy loam to gravelly loamy sand. The soils are described as follows:

<u>Type</u>	<u>Description</u>
26	Elbeth sandy loam, 8 – 15% Slopes

The soils have been described to have moderate to rapid permeabilities. The soils are described as well suited for use as homesites. Possible hazards with soils erosion are present on the site.

SOIL SURVEY MAP
FLYING HORSE NORTH FILING NO. 2
LOT 1, QUARTZ CREEK DRIVE
EL PASO COUNTY, CO.
FOR: JOE LOIDOLT

The Natural Resource Conservation Service (Reference 1), previously the Soil Conservation Service (Reference 2) has been mapped with three soil descriptions. The Soil Survey Map (Reference 1) is presented in Figure 4, and the Soil Survey Descriptions (Reference 2) are presented in Appendix C. The soils are described as having moderate to rapid percolation rates.

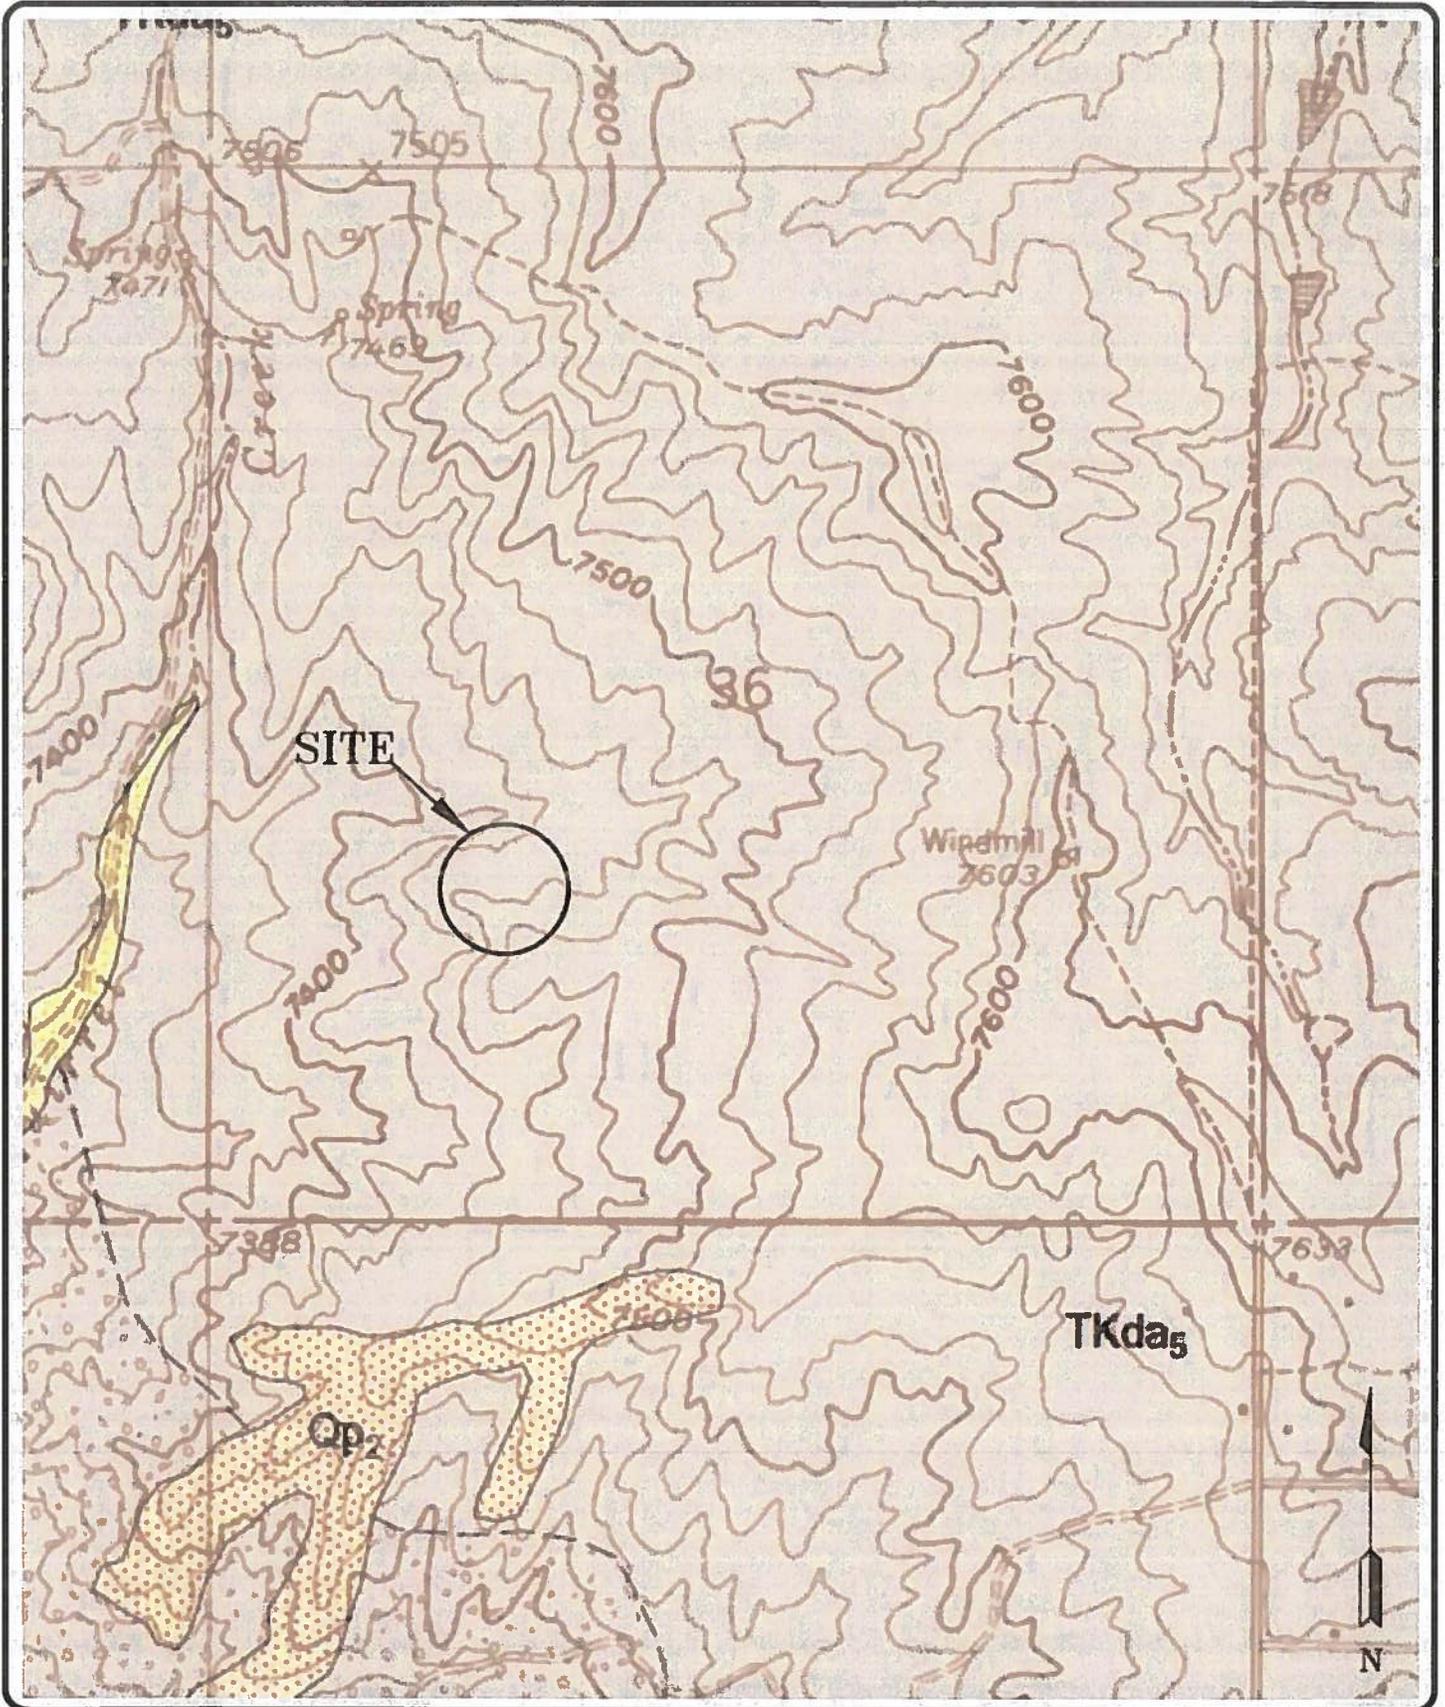
FIG NO:
5

The geology of the site was evaluated using the *Geologic Map of the Black Forest Quadrangle*, by Thorson and Madole in 2003, (Reference 8, Figure 5). The Geology Map for the site is presented in Figure 6. One mappable unit was identified on this site which is described as follows:

BLACK FOREST QUADRANGLE GEOLOGIC MAP
FLYING HORSE NORTH FILING NO. 2
LOT 1, QUARTZ CREEK DRIVE
EL PASO COUNTY, CO.
FOR: JOE LOIDOLT

The soils listed above were mapped from site-specific mapping, the *Geologic Map of the Black Forest Quadrangle* distributed by the Colorado Geologic Survey in 2003 (Reference 8, Figure 5), The *Geologic Map of the Colorado Springs-Castle Rock Area*, distributed by the US Geological Survey in 1979 (Reference 9), and the *Geologic Map of the Denver 1° x 2° Quadrangle*, distributed by the US Geological Survey in 1981 (Reference 10). The test pits were used in evaluating the site and are included in Appendix B. The Geology Map prepared for the site is presented in Figure 6.

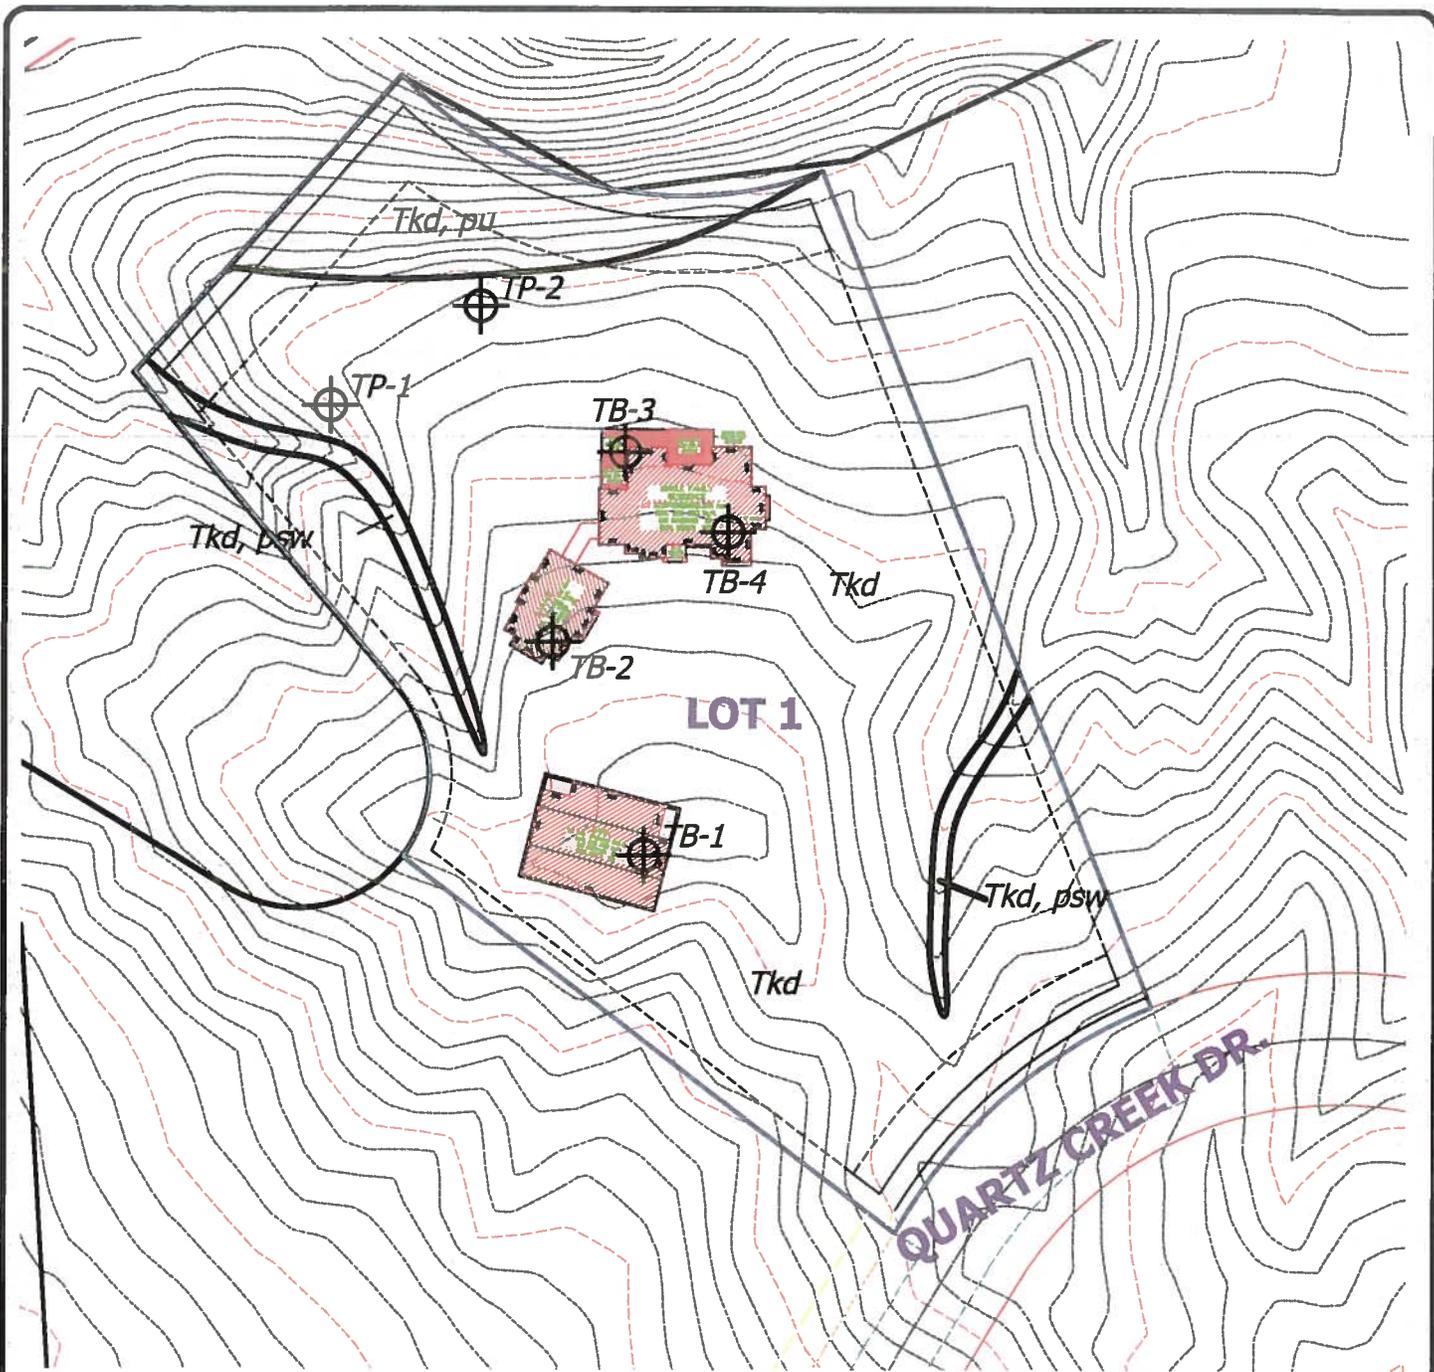
FIG NO.:
6

Tkd Dawson Formation of Tertiary to Cretaceous Age: The materials consist of a thin layer of residual soils overlying the bedrock materials on-site. The residual soils were derived from the in-situ weathering of the bedrock on site. These materials typically consist of silty to clayey sand with potential areas of sandy clays. The bedrock consists of the Dawson Formation. The Dawson Formation typically consists of coarse-grained, arkosic sandstone with interbedded lenses of fine-grained sandstone, siltstone and claystone.

A drainage is located north of the lot and two minor drainage swales are located on the lot. Water was not observed in the drainages at the time of this investigation, however, these areas have the potential for seasonal shallow groundwater. These areas are indicated in the Geology/Engineering Geology Map (Figure 6). Due to the size of the proposed lots these areas can either be avoided or redirected around proposed structures or proposed soil treatment area. The proposed building areas are not affected by these areas. The site does not lie within any floodplain zones according to the FEMA Map No. 08041CO315G dated December 7, 2018 (Figure 7, Reference 11). Exact locations of floodplain and specific drainage studies are beyond the scope of this report.

- Tkd - Dawson Formation of Tertiary to Cretaceous Age: variable layer of residual soils overlying arkosic sandstone with interbedded fine-grained sandstone, siltstone and claystone
- psw - potentially shallow groundwater area
- pu - potentially unstable slope

GEOLOGY/ENGINEERING GEOLOGY MAP
FLYING HORSE NORTH FILING NO. 2
LOT 1, QUARTZ CREEK DRIVE
EL PASO COUNTY, CO.
FOR: JOE LOIDOLT

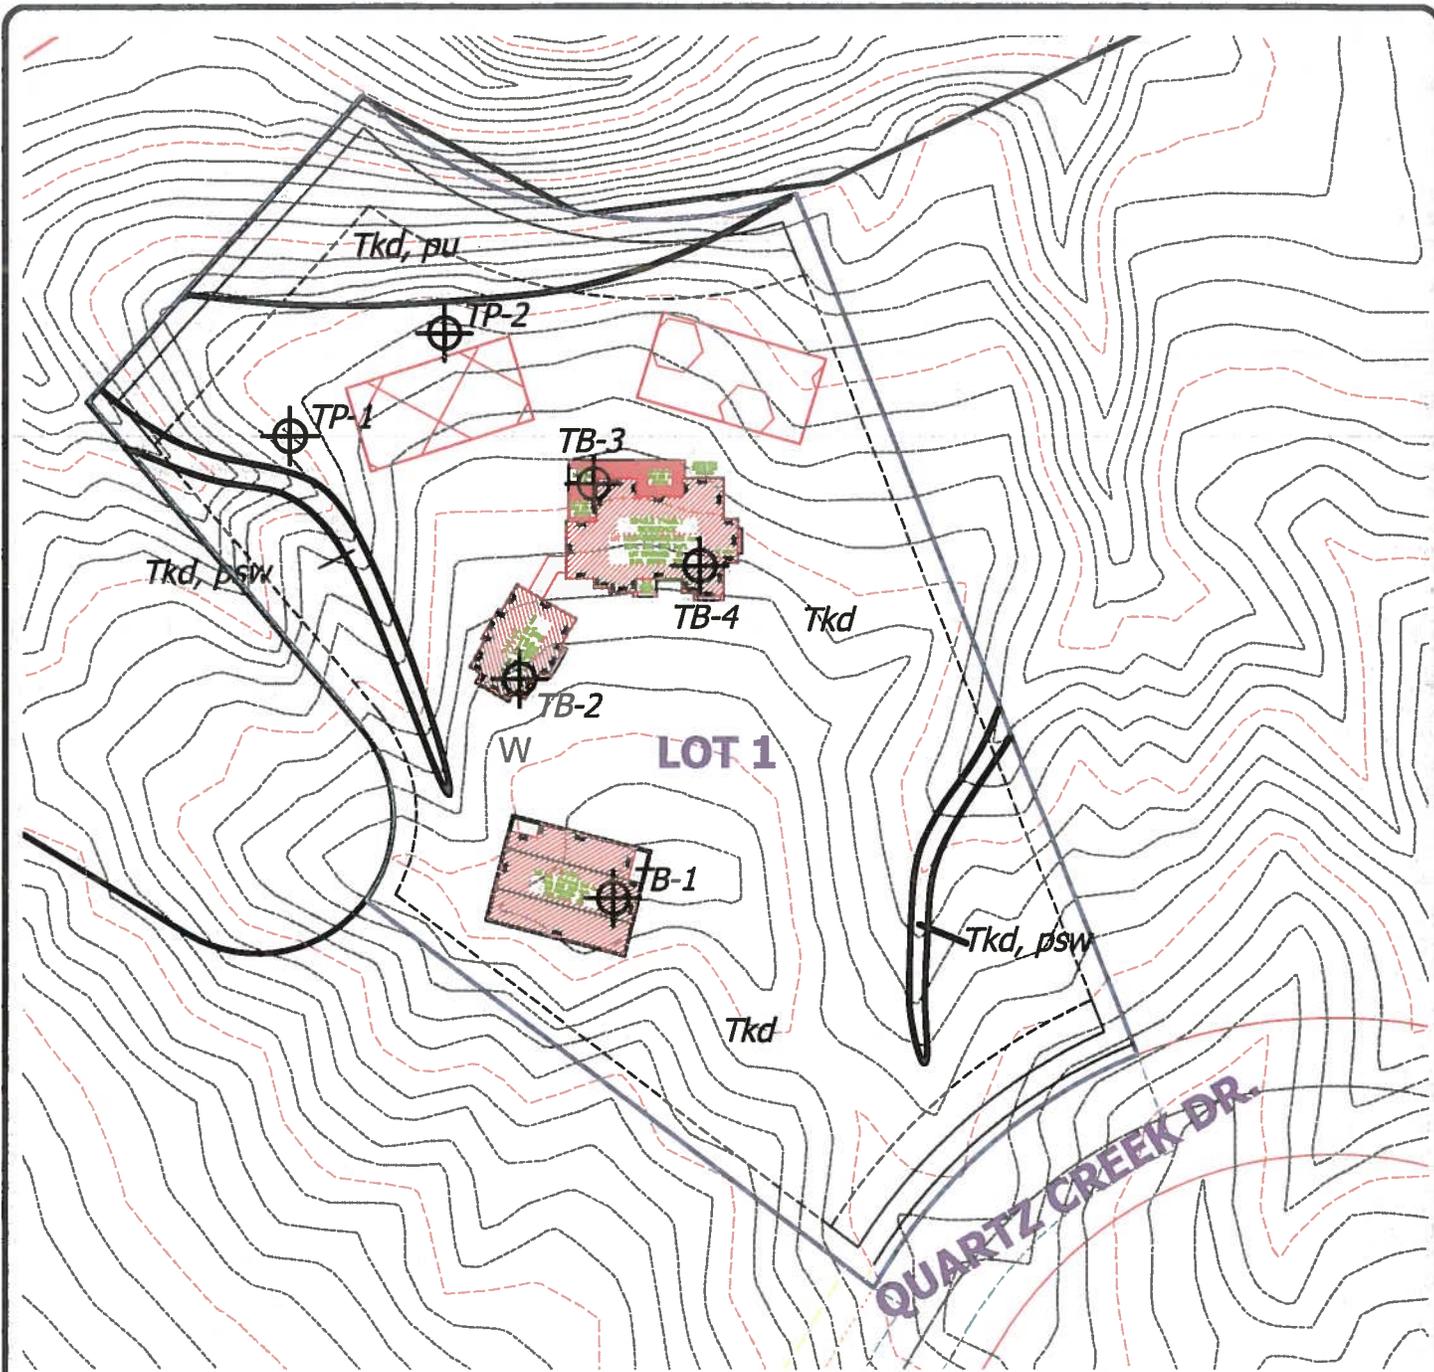
FIG NO.:
8

- OWTS ARE NOT RECOMMENDED IN AREAS OF POTENTIALLY UNSTABLE SLOPES OR POTENTIALLY SEASONAL SHALLOW GROUNDWATER

W *- WATER WELLS MUST BE A MINIMUM OF 100 FT FROM OWTS ABSORPTION FIELDS

SEPTIC SUITABILITY MAP
FLYING HORSE NORTH FILING NO. 2
LOT 1, QUARTZ CREEK DRIVE
EL PASO COUNTY, CO.
FOR: JOE LOIDOLT

In summary, it is our opinion the site is suitable for individual on-site wastewater treatment systems (OWTS) and that contamination of surface and subsurface water resources should not occur provided the OWTS sites are evaluated and installed according to El Paso County and State Guidelines and properly maintained. Based on the testing performed a designed system will be required for the proposed lot. The Septic Suitability Map is presented in Figure 8. Proposed house locations, water wells, and two septic sites for the new lots are indicated. Absorption fields must be located a minimum of 100 feet from any well, including those on adjacent properties. Absorption fields must also be located a minimum of 50 feet from any drainages, floodplains or ponded areas and 25 feet from dry gulches.

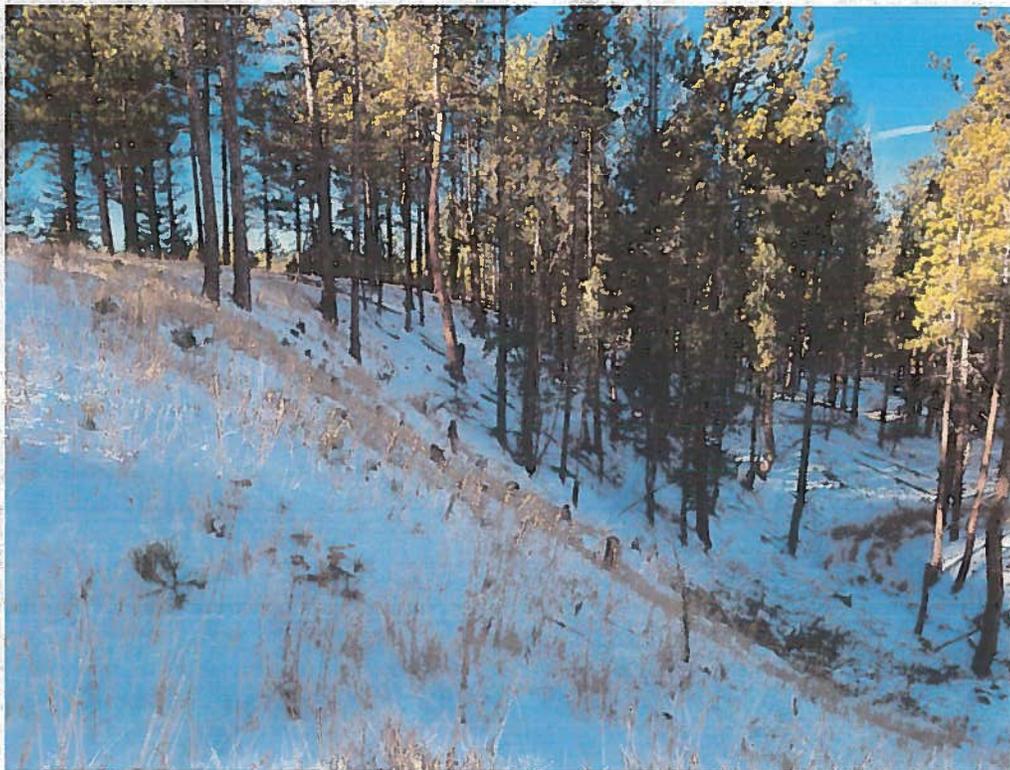
Looking northwest along the potentially unstable slope in the northern side of the site.

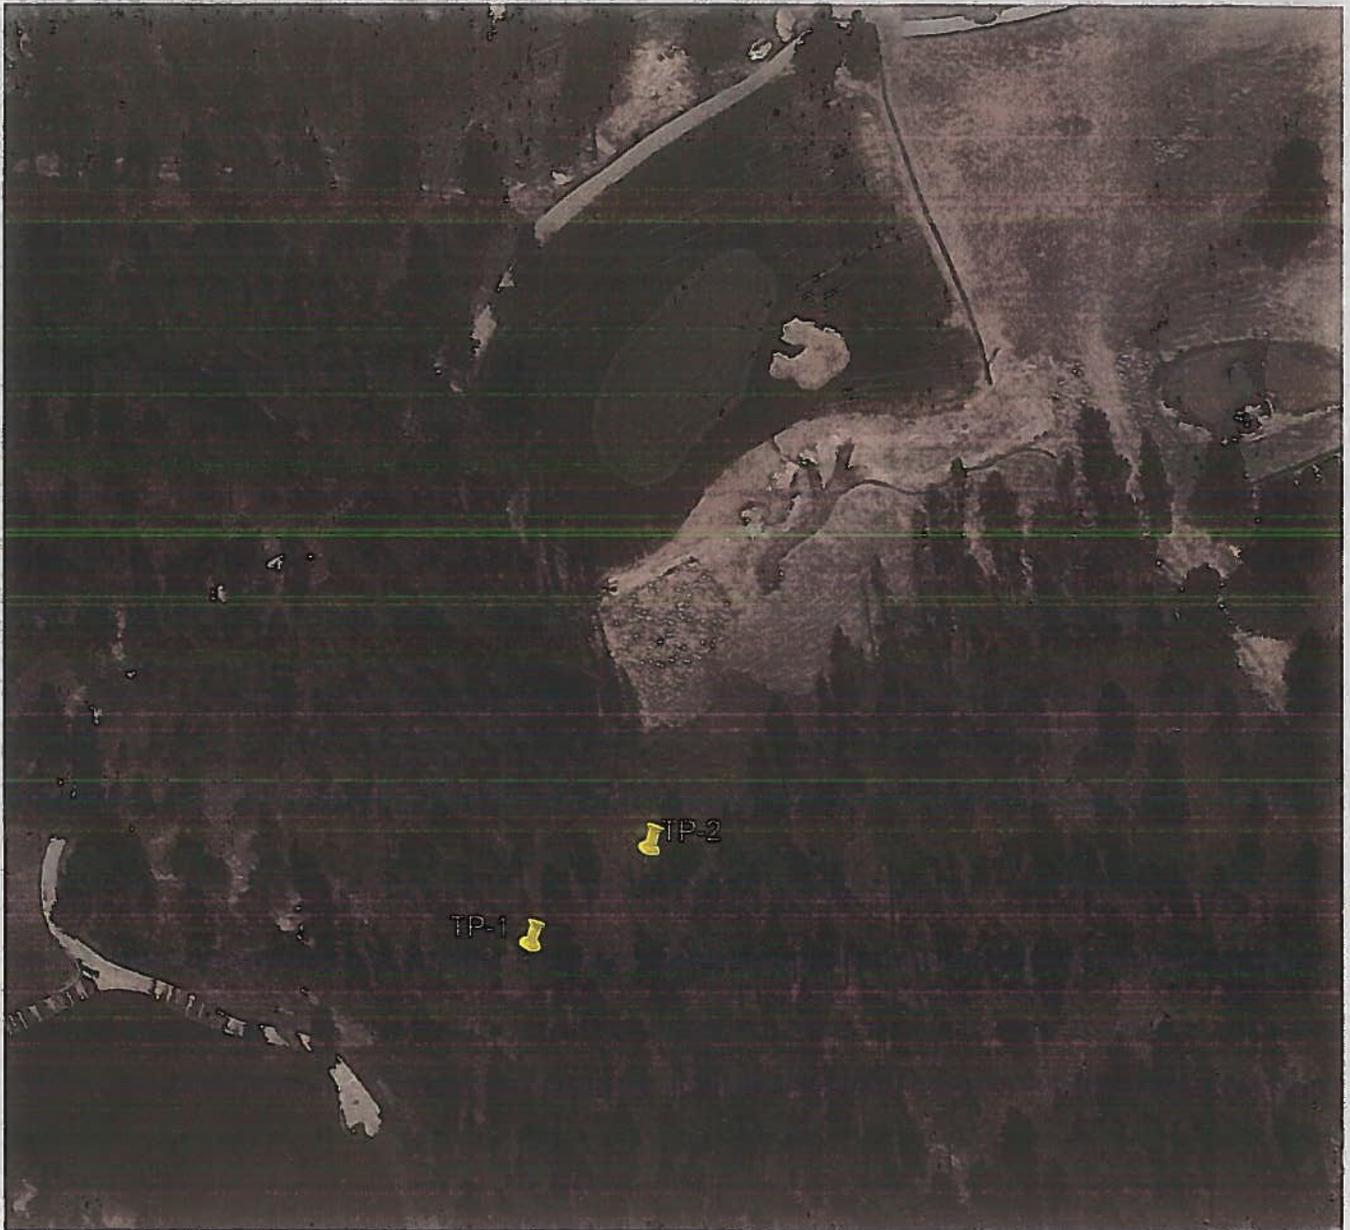
FIG NO.:
1

The locations of the test pits are shown in Figure 1. The test pits were excavated on December 21, 2021, to approximate depths of 6 and 8 feet. Soils encountered in the test pits consisted of sandy clay loam overlying sandy clay in Test Pit No. 1 and sandy clay in Test Pit No. 2. The Test Pit Logs and Laboratory Test Results are shown in Figures 2 through 5. Refusal was reached at 6 feet in Test Pit No. 1. Redoximorphic features were encountered at 6 feet in Test Pit No. 1.

- TP-1 39.004691°, -104.73396°
- TP-2 39.047043°, -104733748°W

TEST PIT LOCATION MAP
FLYING HORSE NORTH, FILING 2, LOT 1
EL PASO COUNTY, COLORADO
FOR: JOE LOIDOLT

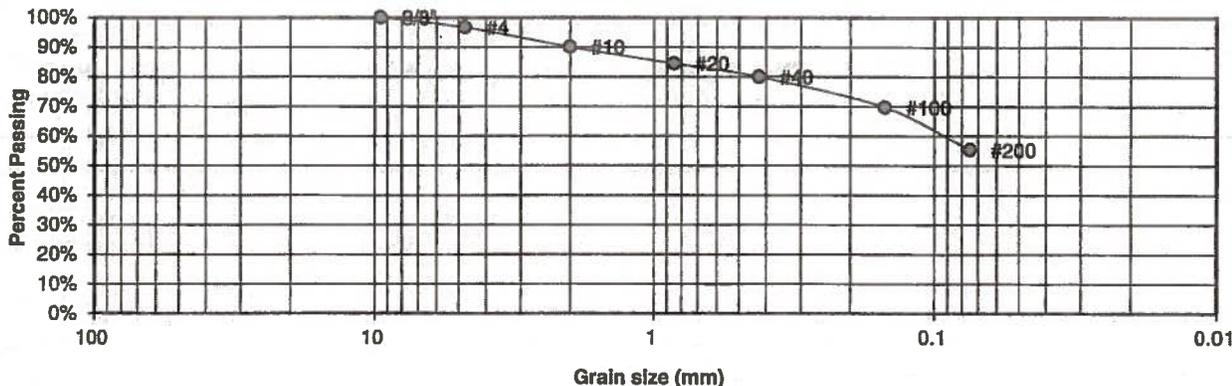
3

BORING NO.	TP-1	<u>UNIFIED CLASSIFICATION</u>	CL	<u>TEST BY</u>	BL
DEPTH(ft)	4	<u>AASHTO CLASSIFICATION</u>		<u>JOB NO.</u>	213271
CLIENT	JOE LOIDOLT				
PROJECT	FLYING HORSE N., F-2, L-1

U.S. Sieve #	Percent Finer
3"	
1 1/2"	
3/4"	
1/2"	
3/8"	100.0%
4	96.8%
10	90.0%
20	84.5%
40	80.0%
100	69.7%
200	55.4%

The soils encountered in the test pits consisted of sandy clay loam and sandy clay. The samples tested had 45 to 70 percent of the soil size particles passing the No. 200 sieve. The test pits were excavated to depths 6 and 7.5 feet.

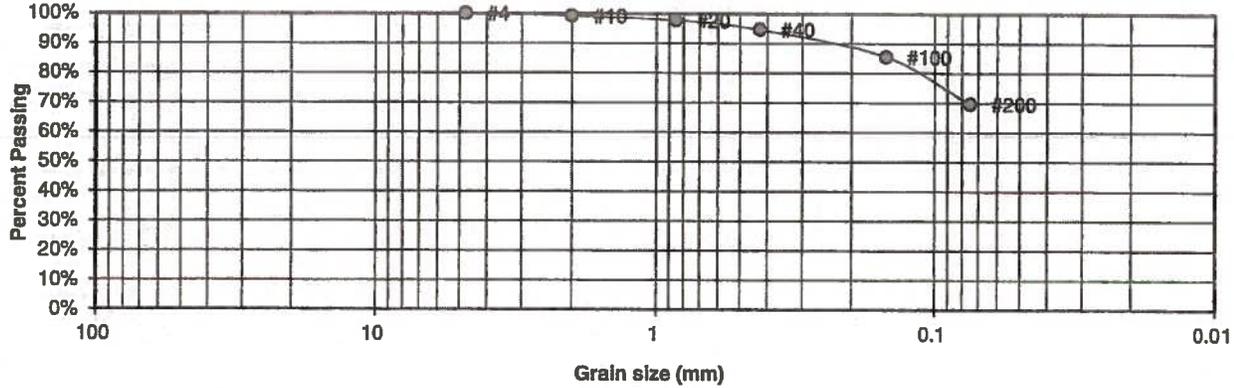
FIG NO.:
4

BORING NO.	TP-2	<u>UNIFIED CLASSIFICATION</u>	CL	<u>TEST BY</u>	BL
DEPTH(ft)	2	<u>AASHTO CLASSIFICATION</u>		<u>JOB NO.</u>	213271
CLIENT	JOE LOIDOLT				
PROJECT	FLYING HORSE N., F-2, L-1

U.S. Sieve #	Percent Finer
3"	
1 1/2"	
3/4"	
1/2"	
3/8"	
4	100.0%
10	99.2%
20	97.8%
40	94.7%
100	85.5%
200	69.6%

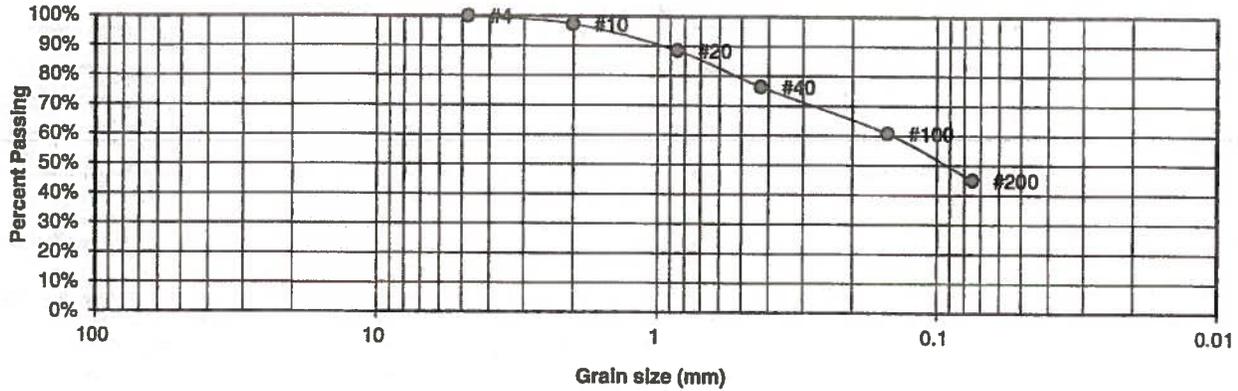
5

BORING NO.	TP-2	<u>UNIFIED CLASSIFICATION</u>	SC	<u>TEST BY</u>	BL
DEPTH(ft)	6	<u>AASHTO CLASSIFICATION</u>		<u>JOB NO.</u>	213271
CLIENT	JOE LOIDOLT				
PROJECT	FLYING HORSE N., F-2, L-1

U.S. Sieve #	Percent Finer
3"	
1 1/2"	
3/4"	
1/2"	
3/8"	
4	100.0%
10	97.4%
20	88.5%
40	76.3%
100	60.8%
200	45.1%
