LAND SUITABILITY ANALYSIS

Freestyle Master Plan

The following Land Suitability Analysis address approximately a 557 acres site within the Banning Lewis Ranch Master Plan and located along the east side of Marksheffel between future Stetson Hills Blvd and Barnes Road and west of the proposed Banning Lewis Parkway alignment.

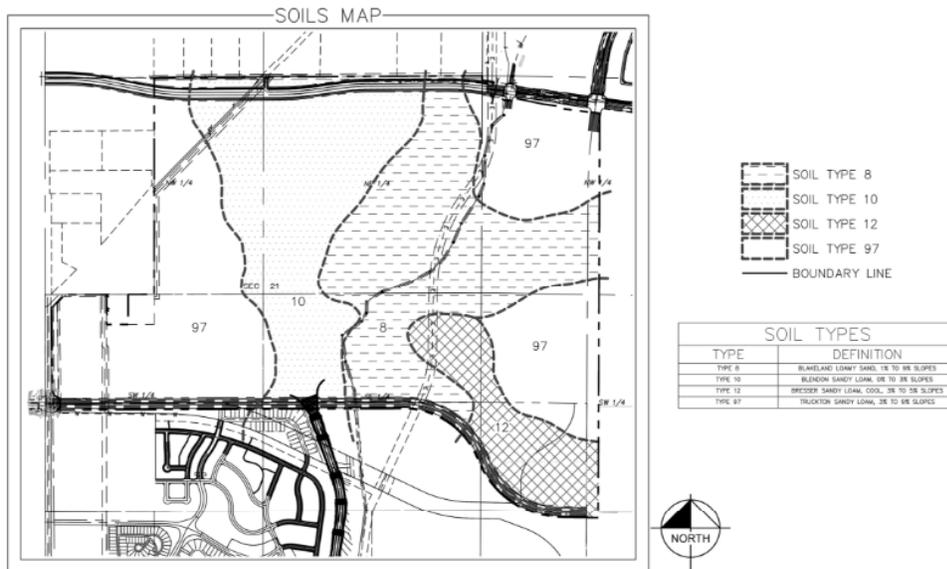
Soil Map:

Soils Analysis & Geologic Inventory:

Type-8—Blakeland loamy sand, 1 to 9 percent slopes

Type 10—Blendon sandy loam, 0 to 3 percent slopes

Type-12—Bresser sandy loam, cool, 3 to 5 percent slopes

Type-97—Truckton sandy loam, 3 to 9 percent slopes

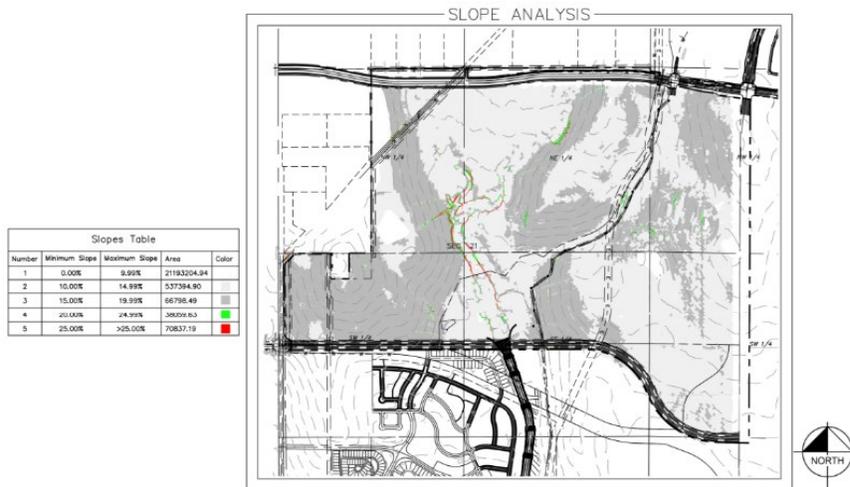
Slope Analysis

A computerized slope analysis was performed on the Freestyle North site and it revealed a few constraints presented by the existing topography. The foothills environment and the upper end of swales don't not impact the proposed land use. There are some small but significant 25% slopes along the specific drainage edges. Some of the steeper slope conditions have been created by man-made activities associated with past utility work in the area. But with the limited and focused slope conditions, there should be no development concerns.

While the site has very few constraining slopes, the steep topography is one of the primary constraints that project will need to deal with in the development of this site. It is recommended that development be concentrated, but not entirely restricted to the areas of 25% slope or less. In areas that exceed 25%, creative and sensible solutions are to be utilized in order to minimize the impact on the site and function of the major drainageways.

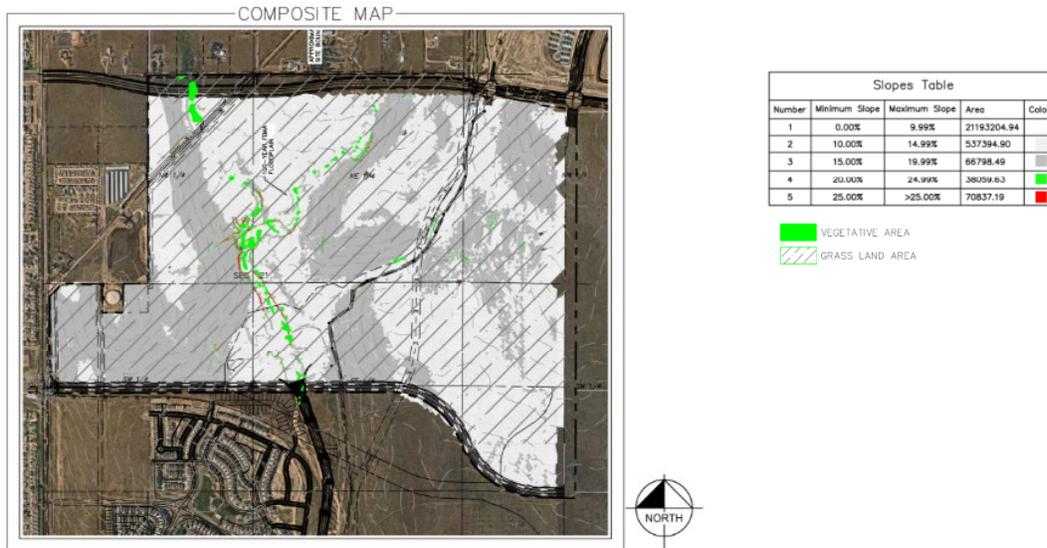
Composite Study:

After the compilation of data regarding the various natural and manmade factors that affect development, a composite analysis has been derived. The map combines data collected from the vegetation, soils and slope analysis. The areas that have the least building impact are those which contain no notable shrub and tree plantings, and slopes are less than 25%. Consideration is also given to preserving the function and character of major drainageways. The medium impact areas are those which contain slopes greater than 25%. The greatest impact areas are those containing large shrub and slopes greater than 25%.

The man-made features are found Markscheffel and the existing central utility easements that have been graded in the past. The natural features of this site that make it unique are its foothill-prairie topography with the knolls and draws. These are the only significant feature on the site, but it should be respected and complimented when laying out roads and building locations. This will also support development that preserve western mountain views.
