Natural Features and Wetland Report for the Waterside Project

El Paso County, Colorado

May 23, 2022

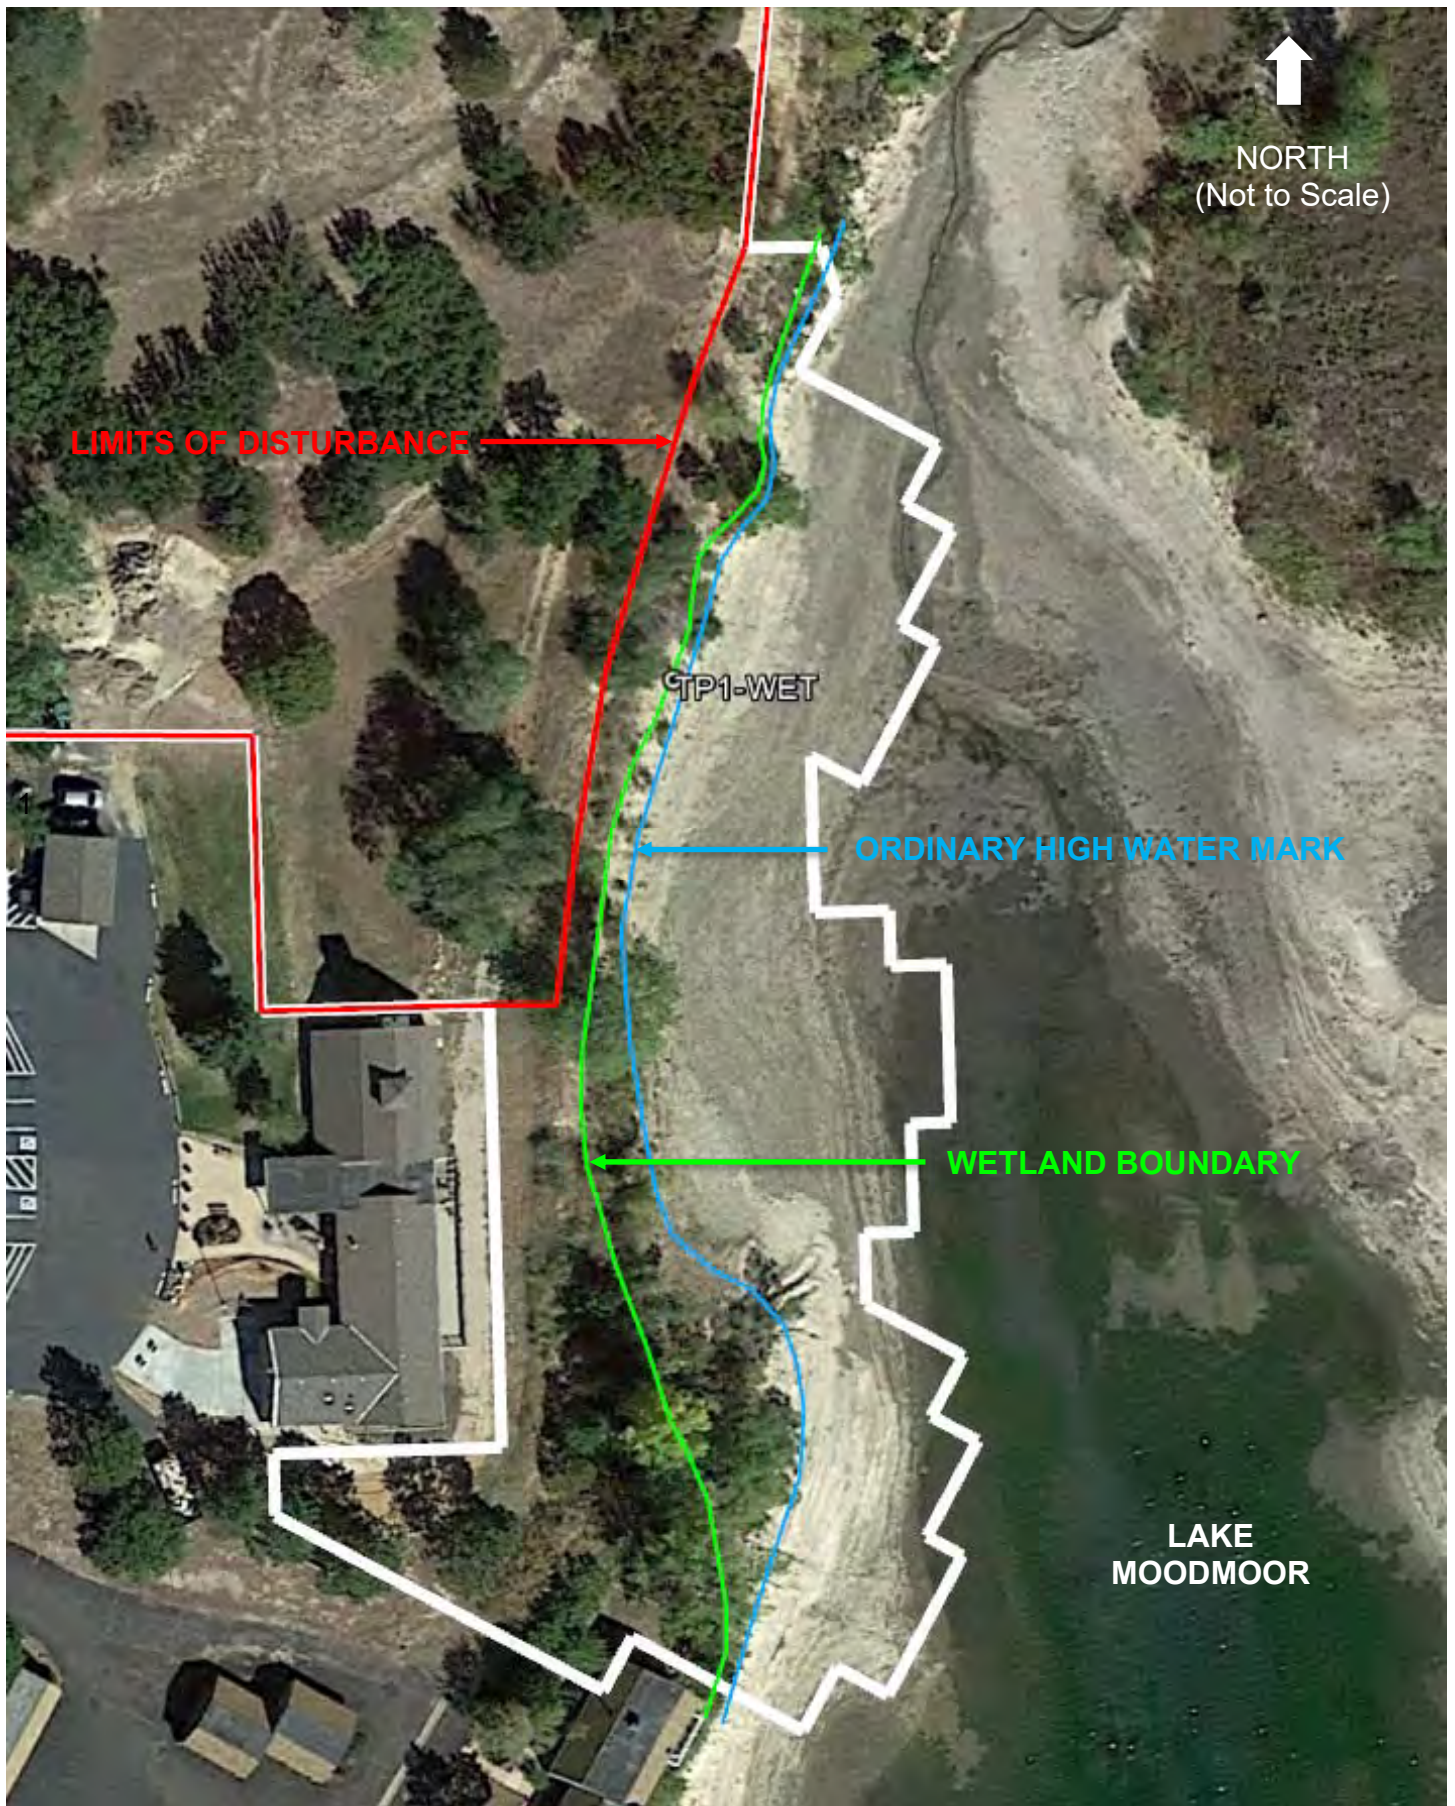
Source: Ecosystem Services, LLC Delineation, 10/13/2021

water mark (OHWM), a clear and distinct shoreline was observed at the base of persistent vegetation. A narrow strip of palustrine shrub-scrub wetland habitat (PSS) occurs above the OHWM that meets all the criteria/indicators needed to be deemed a wetland. Hydrophytic vegetation is present. Species observed include Plains cottonwood, peachleaf willow, and sandbar willow covering 60% of the wetland area with 40% of bare ground. No herbaceous species are currently present as a result of the lake dewatering. Hydric soils are present consisting of sand, a soil type derived from fluvial processes (a process of erosion and movement of sediment driven by water). Wetland hydrology sustaining PSS habitat is present in the form of semi-permanent surface water that is normally pooled within shorelines of Woodmoor Lake.

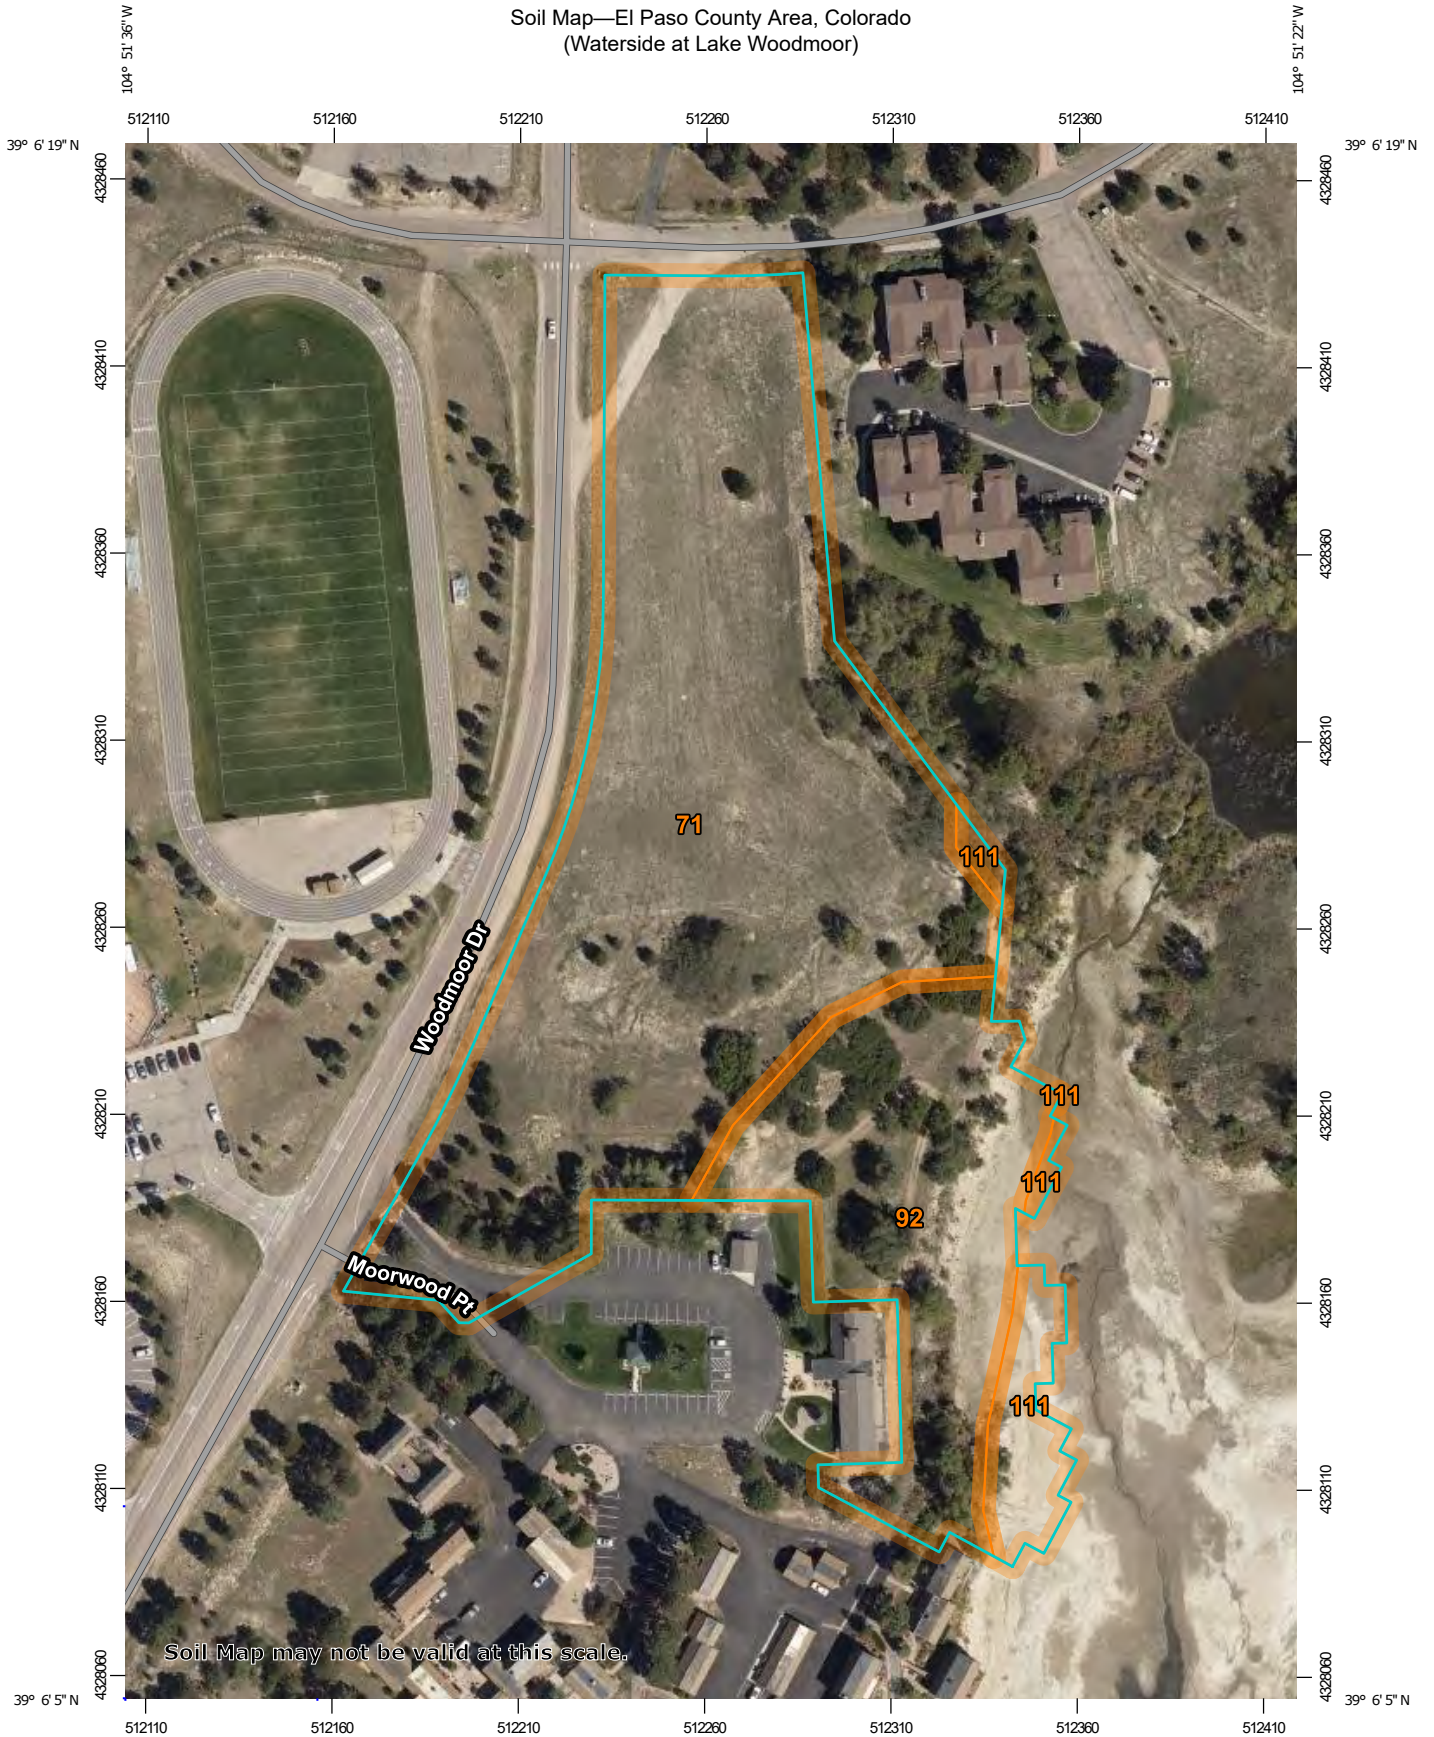
Soil Map—El Paso County Area, Colorado
(Waterside at Lake Woodmoor)

Map Scale: 1:2,030 if printed on A portrait (8.5" x 11") sheet.

Pring coarse sandy loam, 3 to 8 percent slopes (Map Unit #71) is the soil type that underlies 70.5% of the Site is found on hills and formed in parent materials weathered residually or locally transported from the arkose beds of the Dawson and Arapahoe formations (Arkosic alluvium derived from sedimentary rock). This soil type is a deep, well-drained soil in a low run-off class, is not frequently flooded and has a low available water capacity (about 6.0 inches). The depth to water table is more than 80 inches. This soil type is not listed as a Hydric Soil by the USDA; however, it may include minor components of the Pleasant soil type that is found in depressions and is listed as Hydric. The USDA soil survey does not provide a description of the vegetation that is typically associated with this soil type.

Tomah-Crowfoot loamy sands, 3 to 8 percent slopes (Map Unit #92) is the soil type that underlies 24.5% of the is found on hills and alluvial fans and formed in parent material comprised of alluvium derived from arkose and/or residuum weathered from arkose.

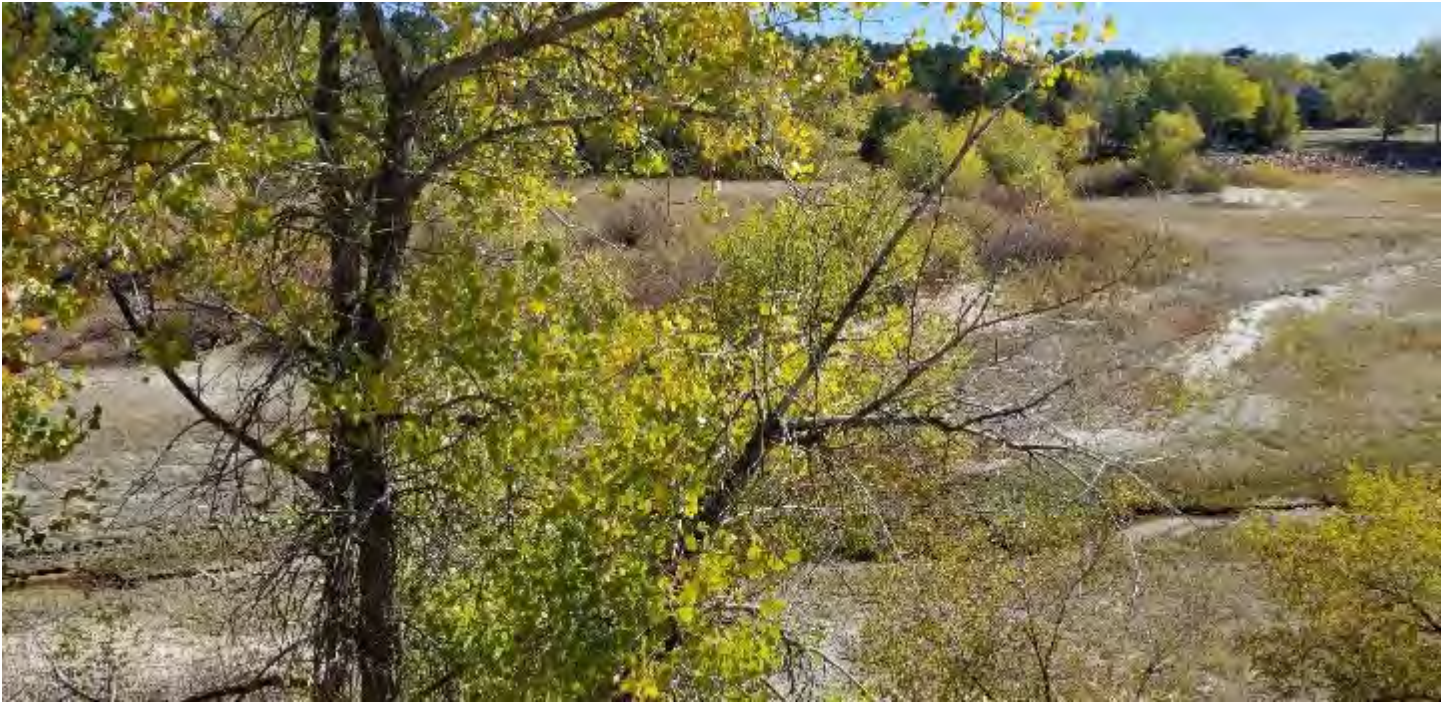
P4 – Overview east of dewatered Woodmoor Lake (middle- and background) and riparian woodland (foreground).

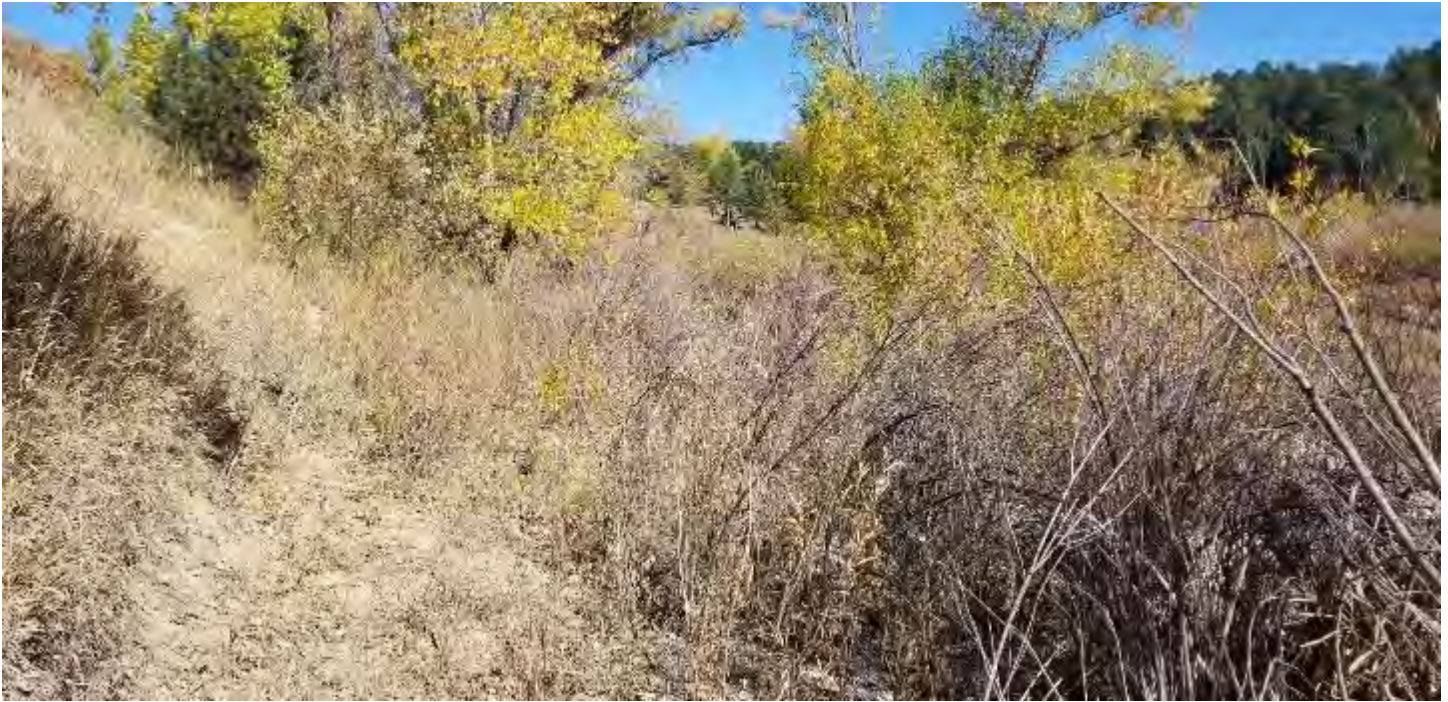
P5 – View north of riparian habitat on hillslope (left) and shrub-scrub wetland (right) along edge of Woodmoor Lake (from north property line)

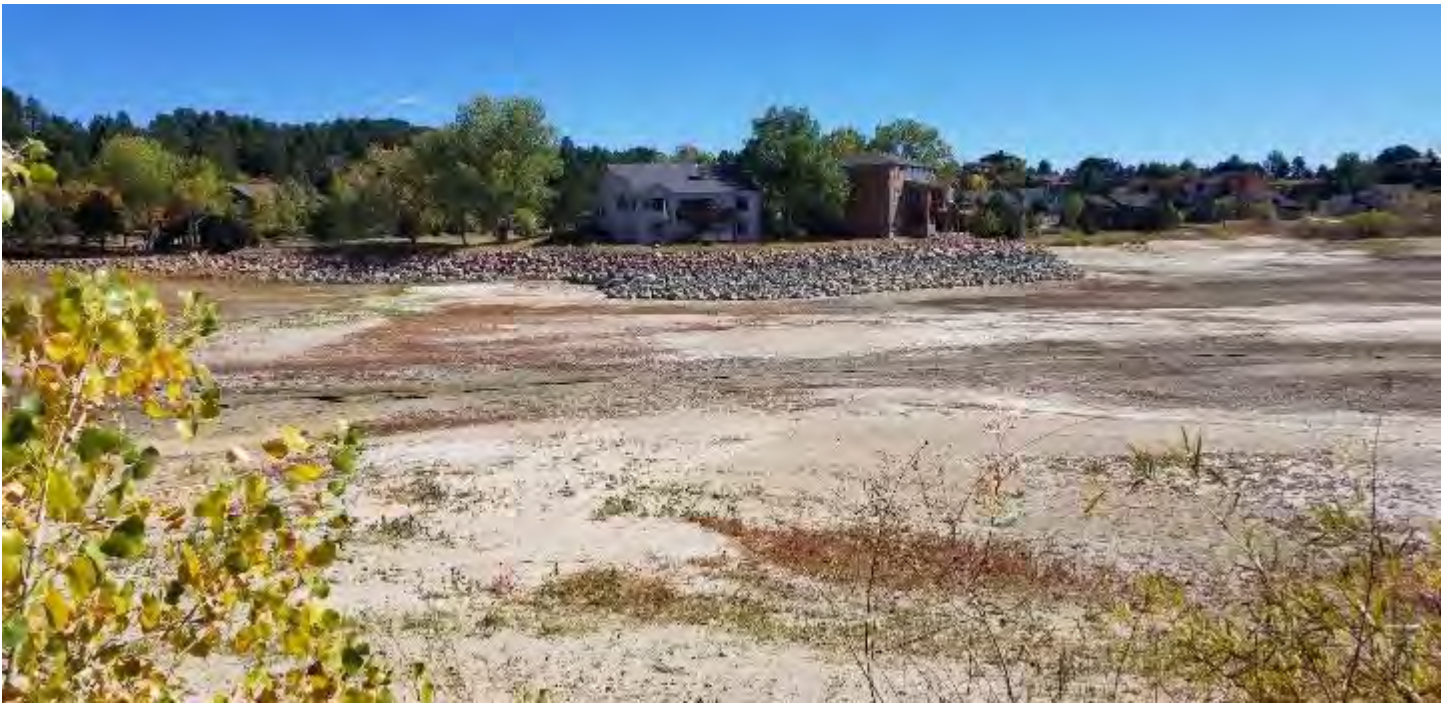
P6 – View east of dewatered Woodmoor Lake (from south property line)

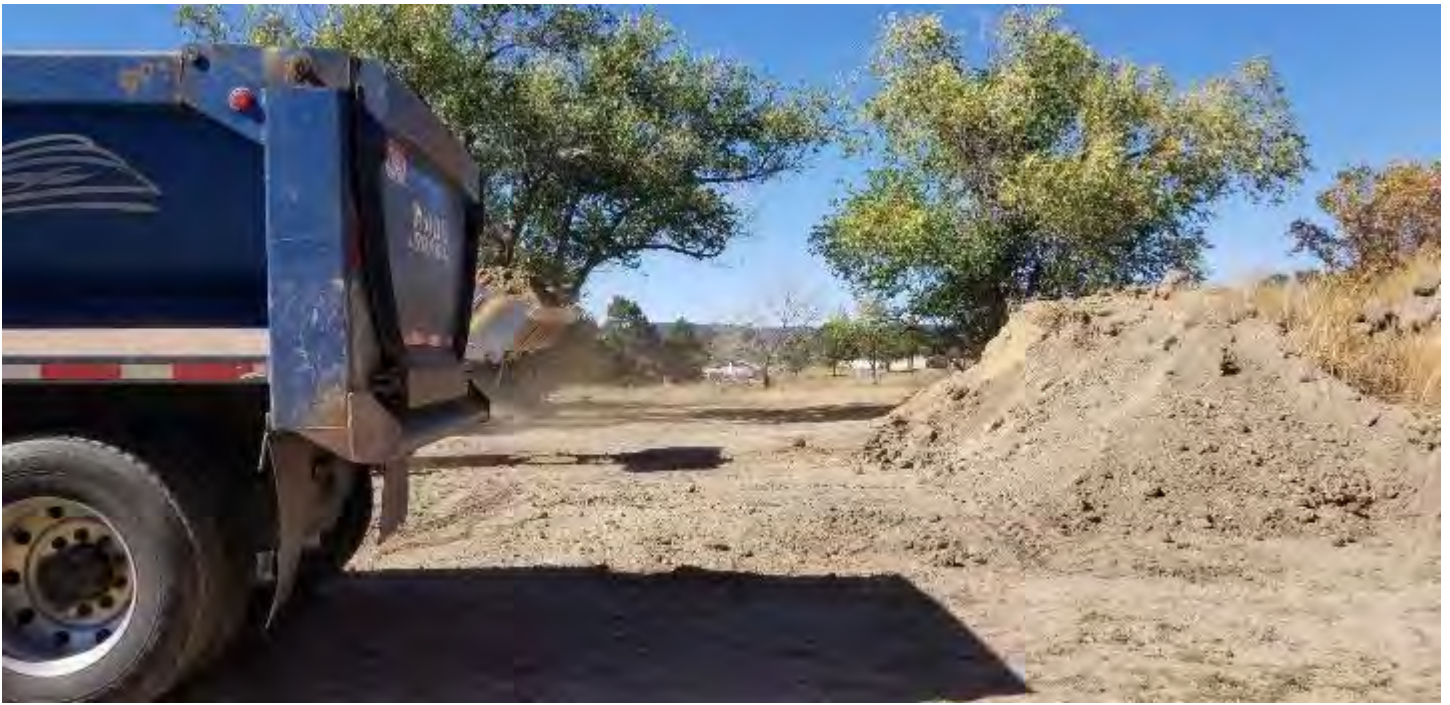
P7 – View west of disturbed ground/stockpile area (foreground) and mid-grass prairie/non-native trees (background).
