## **Wetland Analysis Report**

**18735 Brown Road Project  
El Paso County, Colorado**

**Pinyon Project No.:**  
1/21-149601.BIO002

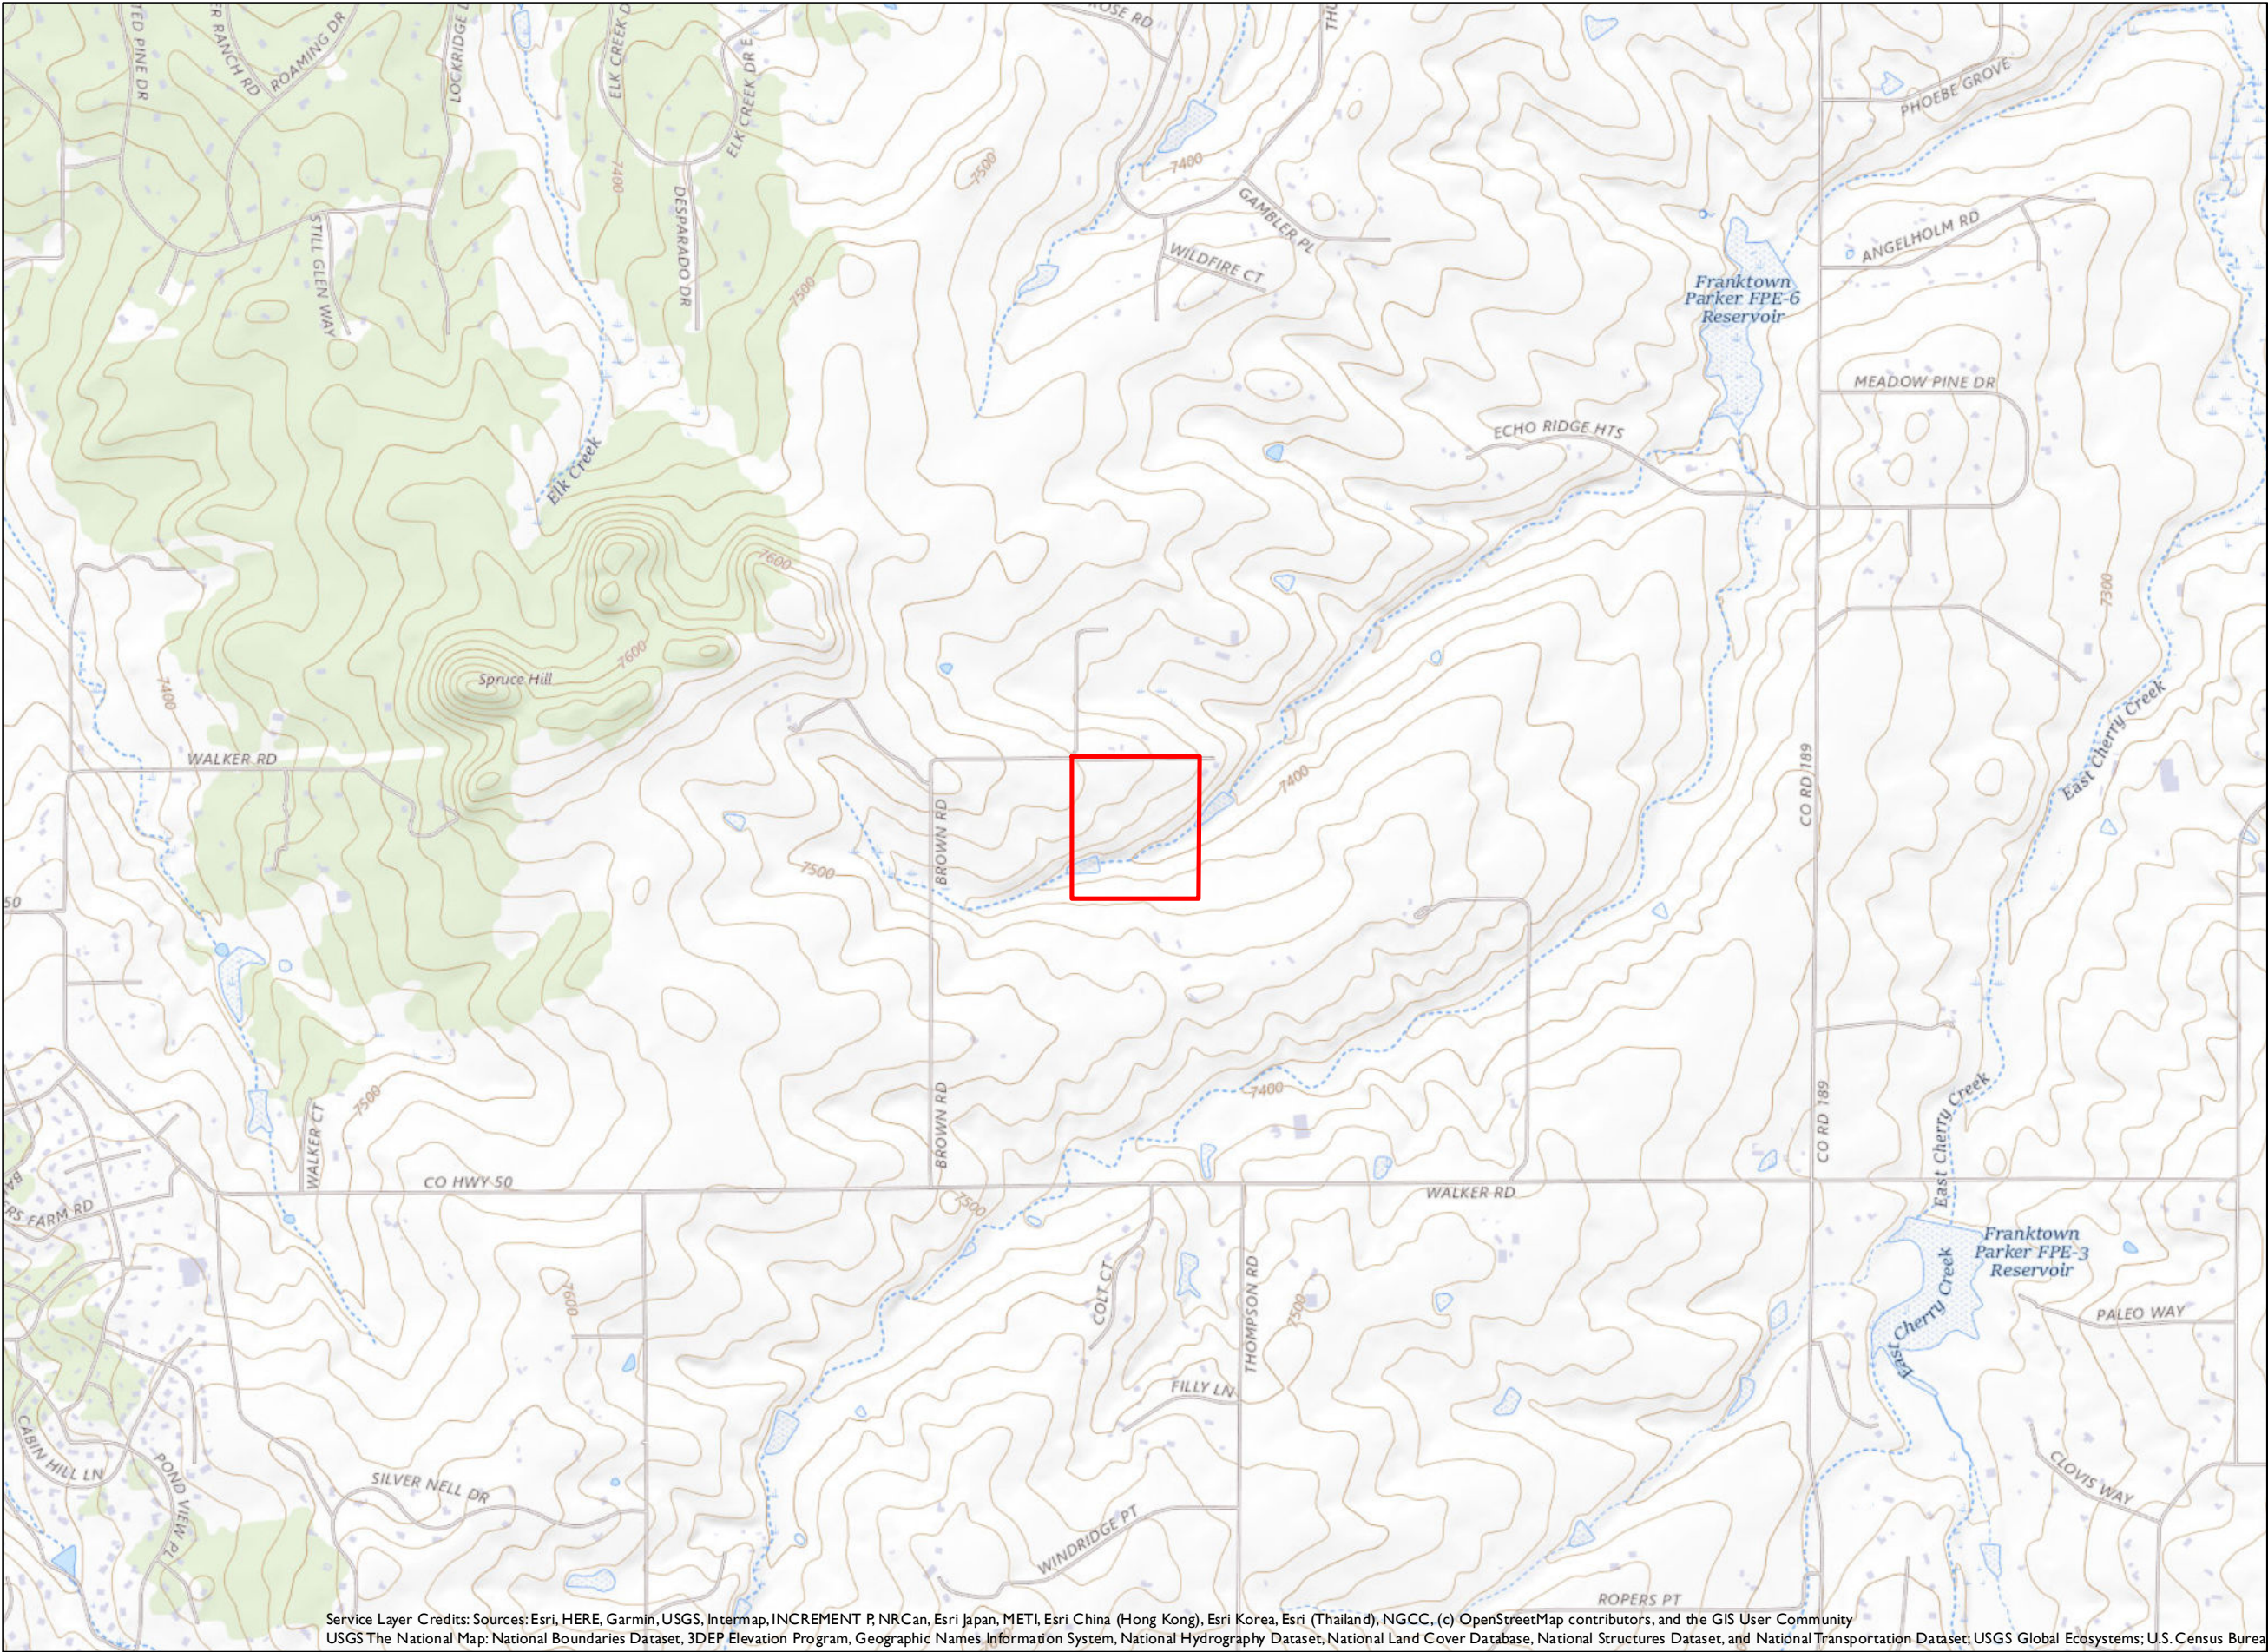
Figure: I

The study area used for this assessment consisted of the 35-acre parcel located at 18735 Brown Road in El Paso County, Colorado. The project location is shown in Figure I and described in Table I-1, below.

**PROJECT LOCATION**

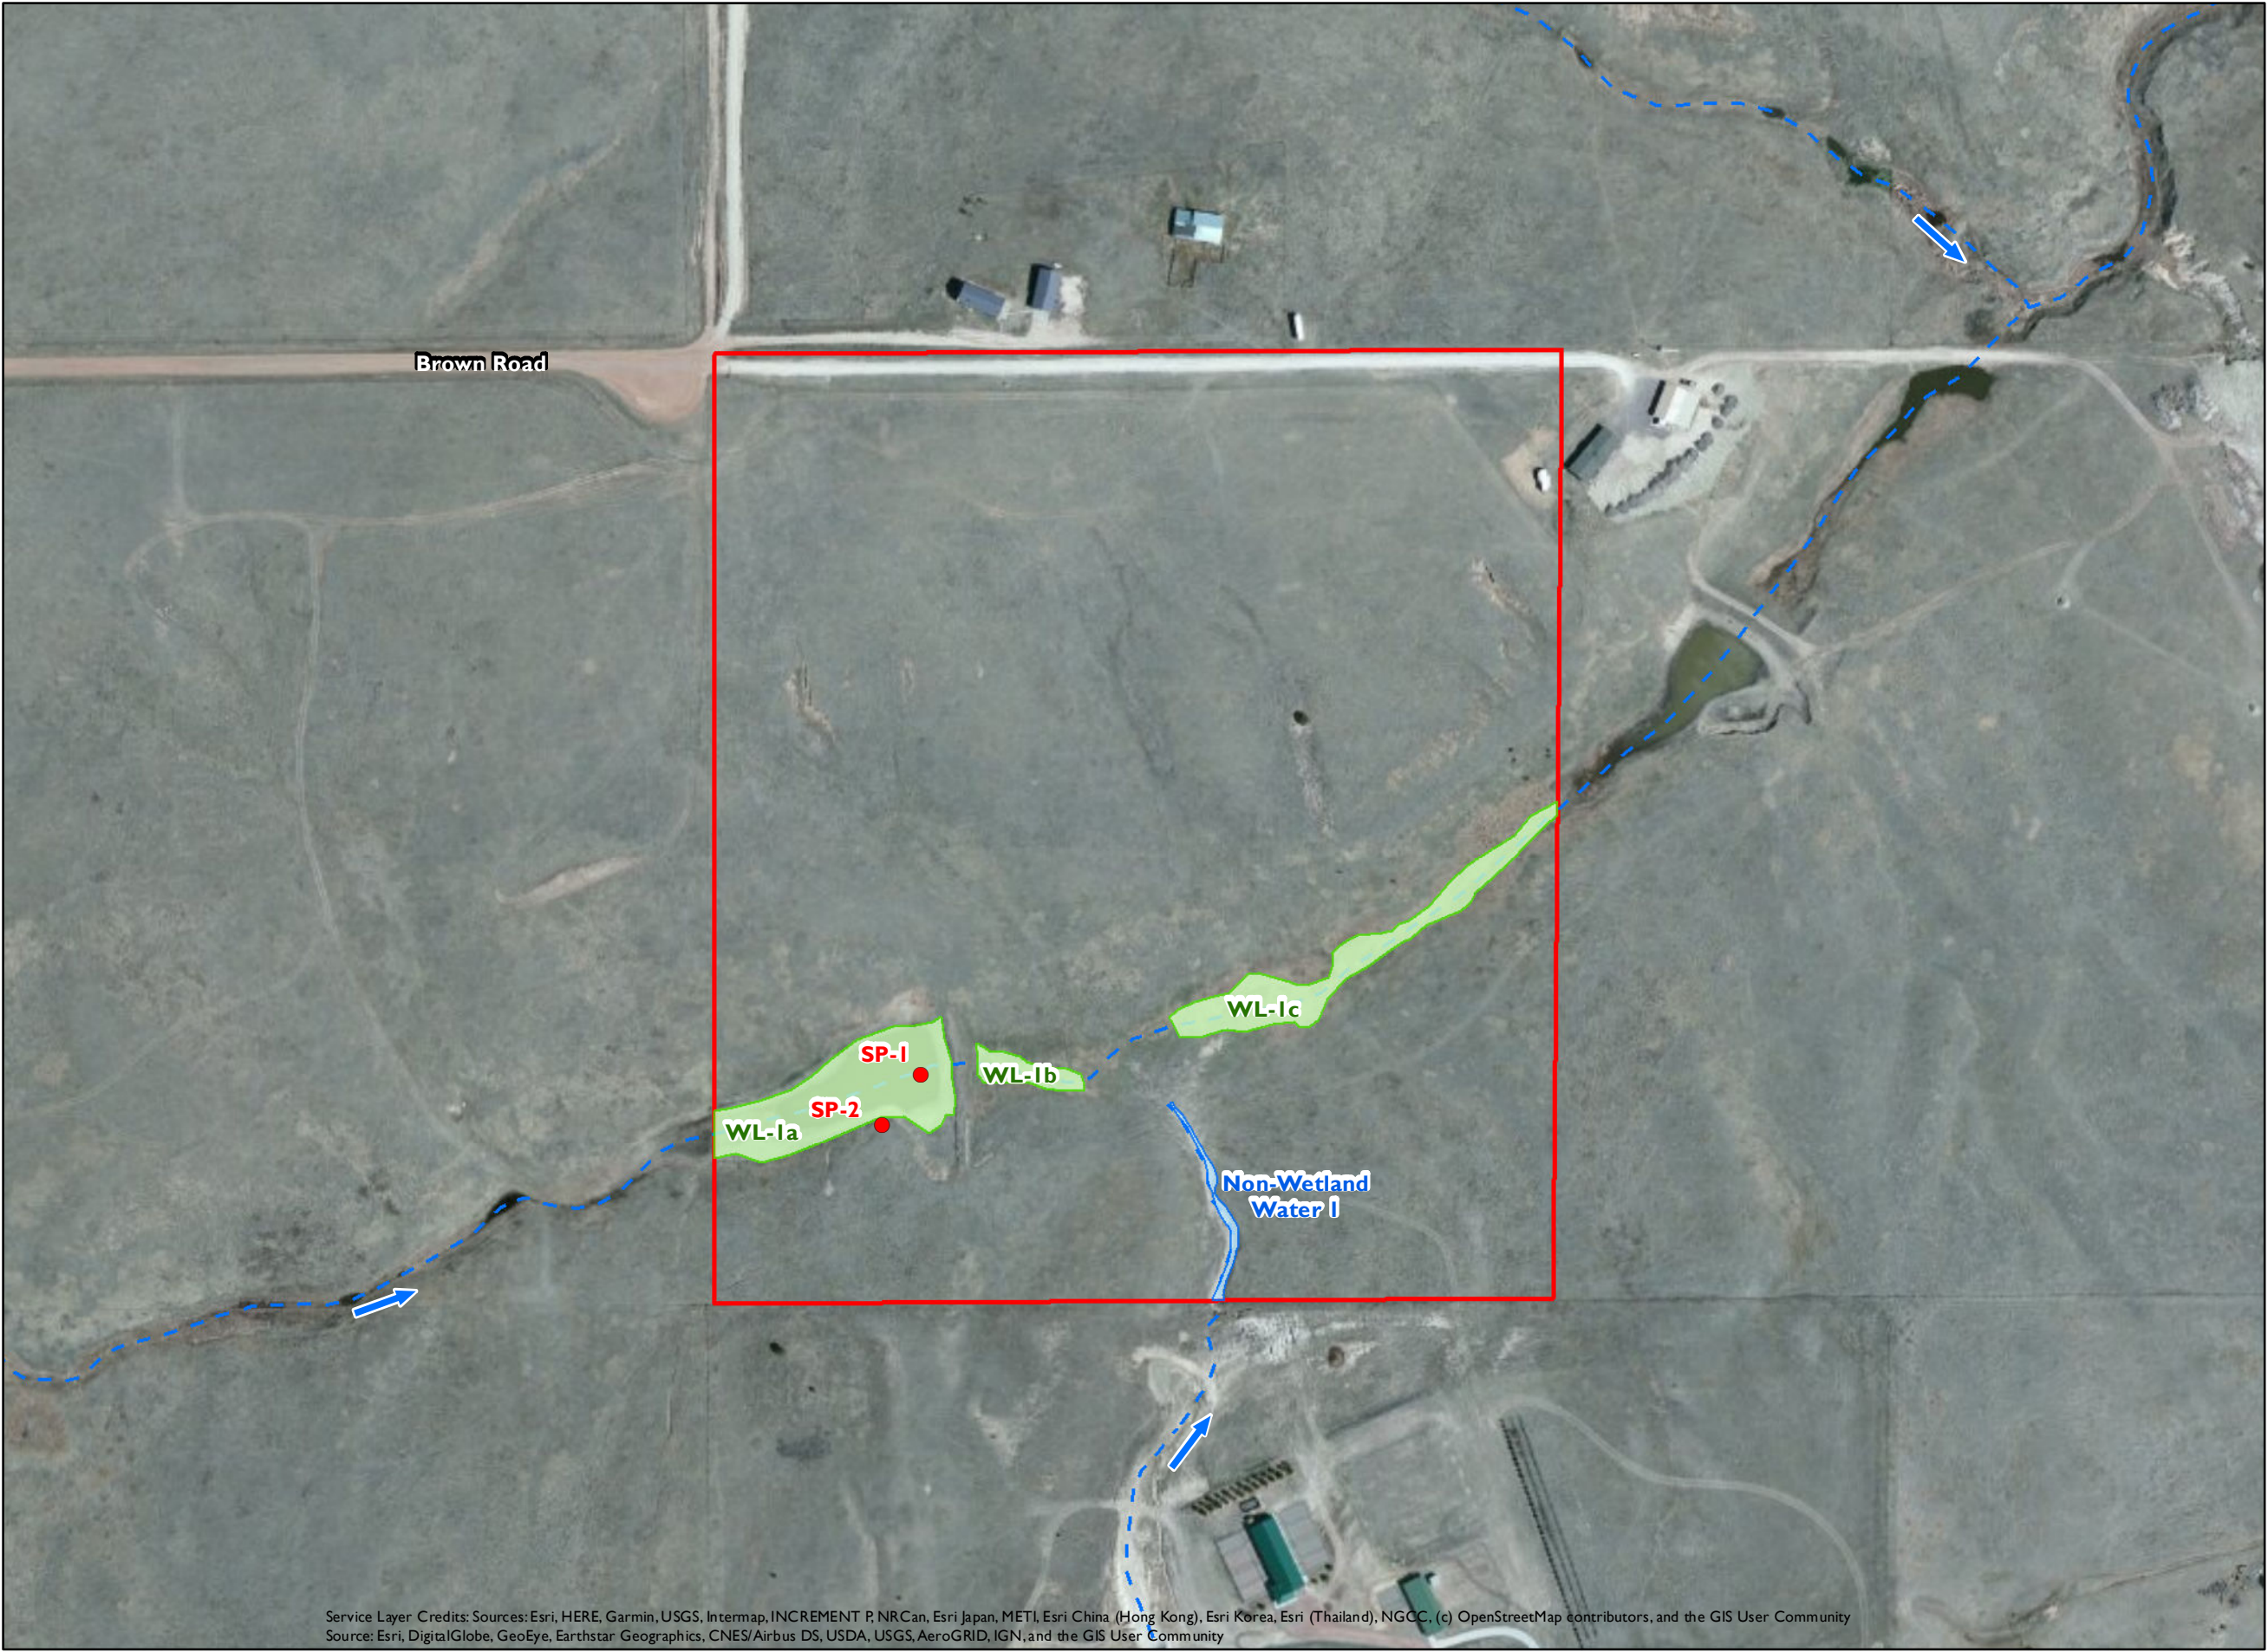
Figure: 2

One drainage (Non-Wetland Water 1) and three wetlands (Wetland 1 complex) are located within the study area (Figure 2, Appendix A). There is evidence of human alteration in the landscape (e.g., evidence of earthwork, changes to the drainage, nearby development). Therefore, some of the natural vegetation, soils, and hydrology have likely been altered by filling, grading, and improvement activities in the past. The following sections summarize the current conditions of the study area.

An OHWM was mapped for Non-Wetland Water 1 located in the south-central section of the study area (Figure 2, Appendix A). This drainage was unnamed (per US Geological Survey [USGS, 2020] maps) and was identified by its hydrogeomorphic features. The main source of hydrology for Non-Wetland Water 1 is likely runoff from the adjacent landscape. During the time of the site visit there was no water; however, based on the topography of the landscape, flow (when present) is assumed to be south to north. Non-Wetland Water 1 extends into the Wetland 1 complex area which drains west to east into Frankton Parker FPE-6 Reservoir (reservoir) (Figure 2). This reservoir connects to East Cherry Creek outside of the study area.

The Wetland 1 complex consisted of three wetlands, Wetland 1a (WL-1a), Wetland 1b (WL-1b), and Wetland 1c (WL-1c) (Figure 2, Appendix A). These wetlands include palustrine emergent (PEM) wetlands. A PEM wetland is a type of wetland dominated by non-woody vegetation (e.g., grasses, sedges) with less than 30 percent cover of either shrubs or trees (Cowardin et al., 1979). In general, these wetlands were dominated

- Study Area (35.88 acres)
- Sampling Point
- Wetlands (1.49 acres)
- Non-Wetland Waters (0.06 acre)
- Unnamed Drainageways
- Flow Direction

BIOLOGICAL RESOURCES

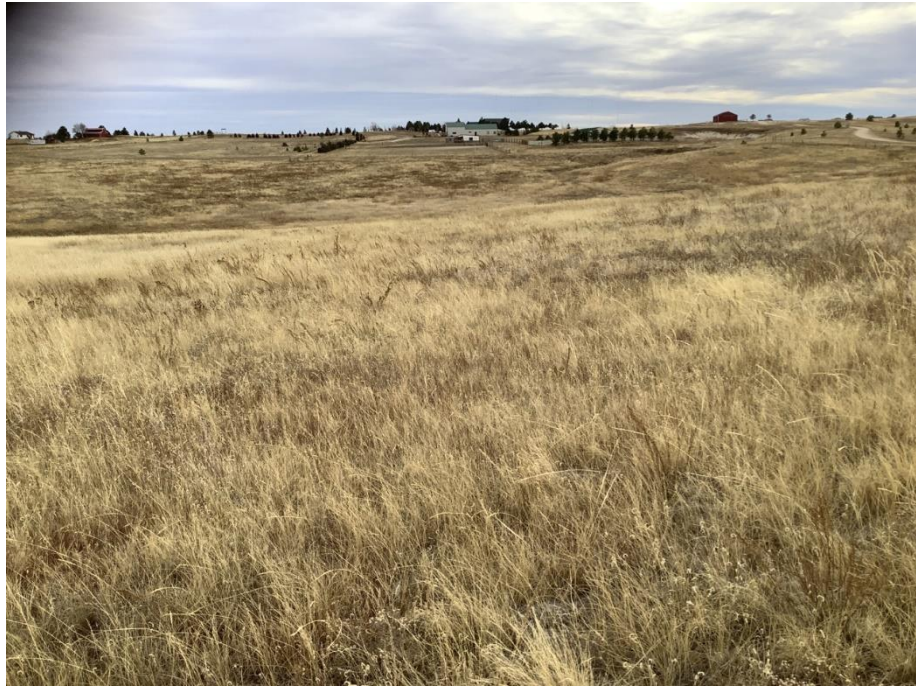
Photo 1. A view of the study area and upland vegetation. Photo facing south from the center of the study area.

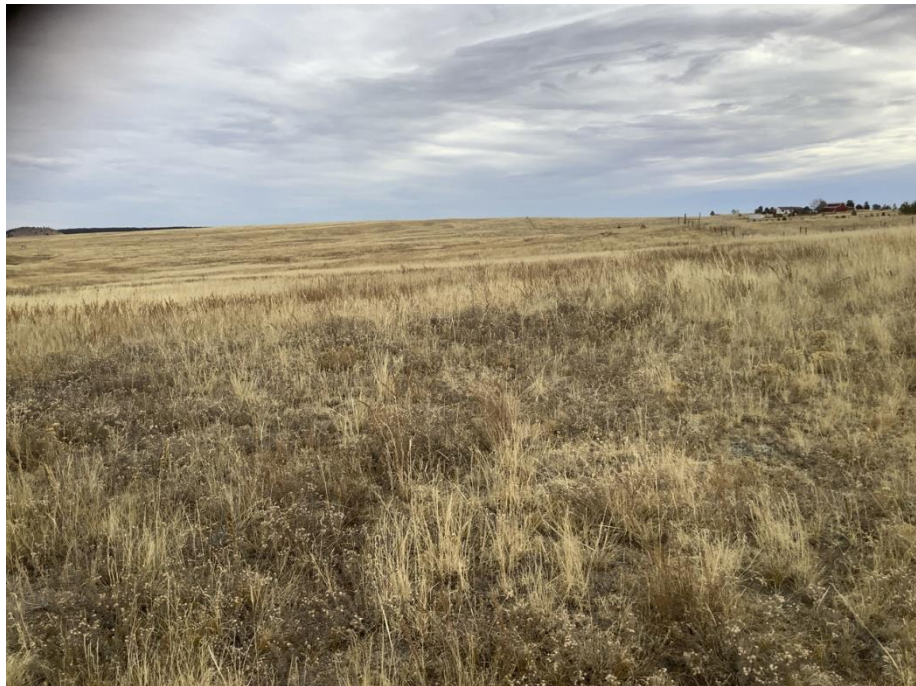
Photo 2. A view of the study area and upland vegetation. Photo facing east from the southeast corner of the study area.

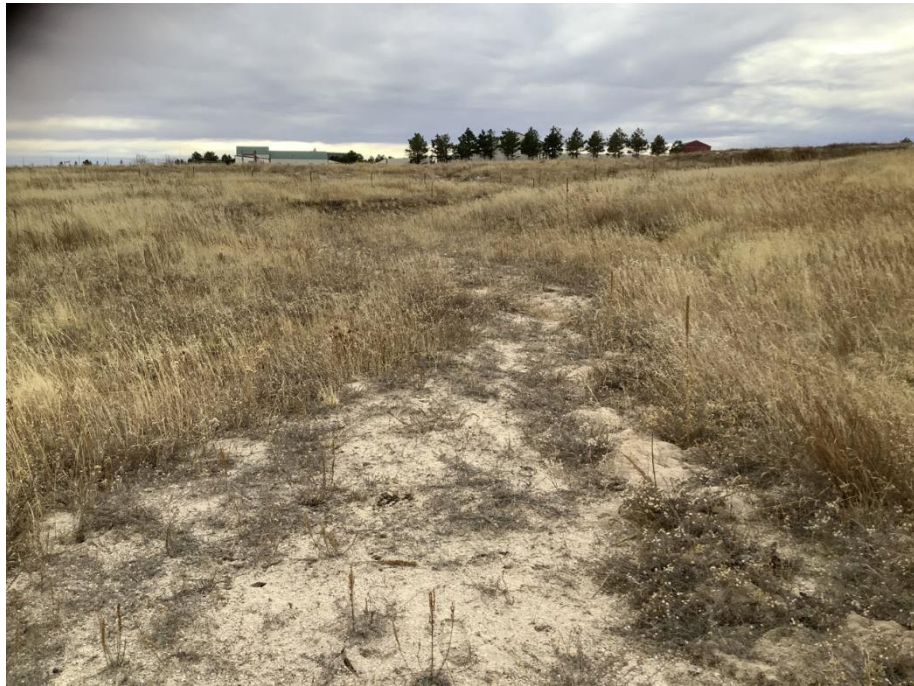
Photo 3. A view of Non-Wetland Water I in the south central section of the study area. Photo facing south.

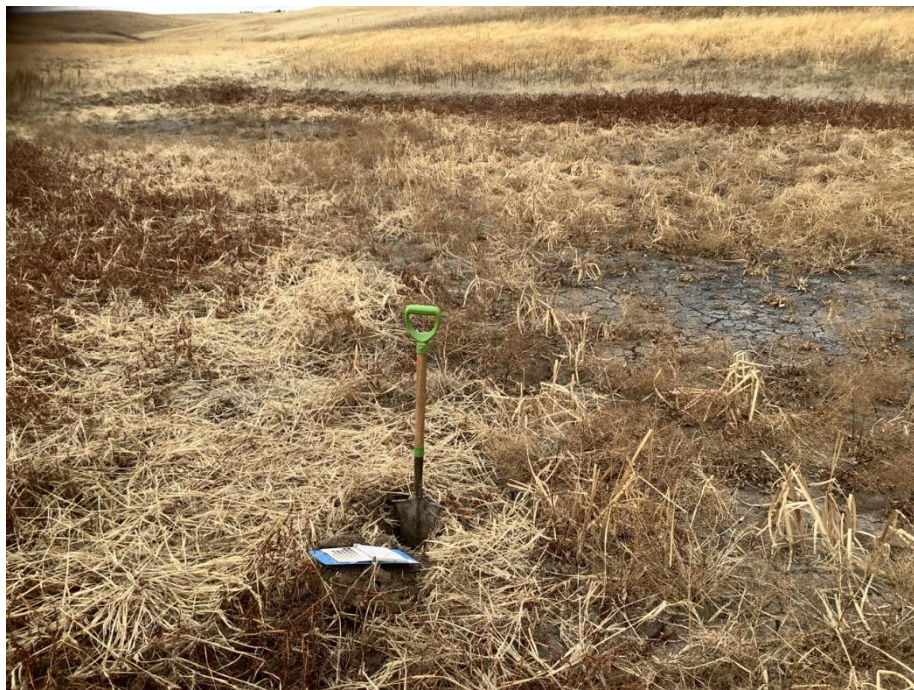
by Baltic rush (*Juncus balticus*), cattail (*Typha sp.*), curly dock (*Rumex crispus*), and reed canary grass (*Phalaris arundinacea*). SP-I was located within WL-1a (Figure 2, Appendix A, Appendix B).

Photo 4. A view of Sampling Point I (SP-I) within Wetland Ia (WL-Ia). SP-I was dominated by reed canary grass (*Phalaris arundinacea*).

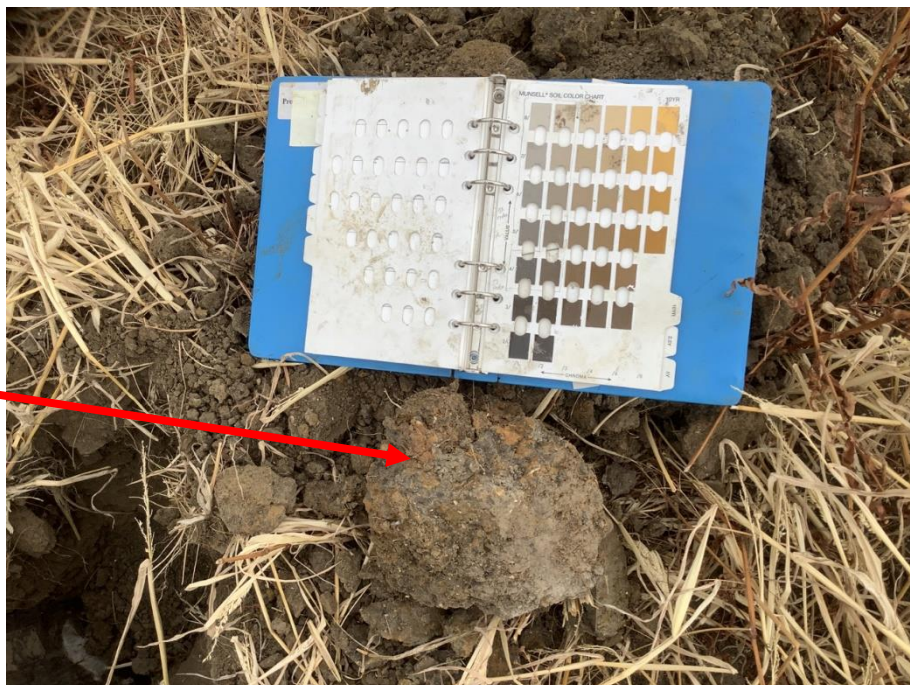
Photo 5. A picture of the hydric soil sample from SP-1. Hydric soil indicator Depleted Matrix (F3) observed within soil sample.

Depleted Matrix (F3) indicator observed. SP-1 passes for hydric soil.

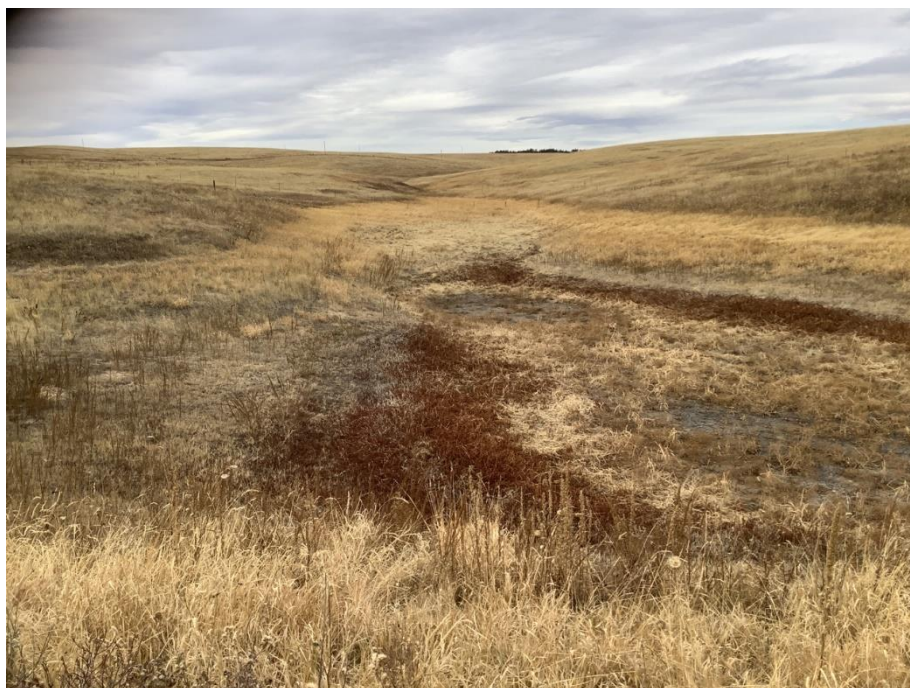
Photo 6. A view of WL-1a from the earthen/riprap dike between WL-1a and Wetland I b (WL-1b). Photo facing west.

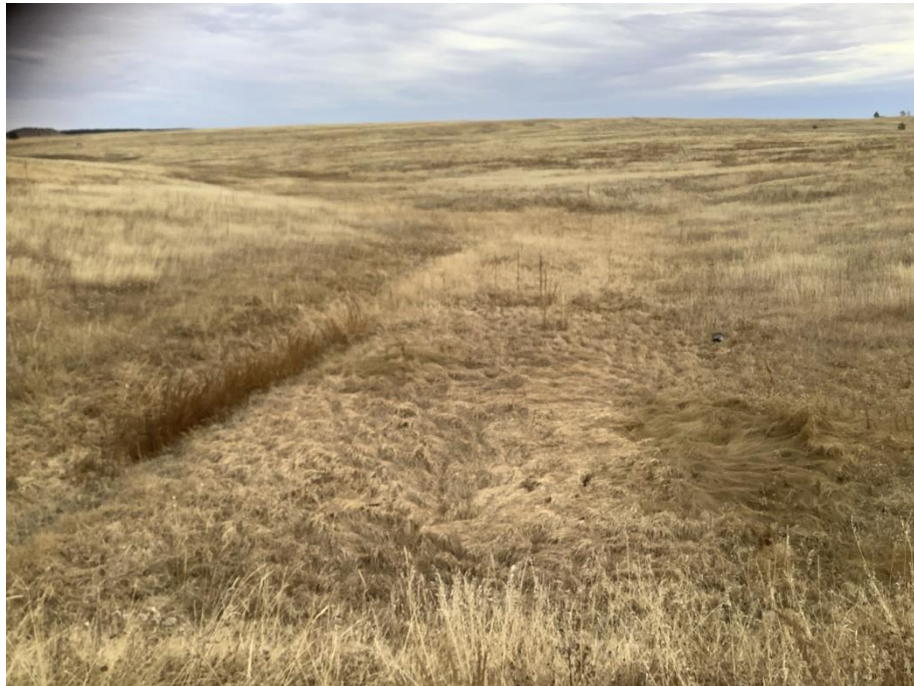
Photo 7. A view of WL-1b from the earthen/rip rap dike between WL-1a and WL-1b. Photo facing east.

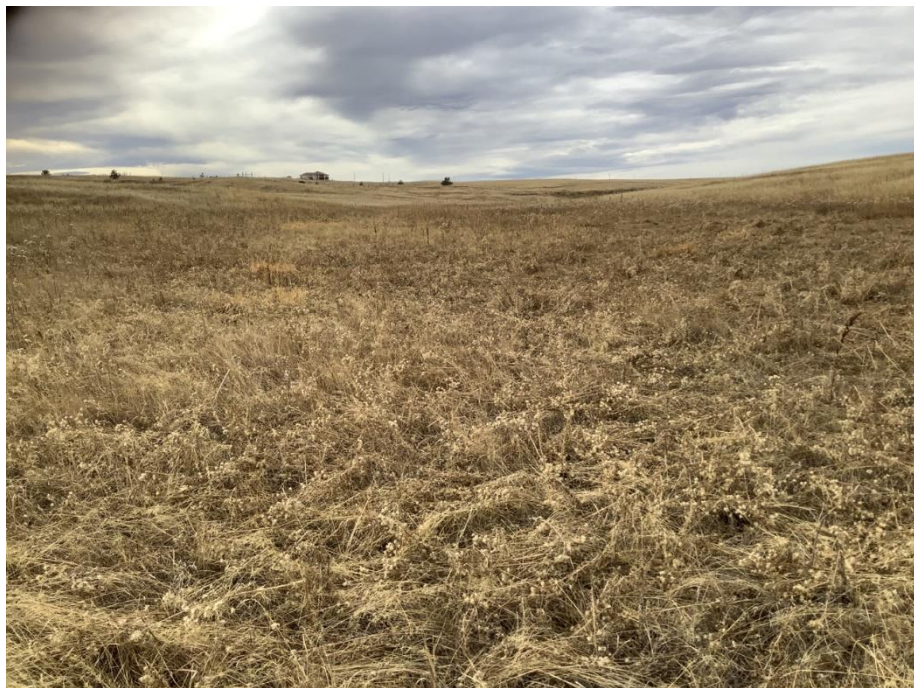
Photo 8. A view of Wetland 1c (WL-1c) located in the eastern section of the study area. WL-1c was dominated by reed canary grass (*Phalaris arundinacea*). Photo facing west.
