**SKYE VISTA SUBDIVISION
NATURAL LANDFORMS, VEGETATION, RIPARIAN ANALYSIS
FINAL PLAT**

December 5, 2024

PREPARED BY:
Matrix Design Group
2435 Research Parkway, Suite 300
Colorado Springs, CO 80920

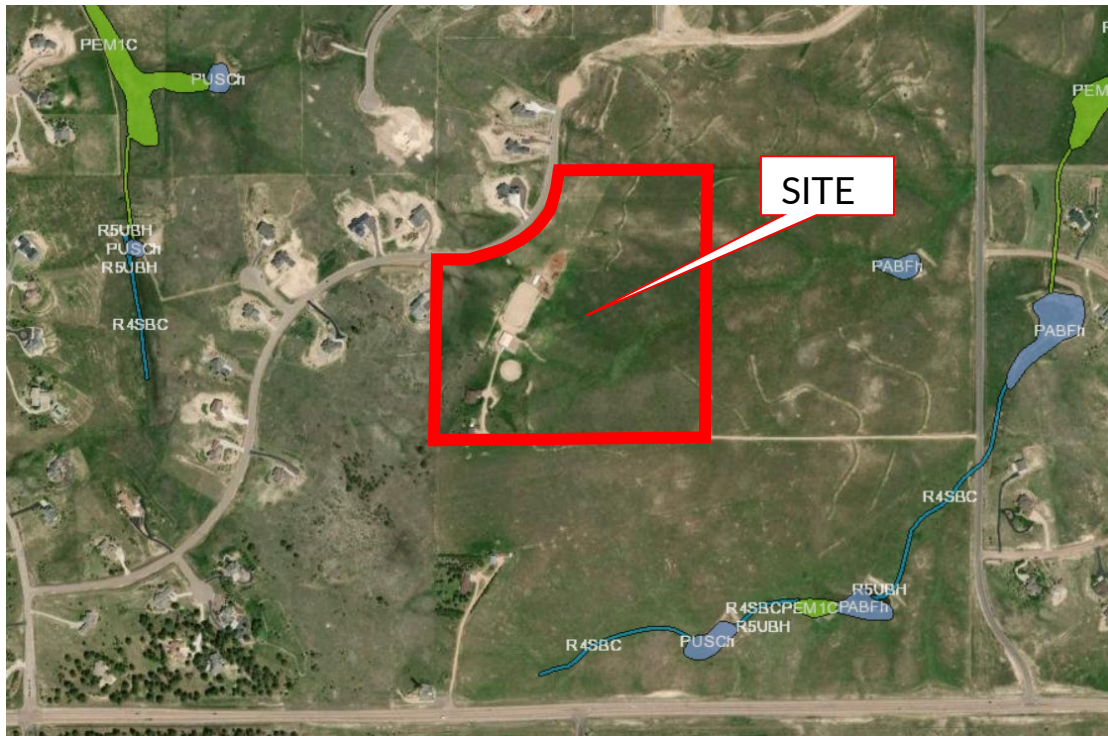
All of the Skye View Subdivision is located within Zone X, area of minimal flood hazard as shown on FEMA Floodmap panel number: 08041C0305G effective 12/7/2018.

There are no identified hydrological or floodplain features as shown on the National Wetlands Inventory and surface waters and wetlands mapper. No wetlands or hydrological features are anticipated to be impacted by this development.

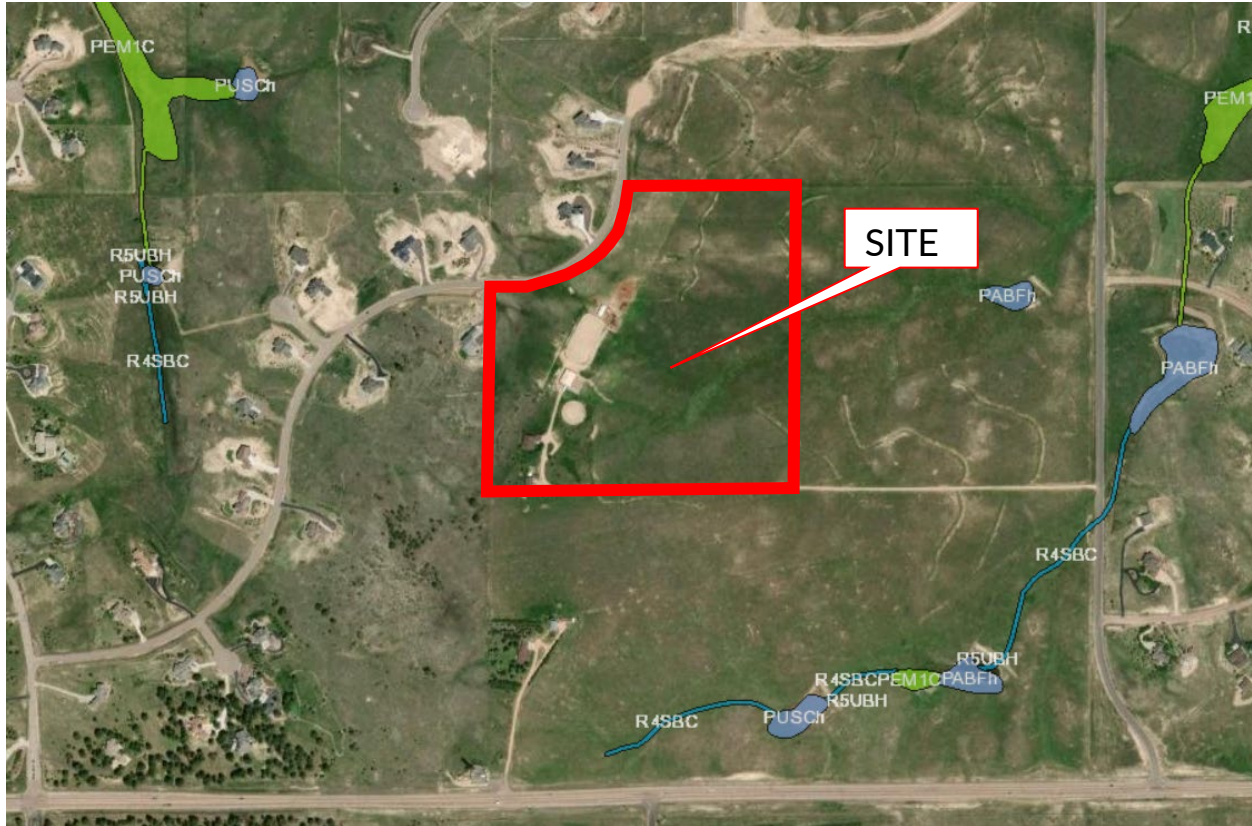
Wetlands: There are no identified hydrological or floodplain features within the Skye Vista Subdivision as shown on the National Wetlands Inventory and surface waters and wetlands mappers. No wetlands or hydrological features are anticipated to be impacted by this development.
