Job No. 188737

Re: Infiltration Testing (ASTM D3385) Summary
Crossroads Mixed Use
Meadowbrook Parkway
El Pso County, Colorado

Double-Ring Infiltrometer - Field Log

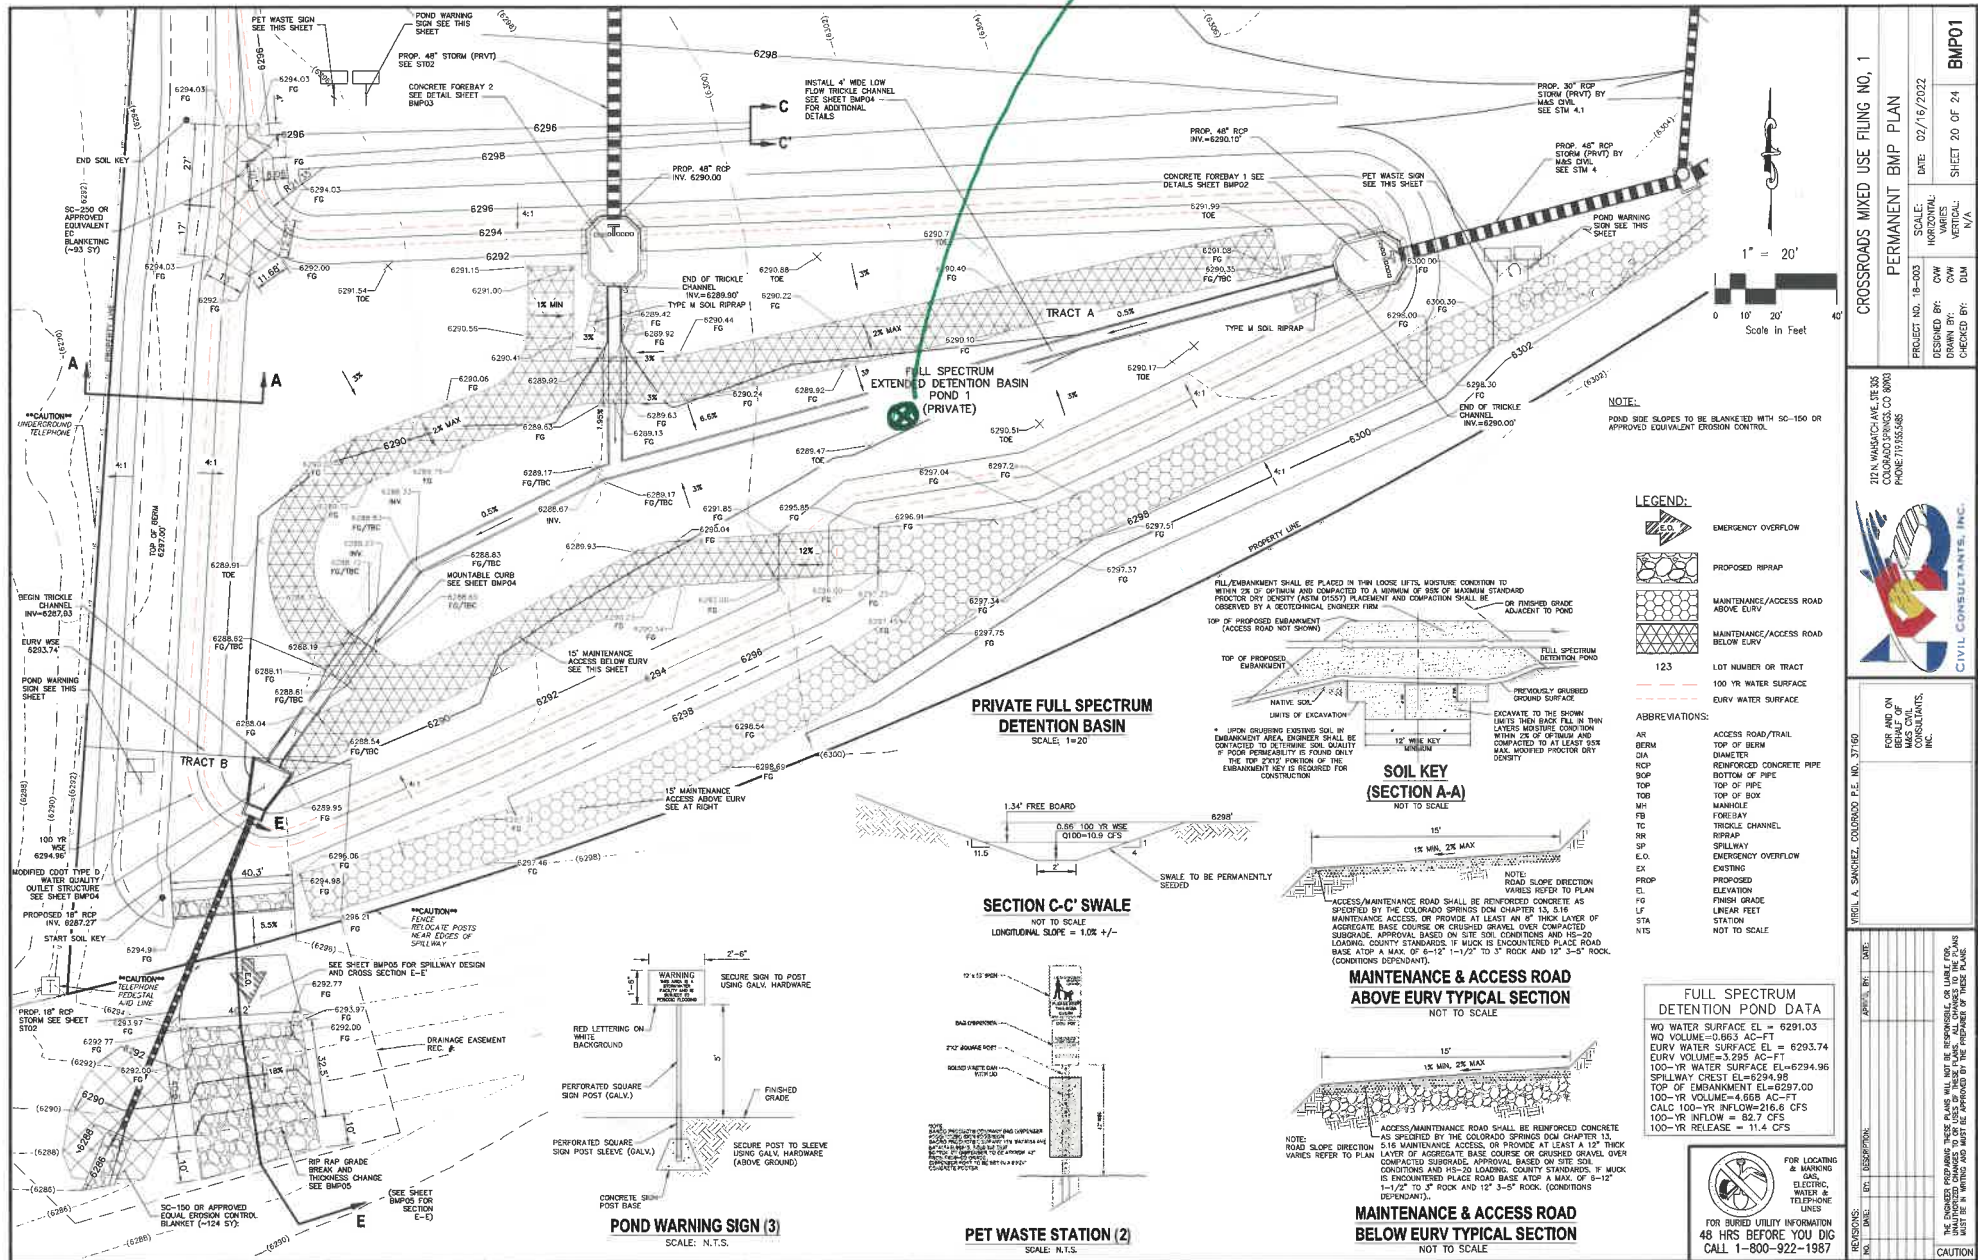
Approximate Testing Location

RMG – Rocky Mountain Group was requested to perform infiltration testing in the detention basin area in accordance with ASTM D3385-18. The testing was performed on May 17, 2022 in the area of the proposed detention basin located in the southwestern portion of the Crossroads Mixed Use Park. We understand this information is planned to be used to aid in design of a proposed underground detention system. We understand the existing detention basin area is cut to the approximate finish grade plan elevation. A total of four infiltration tests were performed at the detention surface.
