**SOIL, GEOLOGY, GEOLOGIC HAZARD,
AND WASTEWATER STUDY,
SADDLEHORN RANCH SUBDIVISION
EL PASO COUNTY, COLORADO**

William Guman and Associates, LTD
731 North Weber Street, Suite 100
Colorado Springs, Colorado 80903

April 29, 2019
Revised April 24, 2020

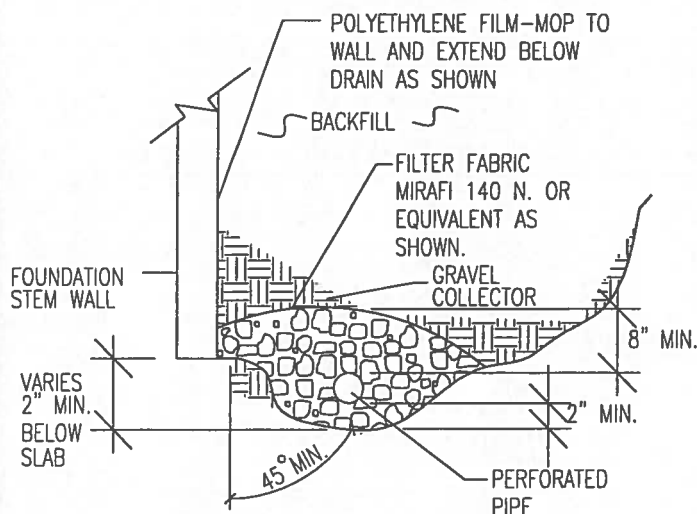
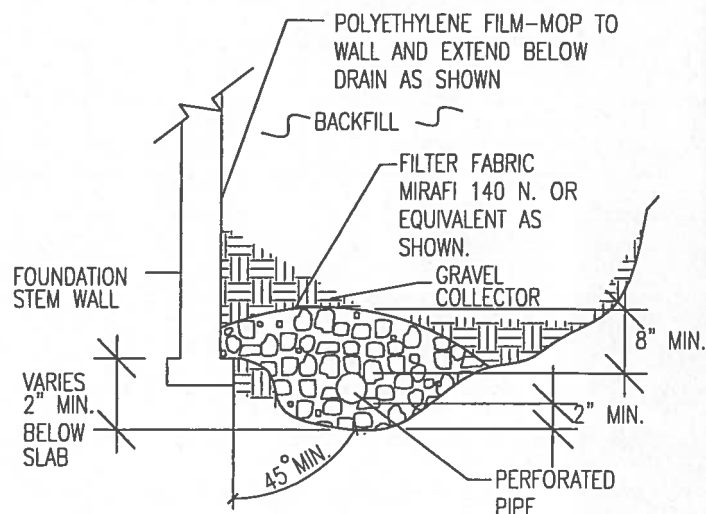
8

-GRAVEL SIZE IS RELATED TO DIAMETER OF PIPE PERFORATIONS-85% GRAVEL GREATER THAN 2x PERFORATION DIAMETER.

Mitigation: In these locations, foundations are subject to severe frost heave and should penetrate to a sufficient depth so as to prevent the formation of ice lenses beneath foundations. At this location and elevation, a foundation depth for frost protection of 30-inches is recommended. In areas where high subsurface moisture conditions are anticipated periodically, a subsurface perimeter drain will be necessary to help prevent the seepage of water into areas below grade. A typical perimeter drain detail is presented in Figure 8. Any grading in these areas should be done in a manner that directs surface flow around construction to avoid areas of ponded water. Areas of organic material will require removal prior to any fill placement. Unstable soil conditions should be expected in areas of shallow groundwater. Where foundations approach the groundwater level, stabilization of the excavations utilizing shot rock may be necessary. Underslab drains or capillary breaks, and interceptor drains may be necessary to prevent intrusion of water into areas below grade. Typical drain details are presented in Figures 9 and 10.

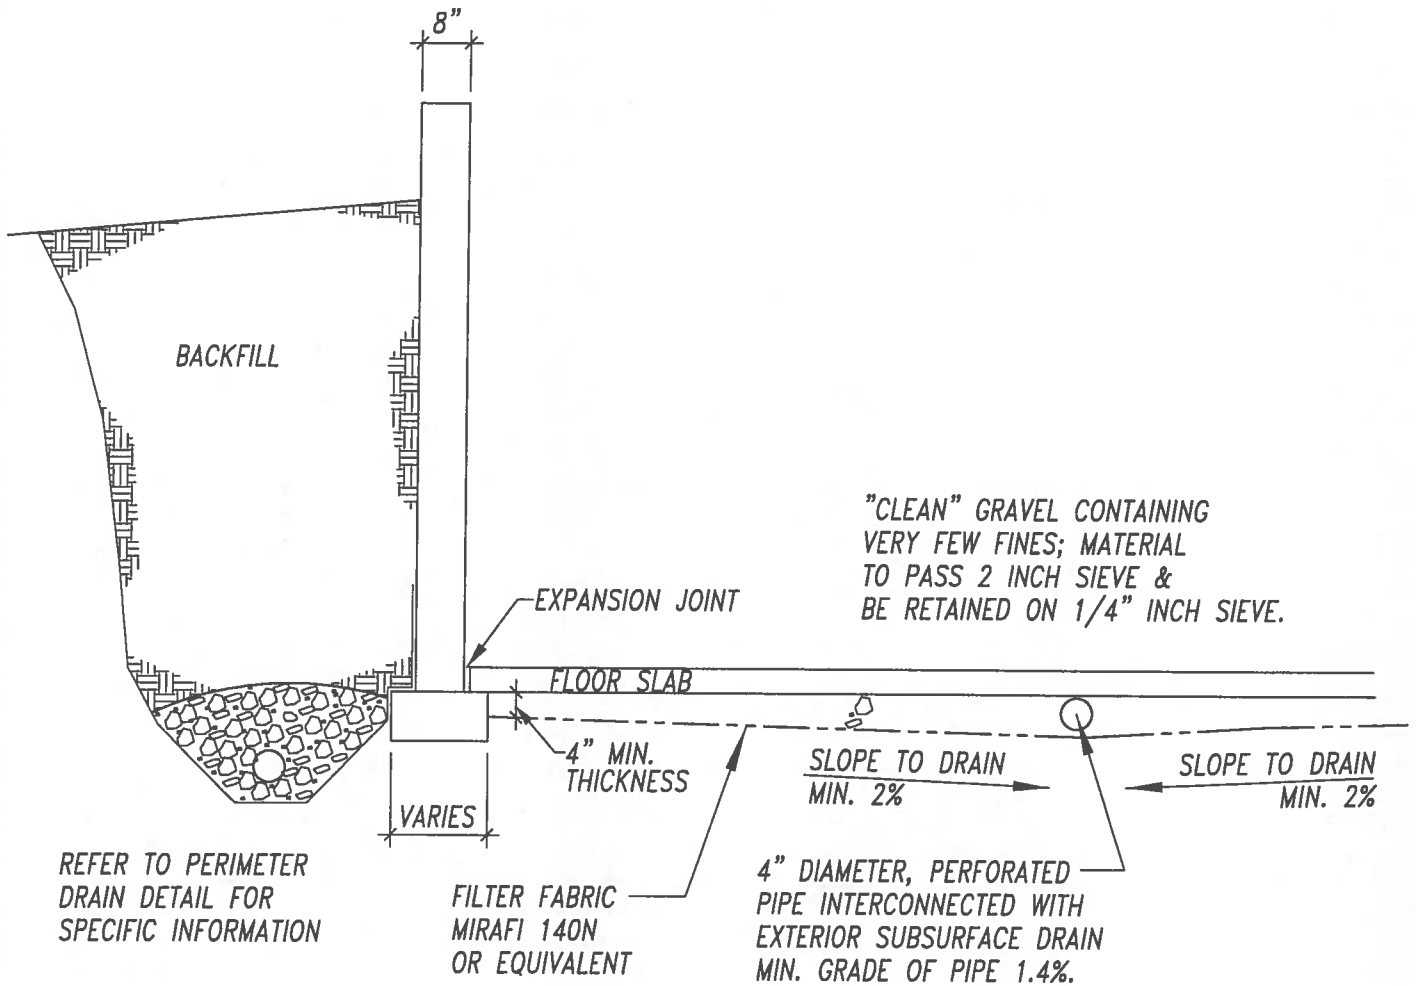
10

TYP. UNDERSLAB DRAINAGE
LAYER (CAPILLARY BREAK)

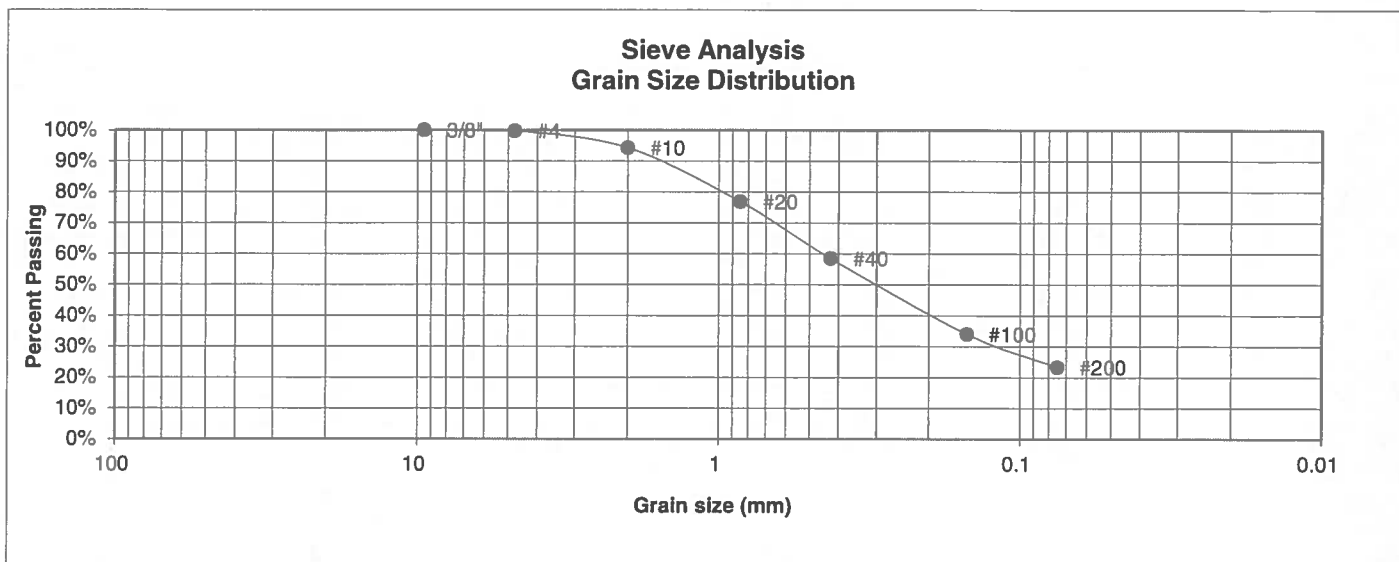
C-13

<u>UNIFIED CLASSIFICATION</u>	SC	<u>CLIENT</u>	GUMAN AND ASSOCIATES
<u>SOIL TYPE #</u>	1	<u>PROJECT</u>	CURTIS RD AND JUGRE ORR RD
<u>TEST PIT #</u>	21	<u>JOB NO.</u>	181823
<u>DEPTH (FT)</u>	5-6	<u>TEST BY</u>	BL

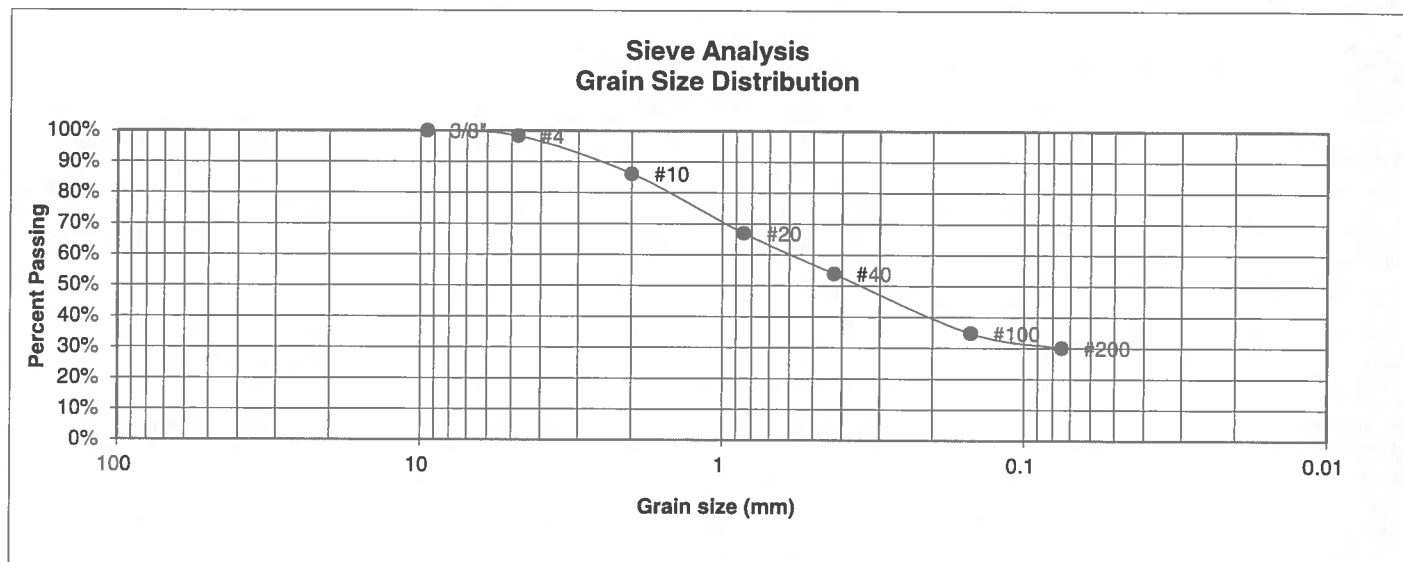
C-14

UNIFIED CLASSIFICATION	SM	CLIENT	GUMAN AND ASSOCIATES
SOIL TYPE #	1	PROJECT	CURTIS RD AND JUGRE ORR RD
TEST PIT #	37	JOB NO.	181823
DEPTH (FT)	6-7	TEST BY	BL

U.S. Sieve #	Percent Finer
3"	
1 1/2"	
3/4"	
1/2"	
3/8"	100.0%
4	98.3%
10	86.2%
20	67.0%
40	53.9%
100	34.8%
200	30.1%

Atterberg Limits	
Plastic Limit	16
Liquid Limit	19
Plastic Index	3

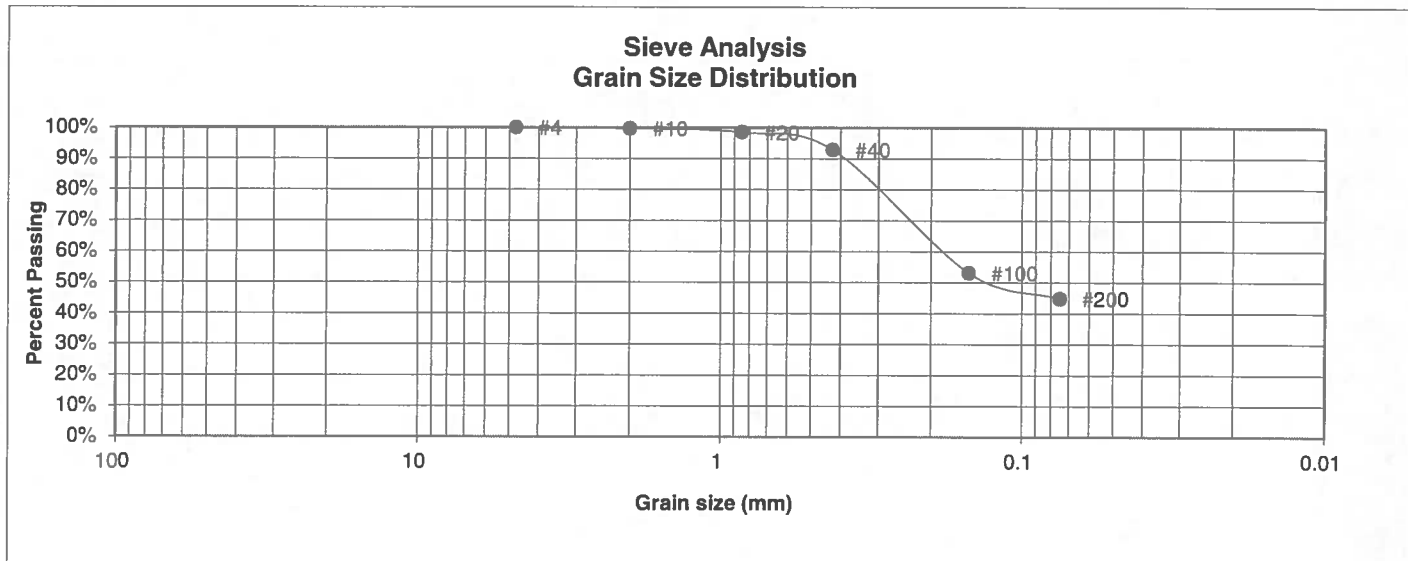
C-24

<u>UNIFIED CLASSIFICATION</u>	SC	<u>CLIENT</u>	GUMAN AND ASSOCIATES
<u>SOIL TYPE #</u>	3	<u>PROJECT</u>	CURTIS RD AND JUGRE ORR RD
<u>TEST PIT #</u>	8	<u>JOB NO.</u>	181823
<u>DEPTH (FT)</u>	4-5	<u>TEST BY</u>	BL

<u>U.S. Sieve #</u>	<u>Percent Finer</u>
3"	
1 1/2"	
3/4"	
1/2"	
3/8"	
4	100.0%
10	99.7%
20	98.5%
40	92.9%
100	53.2%
200	44.8%

<u>Atterberg Limits</u>	
Plastic Limit	16
Liquid Limit	29
Plastic Index	13

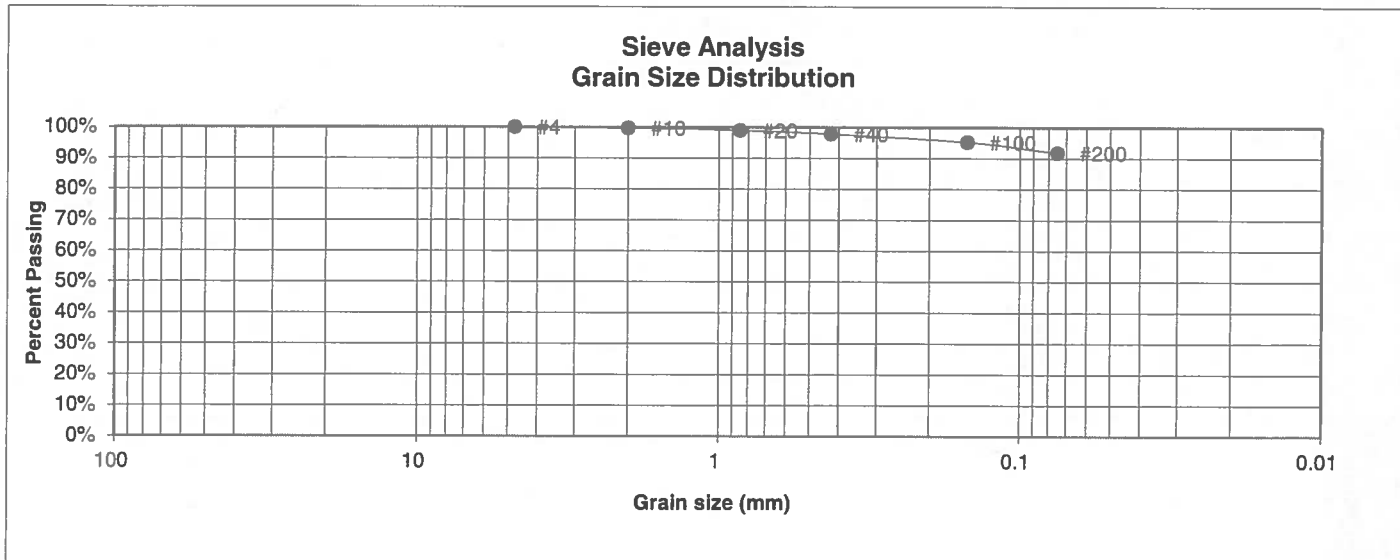
C-31

UNIFIED CLASSIFICATION	CL	CLIENT	GUMAN AND ASSOCIATES
SOIL TYPE #	4	PROJECT	CURTIS RD AND JUGRE ORR RD
TEST PIT #	7	JOB NO.	181823
DEPTH (FT)	6-7	TEST BY	BL

U.S. Sieve #	Percent Finer
3"	
1 1/2"	
3/4"	
1/2"	
3/8"	
4	100.0%
10	99.7%
20	99.0%
40	97.8%
100	95.2%
200	91.8%

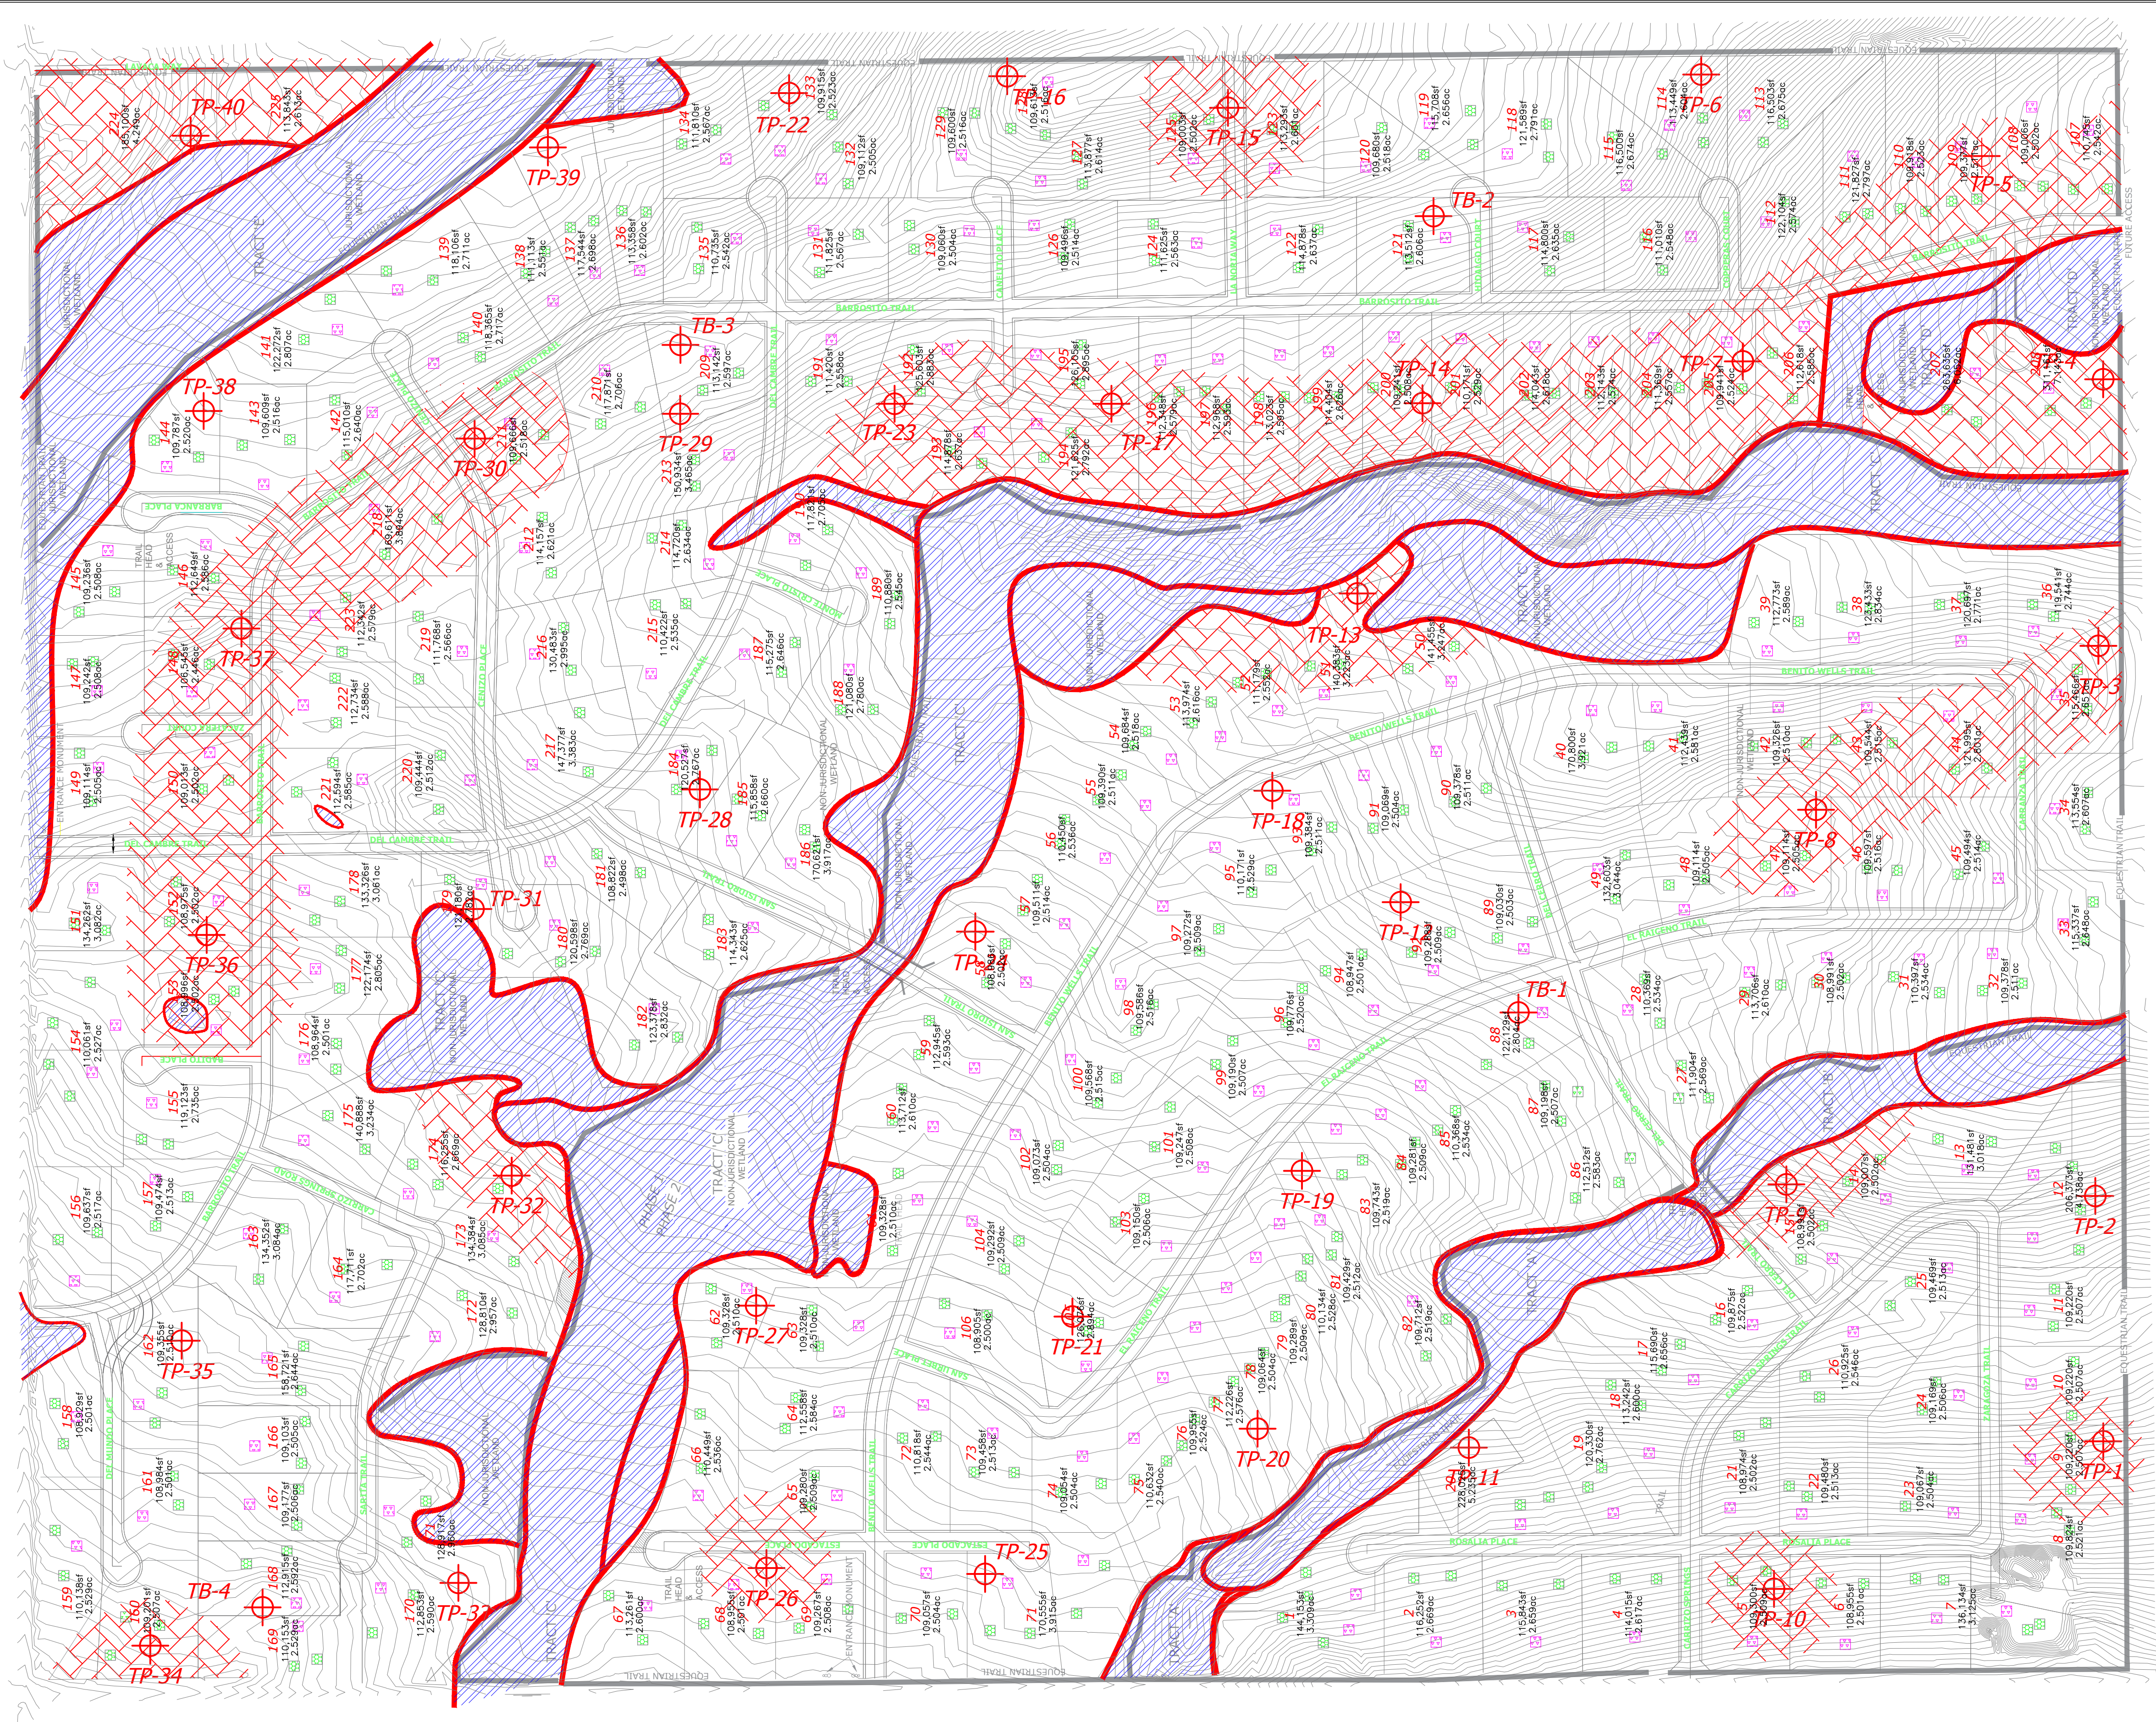
- APPROXIMATE LOCATION OF PERCOLATION TEST
- AREAS WHERE DESIGNED SYSTEMS ARE RECOMMENDED DUE TO UNSUITABLE SOILS, SHALLOW BEDROCK OR SHALLOW GROUNDWATER
- AREAS WHERE CONVENTIONAL SYSTEMS ARE NOT RECOMMENDED
- AREAS WHERE CONVENTIONAL SYSTEMS CAN BE USE UNLESS SHALLOW BEDROCK, SHALLOW GROUNDWATER OR UNSUITABLE SOILS ARE ENCOUNTERED REQUIRING DESIGNED SYSTEMS
- POSSIBLE HOUSE LOCATION
- TWO POSSIBLE OWTS (ON-SITE WASTEWATER TREATMENT SITES)
- APPROXIMATE TEST BORING LOCATIONS
- APPROXIMATE TEST PIT LOCATIONS
