NATURAL FEATURES REPORT
COTTAGES AT MESA RIDGE
EL PASO COUNTY, COLORADO

August 6, 2021

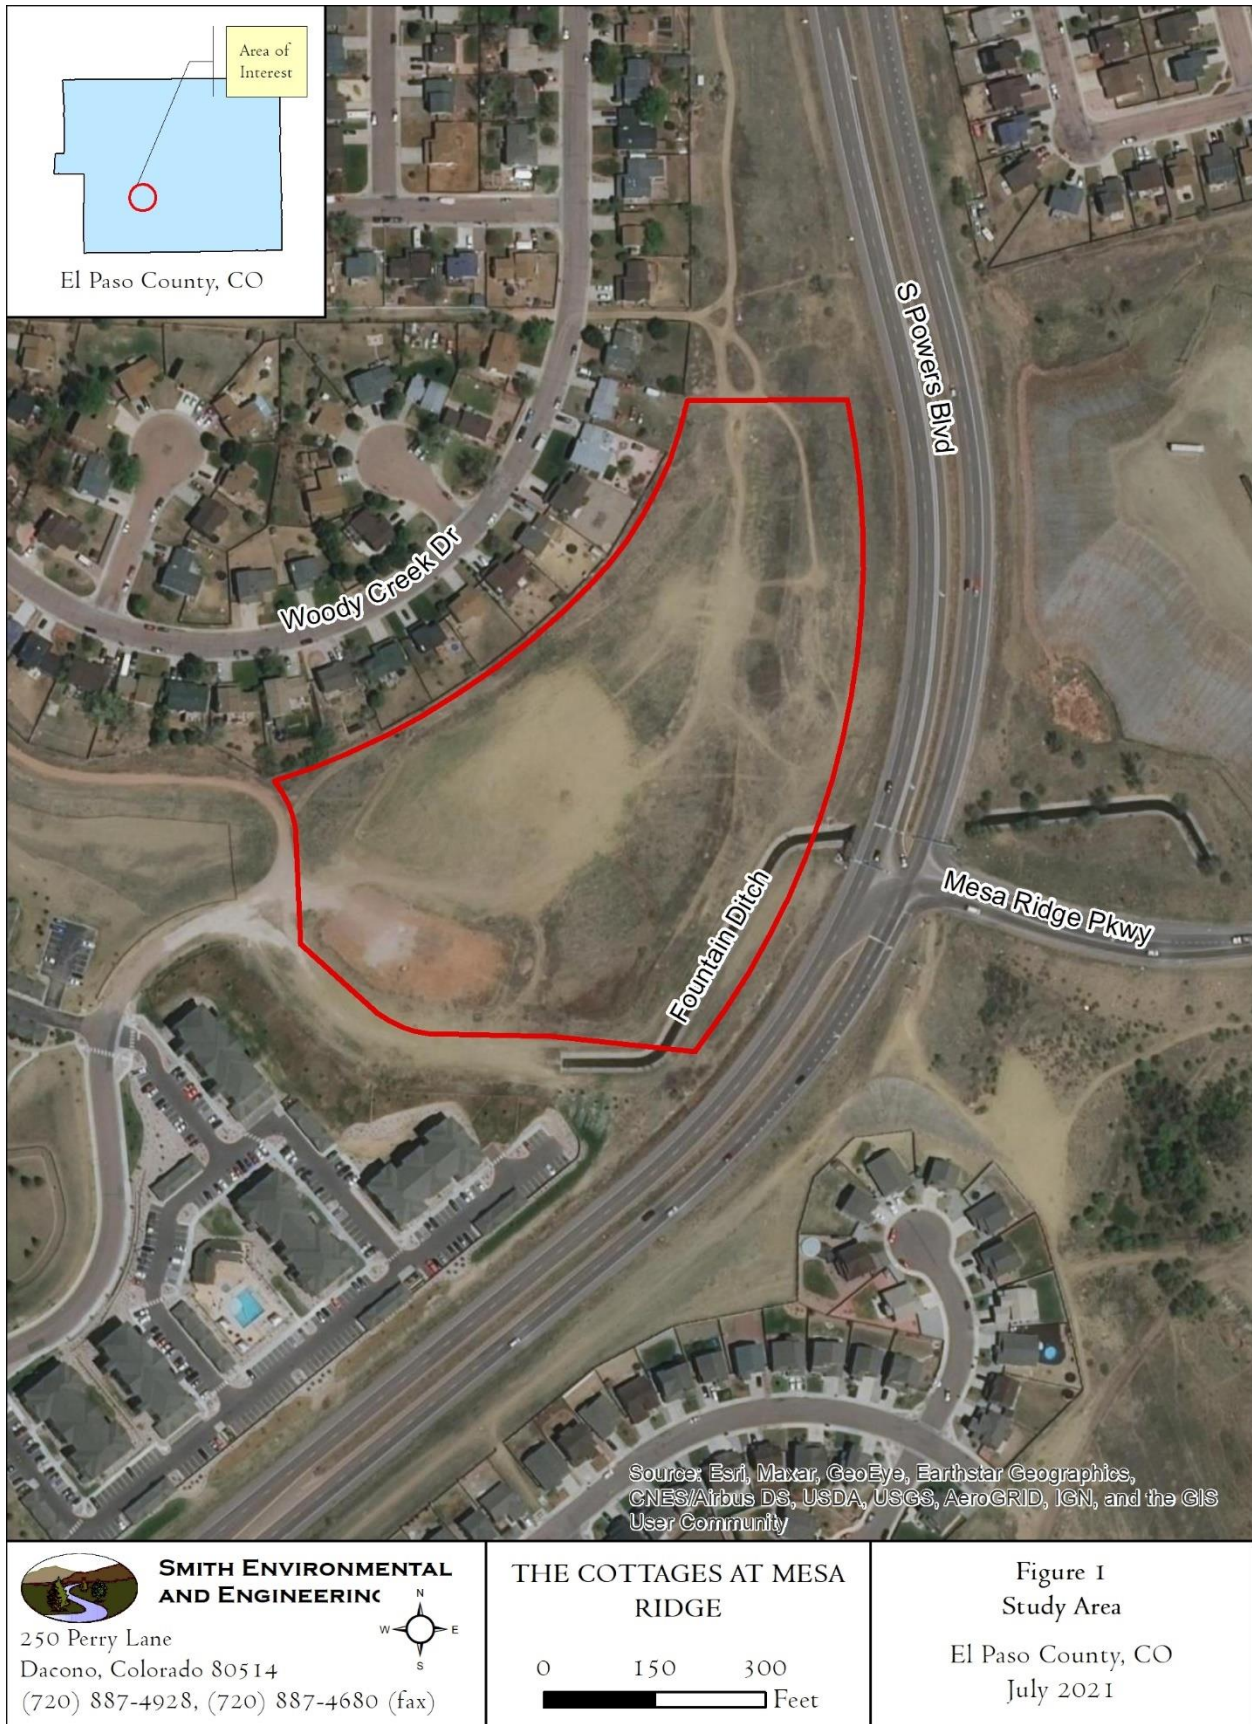
The Study Area (Figure 1) consists of approximately 13 acres located northwest of the intersection of Mesa Ridge Parkway and S Powers Boulevard in unincorporated El Paso County, Colorado. The Study Area occurs at the corner where Sections 20, 21, 28, and 29 of Township 15 South, Range 65 West meet. It is located on the Fountain US Geological Survey (USGS) quadrangle at 38.721538 degrees north, 104.683862 degrees west with an elevation range from approximately 5,765 to 5,800 ft. The Study Area is currently vacant, but it has been subject to ongoing disturbance during development in the local area, most notably in 2019 during the construction of apartments to the southwest. The surrounding area is primarily residential with some remaining vacant land east of S Powers Boulevard.

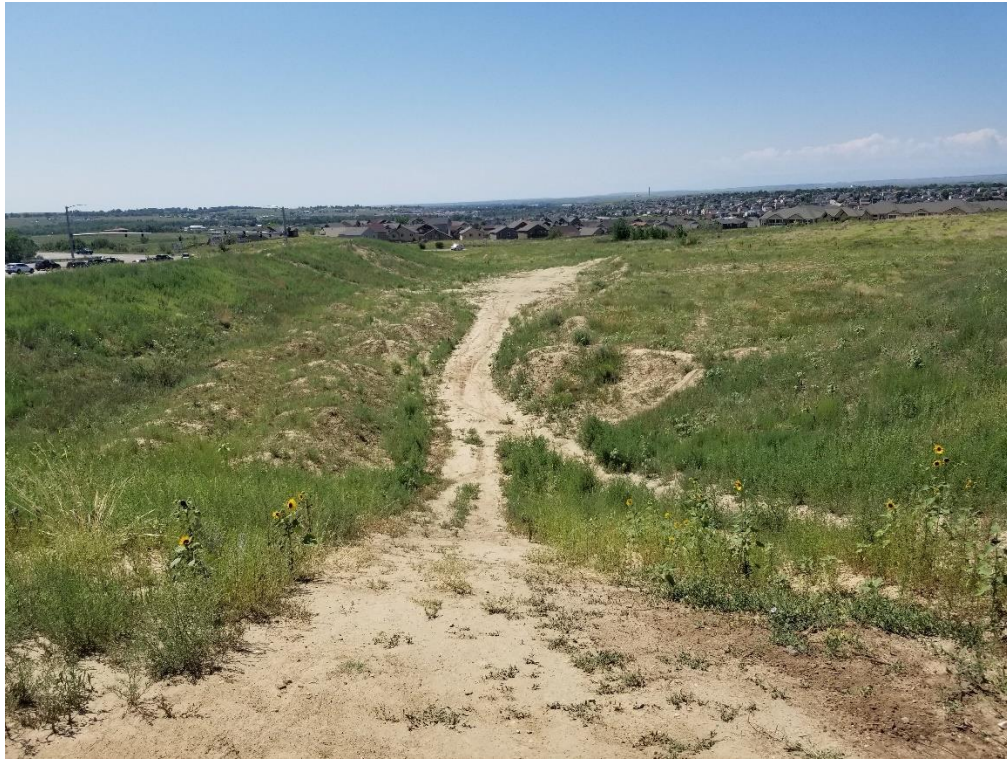
Photo 1. View looking south across the Study Area. Stockpiled soils (mounds) are visible adjacent to the two-track. The view to the southeast is just visible at the top right of the photo.

Historically, the Study Area sloped to the southeast towards the Jimmy Camp Creek drainage, and this same general topographic setting persists (Appendix B). The area is characterized by rolling hills, but no notable geologic or topographic features occur. From higher points within the Study Area, there are significant views to the southeast, an area that remain relatively undeveloped (Photo 1 in Appendix A).

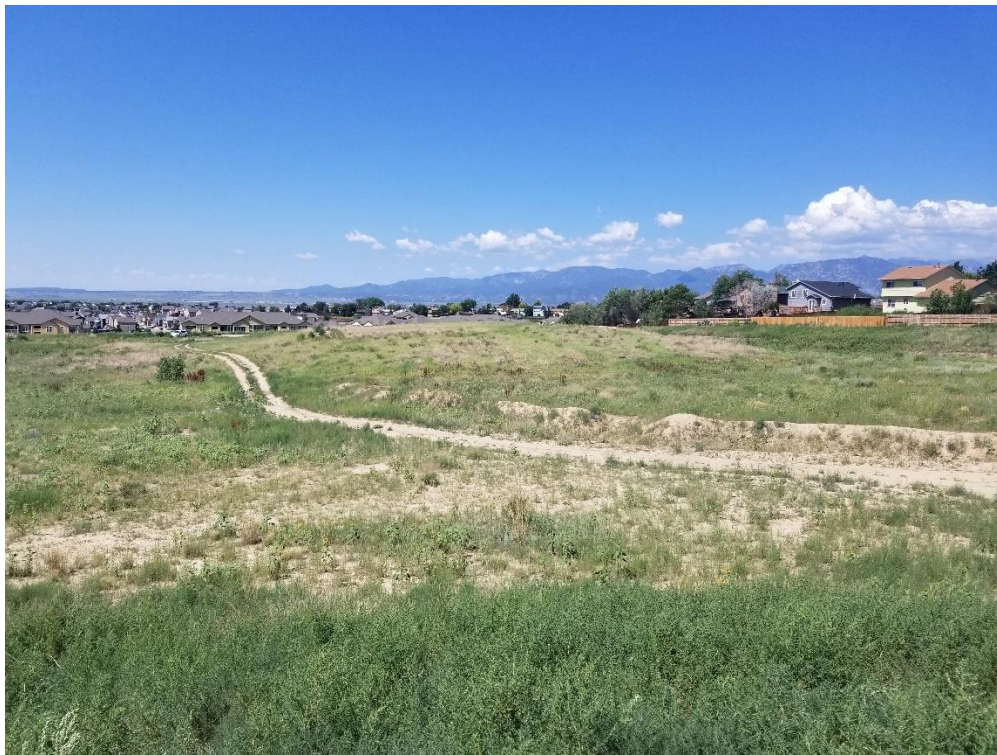
Photo 2. View looking west across the Study Area. The darker green vegetation is kochia, a weedy forb.

The current condition of the Study Area no longer represents a reference condition; per the Ecological Site Description, the Study Area most closely resembles the Increased Bare Ground state (NRCS 2021a). Vegetation in the Study Area consists of an abundance of weedy forbs (mostly nonnative) with a mix of native and nonnative grasses (Table 1). Blue grama (*Bouteloua gracilis*), sideoats grama (*Bouteloua curtipendula*), and western wheatgrass (*Pascopyrum smithii*) were the only grasses expected from the reference condition. Nonnative grasses, most notably smooth brome (*Bromus inermis*), and forbs that favor highly disturbed areas have assumed dominance. There were only a handful of trees and shrubs, including a small patch of cottonwoods (*Populus deltoides*) and saltcedar (*Tamarisk* spp.) in a low spot where runoff collects, and Siberian elms (*Ulmus pumila*), rabbitbrush (*Ericameria nauseosa*), and saltbrush (*Atriplex canescens*) scattered in drier areas.

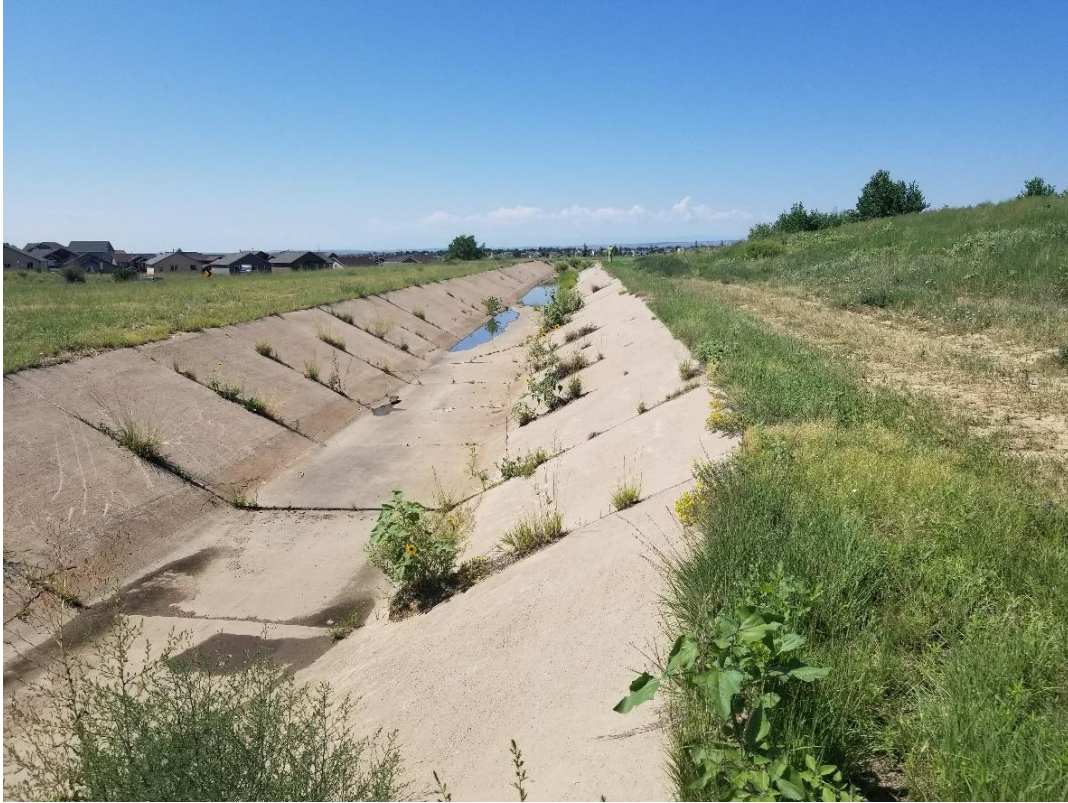
Photo 3. View looking northeast along the Fountain Ditch.

There are no mapped natural drainages (Appendix B), and the only irrigation feature present is the Fountain Ditch, an aboveground concrete-lined structure (Photo 3 in Appendix A and Appendix D). The ditch is unlikely to be considered a WOTUS, and segments of the feature have already been piped, buried, or otherwise modified within and adjacent to the Study Area. The ditch does not support hydrophytic vegetation or hydric soils due to the concrete lining, and therefore, the feature is not considered a wetland.

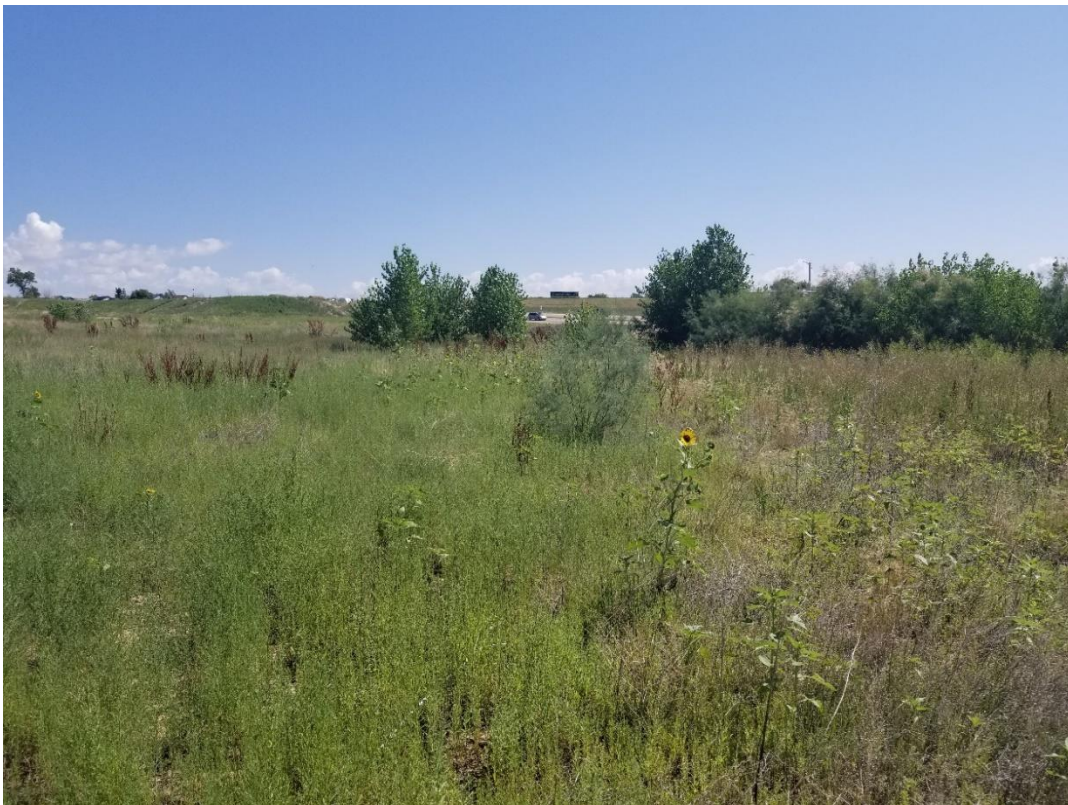
Photo 4. View looking northwest towards a small, treed area with cottonwoods and saltcedar.

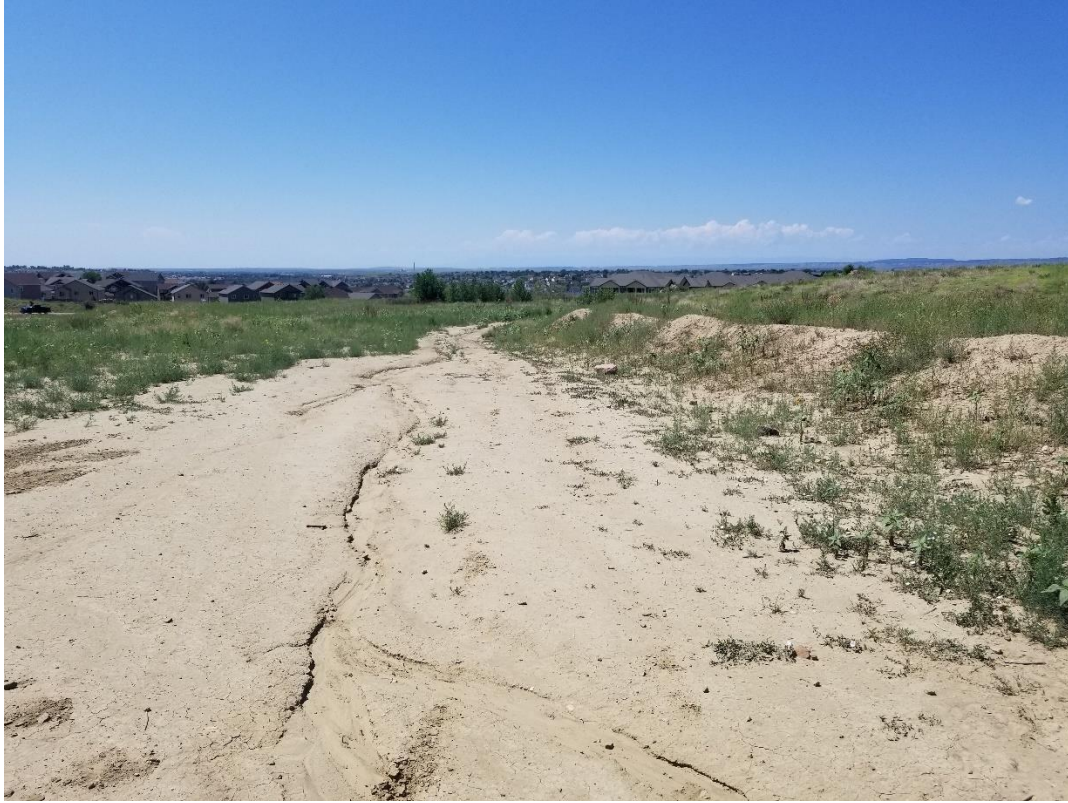
Photo 5. View of a drainage feature observed near the center of the Study Area.

There are several drainage indicators throughout the Study Area, mostly due to the haphazard nature of the current topography. At the north end of the Study Area, where slopes are steep and the surface is largely unvegetated, stormwater runoff is cutting informal channels that convey surface flows south, approximately following a two-track road (Photo 5 in Appendix A). During the site visit, there was ponding in one area along this road, likely representing a low-spot or impermeable soil profile. Additionally, at the southeastern edge of the Study Area, there is vegetation that indicates wetter conditions are present (i.e., willows, cottonwoods, saltcedars). This area is likely receiving stormwater runoff from adjacent areas, but it is also close to the Fountain Ditch. It is possible that seepage from the ditch is also contributing to the wetter conditions. However, there is still not sufficient moisture to support the development of wetlands, and therefore the area would not represent a jurisdictional WOTUS.

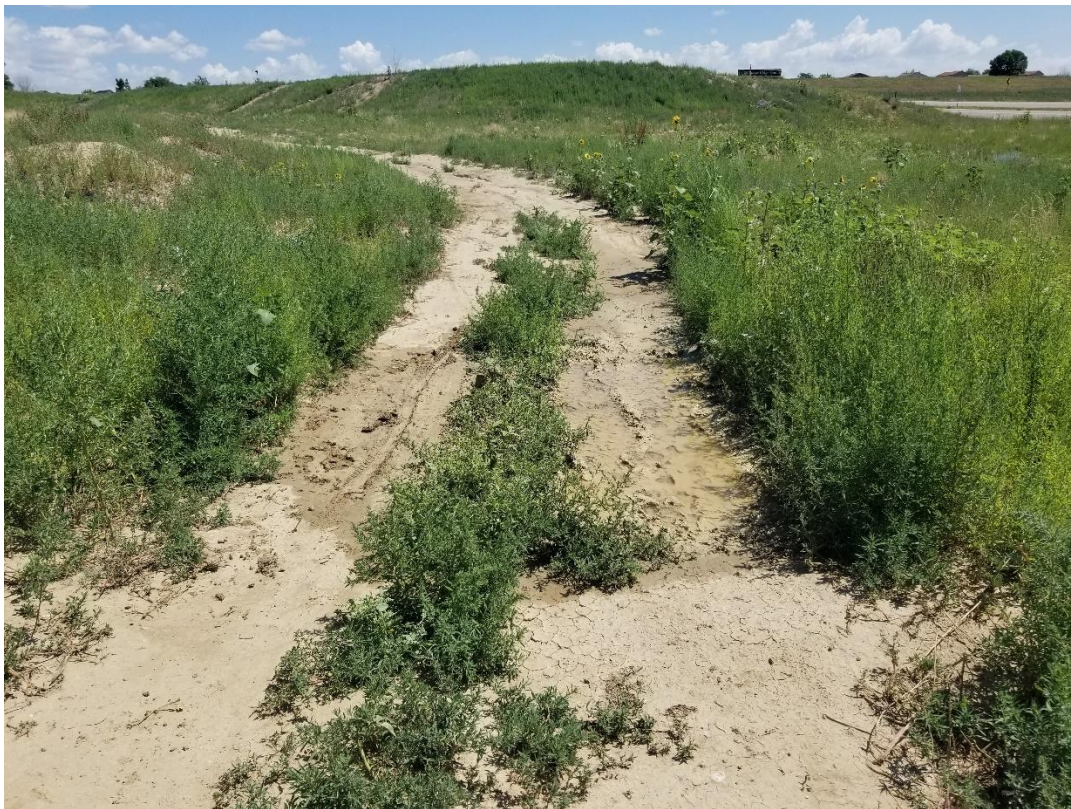
Photo 6. View of a ponded area along the two-track near the south-central portion of the Study Area.

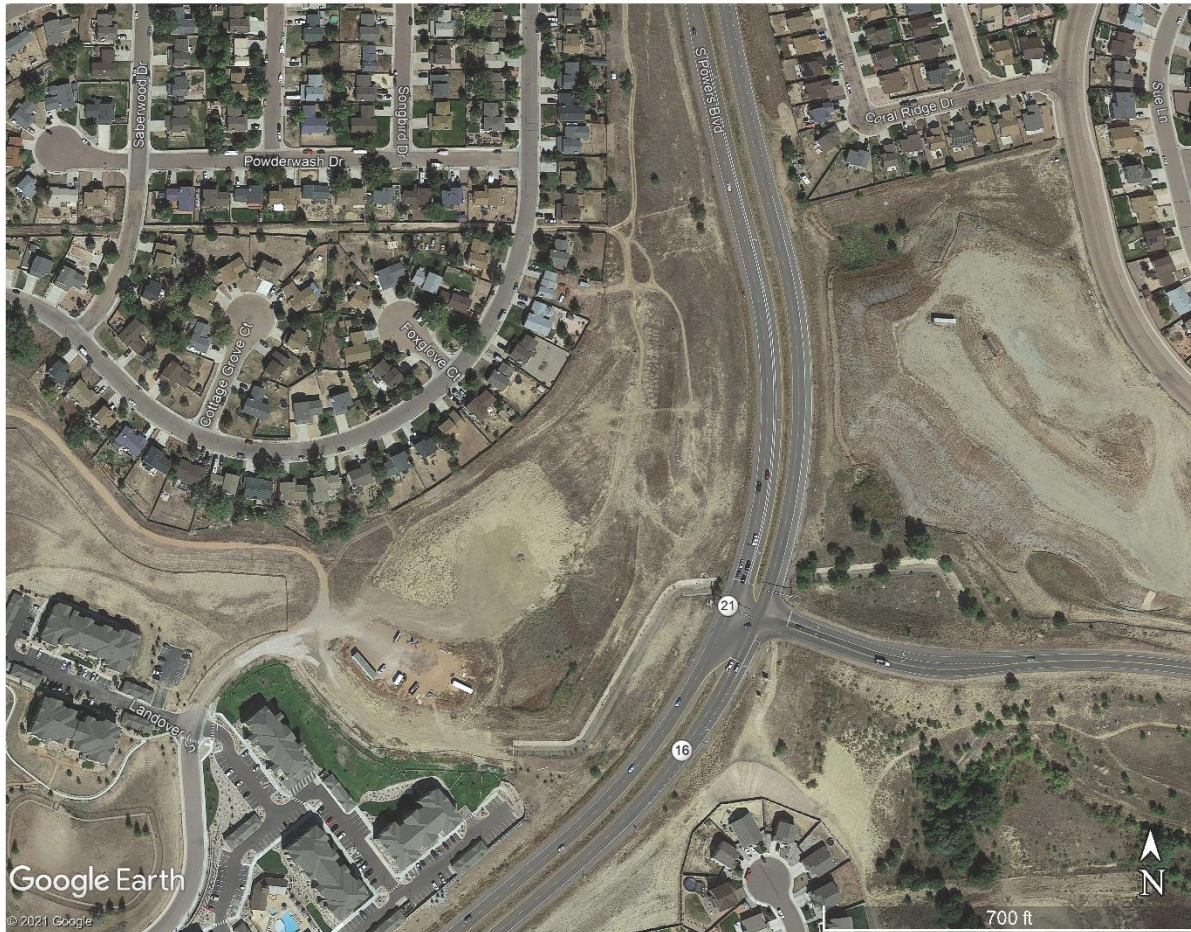
Photo 7. A 2019 aerial image of the Study Area showing active use for construction staging and significant surface disturbance.

The local topography has been substantially altered over time by staging and stockpiling for construction on adjacent properties (Photo 7 in Appendix A and Appendix C). There are areas on the southern end that were used for construction vehicle and equipment staging, and it maintains a very planar surface with some gravel remaining. In other areas, specifically in the northwest and central portions of the Study Area, there is evidence of soil stockpiling that has altered drainage patterns, soil conditions, and vegetation (discussed below). There is also evidence of dumping throughout the site (e.g., landscaping, household, and construction materials), but no obvious signs of hazardous materials.

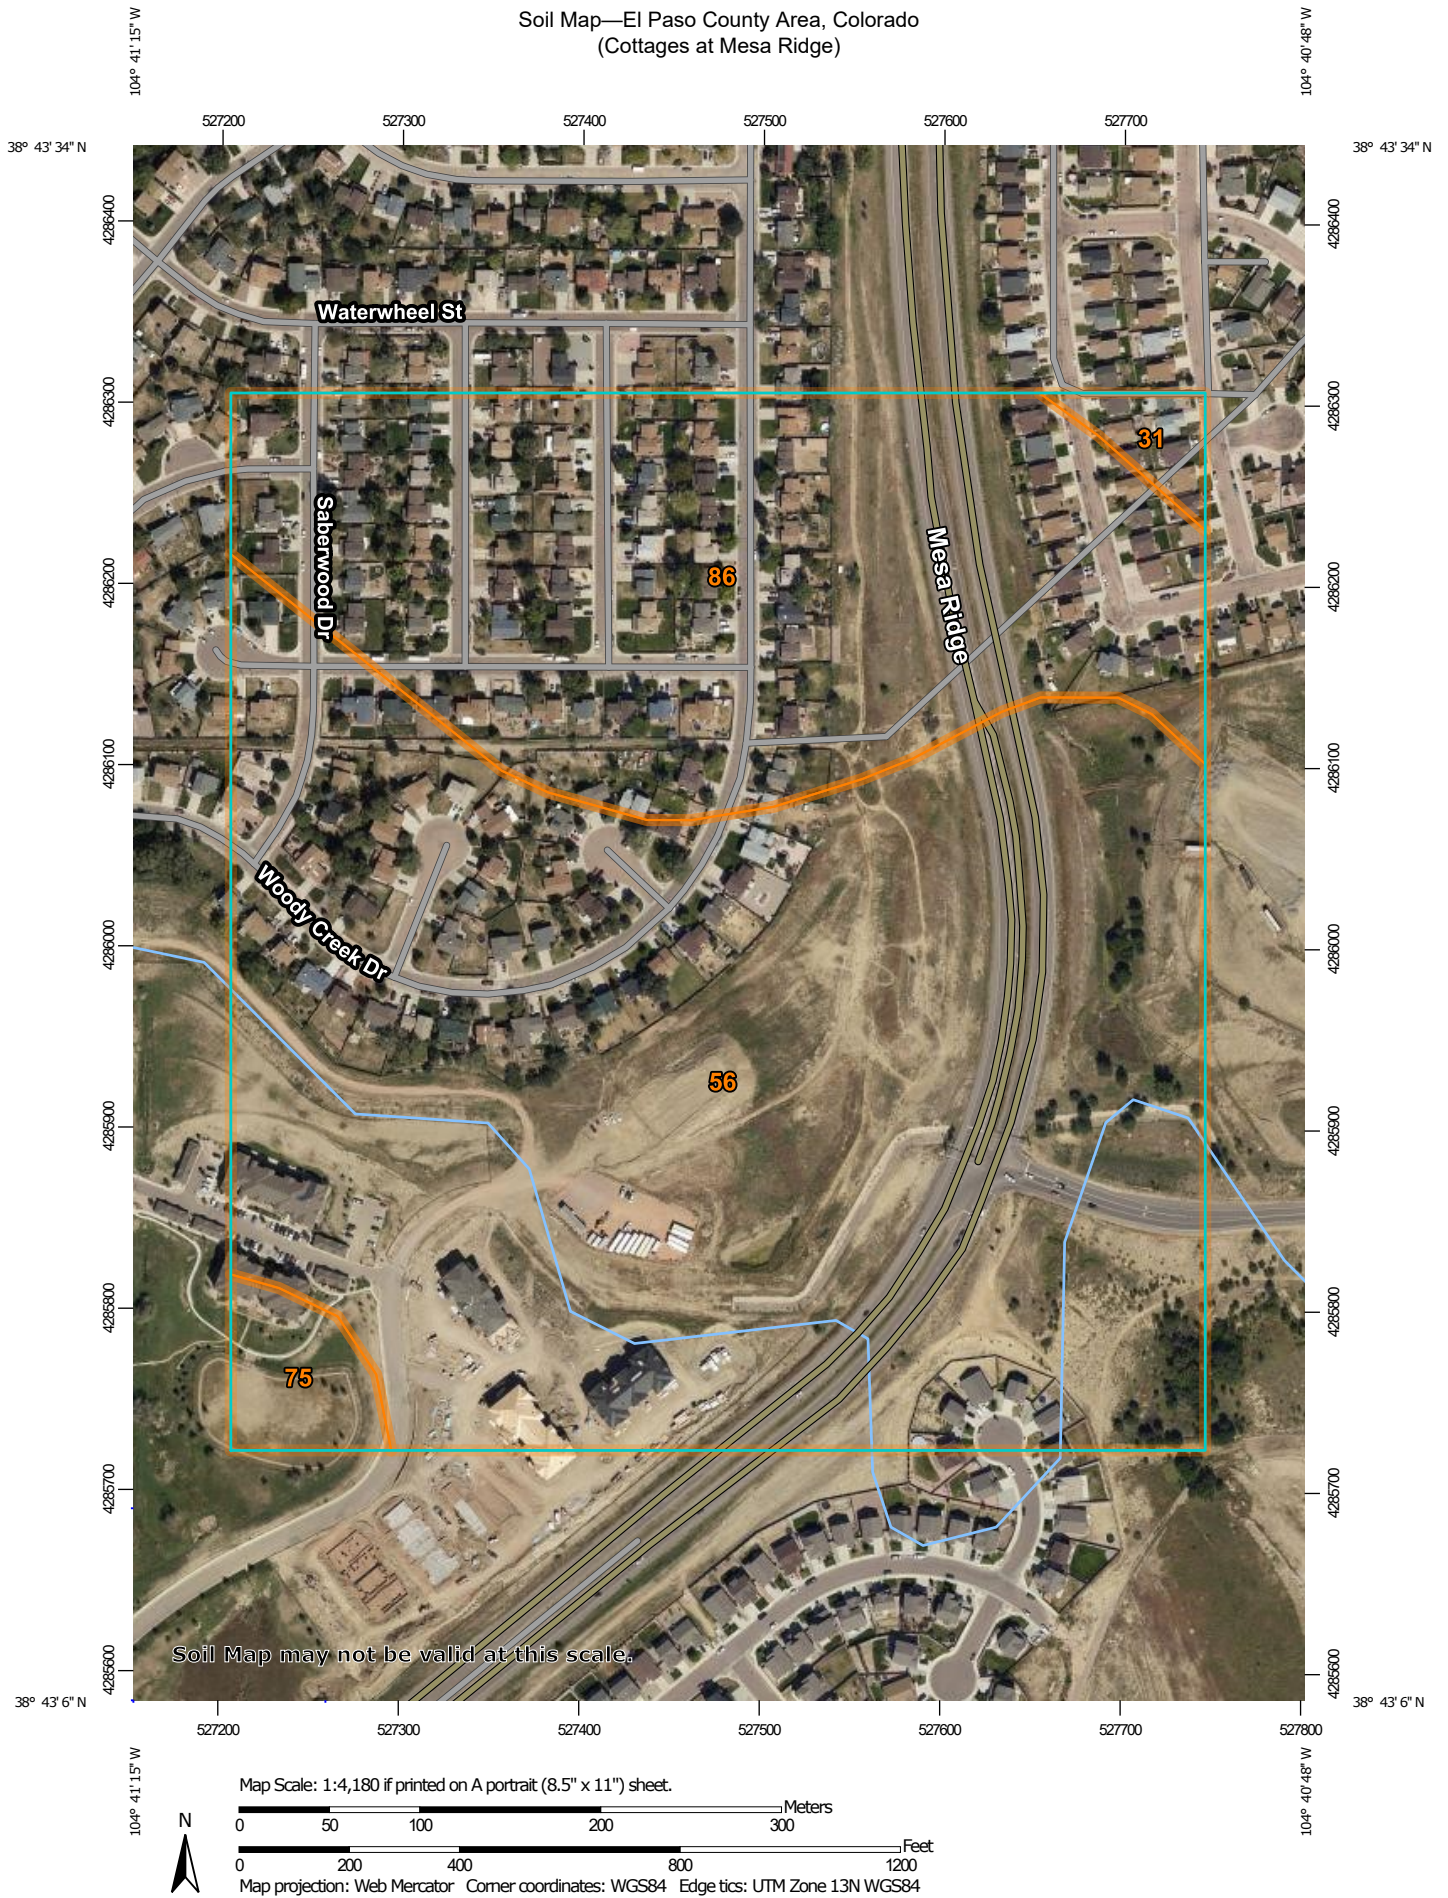
Soil Map—El Paso County Area, Colorado
(Cottages at Mesa Ridge)

Soils within the Study Area are mapped primarily as Nelson-Tassel fine sandy loams, 3 to 18 percent slopes, with a small amount of Stoneham sandy loam, 3 to 8 percent slopes, in the northern extent (NRCS 2021b, Appendix E). Nelson-Tassel soils are found in hills and are well drained. Available water capacity is low, and it does not carry a hydric soil indicator status, meaning it is unlikely to support wetlands. Minor incursions of Pleasant soils can occur in depressions, which do support wetlands. Stoneham soils are similar in that they are found in hills, are well drained, and are not hydric, but they have a high available water capacity. They also can include minor incursions of Pleasant soils. Most notably, neither soil has a farmland classification and as such would not be afforded any protections or special status for agricultural production.
