**Jimmy Camp Creek Drainage  
Basin Planning Study**

DRAFT Basin Characteristics Report

El Paso County  
Department of Public Works  
3275 Akers Drive  
Colorado Springs, Colorado 80922

Stantec  
5725 Mark Dabling Blvd Suite 190  
Colorado Springs, Colorado 80919-  
2221

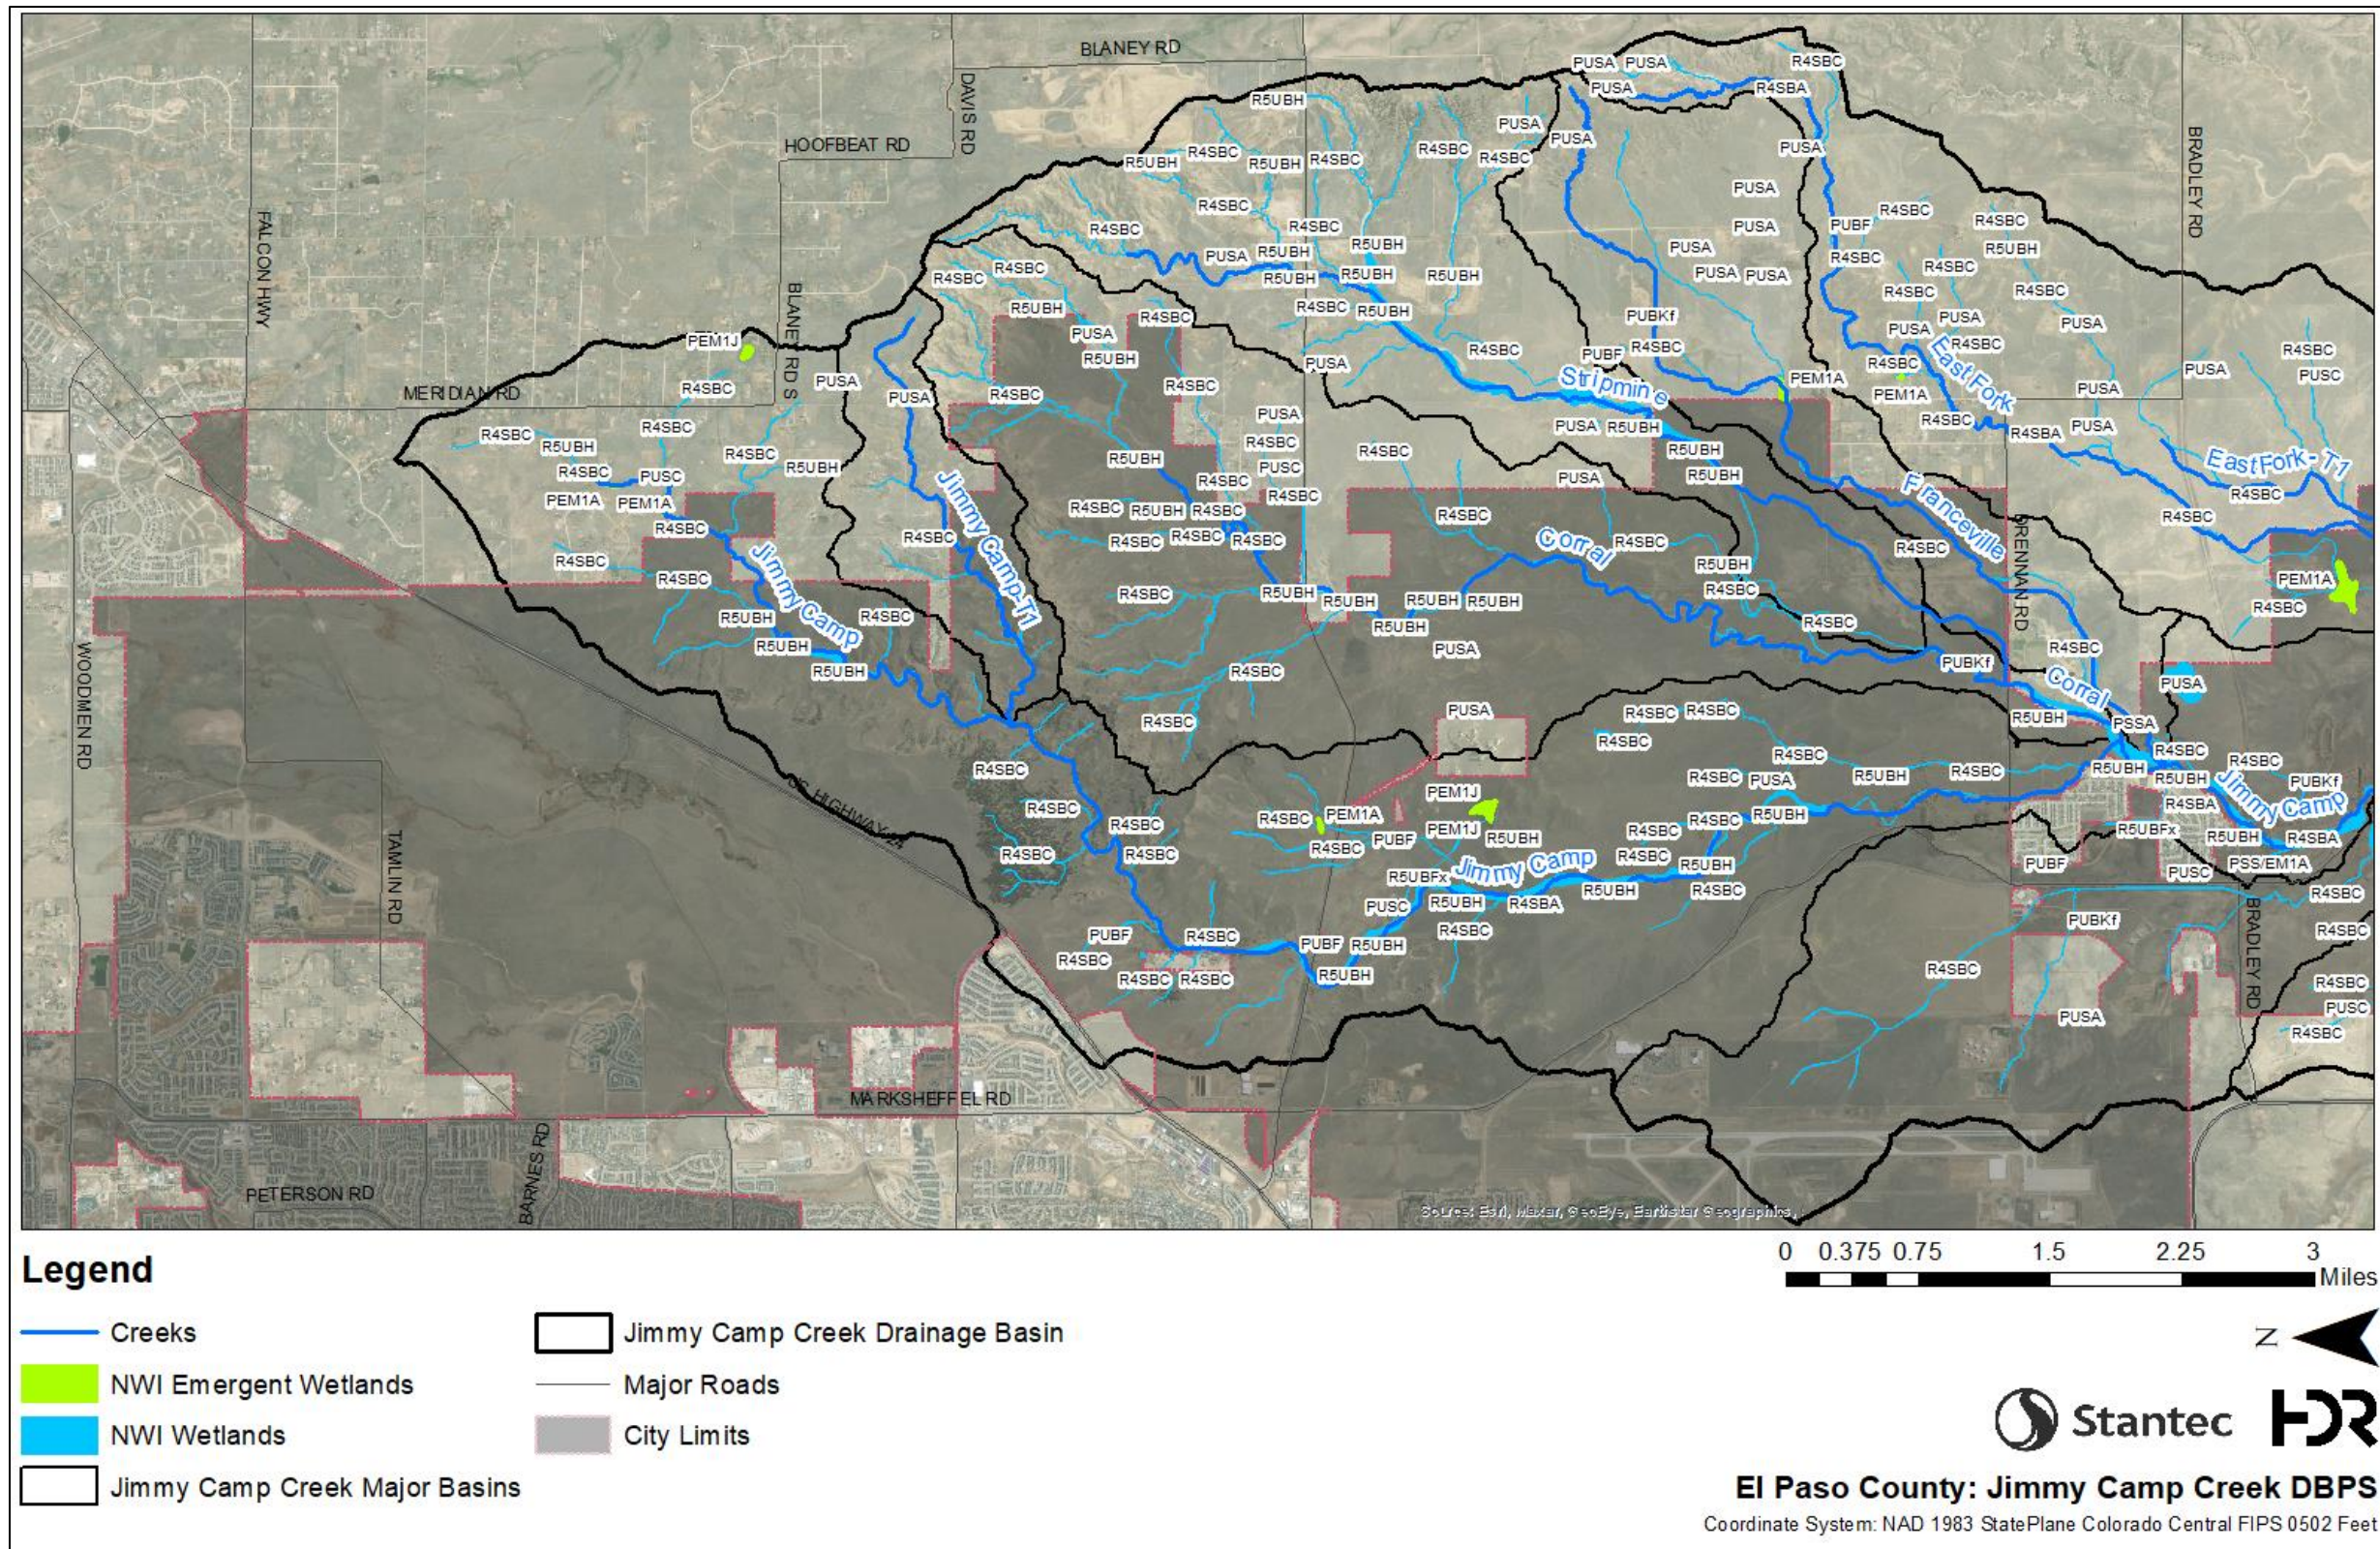
Figure 2-5: NWI Emergent Wetland Areas in Upper Jimmy Camp Creek Drainage Basin

North of Bradley Road, Jimmy Camp Creek has a wide, shallow, and sandy stream channel connected to the surrounding floodplain. The Stripmine Tributary also has a wide, shallow, sandy stream bottom with a developed floodplain. The Franceville Tributary does not have any channelization north of Drennan Road; however, the channel becomes more defined as you travel north at South Franceville Coal Mine Road. Referencing aerial imagery, this channel seems to have a wide, sandy stream channel. The Corral Tributary has a wide, shallow, and sandy stream channel with associated floodplain. This tributary also has a short erosion control barrier, consisting of large rocks and a retaining wall north of State Highway 90. Each of these areas could be conducive to wetland formation, due to the elevation and the presence of partially hydric soils. However, the NWI does not map any emergent wetlands in these areas.

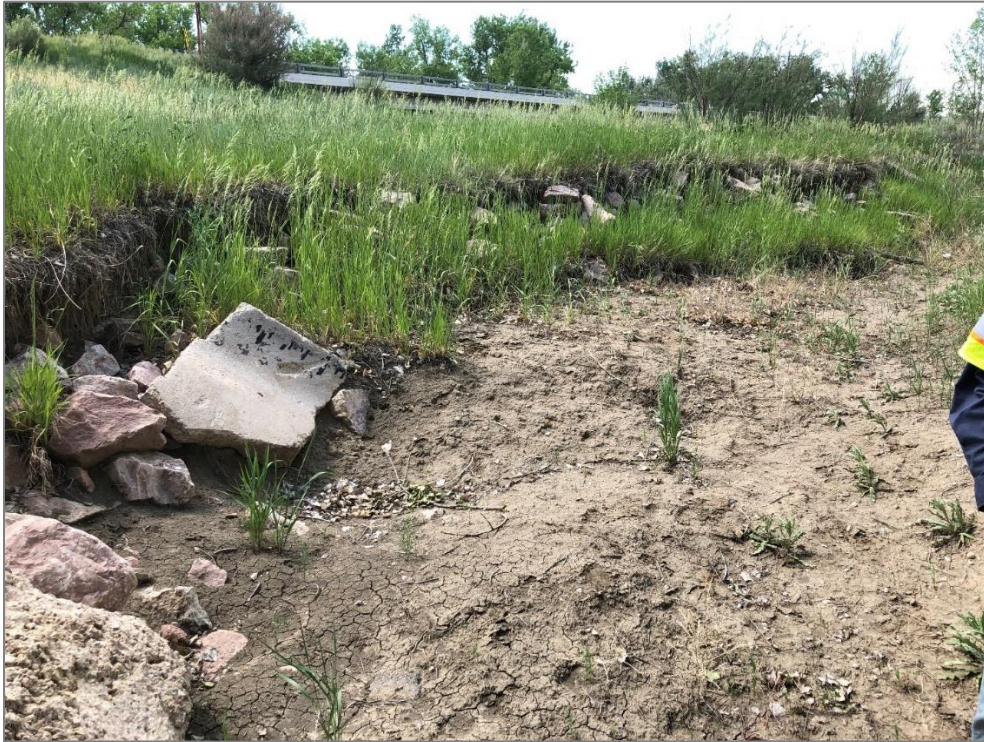
**Figure 2-8. Priority Area 1 on Jimmy Camp Creek Reach J1.**

2. The woody vegetation and herbaceous undercovers increase the resistance of the soil to erosion through root reinforcement and provides cover of the soil.

Removing the forested floodplain would tend to transition the channel to be more like the upstream channels that are significantly wider with more unstable banks.

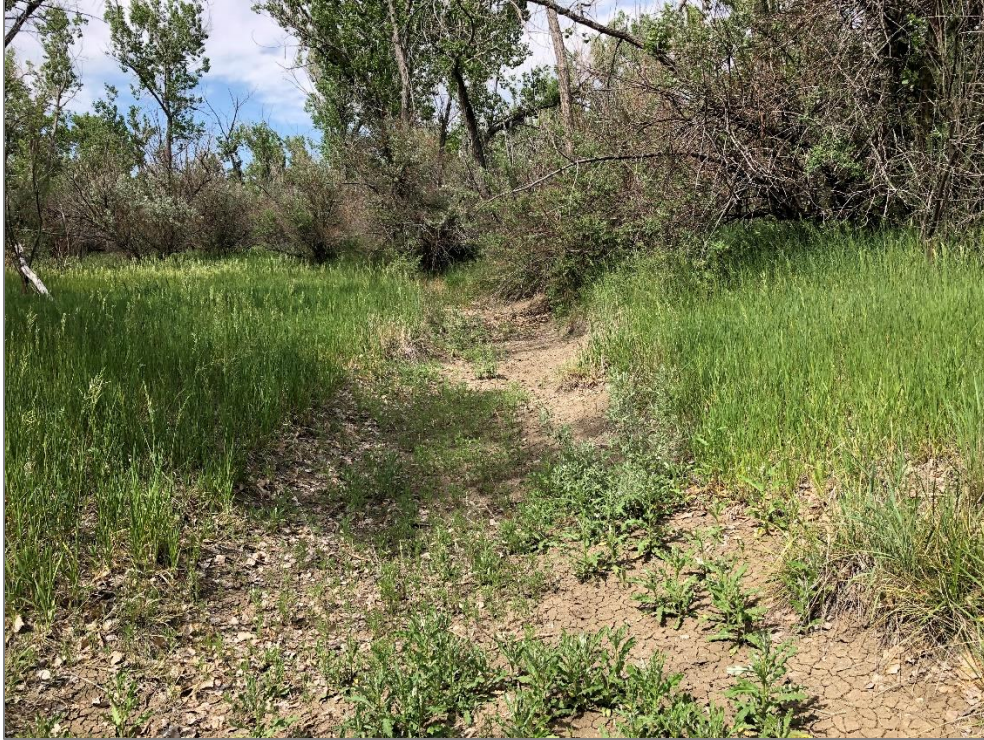
**Figure 2-9. Typical channel condition within Reach J1 on Jimmy Camp Creek.**

Priority Area 1 is located on Jimmy Camp Creek in Reach J1 immediately upstream of Link Road and runs approximately parallel to Link Road for most of the length of the priority area. The bank height is not large, at approximately 4 ft, but there is evidence of an actively eroding bank. At some locations, rubble has been placed along the bank to attempt stabilization as shown in Figure 2-8. The rubble is not continuous, does not have scour protection, and is likely not entirely effective at arresting the bank erosion. The bank is generally only protected by grasses with shallow rooting depths and is composed of erodible sand dominated soils.

In locations where the erosion is already near roadways or bridges, riprap could be used to stabilize the bank. However, large scale channel regrading and bank stabilization should not be performed as this reach contains a wide intact forested floodplain which will assist in stabilizing the stream. Large scale channel reconstruction could inadvertently destroy some of this intact forested floodplain and increase bank instability. Stabilization should only be performed to protect nearby infrastructure. A picture of a typical channel within Reach J1 is shown in Figure 2-9. Note that the main channel is quite small relative to the upstream cross sections. There are likely several reasons for this, one being that the stream is ephemeral, and flow rarely passes through this section of river, the other reasons are that the river is not incised, has ample sediment supply, and most importantly has a thick forested floodplain. The thick forested floodplain has two important features that stabilize river channels:

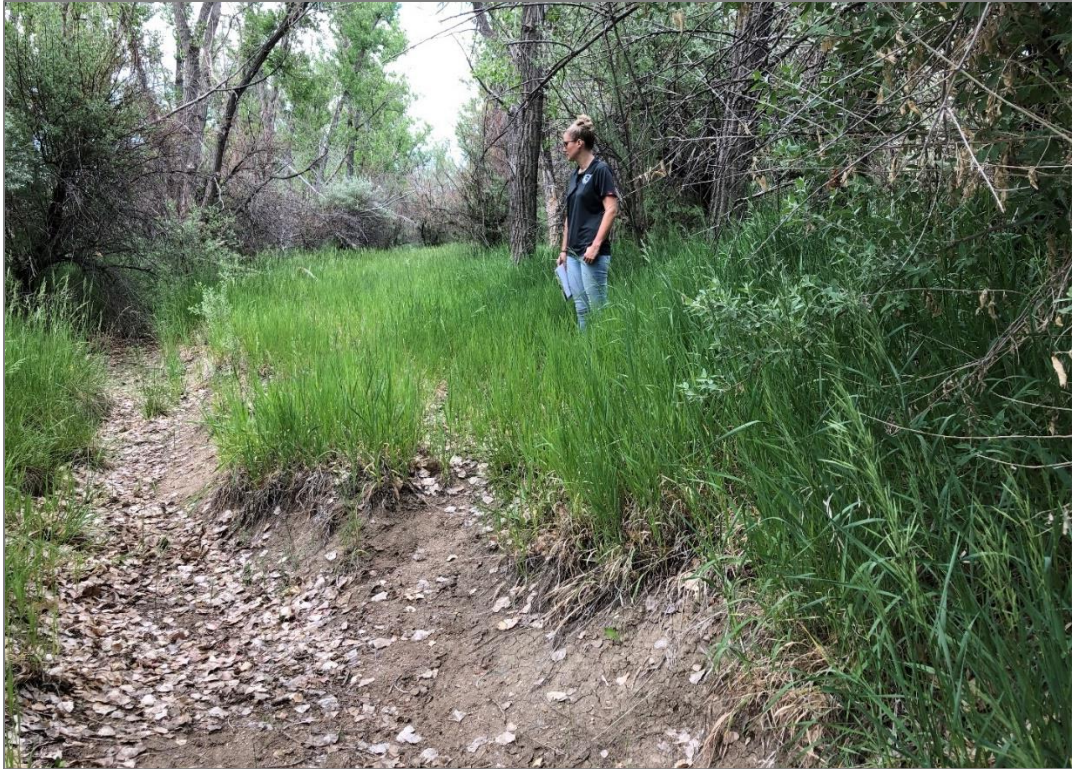
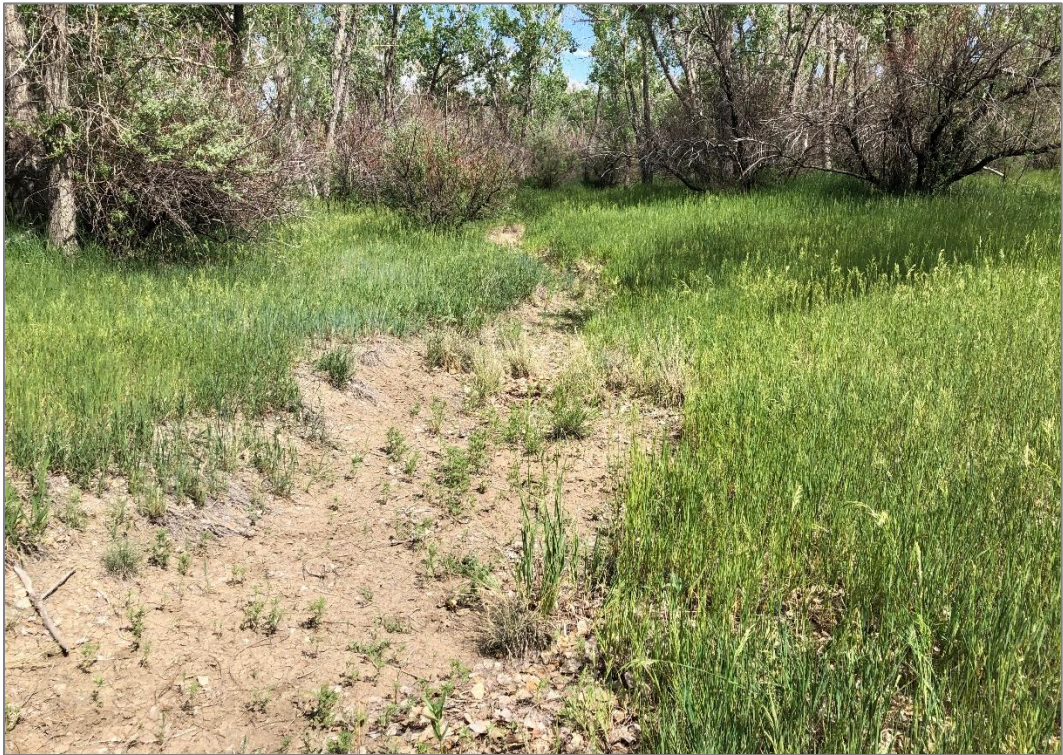
Priority Area 2 is located in Jimmy Camp Creek Reach J2, directly upstream of Reach J1. The channel is similar in size and the banks are generally densely vegetated as shown in Figure 2-10 and Figure 2-11. The same general recommendations are proposed in this reach as for Reach J1.

Figure 2-10. Priority Area 2 on Jimmy Camp Creek Reach J2.

Figure 2-11. Priority Area 2 on Jimmy Camp Creek Reach J2.

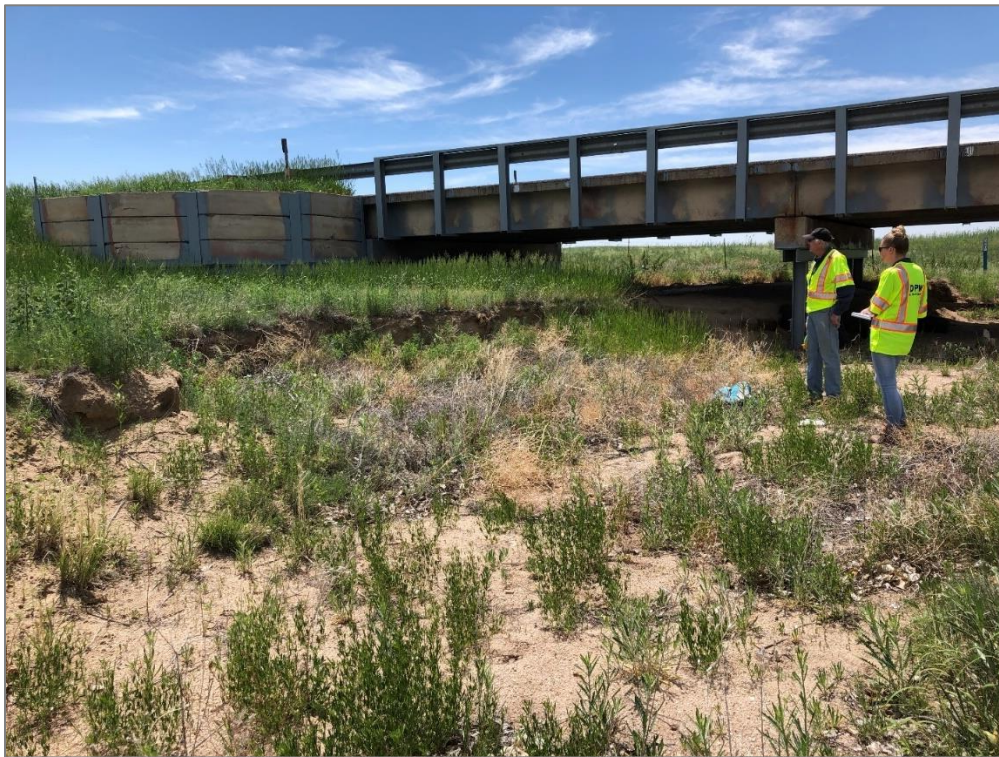
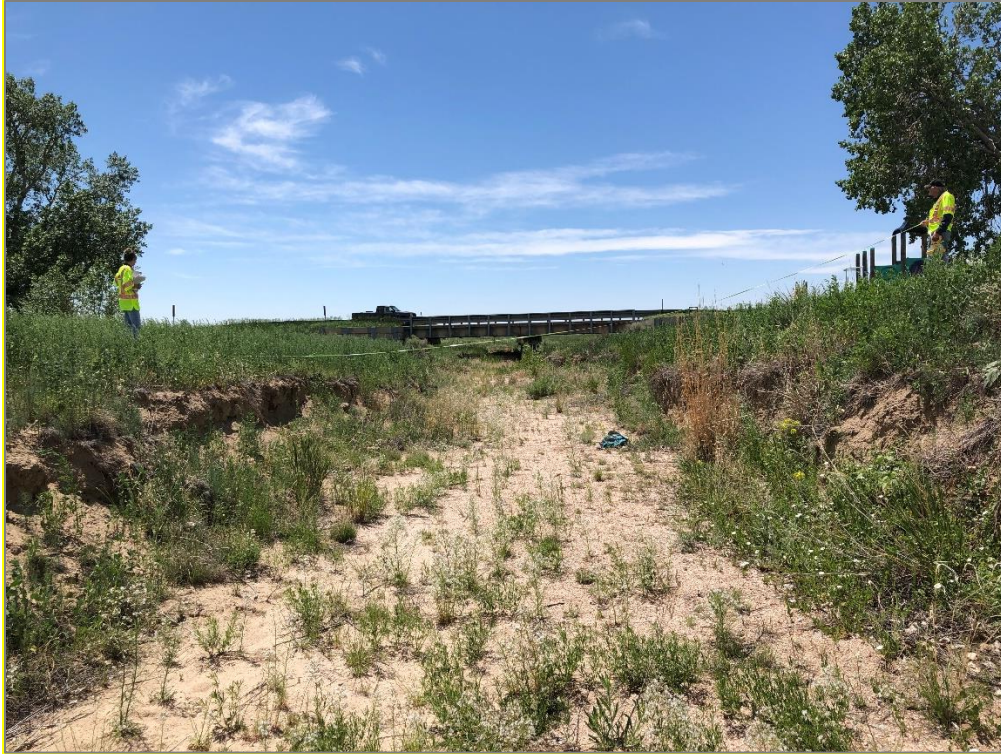
Priority Area 6 is located on East Fork Reach E2 at its crossing with Drennan Road. This area is located much higher in the watershed where little woody vegetation exists in the basin. The reach in this vicinity appears to have incised to some degree, presumably due to the constriction caused by the bridge and perhaps development in the basin immediately upstream, though the development is dispersed with lot sizes of approximately 5 acres and does not appear to have significantly increased the impervious area in the drainage area. The channel does not appear to be incised upstream or downstream of this reach, so the constriction of the bridge is a likely reason for incision in this reach.

**Figure 2-12. Priority Area 6 on East Fork Reach E2.**

**Figure 2-13. Priority Area 6 on East Fork Reach E2.**

When constructing improvements in this reach, exposed banks that are eroding should be graded back to a stable slope and sandy soil should be amended with nutrient rich topsoil to create a more suitable growing medium. Banks should then be revegetated with native woody plants and grasses that would stabilize the banks. Because of the dry climate in this area, it may be difficult to establish woody vegetation and therefore riprap may need to be used to stabilize banks.

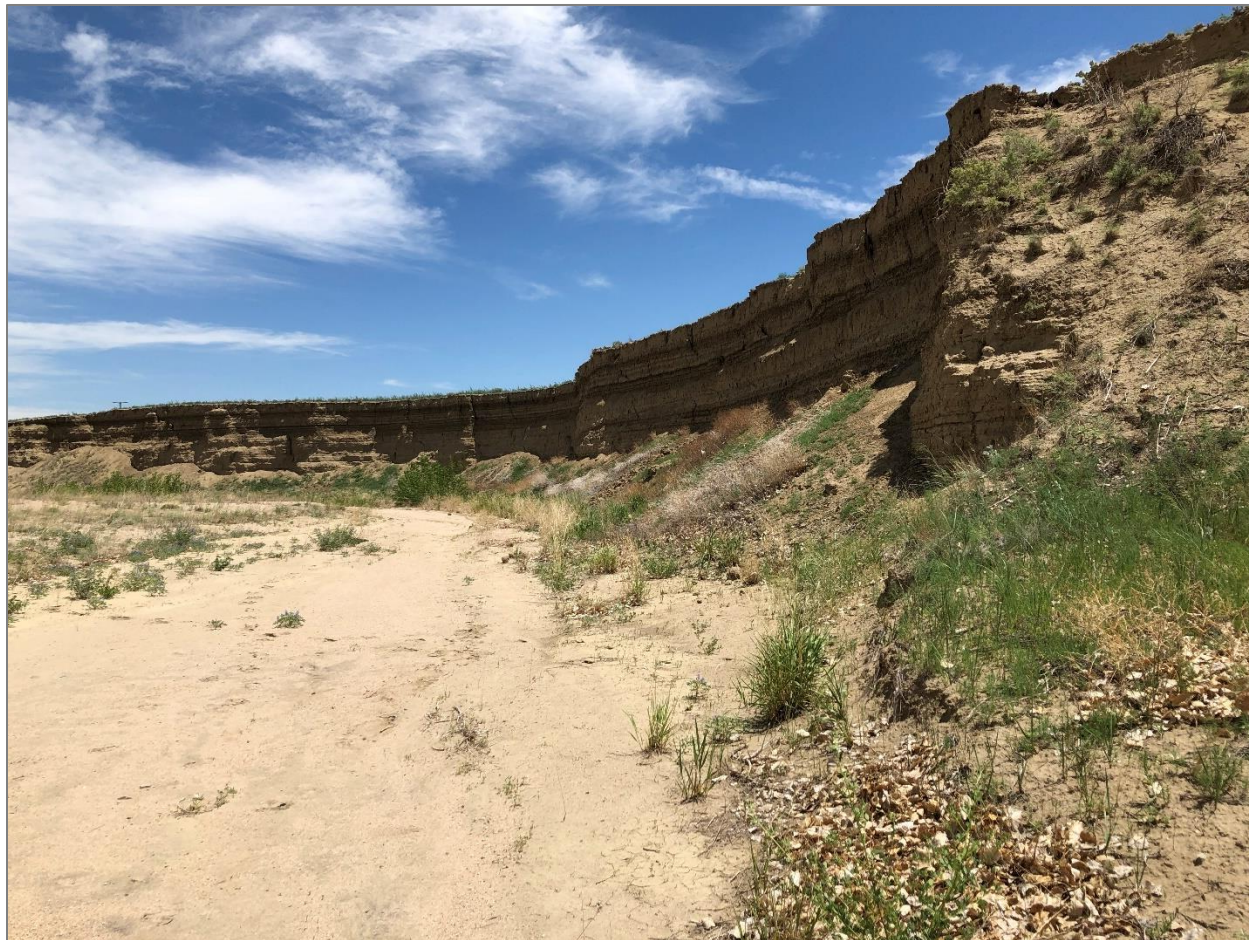
**Figure 2-14. Priority Area 7 on Corral Creek Reach C1.**

Priority Area 7 is located on Corral Creek in Reach C1 downstream of Drennan Road. Its easterly bank in this reach is almost 25 ft high (Figure 2-14). There is established vegetation along the toe of the bank, which is evidence that this bank has not moved in the last few years, but it is likely that bank erosion occurs during high flow years, as evidenced by erosion that occurred between 2011 and 2018. Since 2018, the bank appears relatively stable. Despite the large height of the east bank, the main channel does not appear to be incised as evidenced of the picture immediately upstream (Figure 2-15), that shows a main channel at nearly the same elevation as the floodplain. The high banks in the reach appear to be caused by incision into a terrace that began pre-development in the region. The floodplains in this region are well connected to the main channel and grade stabilization is not recommended for existing conditions flow conditions. However, under conditions of development, where flow volumes are increased, there will likely be grade control required to stabilize the reach.

In general, under the current conditions, there is relatively minor erosion with the exception of Corral Creek priority area 7, which has a 24-foot-high unstable bank. However, this erosion appears to be part of a natural process of gradual erosion into a high existing terrace.

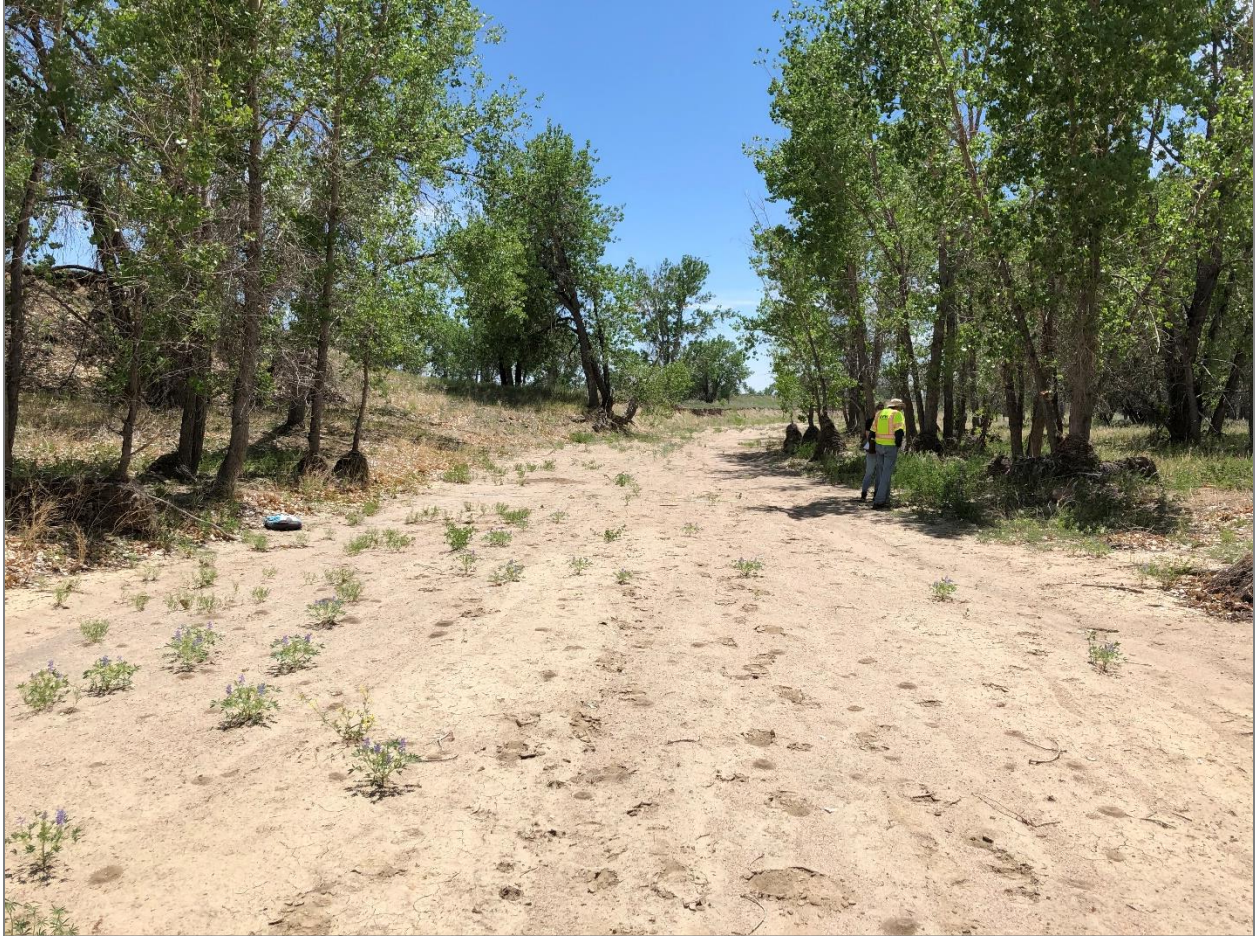
**Figure 2-15. Immediately downstream of Priority Area 7 on Corral Creek.**

Priority Area 8 is located on Corral Creek in Reach C1 downstream of Drennan Road. It is immediately upstream of the Priority Area 7 and has similar characteristics. No site photos were collected in this reach, but there the channel geometry was measured with survey equipment. The bank height of the active channel was less than 1 foot, which is confirmed by the photograph of the main channel shown in Figure 2-15.

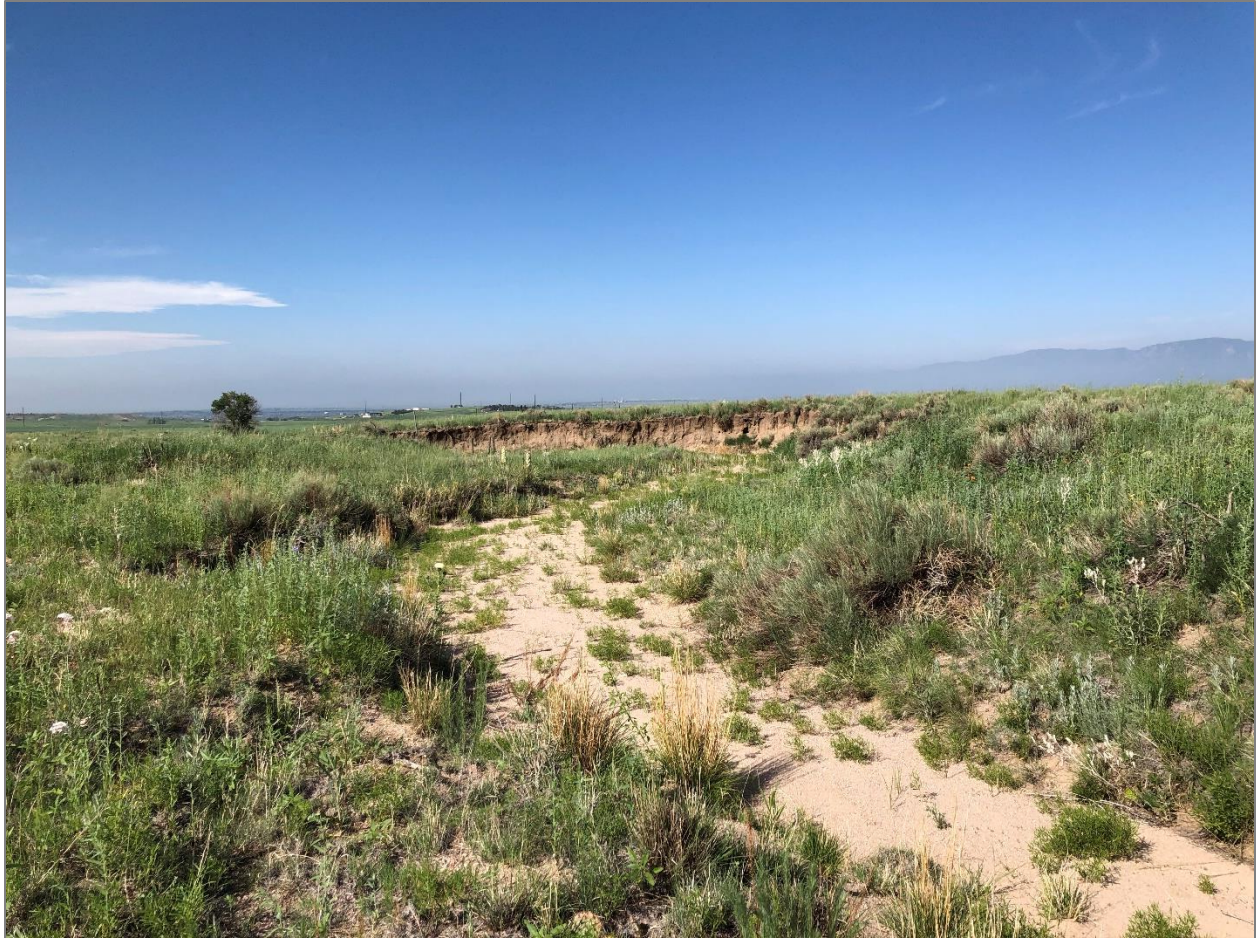
**Figure 2-16. Priority Area 12 on Franceville Tributary Reach UF2.**

Priority Area 12 is located on Franceville Tributary in Reach UF2 downstream of South Franceville Coal Mine Road. A picture looking downstream is shown in Figure 2-16. Banks along the reach are vegetated with herbaceous plants but no woody vegetation. Some banks are 4 to 8 feet high, but these banks are associated with boundaries of the high flows in the channel (i.e. 100-year). The bank heights of the base flow (flows less than 2-year flood) channel are typically less than 2 ft. Therefore, like Corral Creek, the high banks in the reach appear to be caused by incision into a terrace that began pre-development in the region.
