## **The Retreat @TimberRidge**

### **Visual Analysis**

**Retreat at TimberRidge**  
PUD Development Plan

**Land Suitability Analysis**  
**NATURAL FEATURES**  
**ANALYSIS**

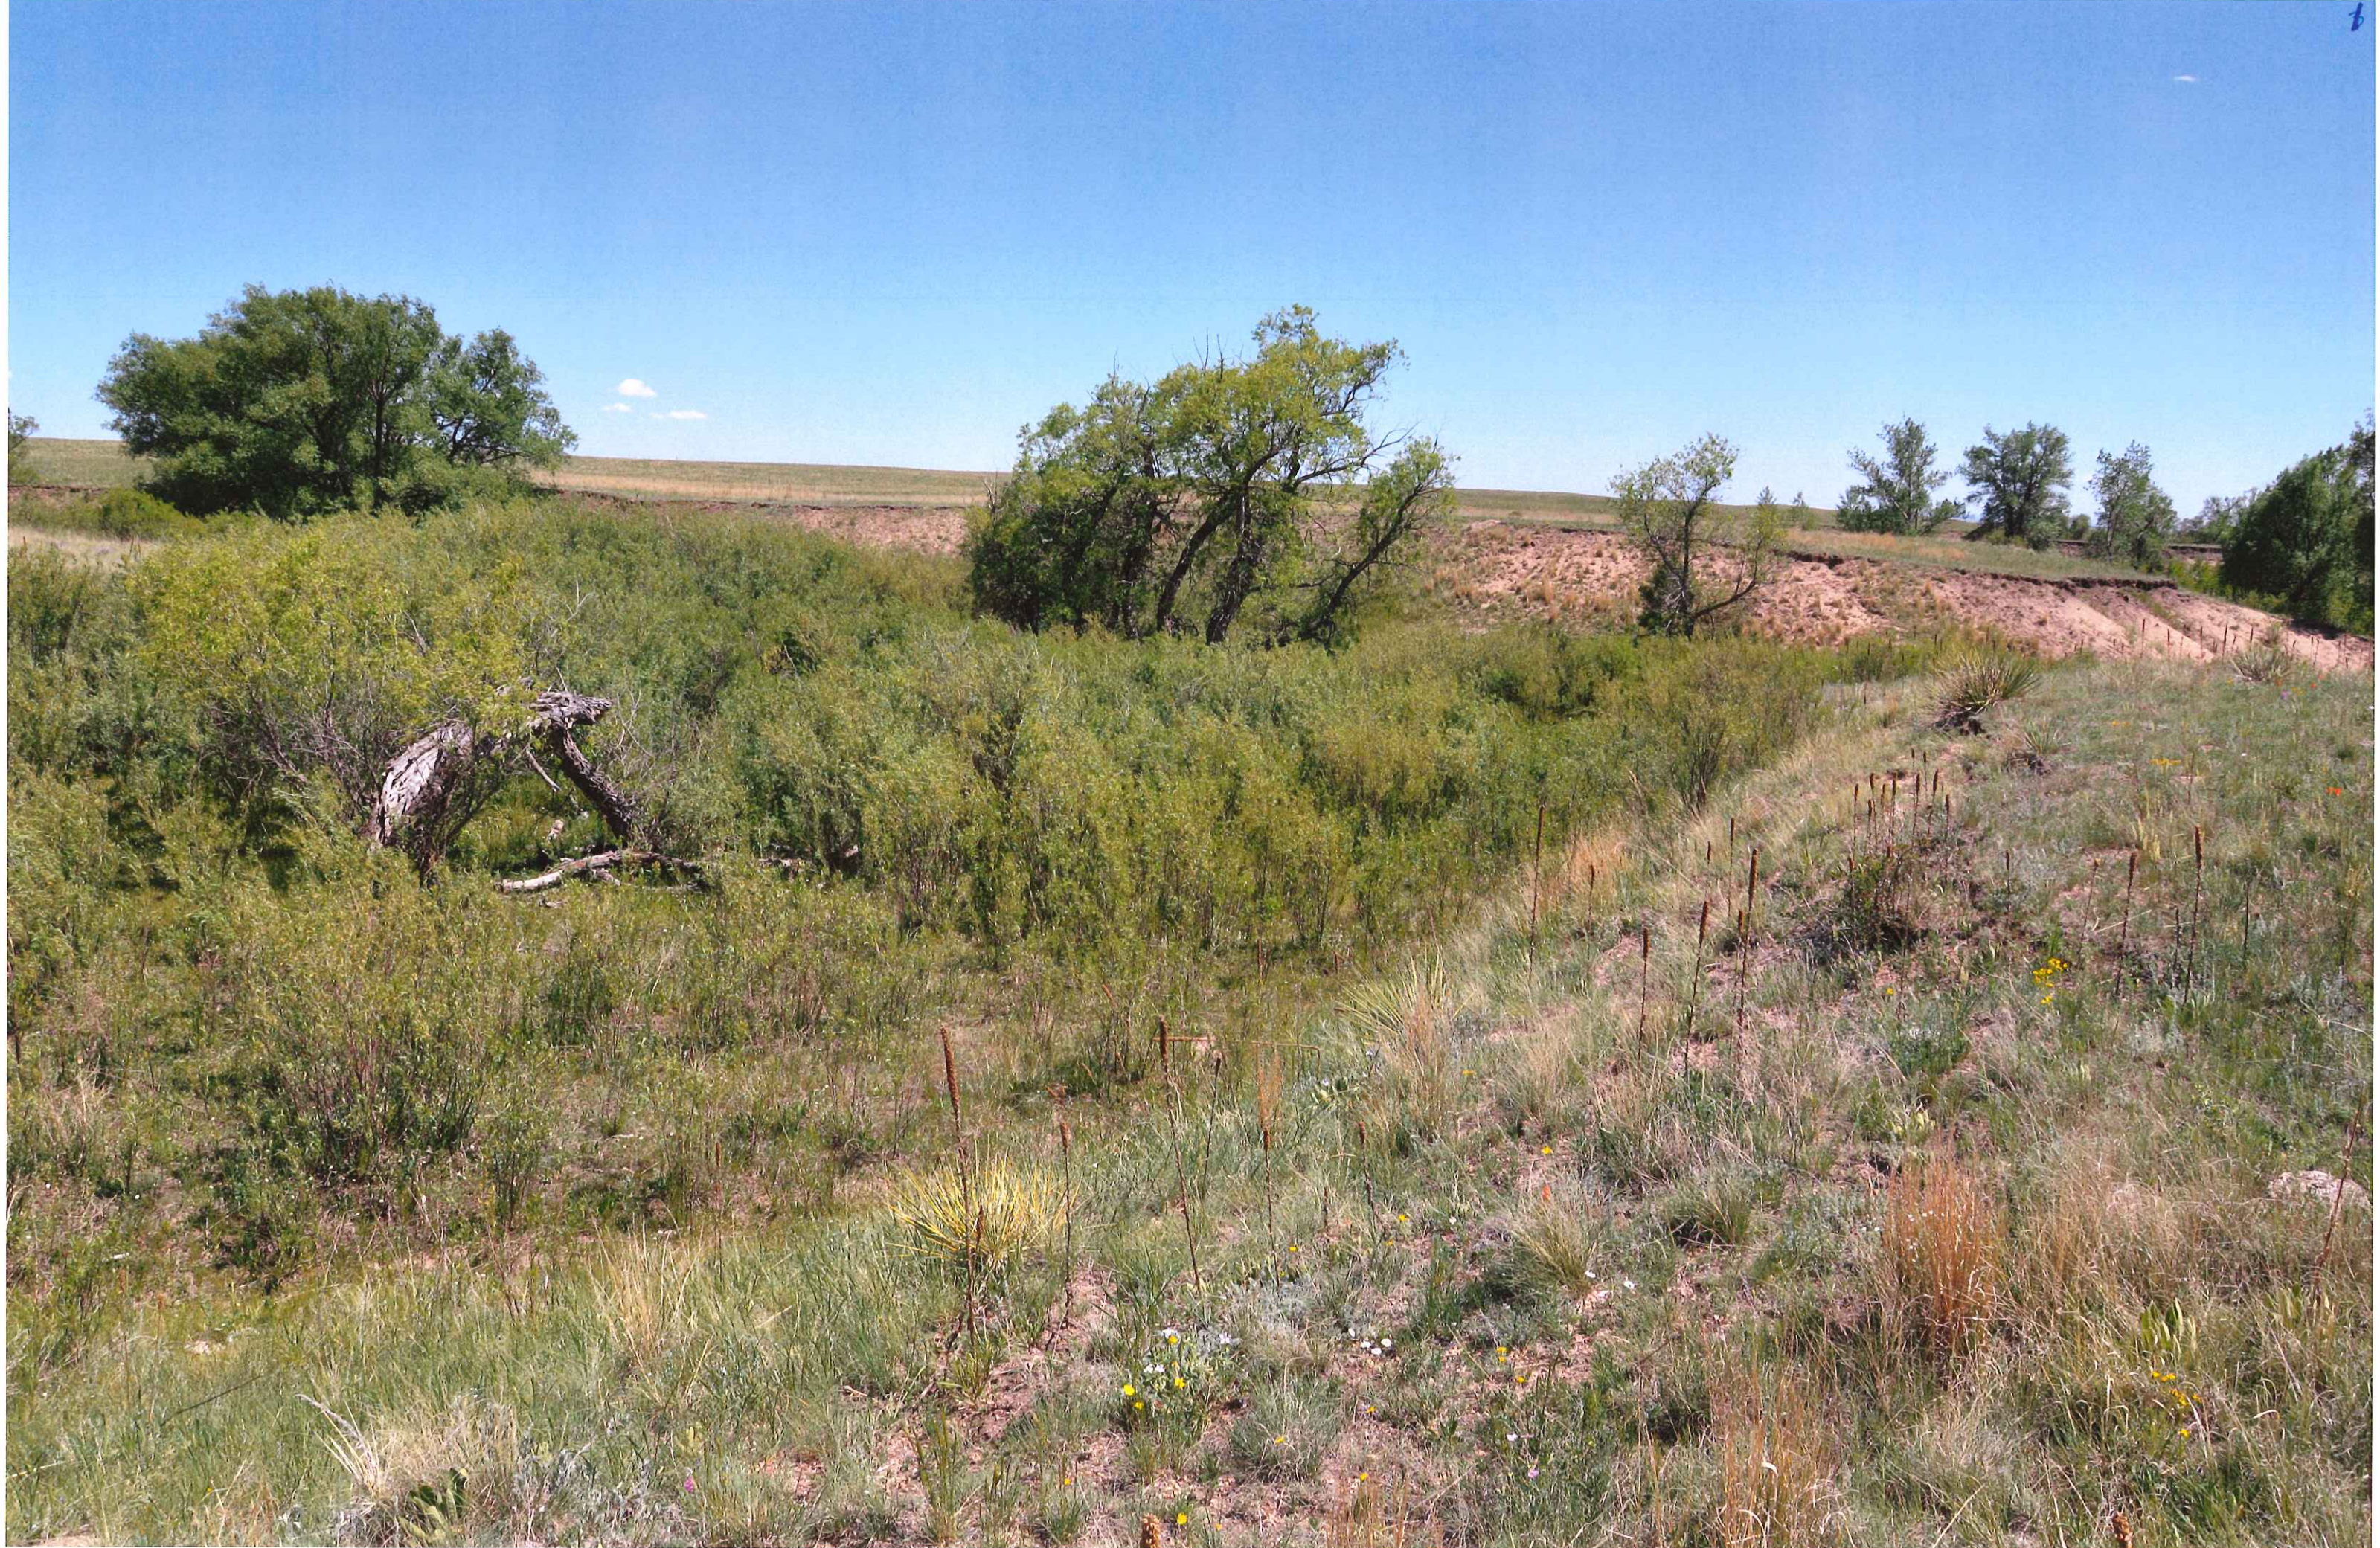
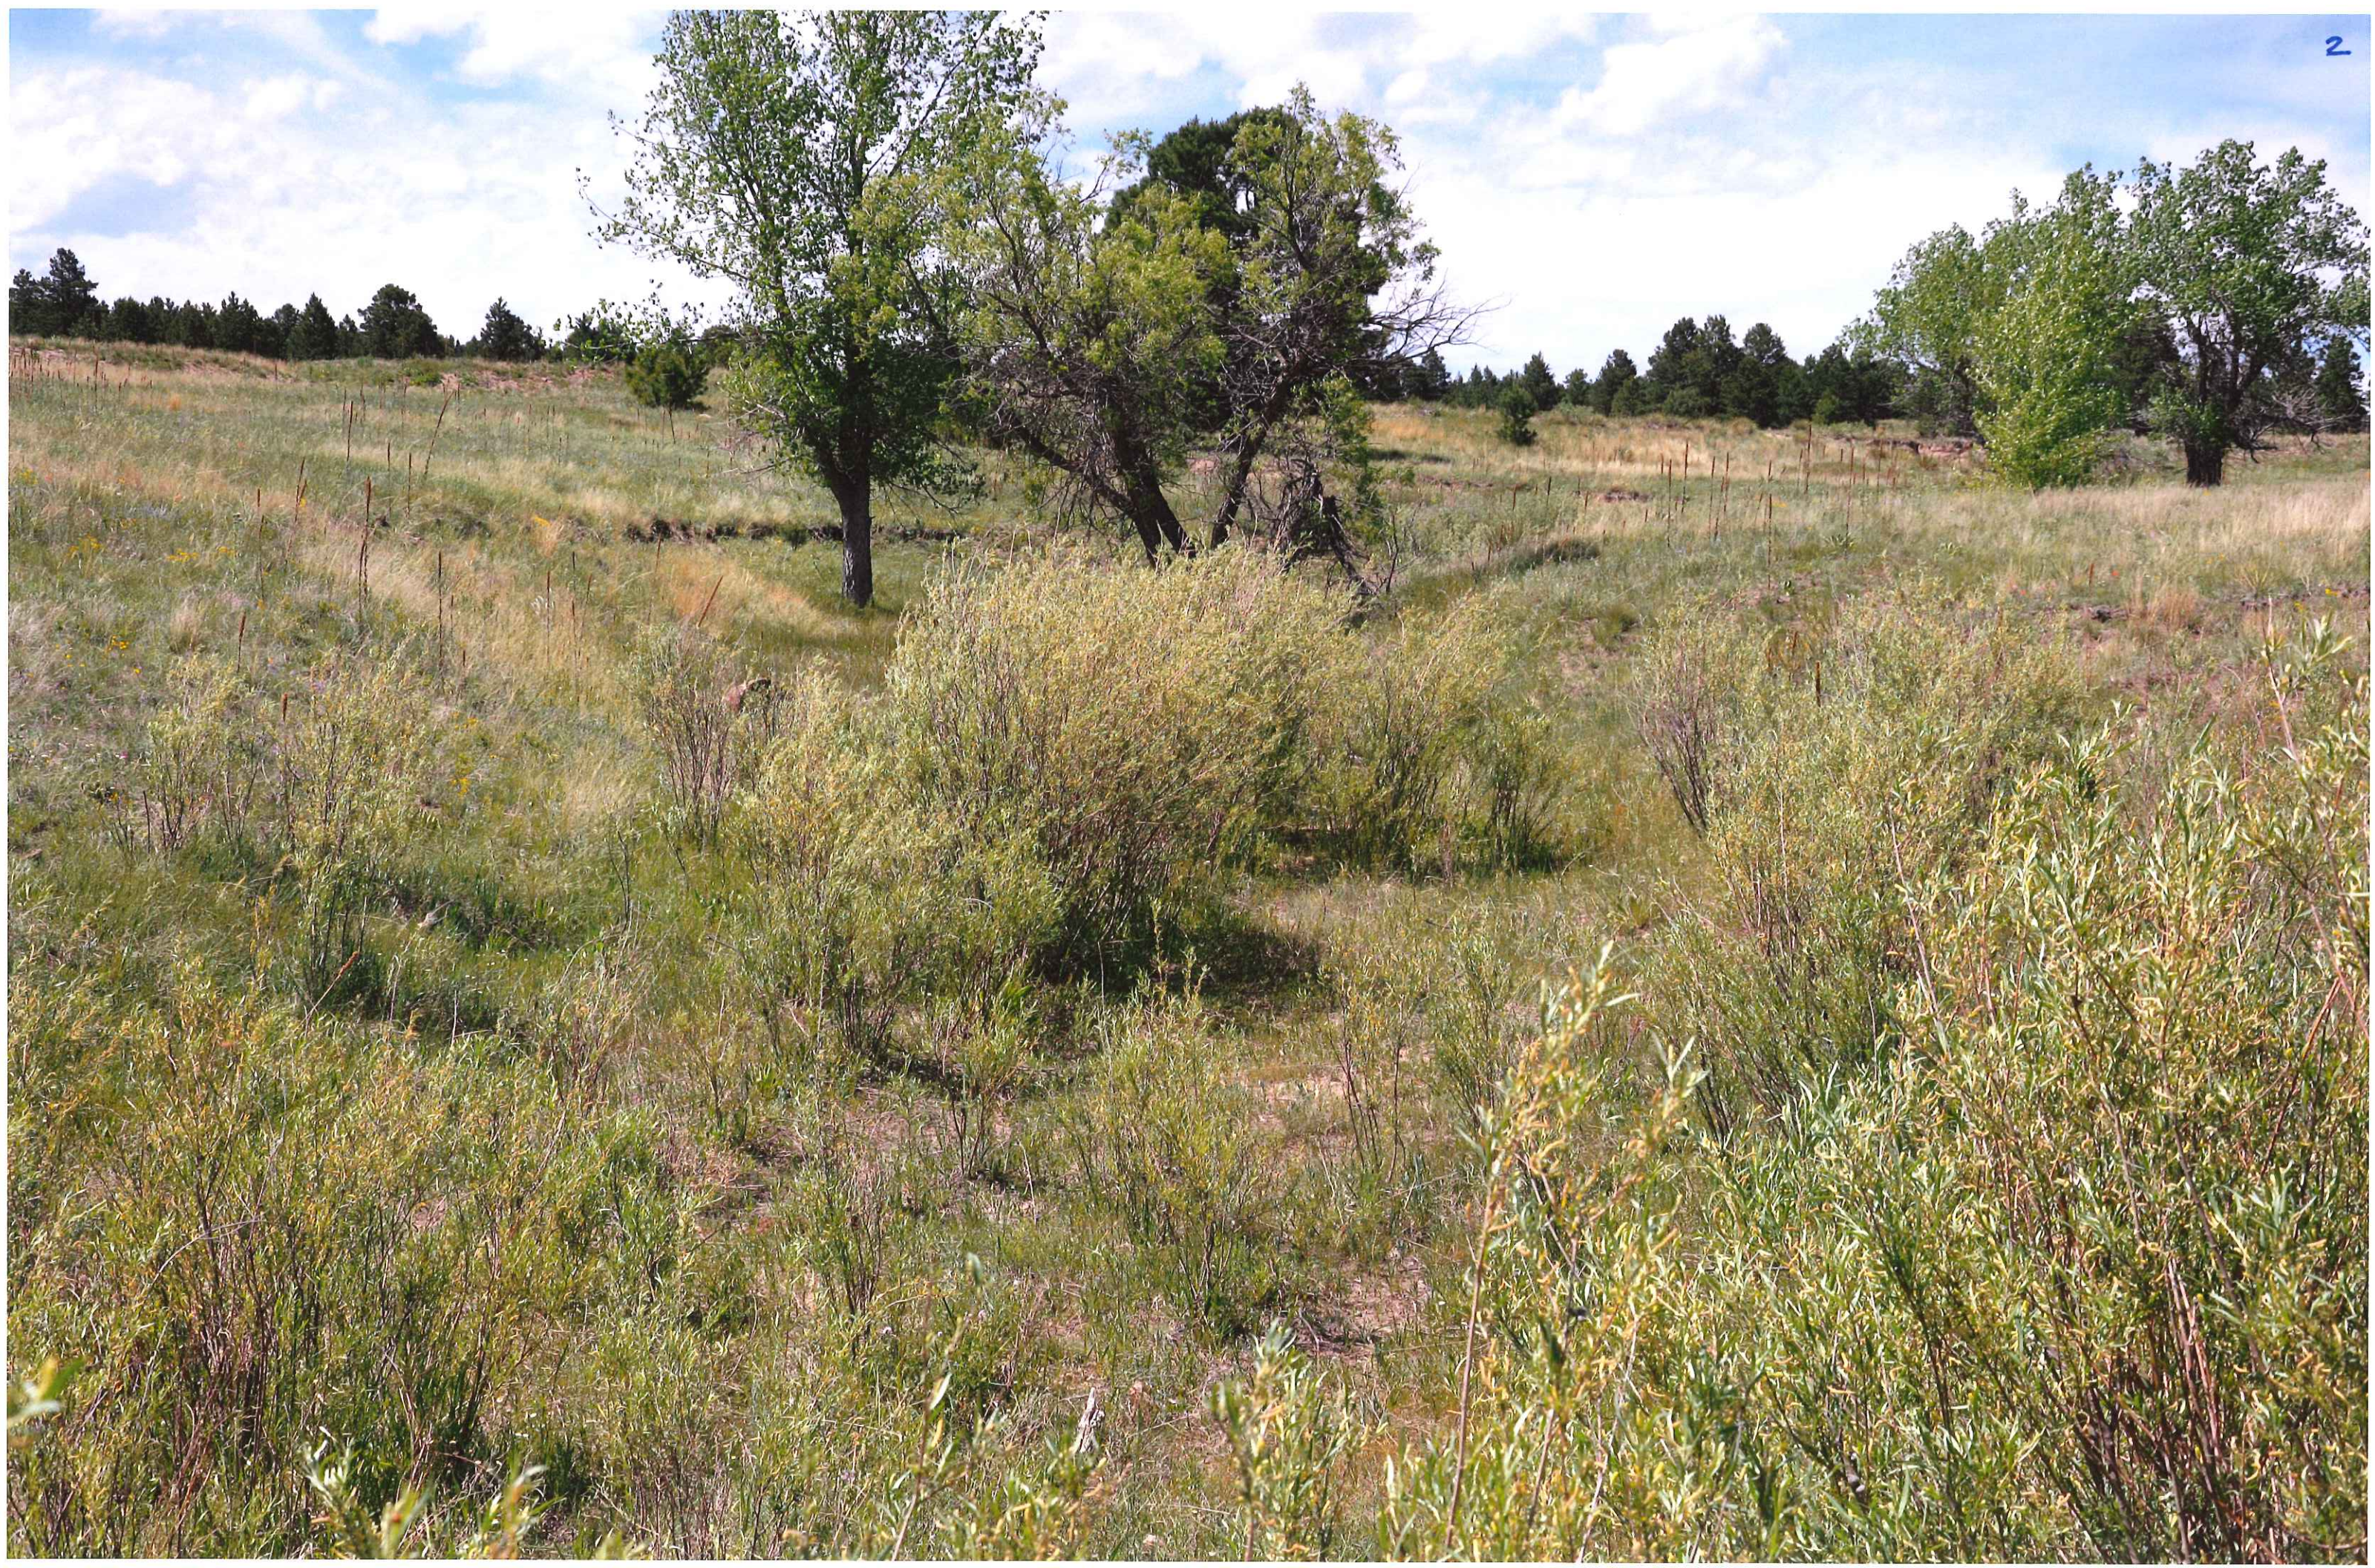
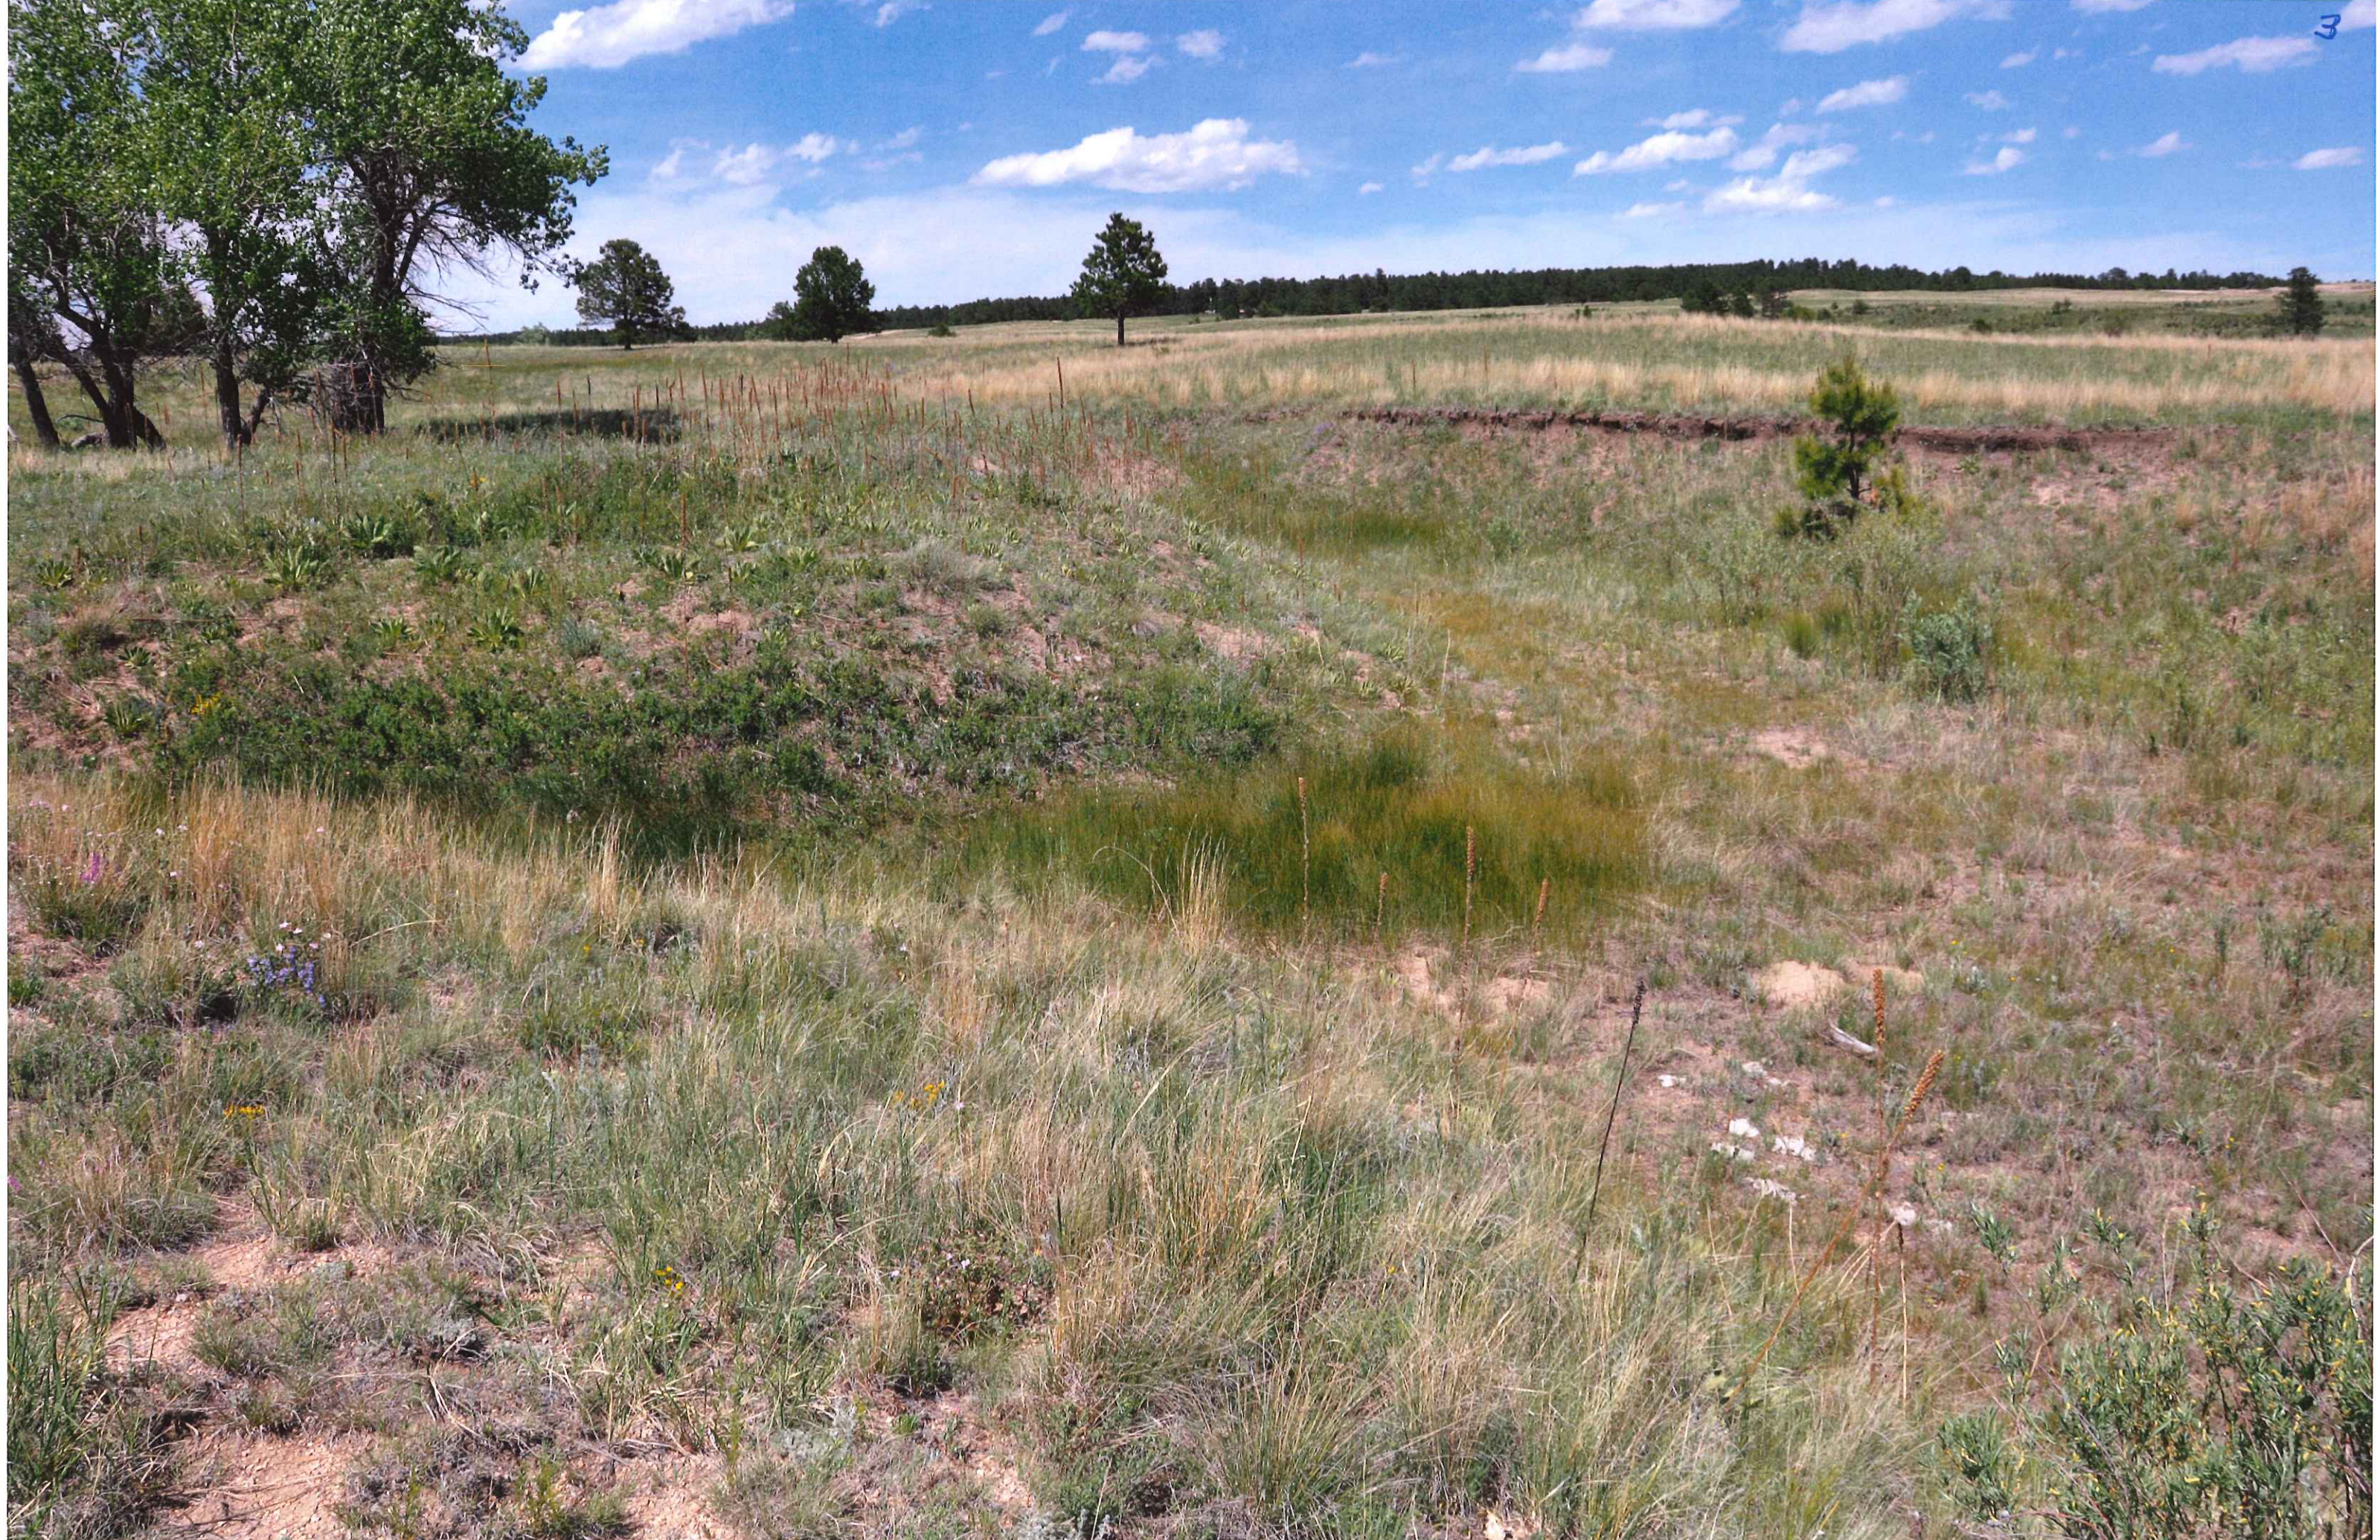
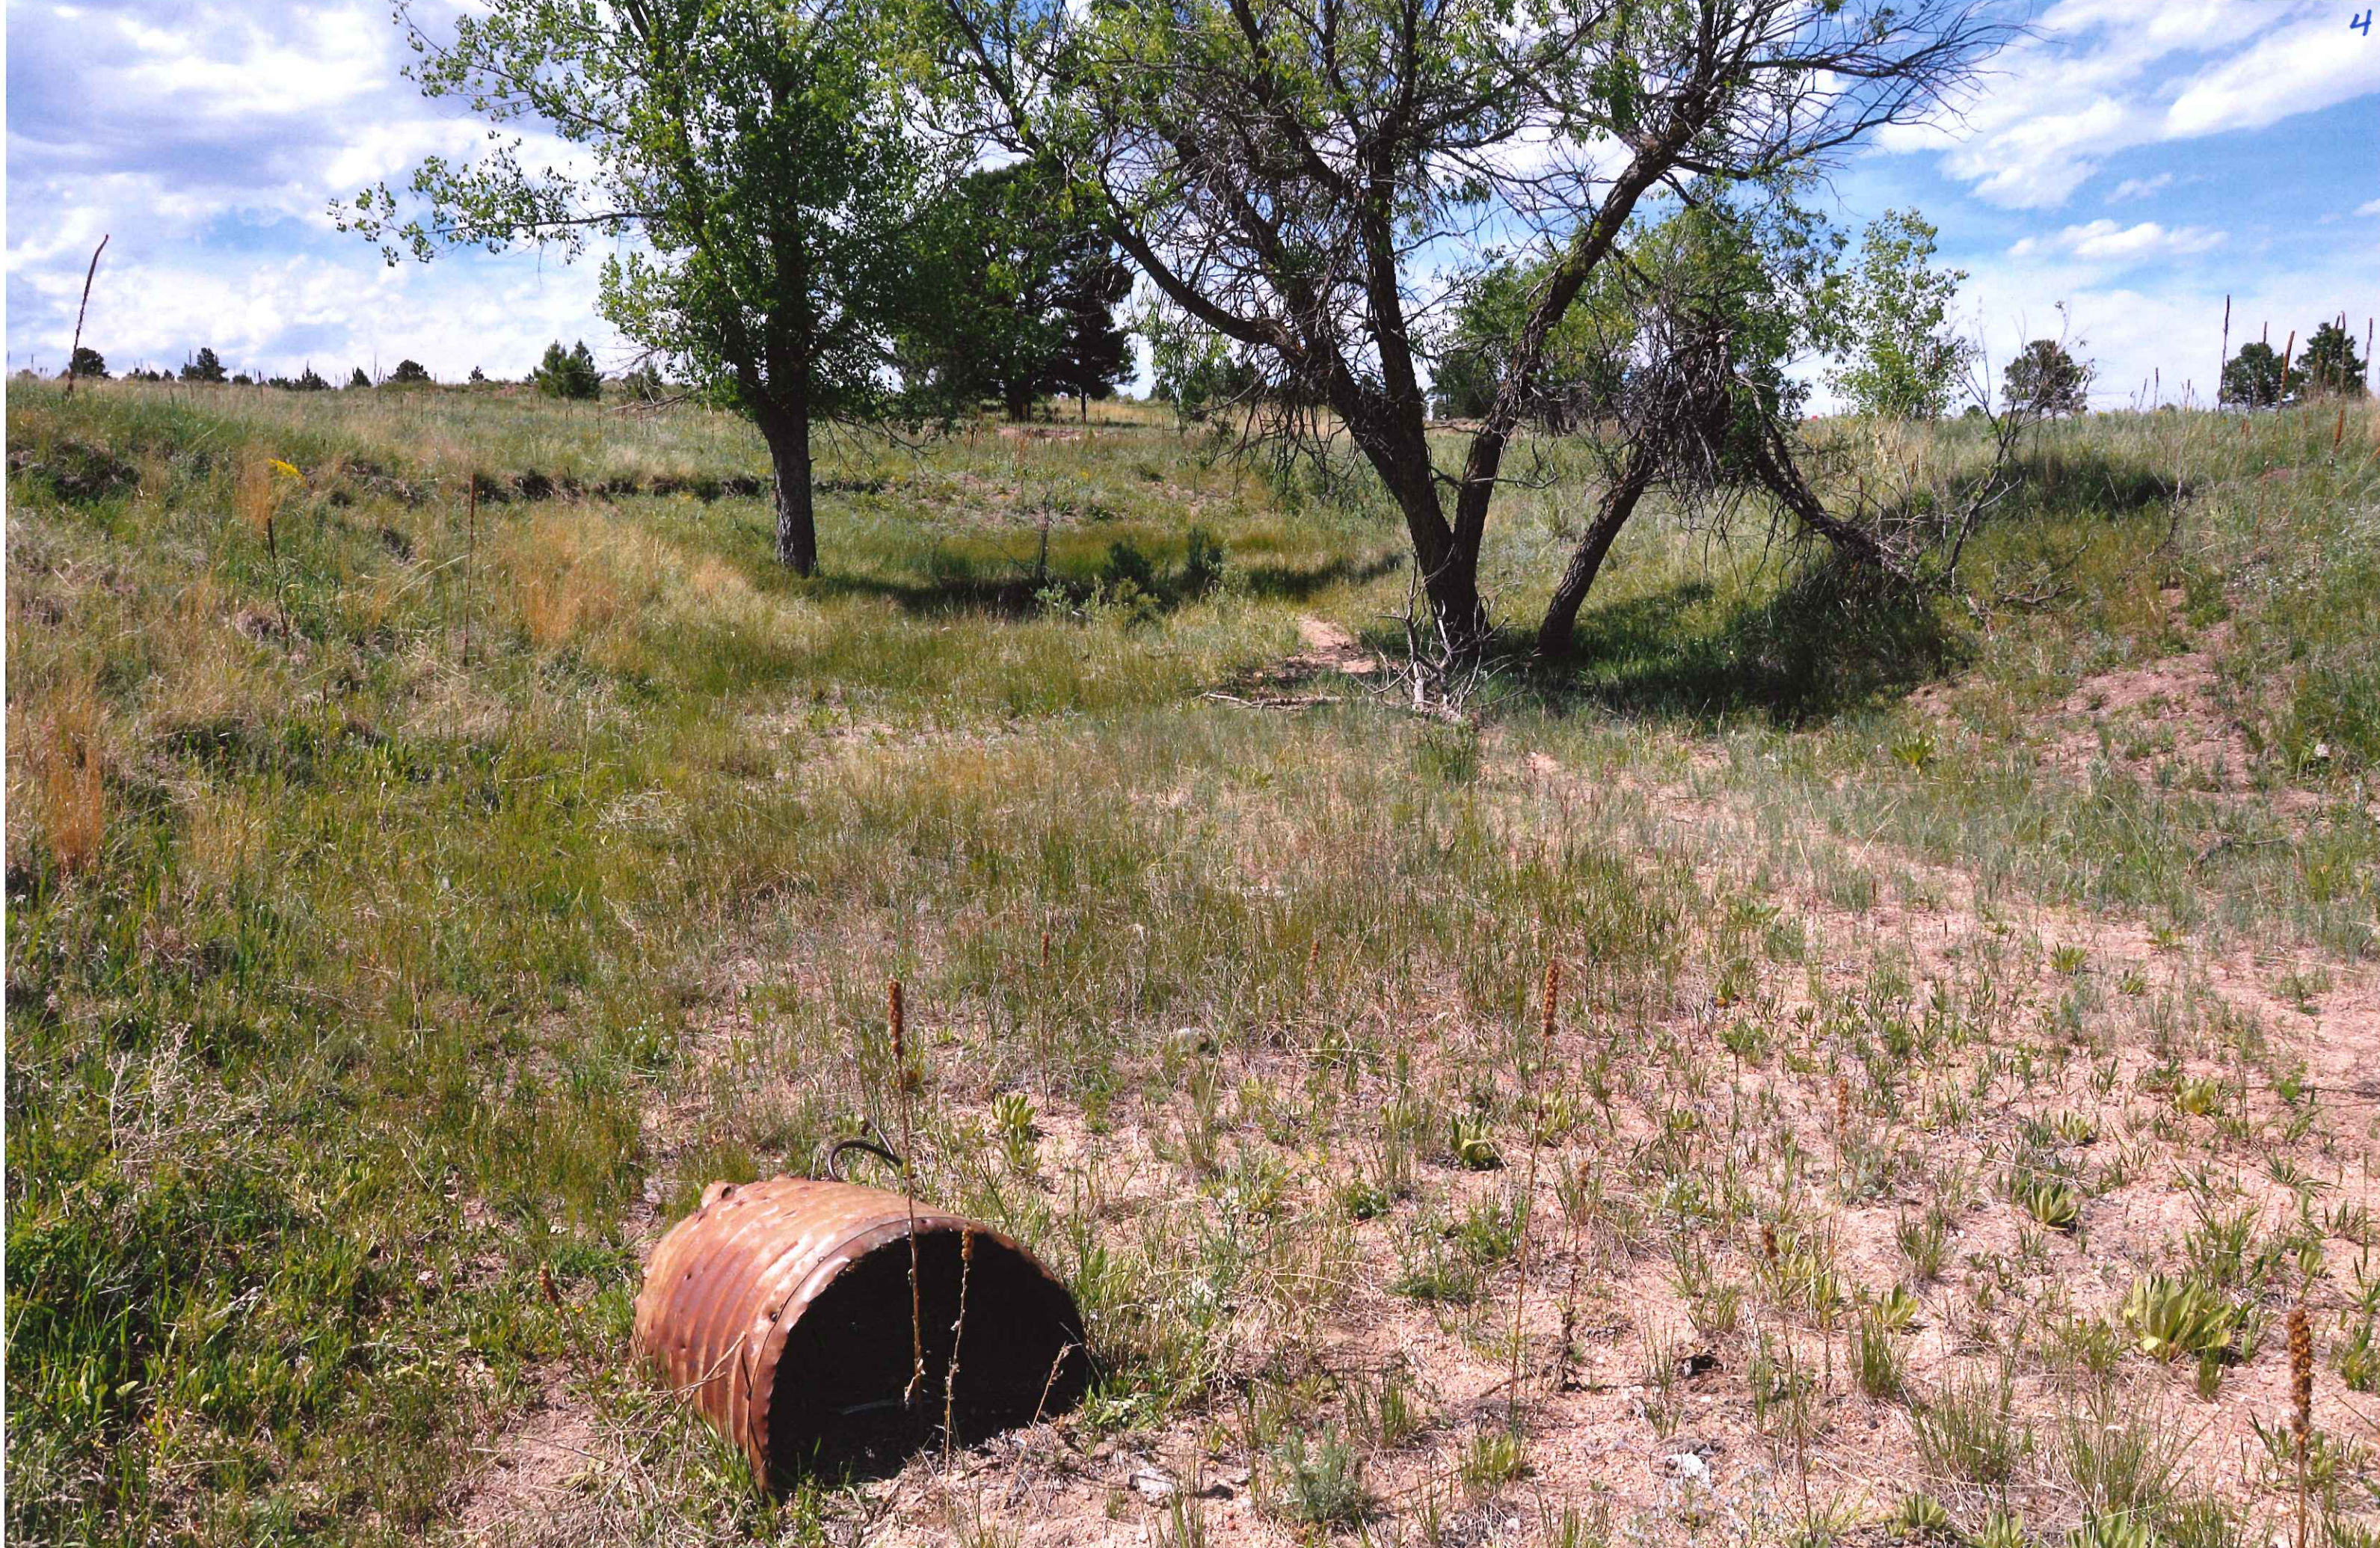
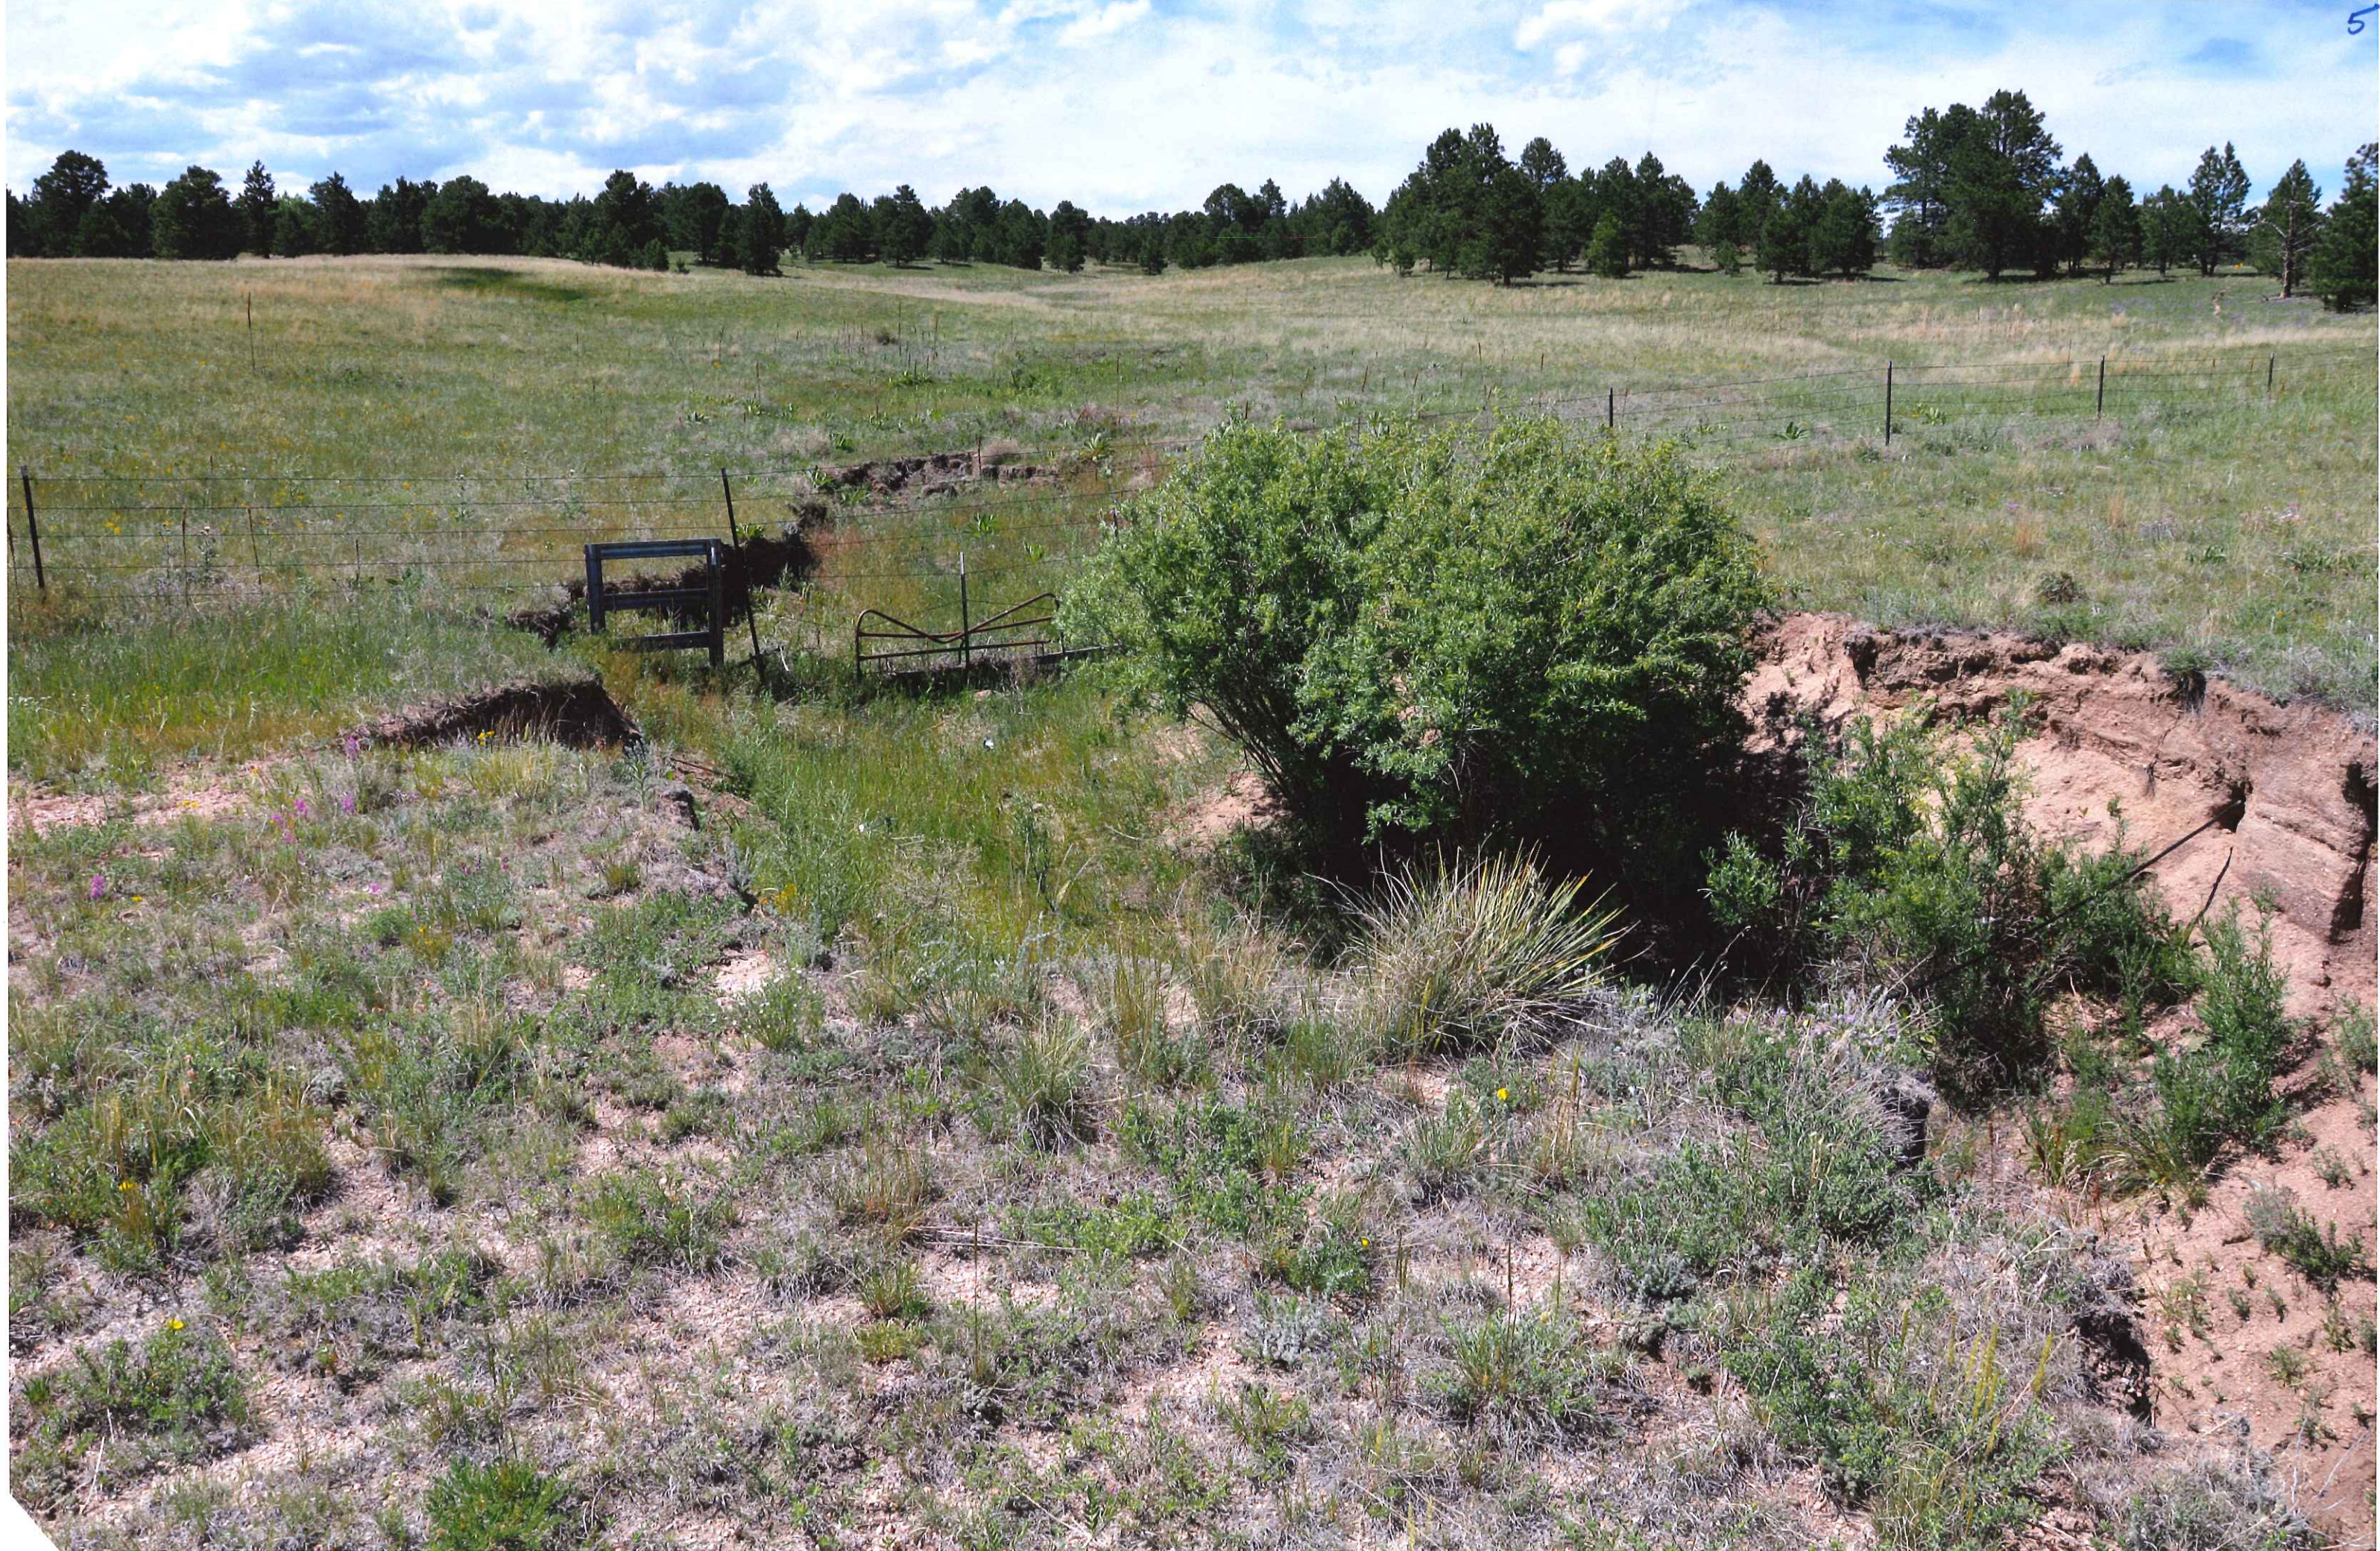
In addition to the Visual Analysis maps found in the Land Suitability Analysis, the following information is presented as an example. The key map and six photos are of a portion of the site where scrub trees and vegetation associated with erosion exist and where development is proposed. The first two photographs are within the proposed neighborhood park. Photo 3 shows the general location of the proposed Aspen Valley Parkway crossing of the eroded area. Photos 4 and 5 are views up the eroded area. Photo 6 is a view of the Aspen Valley Parkway crossing of the eroded area from a different perspective.
