RETREAT AT TIMBERRIDGE

LAND SUITABILITY ANALYSIS

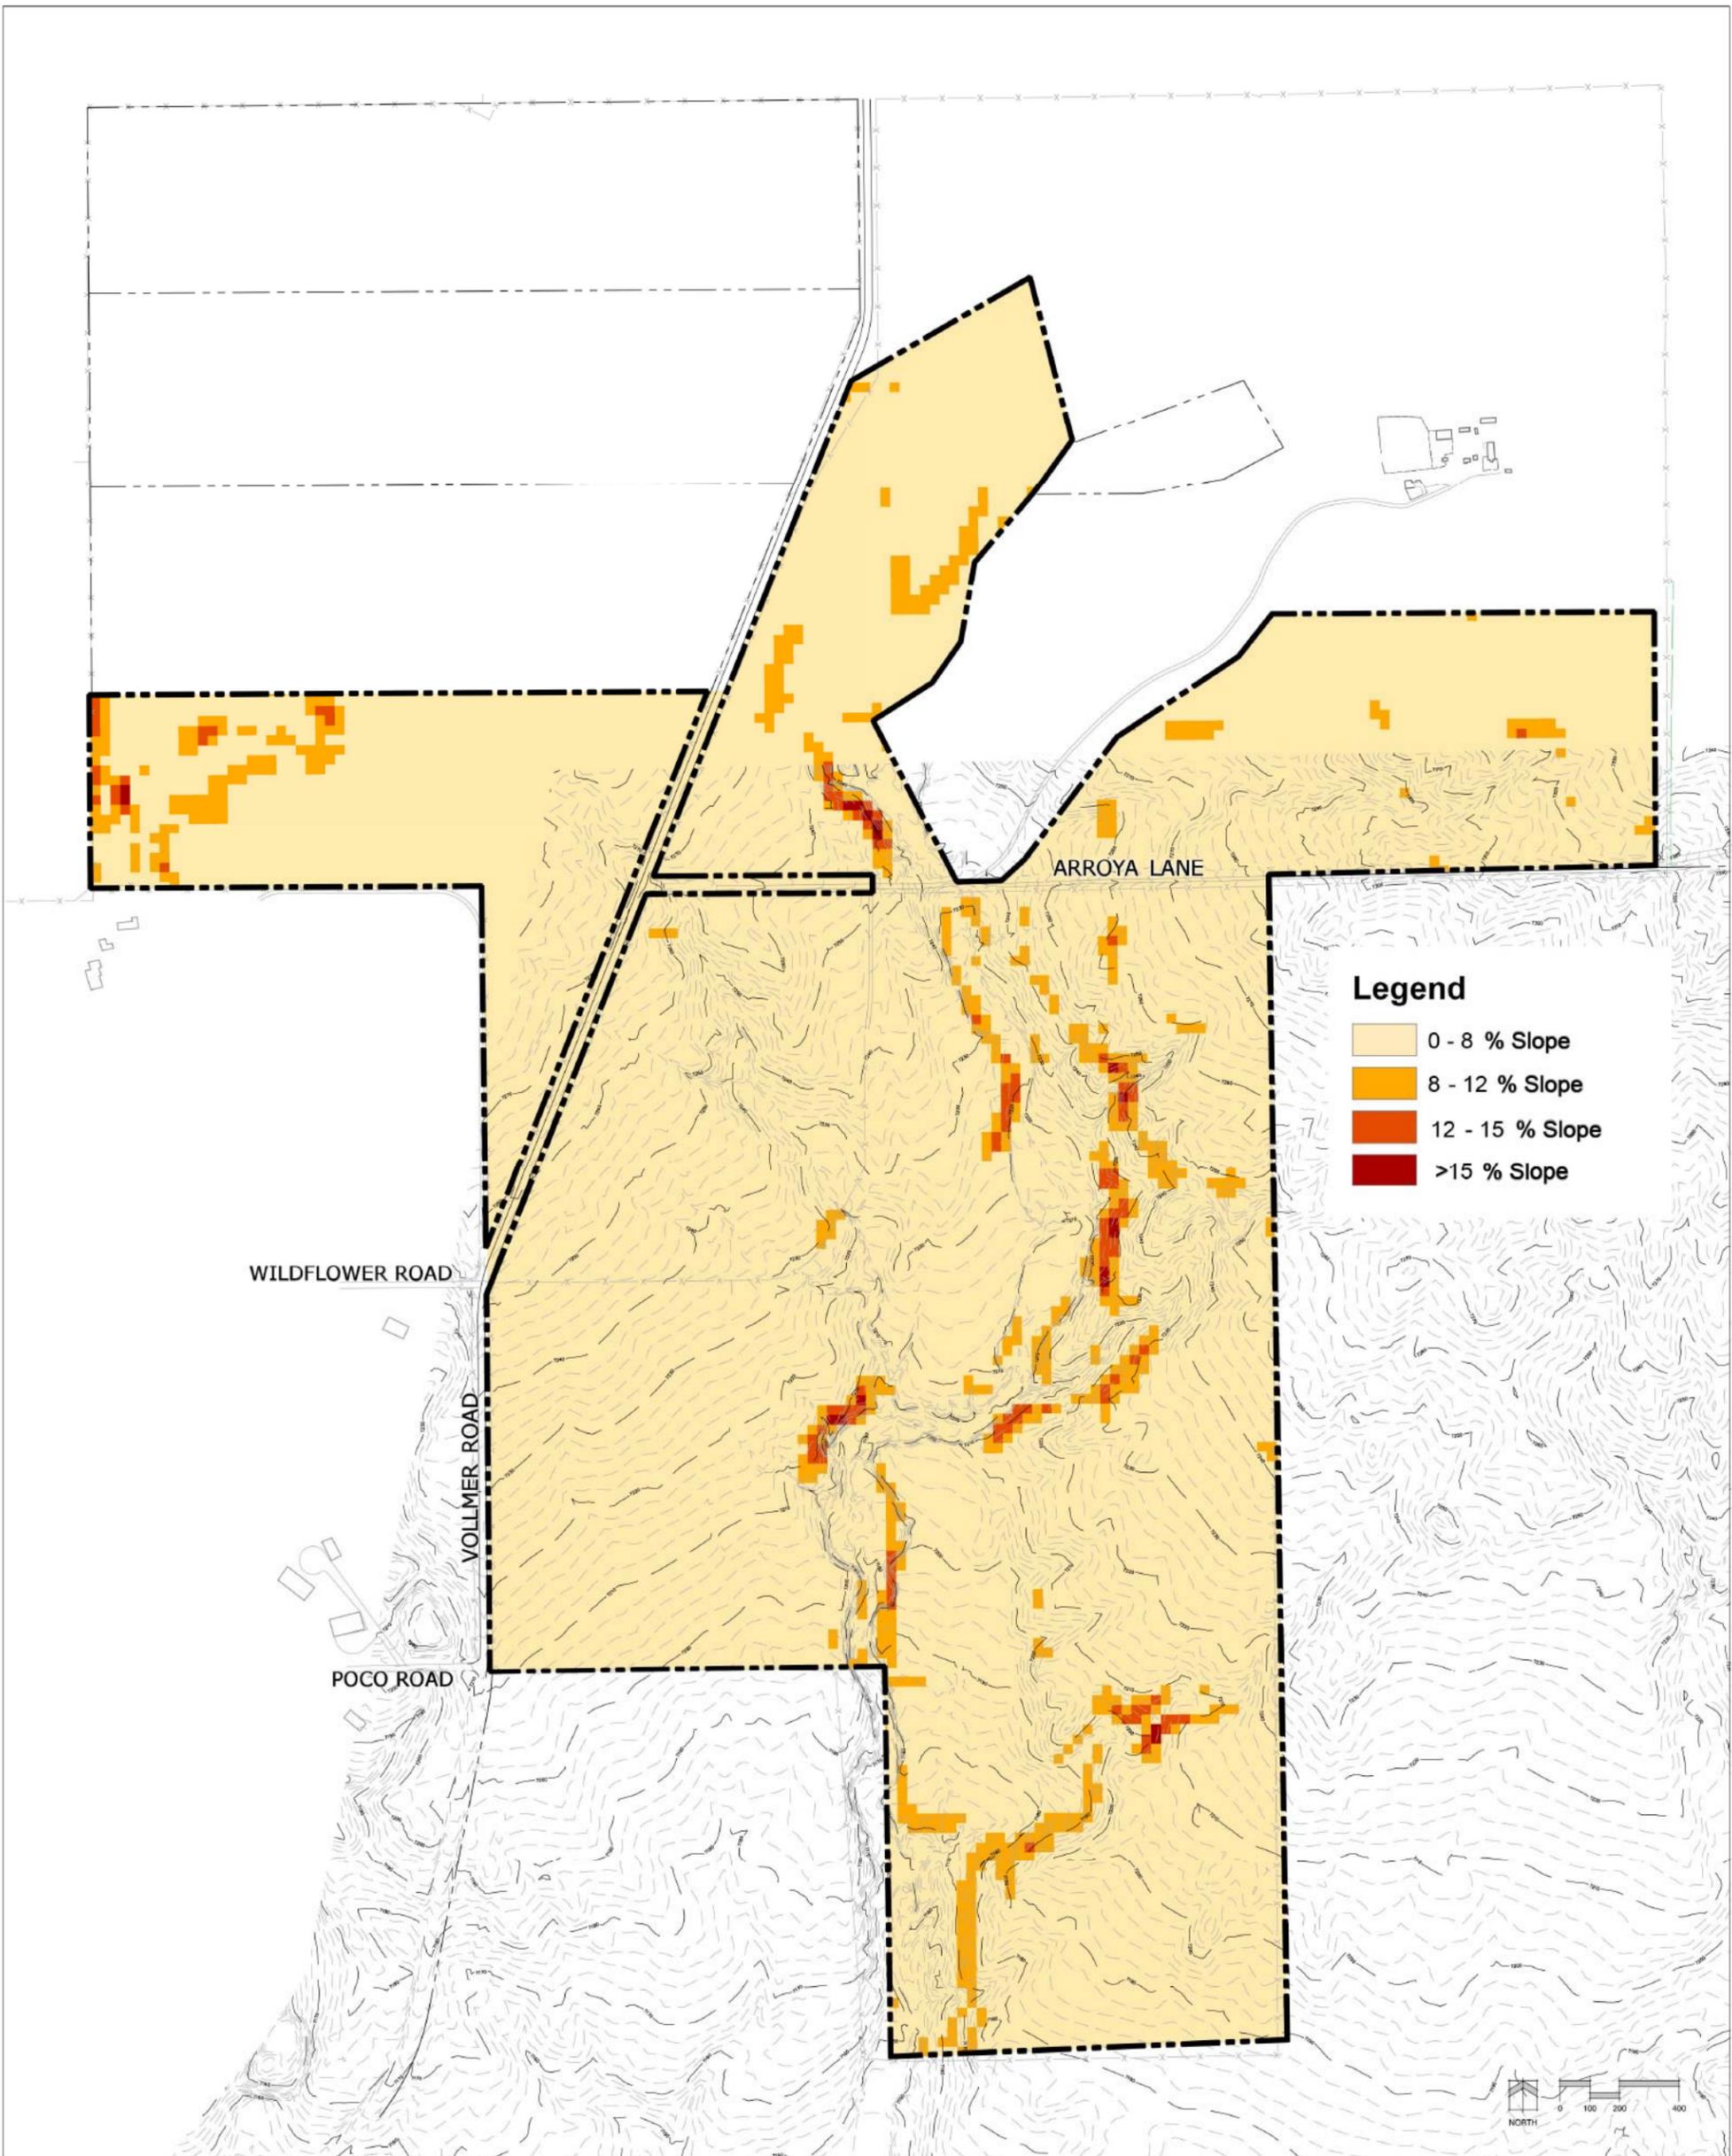
A Slope analysis is one of the primary determinants of development suitability. The site was mapped using two foot contour intervals and slope categories of 0% - 8%; 8% - 12%; 12% - 15%; and greater than 15%, as shown on *Figure 01*. These categories reflect generally accepted ranges that relate to land development as follows:

- 0% - 8% - generally unconstrained
- 8% - 12% - roads can be constructed to meet acceptable grades
- 12% - 15% - some road grade constraints; good building sites
- 15% - 25% - “hillside characteristics” – good building sites if accessible
- Greater than 25% - not found within site

The Slope Analysis reveals that the site is relatively unconstrained by slope other than slopes found within the Sand Creek channel.

Note: Analysis based on ColoradoView DEM 1-Degree Aerial Remote Sensing

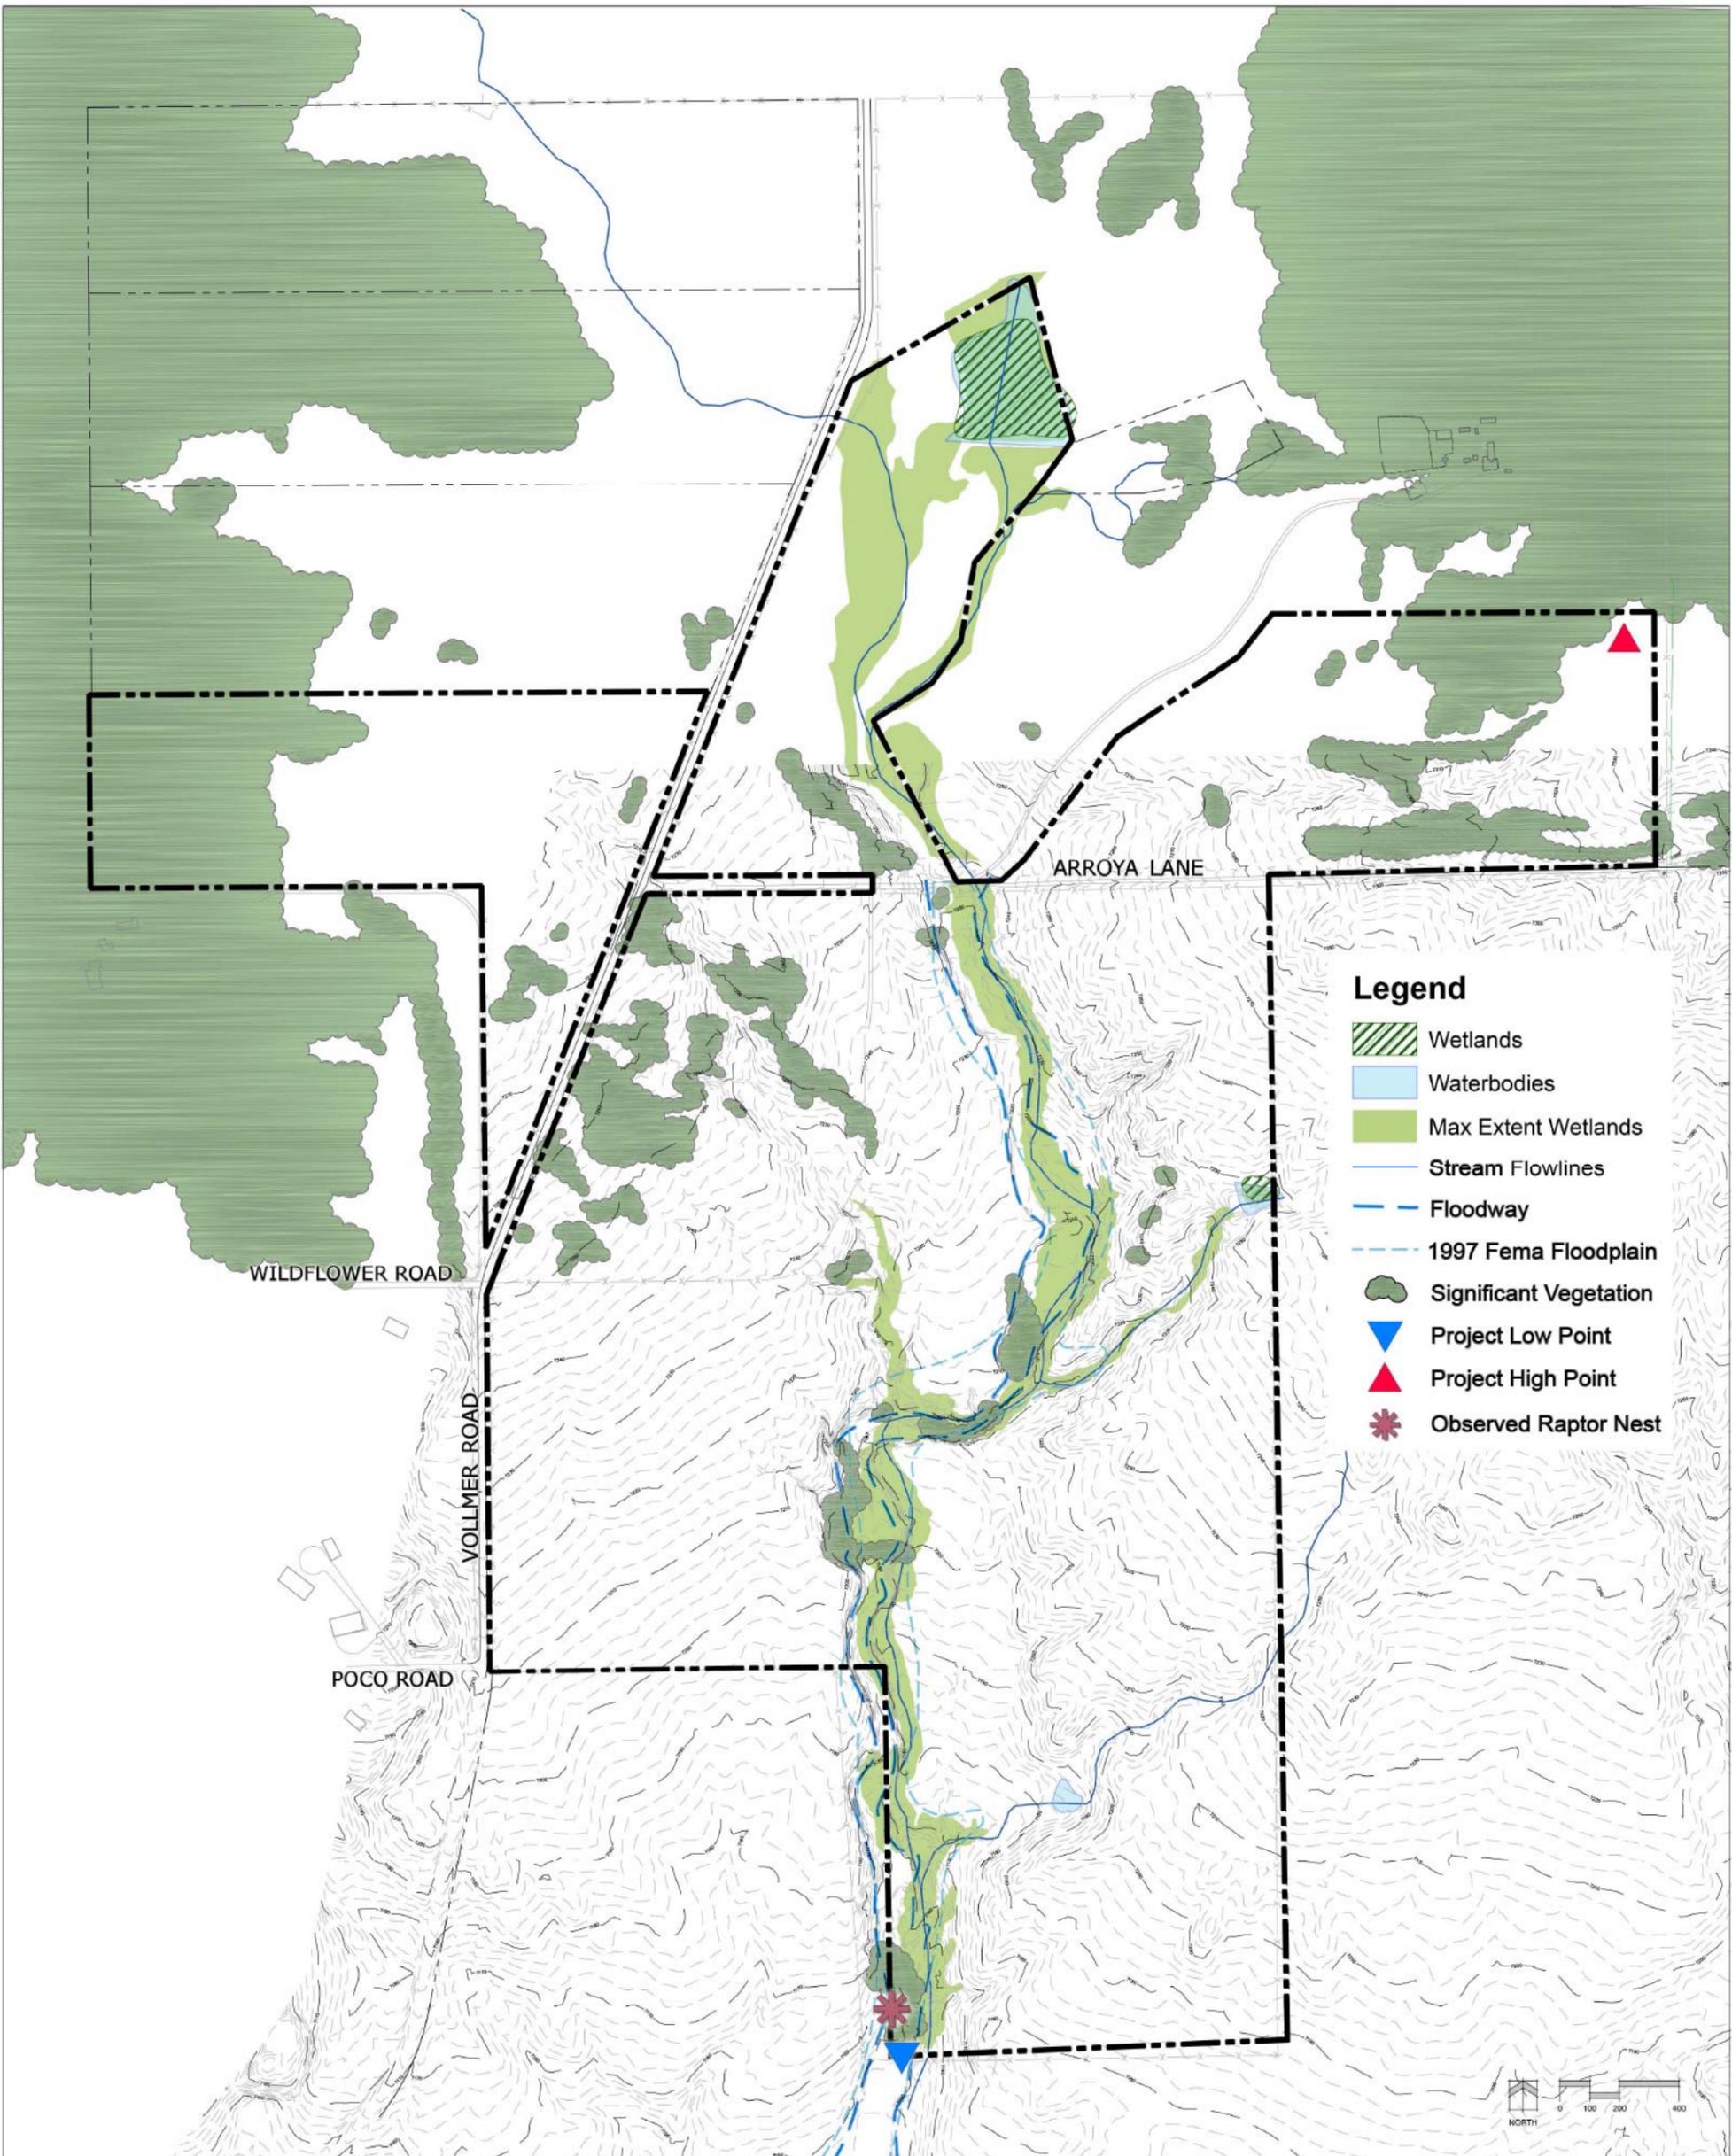
Figure 02, the Natural Features Map, shows the vegetation inventory for The Retreat @ Timber Ridge. The Natural Features Map was initially prepared by CORE Consultants. The site consists of moderately sloped rolling topography that drains to the north/south running Sand Creek channel that bisects the property. The property consists of mostly open meadow areas covered in both short and tall grass species native to the prairie edge to the east. Small concentrations of Ponderosa Pine are found in the northeast corner of the site and south of the Arroya Lane/Vollmer Road intersection. Riparian vegetation including some trees is found in the Sand Creek drainage.

The Sand Creek drainage is the major natural feature of the site. The floodway determined by CORE and FEMA floodplain are depicted in the Natural Features Map, *Figure 02*. It should be preserved as a greenway. The MMDP for the project addresses how drainage detention and water quality will be addressed.

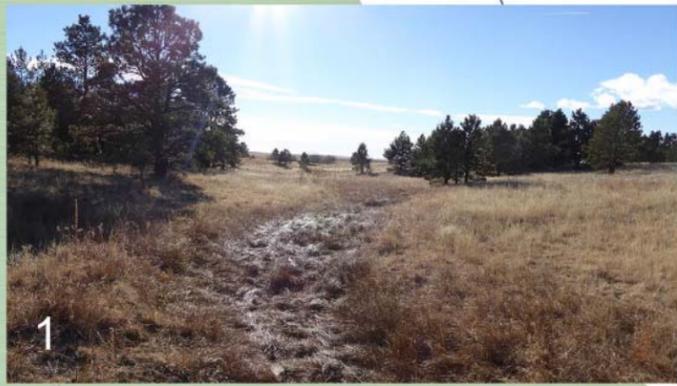
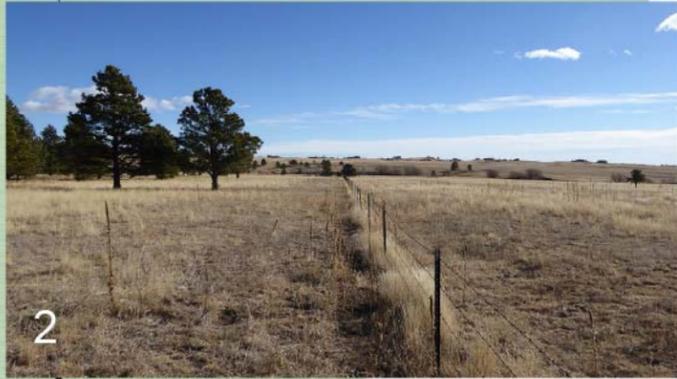
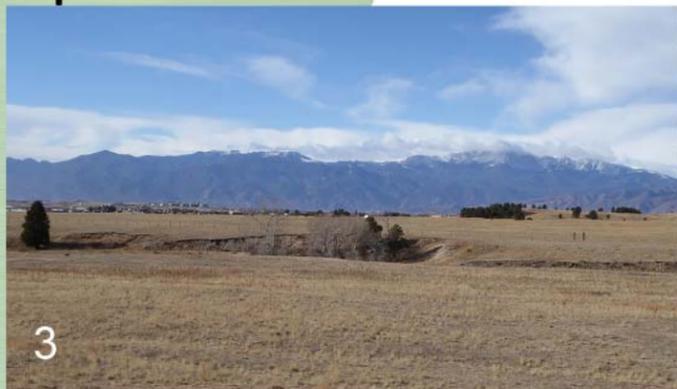
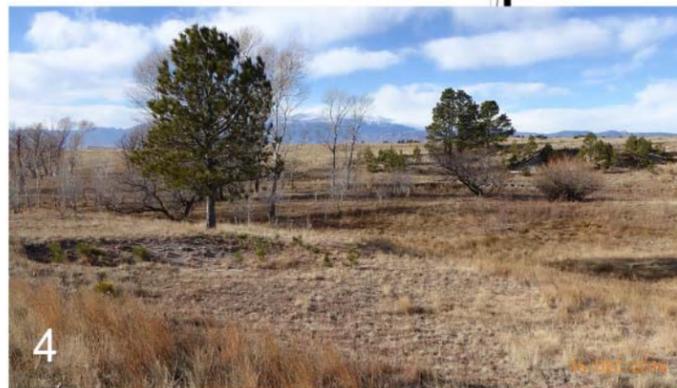
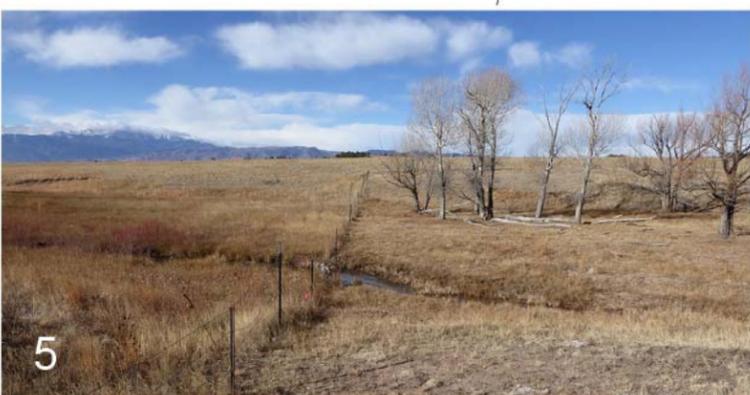
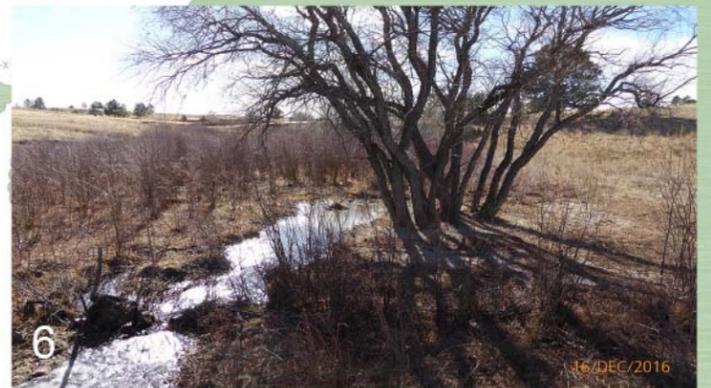
A visual analysis is an important aspect in determining land use alternatives. Visual impressions can add or detract from the image of the site and are significant in determining land use opportunities and constraints. Areas of visibility adjacent to roads, the visual content of short range and long range views from the site, and areas where views are blocked or screened by natural features forming barriers to views are all important considerations in visual analysis and land use planning. *Figure 03* depicts the Visual Inventory of The Retreat @ TimberRidge.

The primary focus of the visual analysis is of the Vollmer Road Corridor. The land use plan should provide a design that extends the visual features of the Ponderosa Pine forest southward along Vollmer Road to provide a visual entry to the timbered area of the Black Forest to the north and to visually reduce the impacts of proposed development.

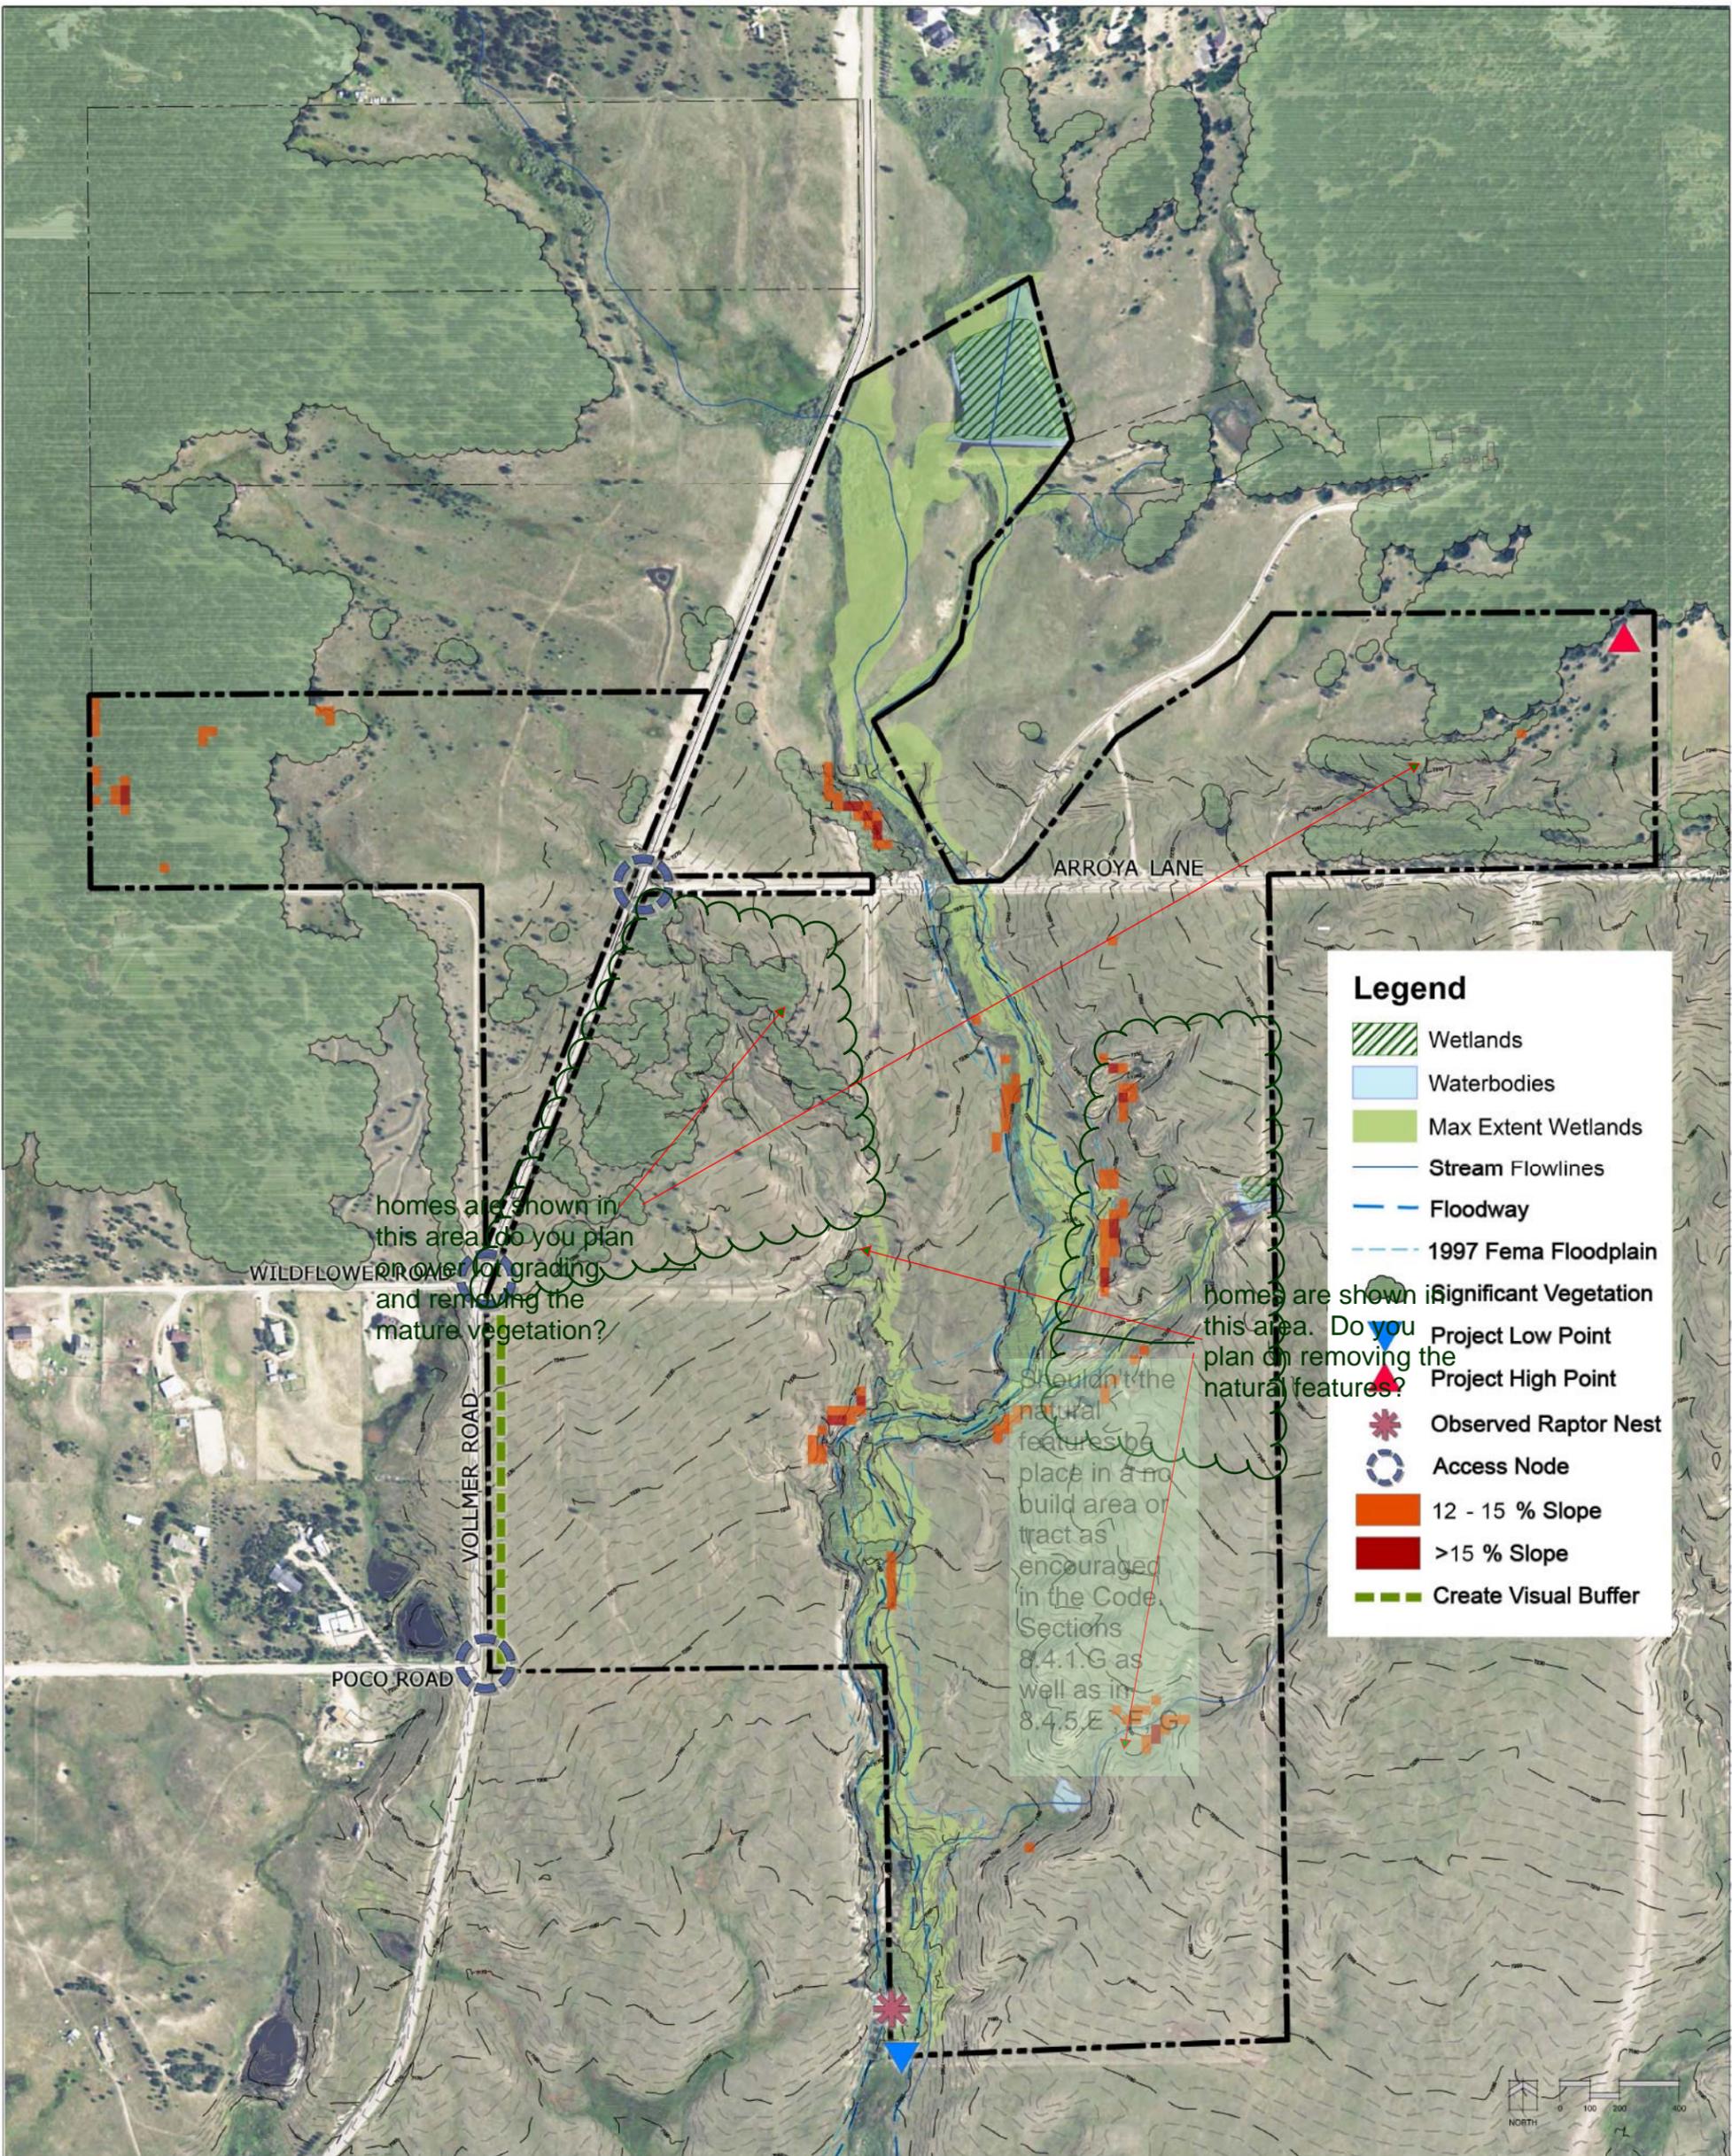
No man-made features are found on this site which would contribute to or influence the design of the subdivision. However, land use plans and county transportation systems will influence any development proposal. This property is within the Black Forest Preservation Plan boundary and is affected by the recommendations of that Plan. Conformance with the Plan is discussed in the Letter of Intent. Vollmer Road is the primary site access. Three access points, shown in *Figure 04*, are allowed based on the access constraints of Vollmer Road.

homes are shown in this area. do you plan on removing the mature vegetation?

Shouldn't the natural features be place in a no build area or tract as encouraged in the Code Sections 8.4.1.G as well as in 8.4.5.E

homes are shown in this area. Do you plan on removing the natural features?

Shouldn't the natural features be place in a no build area or tract as encouraged in the Code. Sections 8.4.1.G as well as in 8.4.5.E , F, G

homes are shown in this area. Do you plan on removing the natural features?

homes are shown in this area, do you plan on over lot grading and removing the mature vegetation?
