Arroya Investments, LLC
P.O. Box 50223
Colorado Springs, CO 80949
CORE Consultants Project Number 16-059

**Re: Impact Identification Report
The Retreat at Timber Ridge Residential Development Project
El Paso County, Colorado**

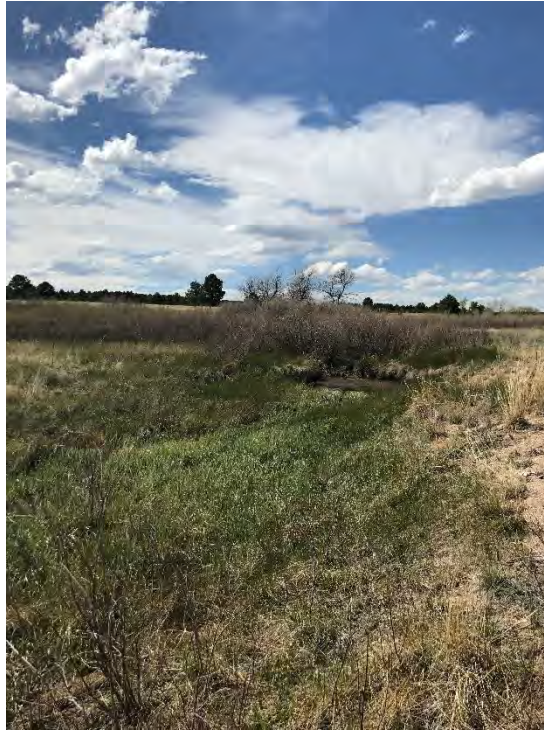
South of Aroya Lane, looking north at SCCW 3

The main channel of Sand Creek south of Arroya Lane presented as perennial throughout most of its stretch within the Project. Surface water was present within SCCW 3 at the time of the field visit; the absence of vegetation across the channel would suggest inundation occurs throughout most of the year. Oxidized rhizospheres (C3) were observed at Sample Point 1 within SCCW 3. SCCW 4 and SCCW 5 presented as seasonally flooded emergent wetlands. The hydrology of SCCW 4 is likely additionally provided, in part, by seepage of the stock pond upstream of the channel (Pond 1). Saturation was observed immediately downstream of the berm at the upstream boundary of SCCW 4. Since saturation was observed at this location and hydrologic connectivity is maintained through the berm, it was determined that a significant nexus exists between SCCW 4 and Pond 1. As such, Pond 1 was determined jurisdictional. Positive hydrologic indicators at Sample Point 4 within SCCW 5 included a high water table (A2), saturation (A3), and hydrogen sulfide odor (C1) (**Appendix III**).

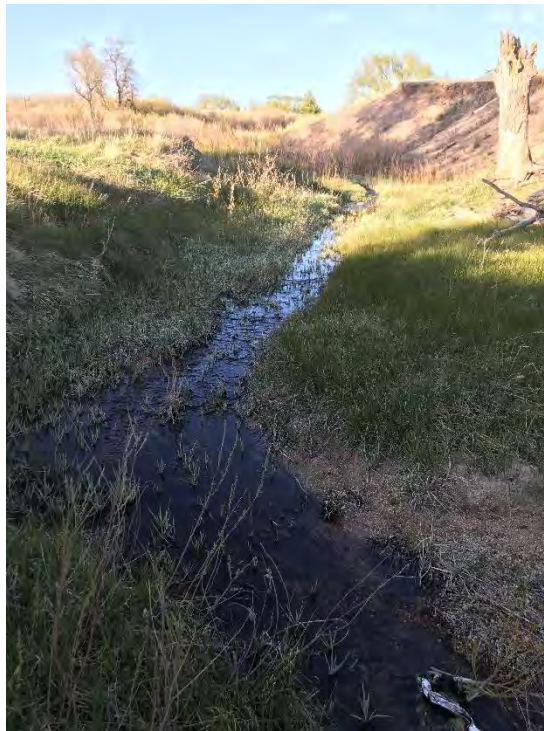
SCCW 3, facing north

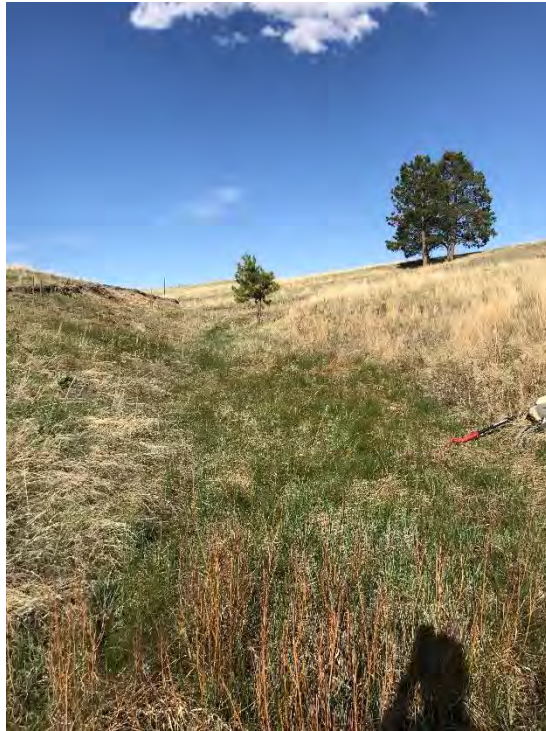
Eastern tributary, facing east

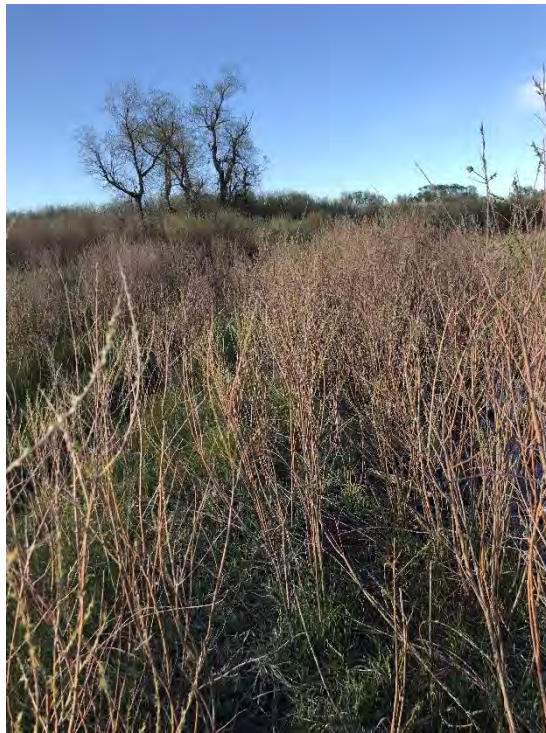
Western tributary, facing west

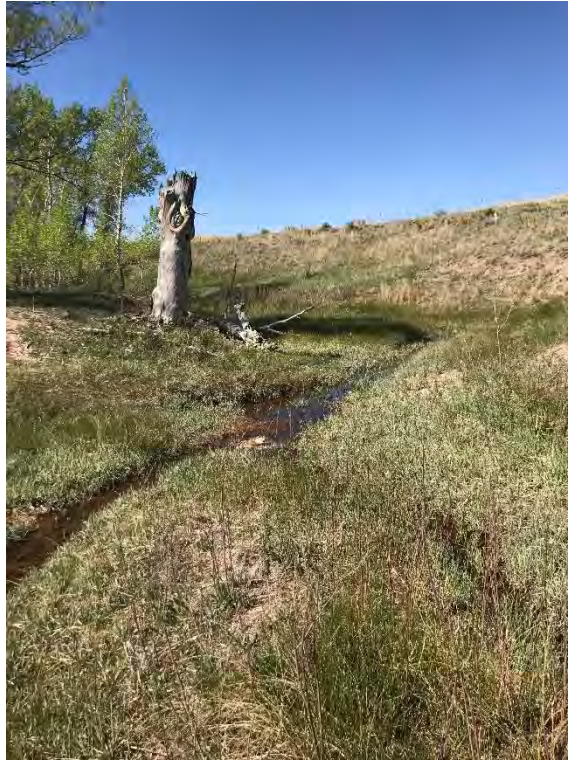
Southern portion of Sand Creek main channel, facing south at SCCW 6

SCCW 6 was characterized as a lower perennial stream channel containing wetlands. A strong headcut is located at the upstream edge of SCCW 6, and flowing water was present throughout its stretch within the Project (**Appendix II**). The low-flow channel resulted in multiple ponded areas and braided channels within this portion of the drainage. Positive hydrology indicators observed at Sample Point 5 within SCCW 6 included oxidized rhizospheres on living roots (C3) and the presence of the water table at 18 inches depth and saturation present at 17 inches depth within the sampling pit (**Appendix III**).

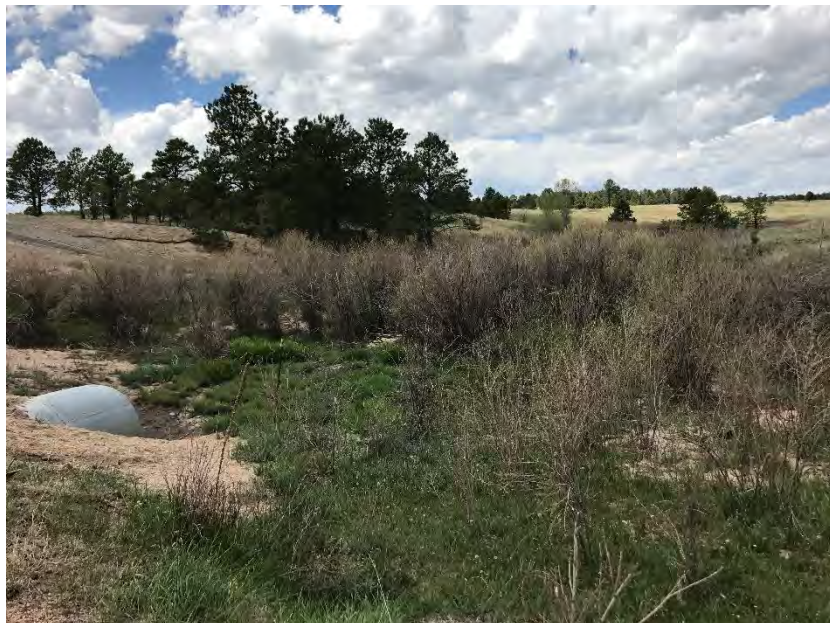
Immediately north of Arroya Lane, facing north at SCCW 2

The hydrology of Sand Creek north of Arroya Lane is provided intermittently by year-round precipitation events. Surface water was not present within SCCW 2; however, field sampling indicated the presence of highly distinct oxidized rhizospheres on living roots (C3). Hydrology of SCCW 2 was characterized as intermittent since surface water was not observed during the growing season at the time of the site visit.
