**Preliminary Acceptance Punchlist**  
**El Paso County – Department of Public Works - Stormwater Section**

Project Name:	El Dorado Springs Apartments
EDARP Filing Number(s):	CON2144, PPR1932
ESQCP Number:	ESQ2128
Attendees:	DPW SW: Benjamin Jones and Shannon Mustoe DPW Development Services: Brad Walters and Todd Lindgren Developer: Contractor Frazee (Justice)
Date of Walk-through:	06/20/2024
Walk-through Number:	1st

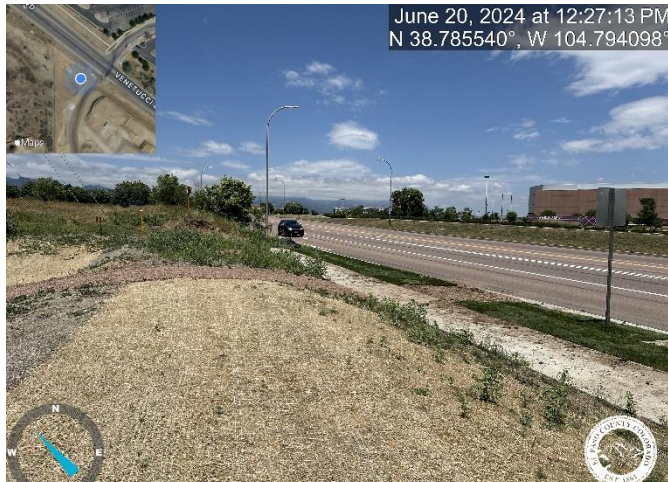
**Photo 1:** Concrete Driveway Apron is gravel instead of concrete as described on plans. Install per approved plans or confirm with your project engineer that this change from the plans is acceptable and then reflect the change on the as-builts.

- Concrete Driveway Apron is gravel instead of concrete as described on plans. Install per approved plans or confirm with your project engineer that this change from the plans is acceptable and then reflect the change on the as-builts. Reference Photo #1.

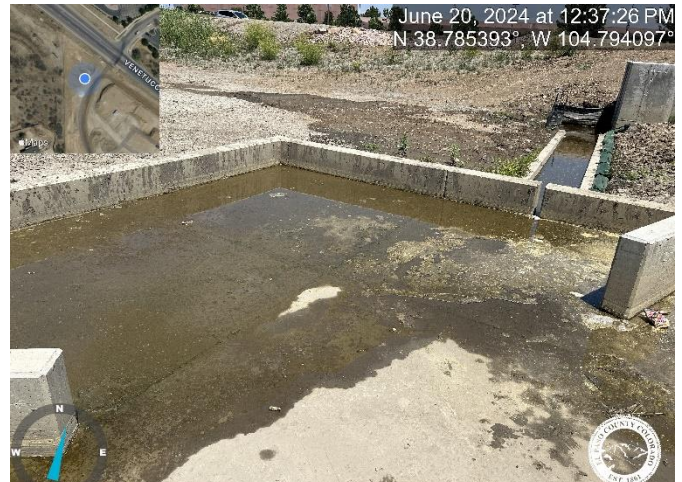
**Photo 2:** Raise pond bottom to top of trickle channel curb with a 3% slope towards trickle channel for positive drainage.

- Raise pond bottom to top of trickle channel curb with a 3% slope towards trickle channel for positive drainage. Reference photo 2.

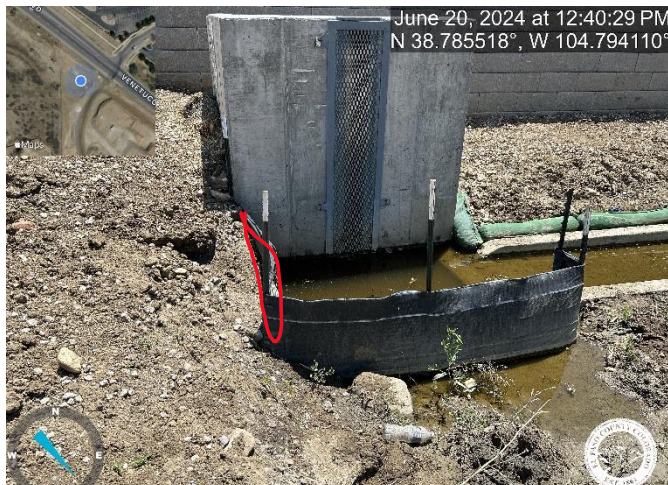
**Photo 3:** Regrade slope adjacent to micro pool to slope per plans. Remove silt fence.

- Steps are missing from inside the outlet structure. Install per approved plans. Reference Photo 5.
  - Regrade slope adjacent to micro pool to slope per plans. Remove silt fence. Reference Photo 3.

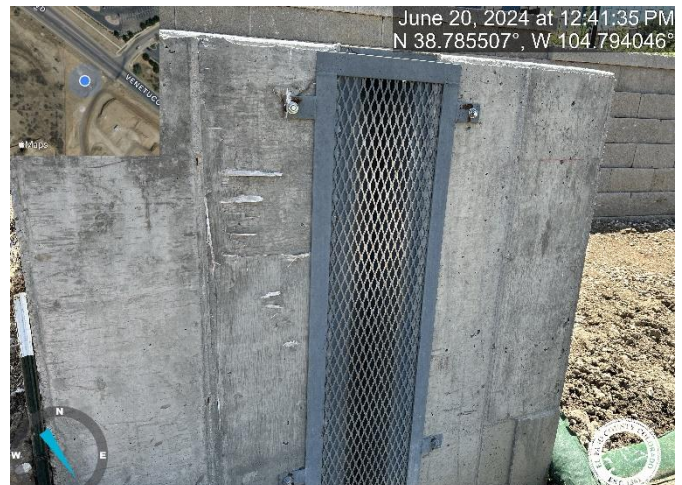
**Photo 4:** Install No. 93 Johnson Vee Wire stainless steel well screen.

- Outfall Structure
  - Well-Screen: Install No. 93 Johnson Vee Wire stainless steel well screen. Reference Photo #4.
  - Standing water is pond bottom. Outlet Pipe is not visible due to it being covered in water. Possible clog somewhere between outlet structure and first manhole box along Venetucci. Reference Photo 6.

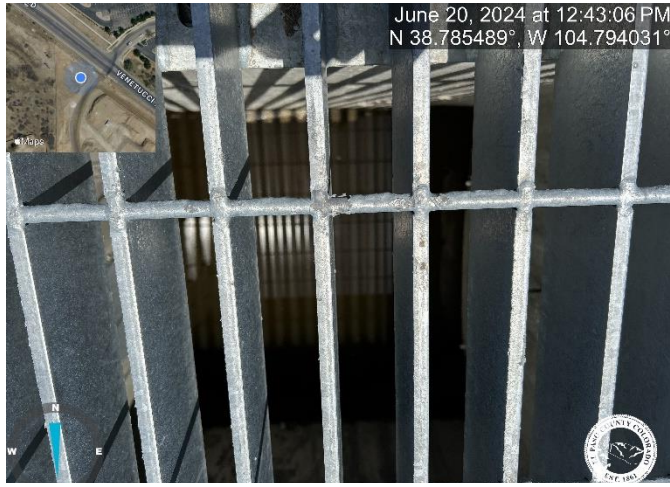
**Photo 5:** Steps are missing from inside the outlet structure. Install per approved plans

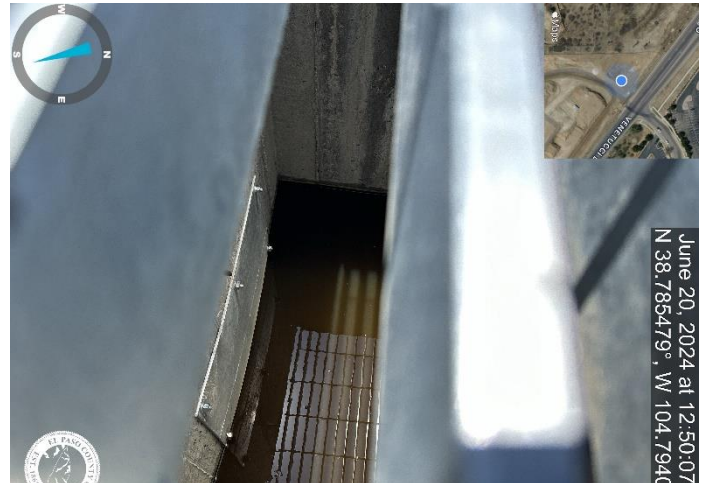
**Photo 6:** Standing water is pond bottom. Outlet Pipe is not visible due to it being covered in water. Possible clog somewhere between outlet structure and first manhole box along Venetucci.

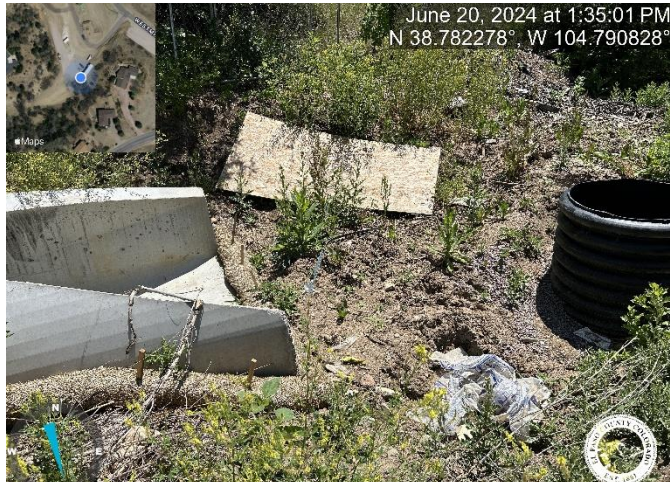
**Photo 7:** Fill in low spot near south outlet structure to allow positive drainage.

- Eliminate gap above trash rack. Reference photo 8.
- Outfall Structure
  - Orifice holes are too small. Install per approved plans or show current hole sizes on as built.
  - Steps are not visible in the outlet structure. Install per plans or show on as built.
- Raise pond bottom to top of trickle channel curb with a 3% slope towards trickle channel for positive drainage. Reference photo 9.
- Warning sign missing
- Water bypassing north forebay. Reference photo 10.
- Either add topsoil to overspill rip rap per approved plans or cut down soil to slope stated on plans. Reference photo 11.
- Clean out sediment from manhole. Reference photo 12.
- Fill in low spot in front of south outlet structure to allow positive drainage. Reference photo 7.

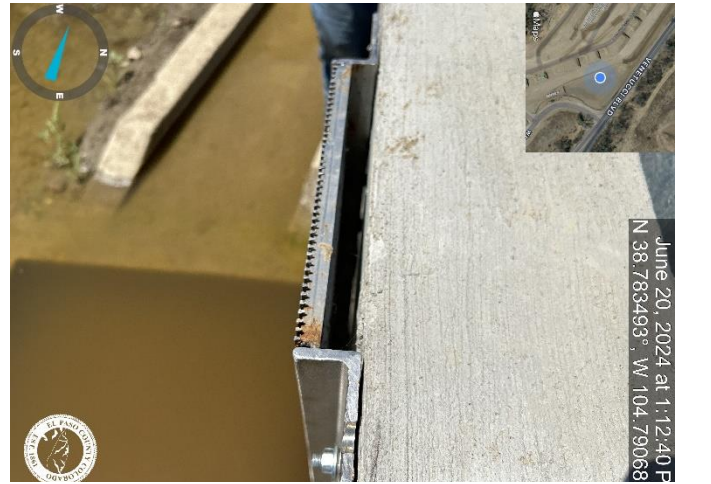
**Photo 8:** Eliminate gap above trash rack.

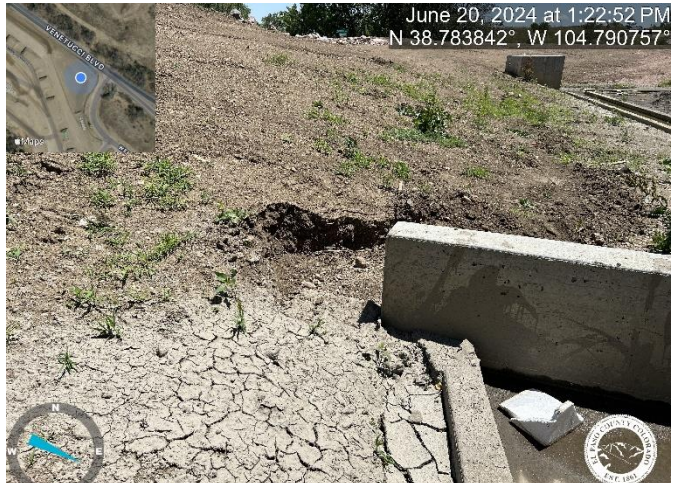
**Photo 10:** Water is bypassing.

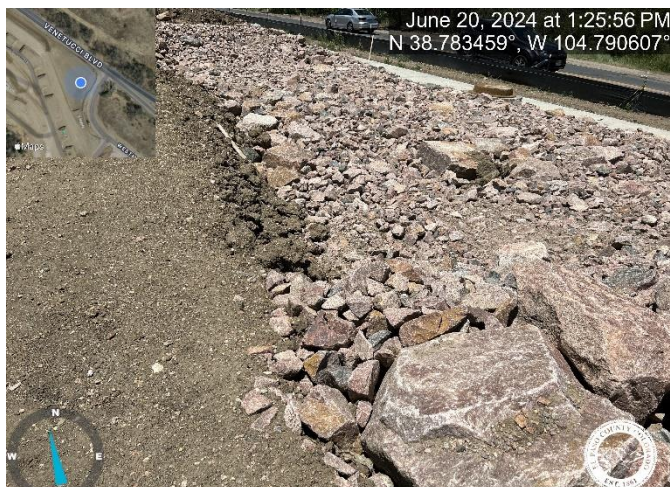
**Photo 11:** Either add top soil to rip rap per approved plans, or cut down soil to slope stated on plans.

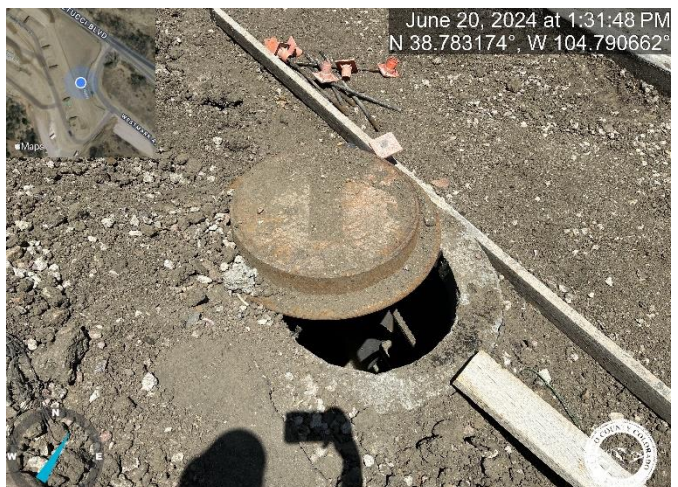
**Photo 12:** Clean out sediment from manhole.
