EL PASO COUNTY IMPACT IDENTIFICATION REPORT

JAYNE'S PARCEL PROJECT
EL PASO COUNTY, COLORADO
PROJECT NO. 22-008

May 2022

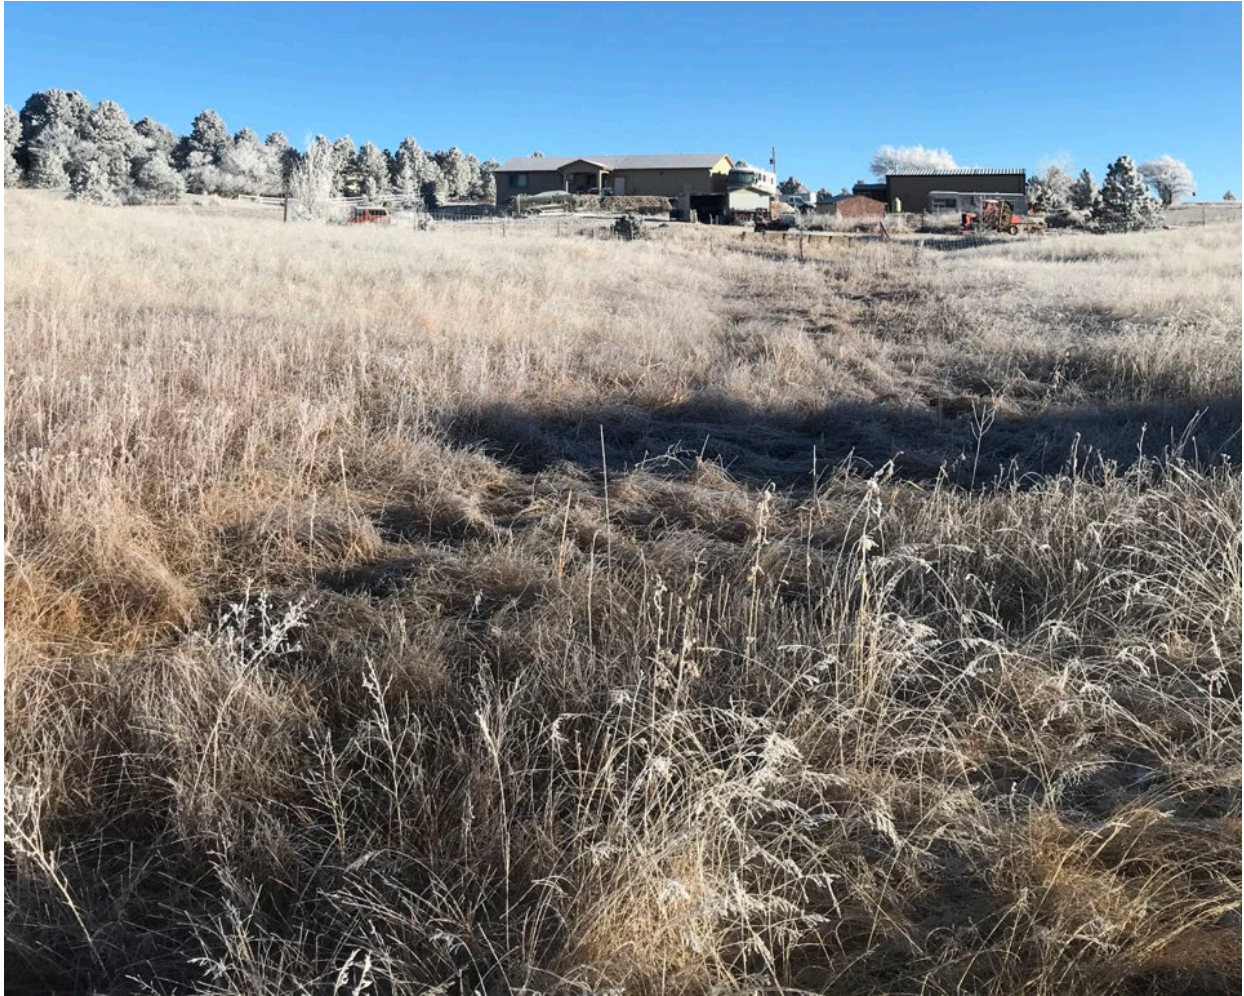
Photo ID	Date	Latitude	Longitude	Subject	Direction Taken
JP_001	1/26/2022	38.975207	-104.670271	Eastern Stream	North
Description: Northern end of the eastern streambed, downstream of the house in the northeastern corner of the Project Area.

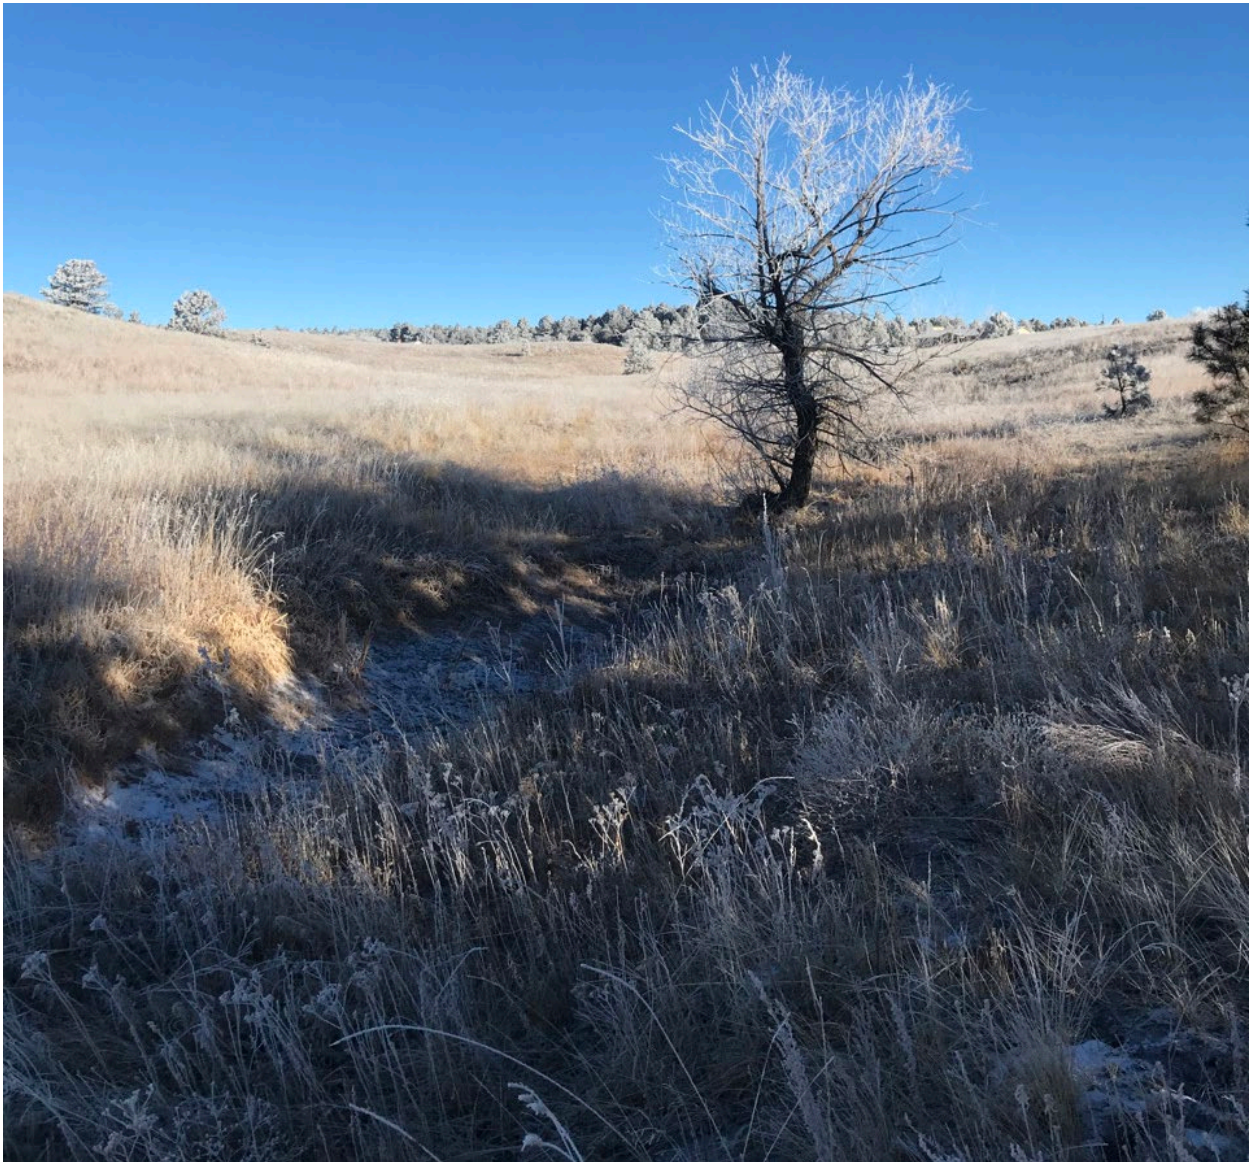
Photo ID	Date	Latitude	Longitude	Subject	Direction Taken
JP_002	1/26/2022	38.973793	-104.670362	Eastern Streambed and Willow	North

Description: Peachleaf willow growing along the eastern streambed, a short distance upstream from the larger pond.

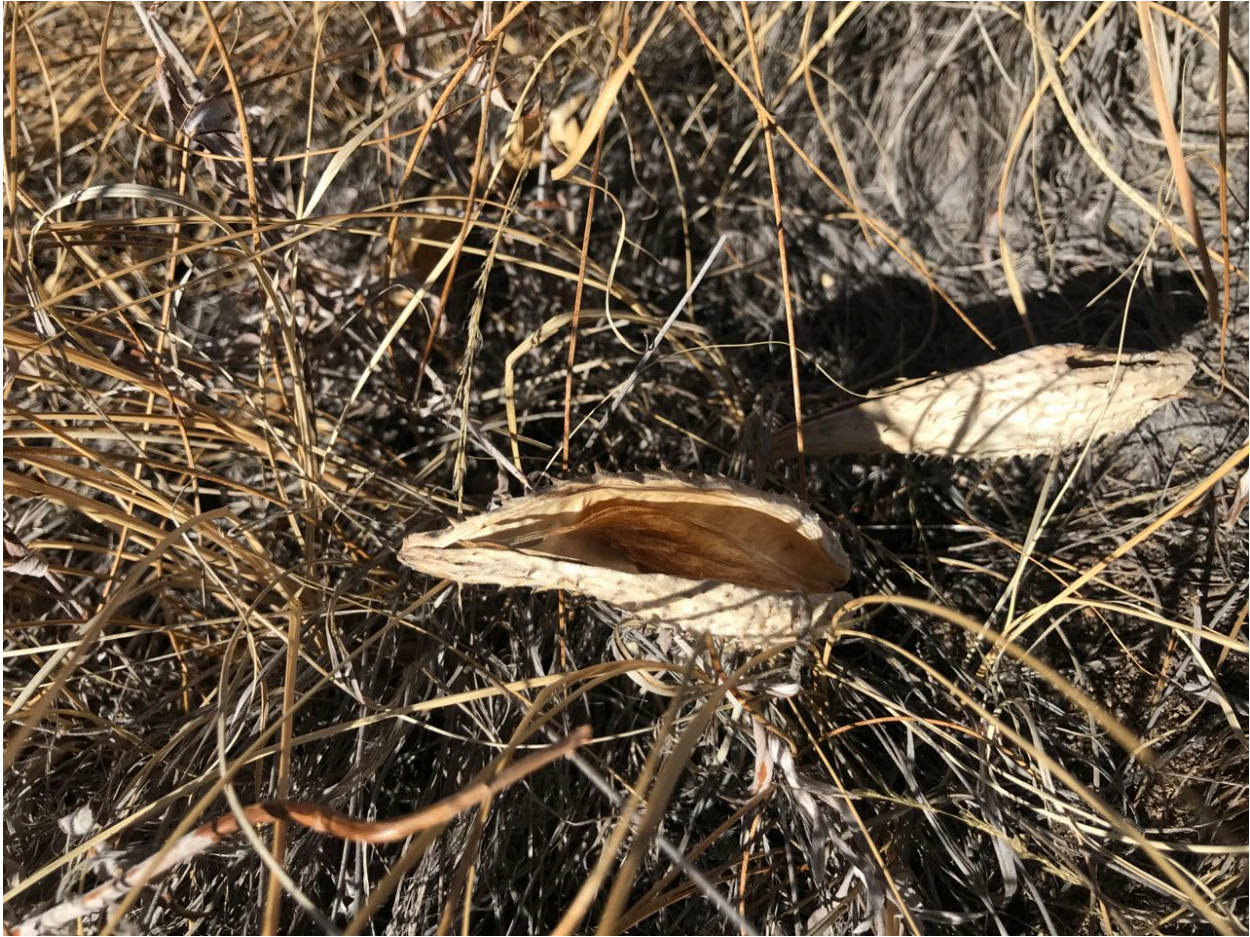
Photo ID	Date	Latitude	Longitude	Subject	Direction Taken
JP_020	1/26/2022	38.970858	-104.676388	Showy Milkweed	N/A
Description: Showy milkweed seed pods found along the western stream.

Showy milkweed (*Asclepias speciosa*) stalks and seed pods were observed in a small area (less than 20 square feet) along the western side of the Project Area, indicating that at least some egg-laying habitat and forage for monarch caterpillars exists in the Project Area (Appendix C). Based on the Project Area's location within the monarch breeding range and along the fall migratory route for more northerly-breeding monarchs, individuals may be present in the Project Area occasionally. A targeted search for milkweed plants was not conducted during the habitat assessment, and because the survey was completed outside of the growing season a general assessment of species abundance was not appropriate.

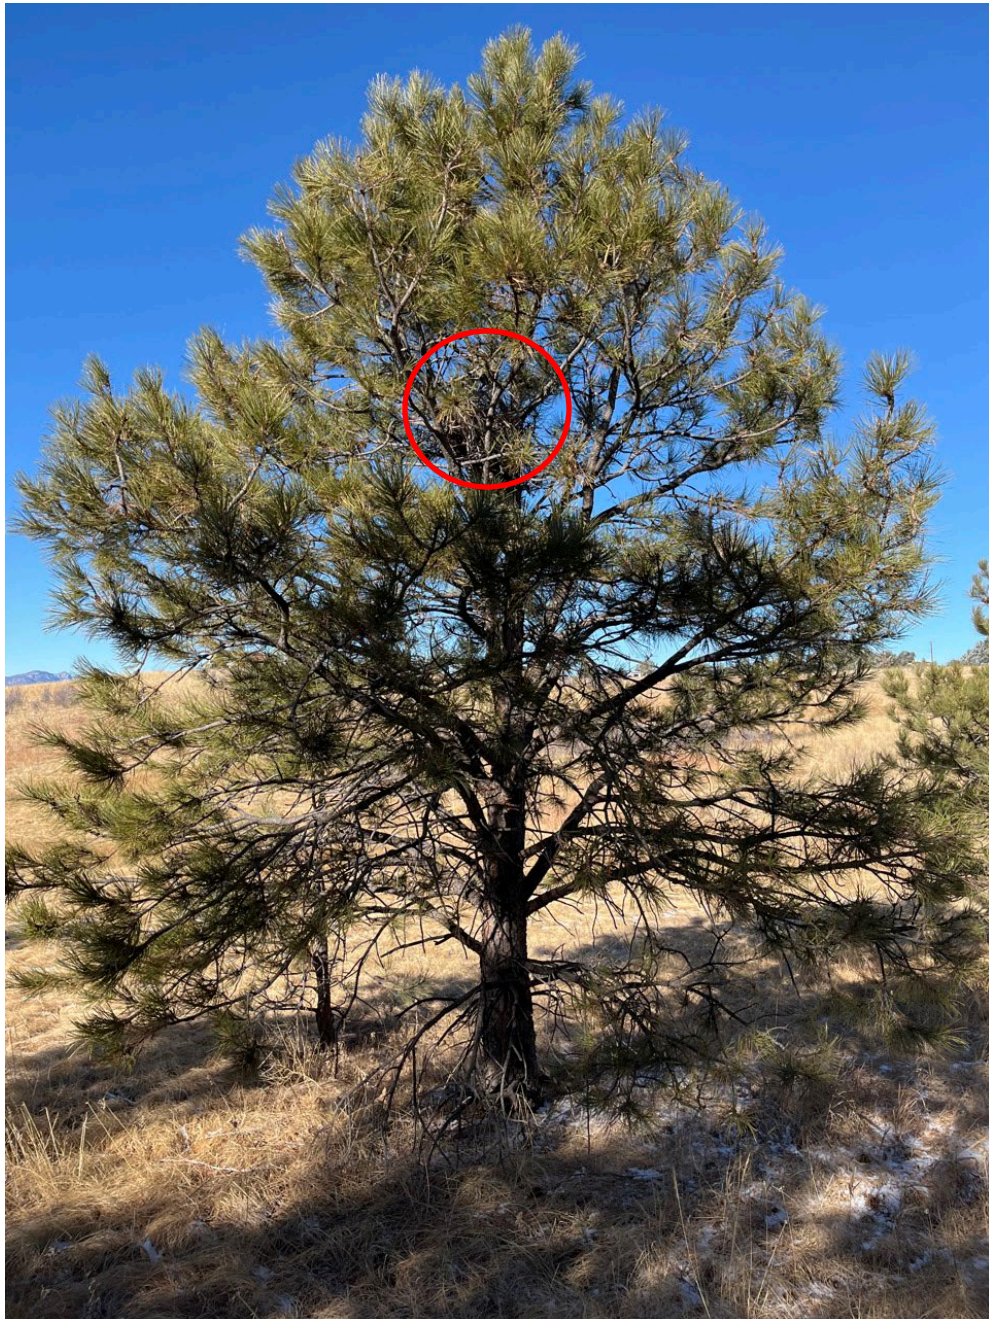
Photo ID	Date	Latitude	Longitude	Subject	Direction Taken
Raptor Nest 1	1/26/2022	38.975089	-104.675872	Inactive Raptor Nest	Northwest
<p>Description: Inactive raptor nest in a small ponderosa pine. This is potentially an inactive, black-billed magpie nest, but has been documented in the event that a small raptor would choose to use it.</p>

The desktop review identified ferruginous hawk as the only USFWS Bird of Conservation Concern with potential to use the Project Area. Site reconnaissance revealed that suitable substrates for nesting raptors were present. Four inactive nests were observed in ponderosa pines within the Project Area during the assessment (Appendix C). Each of the inactive nests was sufficiently large to potentially support nesting raptors, however, the nests cannot be reliably attributed to certain species while inactive. Based on the nest sizes and their relative positions within the trees, none of the nests would support eagles. Another large nest was found on the ground near the north side of the eastern grove of pines (Appendix C). No raptor nests were found in the half-mile buffer. A nesting raptor survey during the breeding season (February 1 through July 15) would confirm the presence or absence of active raptor nests within the Project Area. If raptor nests are found, appropriate raptor nest buffers would be coordinated with CPW and should be adhered to during construction activities (CPW 2020).

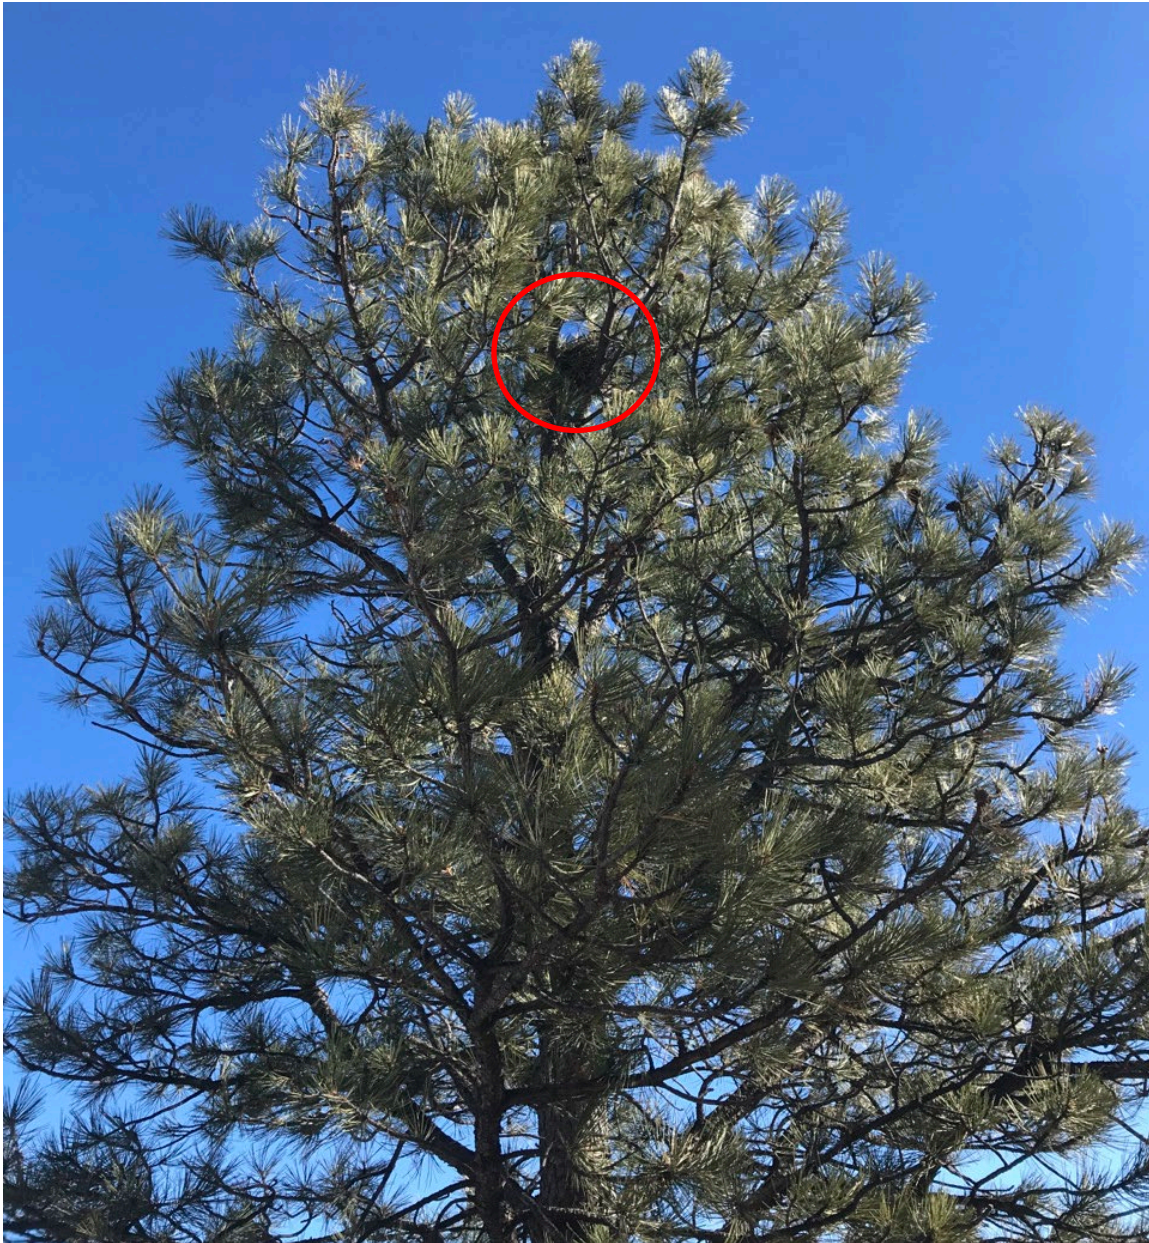
Photo ID	Date	Latitude	Longitude	Subject	Direction Taken
Raptor Nest 2	1/26/2022	38.973163	-104.671617	Inactive Raptor Nest	North
<p>Description: Inactive raptor nest in the crown of a ponderosa pine on the ridge. This is potentially an inactive, black-billed magpie nest, but has been documented in the event that a small raptor would choose to use it.</p>

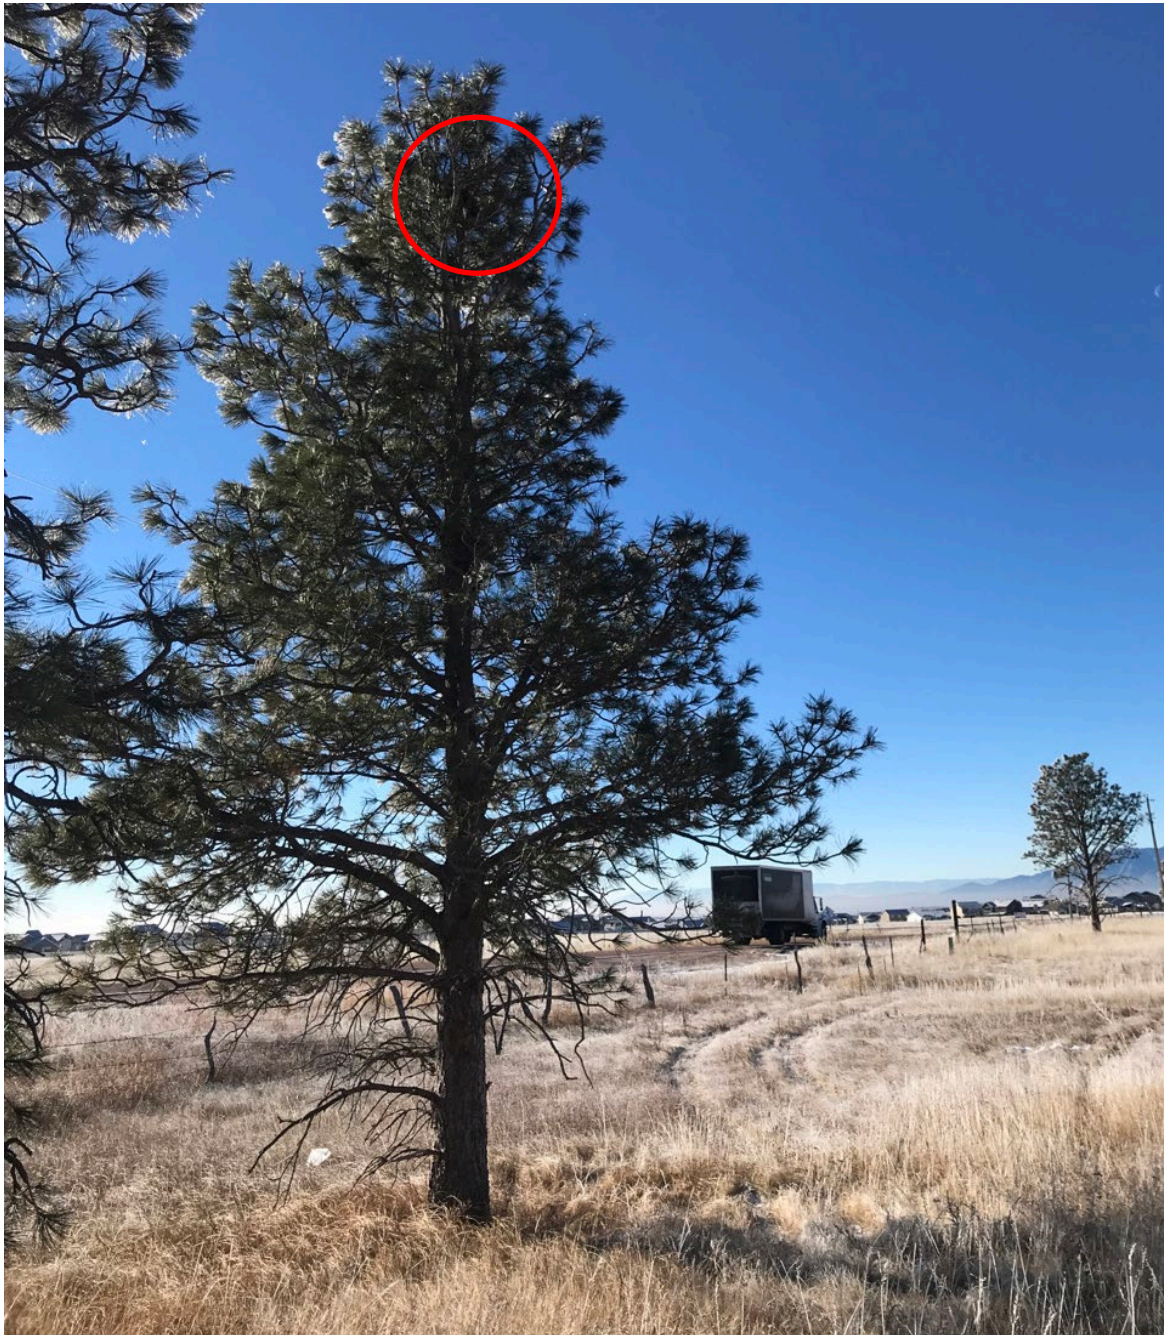
Photo ID	Date	Latitude	Longitude	Subject	Direction Taken
Raptor Nest 3	1/26/2022	38.971883	-104.670614	Inactive Raptor Nest	South
Description: Inactive raptor nest in the crown of a ponderosa pine along Vollmer Road.

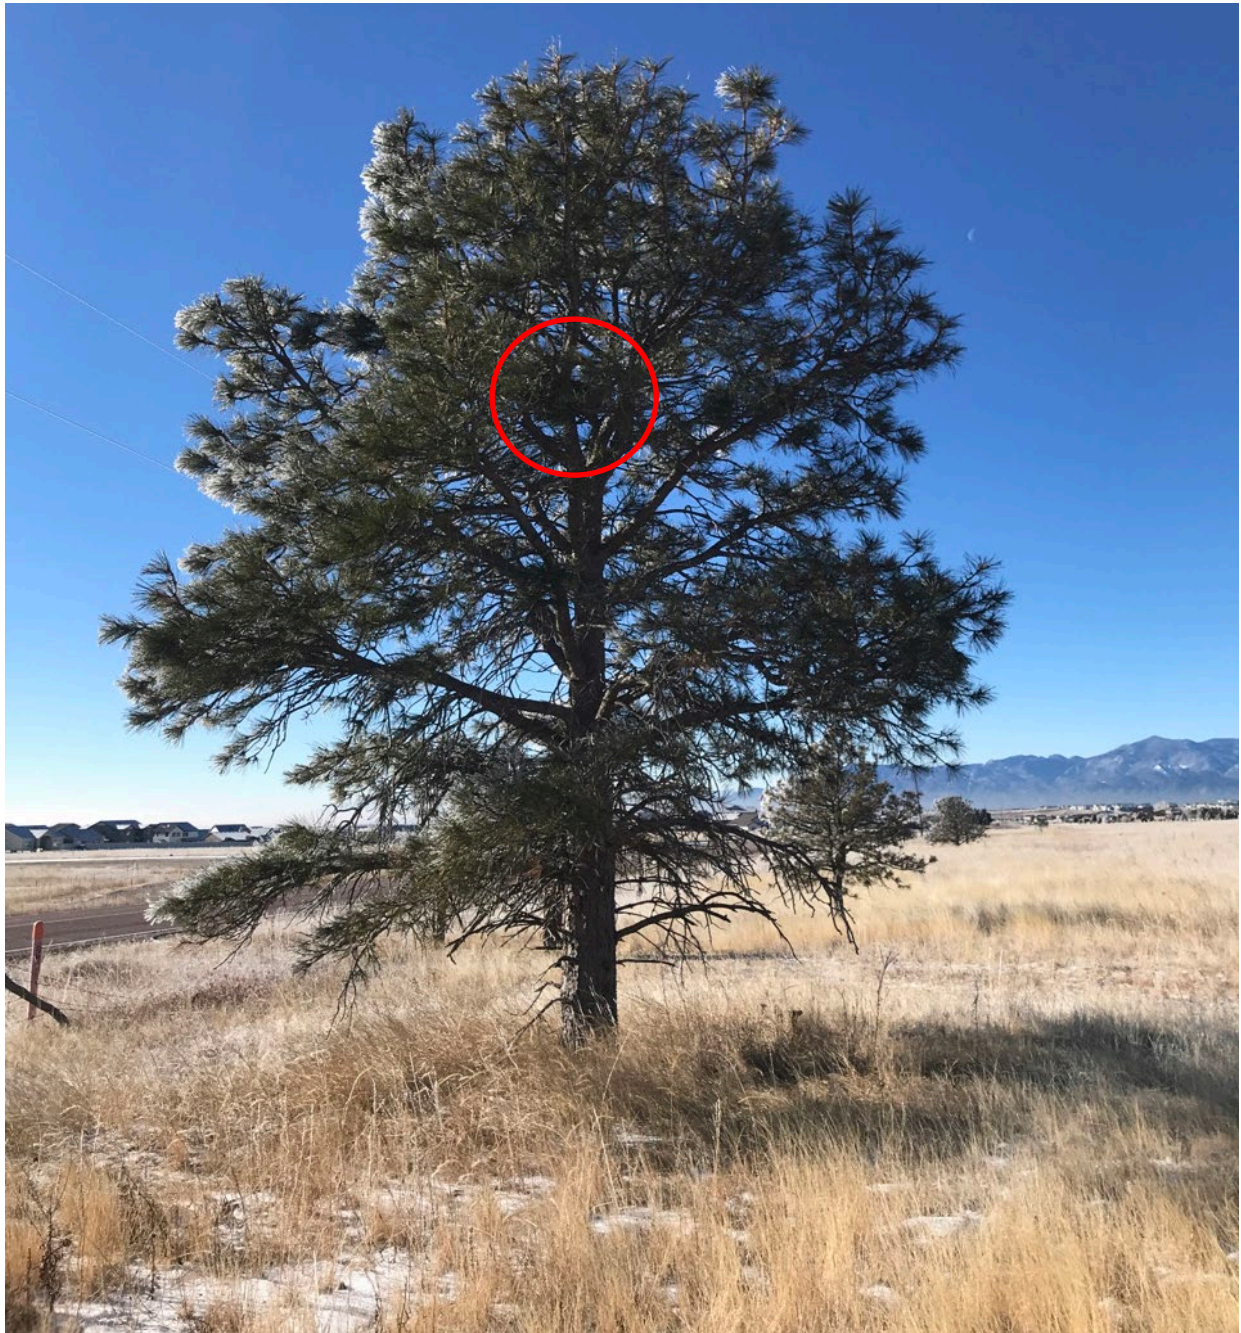
Photo ID	Date	Latitude	Longitude	Subject	Direction Taken
Raptor Nest 4	1/26/2022	38.970957	-104.671537	Inactive Raptor Nest	South
Description: Inactive raptor nest in a ponderosa pine along Vollmer Road.
