SUBJECT: No Permit Required – Palmer Solar (Action No. SPA-2018-00184-SCO)

Palmer Solar Facility Wetland Delineation Report

El Paso County, Colorado

June 2018

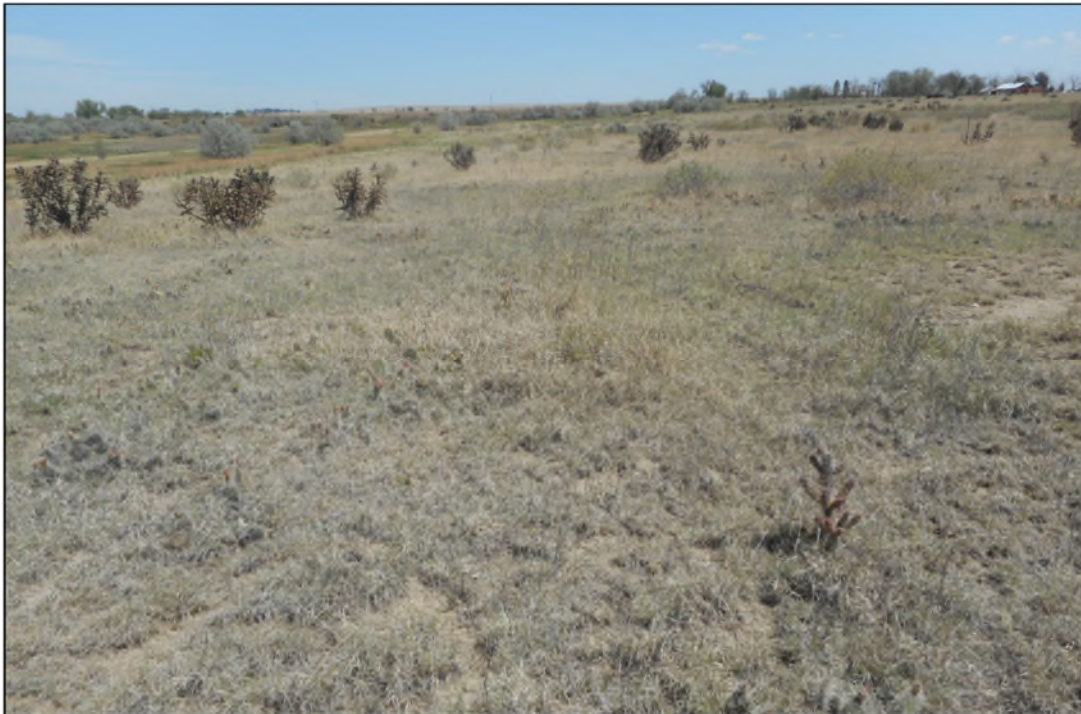
Photo 1: From eastern pole location, looking north/northeast. 6-8-18

The E & E ecologist walked the entire eastern pole location provided by JSI and did not observe any indications of wetlands. Dominant vegetation includes three upland species common to the area: blue grama (*Bouteloua gracilis*), plains prickly pear (*Opuntia polyacantha*), and Cholla cactus (*Opuntia imbricata*) (Attachment A, Photos 1 and 2).

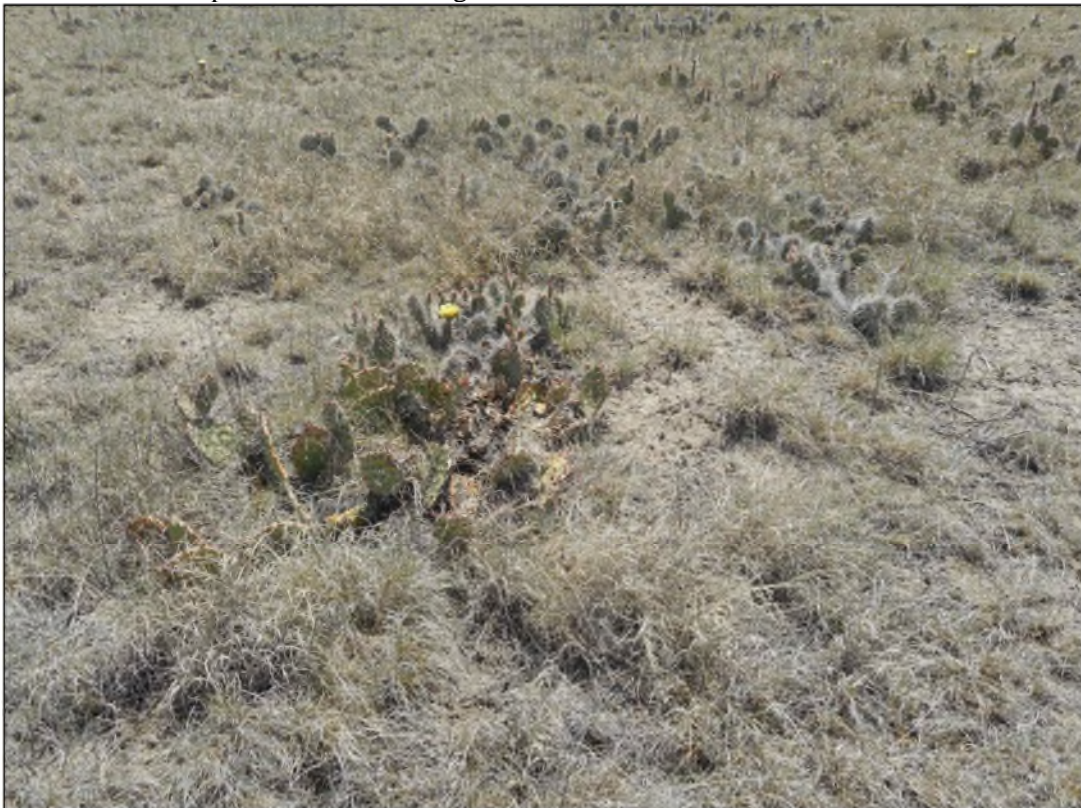
Photo 2: Close-up photo of ground and vegetation, from eastern pole location. 6-8-18

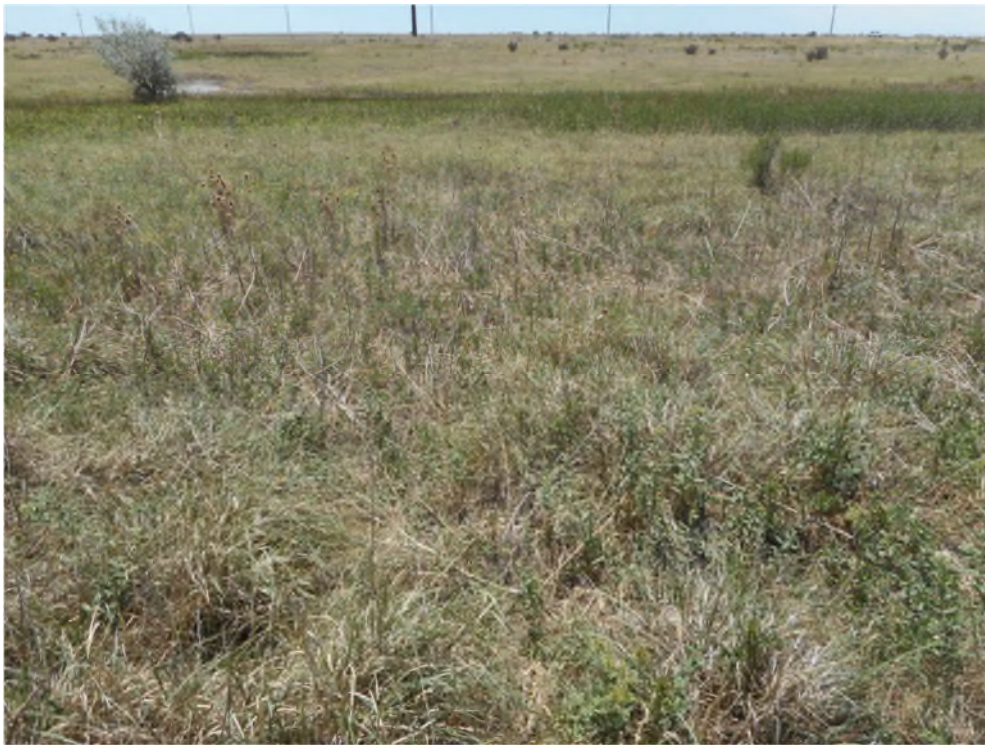
Photo 3: From western pole location, looking east. For visual comparison, wetland is in upper center of photo. 6-8-18

Because it is adjacent to the eastern pole location and identified by the NWI, the ditch that is east of the intermittent stream was examined for wetland characteristics (Attachment A, Photo 3). At Sampling Point 1, which is in the ditch bottom, vegetation was inventoried, a soil sample pit was dug, and signs of hydrology were observed. All wetland indicators were negative, with the exception of 20% cover of one vegetation species that occurs in wetlands (Table 1, Figure 1). However, the presence of a relatively small percentage of cover of wetland vegetation was not sufficient to define the ditch as a wetland. The data sheet from this sampling point is provided in Attachment B.

The western pole location also occurs within an upland. The area is higher in elevation than a nearby wetland, and the soils are dry (Attachment A, Photo 3). The wetland indicator status of the dominant vegetation species, alkali sacaton (*Sporobolus airoides*), is that it could occur either in a wetland or an upland (Table 1, Figure 1). The lack of hydrology and surface water indicate that the vegetation may be responding to fluctuating water table elevations. However, the three wetland indicators are not all present.

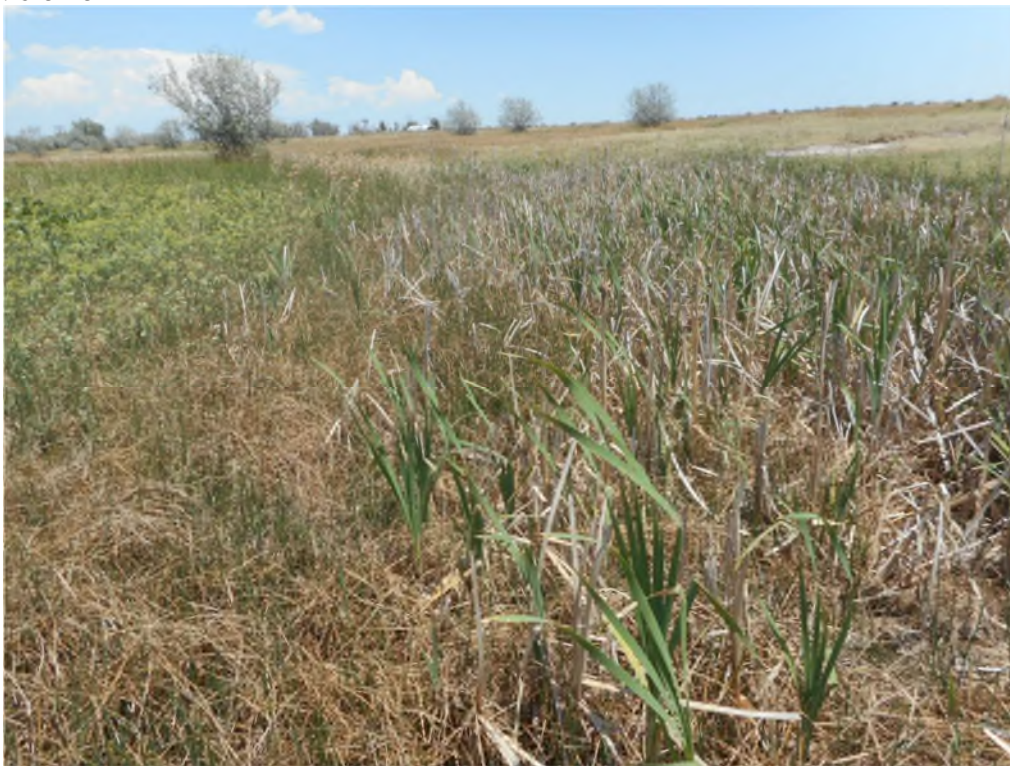
Photo 4: Sampling Point 2, view upstream. 6-8-18

Dominant vegetation at Sampling Point 2 consists of two species: broadleaf cattail (*Typha latifolia*) and common threesquare (*Schoenoplectus pungens*; Attachment A, Photo 4). Both species are hydric (Table 1). Soils showed three different hydric indicators: a dark brown/black matrix; rust-colored patches (when soil is saturated for long periods, iron present in the soil oxidizes and becomes concentrated in patches and along root channels and other parts); and gleying (grayish-colored patches that result from water saturation) (Attachment A, Photo 5). Indicators of the presence of wetland hydrology are a trickle of water near the center of the wetland area and soil saturation within the top 3 inches.

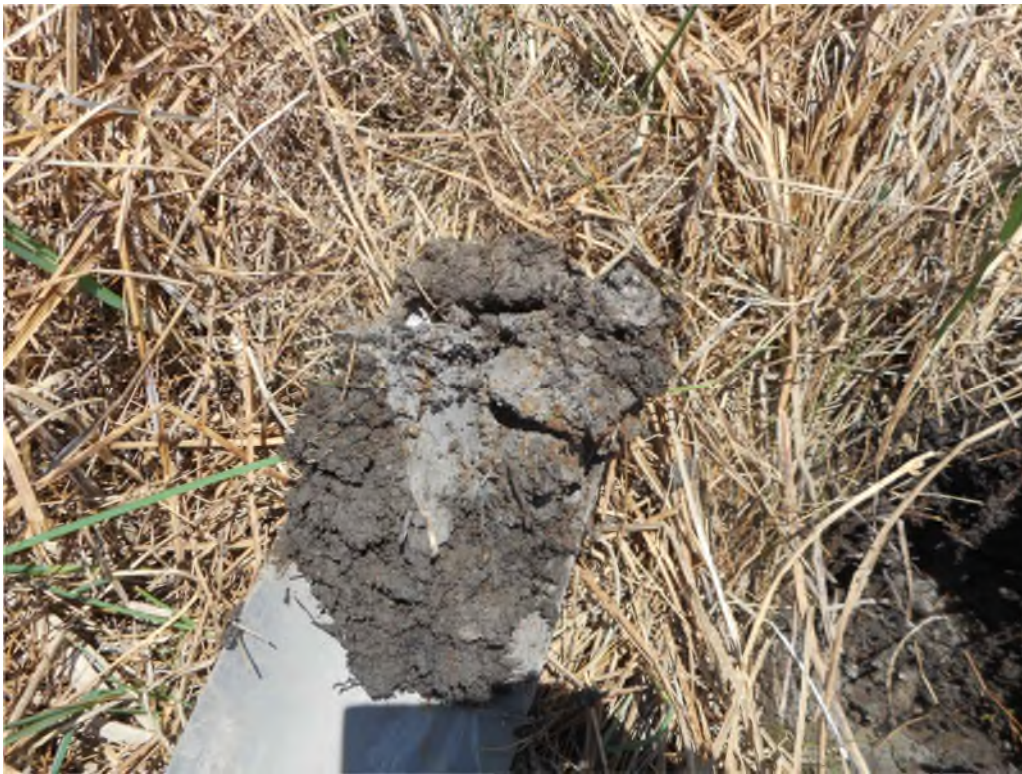
Photo 5: Hydric soils at Sampling Point 2. 6-8-18

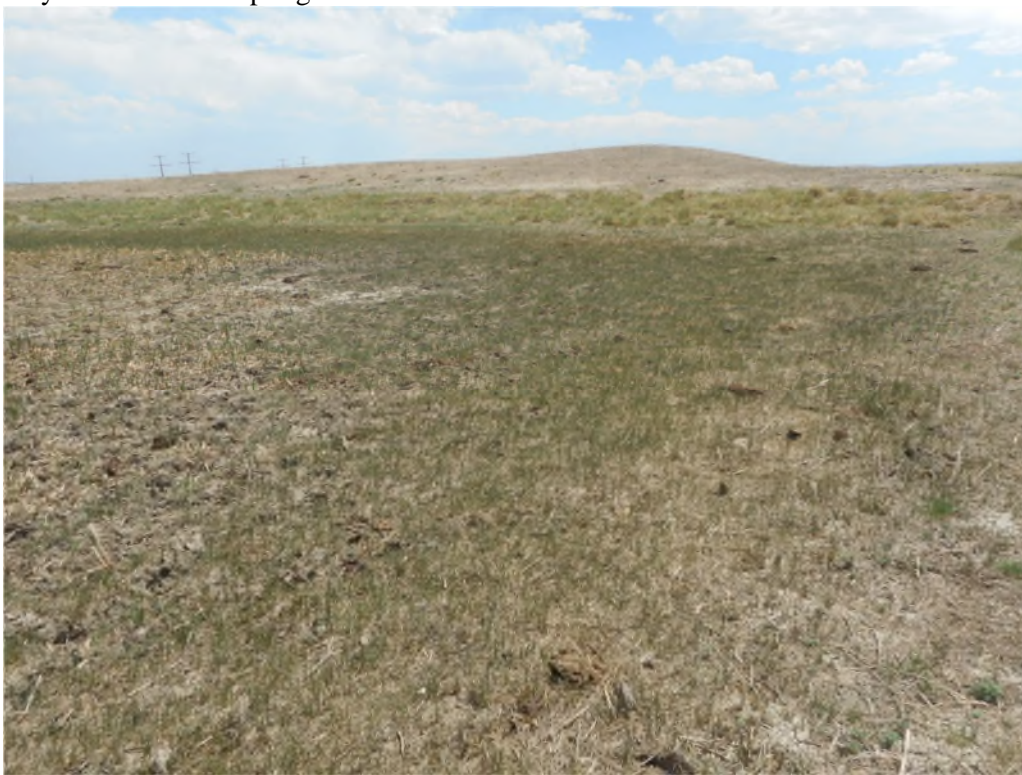
Photo 6: Stock Pond 1 soil surface and vegetation. 6-8-18

The NWI area at the downstream/west end of the intermittent drainage appears to have not held water in the recent past. No water is present, and soils are dry (Attachment A, Photos 6 and 7). Hydric vegetation is present: broadleaf cattail and arctic rush (*Juncus arcticus*). Yet, due to the lack of supporting hydrology, their heights are a fraction of the normal height were they to occur in wetlands, and they appear to be sprouting from remnant root stock.

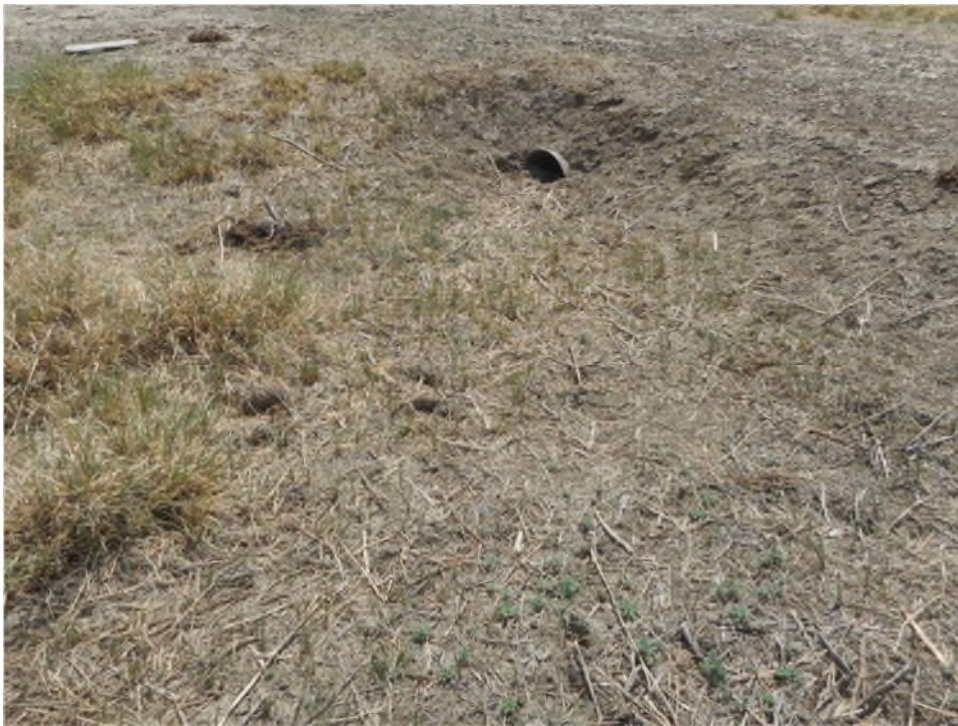
Photo 7: Stock Pond 1 outlet. 6-8-18

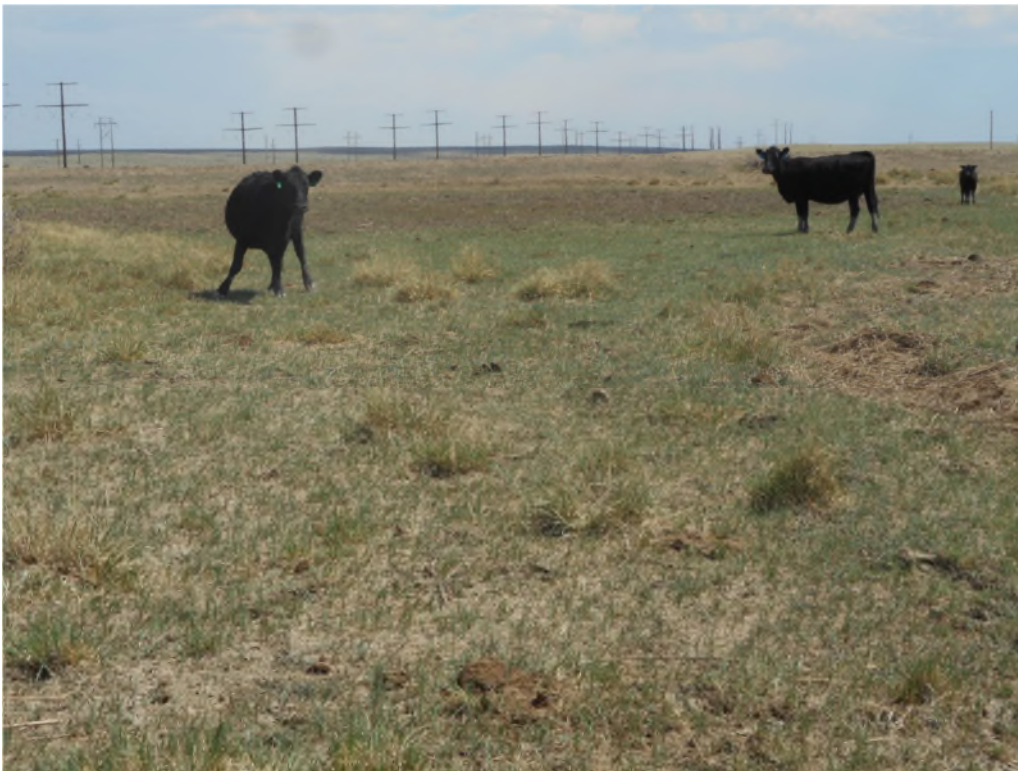
Photo 8: Stock Pond 2. 6-8-18

The NWI area at the upstream end of the intermittent drainage also shows no indication of having held water recently (Attachment A, Photo 8). Hydric soils, hydric vegetation, and a source of hydrology were not observed. The drainage leading into the former stock pond also exhibits no indicators of recent water flow (Attachment A, Photo 9).

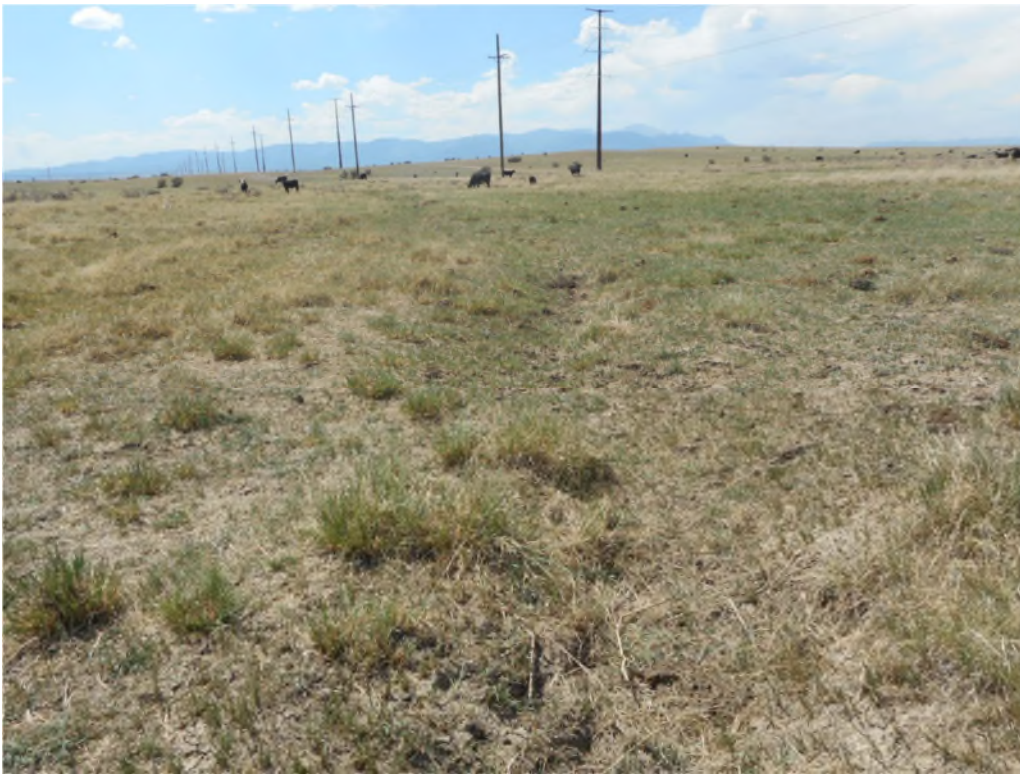
Photo 9: Intermittent drainage (in center of photo) approximately 100' upstream of Former Stock Pond 2. 6-8-18
