## **NATURAL FEATURES AND WETLANDS REPORT**

***Church at Bent Grass Meadows Drive  
El Paso County, CO***

Revised July 13, 2026

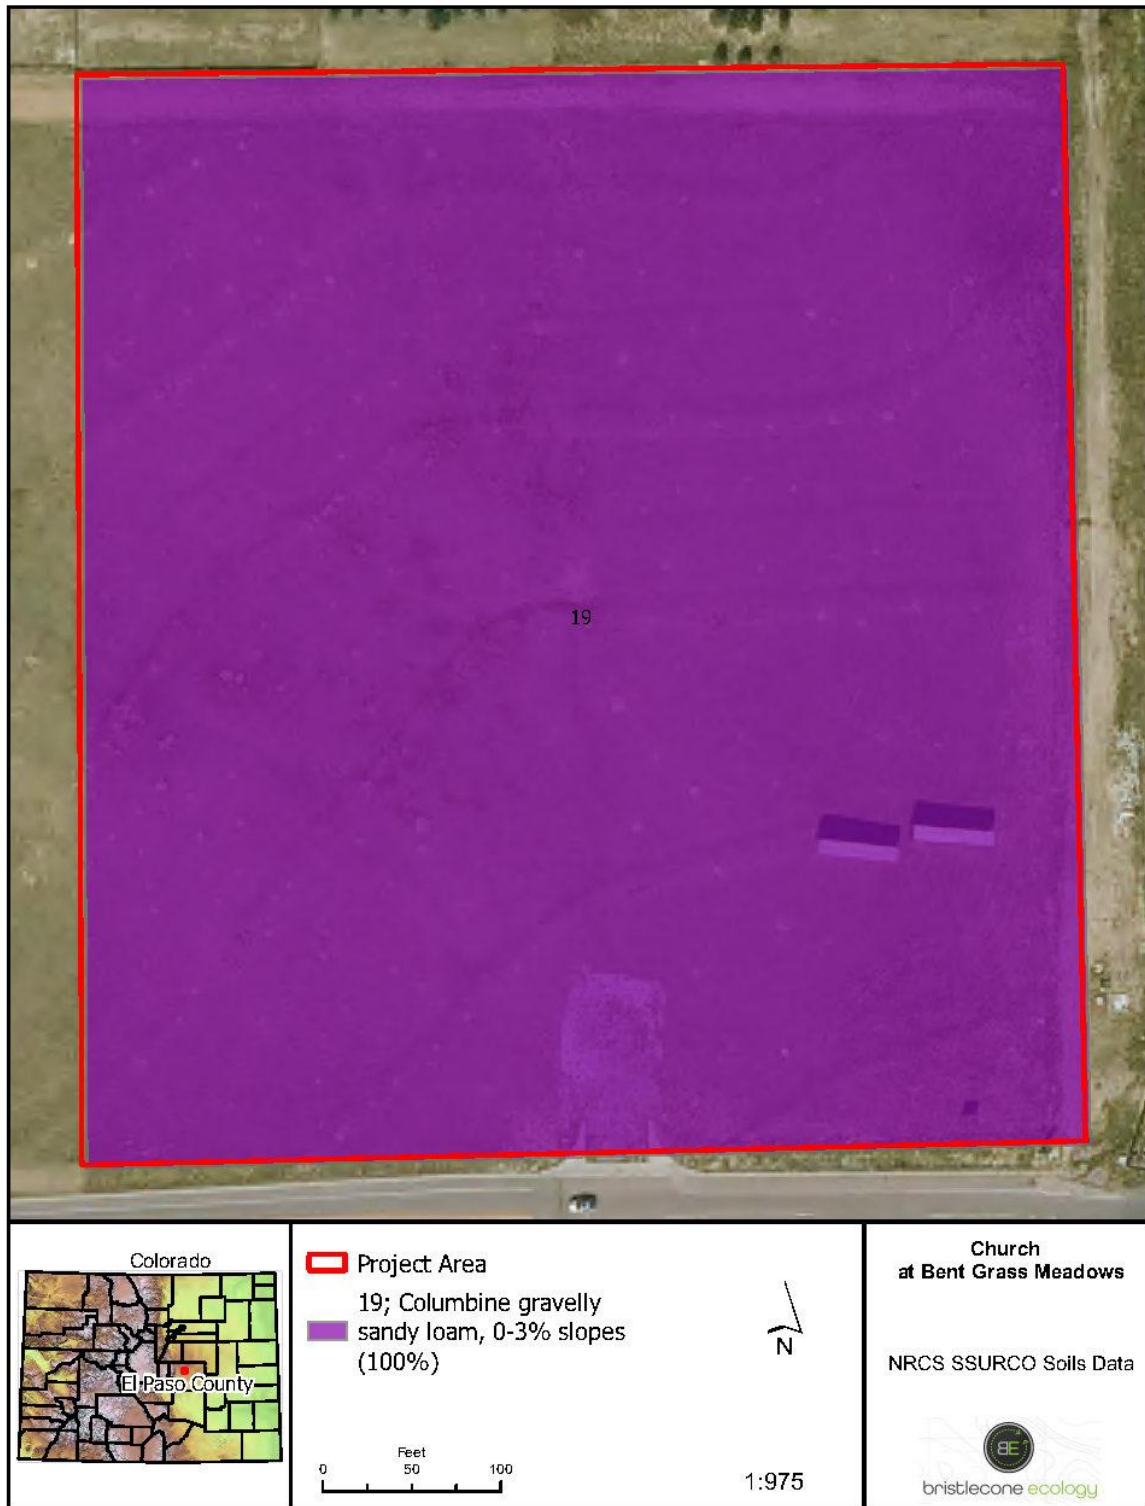
**Figure 2: NRCS SSURGO Soils Data**

Soil survey data and reports were reviewed to determine the potential for the presence of geologic hazards within the Project (NRCS 2024a). County soil survey data indicate that the site is composed entirely of Columbine gravelly sandy loam (0 to 3 percent slopes; 100% of Project area) (NRCS 2024a) (**Figure 2: NRCS SSURGO Soils Data**). This soil is the primary series occupying the Project area; there are also minor components (called “inclusions”) within each series or consociation that could contribute to the overall soil composition at the site.

B.E. reviewed the hydric soil ratings for all soil components present on the Project site to aid in the identification of wetland habitats during the site reconnaissance. Hydric soils are those that form under conditions of saturation, flooding, or ponding long enough during the growing season to develop anaerobic conditions, and their formation is required in order for wetlands to become established. The Columbine soil series occurring on the site are described as having a low hydric rating in El Paso County, with a hydric rating of 2. Hydric ratings are on a scale of 1 to 100, with 100 having greater hydric components and zero having no hydric components (NRCS 2024a). The Pleasant soil series, a minor component of some of the primary series on the site, is rated as hydric in El Paso County and is typically found in depressions and drainages where ponding can regularly occur (NRCS 2024c). Pleasant soil is not likely to be found within the site. Based on these ratings, the overall suitability of the site for the development of hydric soils, and thus the presence of wetlands, is very low.

The Columbine soil series is grouped into Hydrologic Group A (NRCS 2024d). The 'A' grouping includes soils that have a high infiltration rate, which results in the soil having a corresponding high rate of surface and ground water transmission. Additional, detailed soil data for the Project will be presented in a soils/geology/geotechnical report that will be submitted separately.

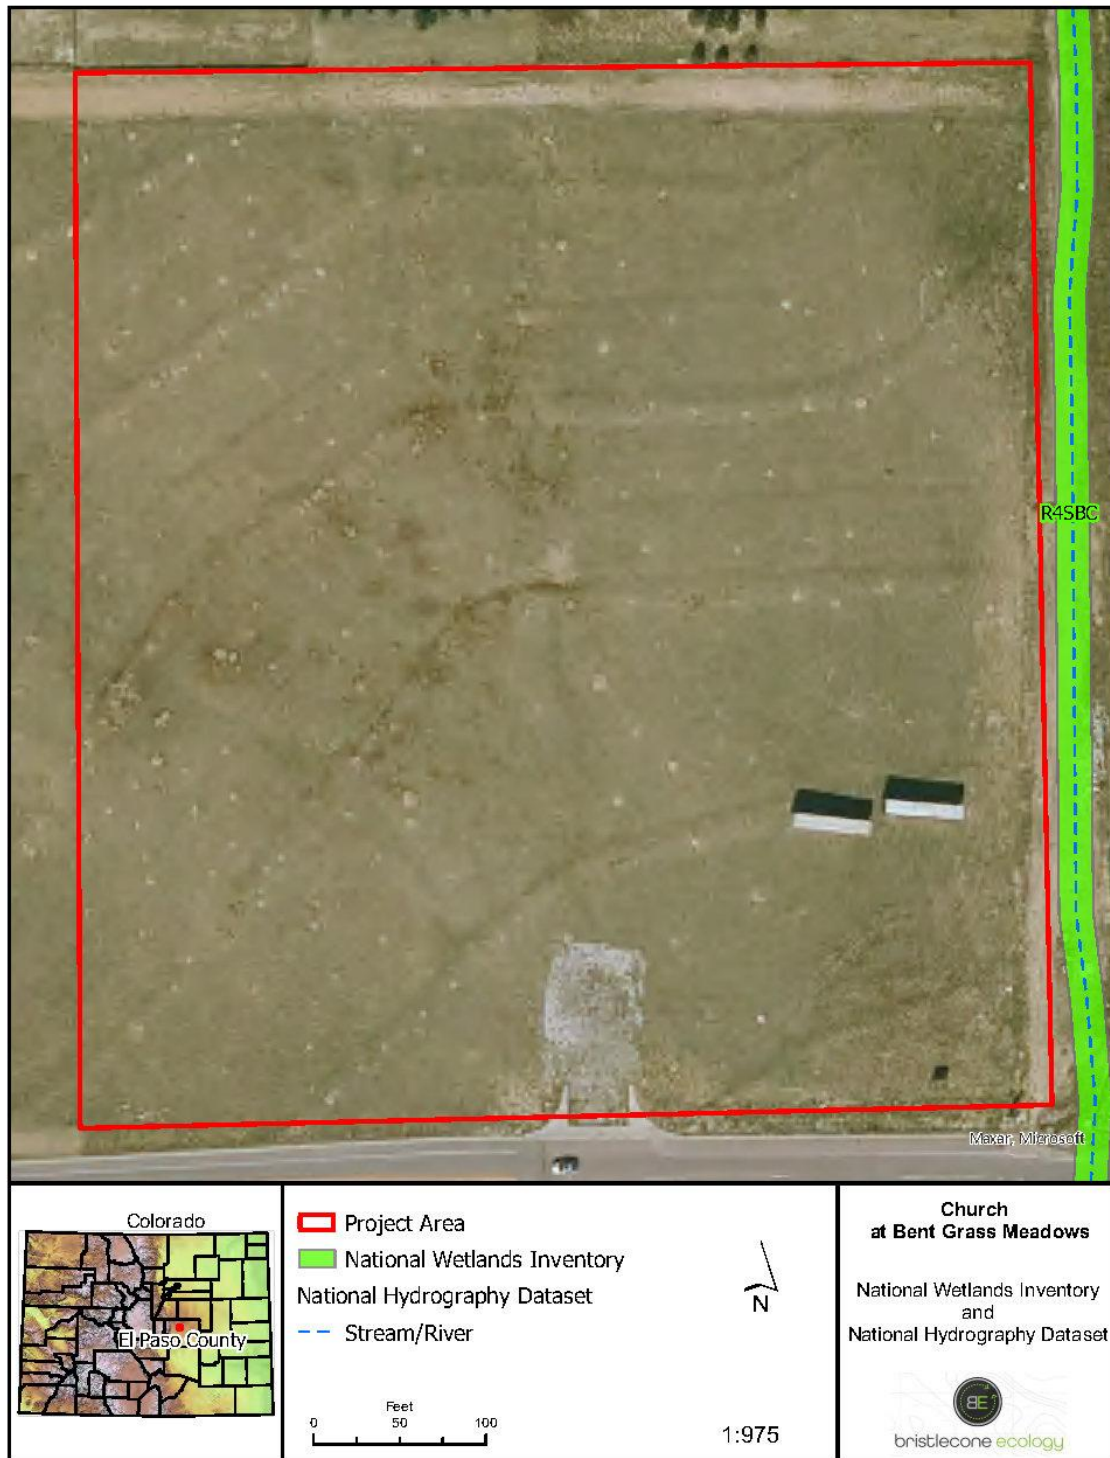
**Figure 3: Aquatic Resources Desktop Review**

Aquatic resources include jurisdictional wetlands and other regulated WOTUS such as streams/rivers, ponds/lakes, and ditches, as well as non-regulated wetlands, streams/rivers, ponds/lakes, ditches, and other surface water features. The USFWS' NWI and USGS' NHD datasets were reviewed for the possible presence of wetlands and streams, respectively, within the Project Area. Aerial imagery (USDA 2019 and Google 2021) was reviewed to locate aquatic features not depicted in the NWI and NHD datasets. NHD and NWI data are notoriously inaccurate, necessitating field inspection to verify the presence or absence of the resources depicted in these datasets. A ditch along Meridian Road was shown in both the NHD and NWI data, listed as R4SBC in the NWI data, located just east of the site (**Figure 3: Aquatic Resources Desktop Review**). No aquatic features were depicted in the data occurring within the site, as shown in **Figure 3**.

Because these desktop data are often inaccurate, the site was also inspected in the field to confirm the absence of aquatic features as depicted in the NHD and NWI data. The site survey confirmed there were no wetlands, streams, or other aquatic resources present on site (see **Appendix A: Photographic Log**).

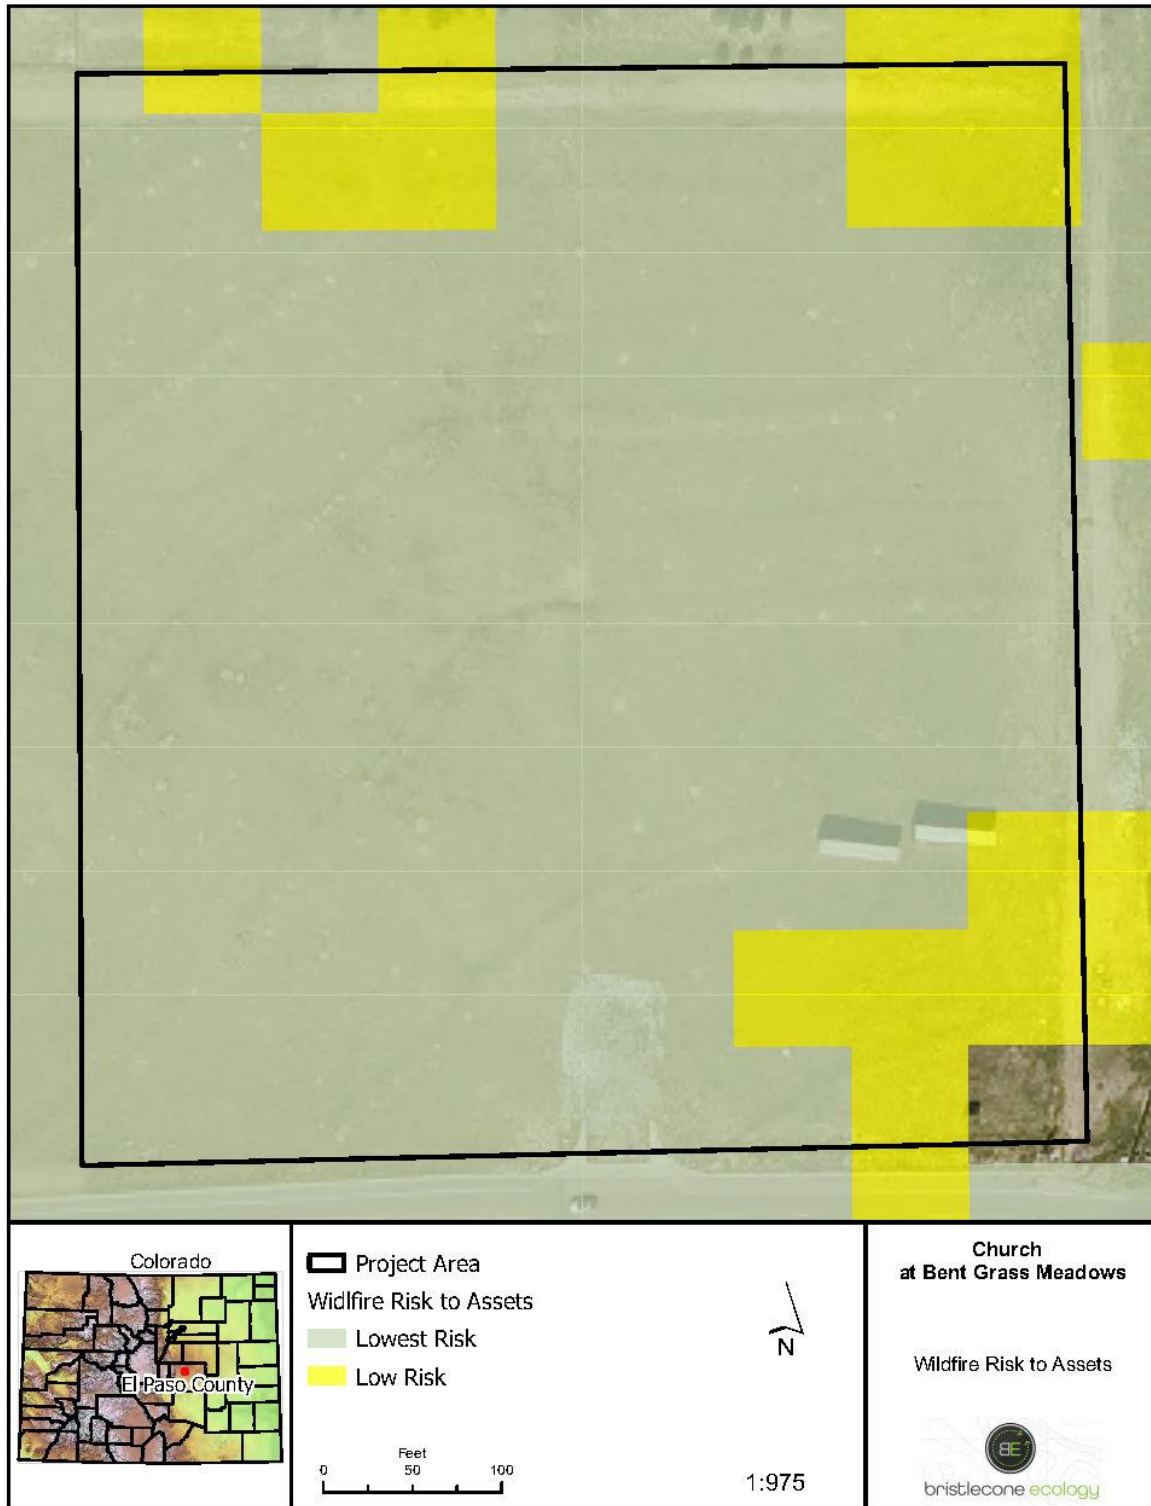
**Figure 4: Wildfire Risk to Assets**

According to WRAP, the Wildfire Risk to Assets at the site is primarily "Lowest Risk" (about 90% of the site), while the remainder of the site is rated as "Low" (about 10% of the site) (CSFS 2020; **Figure 4: Wildfire Risk to Assets**). "Wildfire Risk to Assets" is determined by CSFS by combining the burn probability rating of a site with the values-at-risk rating. While the Project site has a low to very low rating of values and assets that would be adversely impacted by wildfire, the burn probability for the entirety of the site is rated Level 5, or "Moderate" (CSFS 2020; **Figure 5: Wildfire Burn Probability**). The Fire Intensity rating throughout the site is Low to Moderate (CSFS 2020; **Figure 6: Fire Intensity Rating**).

Based on observations during the site visit, B.E. believes the WRAP estimates the Wildfire Risk to Assets accurately, while the Burn Probability and Fire Intensity ratings are overestimated by the WRAP. There is little grass on the site, with buffalograss comprising almost the entirety of the grass that is present. The grass is kept low and thin by the presence of numerous prairie dogs that cover the entire property. The site is best categorized as under Fuel Model 1 described as:

Roughly 90% of the Project area is mapped as ‘Lowest’ wildfire risk to assets while the remaining 10% is mapped as ‘Low’ risk. There is little difference in vegetation composition between the ‘Low’ and ‘Lowest’ risk portions of the site. The site is rated ‘Low’ in terms of values and assets present that could be lost to wildfire, however, it is rated ‘Moderate’ in terms of burn probability based on the available fuels at the site, which includes disturbed and undisturbed weedy grasslands. Fire intensity at the site is rated ‘Low to ‘Moderate throughout the site. B.E., upon analyzing the site’s topography, vegetative composition and cover, and connectivity to habitats with moderate or higher burn probability, proposed a ‘Low’ rating throughout the site for both Burn Probability and Fire Intensity. Fire Intensity and Burn Probability are also highly dependent upon atmospheric conditions at the time of a fire; in a Fuel Model 1, GR 2 (Low Load, Dry Climate Grass) system, recent weather plays a heightened role, which hourly moisture lag times for grasses (versus 1,000-hour lag times for timber).

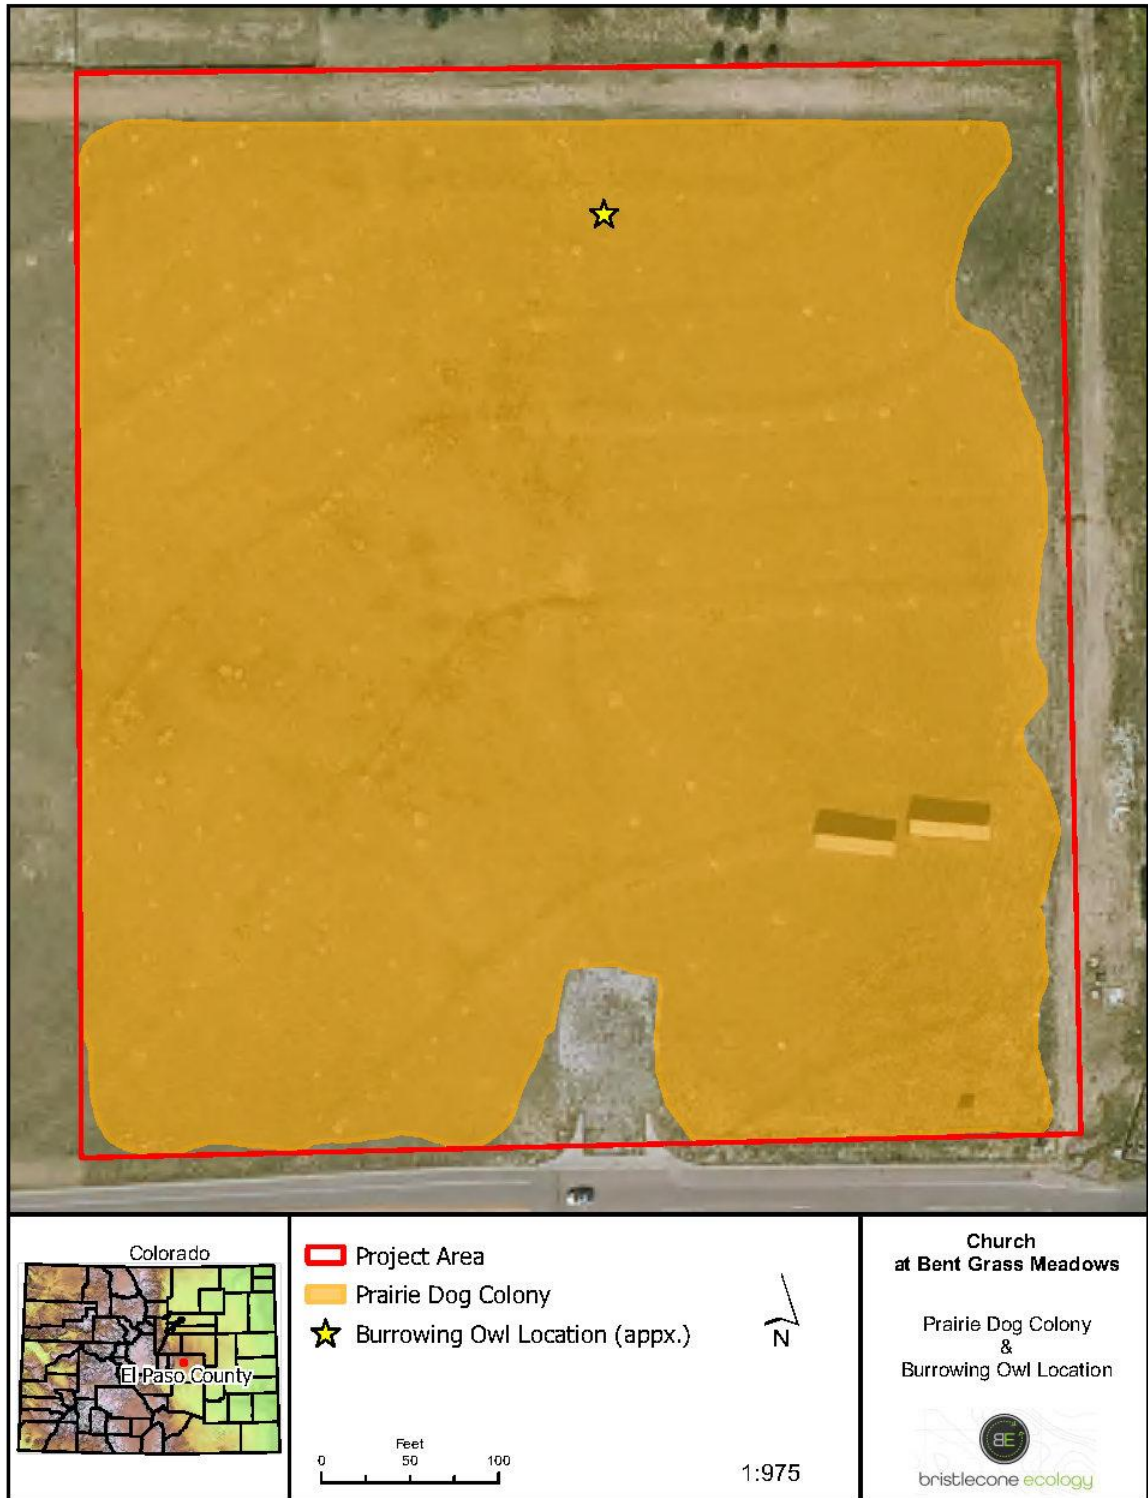
**Figure 8: Black Tailed Prairie Dog & Burrowing Owl Location Map**

In terms of sensitive species, some of the species listed in the SAM data likely occur on the site, though few of the species listed were observed. The majority are either not expected to occur or may occur only rarely based on the limited habitat available. Black-tailed prairie dogs, a state species of concern, were observed during the site reconnaissance; a rough count of 34 individuals during the reconnaissance is likely an underestimate. An approximately 6.8-acre colony was mapped during the site visit (**Figure 8: Black-tailed Prairie Dog & Burrowing Owl Location Map**). The

site is thus also suitable for the state-threatened burrowing owl (*Athene cunicularia*), which uses abandoned prairie dog burrows for nesting. One burrowing owl was observed during the site visit, and a formal survey may be necessary to confirm whether burrowing owls are inhabiting the prairie dog colony prior to construction (**Figure 8**). Other state-listed and state sensitive species were not observed.

Nesting substrates for other migratory birds, including burrowing owls, are present in the form of open grasslands, which are expected to be used by some migratory birds during the breeding season. It is not known whether burrowing owls nest on the site, but one was observed utilizing a burrow during the site visit. This bird could have been a southbound migrant; further study would be required to determine if burrowing owls actively nest on the site. Burrowing owls are a state-listed species and are also protected under the MBTA. A focused survey for burrowing owls following CPW’s *Recommended Survey Protocol and Actions to Protect Nesting Burrowing Owls* (CPW 2008) is recommended to determine whether there are any active nests within the colony prior to construction.

If possible, it is recommended that vegetation clearing/grubbing/grading of the site occur outside of the nesting season (March 15<sup>th</sup> to July 31<sup>st</sup>) to avoid disturbing nesting migratory birds. If such timing restrictions are not possible, B.E. recommends conducting a migratory bird nesting survey during the nesting season to ensure impacts to nesting birds do not occur. In particular, ground

There is potential for general wildlife, including some big game such as pronghorn and possibly mule deer, to occur within the site. However, no big game migratory routes traverse the Project. In addition, ranges for several migratory birds, including the state-threatened burrowing owl, overlap the Project area, and habitat for burrowing owls is present based on the presence of black-tailed prairie dogs. A survey for burrowing owls is recommended prior to construction.

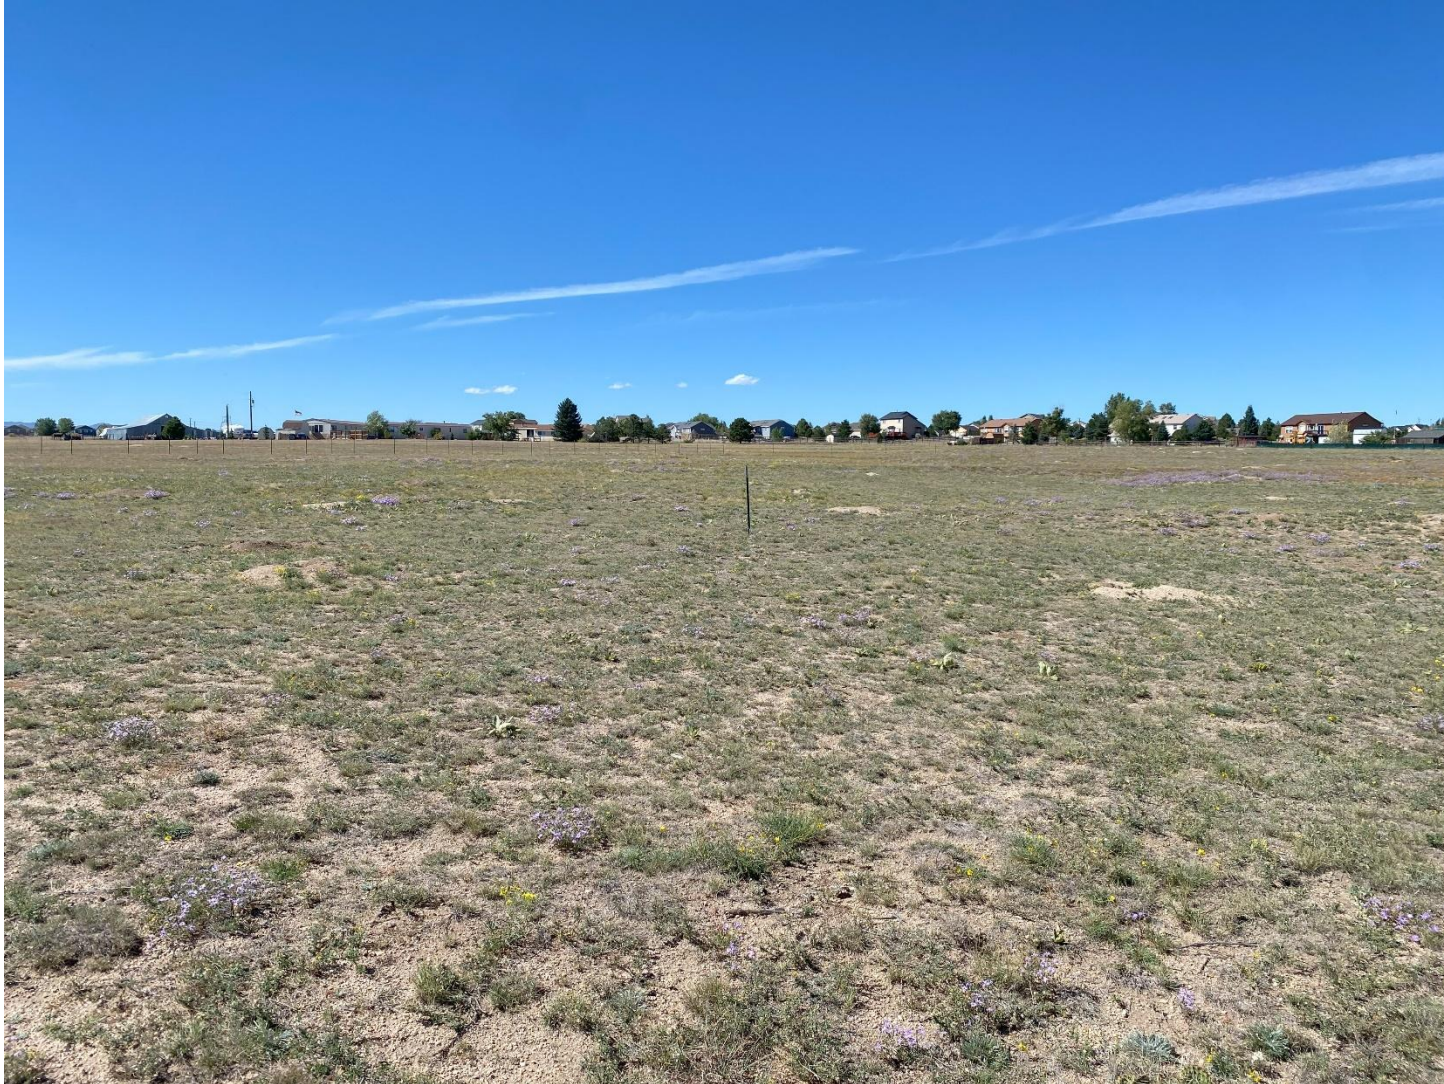
*PHOTO 1 – Overview of typical habitat at the site. Nearly the entire site is flat, weedy, sparsely vegetated, and inhabited by numerous black-tailed prairie dogs (burrows can be seen dotting the landscape).*

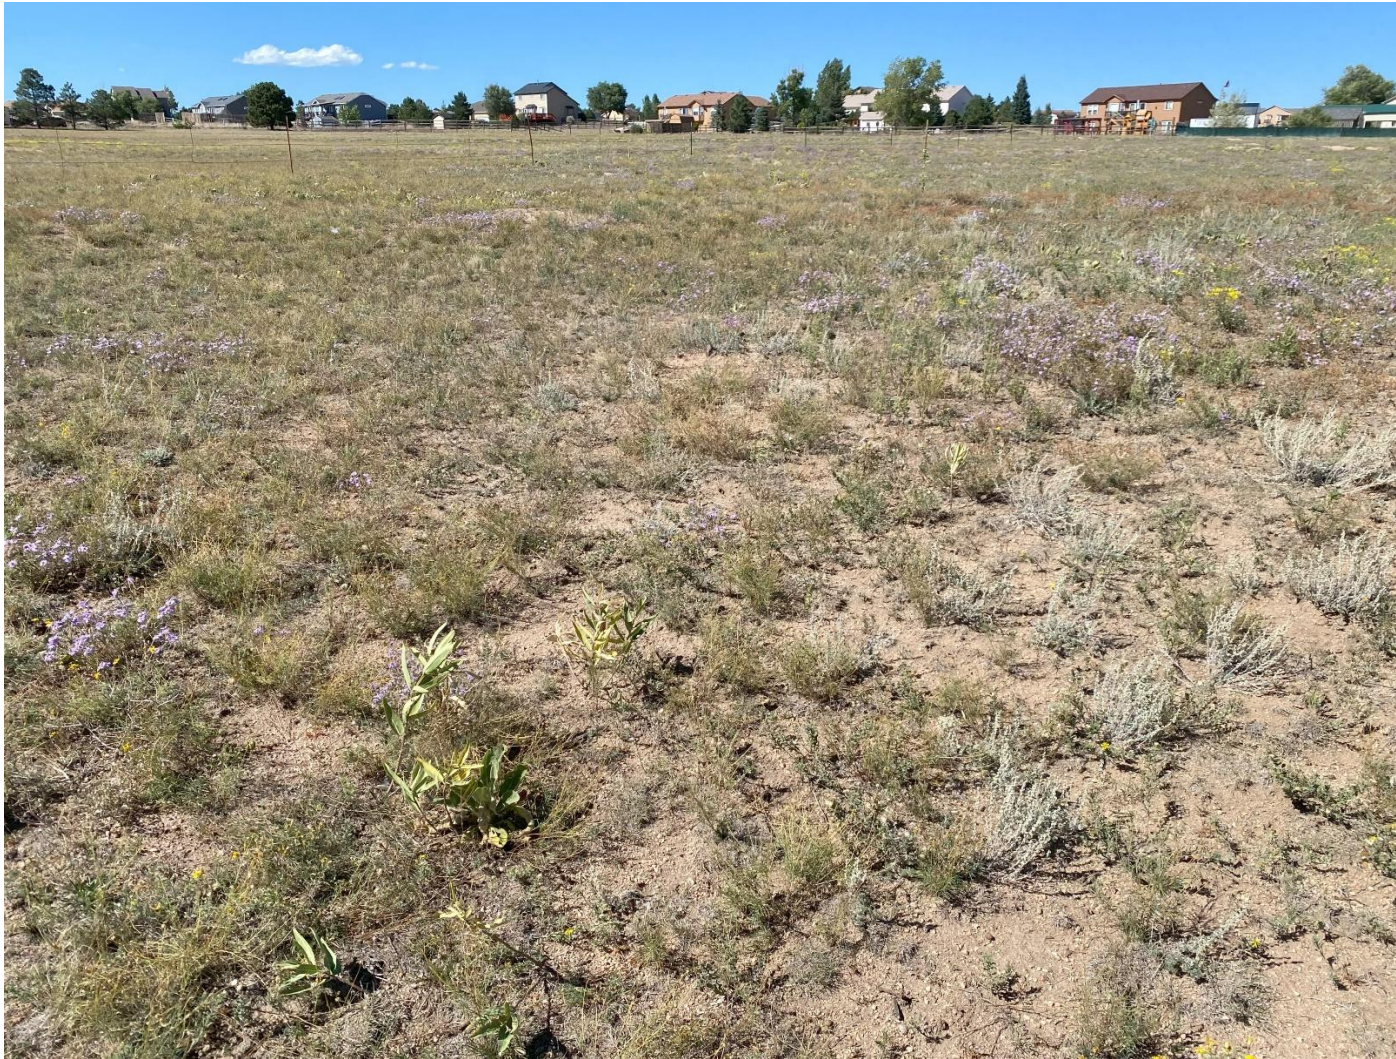
PHOTO 2 – View of the few showy milkweed (*Asclepias speciosa*) plants clustered in two locations at the site. There are perhaps a dozen plants in total, representing very minor potential habitat for monarch butterflies.

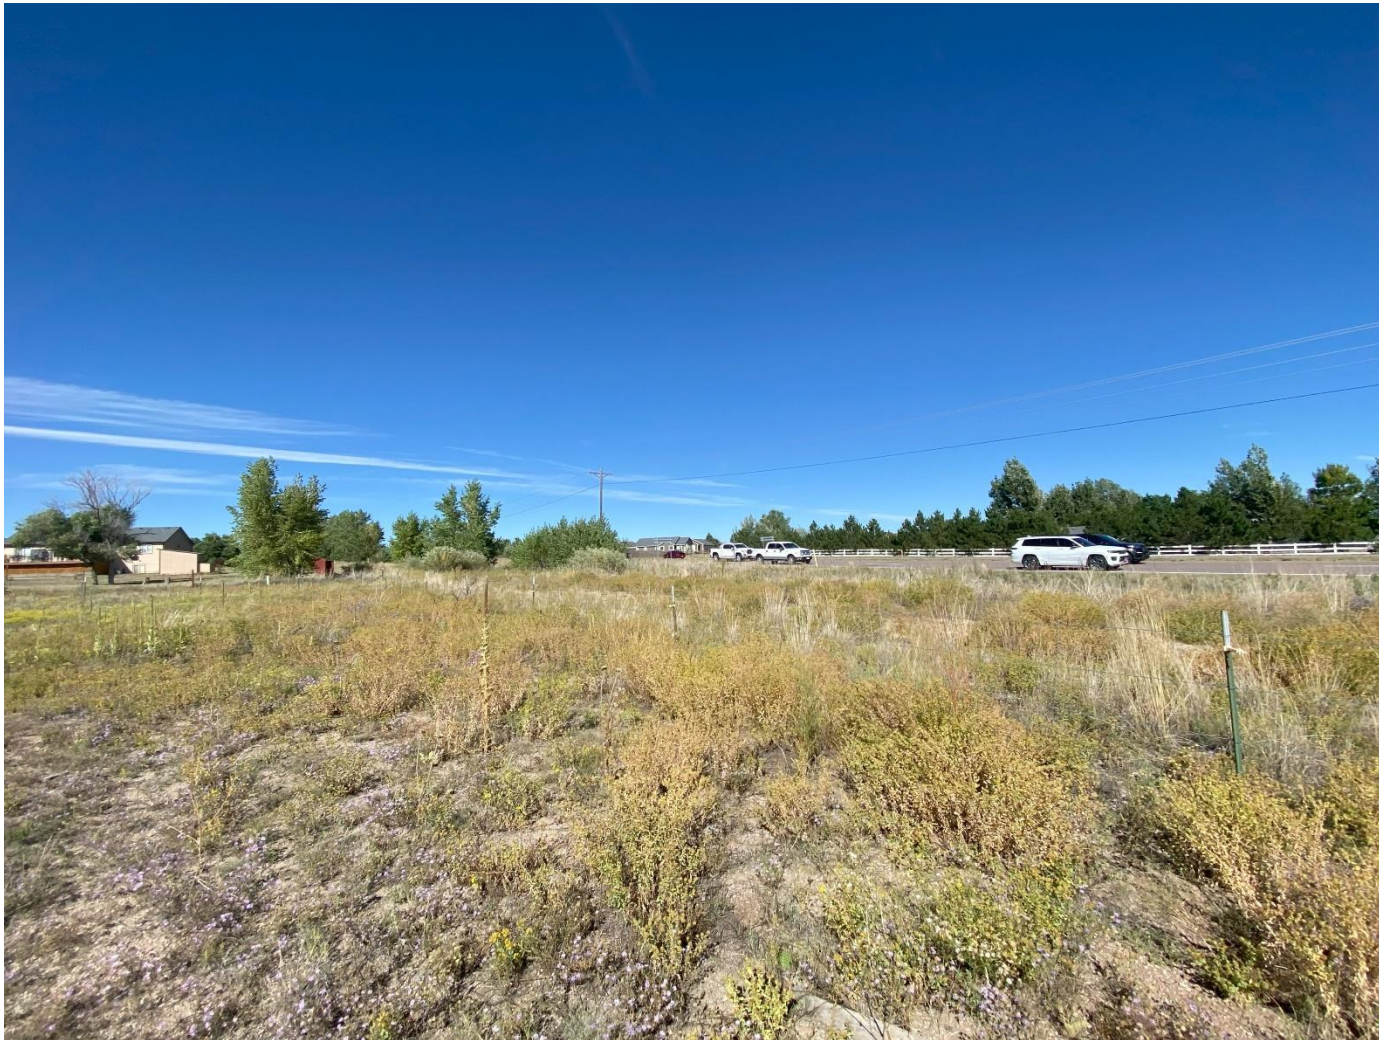
PHOTO 3 – View of the pocket of distinct habitat in the northeast corner where curlycup gumweed (*Grindelia squarosa*) is co-dominant; the rest of the site is uniform in terms of habitat.

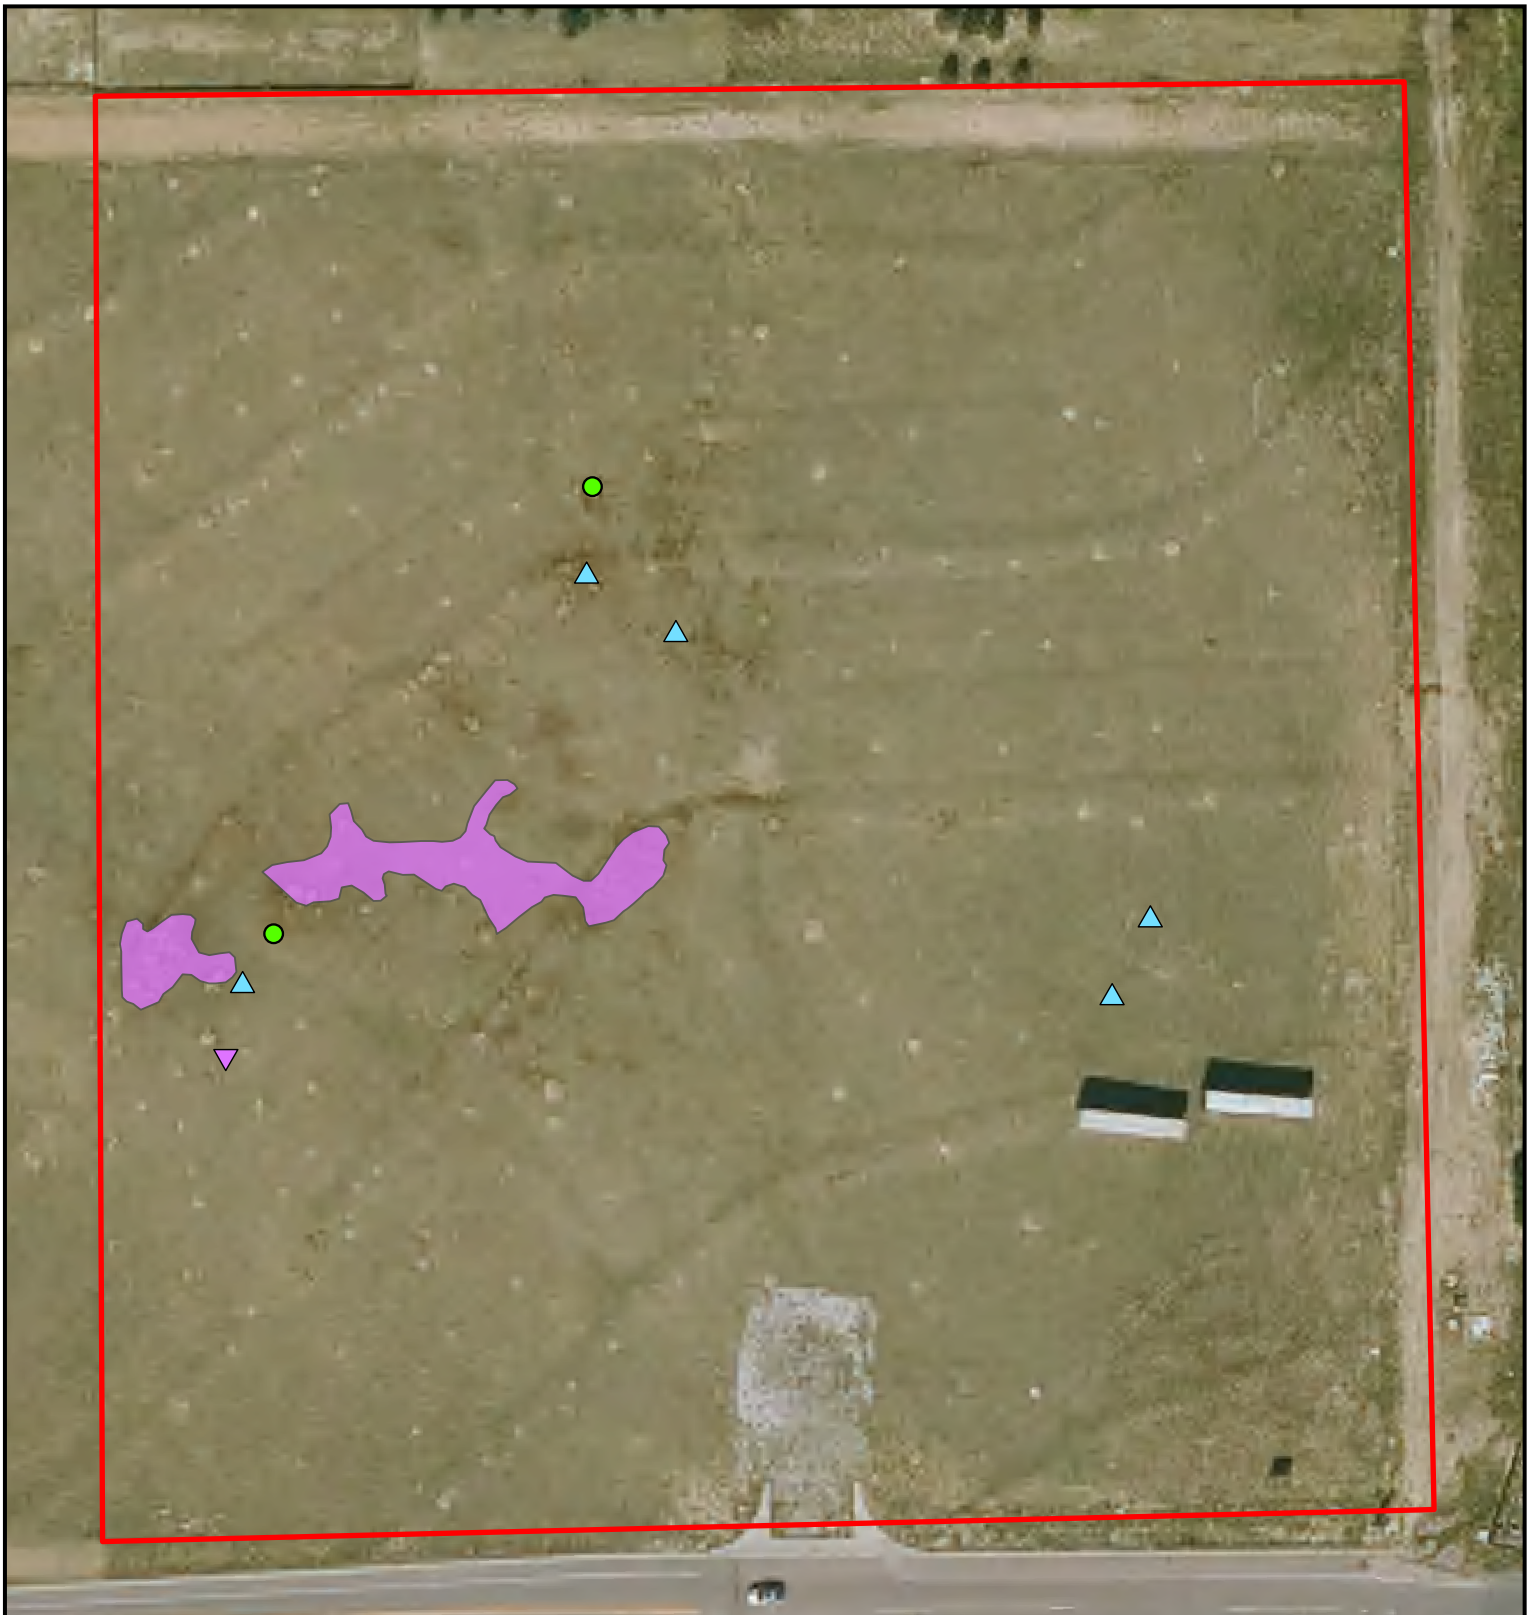
### VEGETATION AND NOXIOUS WEEDS MAP

B.E. surveyed the site for noxious weed infestations and mapped and inventoried any noxious weed populations observed. Noxious weeds are present on the Project site in several areas (**Appendix C: Vegetation Map**). Great mullein was abundant and well-established throughout the site. A few musk thistle individuals were also observed within the center third of the site, but no large populations were present (**Appendix C**). Musk thistle is a List B Noxious Weed while common mullein is a List C species (**Appendix B**).

The most common nuisance weed observed was Russian thistle, which was seen in small concentrations in the center of the western side of the site. Russian thistle is not a listed noxious weed in Colorado but could be treated during treatment for the other weeds.

Treatment should be performed as detailed in the sections above during or just before construction, and after construction has been completed. Post-construction maintenance treatments are an important part of maintaining a weed-free site. Treatment for great mullein and musk thistle is usually done chemically, with herbicide sprayed by a licensed applicator. Mullein can also be effectively controlled mechanically by removing the seed heads of existing plants in summer and spraying new rosettes in the spring.

Noxious weeds are present on the Project site in several areas with limited distribution. The only listed noxious weeds observed were musk thistle, a List B species, and great mullein, a List C species. Musk thistle was observed in limited quantities with sparse individuals spread throughout the center third of the site. Mechanical control of musk thistle may be effective, as it is suggested for infestations smaller than 0.5 acres (CDA 2016). Mechanical control includes tilling, hoeing and digging. Mowing, beheading, and chopping only stimulated more flower production and thus should not be applied. All flower buds and heads must be collected, bagged, and disposed of or destroyed (CDA 2016). Great mullein should be hand pulled, beheaded, and/or sprayed.
