Re: Cultural Resources Survey for proposed Tri-State Vollmer Transmission Line and MVEA Vollmer Substation and Access Road

Figure 1. Project Footprint and Area of Potential Effects for the Tri-State Vollmer Transmission Line

Figure 2. Project Footprint and Area of Potential Effects for the MVEA Vollmer Substation and Access Road

1. Report Title (include County): A Class III Cultural Resource Survey for the Tri-State Vollmer Transmission Line, El Paso County, Colorado.

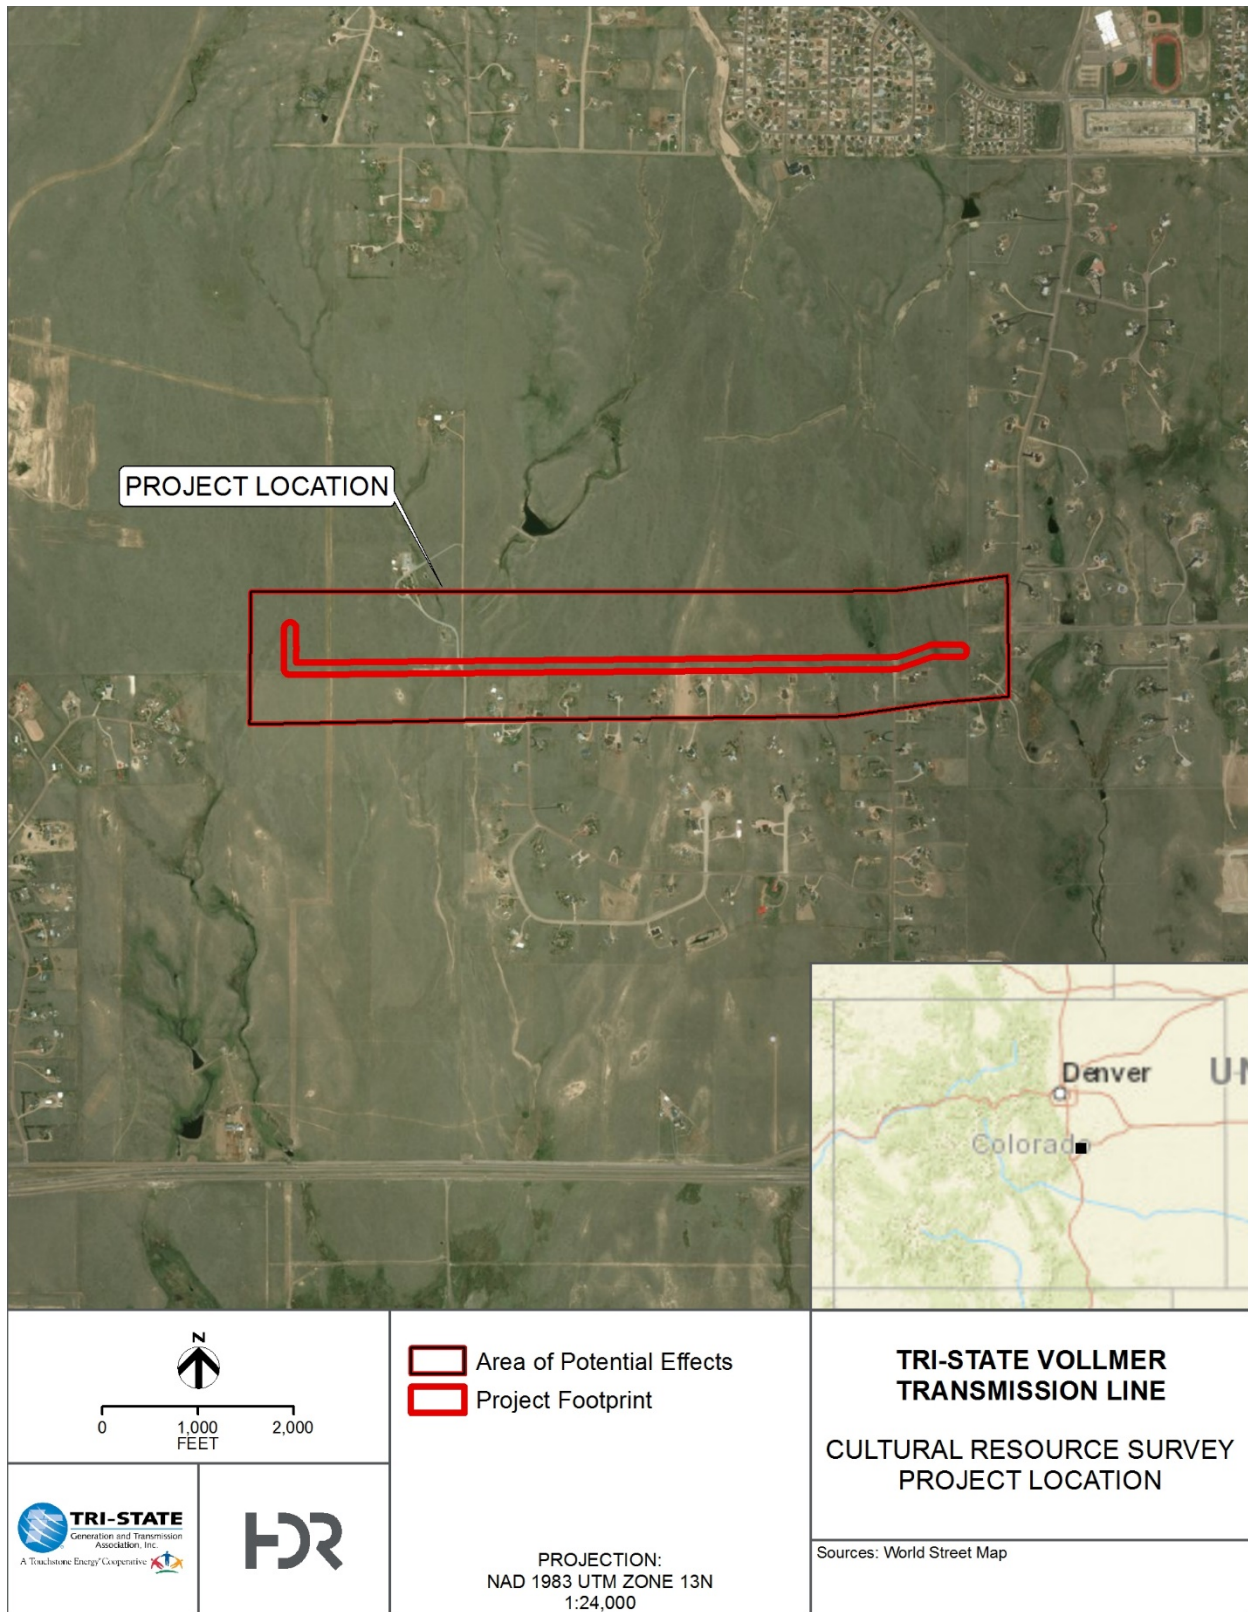
The archaeological survey for the proposed Tri-State 115 kV transmission line consisted of a 7,453-foot transmission line corridor with a 100-foot wide Right-of-Way (ROW) connecting an existing Tri-State transmission line at the east end of the project with the proposed MVEA Vollmer

substation (Figure 1). The total archaeological survey area for the project was 21.7 acres. The archaeological survey consisted of a 25-foot buffer on both sides of the ROW; the archaeological survey corridor was 150 feet wide. A desktop survey of historic built resources was conducted for the larger APE, and no resources were identified for field survey.

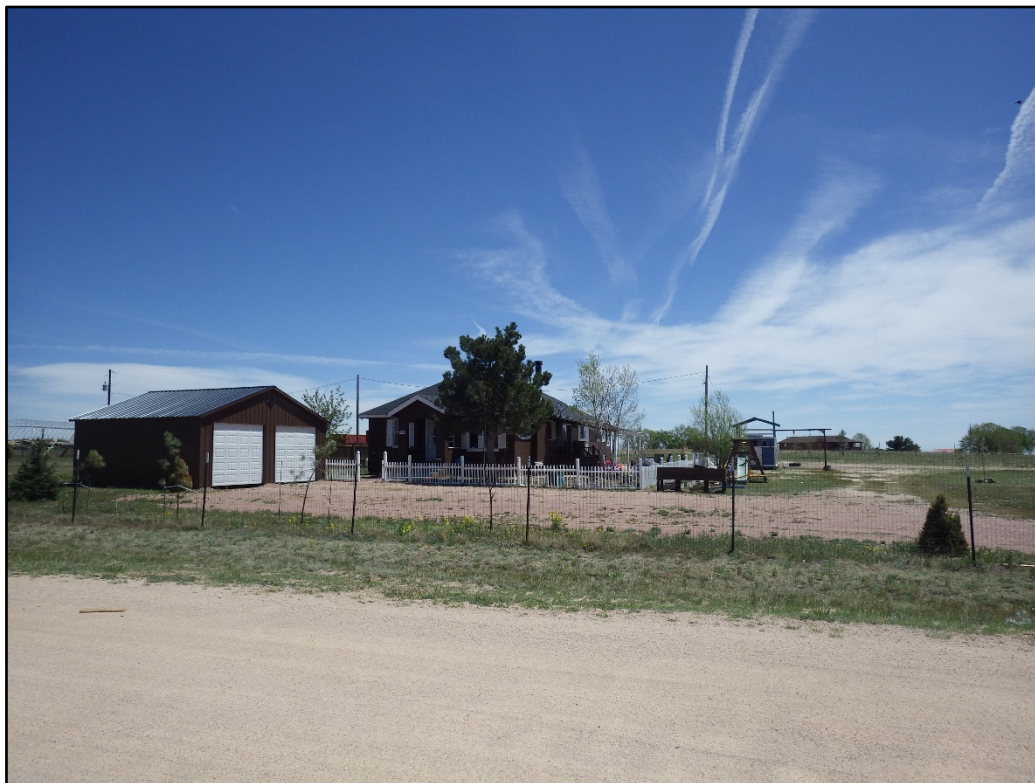
22. Architectural style/building type: Ranch
23. Landscaping or special setting features: The 5 acre property is in a rural area that is on the plains. The area has little topographic changes and is surrounded by agricultural lands. Pikes Peak is visible to the west. There are a few trees planted on the property and include aspens, a ponderosa pine, and small conifers. Other vegetation consists of bunch grasses and maintained lawn. The immediate area around the house is enclosed by a short, decorative picket fence, and the property is enclosed with hogwire and wood slat privacy fencing. The property is at the corner of Mohawk and Brule Roads. There are residential properties to the east, west, and south of the parcel. The eastern portion of the parcel has no buildings or structures.

5EP.8275 property overview looking east-northeast.

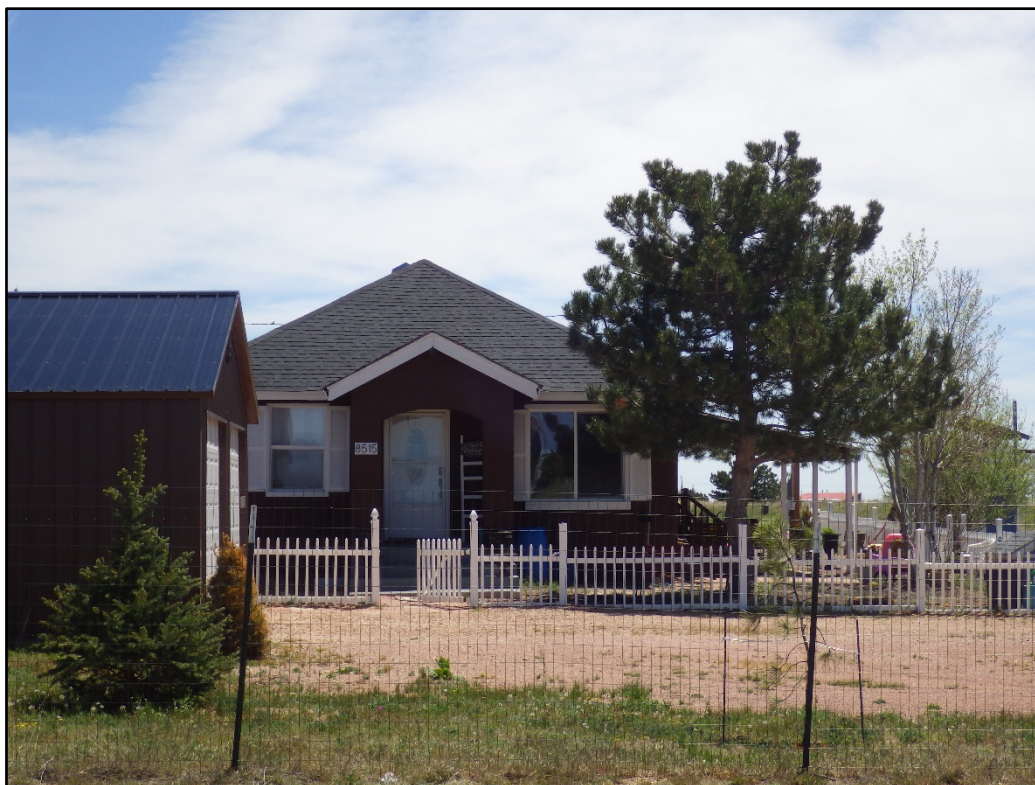
21. General architectural description: Site 5EP.8275 is a single-story, rectangular residence set on a concrete foundation with a hipped roof. The house is wood framed and clad with stucco. The west portion is the original ca. 1969-1970 house, and the east shed roof section was added in 1982. The main entrance is on the west façade where there is a front gabled porch with a raised concrete floor and steps. There are partial walls on the north and south sides of the porch. On the porch there is a single leaf door covered by a storm door. The porch is flanked by a vinyl double hung (north) and sliding (south) windows. The north elevation of the original portion has one sliding vinyl window and two double hung windows. The north and east elevations of the addition were not visible. The south elevation of the original portion has a covered porch with square post supports, and a shed roof on a concrete slab. There is a sliding door entry flanked by sliding vinyl windows. On the west side of the porch, there is an exterior wall chimney with exposed metal flue above the roof line. On the south elevation of the addition, there are two sliding vinyl windows. There is a second interior brick chimney that is between the original portion and addition.

5EP.8275 building 1 west façade.

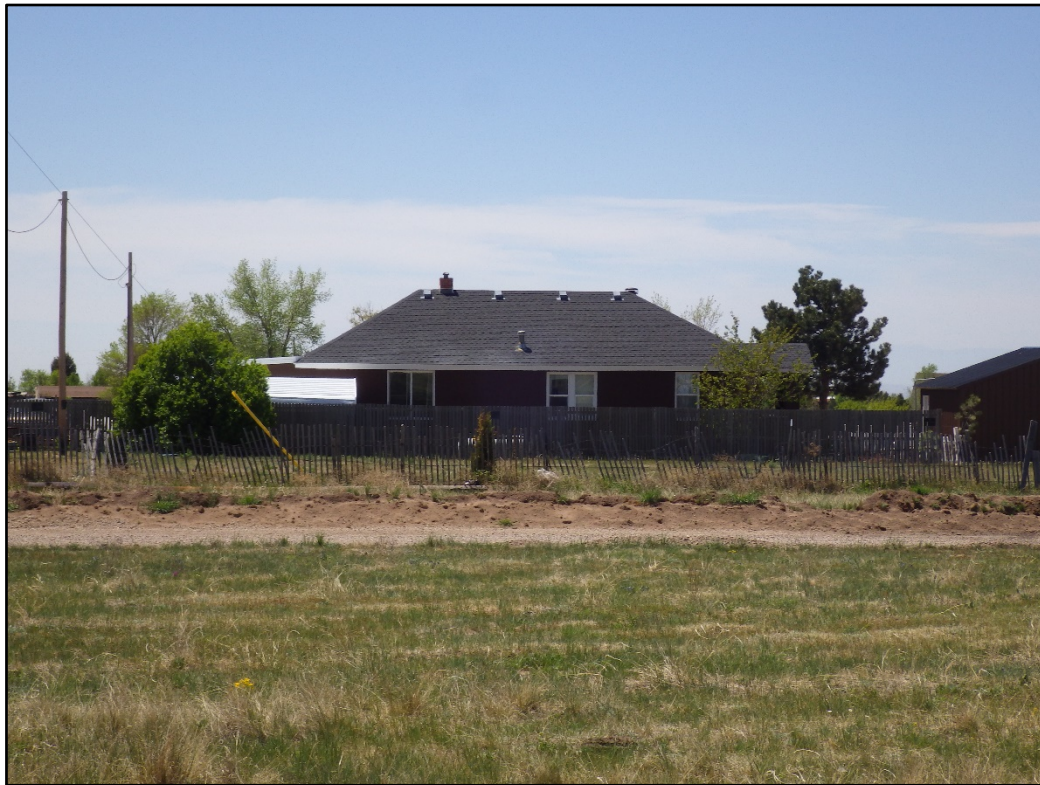
5EP.8275 building 1 north elevation.

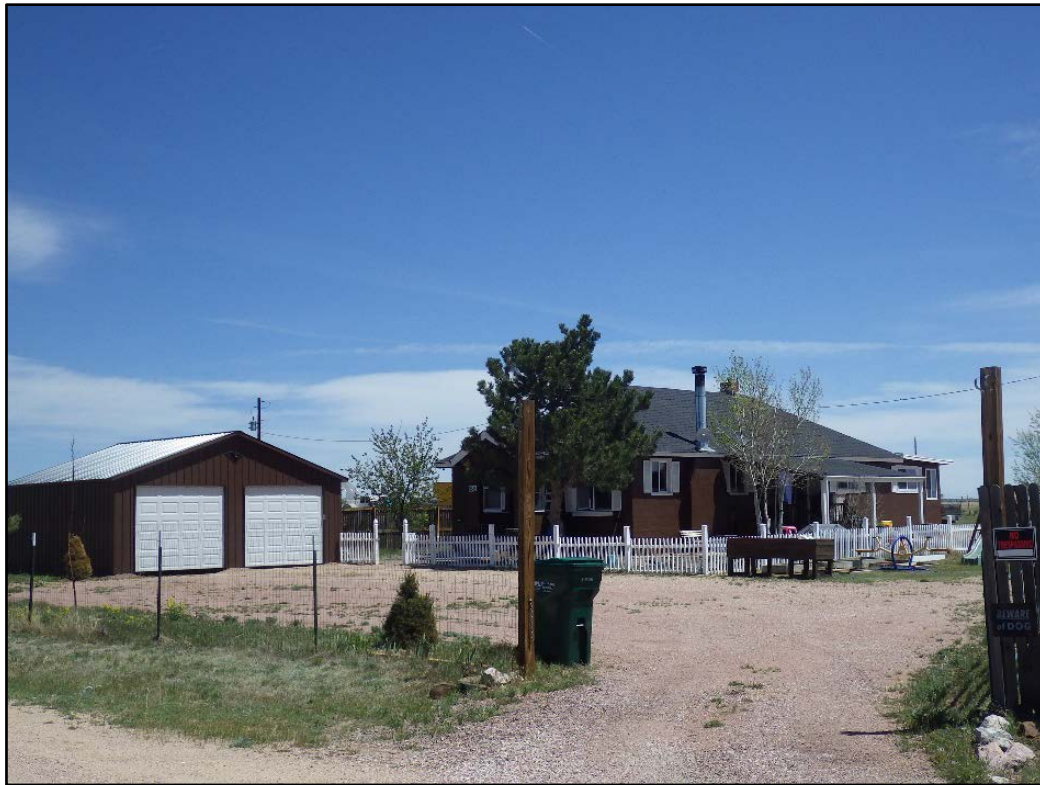
24. Associated buildings, features, or objects: There is a garage (Building 2), a barn (Building 3), a shipping container, and a carport on the property. The garage was built ca. 2006 and expanded between 2015 and 2017. It is approximately 22 x 25 feet, wood framed, has a gabled roof, and is clad in standing seam metal siding. There are two overhead garage doors on the south façade. The barn was constructed ca. 1980. The barn is approximately 42 x 30 feet, wood framed, has a standing seam metal roof, and is clad in horizontal wood boards. There are sliding wood doors on the east and west elevations. The north and south elevations were not visible. On the north side of the barn, there is a shipping container that is used for storage. The carport is on the west side of the house.

5EP.8275 building 1 west façade and south elevation; building 2 south façade and west elevation.

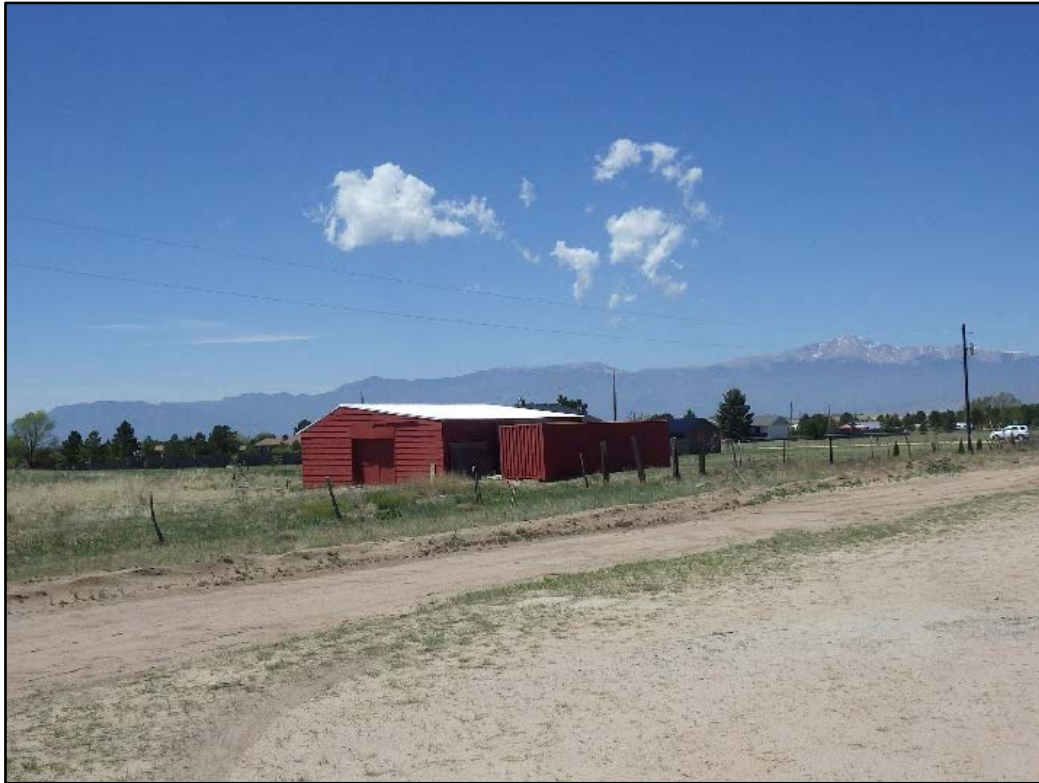
5EP.8275 building 3 and shipping container looking south west.
