**ENTECH**  
ENGINEERING, INC.

December 28, 2021

Re: OWTS – Wastewater Study  
6665 Walker Road  
Parcel No. 51000-00-421  
El Paso County, Colorado

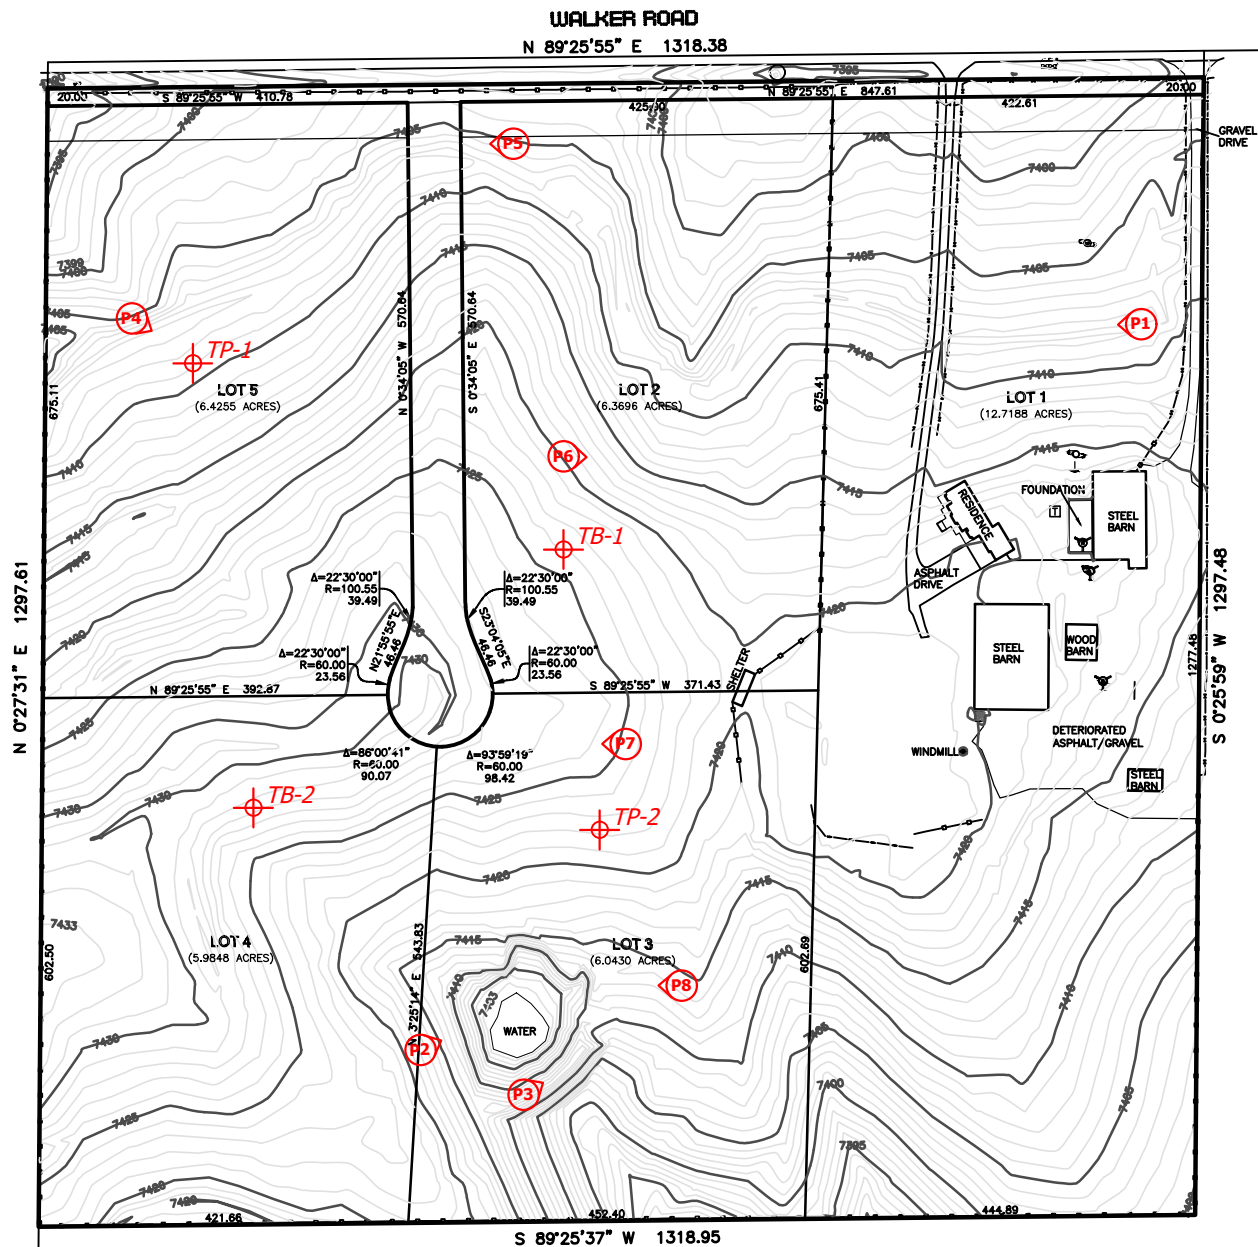
FIG NO.:  
**3**

TP- APPROXIMATE TEST PIT LOCATION AND NUMBER
-

**SITE PLAN/TESTING LOCATION MAP**  
**6665 WALKER ROAD**  
**COLORADO SPRINGS**  
**FOR: KURTIS BROWN**  
**c/o TNE, INC.**

Total acreage involved in the proposed subdivision is 37.5-acres. A total of five lots are proposed with four new rural residential lots. The existing residential structure will remain on Lot 1. The new proposed lot sizes range from 6.0-acres to 6.4-acres, and Lot 1 with the existing house is 12.7-acres. The new lots will be serviced by individual wells and on-site wastewater treatment systems. The Site Plan is presented in Figure 3.

Two test borings and two test pits were drilled on the site to determine general suitability of the soil characteristics for residential construction. The locations of the test borings/pits are indicated on the Site Plan/Test Boring Location Map, Figure 3. The Test Pit Logs are presented in Appendix B. Results of this testing will be discussed later in this report.

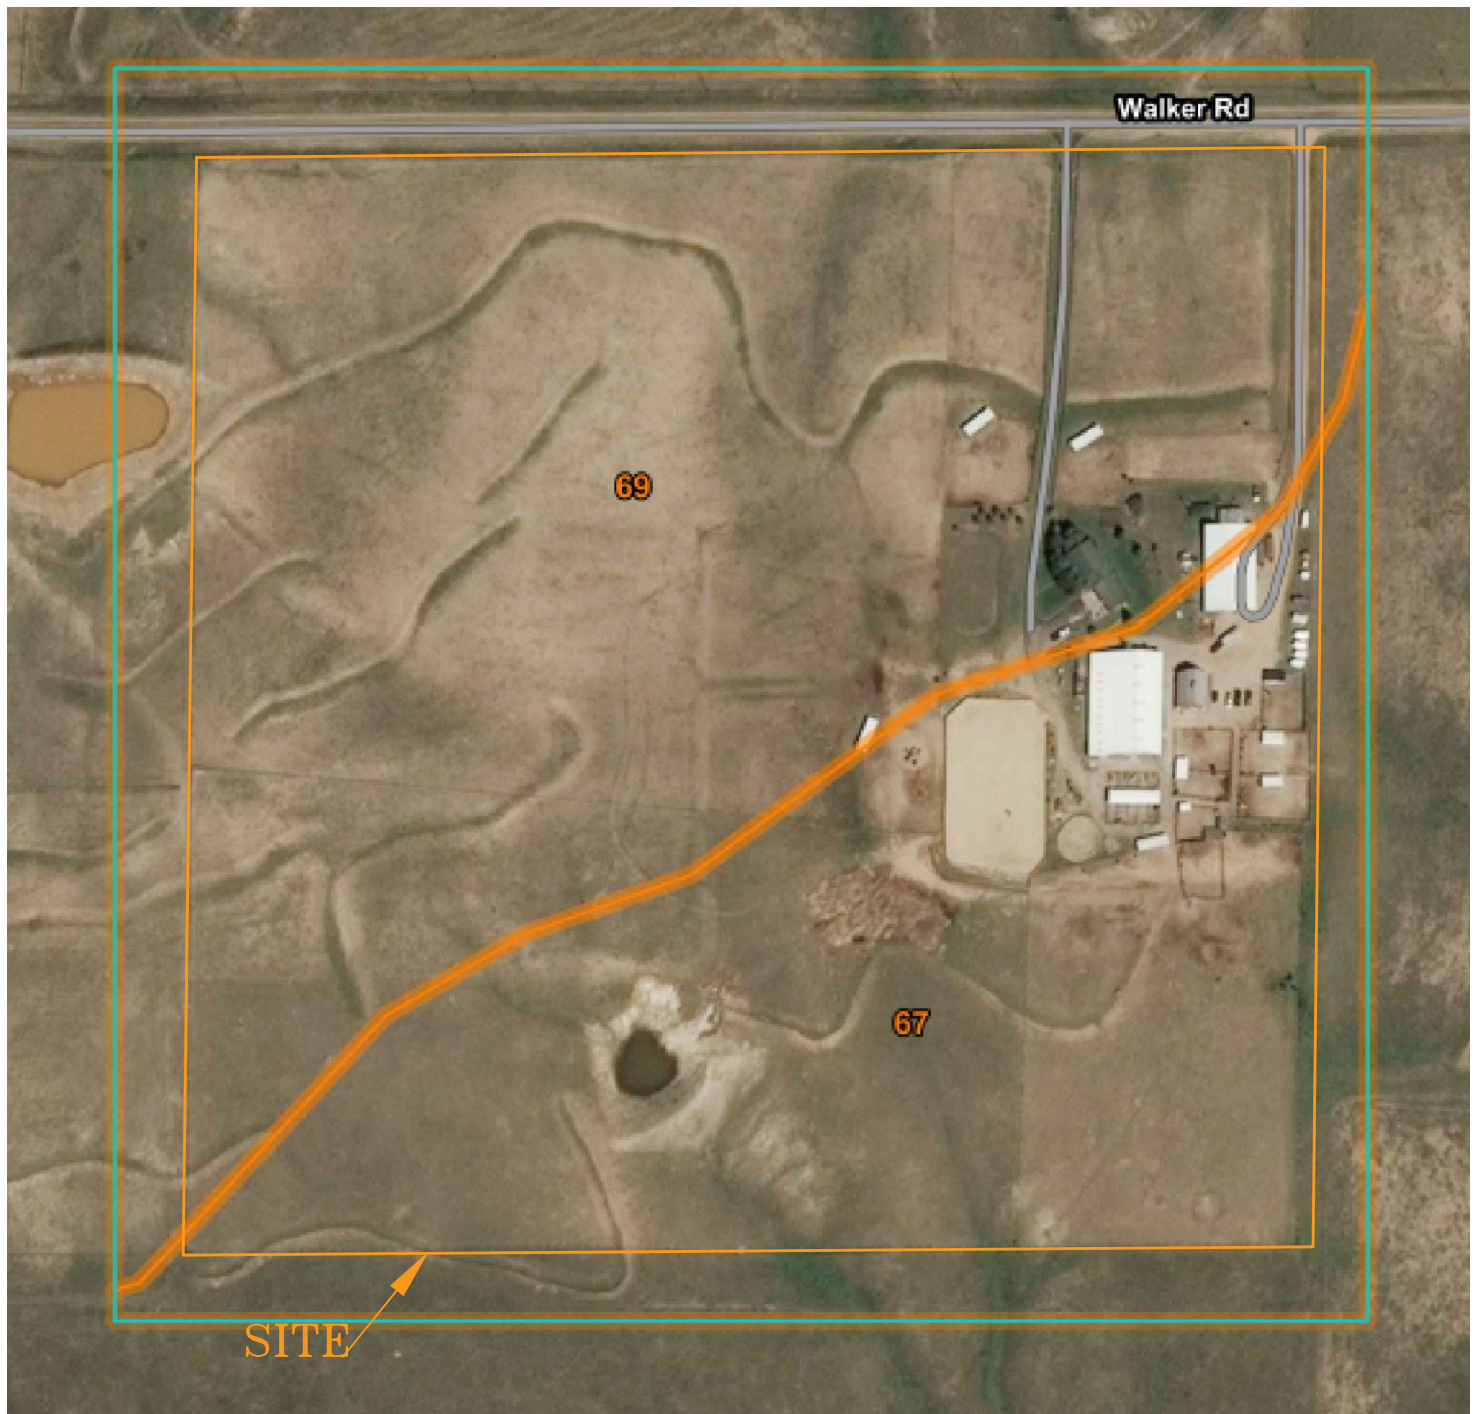
FIG NO.:  
4

SOIL SURVEY MAP  
6665 WALKER ROAD  
COLORADO SPRINGS  
FOR: KURTIS BROWN  
c/o TNE, INC.

The Natural Resource Conservation Service (NRCS) (Reference 1, Figure 4), previously the Soil Conservation Service (Reference 2) has mapped two soil types on the site. Complete descriptions of the soil types are presented in Appendix D. In general, the soils consist of sandy loam to gravelly loamy sand to sandy clay. The soils are described as follows:

<u>Type</u>	<u>Description</u>
67	Peyton sandy loam, 5 to 9 percent slopes
69	Peyton-Pring complex, 8 to 15 percent slopes

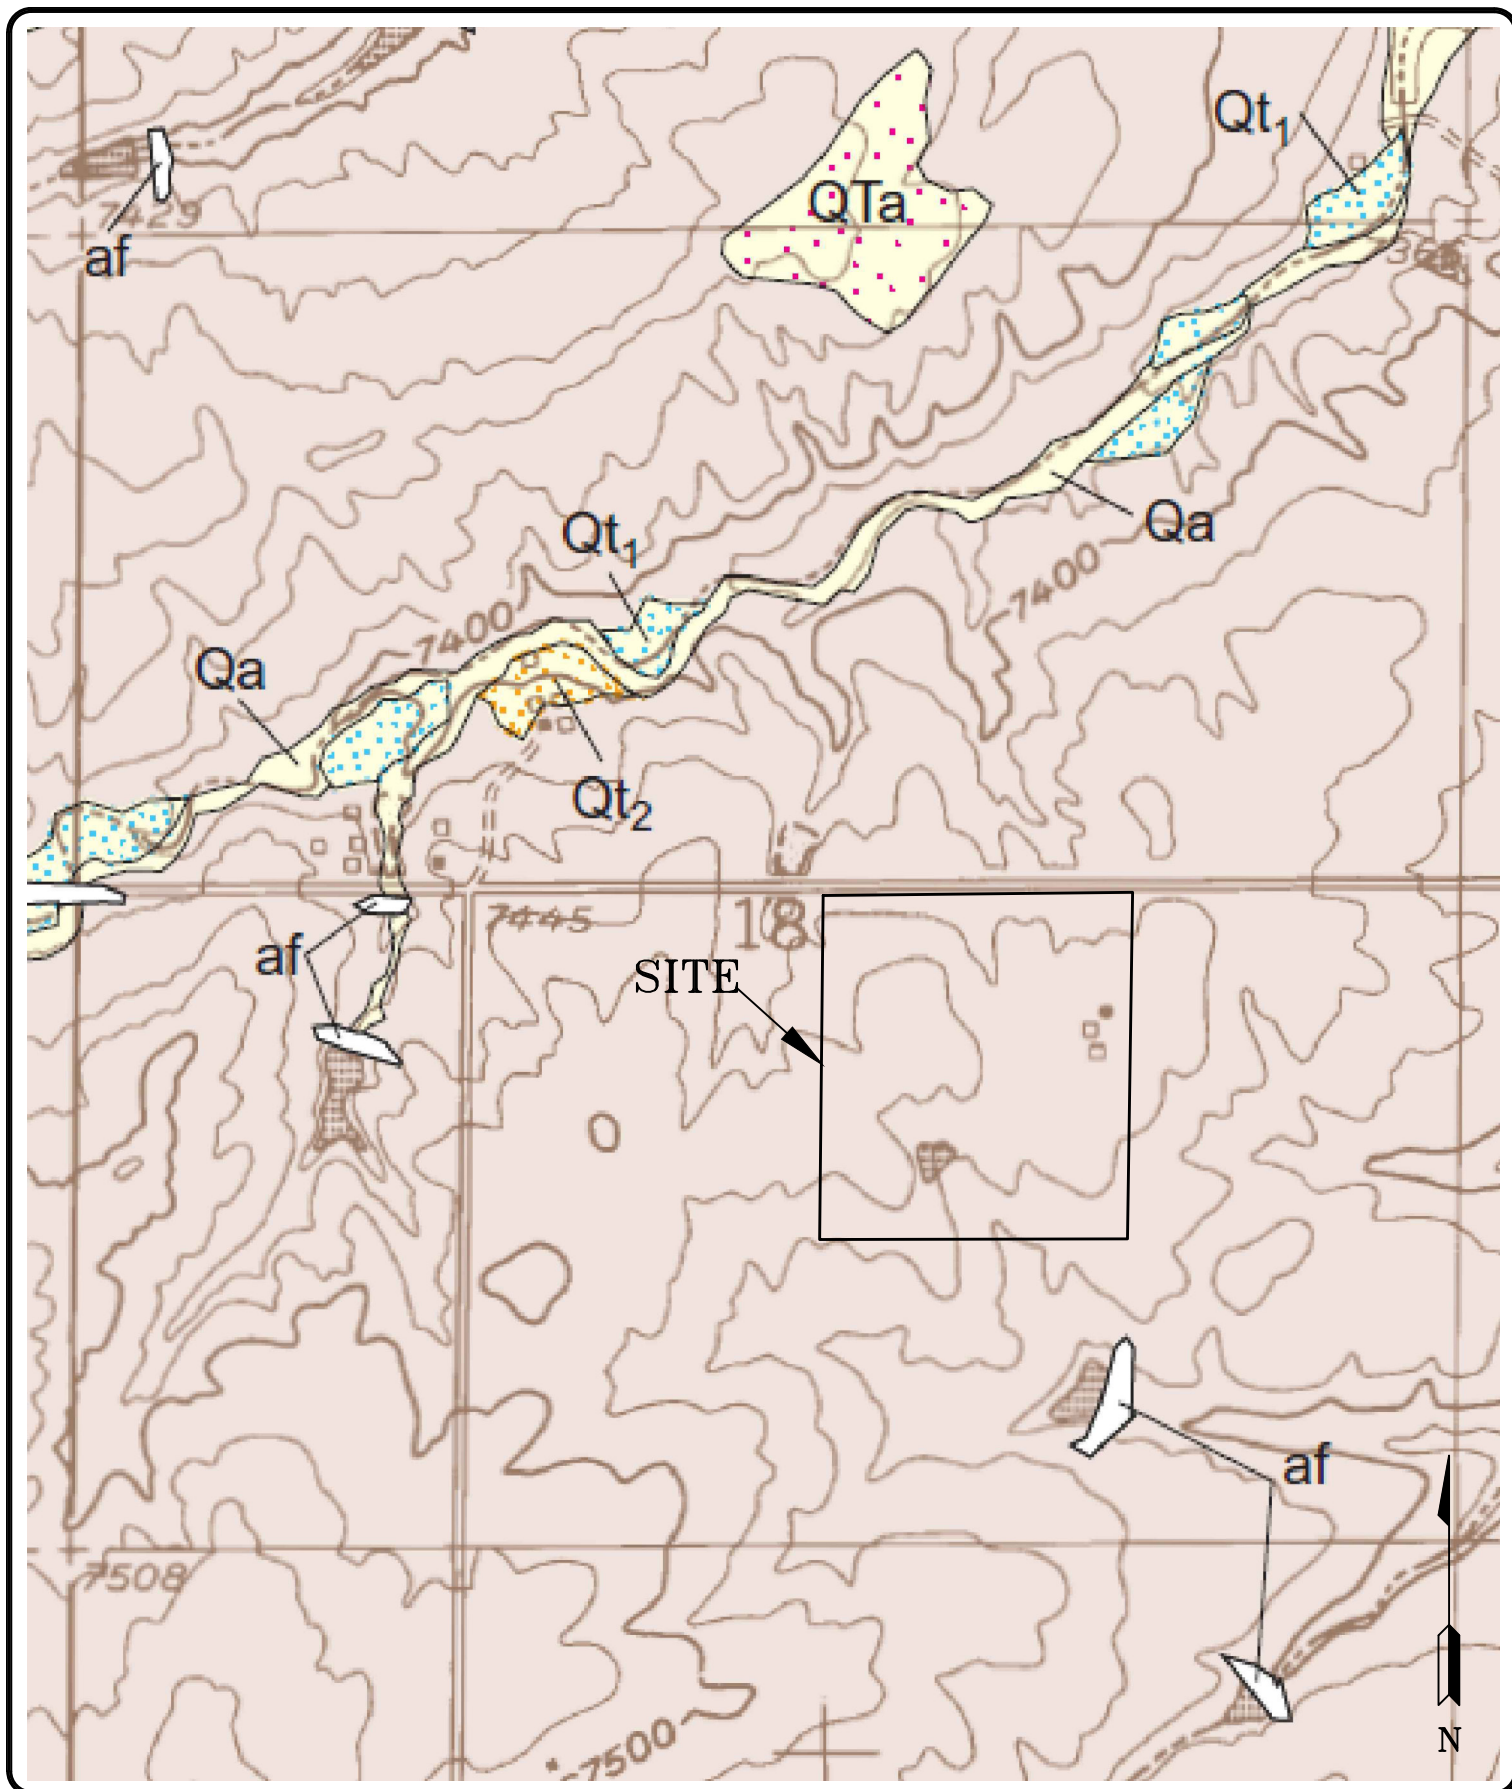
FIG NO.:  
5

BLACK FOREST QUADRANGLE GEOLOGIC MAP  
6665 WALKER ROAD  
COLORADO SPRINGS  
FOR: KURTIS BROWN  
c/o TNE, INC.

The geology of the site was evaluated using the *Geologic Map of the Monument Quadrangle* distributed by the Colorado Geologic Survey in 2003 (Reference 4, Figure 5). The Geology Map for the site is presented in Figure 6. Two mappable units were identified on this site which is described as follows:

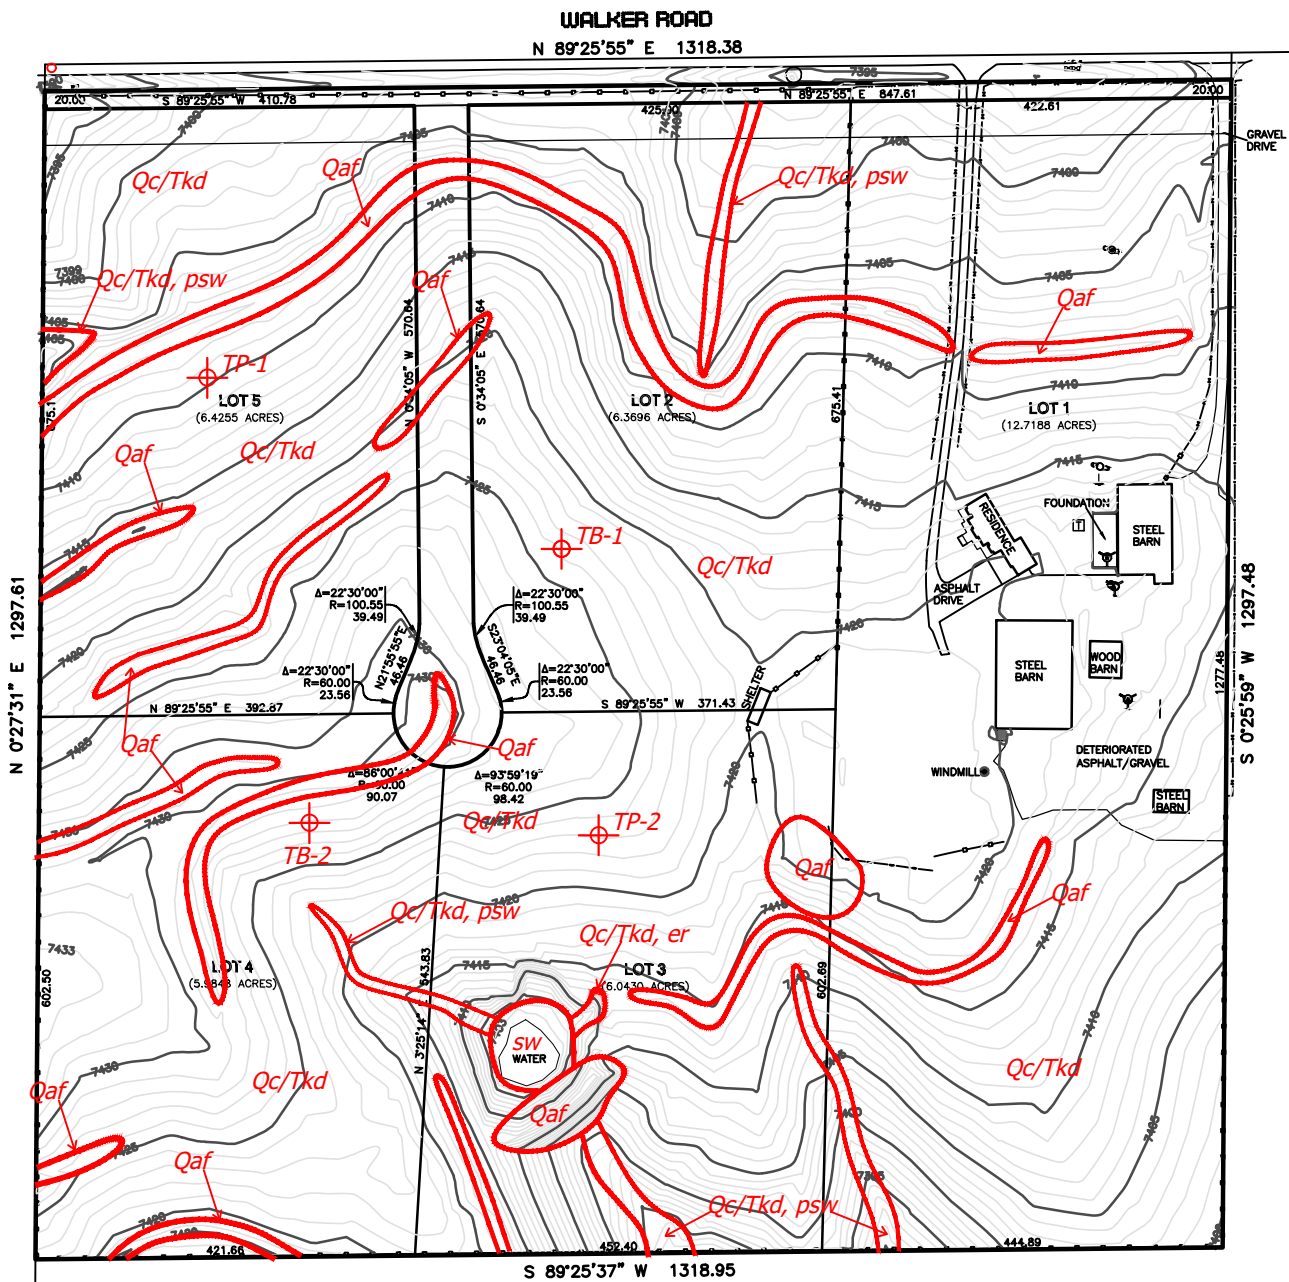
FIG NO.:  
**6**

- Qaf** - Artificial Fill of Holocene Age:  
man made fill deposits associated with erosion berms and earthen dams
- Qc/Tkd** - Colluvium of Quaternary Age Overlying the Dawson Formation of Tertiary to Cretaceous Age:  
Sheetwash and residual soil deposits overlying arkosic sandstone with interbedded siltstone and claystone
- er** - area of erosion
- sw** - seasonal wet area
- psw** - potentially seasonal shallow groundwater area

**GEOLOGY/ENGINEERING GEOLOGY MAP**  
6665 WALKER ROAD  
COLORADO SPINGS  
FOR: KURTIS BROWN  
c/o TNE, INC.

- Qaf Artificial Fill of Holocene Age:** These are man-made fill deposits associated with erosion berms, earthen dams on-site, and a fill pile of manure.
- Qc/Tkd Colluvium of Quaternary Age overlying Dawson Formation of Tertiary to Cretaceous Age:** The materials consist of colluvial and residual soils overlying the bedrock materials on the site. The colluvial soils were deposited by the action of sheetwash and gravity. The residual soils were derived from the in-situ weathering of the bedrock on site. These materials typically consist of silty to clayey sand and sandy clays. The bedrock consists of the Dawson Formation. The Dawson Formation typically consists of coarse-grained, arkosic sandstone with interbedded lenses of fine-grained sandstone, siltstone and claystone.

The soils listed above were mapped from site-specific mapping, the *Geologic Map of the Black Forest Quadrangle* distributed by the Colorado Geologic Survey in 2003 (Reference 4, Figure 5), the *Geologic Map of the Colorado Springs-Castle Rock Area*, distributed by the US Geological Survey in 1979 (Reference 5), and the *Geologic Map of the Denver 1° x 2° Quadrangle*, distributed by the US Geological Survey in 1981 (Reference 6). The test borings were used in evaluating the site and are included in Appendix B. The Geology Map prepared for the site is presented in Figure 6.

The minor drainages have been mapped as potentially seasonal shallow groundwater areas. Additionally, the uphill sides of the erosion berms have the potential for seasonally shallow groundwater. In these areas, we would anticipate the potential for periodically high subsurface moisture conditions, frost heave potential. Construction in any portions of these areas, if required, or immediately adjacent to these areas should follow these precautions.

This is an area where water seasonally ponds behind a dam in the southern portion of the site. It is anticipated that these areas will be avoided by structures. There is sufficient area on Lot 3 to allow room for a structure and access. Construction is not recommended in the seasonally wet area.

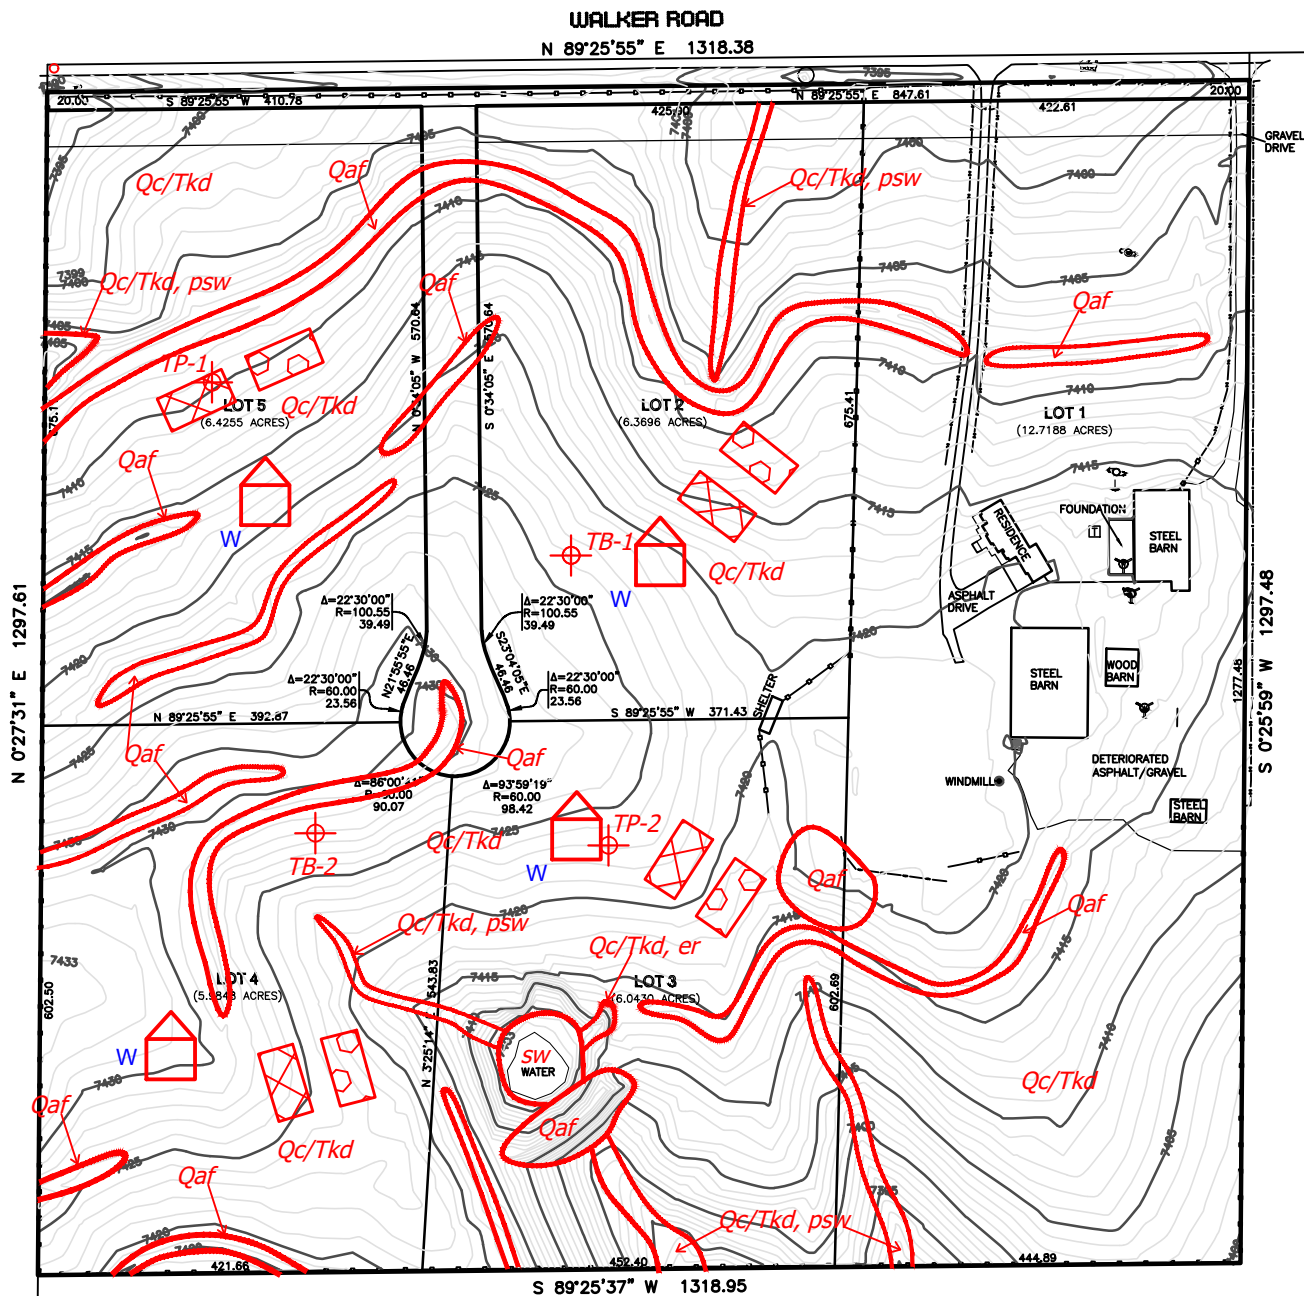
FIG NO.:  
**8**

- POSSIBLE OWTS LOCATIONS
- POSSIBLE OWTS ALTERNATE LOCATIONS

**W** \*- WATER WELLS MUST BE A MINIMUM OF 100 FT FROM OWTS ABSORPTION FIELDS

\* OWTS ABSORPTION FIELDS ARE NOT SUITABLE IN SEASONALLY WET OR POTENTIALLY SEASONAL WET AREAS

**SEPTIC SUITABILITY MAP**  
**6665 WALKER ROAD**  
**COLORADO SPRINGS**  
**FOR: KURTIS BROWN**  
**c/o TNE, INC.**

In summary, it is our opinion the site is suitable for individual on-site wastewater treatment systems (OWTS) and that contamination of surface and subsurface water resources should not occur provided the OWTS sites are evaluated and installed according to El Paso County and State Guidelines and properly maintained. Based on the testing performed designed systems are anticipated for the majority of the lots, depending on soils encountered. The Septic Suitability Map is presented in Figure 8. Potential house locations, water wells, and two septic sites for the new lots are indicated on Figure 8. Absorption fields must be located a minimum of 100 feet from any well, including those on adjacent properties. Absorption fields must also be located a minimum of 50 feet from any drainages, floodplains or ponded areas and 25 feet from dry gulches.

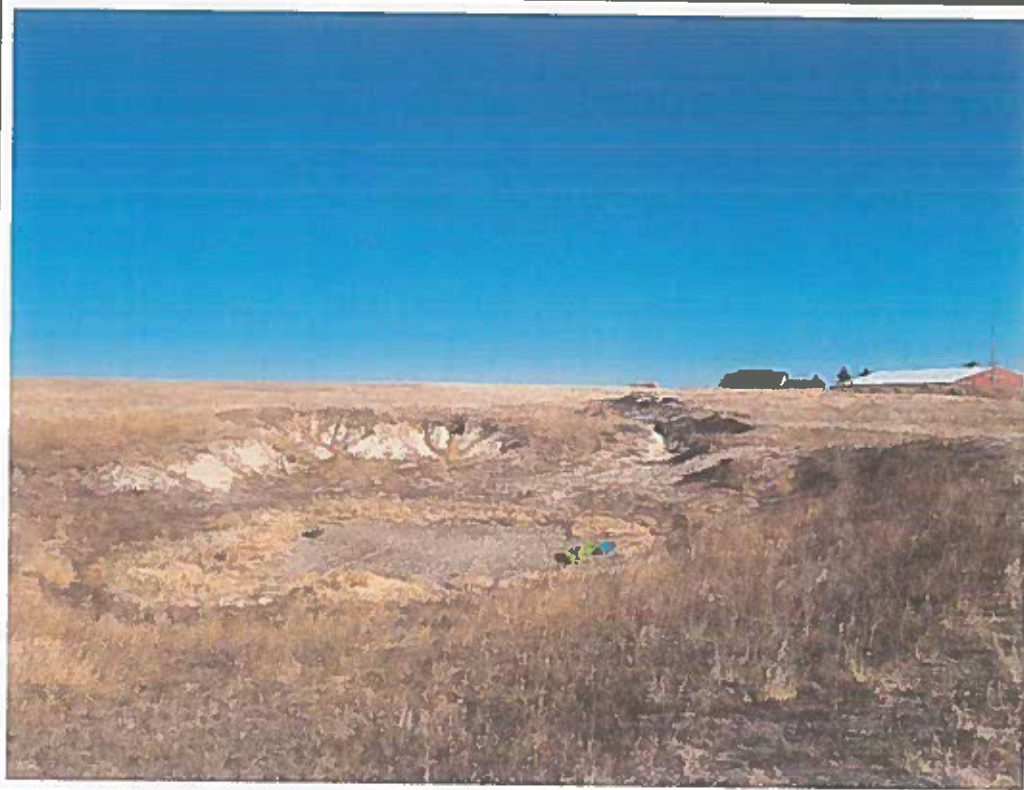
**Looking north at dry  
pond in south-central  
portion of the site.**

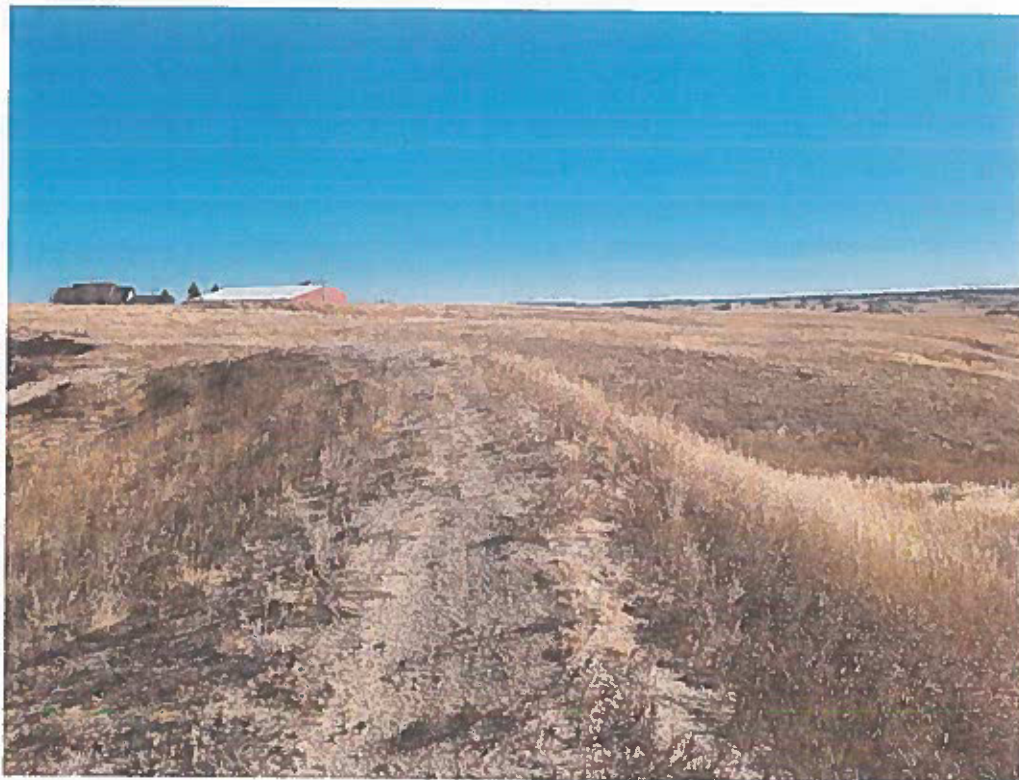
Looking along crest of  
earthen dam in the  
southern portion of the  
site.

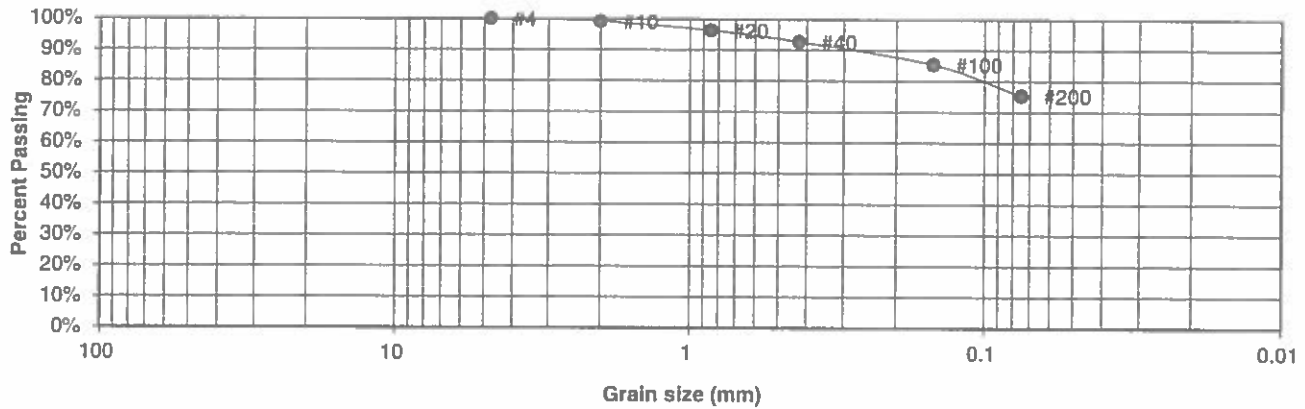
C-1

BORING NO. TP-1  
 DEPTH(ft) 2  
 CLIENT KURITS BROWN  
 PROJECT 6665 WALKER ROAD

U.S. Sieve #	Percent Finer
3"	
1 1/2"	
3/4"	
1/2"	
3/8"	
4	100.0%
10	99.2%
20	96.3%
40	92.7%
100	85.4%
200	75.3%

Soils encountered in the test pits consisted of sandy clay overlying sandy clay to sandy clay loam bedrock. Testing on the samples of the limiting layers encountered in the test pits resulted in 26 to 75 percent of the soil size particles passing the No. 200 sieve.

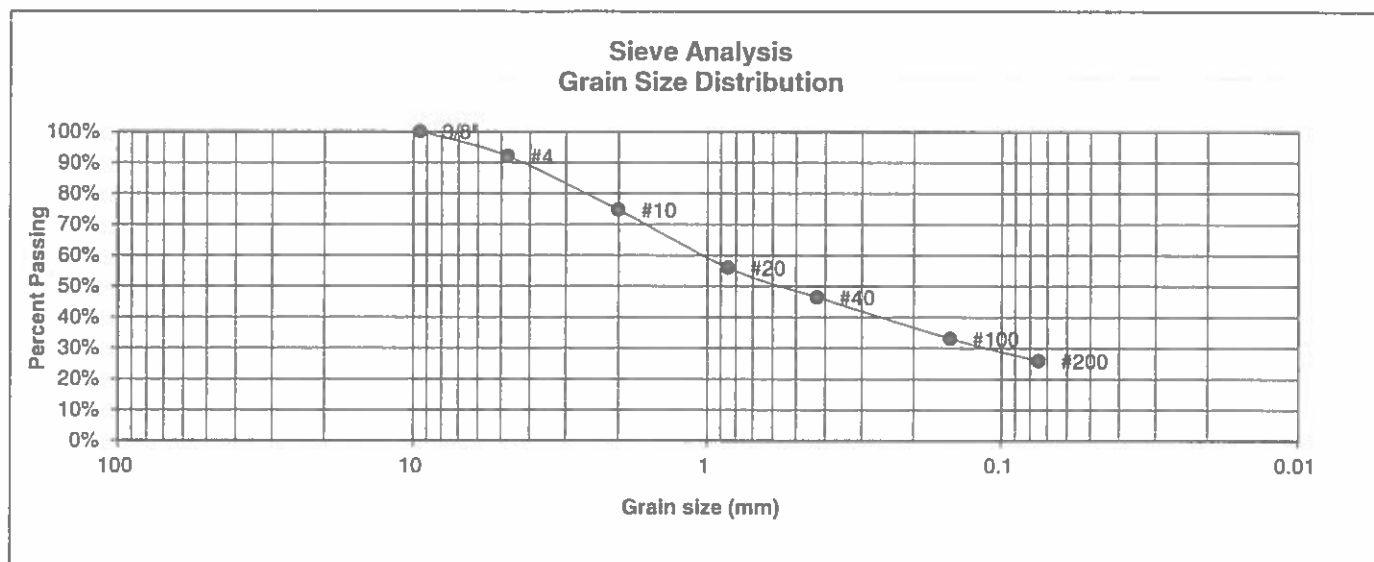
C-2

BORING NO.	TP-2	UNIFIED CLASSIFICATION	SC	TEST BY	BL
DEPTH(ft)	2-3	AASHTO CLASSIFICATION		JOB NO.	212979
CLIENT	KURITS BROWN				
PROJECT	6665 WALKER ROAD

U.S. Sieve #	Percent Finer
3"	
1 1/2"	
3/4"	
1/2"	
3/8"	100.0%
4	92.0%
10	74.7%
20	56.0%
40	46.5%
100	33.1%
200	26.0%
